FINAL
MONITORING REPORT (MY2)

WARREN WILSON COLLEGE STREAM MITIGATION SITE

Buncombe County, North Carolina

Data Collection: January - October 2021
Submission: January 2022

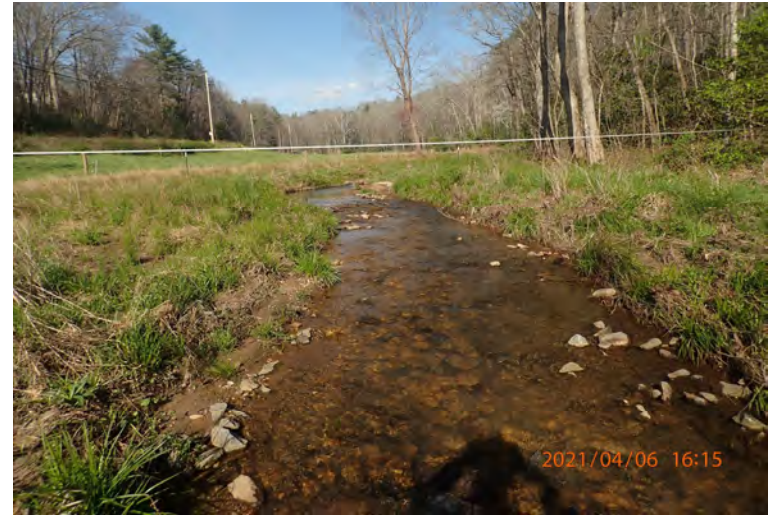
SUMMARY DATA	
Bankfull Elevation:	2549.8
Bankfull Cross-Sectional Area:	27.2
Bankfull Width:	31.9
Flood Prone Area Elevation:	2551.8
Flood Prone Width:	100.0
Max Depth at Bankfull:	2.0
Low Bank Height:	2.0
Mean Depth at Bankfull:	0.9
W / D Ratio:	37.4
Entrenchment Ratio:	3.1
Bank Height Ratio:	1.0

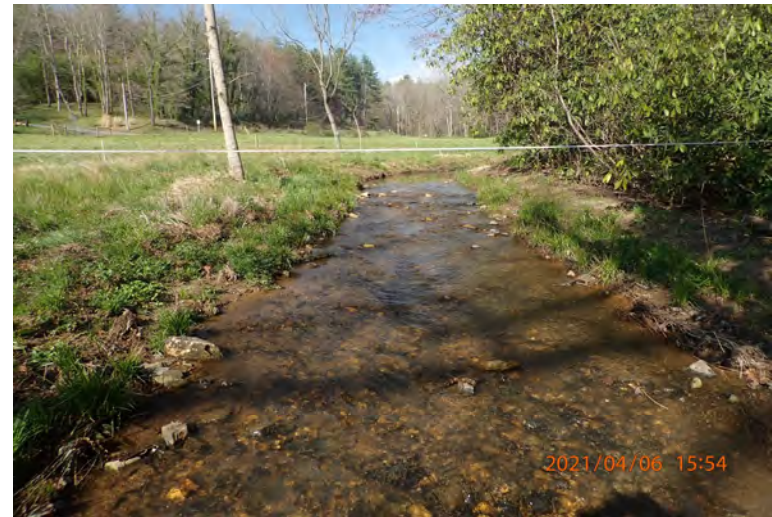
Site	Warren Wilson
Watershed:	French Broad, 06010105
XS ID	UT 3, XS - 4, Riffle
Feature	Riffle
Date:	4/6/2021
Field Crew:	Perkinson

SUMMARY DATA	
Bankfull Elevation:	2558.2
Bankfull Cross-Sectional Area:	17.0
Bankfull Width:	18.2
Flood Prone Area Elevation:	2559.6
Flood Prone Width:	100.0
Max Depth at Bankfull:	1.4
Low Bank Height:	1.4
Mean Depth at Bankfull:	0.9
W / D Ratio:	19.4
Entrenchment Ratio:	5.5
Bank Height Ratio:	1.0
