**Big Warrior Creek Stream Restoration
2006 Monitoring Report
Monitoring Year Two**

Ecosystem Enhancement Program Project Number 00412

Submitted: January 19, 2007

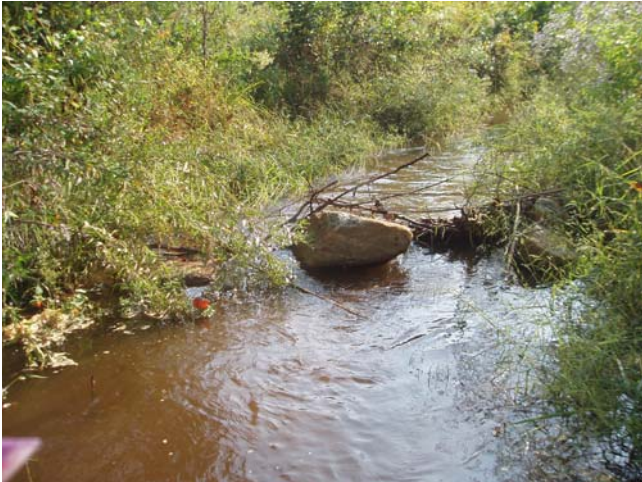
BWPA1 facing upstream

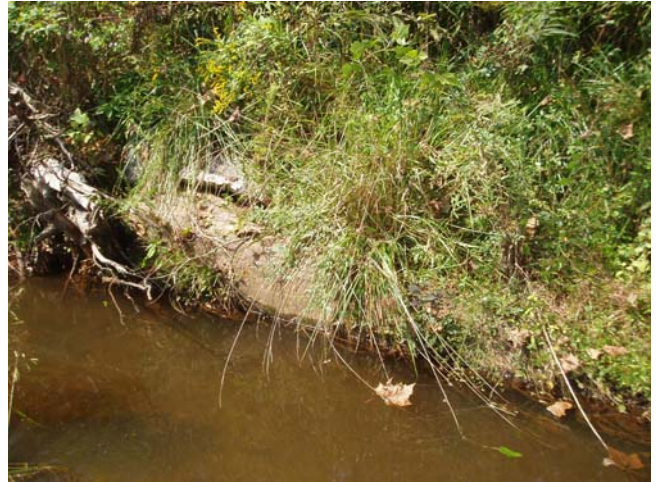
BWPA2 facing left bank

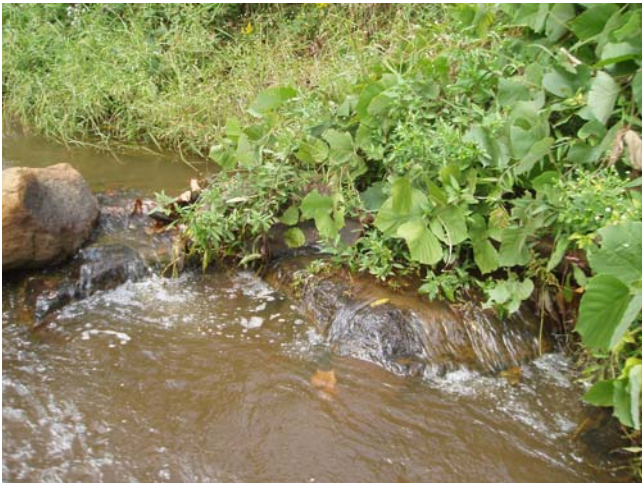
BWPA3 facing left bank, upstream

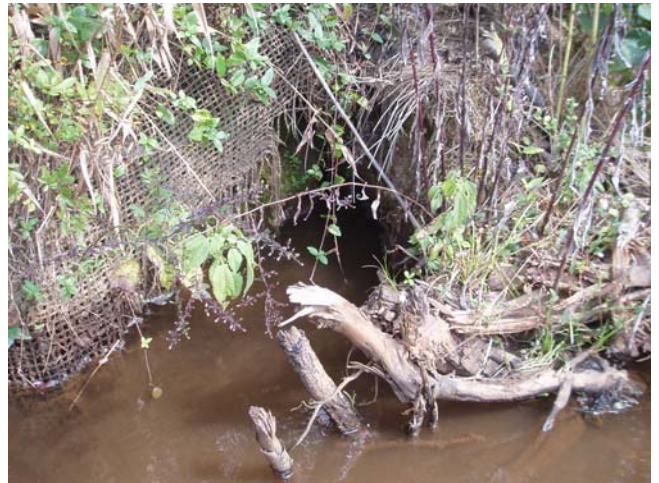
BWPA4 facing left bank

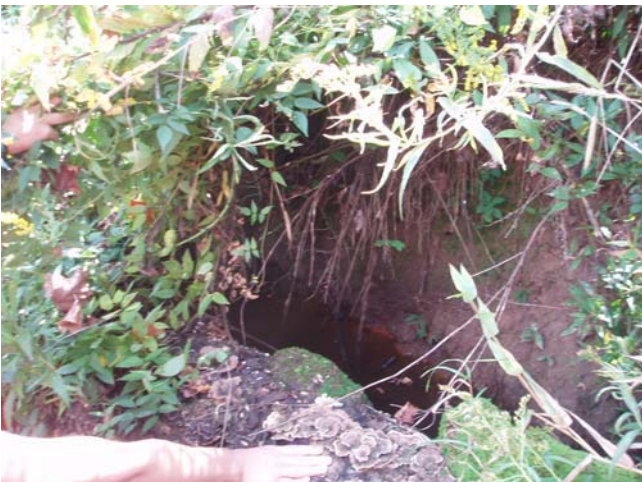
BWPA5 facing left bank

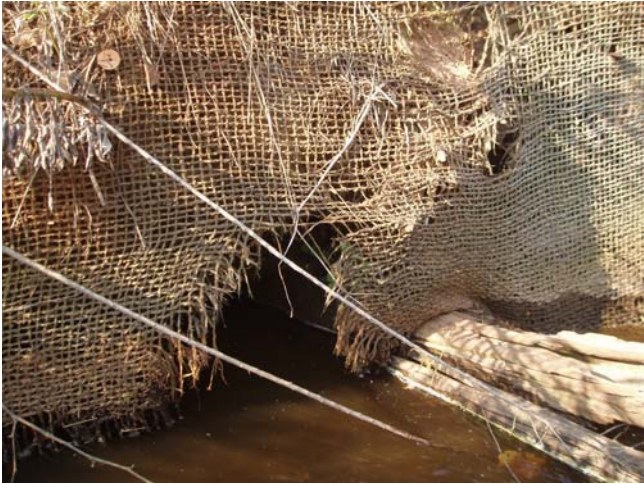
BWPA7 facing left bank

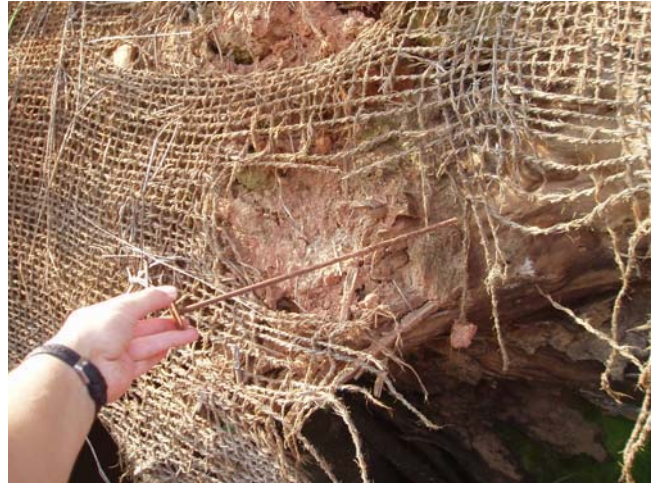
BWPA8 facing left bank

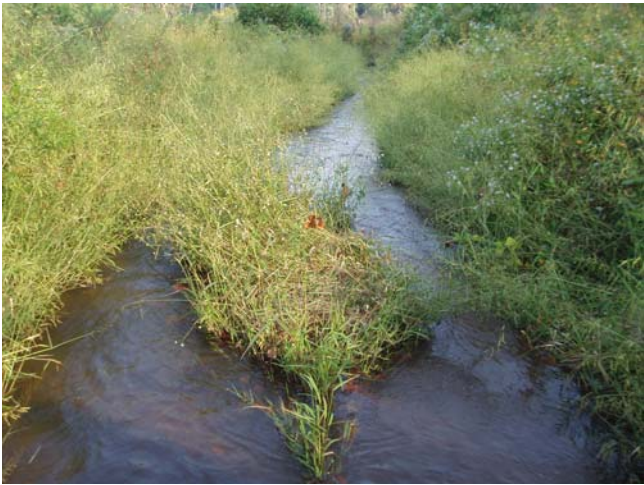
BWPA9 facing downstream

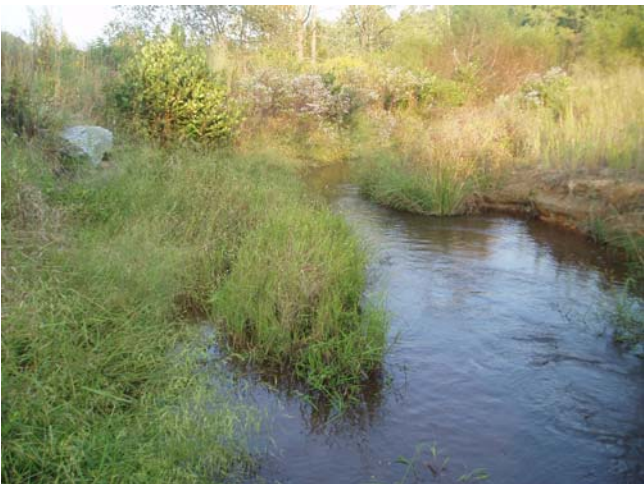
BWPA11 facing downstream

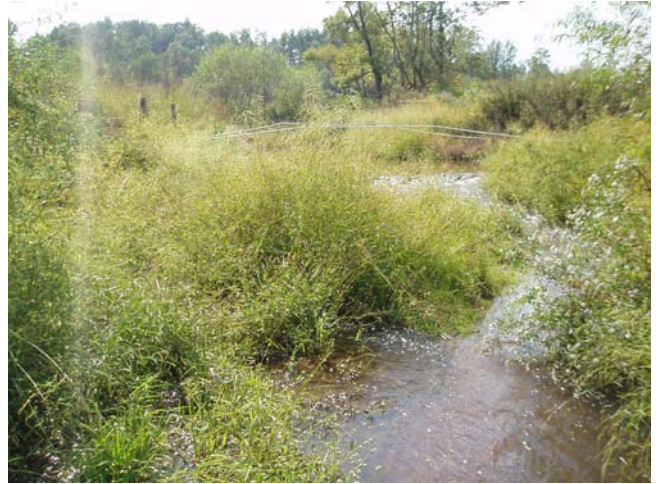
BWPA13	Structure degradation	49+60	Stability	BWPA13
BWPA14	Aggradation, mid-channel bar formation	52+00	Inadequate sediment transport	BWPA14
BWPA15	Structure degradation	54+80	Scour	BWPA15
BWPA16	Structure degradation	56+00	Floodplain flow is undermining log structure	BWPA16
BWPA17	Structure degradation	62+60	Scour	BWPA17
BWPA18	Structure degradation	64+90	Scour	BWPA18
BWPA19	Structure degradation	67+00	Stability	BWPA19

BWPA14 facing upstream

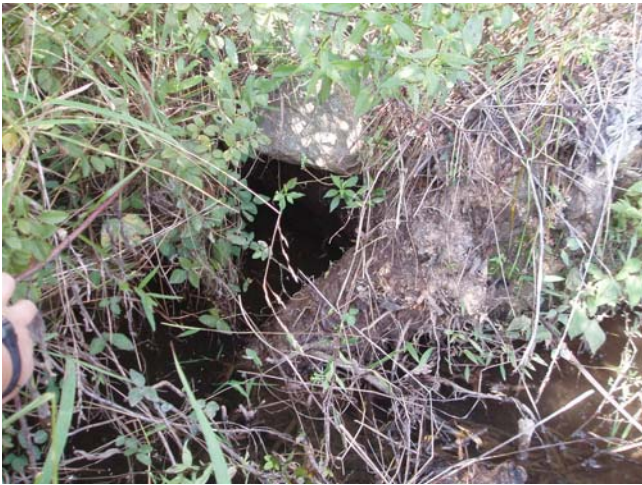
BWPA15 facing left bank

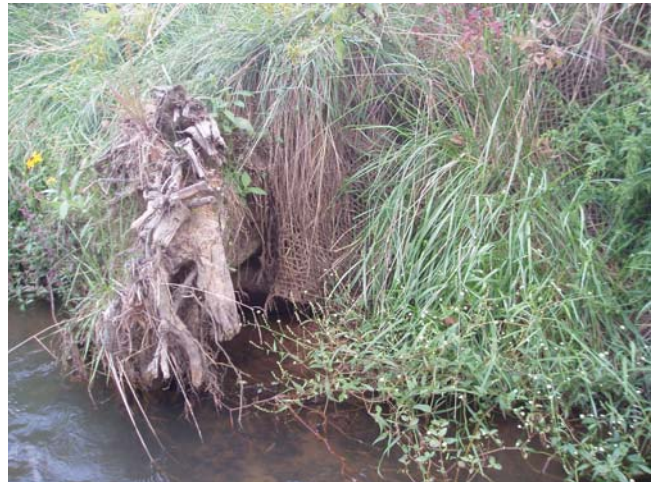
BWPA18 facing left bank

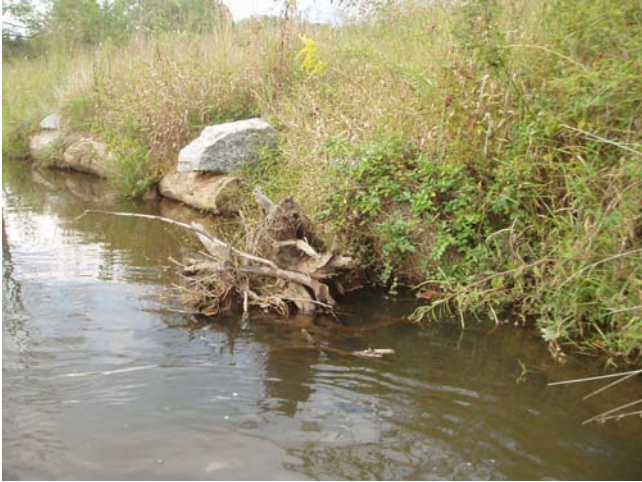
BWPA19 facing downstream
