**Big Warrior Creek Stream Restoration
2007 Final Monitoring Report
Monitoring Year Three**

Ecosystem Enhancement Program Project Number 00412

Prepared by: URS Corporation – North Carolina
1600 Perimeter Park Drive, Suite 400
Morrisville, NC 27560

Submitted: February 26, 2007

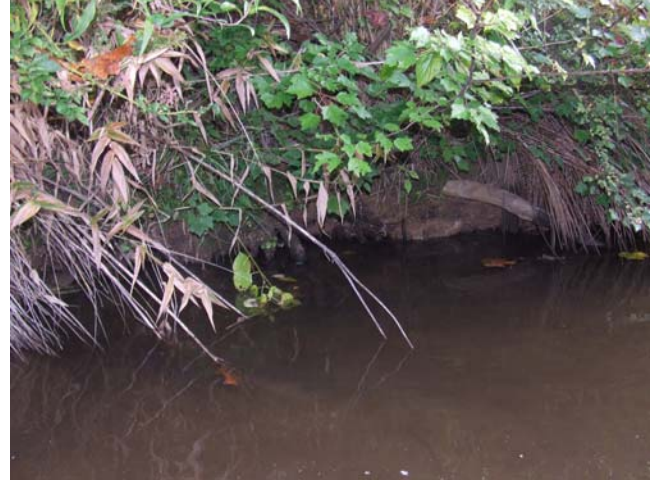
Table B1a. Stream Problem Areas – Big Warrior Creek				
Big Warrior Creek				
EEP Project Number 00412				
Feature #	Feature Issue	Station	Suspected Cause	Photo #
BWPA1	Structure degradation	5+00	Bank scour behind rootwad	BWPA1
BWPA2	Structure failure	11+00	Scour	BWPA2
BWPA3	Structure failure	12+60	Rocks obstructing flow, causing flow diversion into banks	BWPA3
BWPA4	Structure failure	17+60	Scour	BWPA4
BWPA5	Ponding	22+40	Beaver presence / beaver dam	BWPA5
BWPA6	Structure degradation	23+60	Scour behind log vane	BWPA6
BWPA7	Bank erosion	34+50	Scour	BWPA7
BWPA8	Bank erosion	34+75	Scour	BWPA8
BWPA9	Bank erosion	34+90	Scour	BWPA9
BWPA10	Aggradation, mid-channel bar formation	43+00	Inadequate sediment transport	BWPA10
BWPA11	Aggradation, mid-channel bar formation	40+00	Upstream erosion	BWPA11
BWPA12	Structure failure	42+60	Rocks obstructing flow, causing flow diversion into banks	BWPA12
BWPA13	Aggradation, lateral bar formation	44+70	Lateral migration of channel	BWPA13

BWPA2 facing left bank

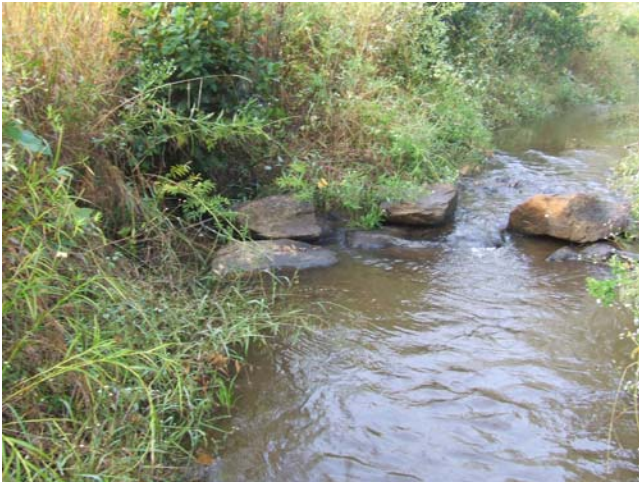
BWPA3 facing upstream

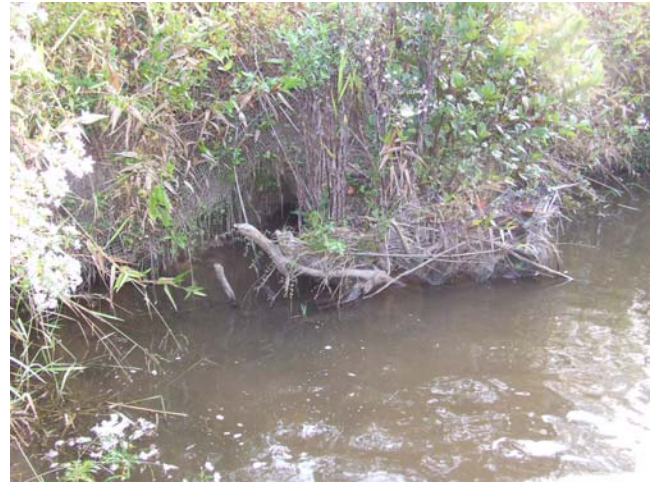
BWPA4 facing left bank

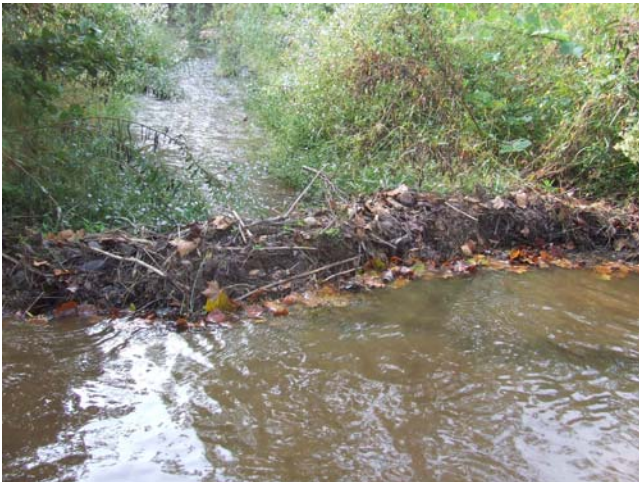
BWPA5 facing downstream

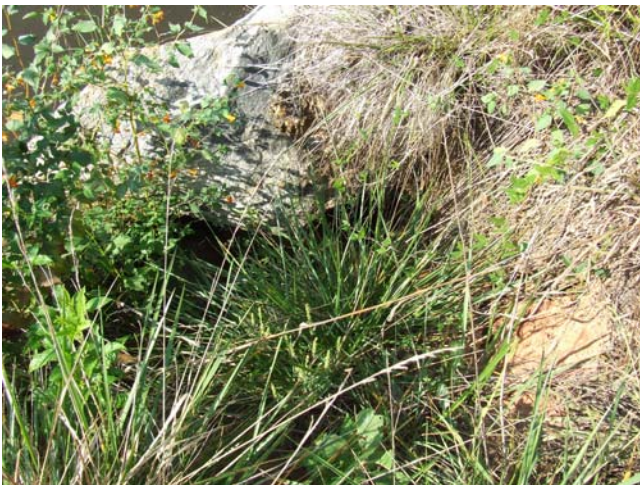
BWPA9 facing left bank

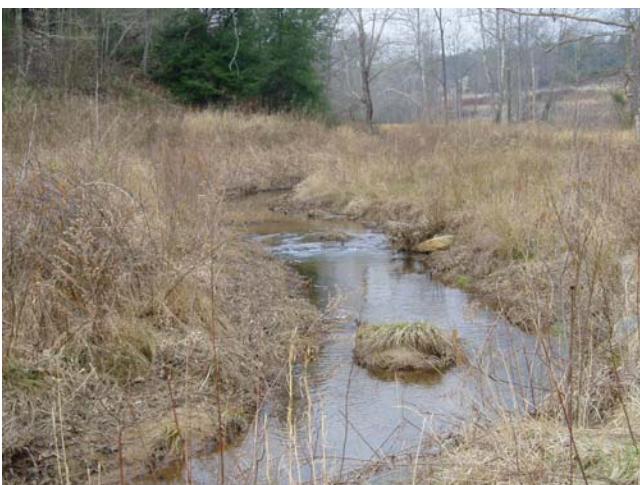
BWPA11 facing upstream

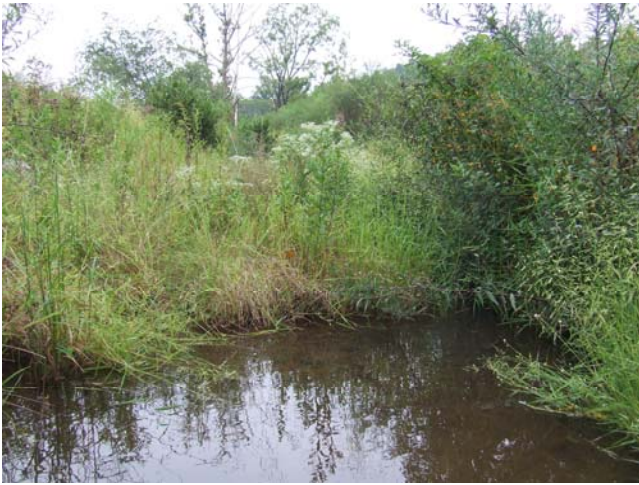
BWPA13 facing downstream

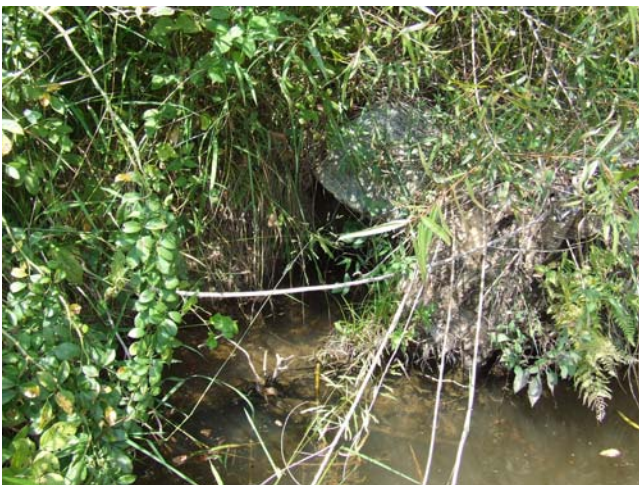
BWPA14	Bank erosion	49+75	Lateral migration of channel	BWPA14
BWPA15	Structure degradation	49+60	Stability	BWPA15
BWPA16	Aggradation, mid-channel bar formation	52+00	Inadequate sediment transport	BWPA16
BWPA17	Structure degradation	54+80	Scour	BWPA17
BWPA18	Structure degradation	56+00	Floodplain flow is undermining log structure	BWPA18
BWPA19	Structure degradation	56+10	Scour	BWPA19
BWPA20	Structure degradation	62+60	Scour	BWPA20
BWPA21	Structure degradation	63+10	Scour	BWPA21
BWPA22	Structure degradation	64+90	Scour	BWPA22
BWPA23	Bank erosion	65+20	Scour	BWPA23
BWPA24	Structure degradation	67+00	Stability	BWPA24
BWPA25	Aggradation, mid-channel bar formation	67+80	Upstream erosion	BWPA25

BWPA17 facing left bank

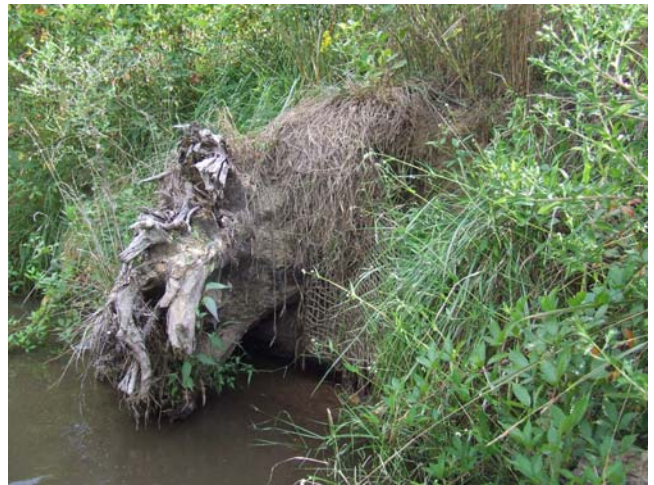
BWPA22 facing left bank

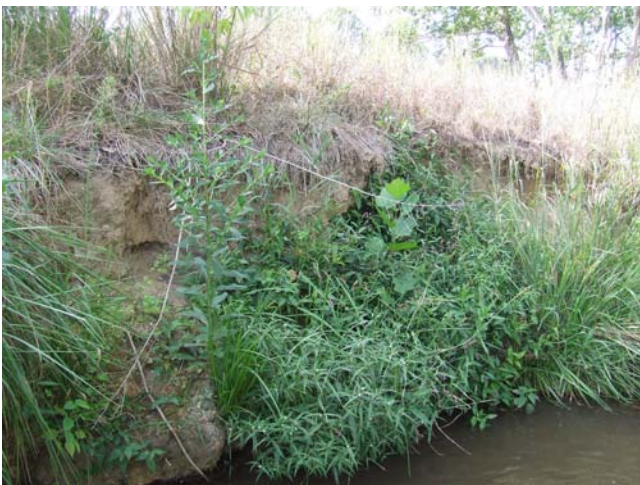
BWPA23 facing left bank

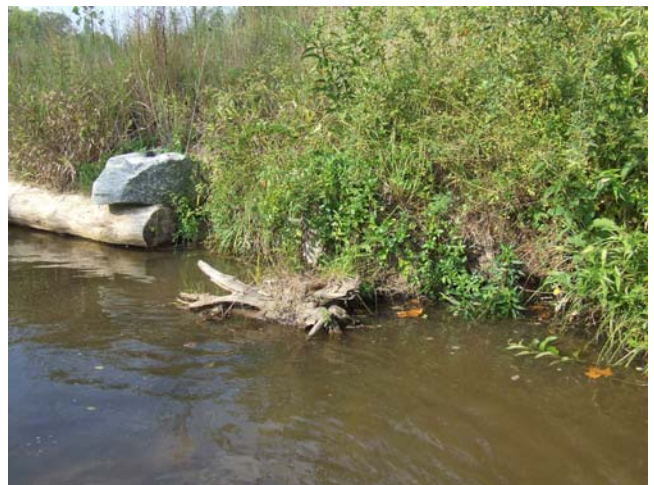
BWPA24 facing downstream

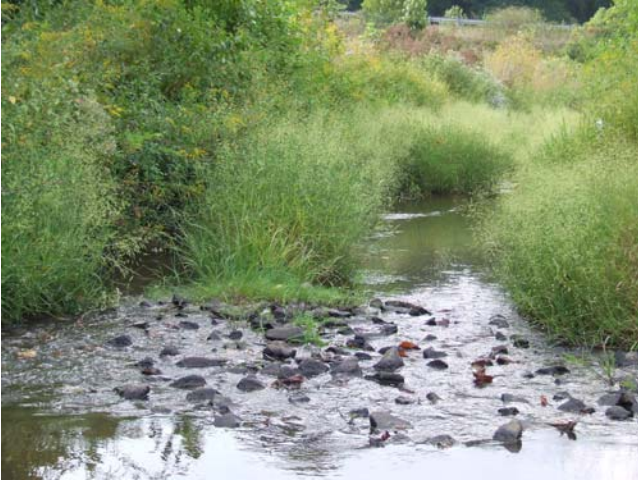
BWPA25 facing downstream
