Big Warrior Creek Stream Restoration 2008 Final Monitoring Report Monitoring Year Four

Ecosystem Enhancement Program Project Number 000412

Submitted: February 17, 2009

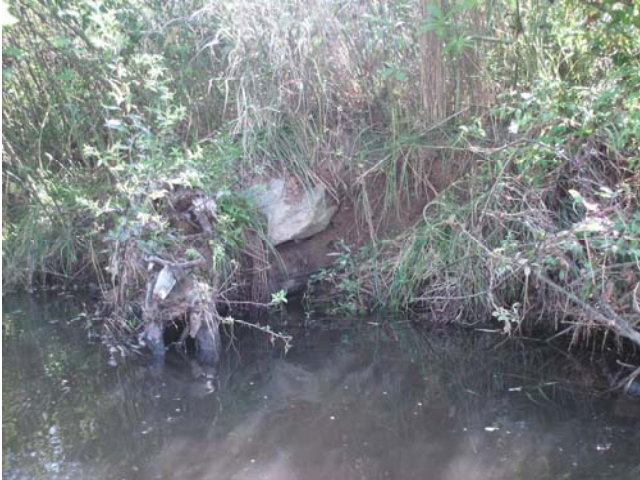
BWPA22 facing right bank

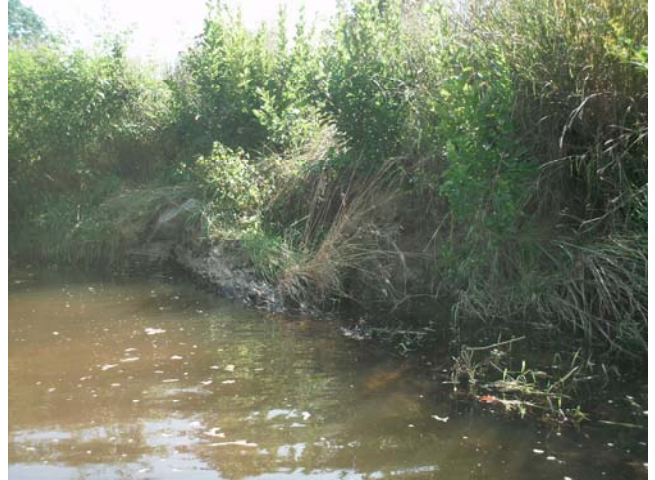
BWPA23 facing upstream

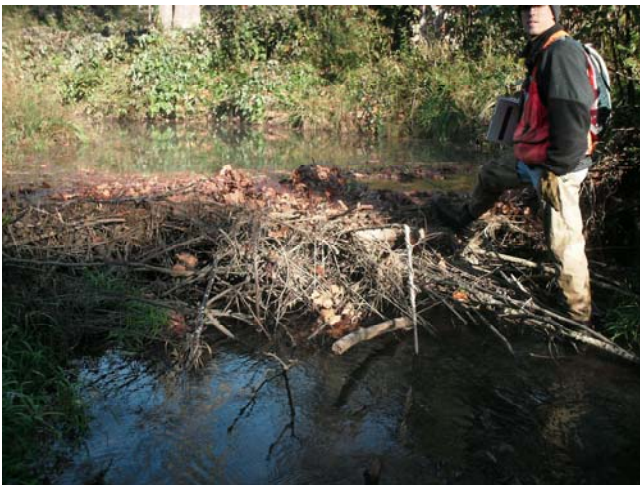
BW26 facing upstream (10/23/08)

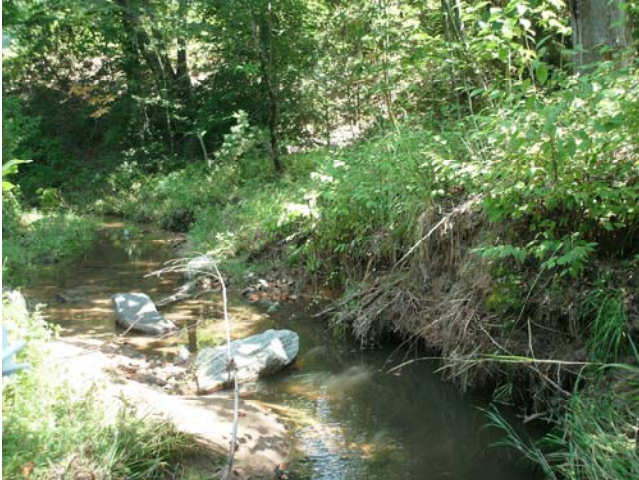
MCPA3 facing downstream

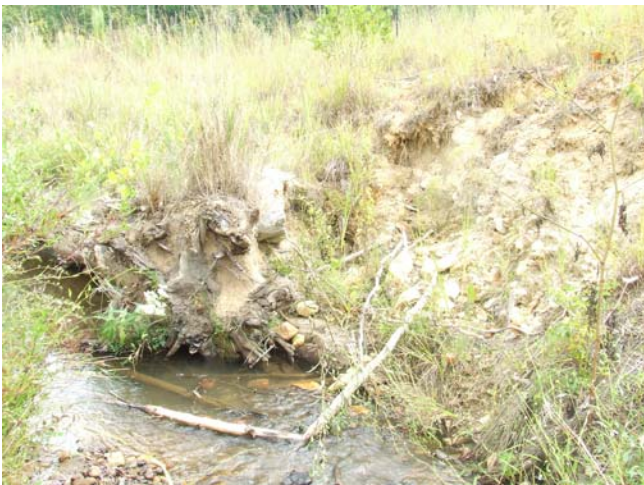
MCPA5 facing downstream (9/12/07)
