**Big Warrior Creek Stream Restoration
2009 Final Monitoring Report
Monitoring Year Five**

Ecosystem Enhancement Program Project Number 00412

Submitted: April 23, 2010

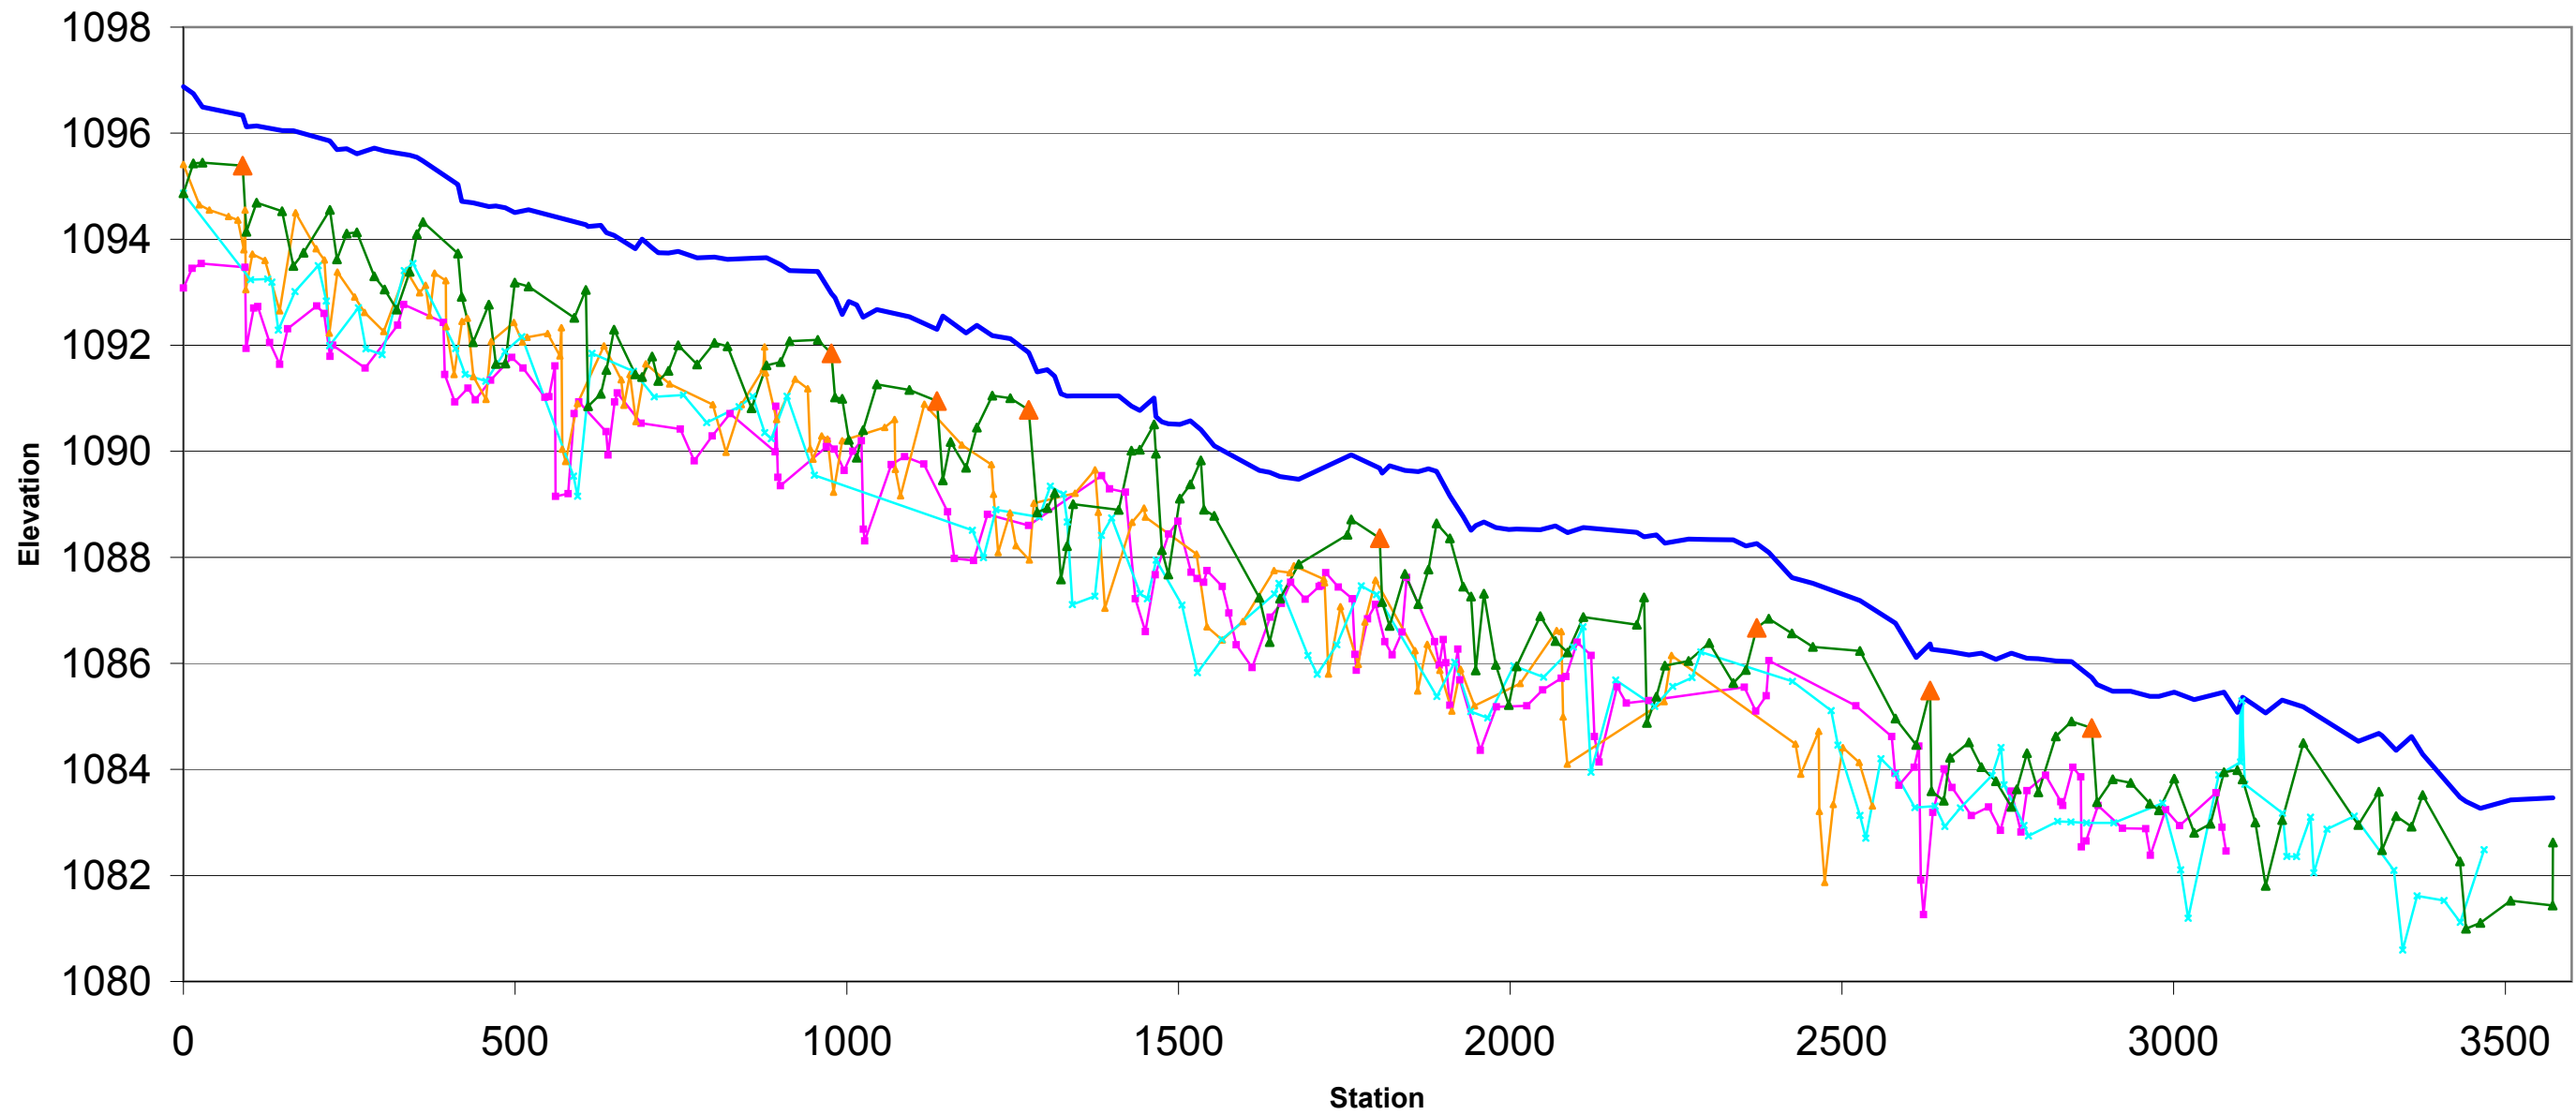
Surveyed 3000 ft per EEP protocol

Set downstream-most point of 2005 survey to the 2008 downstream-most culvert reading.

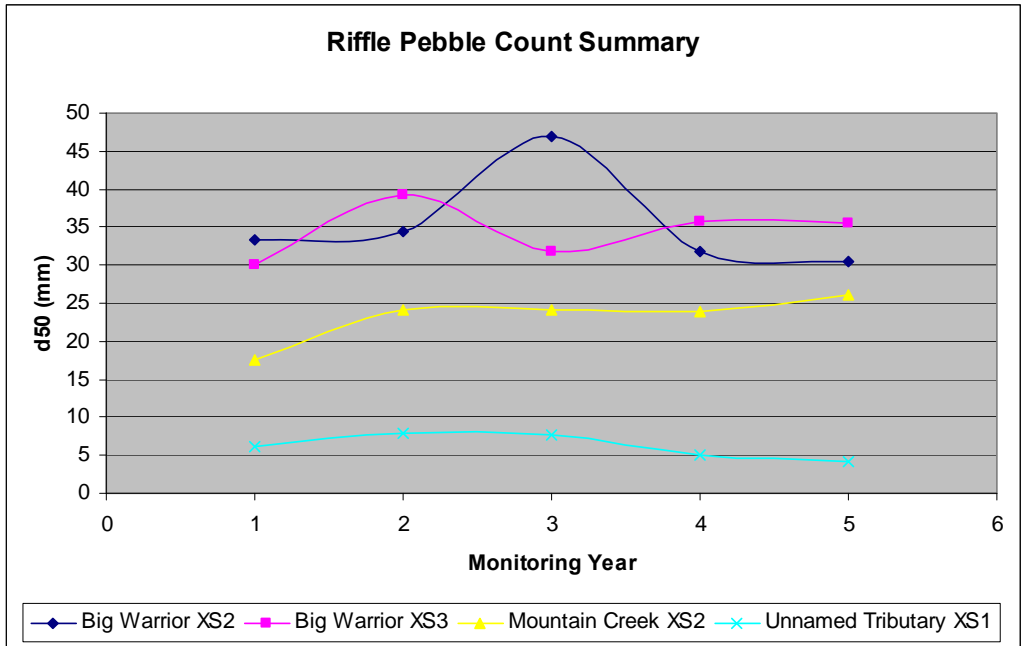
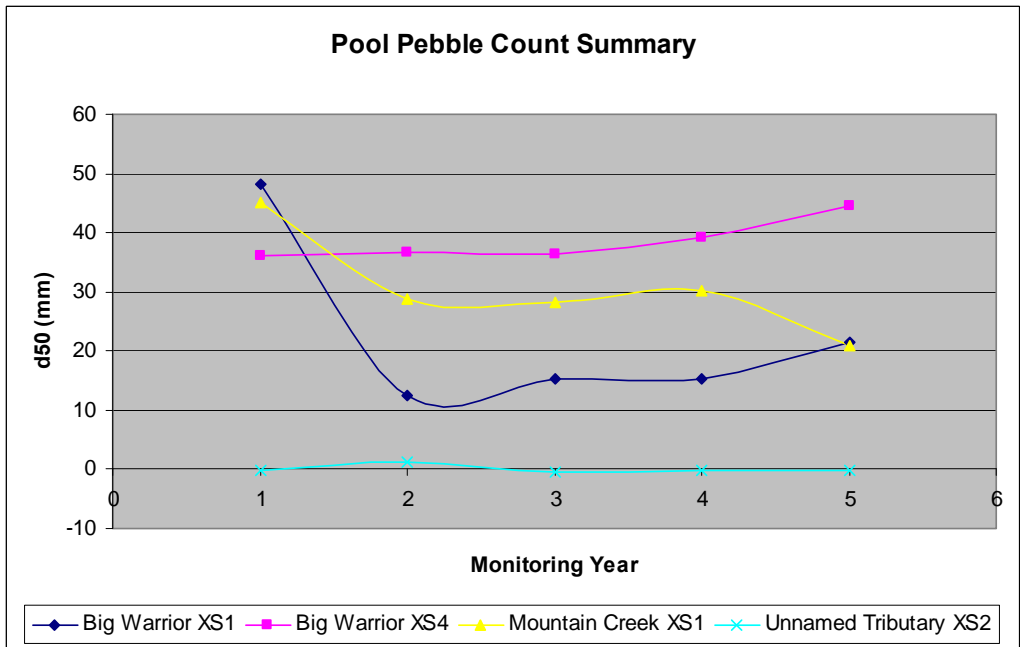
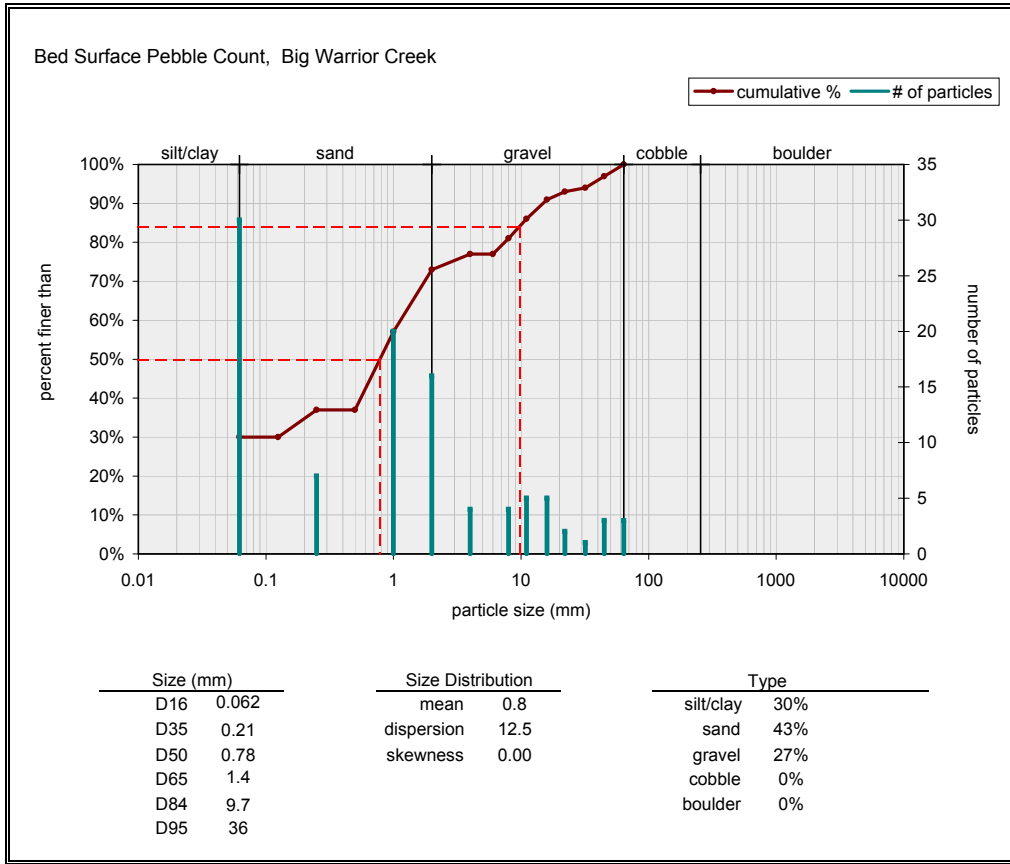
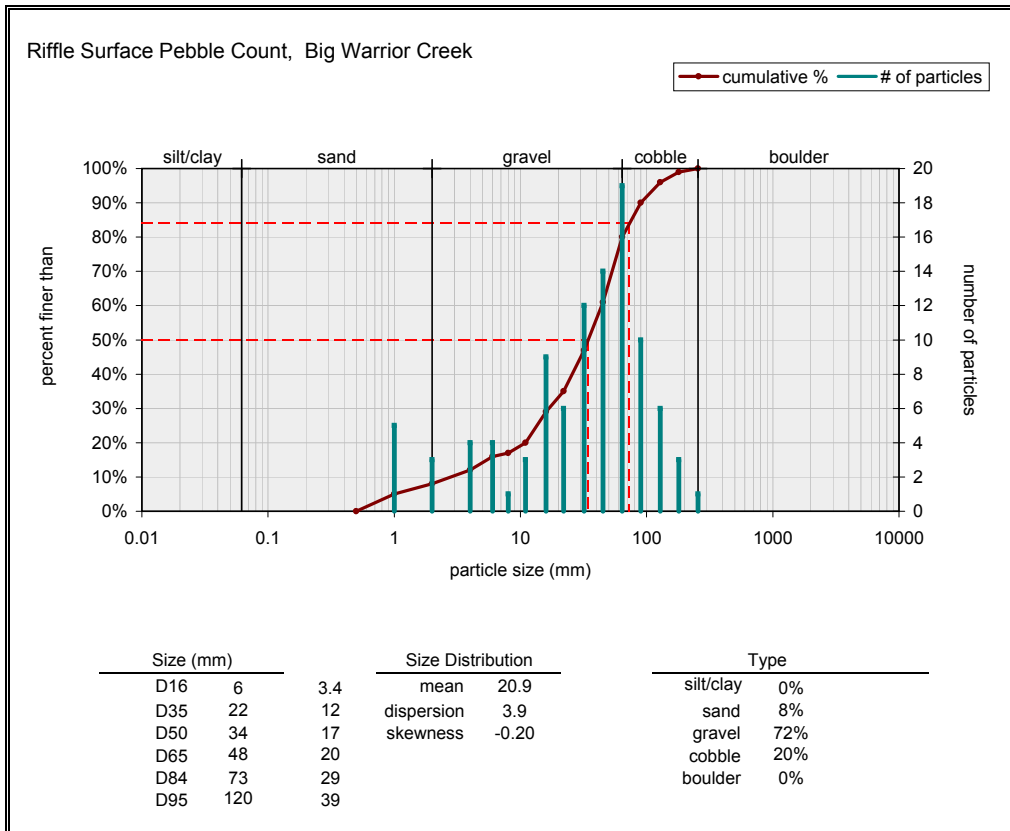
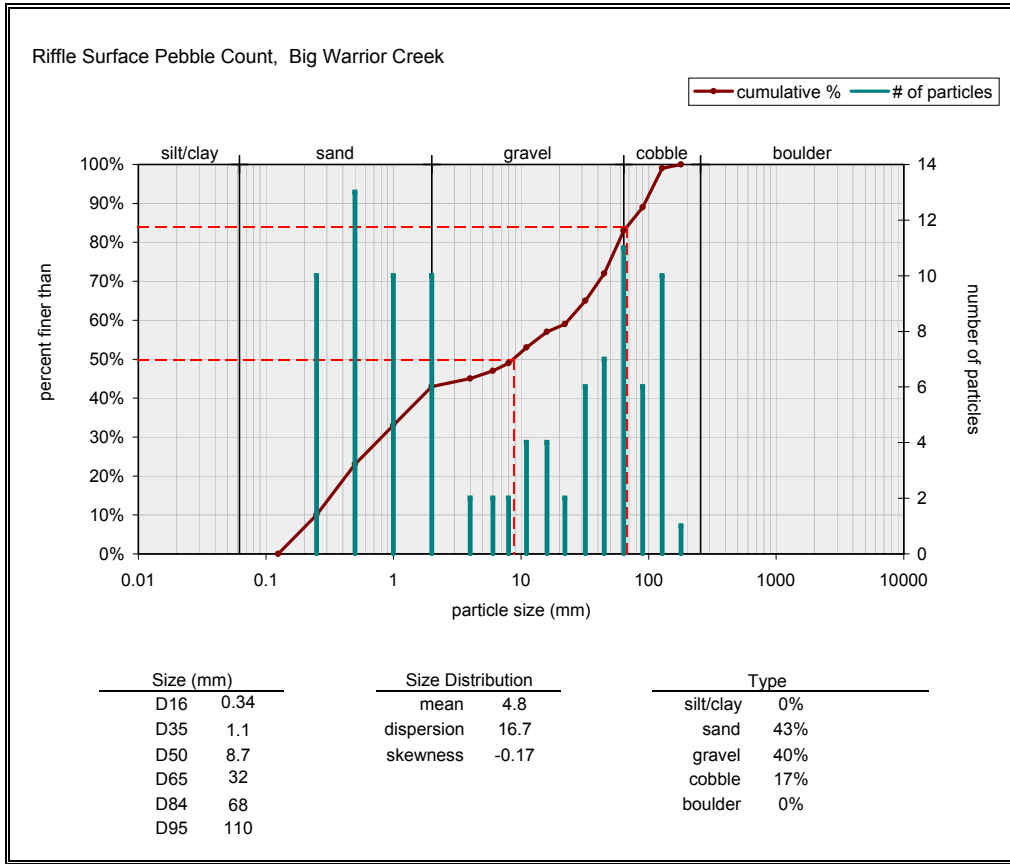
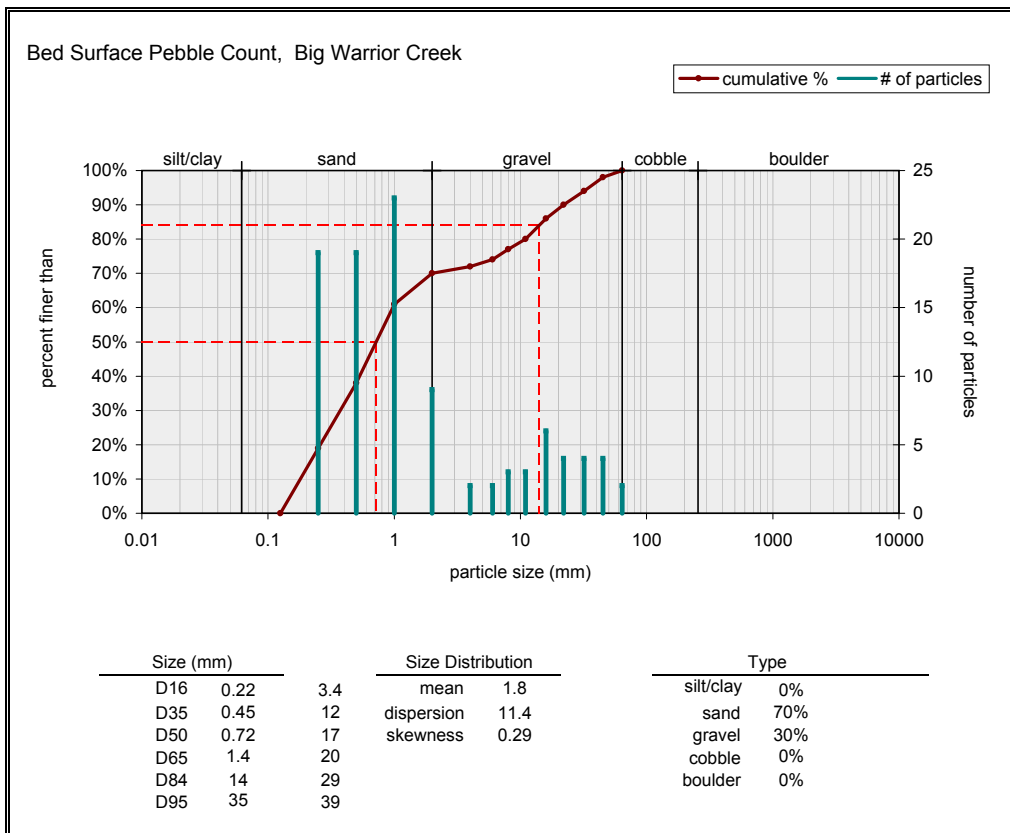
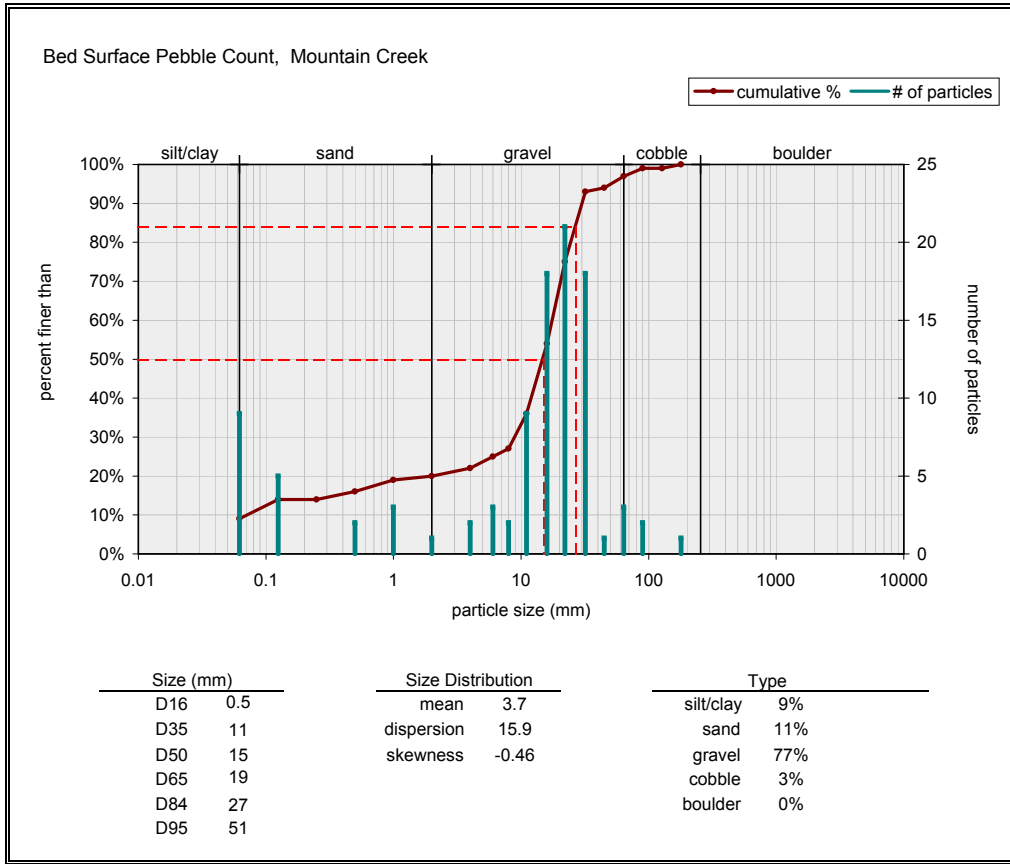
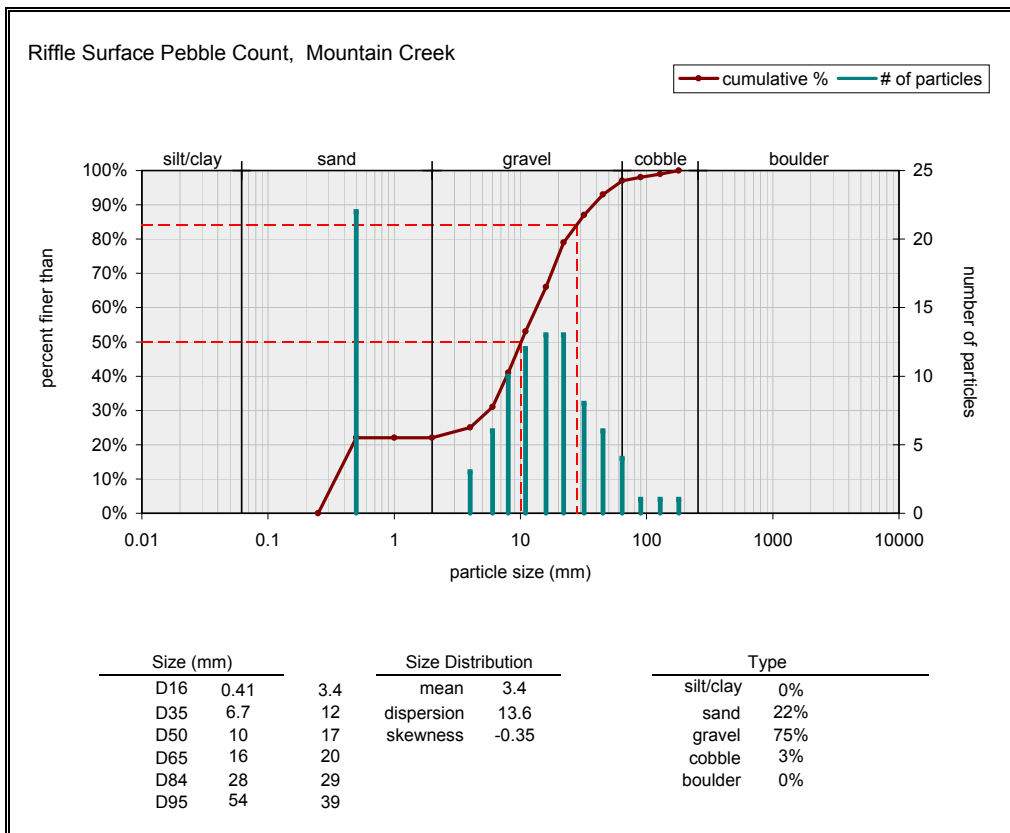
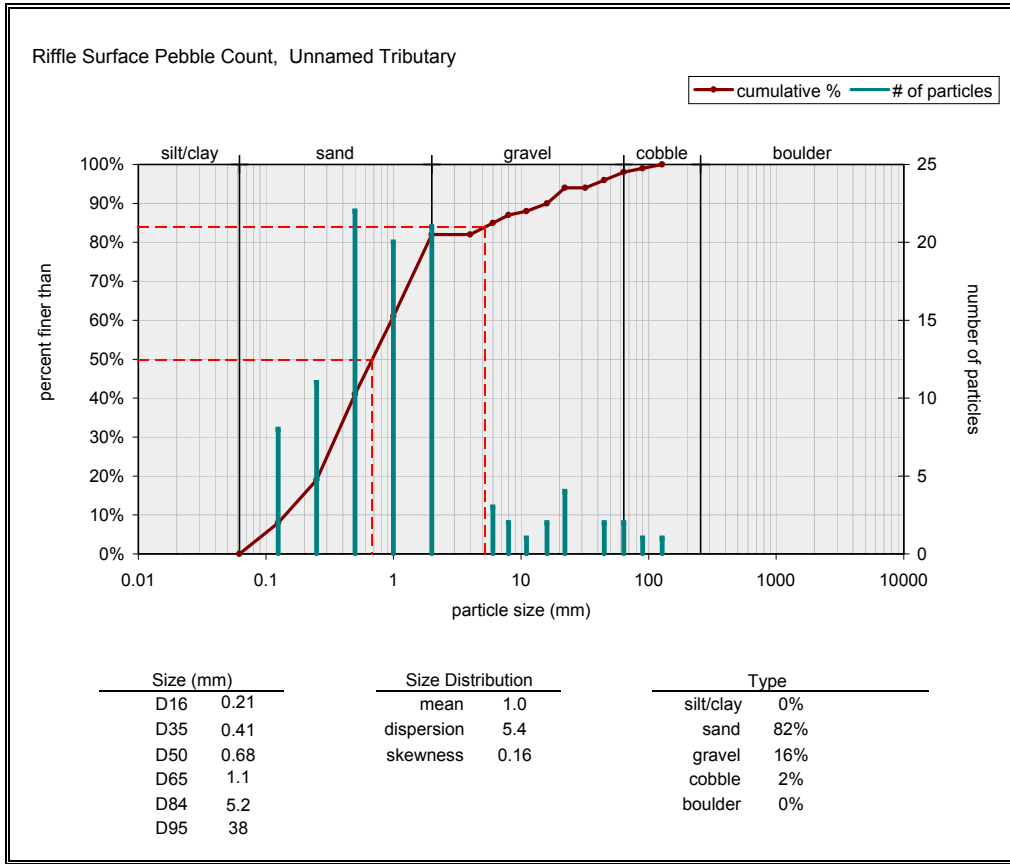
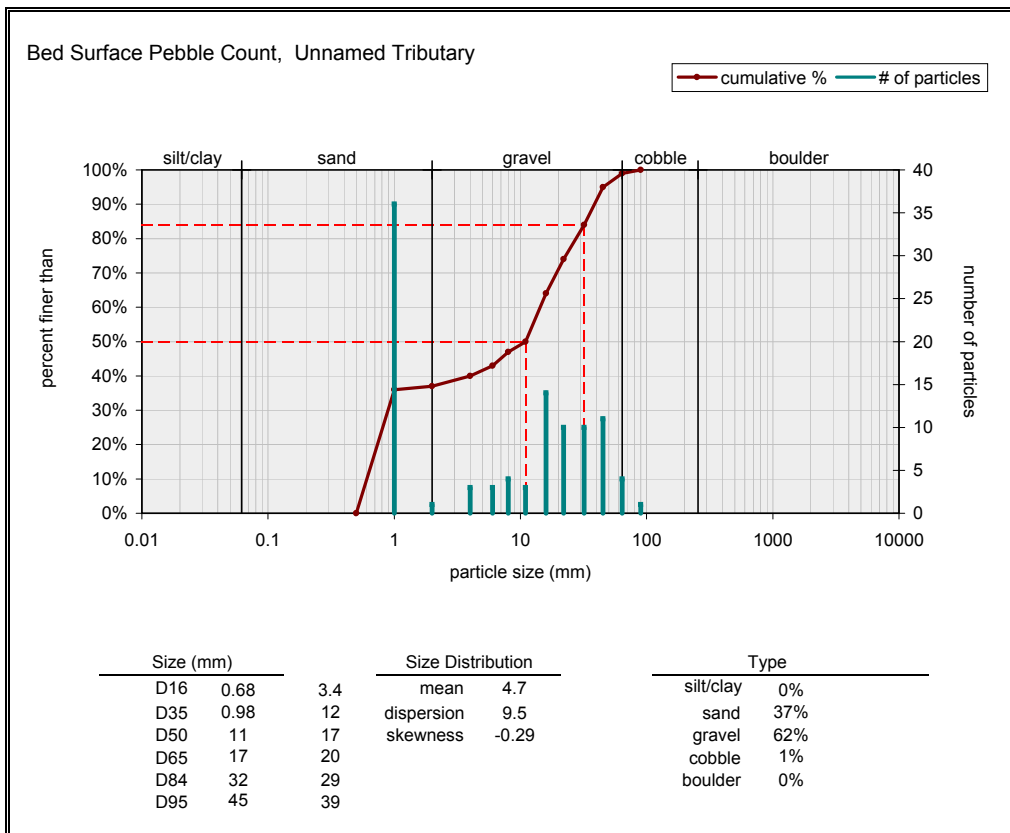
Figure 6: Pebble Count Summaries

In a riffle cross section, a stable system is indicated by a d50 maintaining or increasing. Maintaining a d50 indicates the riffles are not filling with sediment and pools are not moving into the reach. Fining of the riffle's bed material is not shown in Big Warrior's cross sections. In a pool cross section, the bed material in a stable system typically remains small. The pool's bed material is not getting significantly larger, even the slight increase in Big Warrior's XS4 bed material is not seen as significant.
