**WELLS CREEK
FINAL MONITORING REPORT
YEAR 2 OF 5
2006**

EEP Project # 414
Alamance County, North Carolina

1025 Wade Avenue
Raleigh, NC 27605
Phone: (919)789-9977
Project Manager:
Phillip Todd
ptodd@sepiengineering.com

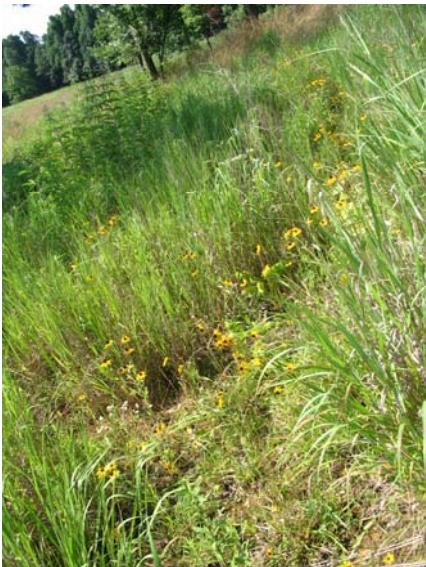
Photo 2: UT 18+50 Right bank bare floodplain

Table VI. Vegetative Problem Areas			
Feature/Issue	Station # / Range	Probable Cause	Photo #
Bare Flood Plain	UT - Station 11+80	area washed from storm events	6
	UT - Station 12+50	area washed from storm events	5
	UT - Station 14+20	area washed from storm events	4
	UT - Station 18+50	area washed from storm events	2
Invasive/Exotic Populations	Reach 1 - Station # 20+50 Lt	Japanese grass overtaking area - from off site	8
	Reach 1 - down from Crest Gauge	Japanese grass overtaking area - from off site	1
	Reach 2 - Station #11-13	Japanese grass overtaking area - from off site	7

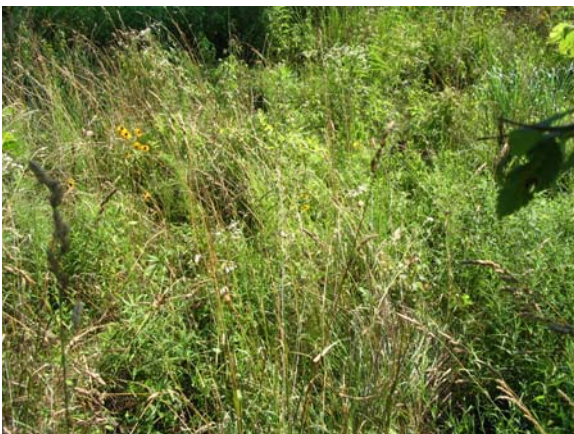
Photo 3: UT 19+00 Right Bank Japanese grass

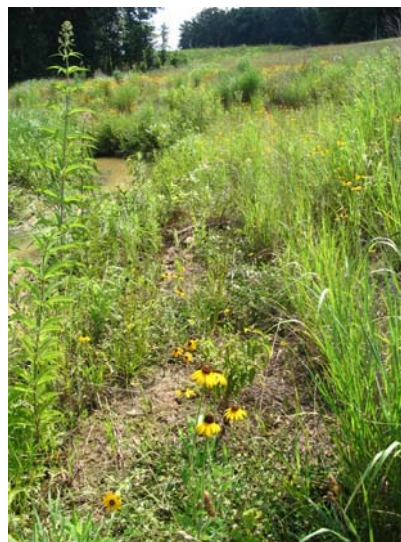
Photo 6: UT 11+80 Left bank barren floodplain
