**WELLS CREEK
FINAL MONITORING REPORT
YEAR 3 OF 5
2007**

EEP Project # 414
Alamance County, North Carolina

1025 Wade Avenue
Raleigh, NC 27605
Phone: (919)789-9977
Project Manager:
Phillip Todd
ptodd@sepiengineering.com

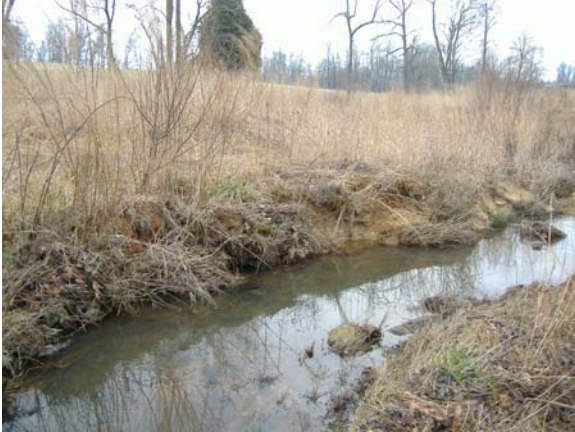
Photo 1: Bank Erosion (Station 10+85 along plan view).

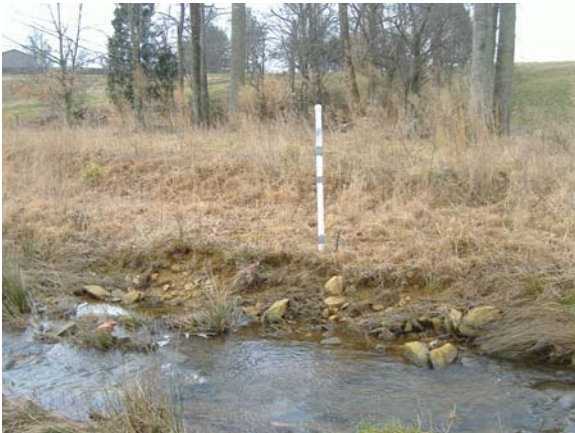
Photo 2: Bank erosion (Station 22+20 along plan view).

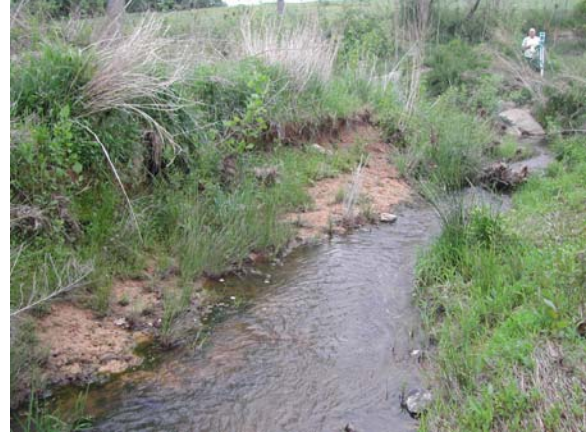
Photo 3. Past Bank Erosion Stabilizing.

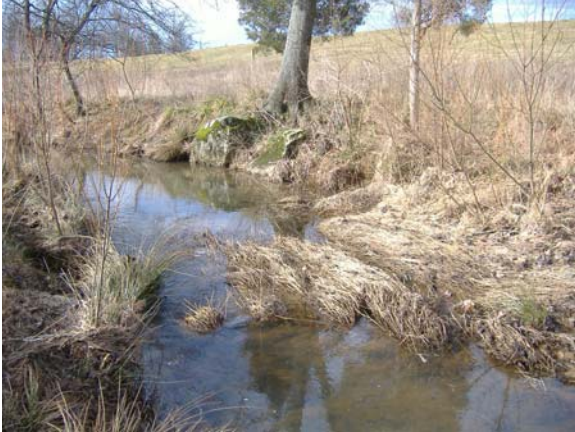
Photo 1: Representative grass aggradation problem area (19+06.73 along plan view).

18+25.08		
Aggradation (cattails)	18+63.51	Channel too wide; narrowing to a stable dimension	Photo 2
	18+68.58		
Aggradation (grass)	19+06.73	Channel built too wide; narrowing to a stable dimension	Photo 1
	19+20.77		
Aggradation (grass)	19+69.79	Channel built too wide; narrowing to a stable dimension	
	19+82.28		
Aggradation (grass)	19+96.65	Channel built too wide; narrowing to a stable dimension	
	20+05.09		
Aggradation (grass)	21+55.88	Channel built too wide; narrowing to a stable dimension	
	21+65.65		
Central Bar	21+65.65	Deposition from upstream sediment sources.	
	21+76.54

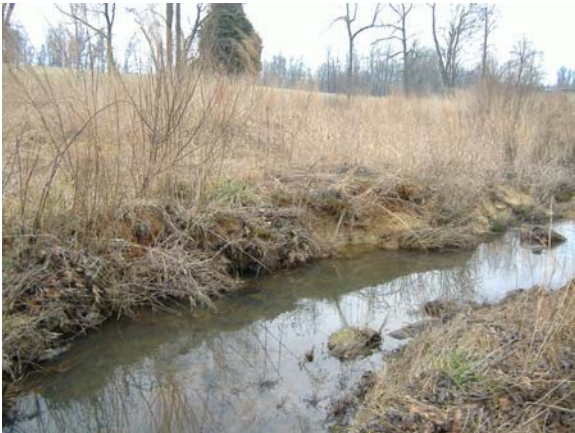
Photo 3: Representative problem root wad and bank erosion (10+82.28 along plan view). Root wads located in bank along left side of picture.

Wells Creek Reach 1			
Feature Issue	Station numbers	Suspected Cause	Photo number
Aggradation (grass)	10+18.30	Channel built too wide for riffle; narrowing to a stable dimension	
	10+47.44		
Rootwad	10+82.16	Location of rootwads upstream creating backeddys around downstream rootwads and contributing to bank erosion problem directly downstream	Photo 3
Rootwad	10+87.90		
Rootwad	10+92.28		
Cross-Vane	12+75.47	Piping around right side of structure.	Photo 4
Aggradation (grass)	15+57.26	Channel built too wide; narrowing to a stable dimension	
	16+12.68		
Aggradation (grass)	17+51.49	Downstream J-hook elevation higher which created deposition upstream; eventually built up so grasses growing in channel	
	17+70.64		
Aggradation (grass)	17+91.04	Channel built too wide; narrowing to a stable dimension	
	18+03.11		
Bar Formation	18+03.11	Downstream rootwads and cross-vane causing deposition upstream and creation of a central bar with grasses.

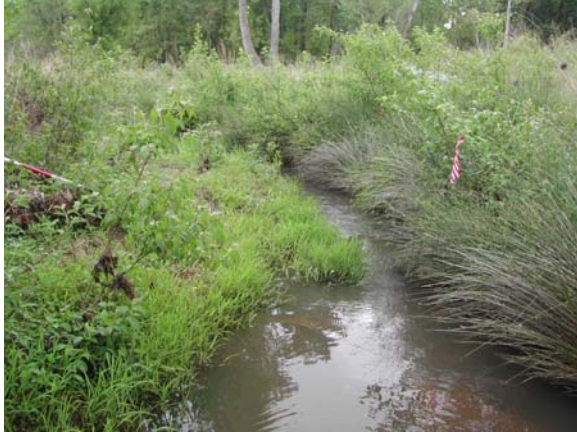
Photo 1: Representative grass aggradation/lateral bar problem area (Station 18+15 along plan view).

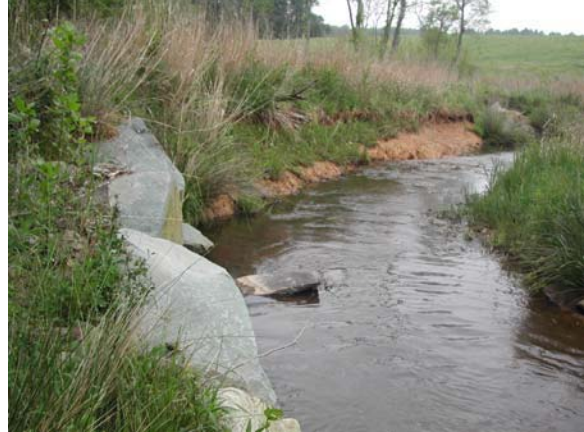
Photo 2: Representative problem j-hook and bank erosion (Station 15+03 along plan view).

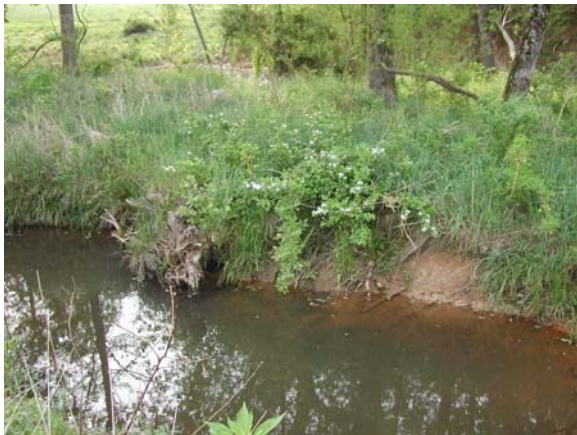
Photo 3: Representative problem root wad and bank erosion (Station 11+94 along plan view).

Wells Creek Reach 2			
Feature Issue	Station numbers	Suspected Cause	Photo number
Rootwad	11+91.52	Angle/placement possibly cause of bank erosion directly up- and downstream.	Photo 3
Aggradation (grass lateral bar)	12+16.28 12+53.87	Channel built too wide. Stream naturally narrowing at a stable dimension.	
Rootwad	12+79.46	Placement angle/size is major cause of severe erosion directly downstream.	
Aggradation (grass)	13+12.45 13.41.21	Channel built too wide. Stream naturally narrowing at a stable dimension.	
J-hook	13+41.87	See above comment.	
J-hook	14+03.21	Significant piping around right side of structure, minor piping around left side.	
J-hook	15+07.75	Placement/angle possible cause of downstream adjacent erosion.	Photo 2
J-hook (severe)	15+98.98	Placement/angle probable cause of downstream adjacent erosion. Flow being directed into bank.	
Aggradation (grass)	16+30.11 16+62.22	Channel built too wide. Stream naturally narrowing at a stable dimension. Appears to be remnants of previous erosion now healed over leaving a side-bar in the channel.

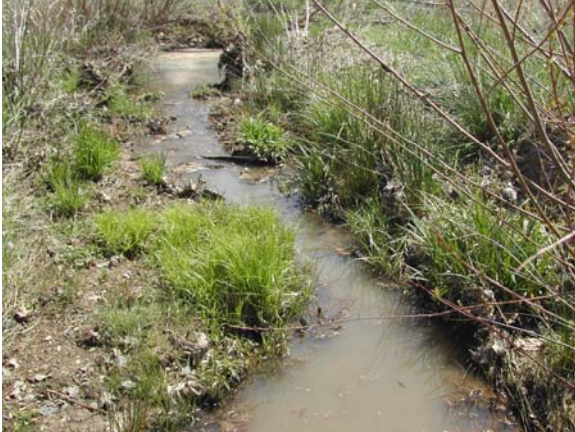
Photo 1: Representative grass aggradation problem area (12+55.96 along plan view).

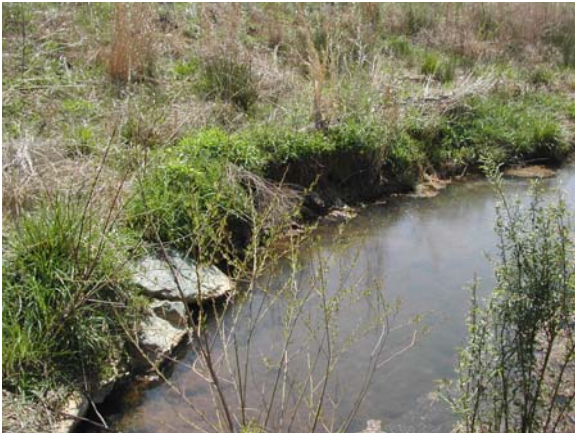
Photo2: Representative problem j-hook and bank erosion (10+10.93 along plan view).

Wells Creek Reach UT			
Feature Issue	Station numbers	Suspected Cause	Photo number
J-hook	10+00.00	Improper angle and placement of J-hook may be cause of adjacent bank erosion	Photo 2
Aggradation (grass)	10+37.57 10+40.00	Channel narrowing to stable state	
Aggradation (grass)	10+93.71 11+10.53	Channel narrowing to stable state	
Aggradation (cattail)	11+55.36 11+77.17	Channel narrowing to stable state	
Aggradation (grass)	11+77.17 12+12.44	Channel narrowing to stable state	
Aggradation (grass)	12+58.40 12+70.34	Channel narrowing to stable state	Photo 1
Aggradation (grass)/Lateral Bar Formation	13+35.05 13+83.44	Channel narrowing to stable state as evidenced by lateral bar formation.	
Aggradation (grass)	14+21.44 14+46.88	Channel narrowing to stable state	
Aggradation (grass)	14+86.35 15+25.19	Channel narrowing to stable state	
Aggradation (grass)	15+87.53 16+30.15	Channel narrowing to stable state	
J-hook	16+35.89	Angle and/or placement of J-hook causing bank erosion downstream
