**WELLS CREEK
FINAL MONITORING REPORT
YEAR 4
2008**

EEP Project # 414
Alamance County, North Carolina

Original Design Firm:
ARCADIS G&M of North Carolina, Inc.
801 Corporate Center Drive, Suite 300
Raleigh, NC 27607

Monitoring Firm:

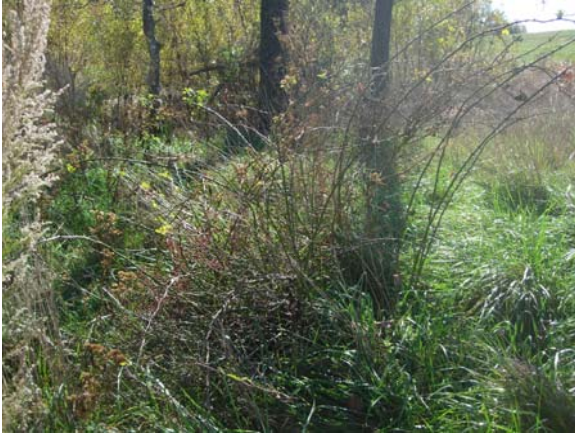
Photo 1: Multiflora rose (*Rosa multiflora*) growth (Station No. 17+42; view upstream on right bank; 11-6-2008).

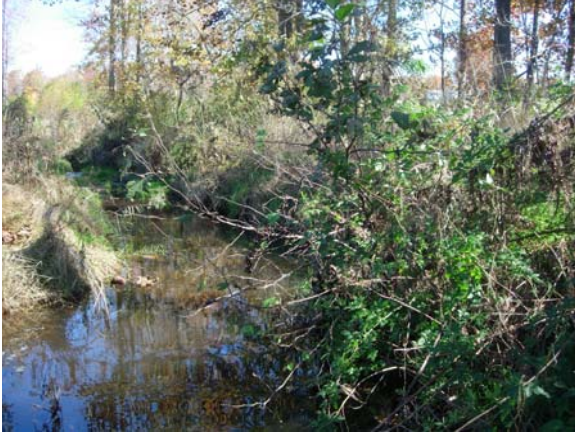
Photo 1: Multiflora rose (*Rosa multiflora*) growth (Station No. 13+99; view downstream on right bank; 11-6-2008).

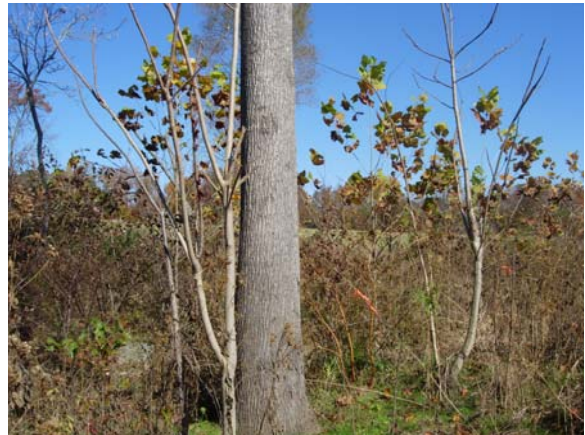
Photo 4: Tree of Heaven (*Ailanthus altissima*) growth (Station No. 17+83; view is within Vegetation Plot 9, *Ailanthus* trees appear leafless in photo; 11-6-2008).

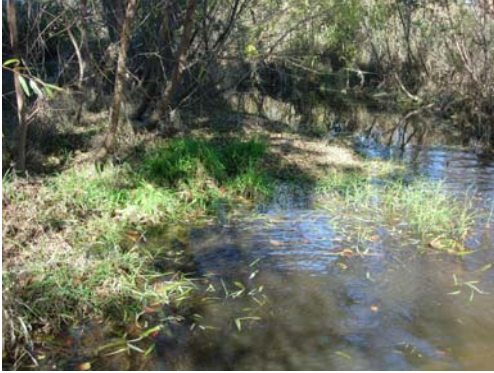
Photo 1: Representative aggradation/midbar problem area (Station No. 18+04; view upstream; 11-6-2008).

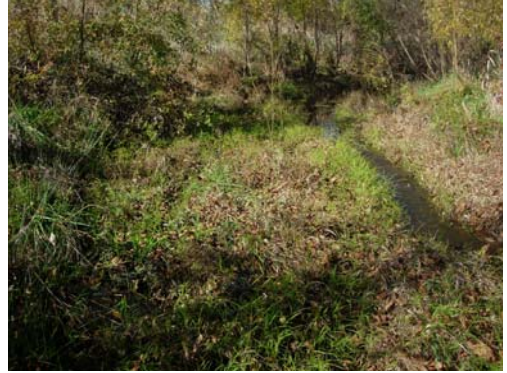
Photo 2: Representative aggradation problem area (Station No. 15+74; view downstream; 11-6-2008).

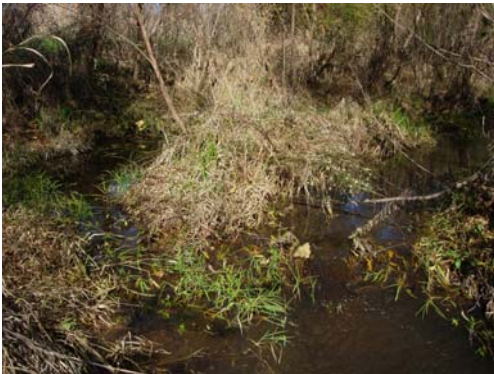
Photo 3: Representative midbar problem area (Station No. 18+02; view downstream; 11-6-2008).

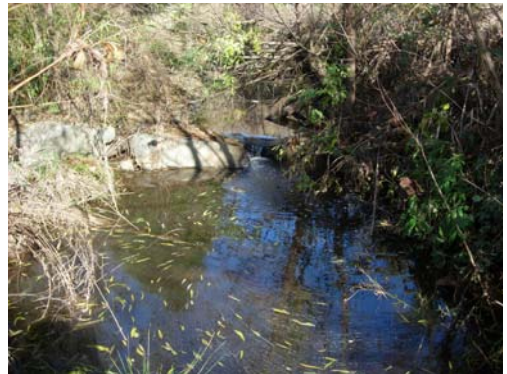
Photo 4: Representative crossvane problem area (Station No. 12+75; view upstream; 11-6-2008).

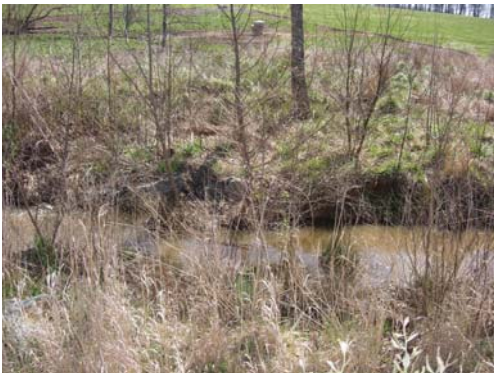
Photo 5: Representative bank erosion problem area (Station No. 10+83; view across stream toward left bank on 3-20-2008).

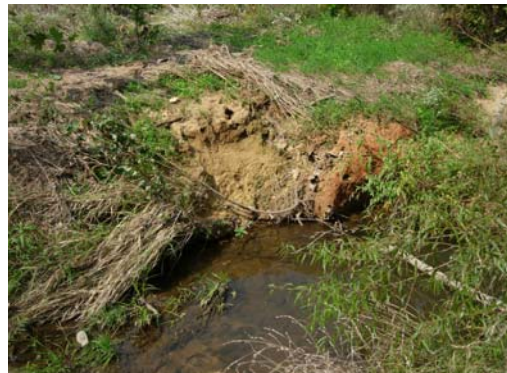
9/8/2008	Unknown	Several bankfull events resulting from 9/1/2008 storm event. Note wrack lines located above the top of bank elevation in photo.	Photo 6 in SR-1 SPA Photolog

Photo 6: Evidence of bankfull event (Station No. 12+75; view of right bank, note vegetation impact on bank; 9-8-2008).

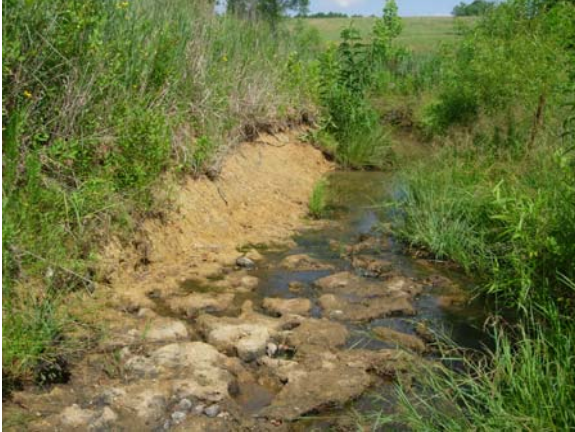
Photo 1: Representative bank erosion problem area (Station No. 17+11; view upstream; 6-17-2008).

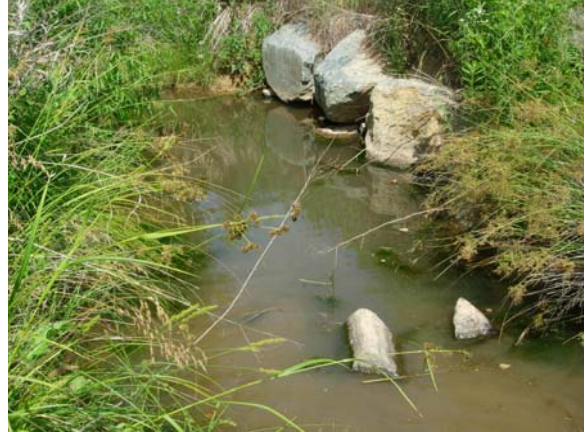
Photo 2: Representative problem j-hook and bank erosion (Station No. 17+74; view downstream; 6-17-2008).

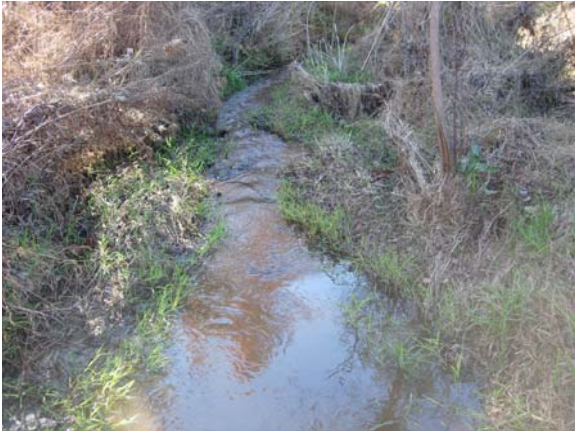
Photo 3: Representative side bar problem area (Station No. 14+08; view downstream; 11-6-2008).

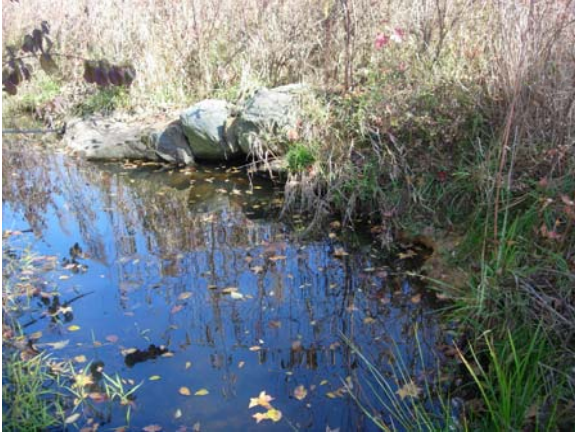
Photo 1: Representative jhook and bank erosion problem area (Station No. 16+42; bank erosion is in the right corner of picture; view downstream; 11-6-2008).

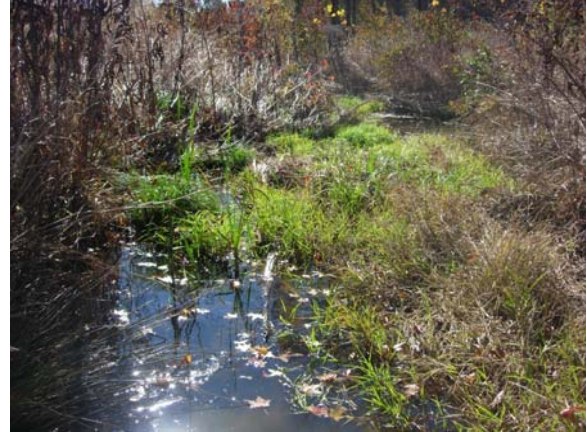
Photo 3: Representative sidebar problem area (Station No. 10+96; view downstream; 11-6-2008).

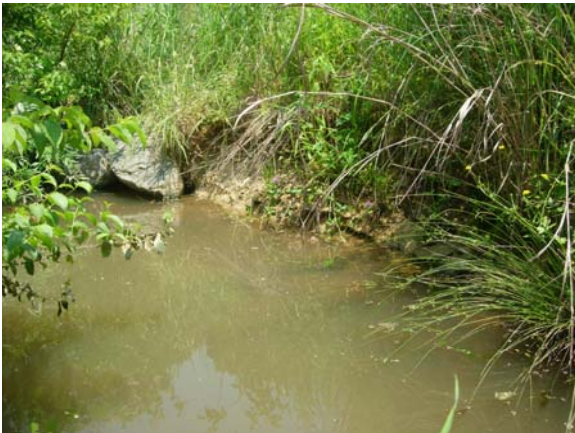
Photo 2: Representative bank erosion problem area (Station No. 10+11; view downstream of left bank; 6-10-2008).

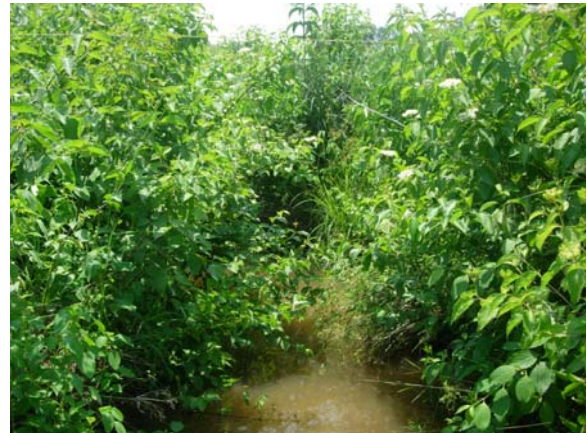
Photo 4: Representative aggradation problem area (Station No. 11+99; view downstream; 6-9-2008).
