**WELLS CREEK
FINAL MONITORING REPORT
YEAR 5 OF 5
2009**

EEP Project # 414
Alamance County, North Carolina

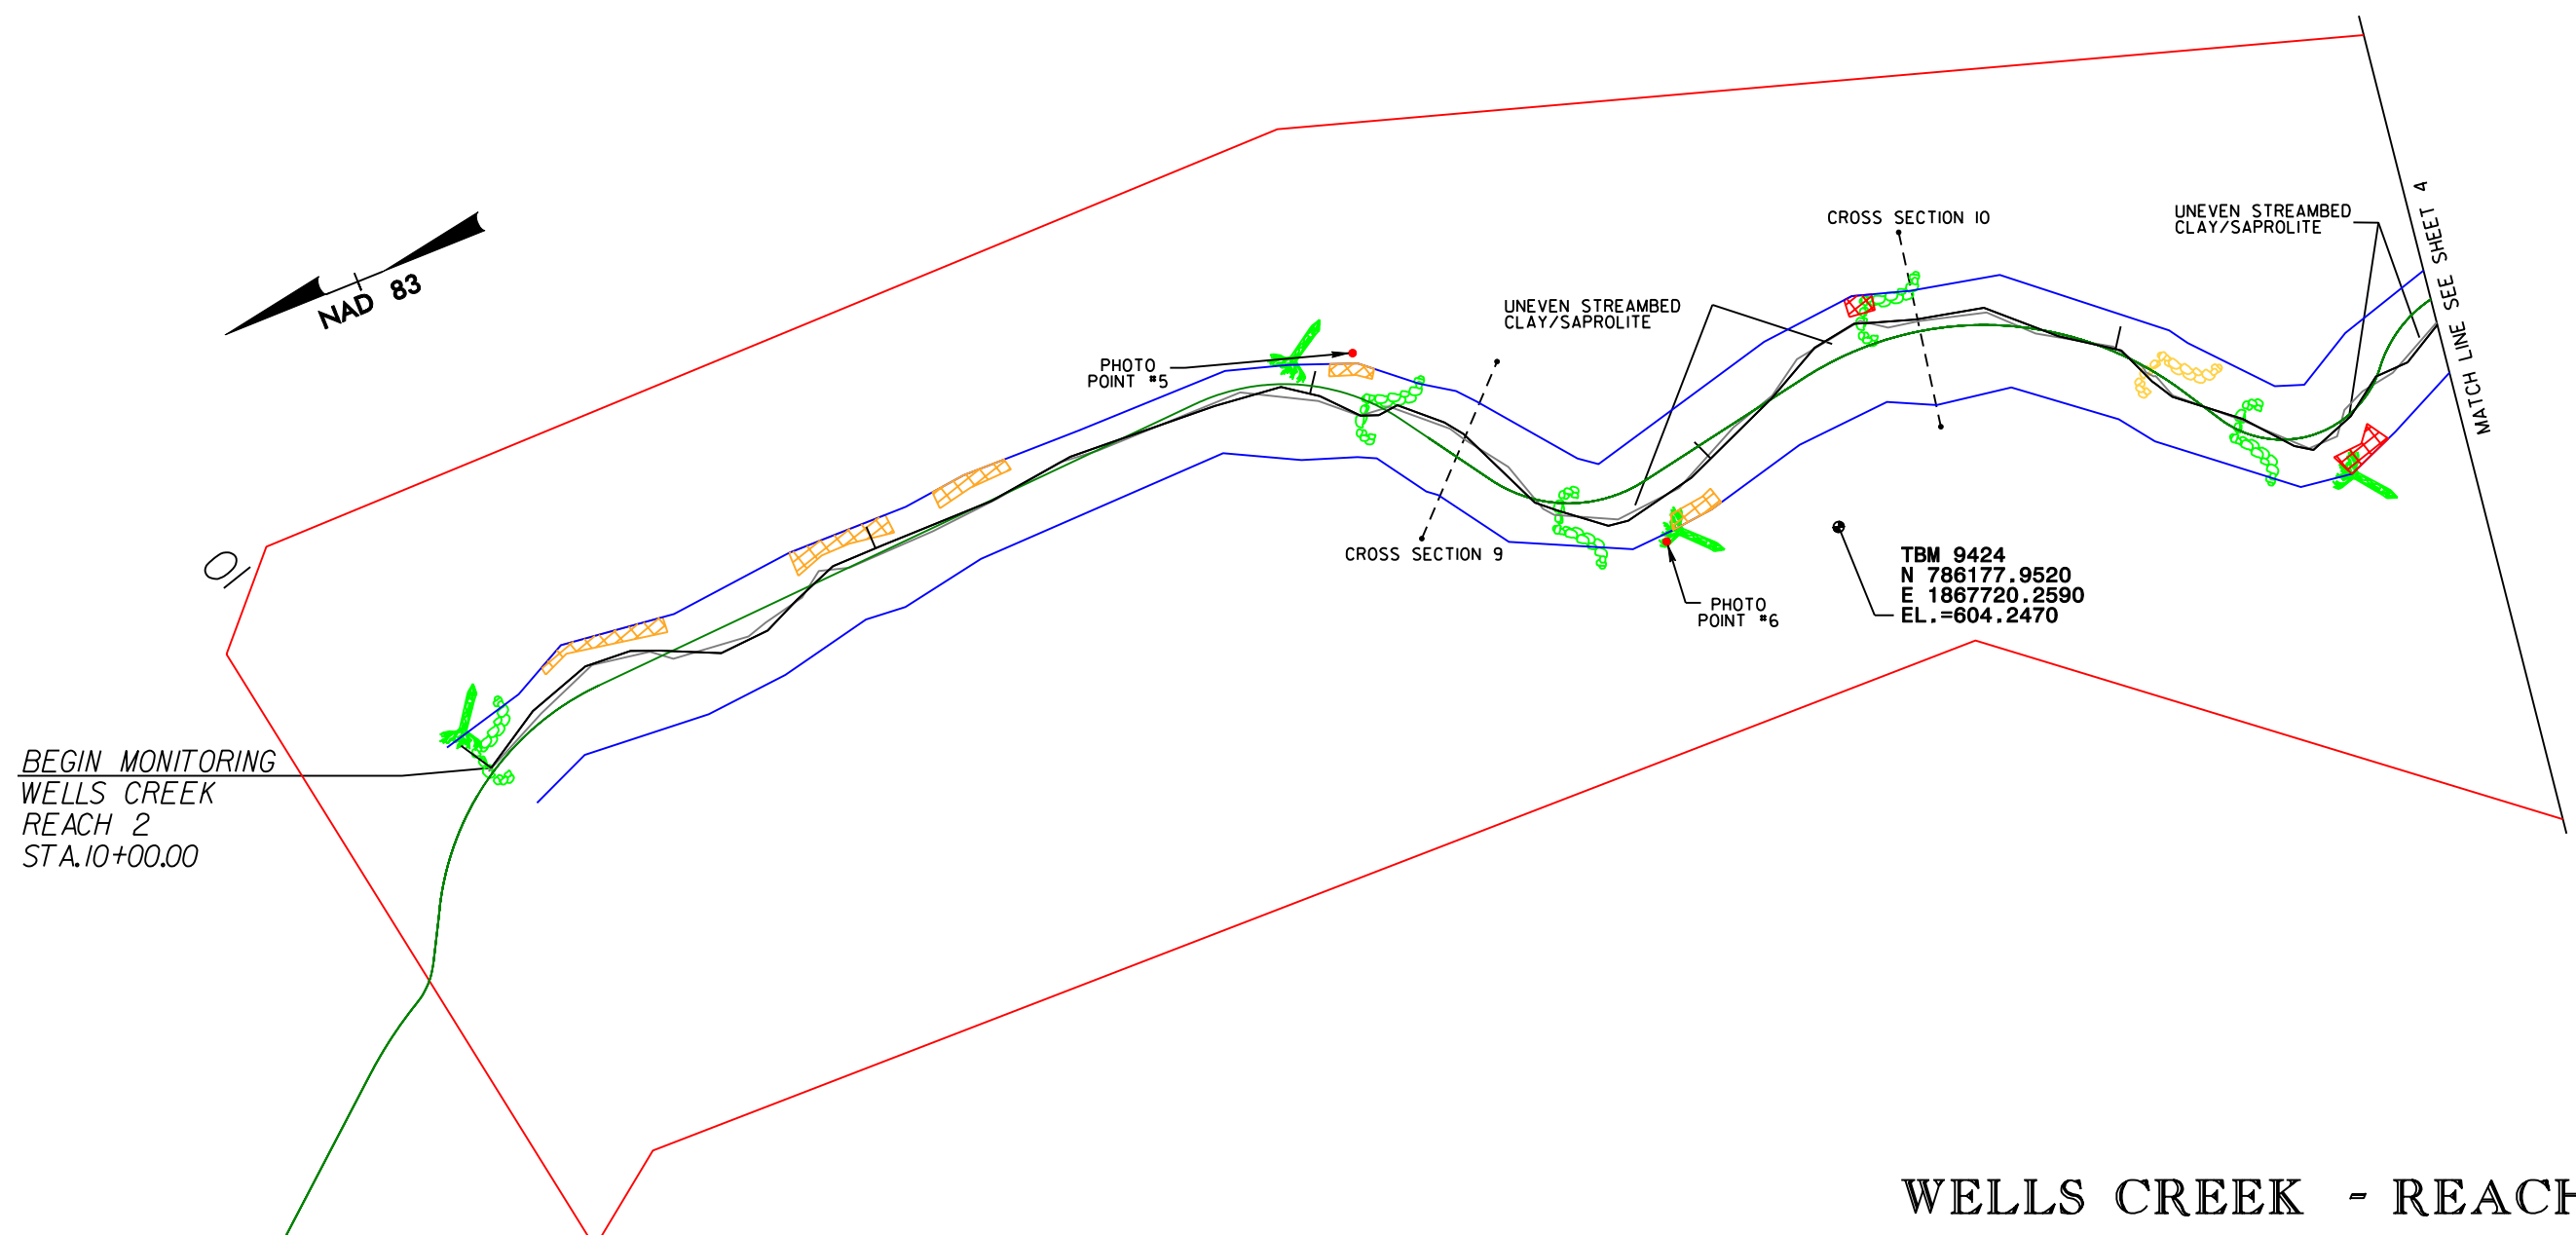
WELLS CREEK - REACH 2

*The beaver dam listed last year at the very end of Reach 2 was either removed or washed downstream, as it was observed to be absent on May 12, 2009.

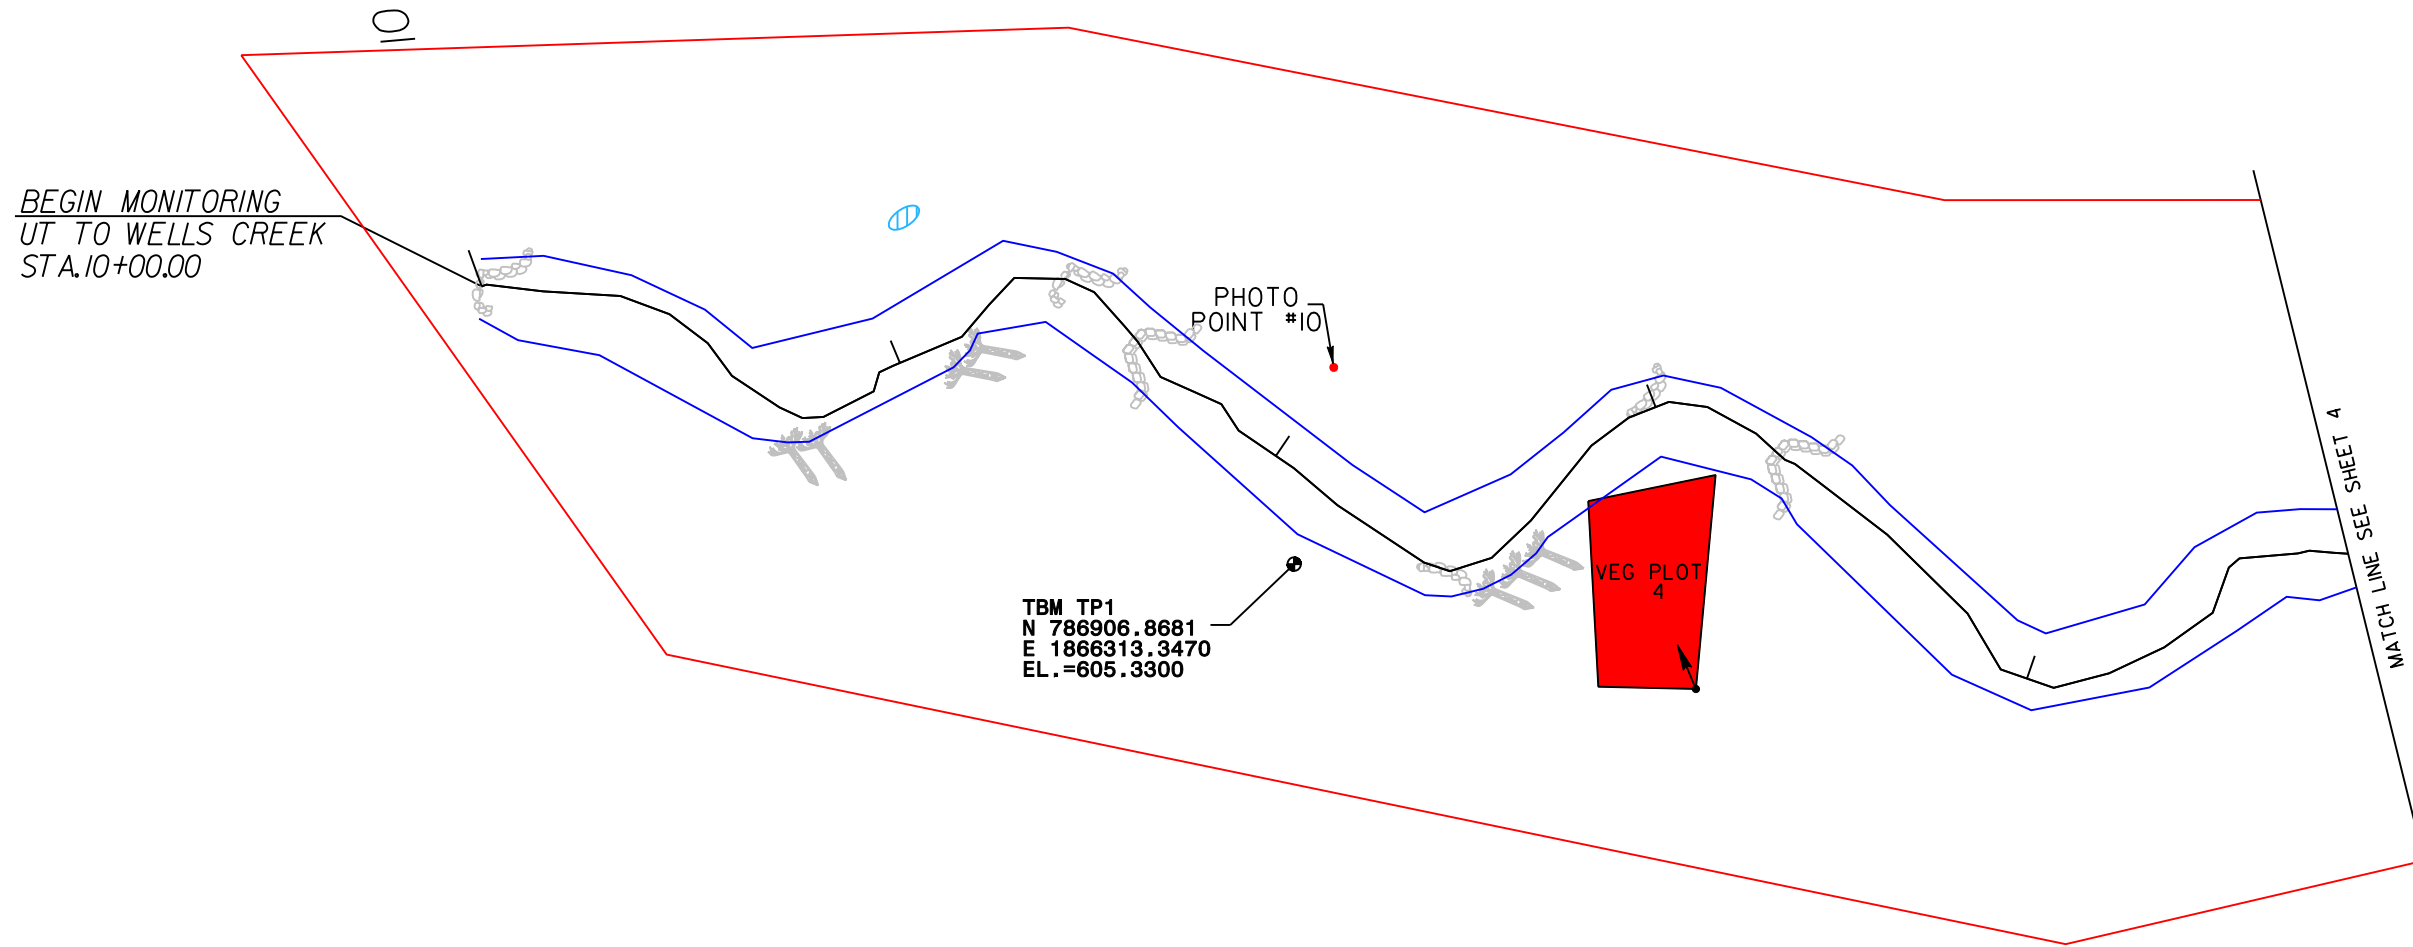
UT TO WELLS CREEK

The stem densities on Reaches 2 and the UT are well above the Monitoring Year 5 stem density goal (260 stems per acre), except for in Vegetation Plot (VP) #4 on Reach UT that had a stem density of 97 stems per acre. Stem densities on Reach 1 were below the Monitoring Year 5 goal (260 stems/acre). This trend may be influenced by populations of both fescue (*Festuca spp.*) and Japanese stilt grass (*Microstegium virmineum*) at Monitoring Reach 1. The overall survival rate among all vegetation plots was just over 51% in Monitoring Year 5. The only vegetation-specific problem areas documented in Monitoring Year 5 were associated with invasive species. Invasive species documented at one or more of the reaches include: *Rosa multiflora*, *Ligustrum sinense*, *Microstegium virmineum*, and *Ailanthus altissima* (see Plan Views in Appendix A).
