WHITELACE CREEK STREAM ENHANCEMENT
AND WETLAND RESTORATION SITE
MONITORING REPORT (YEAR 2 OF 5)

Lenoir County, North Carolina
EEP Project No. 420

Status of Plan: Final
Submission Date: March 2008

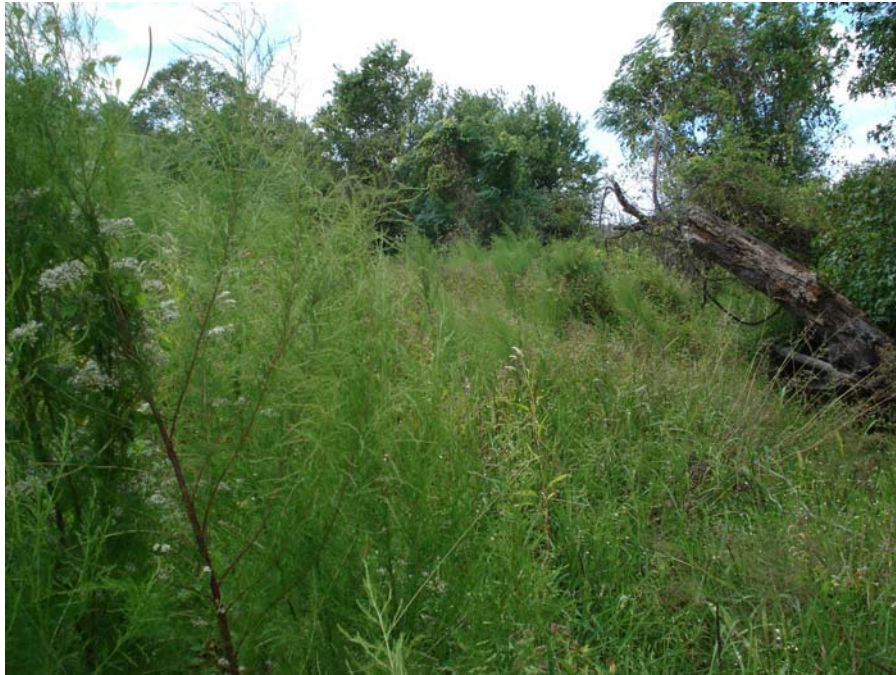
Photo Station 1: Vegetation Plot 1 (9/18/07)

Tract	Well ID	Well Hydrology Threshold Met?	Tract Mean	Vegetation Plot ID	Vegetation Density Met (320 stems/acre)	Tract Mean
Site	1	Y	71%	VP1	N (162)	30%
	2	N		VP2	N (162)	
	3	Y		VP4	Y (445)	
	4	N		VP6	N (162)	
	5	Y		VP8	Y (445)	
	6	Y		VP9	Y (405)	
	7	Y		VP11	N (81)	
Reference	Ref Site 1	Y	100%	VP14	N (81)	(238 stems/acre)
	Ref Site 2	Y		VP15	N (202)	
	Ref Site 3	Y

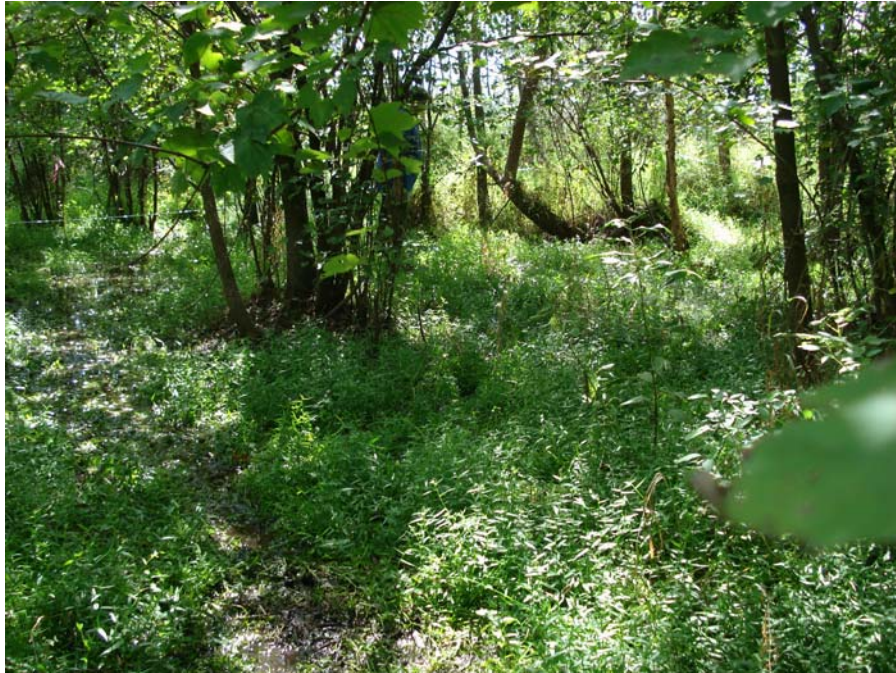
Photo Station 7: Vegetation Plot 11 (9/18/07)

Photo 4. Flooding, dead planted tree and *Murdannia keisak* at Veg Plot 11 (9/23/07)

allowing the site hydrology to return to conditions outlined in the restoration plan. However, beaver activity is likely to continue. Therefore, the site should be replanted with trees of appropriate species and size to withstand periodic inundation.
