WHITELACE CREEK STREAM ENHANCEMENT  
AND WETLAND RESTORATION SITE  
MONITORING REPORT (YEAR 3 OF 5)

Lenoir County, North Carolina  
EEP Project No. 420

Status of Plan: Final  
Submission Date: April 2009

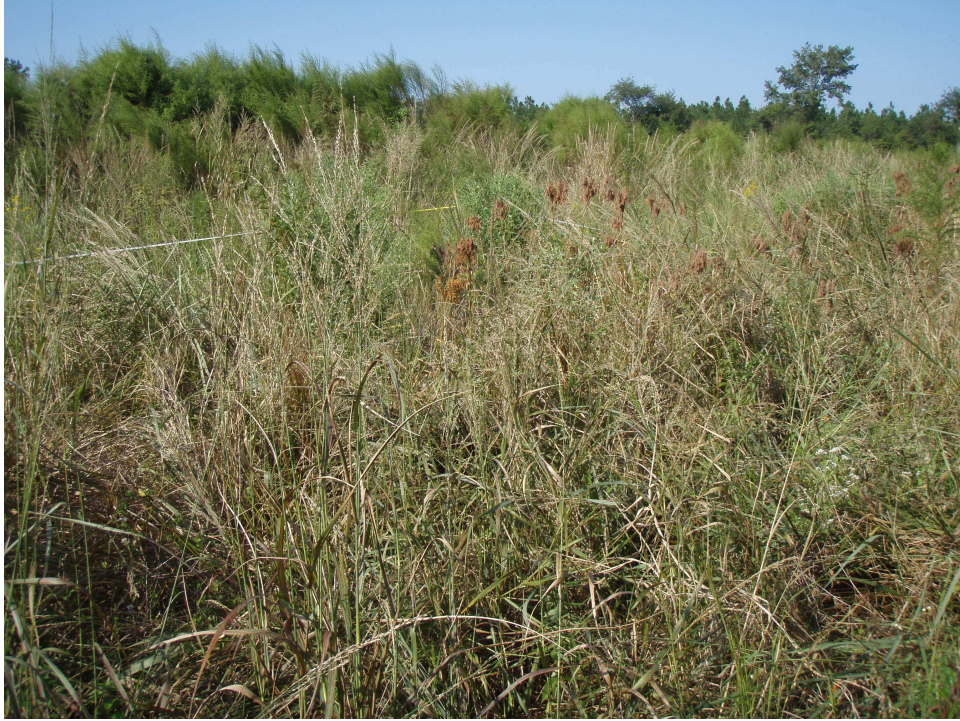
Photo Station 3: Vegetation Plot 4 (9/18/08)

Monitoring revealed that 3 of the 9 plots (33%) met the 3-year vegetative success criteria of 320 planted stems or greater per acre (plots 4, 8, & 9). The remaining six plots failed to meet the success criteria in Year 3. These plots also failed to meet the criteria in Year 2 of monitoring. There are a number of issues causing the failure of these plots. There was a relatively low number of healthy plant species in vegetation plots 1 and 2, likely due to previous heavy flooding in 2006 as noted in the Year 1 monitoring report. In 2007, the higher areas onsite were adversely affected by an extreme drought while the lower areas onsite were flooded by beaver activity. In 2008, beaver activity continued to be an issue, as well as drought later in the growing season. Plot 15 is dry and may have poor soil conditions which led to the death of a number of plants this year during the drought. Resprouts were not observed in any plots, therefore vegetation numbers are not likely to improve.

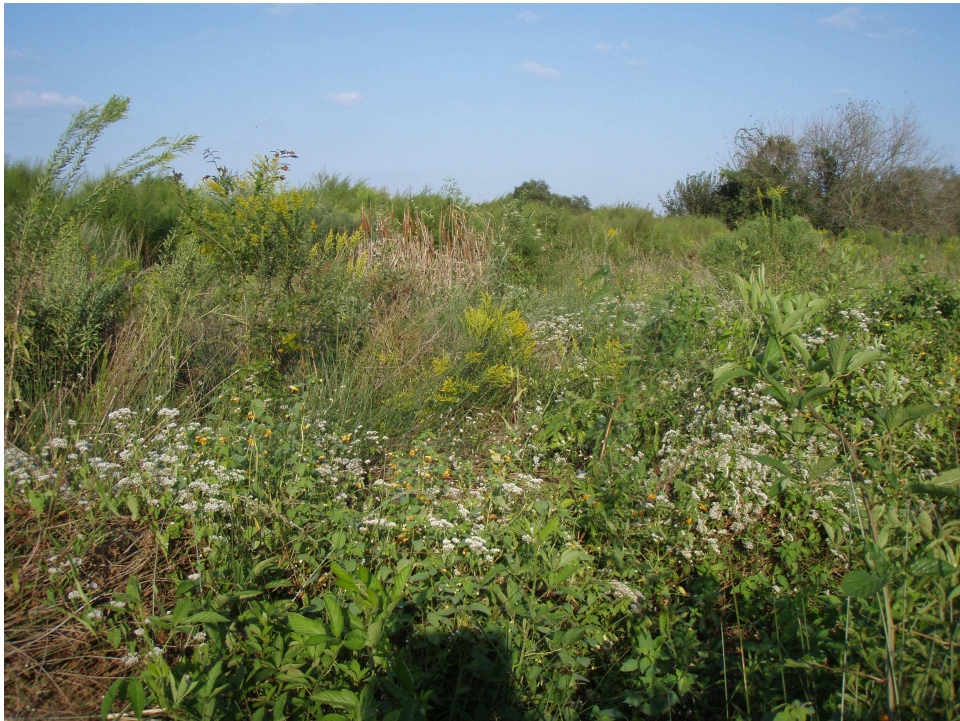
Photo Station 4: Vegetation Plot 6 (9/18/08)

<b>Tract</b>	<b>Well ID</b>	<b>Well Hydrology Threshold Met?</b>	<b>Tract Mean</b>	<b>Vegetation Plot ID</b>	<b>Vegetation Density Met (320 stems/acre)</b>	<b>Tract Mean</b>
Site	1	Y	100%	VP1	N (243)	30%
	2	Y		VP2	N (121)	
	3	Y		VP4	Y (445)	
	4	Y		VP6	N (162)	
	5	Y		VP8	Y (364)	
	6	Y		VP9	Y (364)	
	7	Y		VP11	N (81)	
Reference	Ref Site 1	Unknown*	Unknown*	VP14	N (162)	(225 stems/acre)
	Ref Site 2	Unknown*		VP15	N (81)	
	Ref Site 3	Y
