Whittier Creek Mitigation Project

Year 2 (2023) Monitoring Report

Surry County, North Carolina

DMS Project ID No. 100020

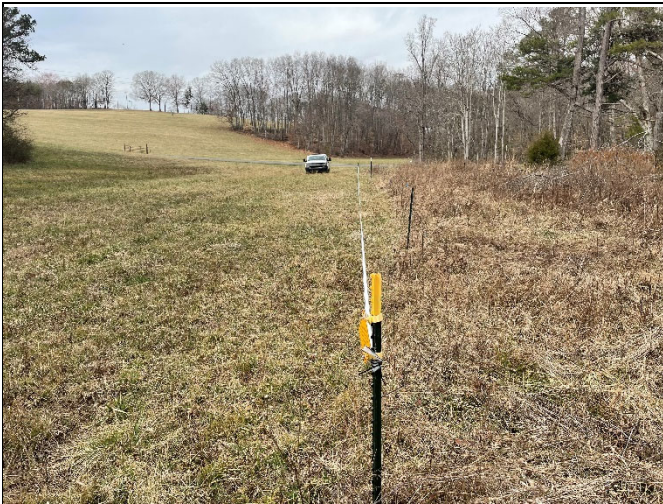
Encroachment to the CE on UT4a resolved (2/16/2023)
