**WILD MITIGATION SITE, OBIDS CREEK,
ASHE COUNTY**

Year 3 Monitoring Report

Period covered: June 30, 2005 - June 27, 2006

North Carolina Ecosystem Enhancement Program

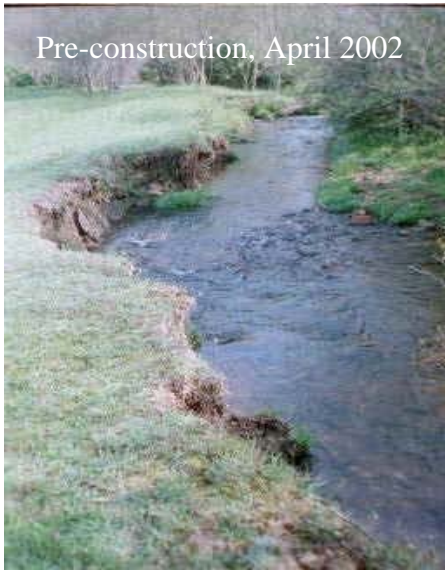
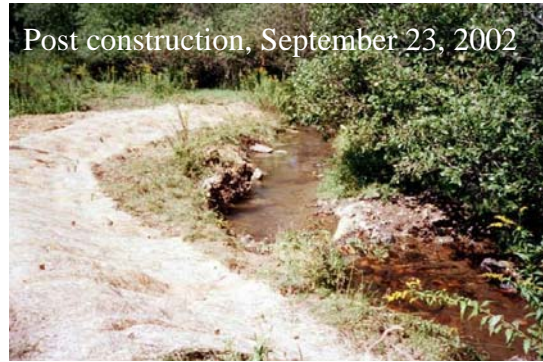
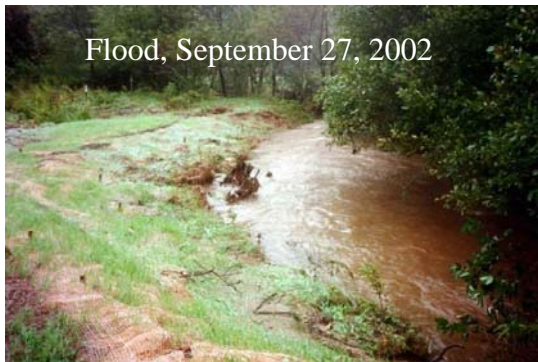
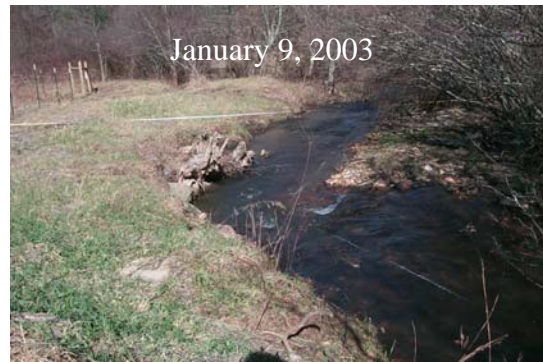
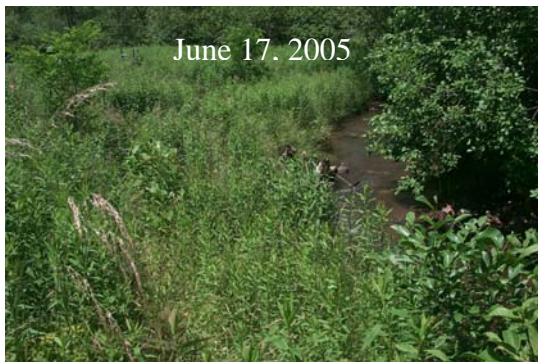
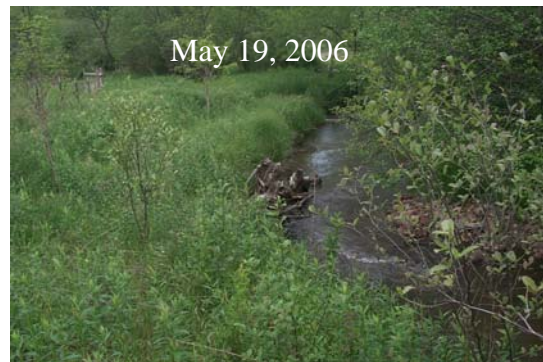
Appendix 1: Photo log of the Wild mitigation site looking downstream from station 7+75 to 8+50, Obids Creek, Ashe County, April 2002 – May 2006.

Since completion of the as-built report (Mickey and Scott 2003) Obids Creek at the Wild mitigation site has remained stable as seen in the photographic log (Appendices 1-4). There have been no bank failures or serious structural failures, except at cross-section 12+74. All necessary repair work was completed. The stream is stable and functioning properly. The riparian vegetation is thriving and helping to re-build and stabilize the streambanks.
