**WILD MITIGATION SITE, OBIDS CREEK,  
ASHE COUNTY**

Year 5 Monitoring and Closeout Report

Period covered: June 27, 2006 – December 31, 2007

North Carolina Ecosystem Enhancement Program

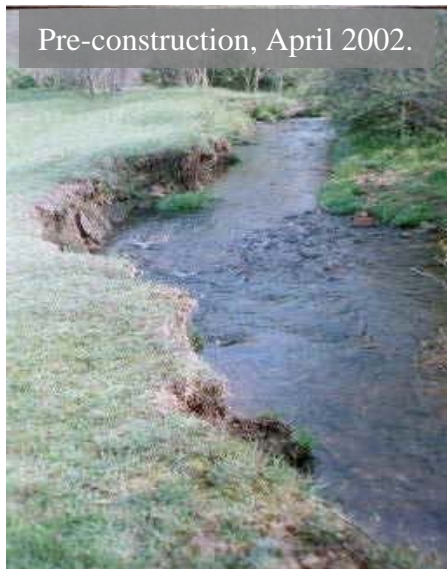
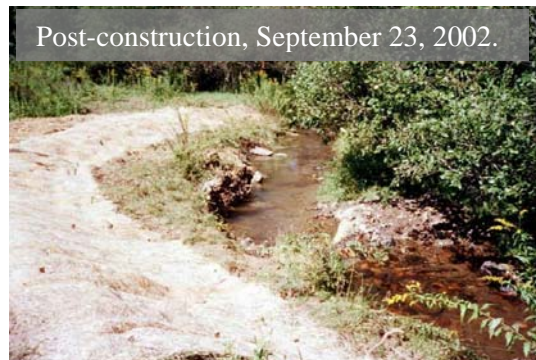
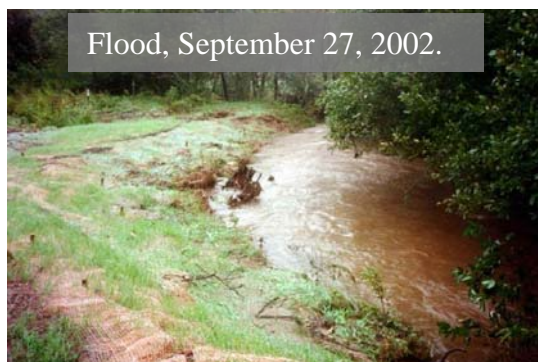
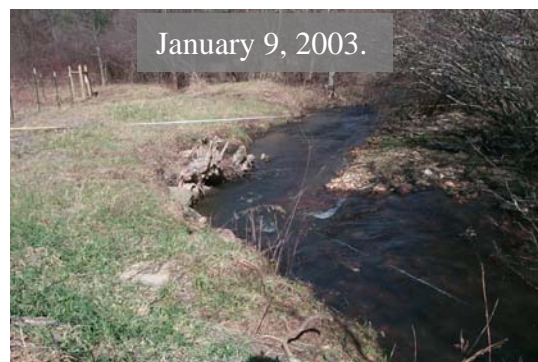
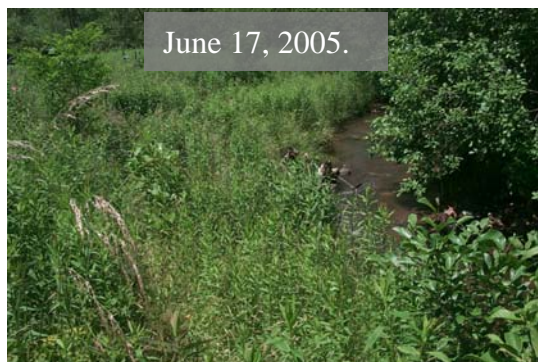
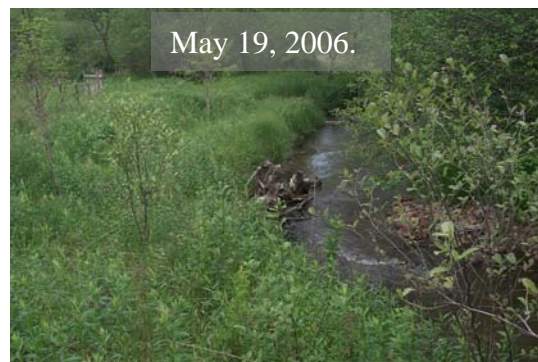
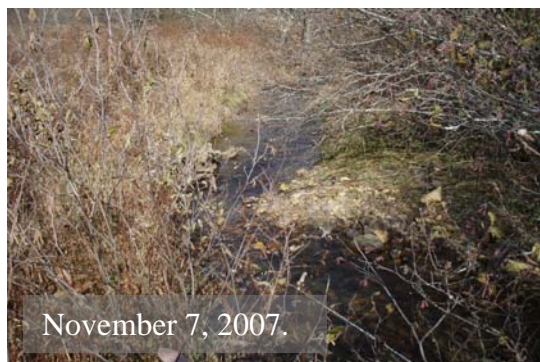
**Appendix 1: Photo log of the Wild mitigation site looking downstream from station 7+75 to 8+50, Obids Creek, Ashe County, April 2002 – November 2007.**

Since completion of the as-built report (Mickey and Scott 2003) Obids Creek at the Wild mitigation site has remained stable as seen in the photographic log (Appendices 1-4). There have been no major bank failures or serious structural failures, except at cross-section 12+74. All necessary repair work was completed in 2006, and the repairs have alleviated those areas of instability. The longitudinal profile and cross-section data, through five years of monitoring, have revealed that the stream channel and banks are essentially stable. Those areas identified as potential problem sites were not due to stream enhancement activities, but natural storm events
