Table of Contents

1.0 Executive Summary

This Annual Monitoring Report documents the results of monitoring activities during the 2011 growing season on the Wolf Pond Stream Restoration Project. Construction of the site, including planting of trees, was completed in March 2008. The 2011 data documents results from the fourth year of geomorphic and vegetation monitoring at the site.

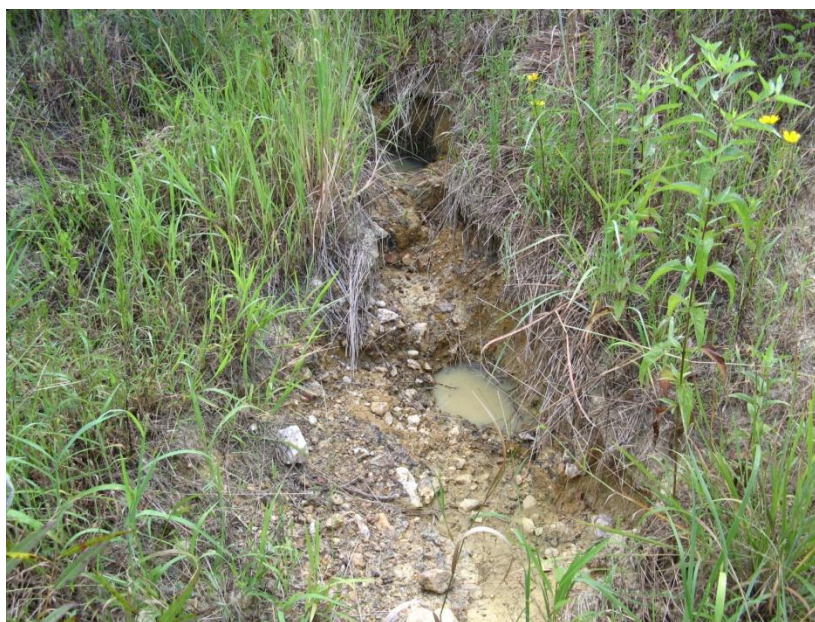
A second factor affecting the stability of the stream occurs outside of the riparian buffer on Reaches 2 and 3 where farming practices are causing an increase in sediment load throughout both reaches and impacting the morphology of the stream. The grading of the adjacent field in winter of 2010 increased the concentration of flows through swales into the reach causing erosion in a swale transecting the buffer (See photo 3.1.3-1 below). This was identified as problem area MY4 PA-2 located at station 3+29 in Reach 2.

Photo 3.1.3-1 – Eroding swale through buffer

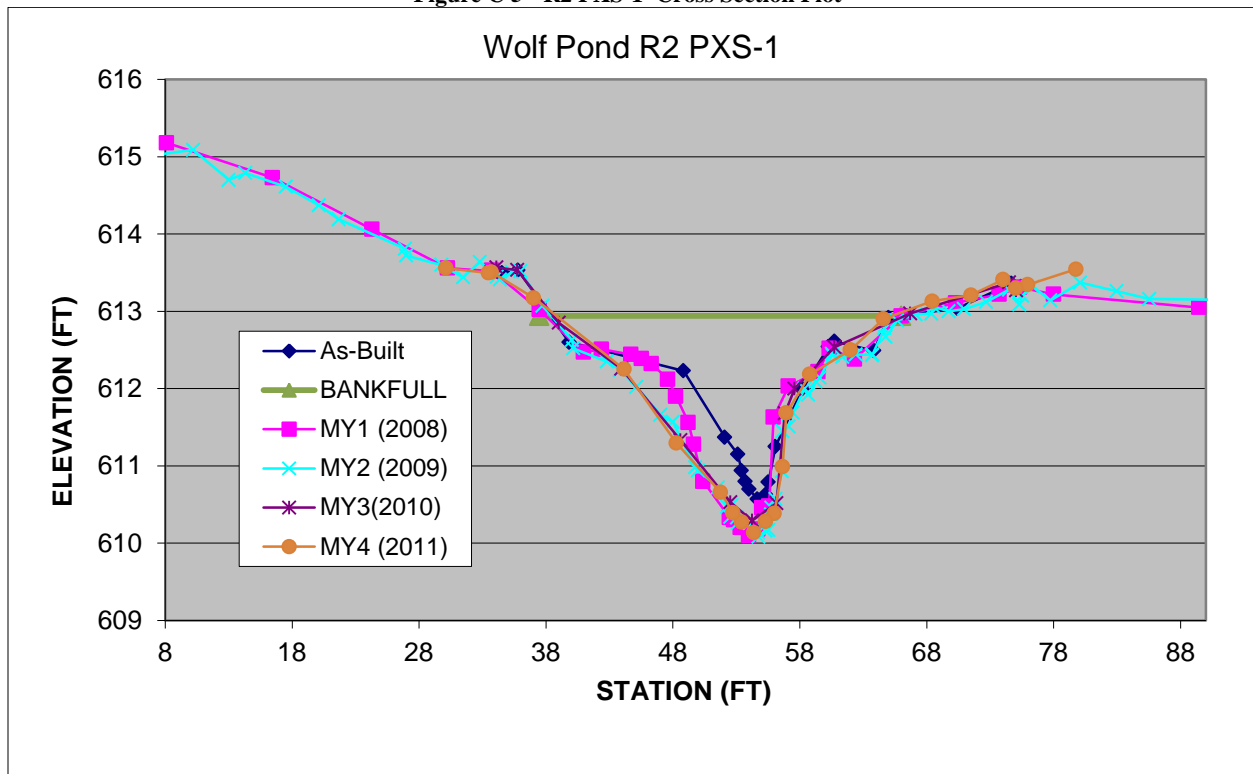
Figure C 5 - R2 PXS-1 Cross Section Plot

Problem area MY4 PA-5 is bank scour on the outside of a bend that occurs at station 108+09 in Reach 2 and can be attributed to a steep point bar on the inside of a tight radius bend. Evidence of the bank issue can be seen by the changes in WP R2 PXS-1 left bank cross section as well which is as station 108+12.

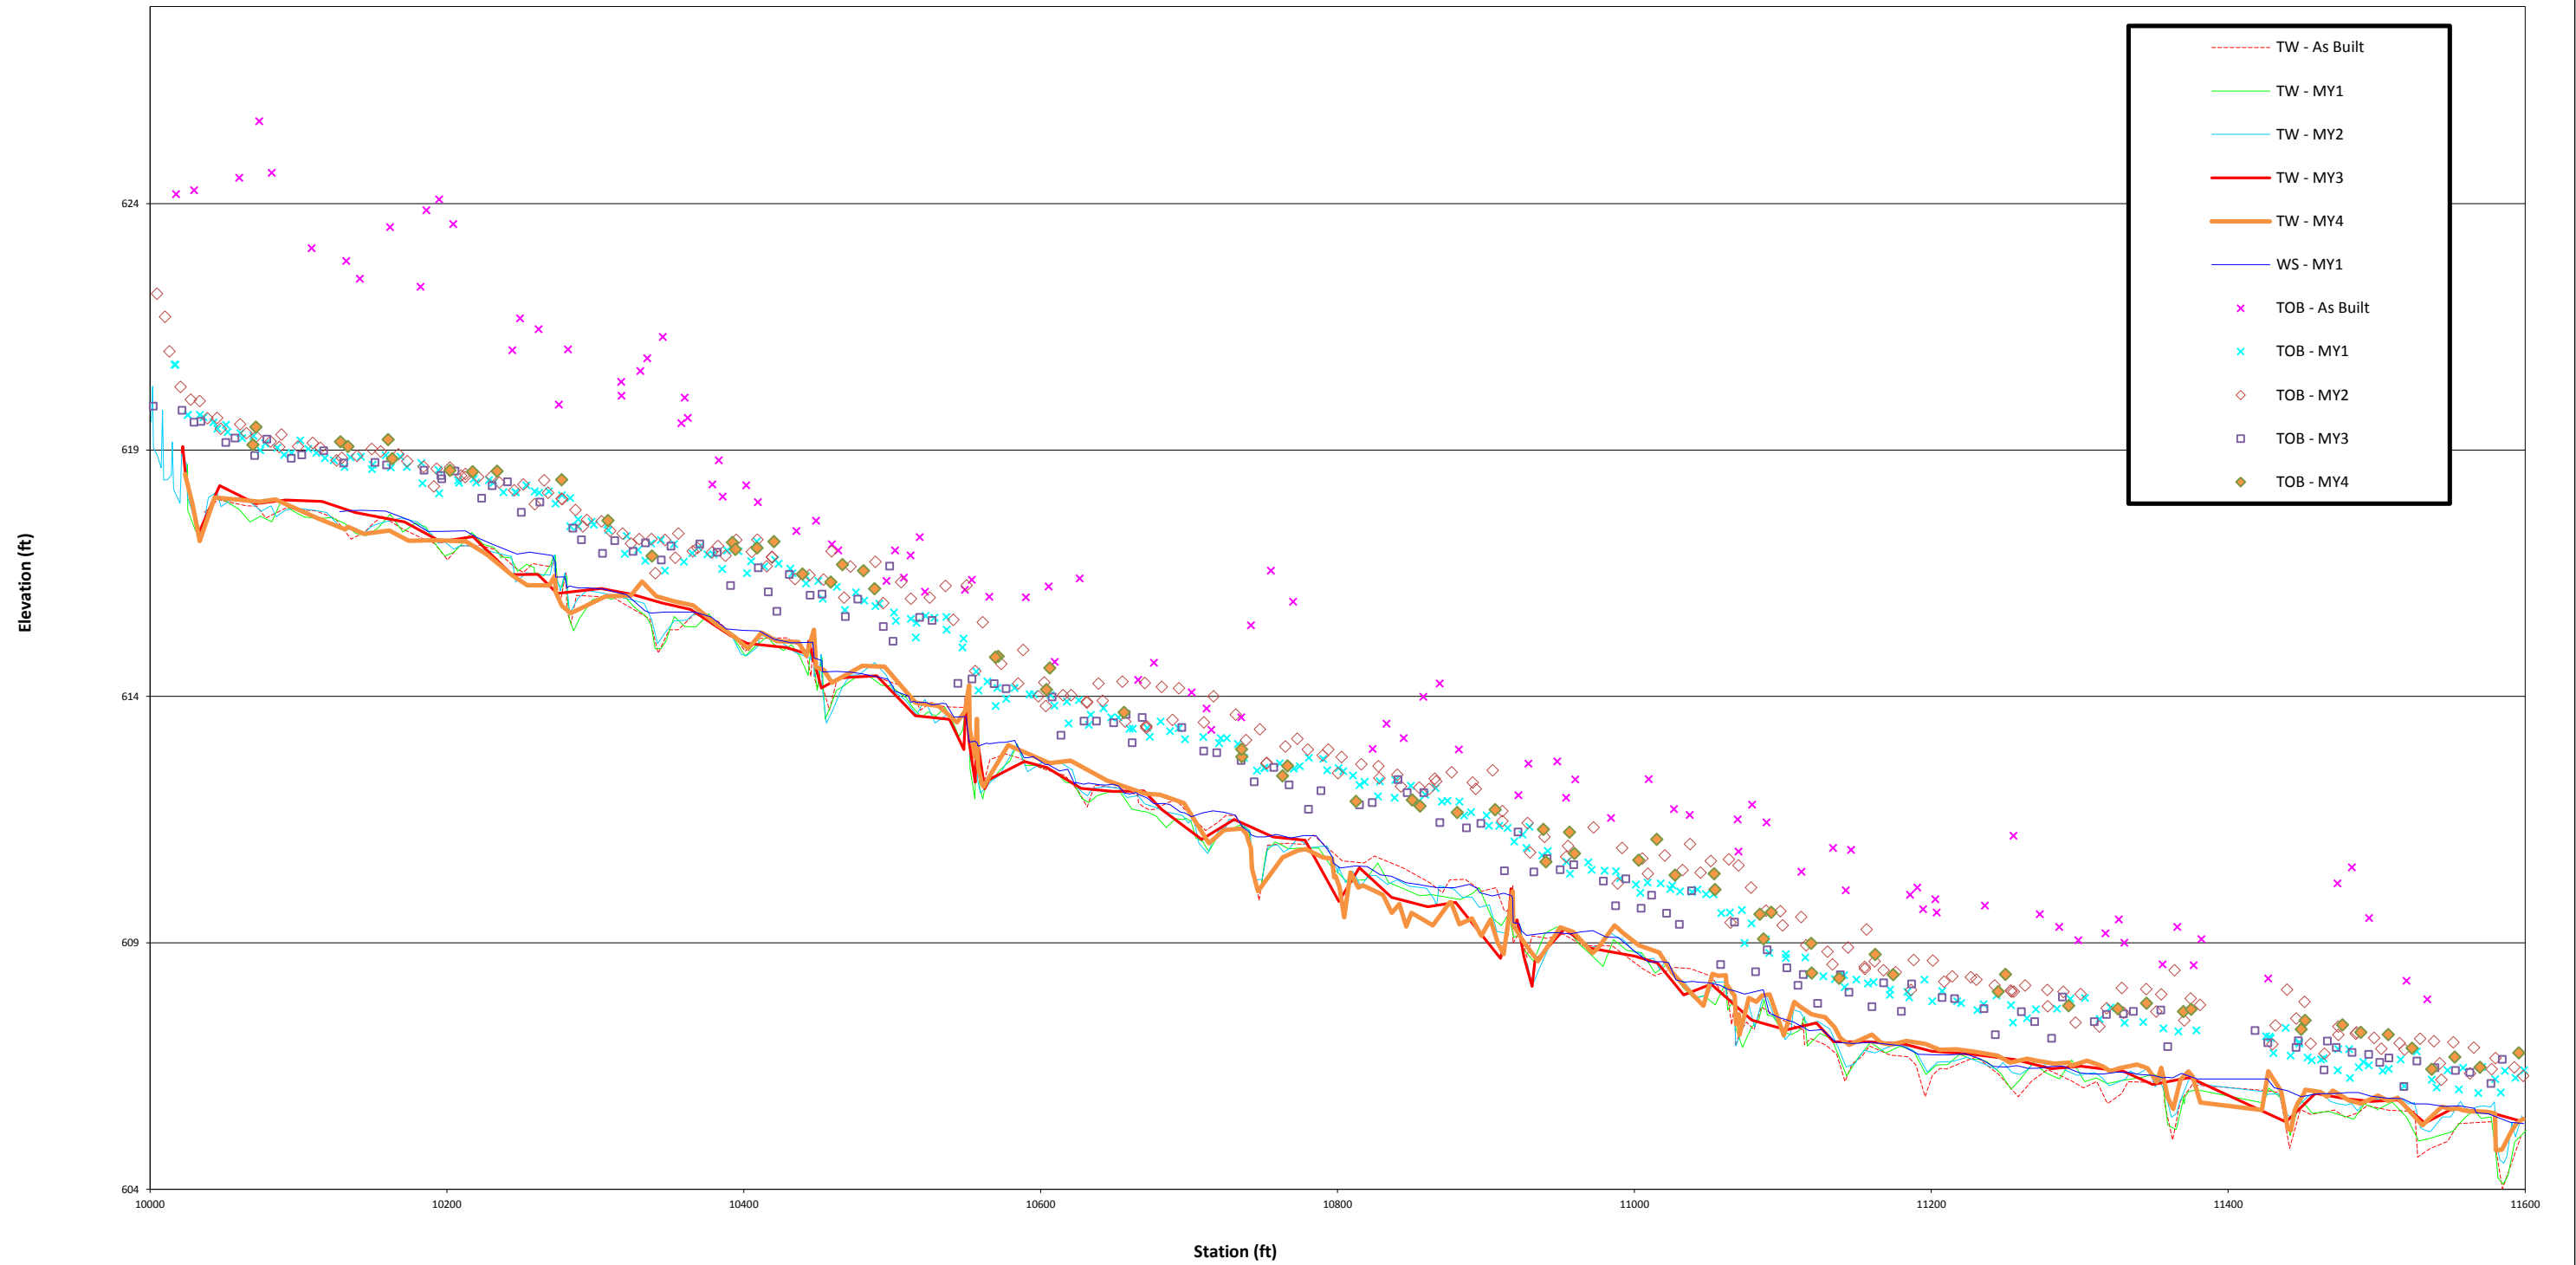
Figure C 10 - Reach 2 Longitudinal Profile

The longitudinal profile survey was conducted in September 2011, and the results are presented in Appendix C. The profile survey showed some adjustment in channel dimensions and profile. Reach 2 (R2) showed a flattening of features from station 111+50 downstream to station 116+00. This has resulted in a change in the riffle lengths, the pool lengths and the riffle pool ratio. As mentioned above, vegetation growth in the stream bed and deposition due to the backwater above culverts in this area was the cause of most adjustments. A headcut was discovered in Reach 2 at station 08+00. The headcut results from the flattening of the reach from this point downstream and is the transition from the original reach slope to the new lower slope. Note that the Elevation values for Reach 2 profile are in 5 foot increments while Reach 1 and 3 are in 2 foot increments

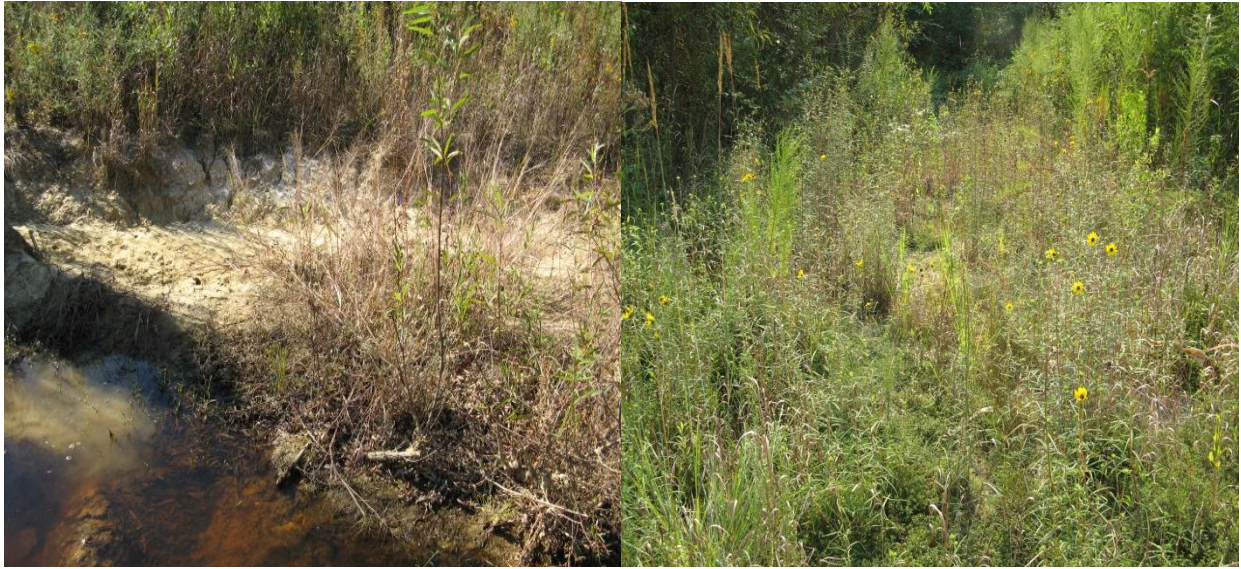
Typical Problem Area from MY3 before and after

At the time of data collection in September 2011, all four problem areas identified in MY3 2010 have had repairs made, been replanted and experienced a normal growing season. The effectiveness of these measures was good and all four areas are stable with good vegetative growth. See problem area photos for an example. Six new problem areas were observed. Five are in Reach 2 and one in Reach 1. All six problem areas will be repaired and replanted as needed during the winter/spring of 2011/2012. See discussion in Morphology Results above.
