Table of Contents

1.0 Executive Summary

*Wolf Pond Mitigation Site
Annual Monitoring Report for 2012 (Year 5)*

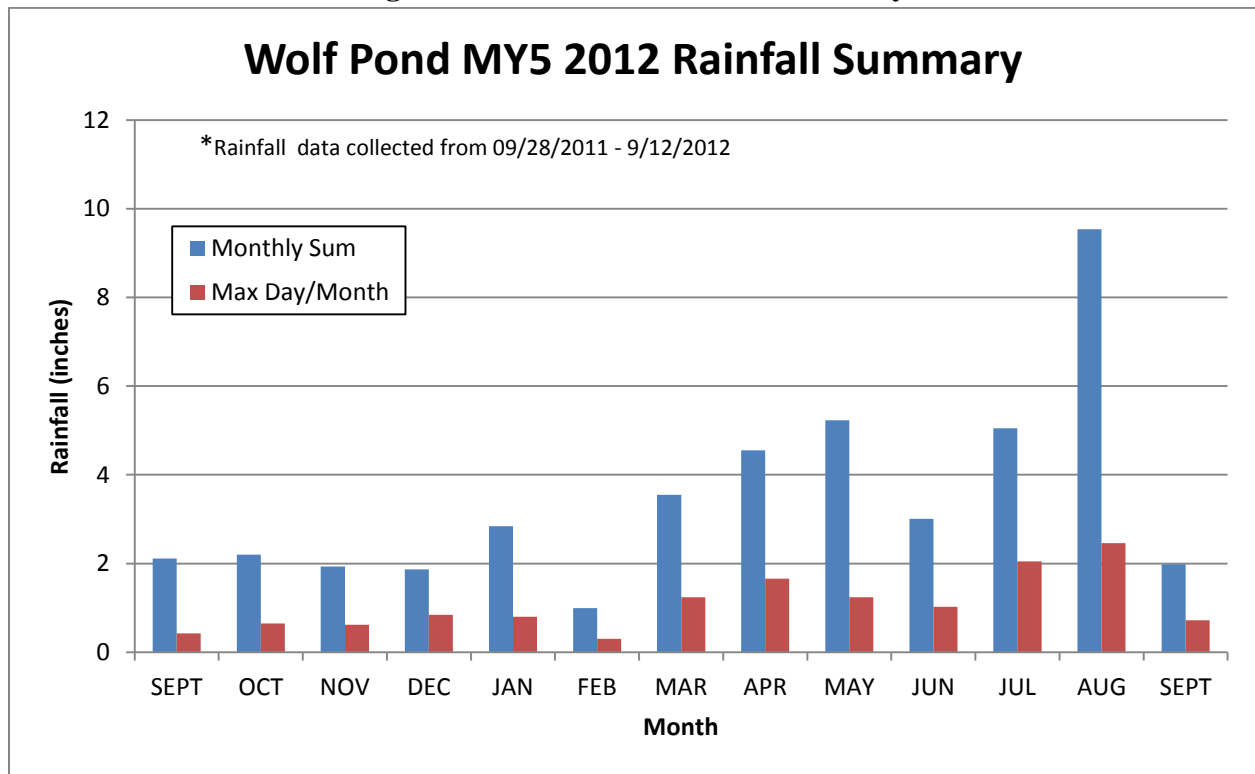
Figure 2 – MY5 Rainfall Data Summary

Rainfall data is collected by an automated rain gauge, confirmed with a manual rain gauge and calibrated by comparison with nearby NOAA rain data. The data shows that a normal rainfall amount of 44.85 inches occurred at this site for the entire monitoring period. The average monthly rainfall for the 2012 growing season was 3.45 inches with a maximum of 9.54 inches occurring in August. The average maximum single day amount per month was 1.08 inches with a maximum of 2.46 inches occurring in August. Complete daily rainfall data is shown in Appendix F.

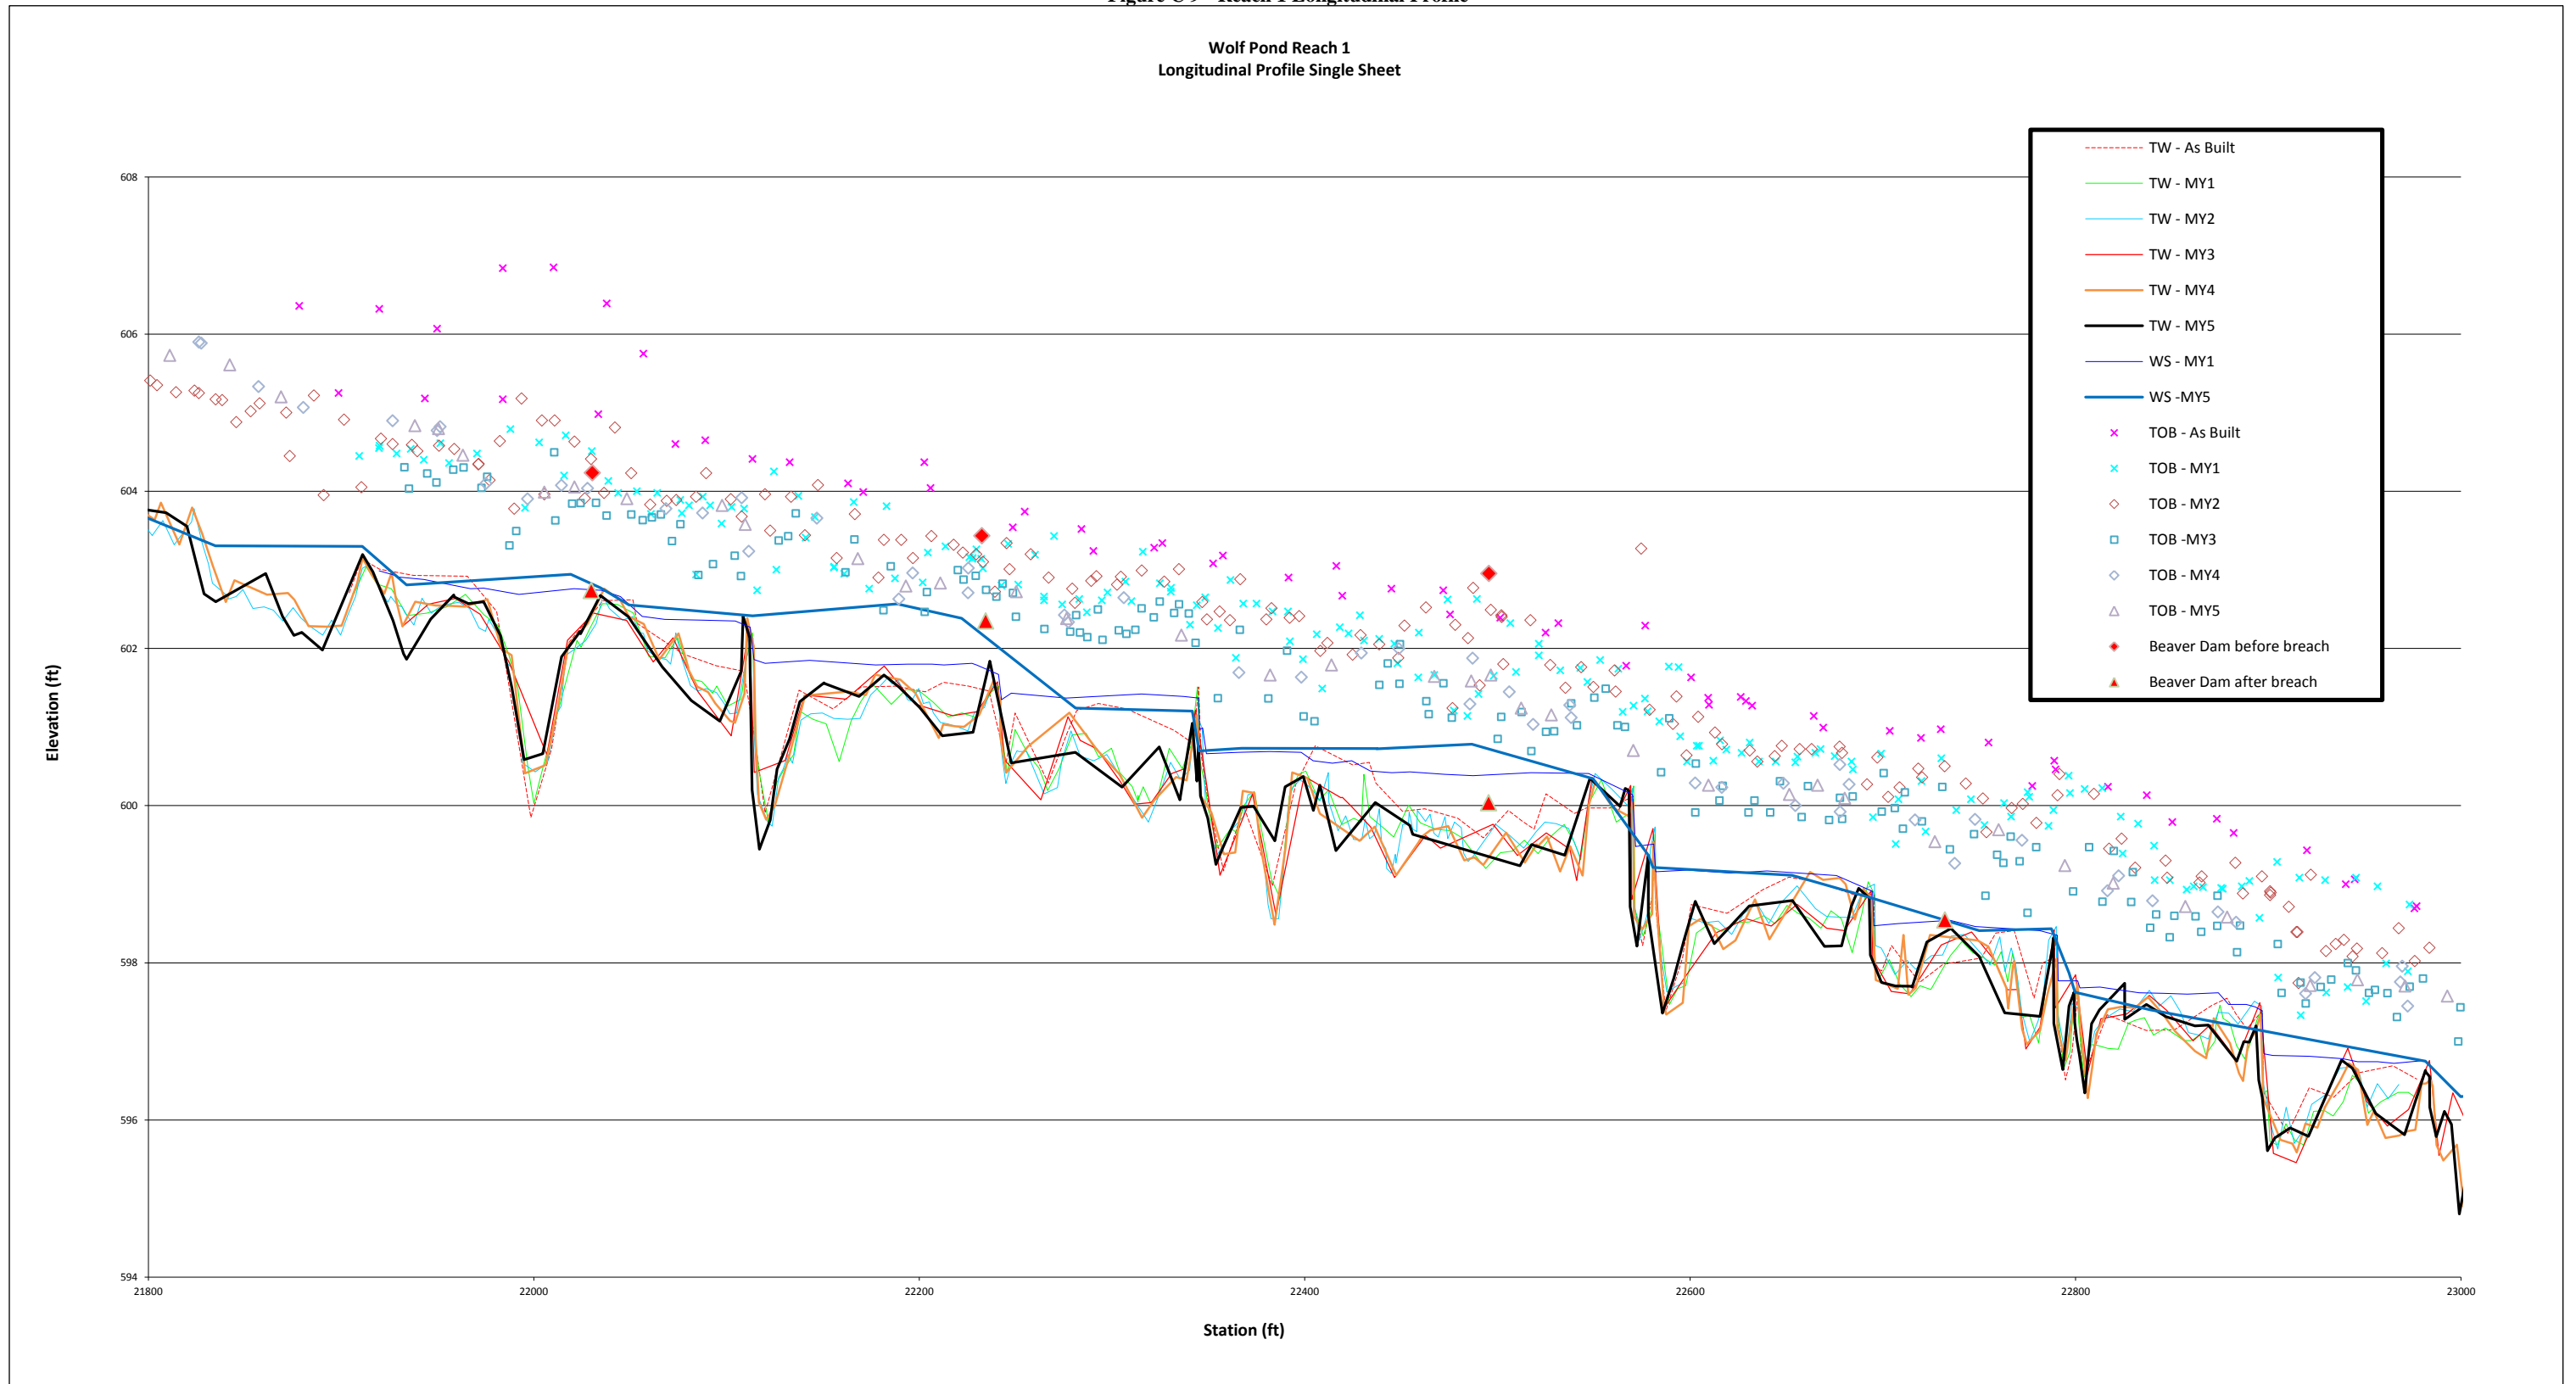
Figure C 9 - Reach 1 Longitudinal Profile

There has been a rapid influx of beavers (*Castor canadensis*) in Reach 1. Five beaver dams were breached during the fall survey. Major dams are noted in the reach profiles in Appendix C.

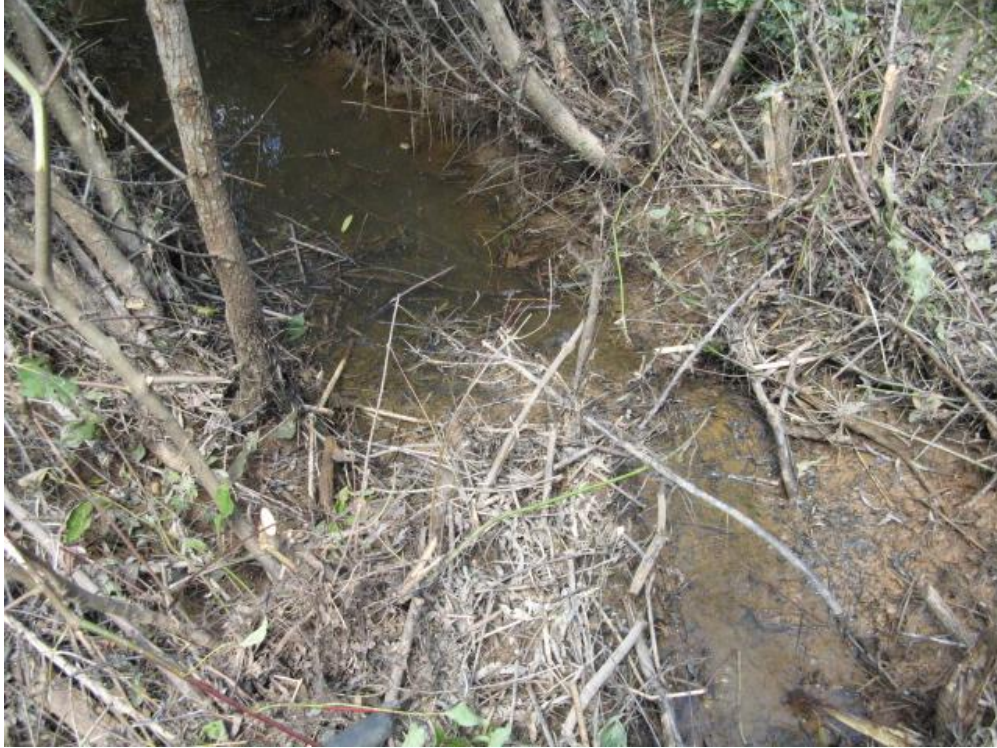
Photo Point 27 (sill is under beaver dam)

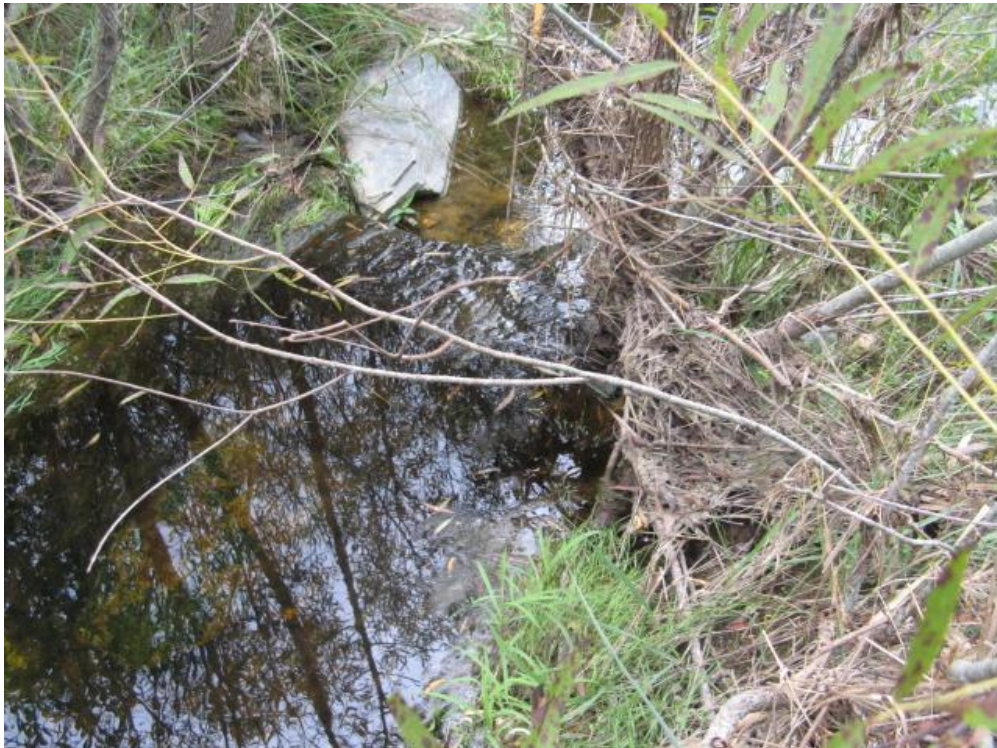
Problem Area MY4 PA-4

MY4-PA4 is left bank scour and a cutoff channel around the right arm of a cross vane in Reach 2 caused by a willow growing just upstream of the vane. Debris has built up the right bank of the vane arm (as it is designed to do) and the problem has stabilized although the scour wall is still there. The offending tree will still need to be removed.
