**MITIGATION REPORT
FOR
ZACKS' FORK CREEK STREAM RESTORATION**

**LENOIR, CALDWELL COUNTY, NORTH CAROLINA
CONTRACT # AW03003-A**

Revised: February 14, 2008

ZACKS FORK CREEK
November 29, 2006 Site Inspection

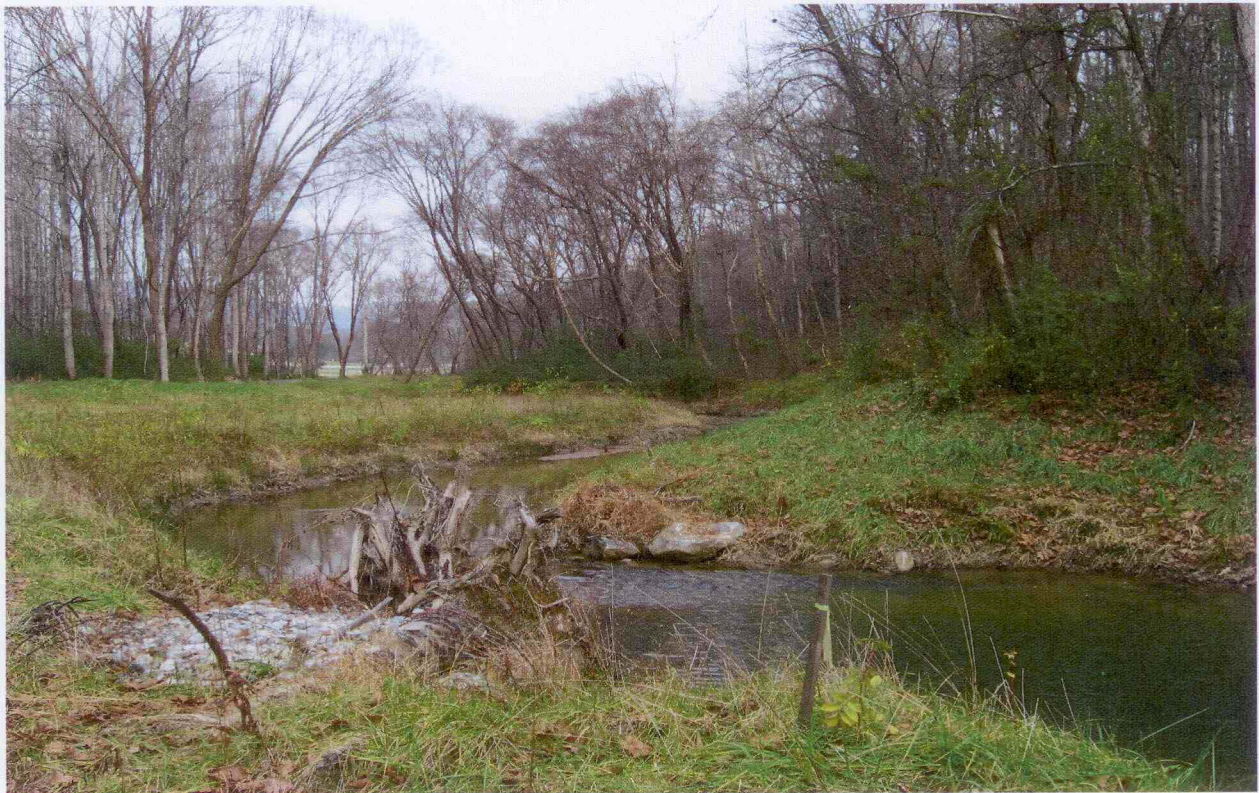
Picture 772

765	Looking downstream @ Station 37+00
767	Looking downstream @ Station 38+50
772	Looking upstream @ Station 45+50
774	Looking downstream @ Station 47+50 (last structure – Cross Vane) (Erosion at connection to bank to be addressed in Dec. 2006 Monitoring Report)
780	Looking downstream @ Station 49+00 (existing channel)
