Zacks Fork Creek Stream Restoration Monitoring Report

Monitoring Year: 2008
Measurement Year: 3
As-Built Date: 2005
NCEEP Project #: AW03003A

Submitted on December 17, 2008
Revised on February 4, 2009

Prepared by: Environmental Services, Inc.
524 S. New Hope Road
Raleigh, NC 27610

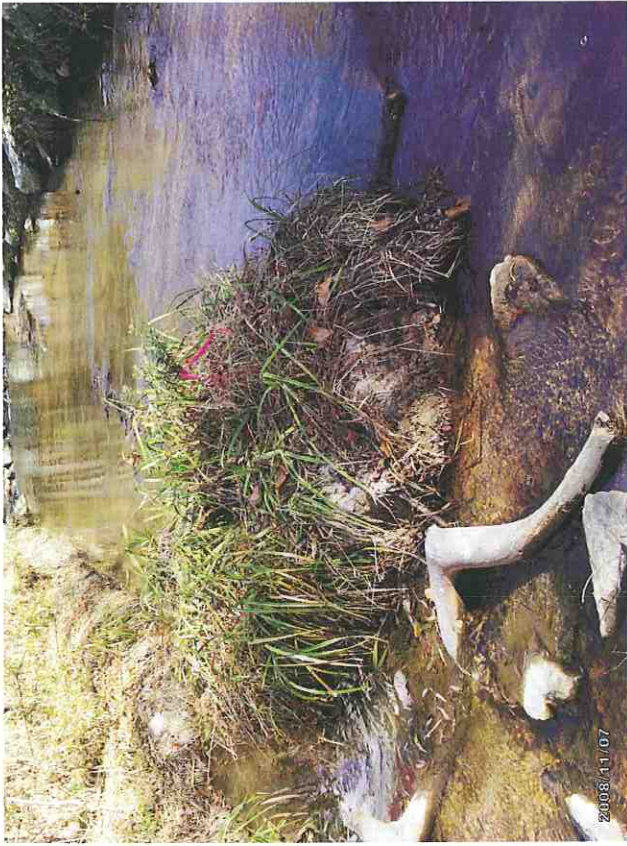
Problem Area 1 - vegetated mid-bar

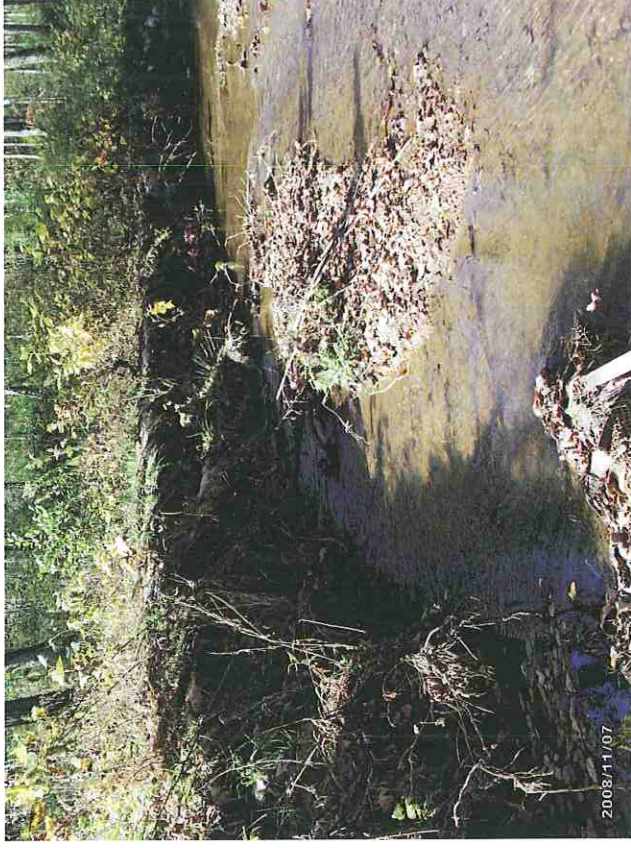
Problem Area 8 - mid-bar and active bank erosion

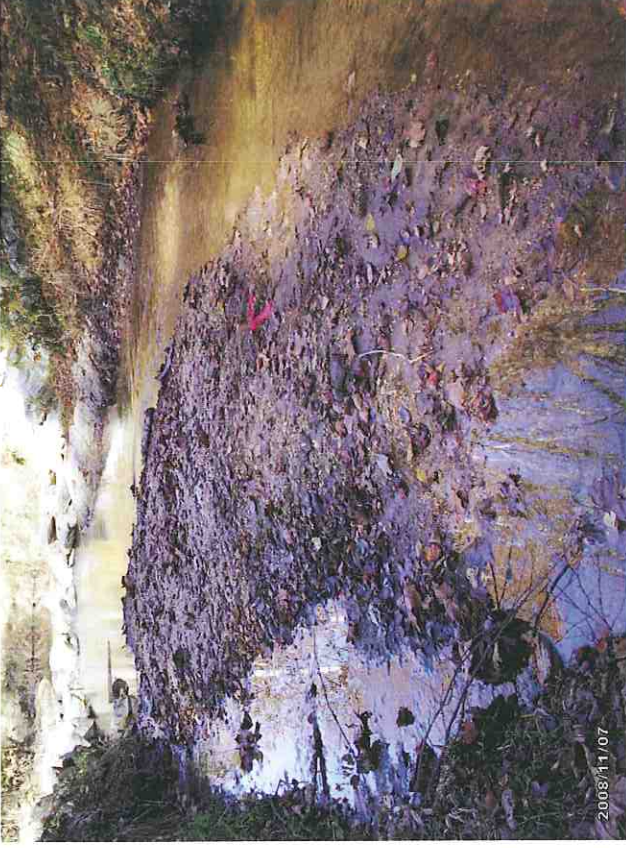
Problem Area 10 - mid-bar accreting
