Pond Haven Buffer Restoration Site

**Year 2 Monitoring Report
Granville County, North Carolina
Tar-Pamlico River Basin - 03020101**

**DMS Contract 7873
DMS Project Number 100118
DWR Project Number 20190646**

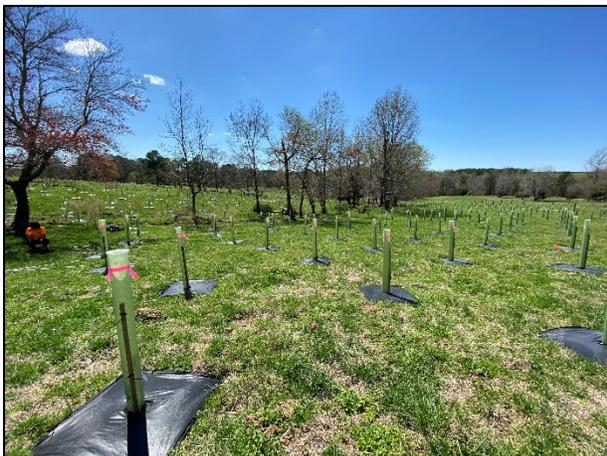
Plot 6 MY00 – 3/30/2021

- Suggest adding a random plot or two next to fix plot #6 to demonstrate if this is an isolated area of lower density.
KCI Response: Plot R4 will be placed near Plot F6 in MY03 to check the density and species composition of this area.
