BEAVERDAM CREEK WATERSHED PLAN

Funded by: North Carolina 319 Program
Grant Applicant: Watauga River Partners

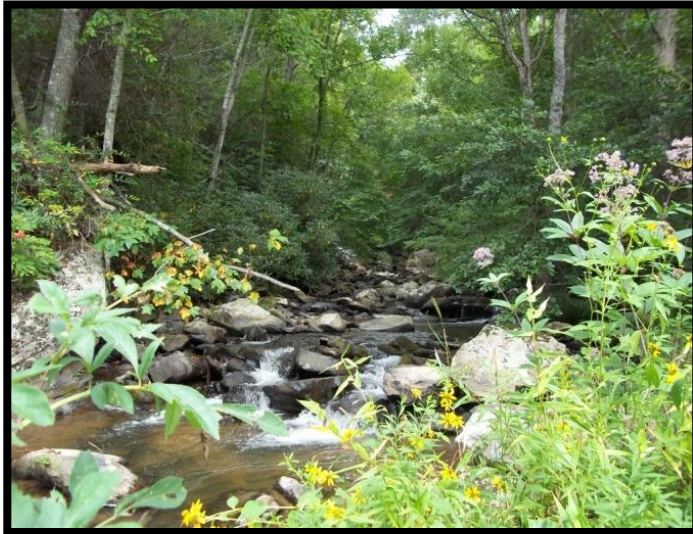
Beaverdam Creek at the Confluence with Watauga River.

The project team conducted a site visit to the confluence to determine its characteristics: the sediment load in this portion is illustrative of conditions and the overall health of the water in the watershed upstream. Beaverdam Creek at this location is a high-gradient (steep) stream with sandy sediment evident. High amounts of deposition were noted here, indicating sediment travelling from upstream. This section of the creek does not evidence much erosion and has mostly native plants growing along the banks (see photo at left). The team noted the presence of invertebrates that indicate good water quality such as stoneflies and mayflies. However, some algae were also present as well as foam, most likely from the presence of phosphorous.

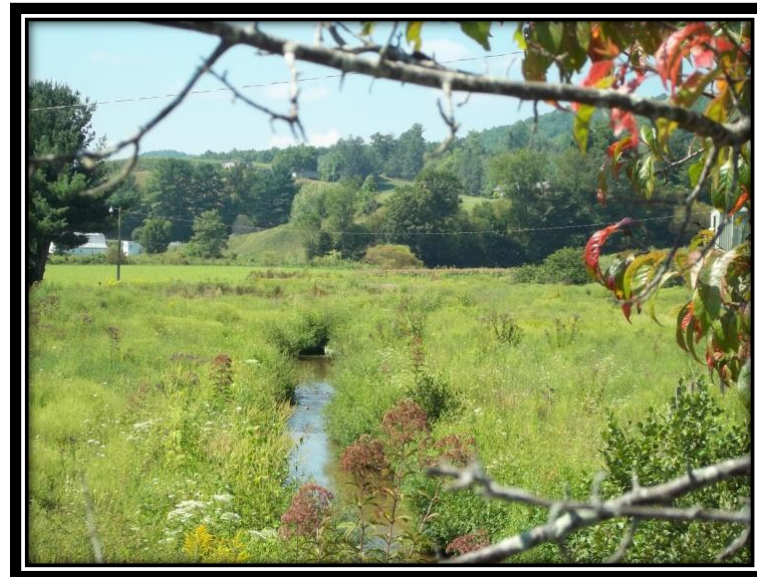
A mature meadow along the stream acts as a buffer and helps to stabilize the streambanks.

The lack of riparian buffers is a significant factor leading to erosion: native woodland and herbaceous plants help to reduce sedimentation by stabilizing banks with their roots as well as remediate pollutants before entering the stream. As landowners mow or allow cattle to graze up to the edge of the water, the stream will lose native plants that stabilize the bank and eventually begin to lose land to erosion.

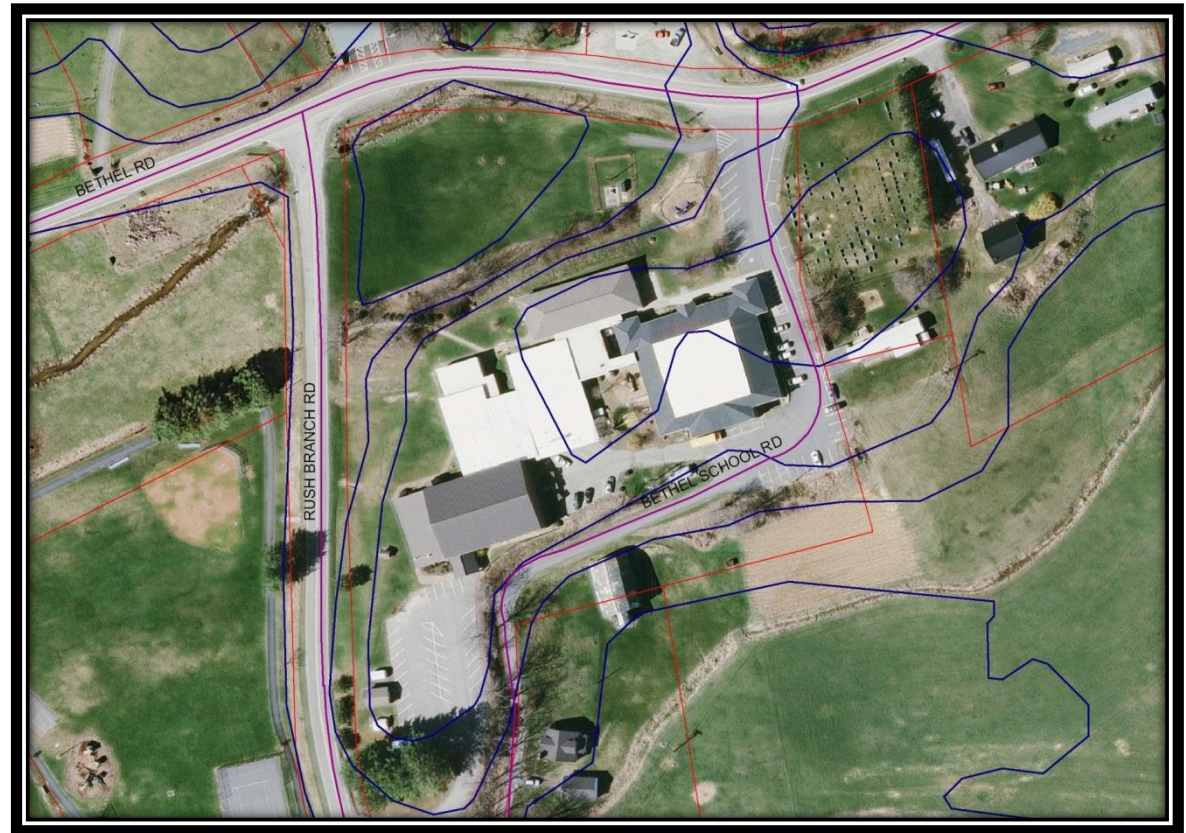
Figure 8: Aerial photo of Bethel Elementary School showing extent of rooftops and parking with contours shown in blue.

The local elementary school has the largest concentration of impervious surface in the watershed including the rooftop and parking lot. Built upon a steep slope, the school is challenged with significant stormwater issues from eroding slopes to sediment deposition. Kids using the playground must walk through the storm drain creating a potential safety issue. The project team is recommending measures to help slowly filter stormwater before it drains through culverts and into Beaverdam Creek. One proposed measure is a large rain garden, or bioretention swale to capture and treat stormwater coming from the building's rooftop. Students at the school have already begun working with County Extension Agent, Wendy Patoprsty, to determine the amount of rain water coming from the rooftop.

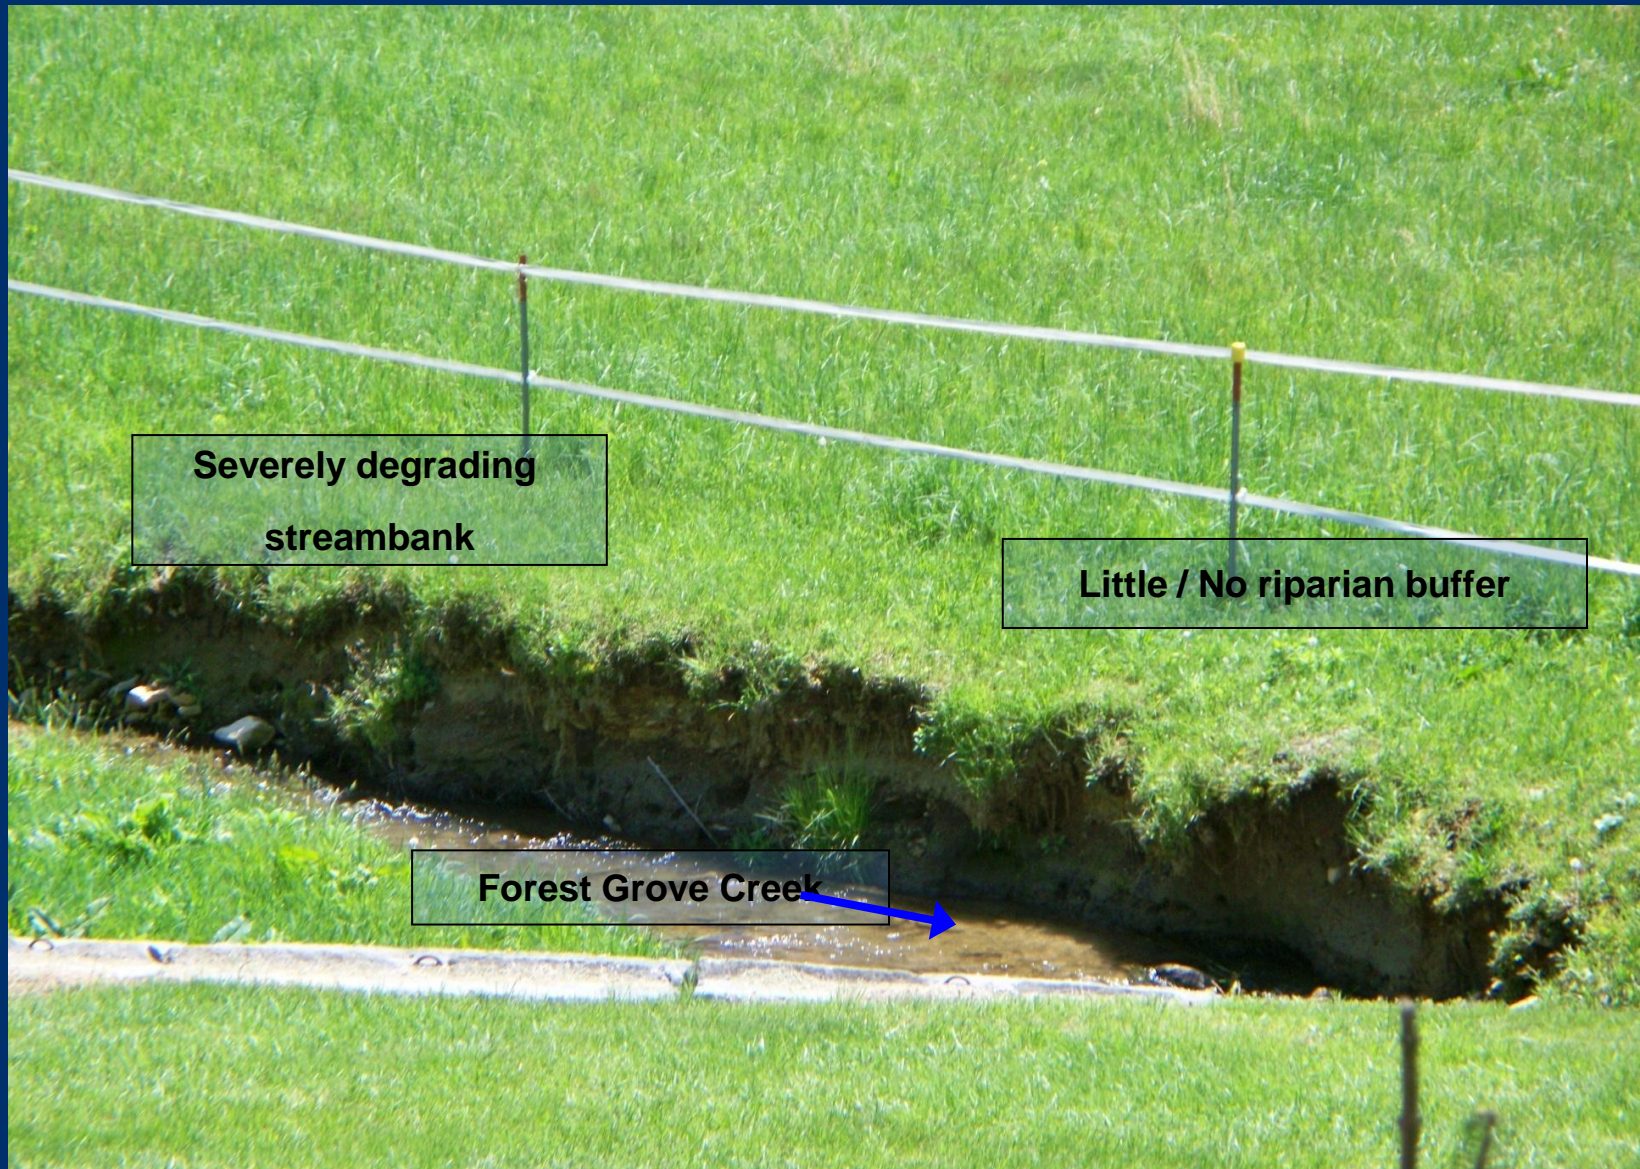
Forest Grove Creek

**Severely degrading
streambank**

Little / No riparian buffer
