Aluminum Box Culverts with Bottoms Review

North Carolina Department of Environment and Natural Resources

Division of Water Quality

February 2012

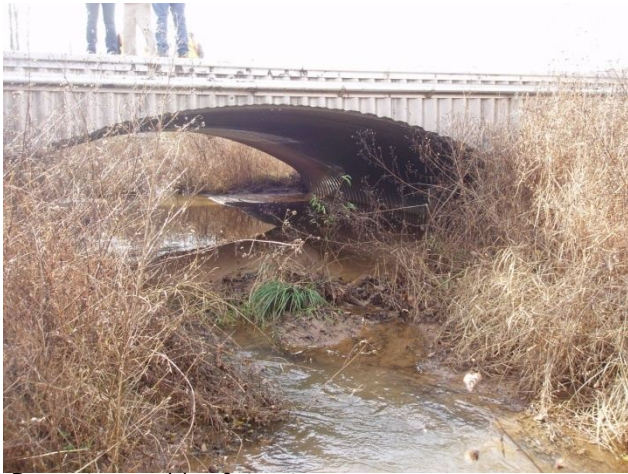
Downstream side of structure

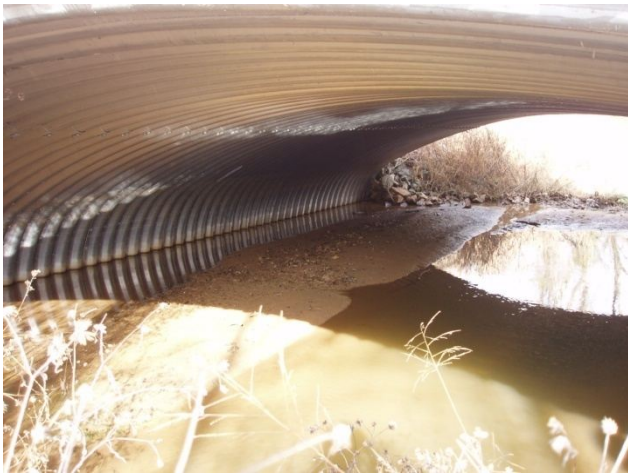
Downstream through structure

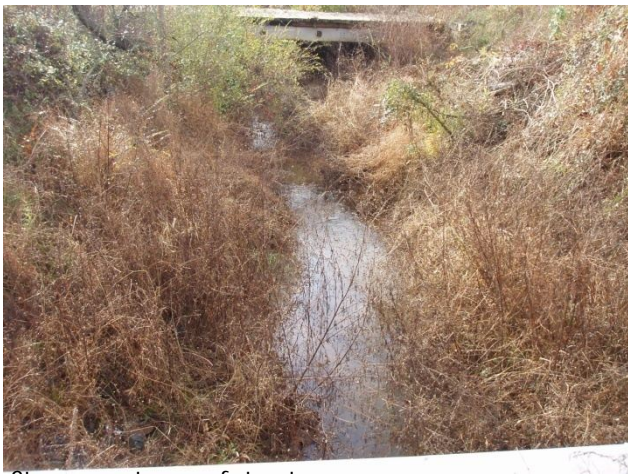
Stream upstream of structure

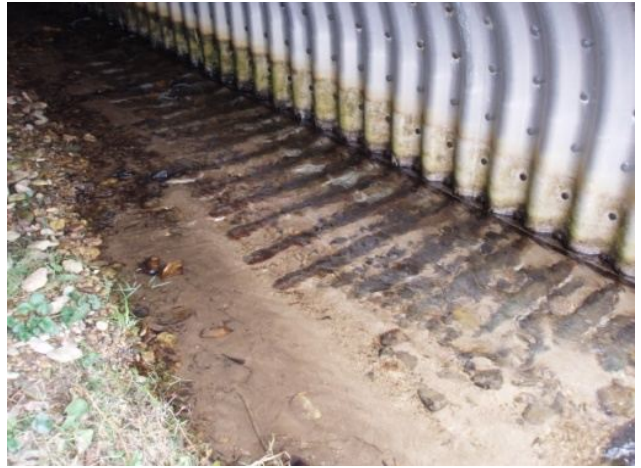
The natural channel width is approximately four feet. The stream widens out to approximately 14 feet in the area excavated at the inlet. The flow enters the culvert on the right side against the wall. Within the first few feet of the inlet of the culvert, the water becomes very shallow (approximately two-inches) and sheet flows down a shallow slope to the left side of the culvert against the wall where it reconcentrates and continues to flow against the wall until exiting the structure.

Main flow at outlet of structure

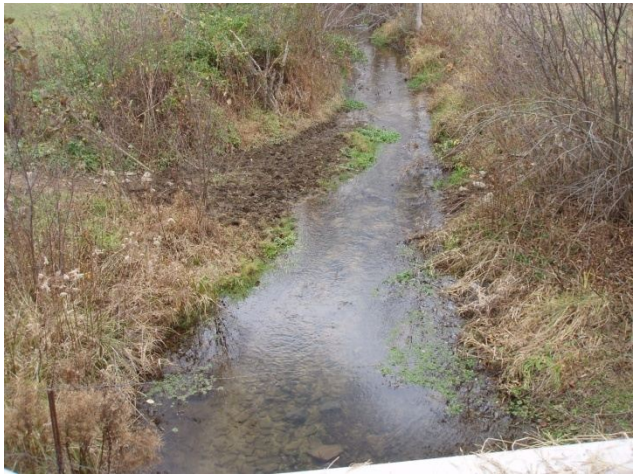
There was a small amount of riprap placed on the banks for stabilization and the banks appeared to be well vegetated and stable. There is an active horse pasture on the northeast and southeast side of the crossing. As observed during the visit, the horses access the pastures on both sides of the stream by crossing through the stream. While the horse crossing was muddy, it did not appear to be affecting stream or bank stability. There are no signs of scour at either the inlet or outlet headwalls of the structure. Some floodplain does exist, but would most likely only be accessible during higher flow events.

Upstream of structure (horse crossing on left side middle)

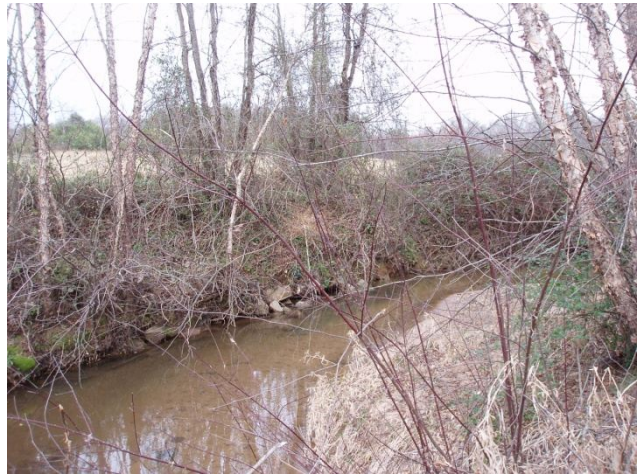
Upstream of structure

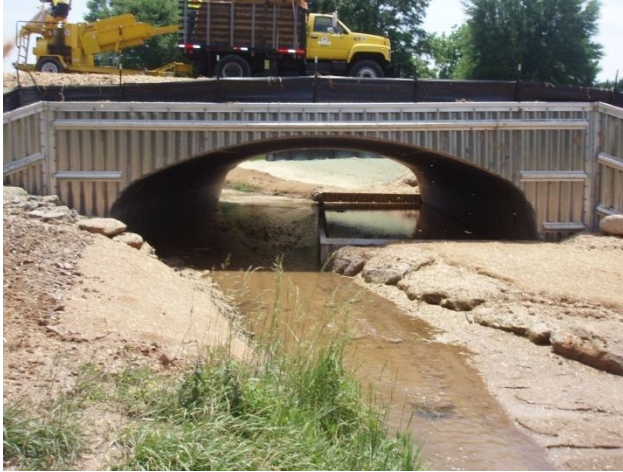
Inlet of structure (under construction)

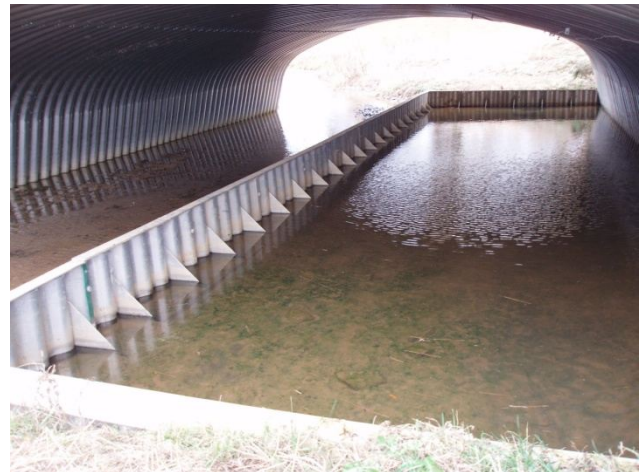
During construction, the structure was buried and backfilled with approximately fifteen-inches of native material backfill, which is sand with pebbles. The bottom of the culvert was not visible at any point. Unique to this structure is a knee wall. This wall is a three-sided piece attached to the wall and floor of the structure and occupies about half the floor of the structure and is about three feet tall. It is meant to act as a constructed bench. The area inside the knee wall is open, with the intent that it would fill with sediment as higher flows allow. Inside the wall there was a thin layer of sediment and several inches of water. The knee wall can be seen in the photographs included below (Figure 31).

Downstream through structure (knee wall on right)

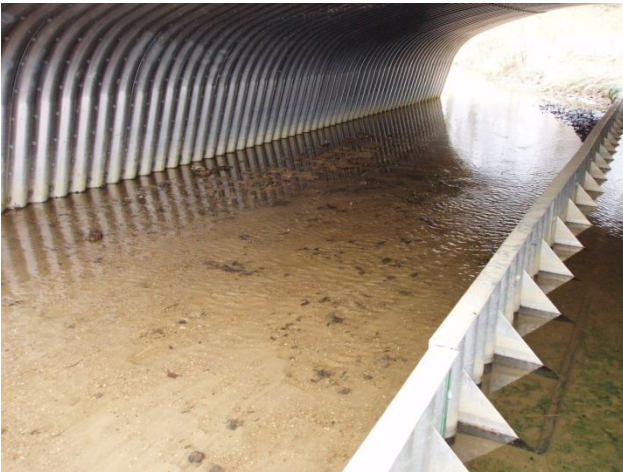
Downstream through structure

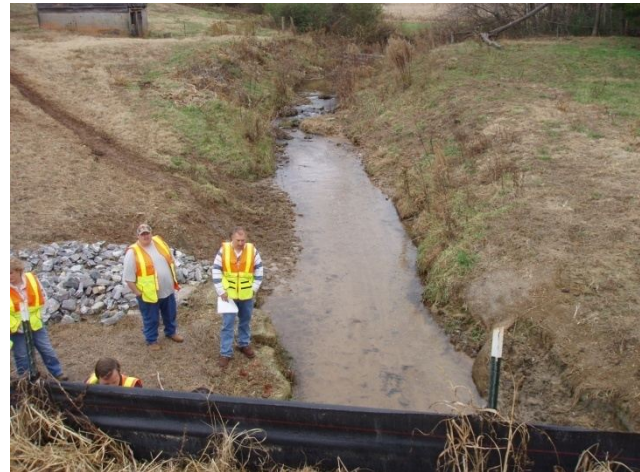
Upstream of structure

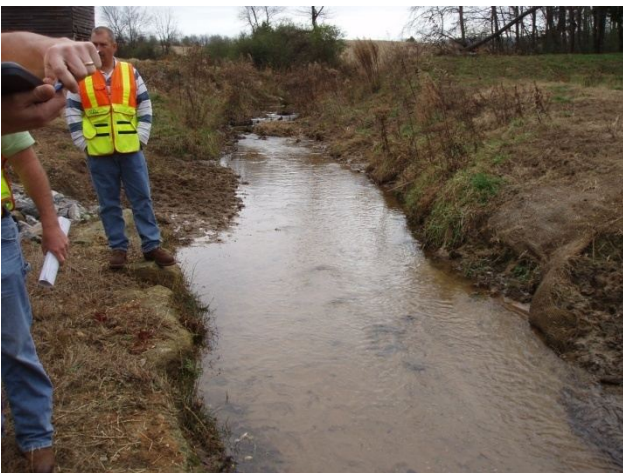
Upstream of structure

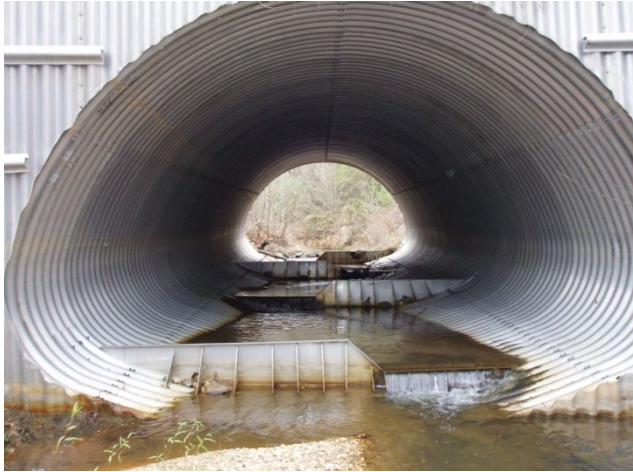
This is the only structure included in the review that has a series of baffles built into the structure. The baffles were required because of the slope of the structure (about four percent) and may have been requested by the U.S. Fish and Wildlife Service. As can be seen in the photographs below (Figure 36), the spillway portion of the baffles is twelve-inches high; the rest of the baffles are twenty-eight-inches high. The spillway portion of the baffles is approximately one-third the width of the structure. Water was observed spilling over the baffles. The structure is located on Zilpher Creek, approximately 0.16 miles upstream of the confluence with the Dan River. As a result, the creek occasionally receives flooding from the river. Waterlines and staining on the walls indicate that water depths have reached six feet numerous times, and have reached as high as ten feet.

Upstream through structure

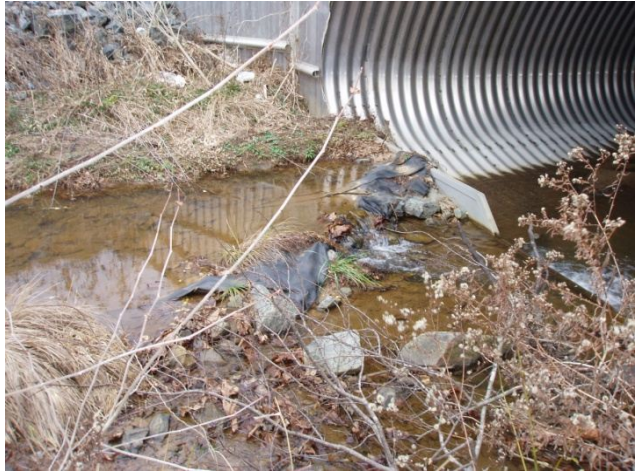
Intlet of structure

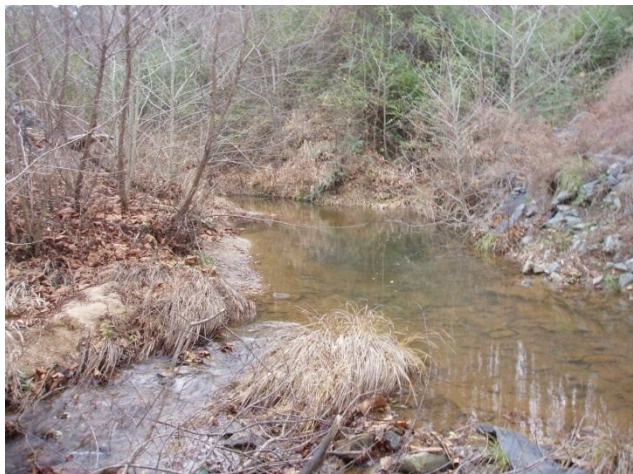
Upstream of structure

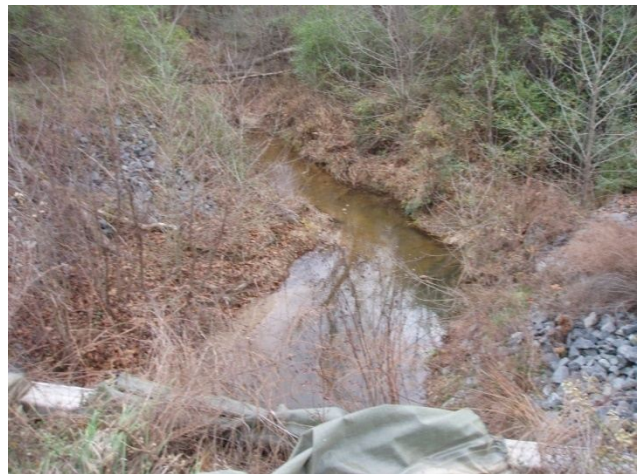
Upstream of structure

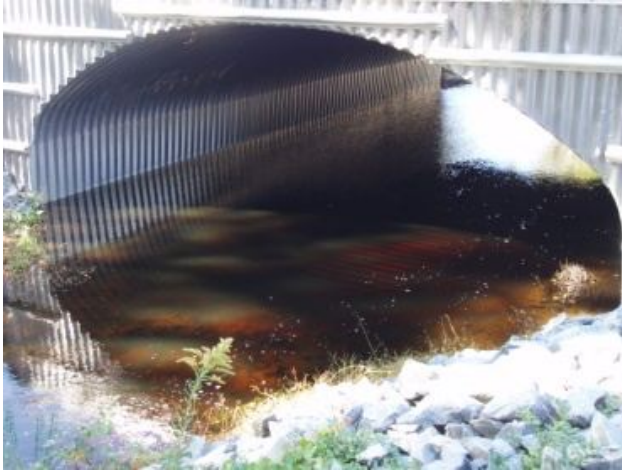
Outlet of structure

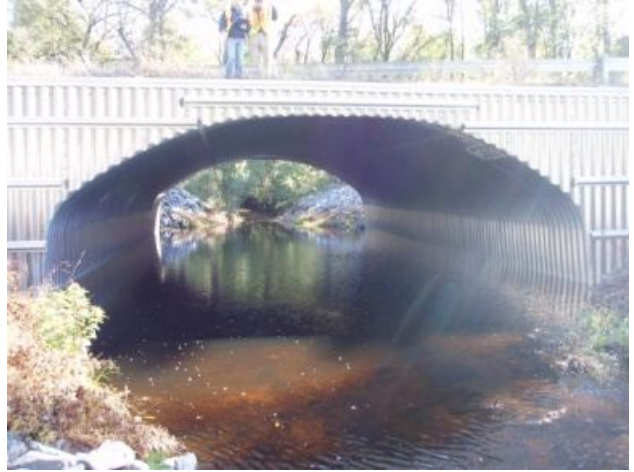
Inlet of structure

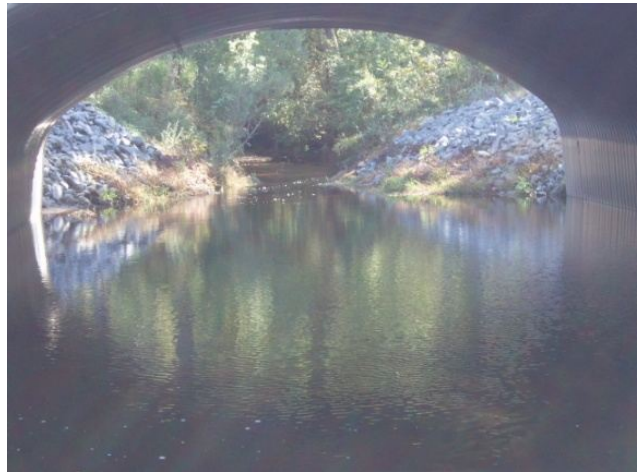
Upstream through structure

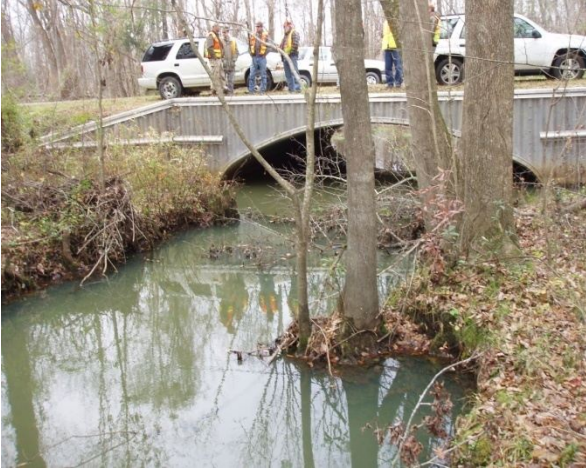
Outlet of structure

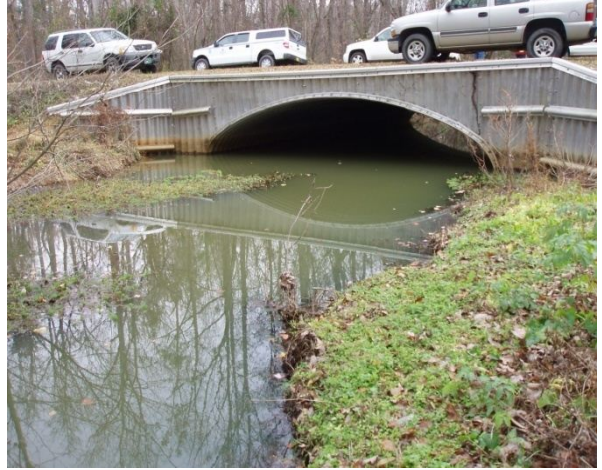
Inlet of structure

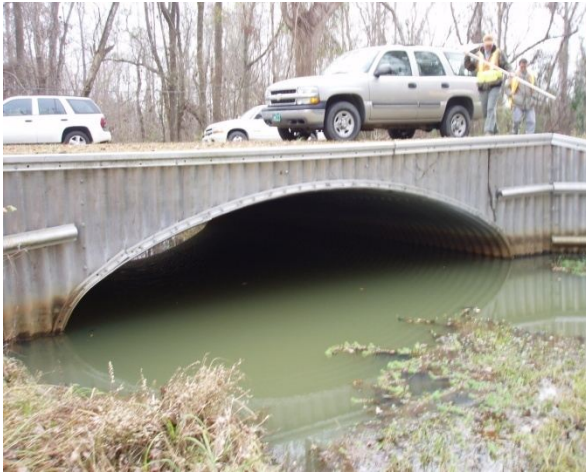
Inlet of structure – no fill against headwall

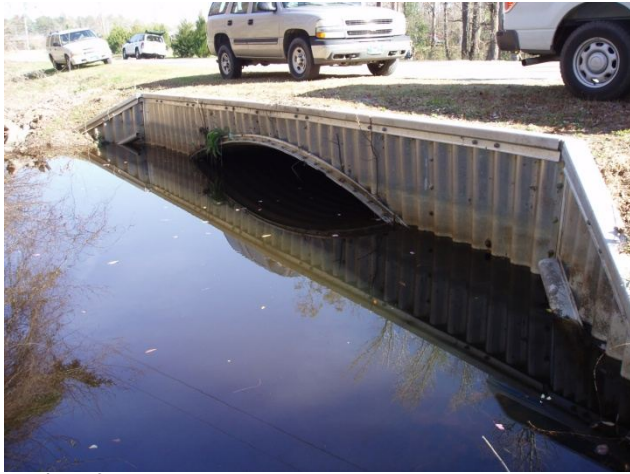
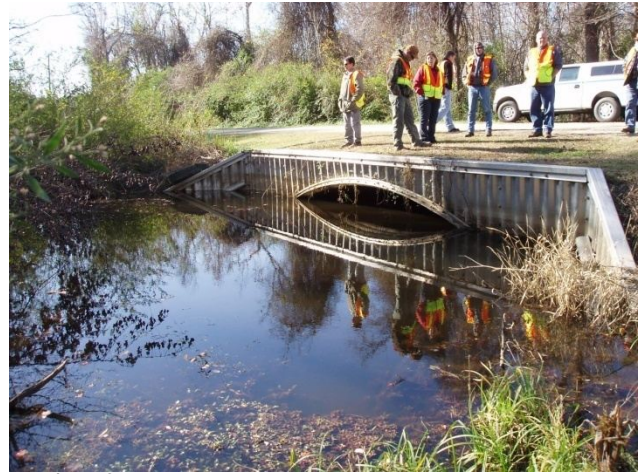
No rip-rap was noticed on the upstream side; however, a small amount of marl was placed on the outlet side of the structure for bank stabilization. The banks appeared stable and well vegetated. The area is very low with a nice floodplain that could easily be accessed when necessary. Scour was not observed at the headwalls. However, as can be seen in the photographs of the structure presented below, no fill was placed at the headwall to bring the banks even to the existing bank or the structure opening.

Inlet of structure

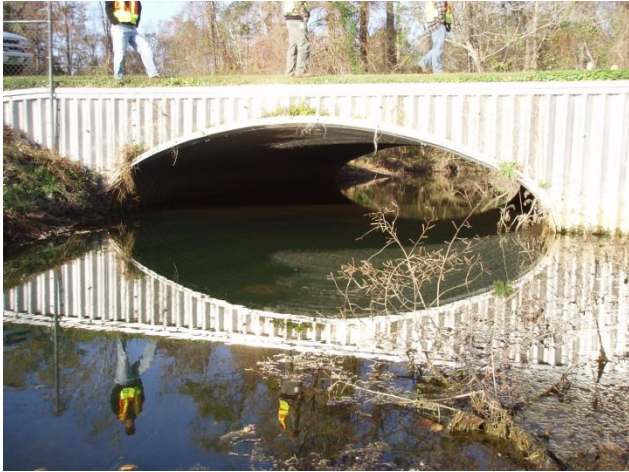
The banks on the right side of the stream at the headwall on both the upstream and downstream side did not have fill placed up to the opening. Since this situation is common to both sides, it is doubtful that it is due to scour and most likely a relict condition from the previous structure. The left banks do not show any signs of scour and do have fill to the opening.

Inlet of structure

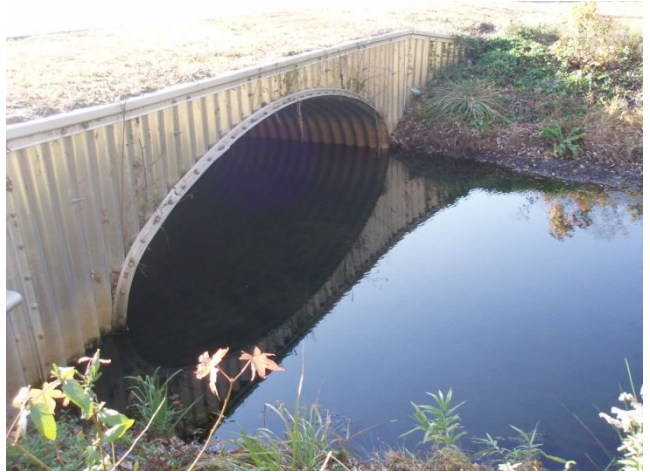
Outlet of structure

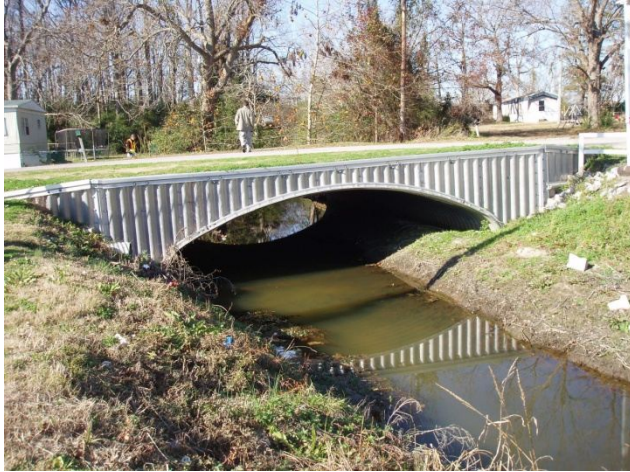
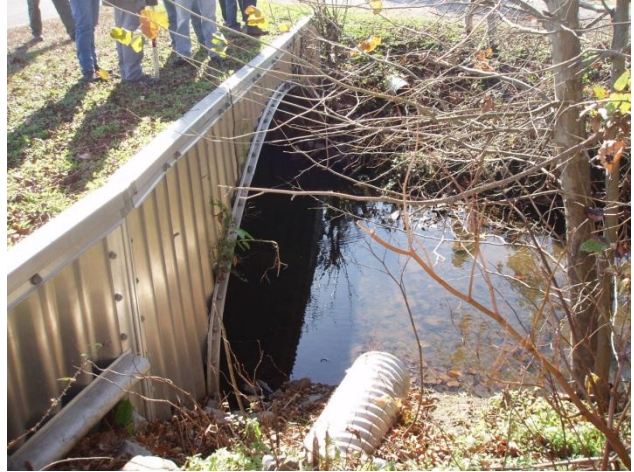
Small amounts of rip-rap were used on all four corners of the structure to help stabilize the banks. There was more rip-rap used on the upstream side than on the downstream side. Much of it has vegetation growing over it. All banks appeared stable, but steep on the downstream side. The downstream channel had been channelized, modified, and most likely fill had been brought in for development of the adjacent properties. The downstream channel appeared more natural. No scour was noticed at either headwall.

Outlet of structure
