Hurricane Helene Effects on Benthic Macroinvertebrates of 11 North Carolina Streams, a Preliminary Analysis

Nov. 19 – Dec. 6, 2024

North Carolina Department of Environmental Quality
Division of Water Resources
Water Sciences Section

Biological Assessment Branch SUMMARY

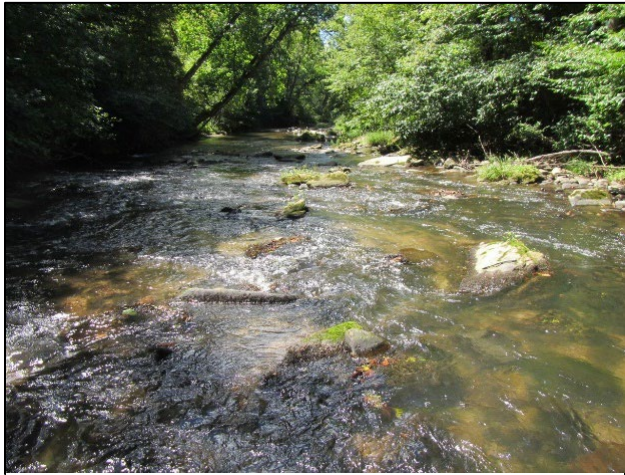
Broad River at SR 2802 facing upstream prior to Hurricane Helene, August 2015.

Macroinvertebrate habitat scored moderate (70/100), which was significantly less than when the site was previously assessed in August 2015 (85/100). Facing upstream, riparian vegetation on the right bank appeared intact. However, left bank vegetation was sparser with deeply incised, nearly vertical straight banks. Physical-chemical parameters measured were within normal ranges for this river (Table 3). Water was clear with a turbidity of 2.01.

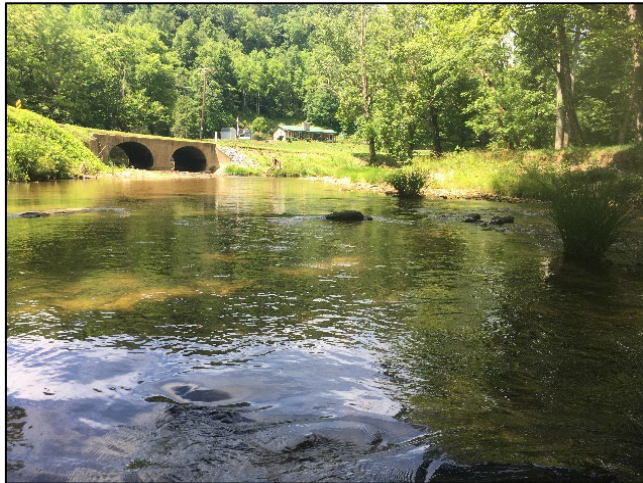
Hungry River off SR 1799 facing upstream prior to Hurricane Helene,

Macroinvertebrate habitat scored low (52/100), but was similar to the site's previous assessment in June 2021 (57/100). However, DWR biologists noted significant new sand deposits in the channel, with 8-12-inch-high sand wrack lines in the mainstream channel. Although this site has had historical issues with sand and fine sediment

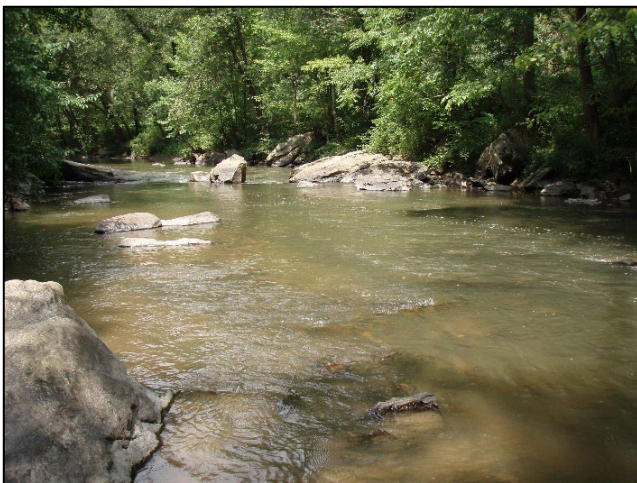
Ivy Creek at US25-70 BUS near Marshall facing downstream, July 2012.

Macroinvertebrate habitat scored low (56/100), which was significantly less than when the site was previously assessed in September 2022 (73/100). Facing upstream, left bank riparian vegetation was completely removed by the extreme flows. Physical-chemical parameters measured were within normal ranges for a healthy river of this size in this ecoregion (Appendix Table 1). Water was clear, but turbidity was 8.28 NTU, indicating that active erosion and suspension of alluvial deposits of sand and fine sediments are still ongoing more than two months post-Hurricane Helene.

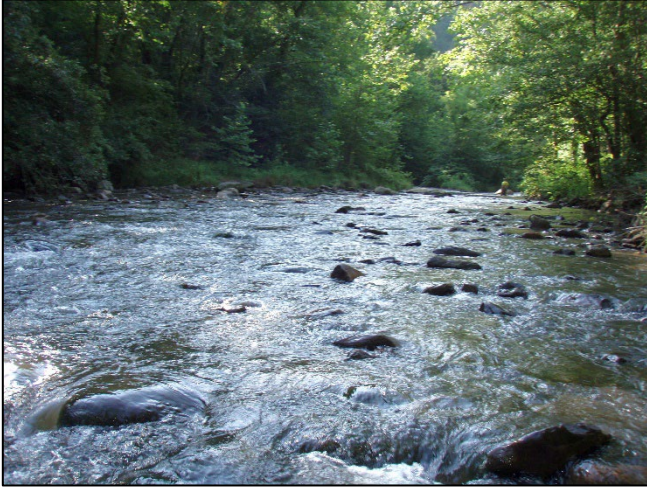
Spring Creek at NC 209 near Hot Springs facing upstream, July 2012.

Macroinvertebrate habitat scored low (57/100), which was significantly less than when the site was previously assessed in September 2022 (77/100). Facing upstream, left bank riparian vegetation was completely removed due to scour during major flood stage. Physical-chemical parameters measured were within normal ranges for a healthy river of this size in this ecoregion (Appendix Table 1). Water was clear and turbidity was 0.71 NTU despite ongoing in-stream habitat modification work continuing in the watershed.

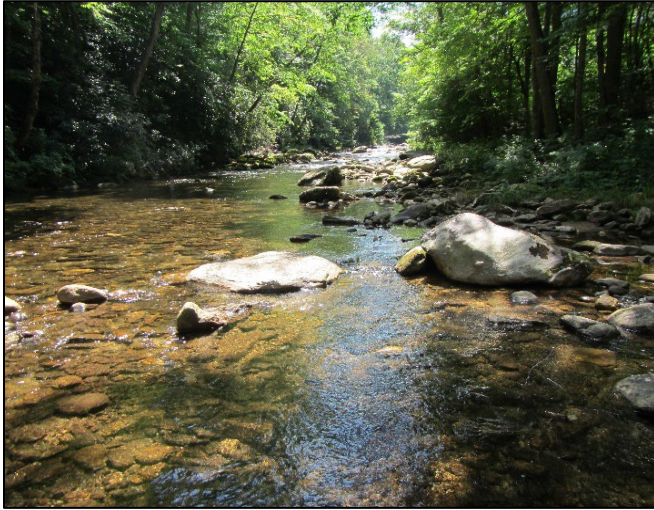
West Fork Pigeon River at SR 1216 facing upstream, August 2017.

USGS reported zero landslides in the watershed upstream of the sampling site and none were observed by DWR biologists. Macroinvertebrate habitat scored high (90/100), which was very similar to when the site was previously assessed in April 2019 (92/100). Despite the flooding, riparian vegetation was almost completely intact despite some small debris- and wrack lines near pull-offs and parking along NC 215. Again, given the heavily intact forest cover in this watershed and the corresponding lack of landslides and landslide related impacts, it is unsurprising this catchment was relatively unscathed.

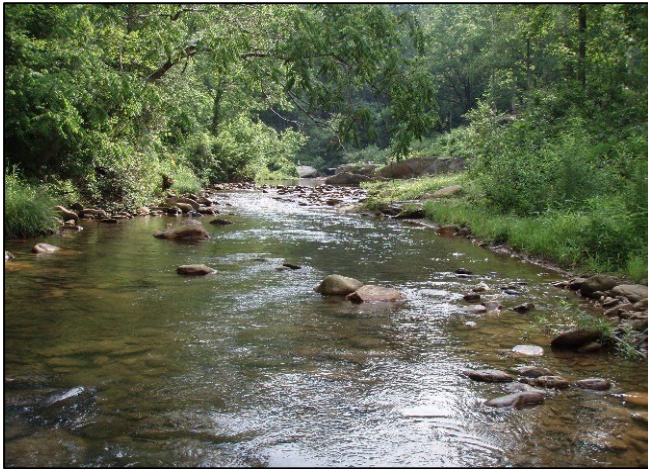
Gragg Prong looking upstream. This photo was taken in 2018 before Helene.

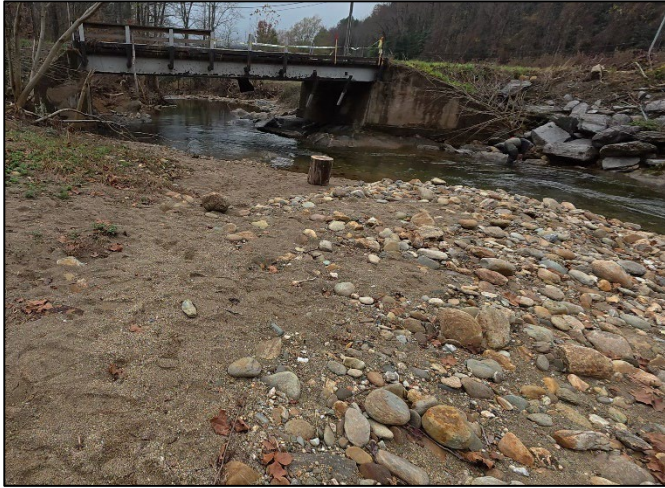
Gragg Prong looking downstream. This photo was taken after Hurricane Helene.

Colonizable macroinvertebrate habitat was present and in good condition. A thin layer of periphyton was observed on the instream habitat, suggesting scour was minimal. Physical-chemical parameters measured were within normal ranges for a healthy stream of this size in this ecoregion (Table 3). Water was clear with a turbidity measure of 1.2 NTU. Overall, Gragg Prong appears little affected by Hurricane Helene.

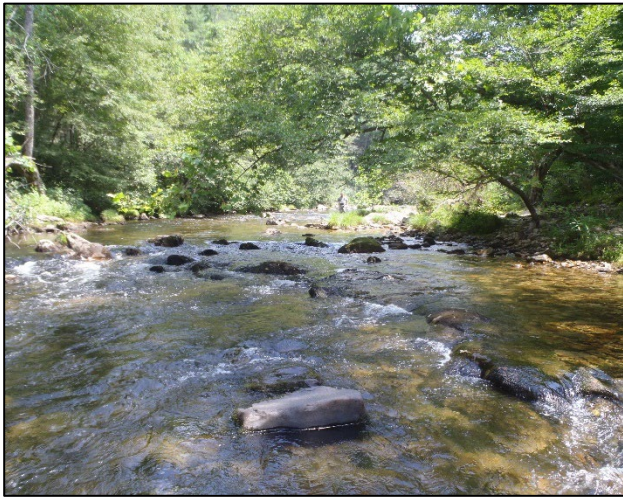
Wilson Creek, pre-Helene, July 2017.

Macroinvertebrate habitat was excellent (89/100) but was slightly affected by scour as little evidence of periphyton was noted on the rocks. Physical-chemical parameters measured were within normal ranges for a healthy stream of this size in this ecoregion (Table 3). Water was clear with a turbidity measure of 0.9 NTU.

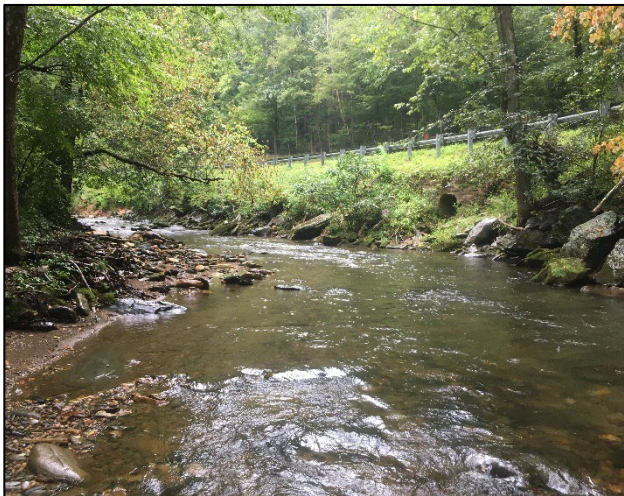
Buck Creek pre-Helene, July 2017.

Macroinvertebrate habitat was severely affected (75/100) by the flooding and scour, with the edge habitat almost completely gone. Periphyton was notably absent, and the channel was scoured down to bedrock in places. In some areas the stream was a small, wetted channel amidst a large, dry boulder and cobble field. While physical-chemical parameters measured were within normal ranges, the water was only relatively clear, with a turbidity measure of 3.0 NTU, likely due to ongoing in-stream construction work occurring in the upstream catchment. Buck Creek has historically rated Excellent or Good based on the macroinvertebrate fauna present. If rated for this study, Buck Creek would have received a Fair rating, or three bioclassifications below Excellent.

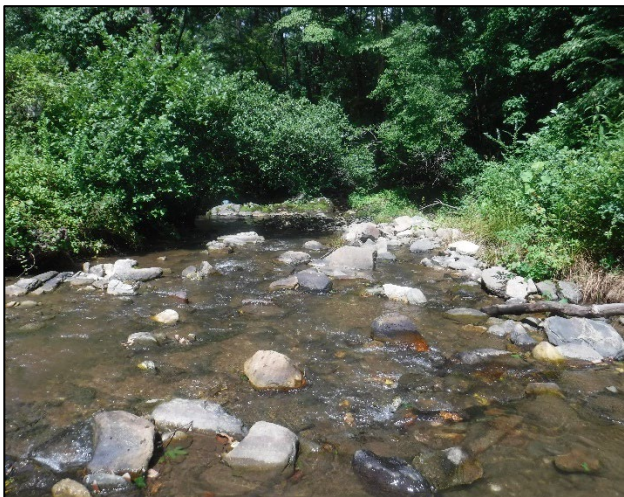
Catawba River at SR 1274, July 2022.

Macroinvertebrate habitat was not overtly affected (89/100) by the flooding and scour. It is likely that the very small drainage area simply could not provide enough water to enable major flooding. It was noted that the very low bridge over the stream was not overtopped by the flood and lacked a debris wrack line. Additional photo evidence shows that the high water was sufficient to expose the root systems of bank vegetation only up to 2-3 feet of the bank. Physical-chemical parameters measured were within normal ranges for a healthy stream of this size (Table 3).

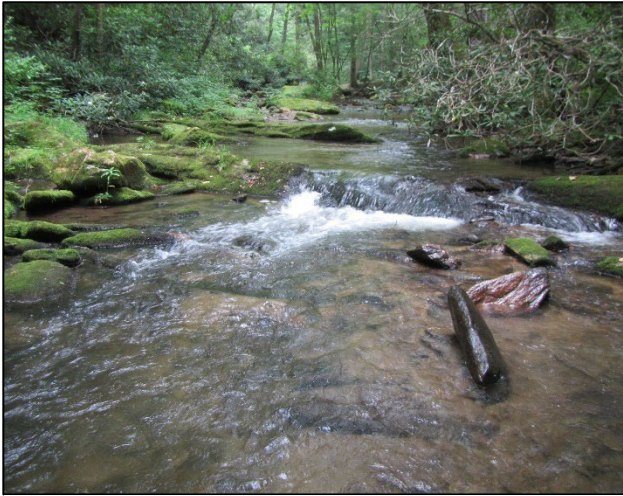
Little Buck Creek pre-Helene, July 2022.

Macroinvertebrate habitat on Little Buck Creek was unaffected by Hurricane Helene flooding scoring an excellent 89/100, with both riffles and (streambank) edge habitats intact. Periphyton was present on the surface of instream rocks. Riparian vegetation was present, with the only evidence of flooding some significant overbank deposits of sand. A large tree had fallen into the stream channel at the site and acted as a debris dam, but the vast majority of the riparian was intact. Physical-chemical parameters measured were within normal ranges for a healthy stream of this size in this ecoregion (Table 3). Water was clear with a turbidity of 1.9 NTU. Little Buck Creek was largely unaffected by Hurricane Helene and harbored a diverse and healthy macroinvertebrate fauna.

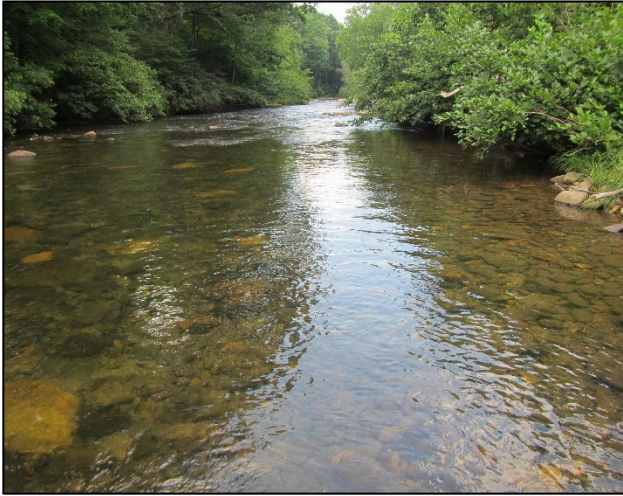
South Toe River near Celo, pre-Helene, July 2021.
