Whittier Creek Mitigation Project

Year 1 (2022) Monitoring Report

Surry County, North Carolina

DMS Project ID No. 100020

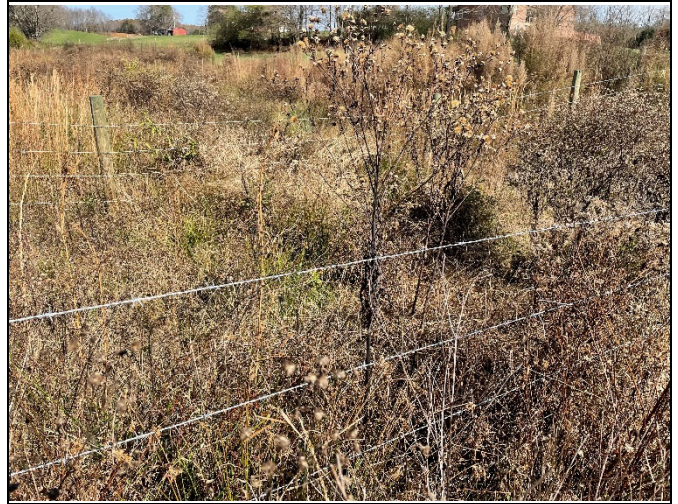
PP-44: Reach UT5, upstream, Station 13+00 at ford crossing

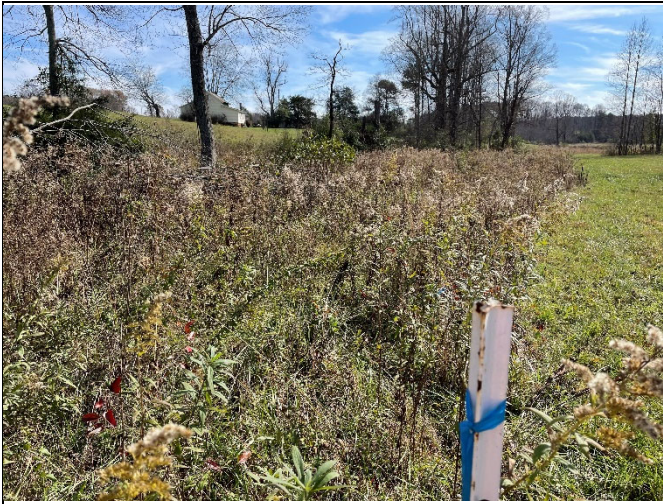
Vegetation Plot 3

- Red line changes to structures (rock vanes) replaced by various other structure types in project reaches noted.
- Crossing type change from culvert to rock ford on UT5 noted.
- Armoring of Reach 7 first two meander bends noted.
- Extra stems planted during planting completed in January 2022 noted.
- Intention to treat fescue in near Veg Plot 3 and multiflora rose along left bank of UT4A in late 2022 noted.

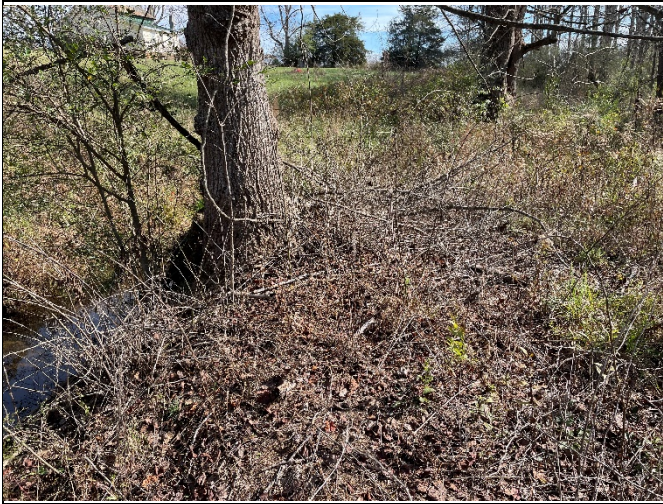
Invasive treatment along UT4a (11/19/2022)

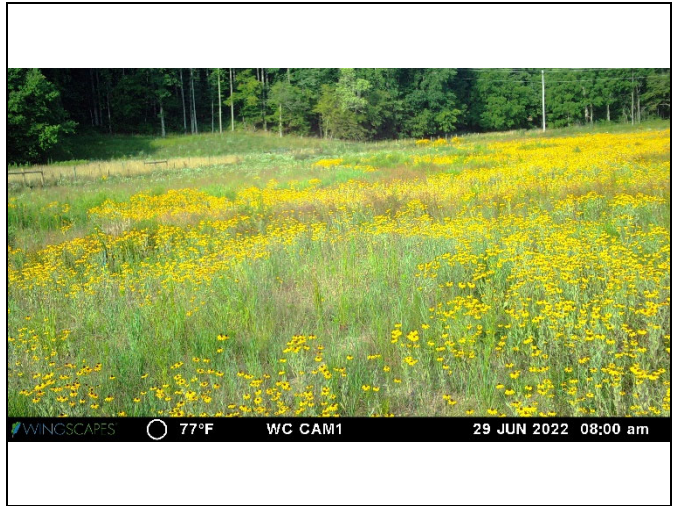
Site Camera Located to Capture Storm Events. Due to Installing in June the Early Year Storm Events were not Captured. 6/29/2022
