STATE OF NORTH CAROLINA, *ex. rel.*,
NORTH CAROLINA DEPARTMENT OF
ENVIRONMENTAL QUALITY,

COLONIAL PIPELINE COMPANY,

COMPLAINT AND MOTION
FOR PRELIMINARY AND
PERMANENT INJUNCTIVE RELIEF

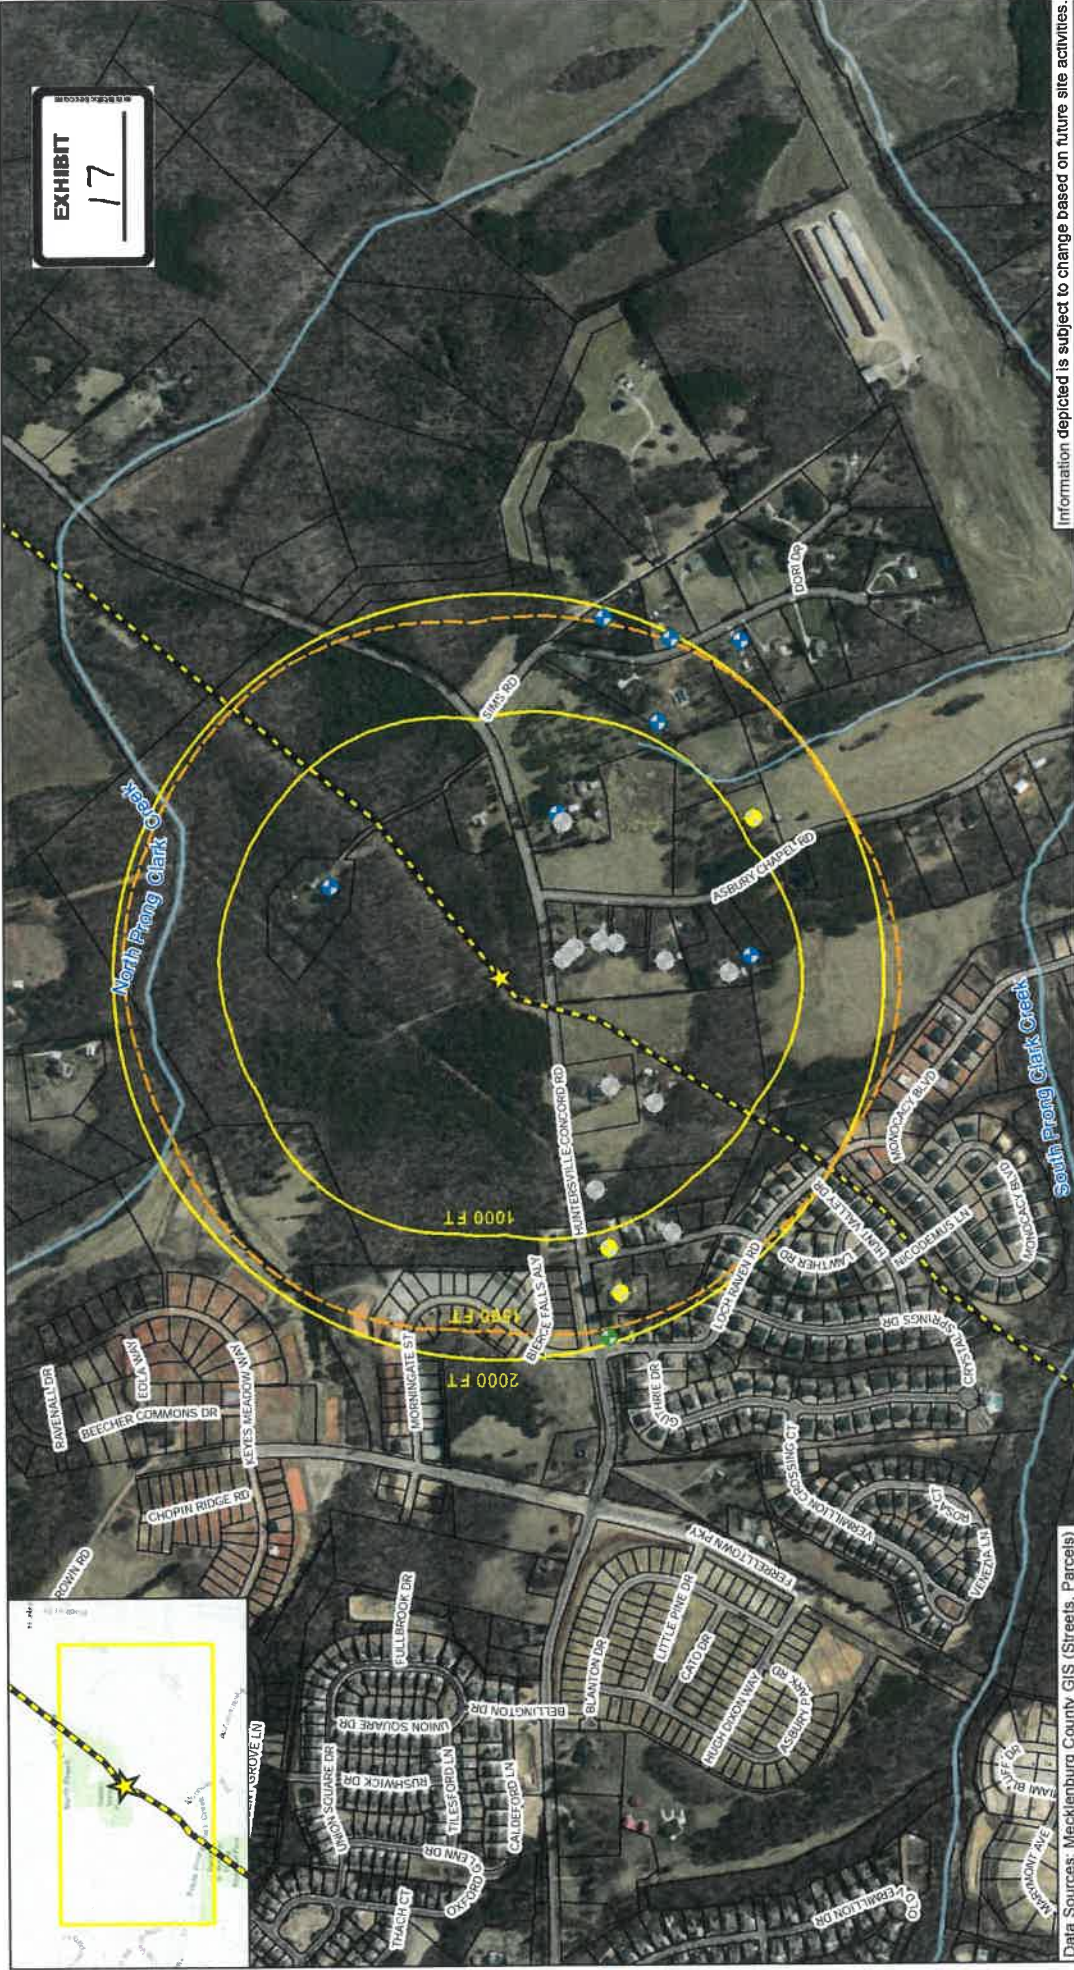
Information depicted is subject to change based on future site activities.

<p>Potential Receptor Map Colonial Pipeline Company 2020-L1-SR2448 Huntersville, North Carolina</p>				<p>Water Supply Well (Non-Potable Use)</p> <p>Water Supply Well (Inactive Use)</p>	<p>FIGURE 4</p>
<p>★ Release Site</p> <p>— Pipeline</p> <p>▭ Parcel Boundaries</p>	<p>⊕ Water Supply Well (Potable Use)</p> <p>⊖ Water Supply Well (Abandoned)</p> <p>⊙ 1,500-Foot Radius from Edge of October 2021 Free Product Boundary</p> <p>⊙ 2,000-Foot Radius from Point of Release</p>	<p>Water Supply Well (Potable Use)</p> <p>Water Supply Well (Abandoned)</p>	<p>Water Supply Well (Non-Potable Use)</p> <p>Water Supply Well (Inactive Use)</p>	<p>0 600 1,200 1,800 Feet</p>	
<p>Data Sources: Mecklenburg County GIS (Streets, Parcels)</p>	<p>Checked By: AS</p> <p>Created By: CW</p> <p>Scale: 1" = 625 FT</p> <p>Date/Time: 10/30/2021; 14:22</p> <p>Project No.: CPC20126</p>

Properties within a 1,500 foot radius of the release area obtain potable water from public water supply or private WSWs (**Figure 4**). Water services for the Town of Huntersville are provided by the City of Charlotte. Field reconnaissance and the Mecklenburg County geographic information systems database were utilized to evaluate for the presence of WSWs within a 1,500-foot radius of the release area, and to evaluate if each property in the search area was connected to the public water supply.

The Site is located within the Yadkin Pee-Dee River Basin. North Prong Clarke Creek is located approximately 1,800 feet north of the release area and South Prong Clarke Creek is located approximately 2,700 feet south of the release area, both of which are classified as Class C water bodies by the NCDEQ Division of Water Resources, meaning that they are protected for non-drinking water purposes such as biological integrity, fishing, and infrequent secondary recreational purposes (i.e., wading). A groundwater seep and ephemeral stream are located approximately 1,200 feet southeast of the release area. The ephemeral stream flows to South Prong Clarke Creek. The North and South Prong Clarke Creek, respectively, and the unnamed ephemeral tributary to South Prong Clarke Creek are shown on **Figure 4**.

Twenty WSWs have been identified within a 1,500-foot radius of the release site (**Figure 4**), of which eleven have been abandoned since the release occurred. Eleven WSWs, including two inactive wells and one non-potable use well remain within a 1,500-foot radius of the release site. Well abandonment records are provided as **Appendix D**. Well use and owner information is summarized in **Table 2**.

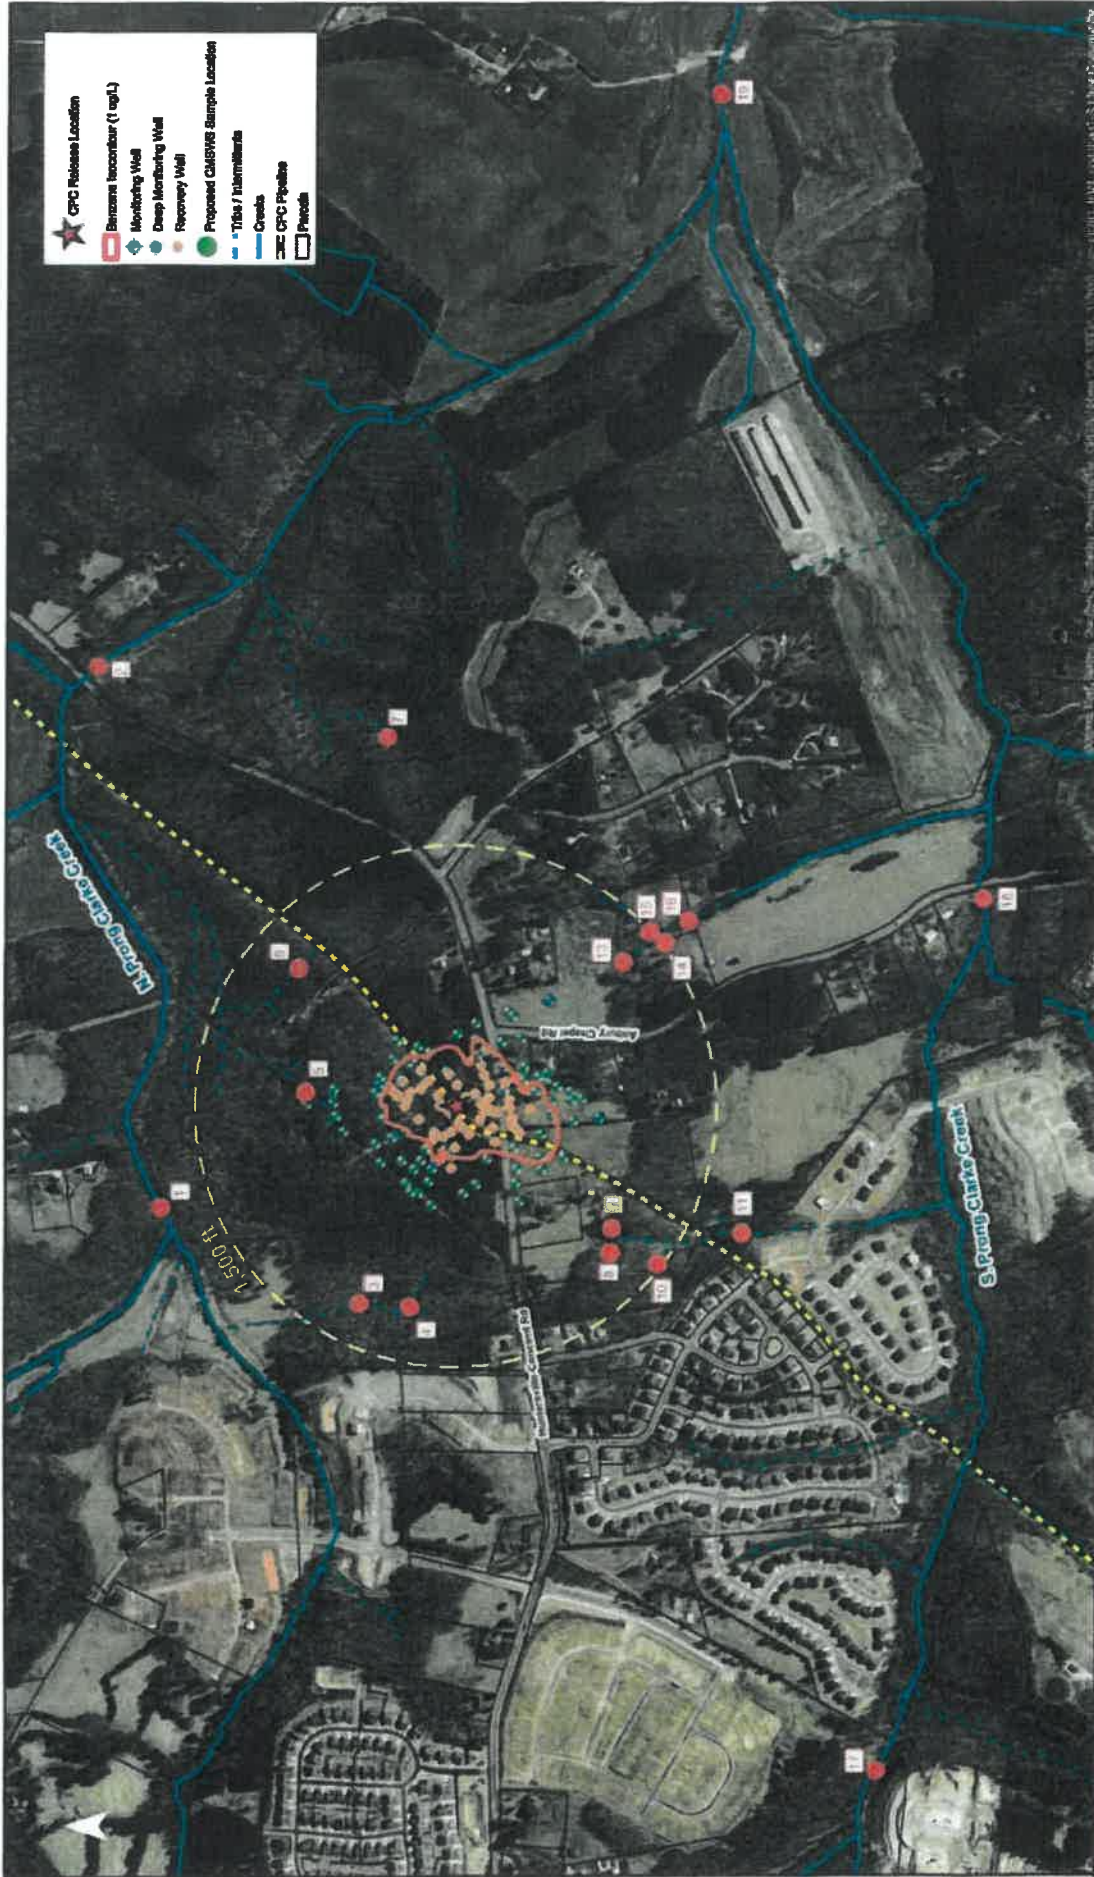
- CPC Release Location
- Benzene Incubator (1 up/L)
- Monitoring Well
- Deep Monitoring Well
- Recovery Well
- Proposed CAUSWS Sample Location
- Tides / Intermittents
- Creeks
- CPC Pipeline
- Ponds

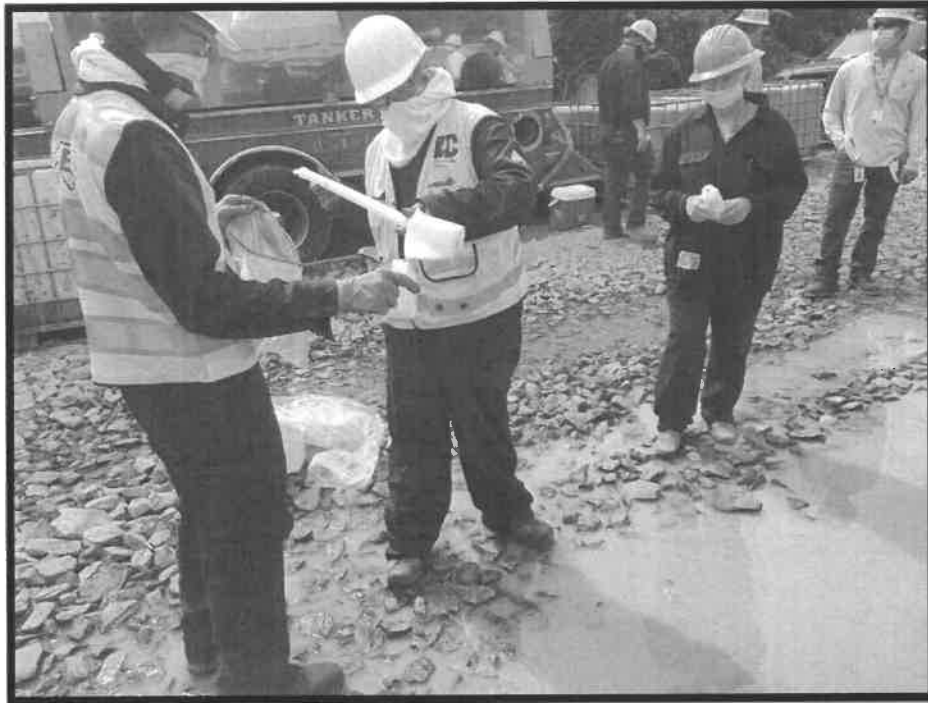
Sample Three Photograph:

Sample Three: Surface Water #1 sample was collected from a large puddle in front of the fire truck used to mix the Encapsulator product. The sample was collected using a three-foot dipper. Staff observed sediment in each sample.

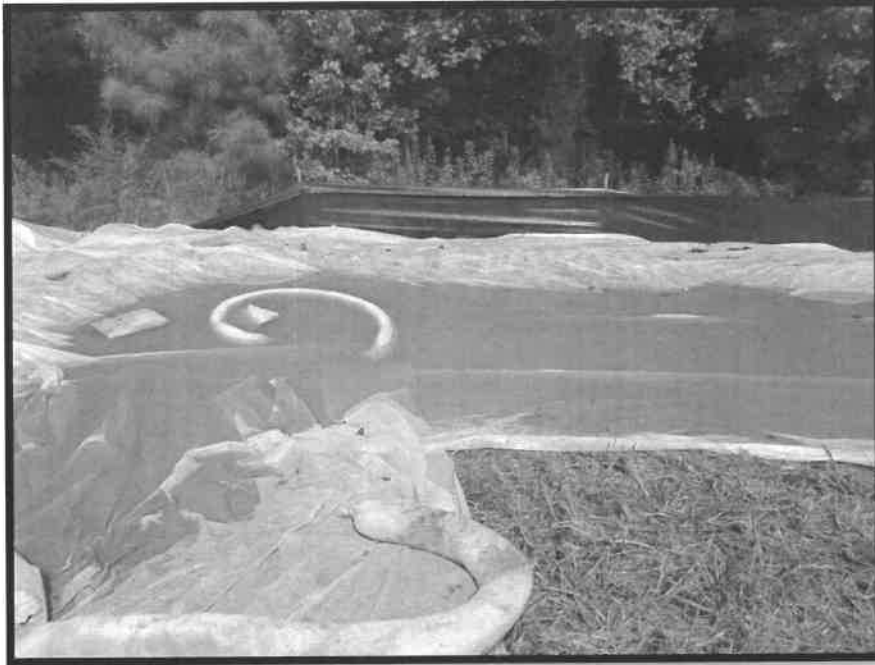
Sample Four Photographs:

Sample Four: After the group surveyed the area around the open excavation where the pipe was being repaired (cutting and welding), the sample location for Surface Sample #2 was identified. On the west side of the excavation, there was a stormwater collection system lined with plastic, and standing water was observed along the entire system. After speaking with site personnel, it was agreed to collect Sample Four on the south end of the stormwater collection system where transport trucks were loaded. Some sheen and foam were observed on the water's surface.

Montrose's consultant, Alex Testoff, collected the sample by dipping a 1000 mL bottle into the water and filling each of the four sample bottles with 250 mL of surface water.
