Annual Monitoring Report (MY2)

BOSEMAN BUFFER MITIGATION SITE

Edgecombe County, NC
NCDEQ Contract No. 7872
DMS ID No. 100119
DWR Project No. 2019-0800
RFP No. 16-007711

ANNUAL MONITORING REPORT (MY2)
BOSEMAN BUFFER MITIGATION SITE

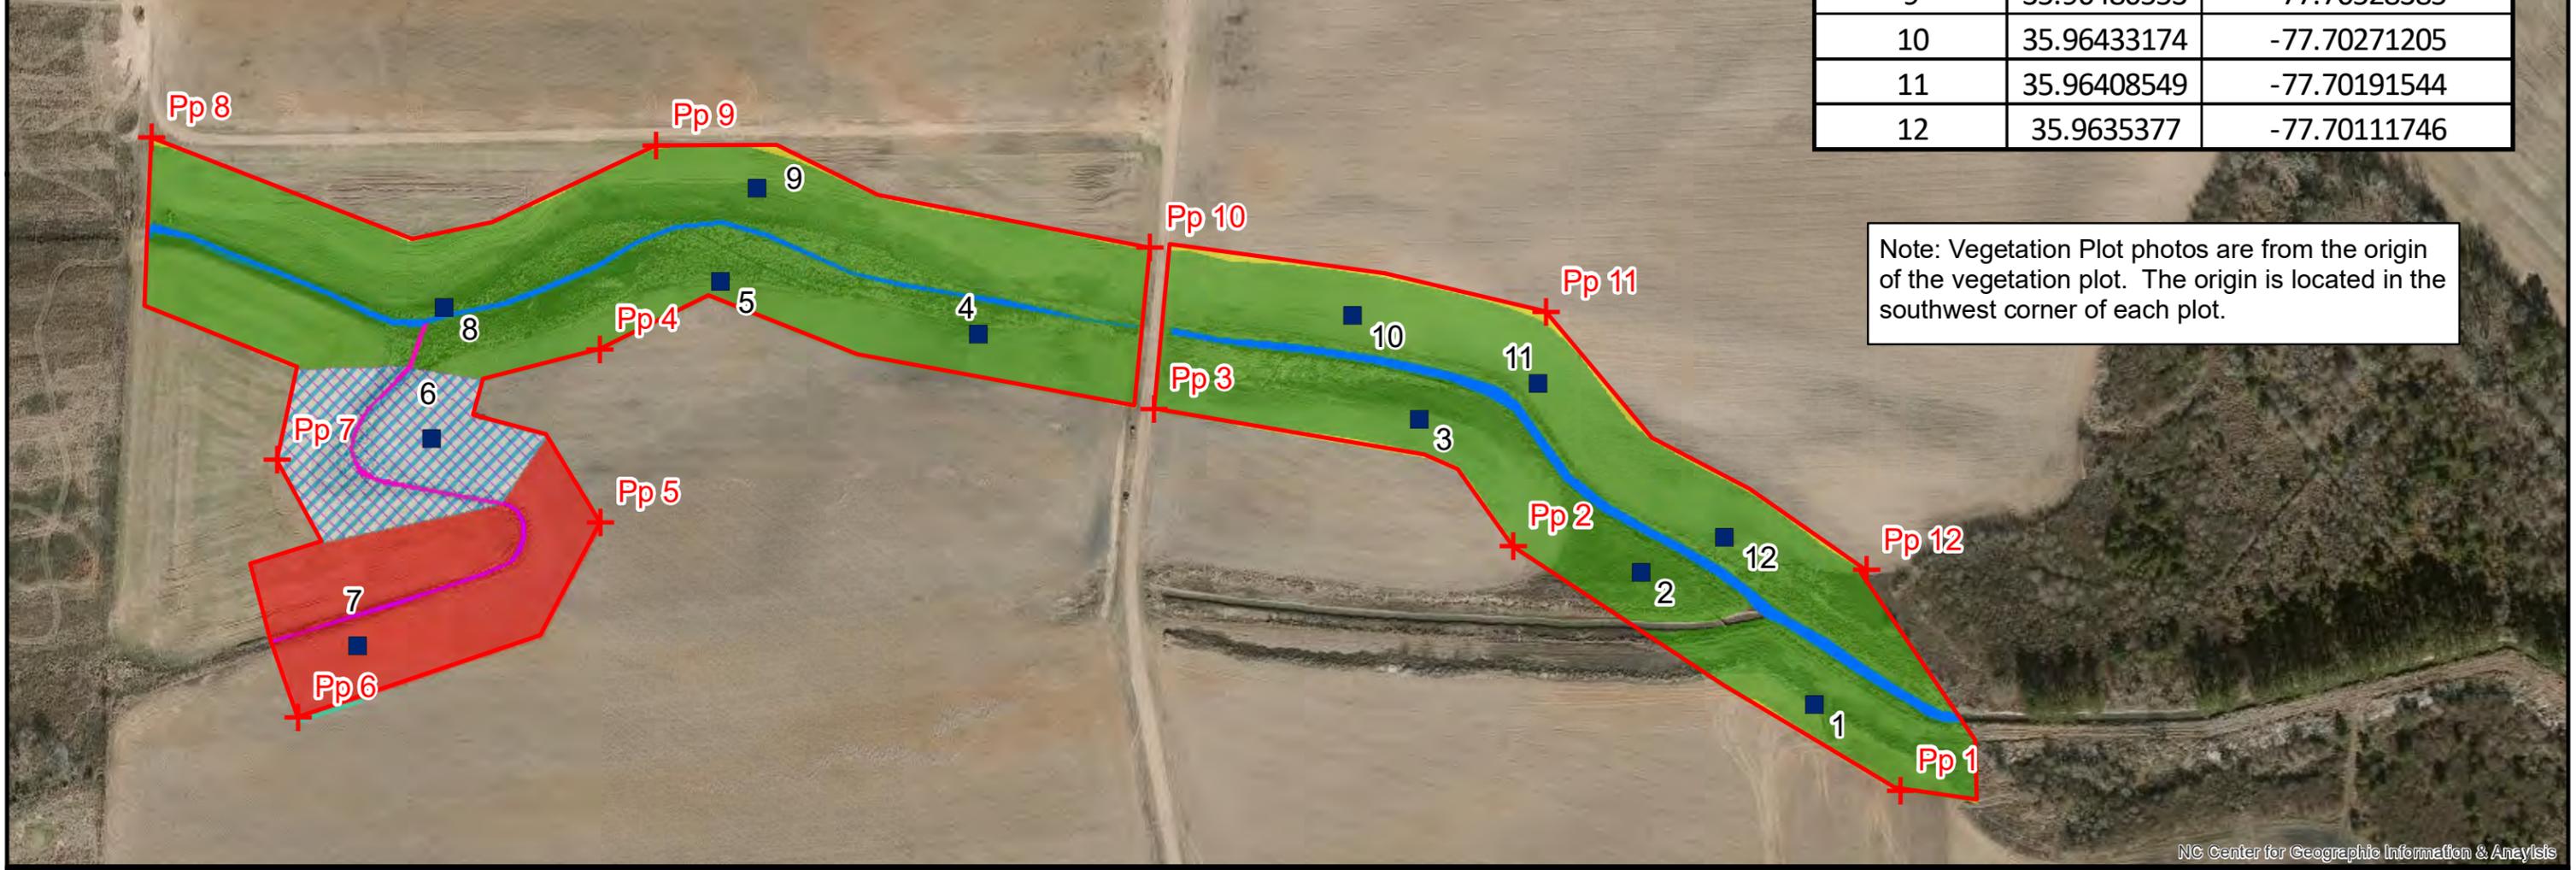
- Vegetation Plot (N=12)
- + Photo Points
- Conservation Easement 14.9 acres
- ~ UT 1 (At Least Intermittent)
- ~ UT 2 Reach 2a (Ephemeral)
- ~ UT 2 Reach 2b (At Least Intermittent)
- Buffer Restoration (0-100') UT 1
- Buffer Restoration (101-200') UT 1
- Buffer Restoration (0-100') UT 2 Reach 2a (Ephemeral)
- Buffer Restoration (101-200') UT 2 Reach 2a (Ephemeral)
- Buffer Restoration (0-100') UT 2 Reach 2b
- Buffer Restoration (101-200') UT 2 Reach 2b

Origin Latitude/Longitude (Decimal Degrees)		
Plot Number	Y Coordinate	X Coordinate
1	35.96294899	-77.70073591
2	35.96341822	-77.70147906
3	35.96396443	-77.70243013
4	35.964284	-77.70433461
5	35.96448024	-77.70544498
6	35.96394198	-77.70670793
7	35.96322236	-77.7070397
8	35.96440173	-77.70664643
9	35.96480553	-77.70528385
10	35.96433174	-77.70271205
11	35.96408549	-77.70191544
12	35.9635377	-77.70111746

Note: Vegetation Plot photos are from the origin of the vegetation plot. The origin is located in the southwest corner of each plot.

Current Condition Monitoring Plan View
Boseman Buffer Mitigation Site
Annual Monitoring Report (MY2)
Tar-Pamlico 03020101
Edgecombe County, North Carolina
December 2021
 2017 Aerial from NCOneMap

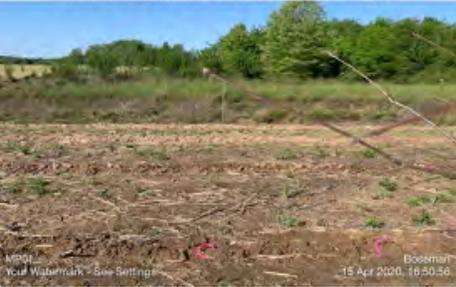
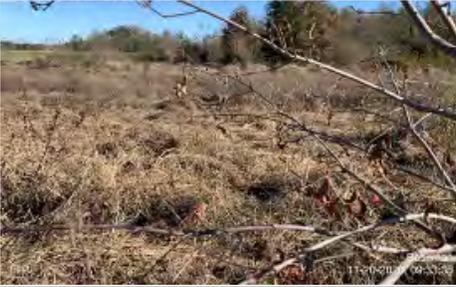
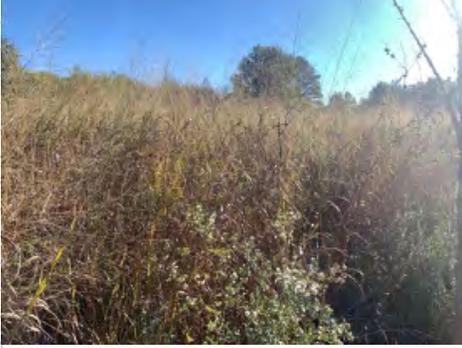
Photo Location	Baseline 2020	MY1 2020	MY2 2021
MP1

<p>31°NE (T) ● 35°57'46"N, 77°42'2"W ±16ft ▲ 64ft</p> <p>MP01 Your Watermark - See Settings 15 Apr 2020, 16:50:56</p>

<p>25°NE (T) ● 35.962985°, -77.700758° ±13ft ▲ 64ft</p> <p>11-20-2020, 09:33:59</p>

and annual monitoring for planted stems including individual plot photo documentation, overall site photo documentation, biannual visual assessments for project status and easement integrity including herbaceous and/or invasive species competition, stem mortality, stand health, incidental damage from agricultural equipment, and stem loss or damage from natural causes such as fire, disease, or animal predation. Figure 3 (Appendix 1) illustrates the location of project easement, permanent vegetation plots/photo points, as well as overall site photo points.

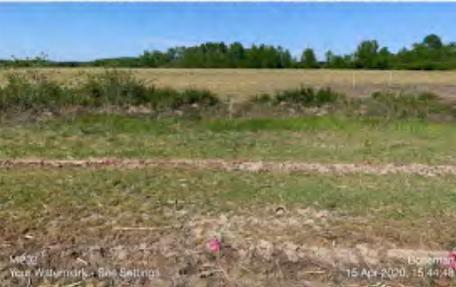
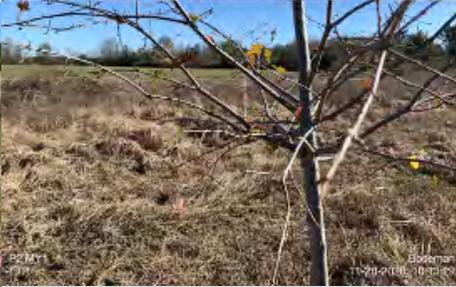
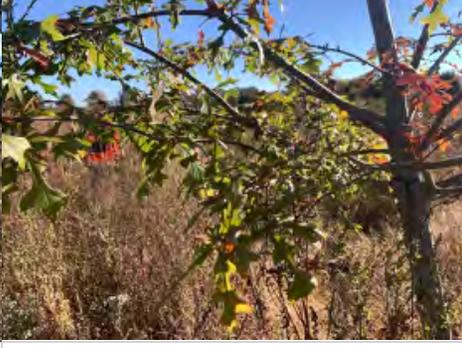
MP2

<p>34°NE (T) ● 35°57'48"N, 77°42'5"W ±78ft ▲ 62ft</p> <p>MP02 Your Watermark - See Settings 15 Apr 2020, 15:44:44</p>

<p>47°NE (T) ● 35.963427°, -77.701475° ±13ft ▲ 61ft</p> <p>P2 MY1 11-20-2020, 10:10:59</p>

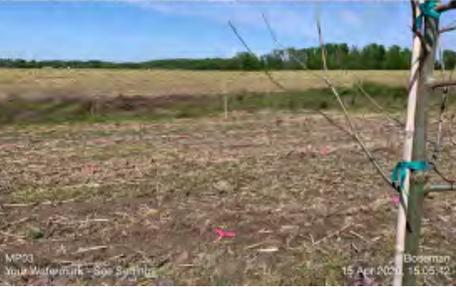
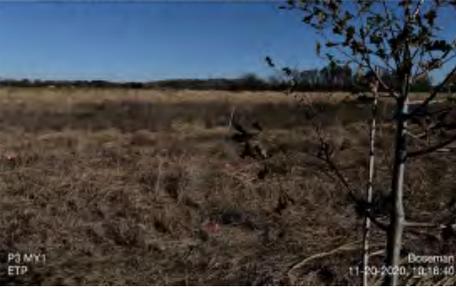
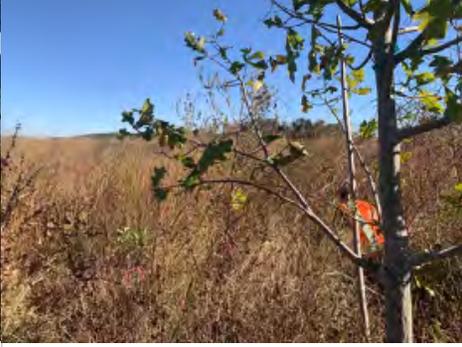
MP3

<p>38°NE (T) ● 35°57'50"N, 77°42'8"W ±22ft ▲ 61ft</p> <p>MP03 Your Watermark - See Settings 15 Apr 2020, 15:05:42</p>

<p>9°N (T) ● 35.963980°, -77.702434° ±16ft ▲ 61ft</p> <p>P3 MY1 ETP 11-20-2020, 10:16:40</p>

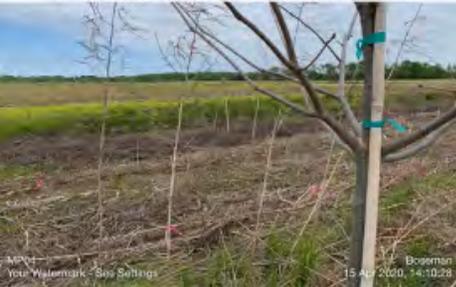
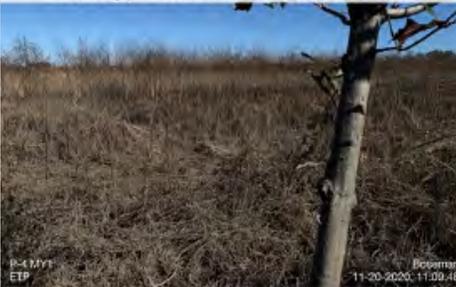
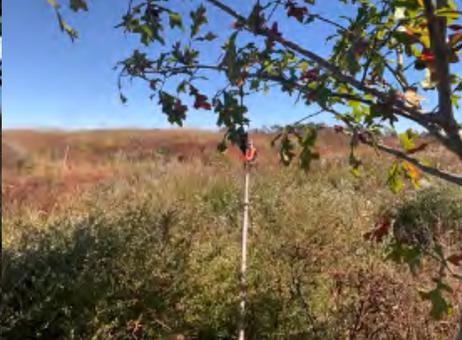
MP4

<p>44°NE (T) ● 35°57'51"N, 77°42'15"W ±13ft ▲ 61ft</p> <p>MP04 Your Watermark - See Settings 15 Apr 2020, 14:10:26</p>

<p>29°NE (T) ● 35.964316°, -77.704332° ±13ft ▲ 60ft</p> <p>P4 MY1 ETP 11-20-2020, 11:09:48</p>

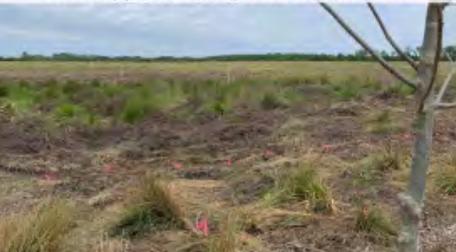
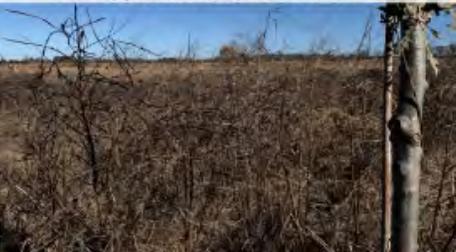
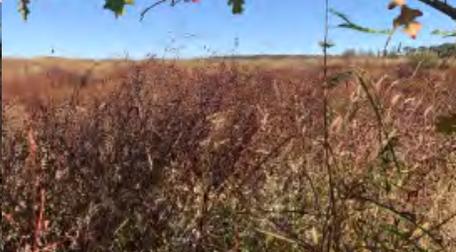
Photo Location	Baseline 2020	MY1 2020	MY2 2021
MP5

<p data-bbox="520 110 976 138">NW N NE E 300 0 30 60 90 120 37°NE (T) 35°57'52"N, 77°42'19"W ±39ft ▲62ft MP5 Your Watermark - Saw Settings 15 Apr 2020, 13:28:55 Boseman</p>

<p data-bbox="982 110 1438 138">NW N NE E 300 0 30 60 90 120 29°NE (T) 35.964523°, -77.705432° ±16ft ▲62ft P-5 MY1 11-20-2020, 11:32:03 Boseman</p>

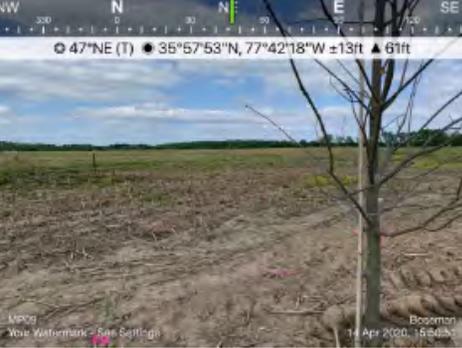
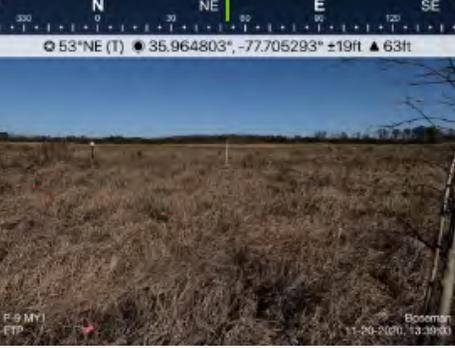
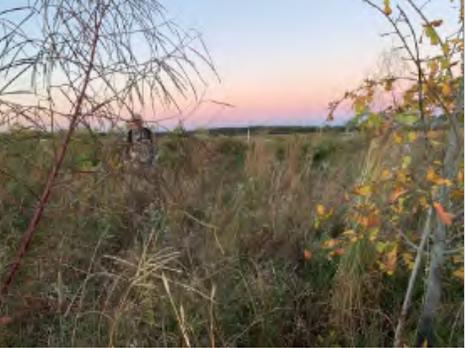
Photo Location	Baseline 2020	MY1 2020	MY2 2021
MP9

<p>47°NE (T) ● 35°57'53"N, 77°42'18"W ±13ft ▲ 61ft</p> <p>MP9 Water Watermark - See Settings 14 Apr 2020, 16:56:33</p>

<p>53°NE (T) ● 35.964803°, -77.705293° ±19ft ▲ 63ft</p> <p>P-9 MY1 ETP 11-20-2020, 13:39:03</p>

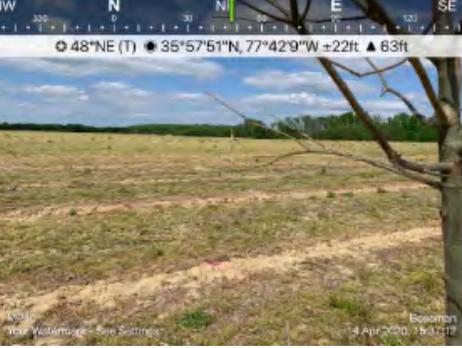
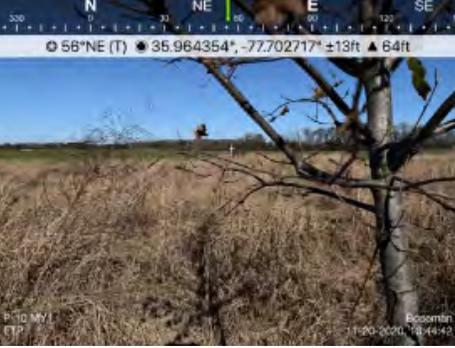
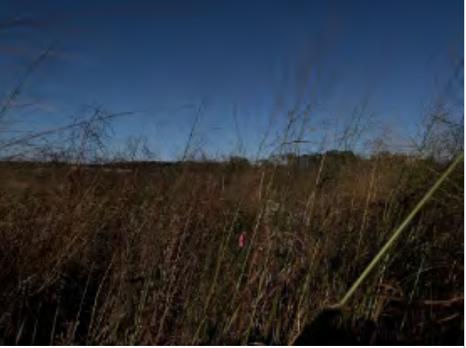
MP10

<p>48°NE (T) ● 35°57'51"N, 77°42'9"W ±22ft ▲ 63ft</p> <p>MP10 Water Watermark - See Settings 14 Apr 2020, 15:37:12</p>

<p>56°NE (T) ● 35.964354°, -77.702717° ±13ft ▲ 64ft</p> <p>P-10 MY1 ETP 11-20-2020, 13:44:42</p>

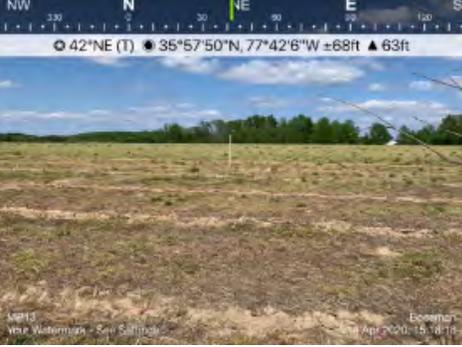
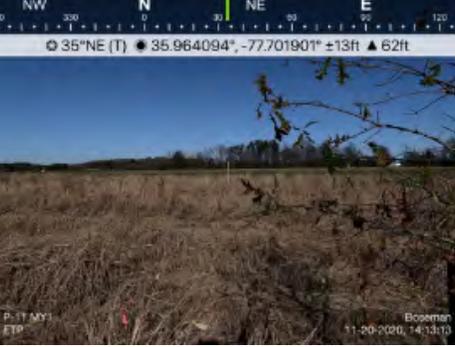
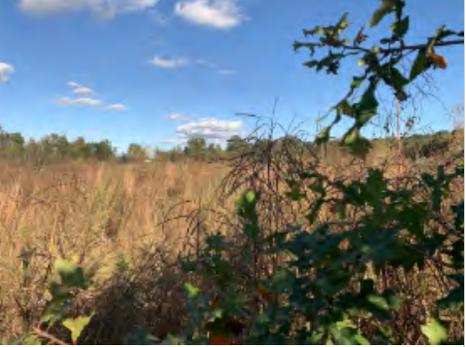
MP11

<p>42°NE (T) ● 35°57'50"N, 77°42'6"W ±68ft ▲ 63ft</p> <p>MP11 Water Watermark - See Settings 14 Apr 2020, 15:18:19</p>

<p>35°NE (T) ● 35.964094°, -77.701901° ±13ft ▲ 62ft</p> <p>P-11 MY1 ETP 11-20-2020, 14:33:13</p>

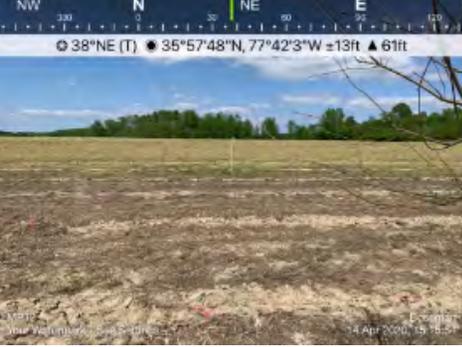
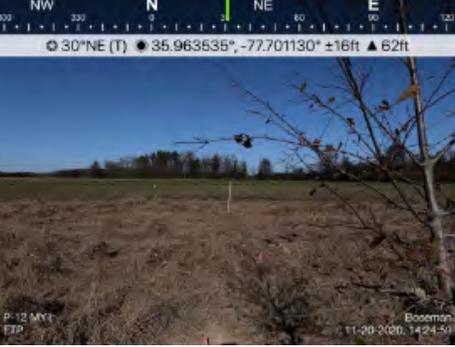
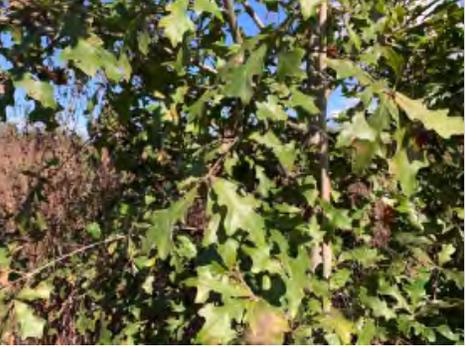
MP12

<p>38°NE (T) ● 35°57'48"N, 77°42'3"W ±13ft ▲ 61ft</p> <p>MP12 Water Watermark - See Settings 14 Apr 2020, 15:15:57</p>

<p>30°NE (T) ● 35.963535°, -77.701130° ±16ft ▲ 62ft</p> <p>P-12 MY1 ETP 11-20-2020, 14:24:50</p>

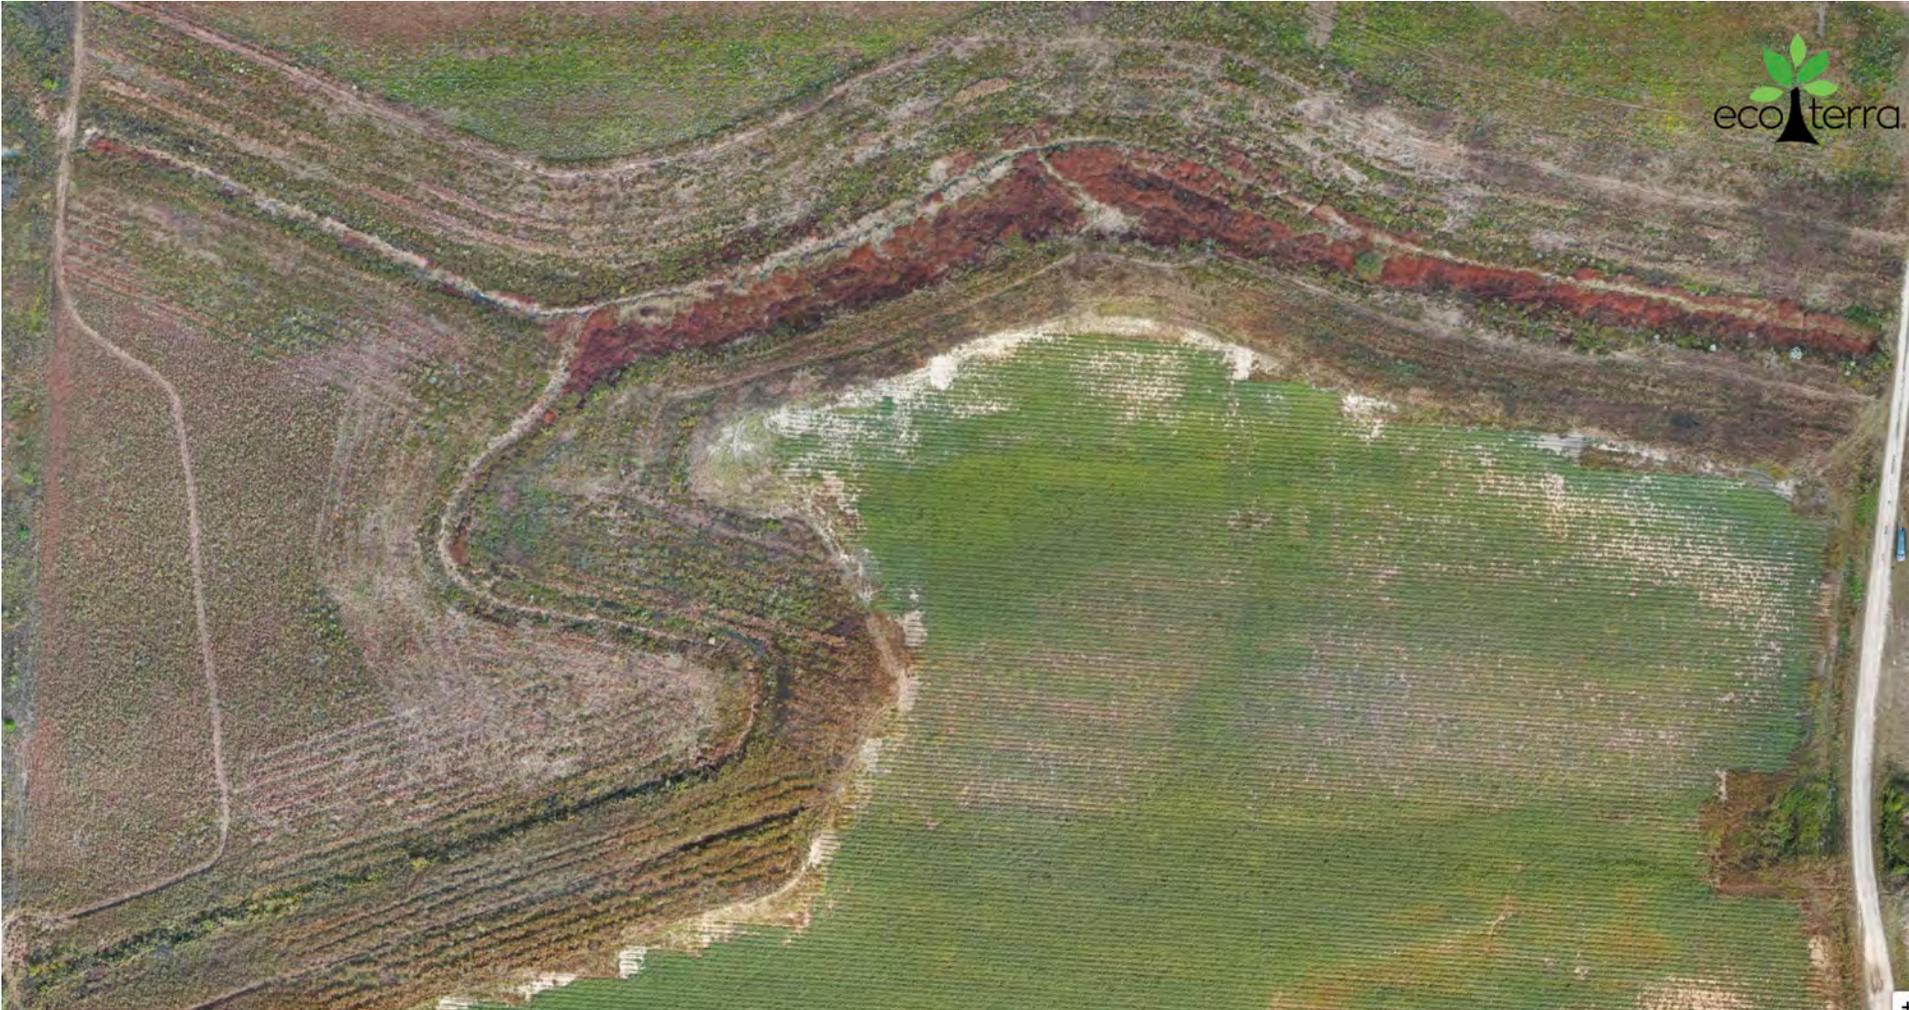
Boseman Buffer Mitigation Site Aerial - MY2 (November 2021)

West Project Side

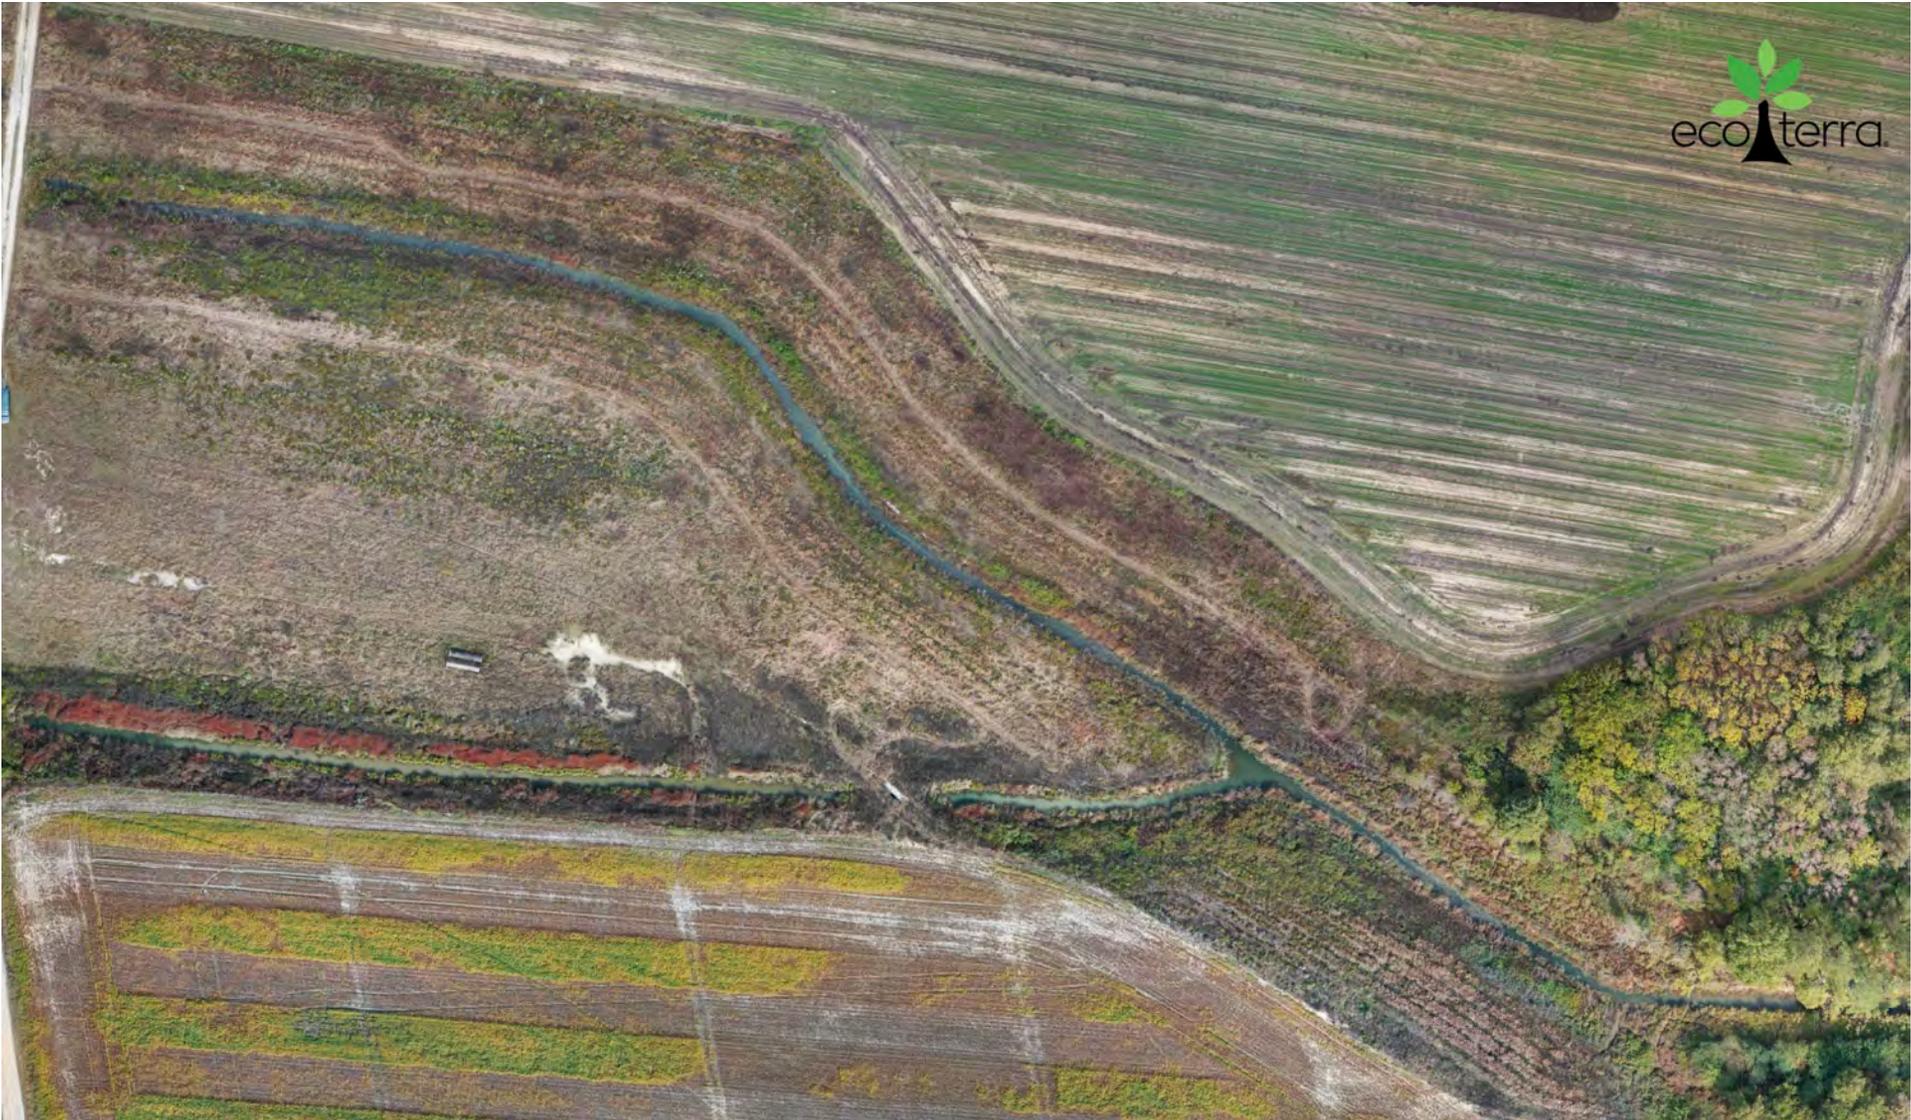
Boseman Buffer Mitigation Site Aerial - MY2 (November 2021)

East Project Side
