MY01 MONITORING REPORT

Hip Bone Creek Restoration Site
Chatham County
Cape Fear River Basin - 03040101

DMS Project #100059

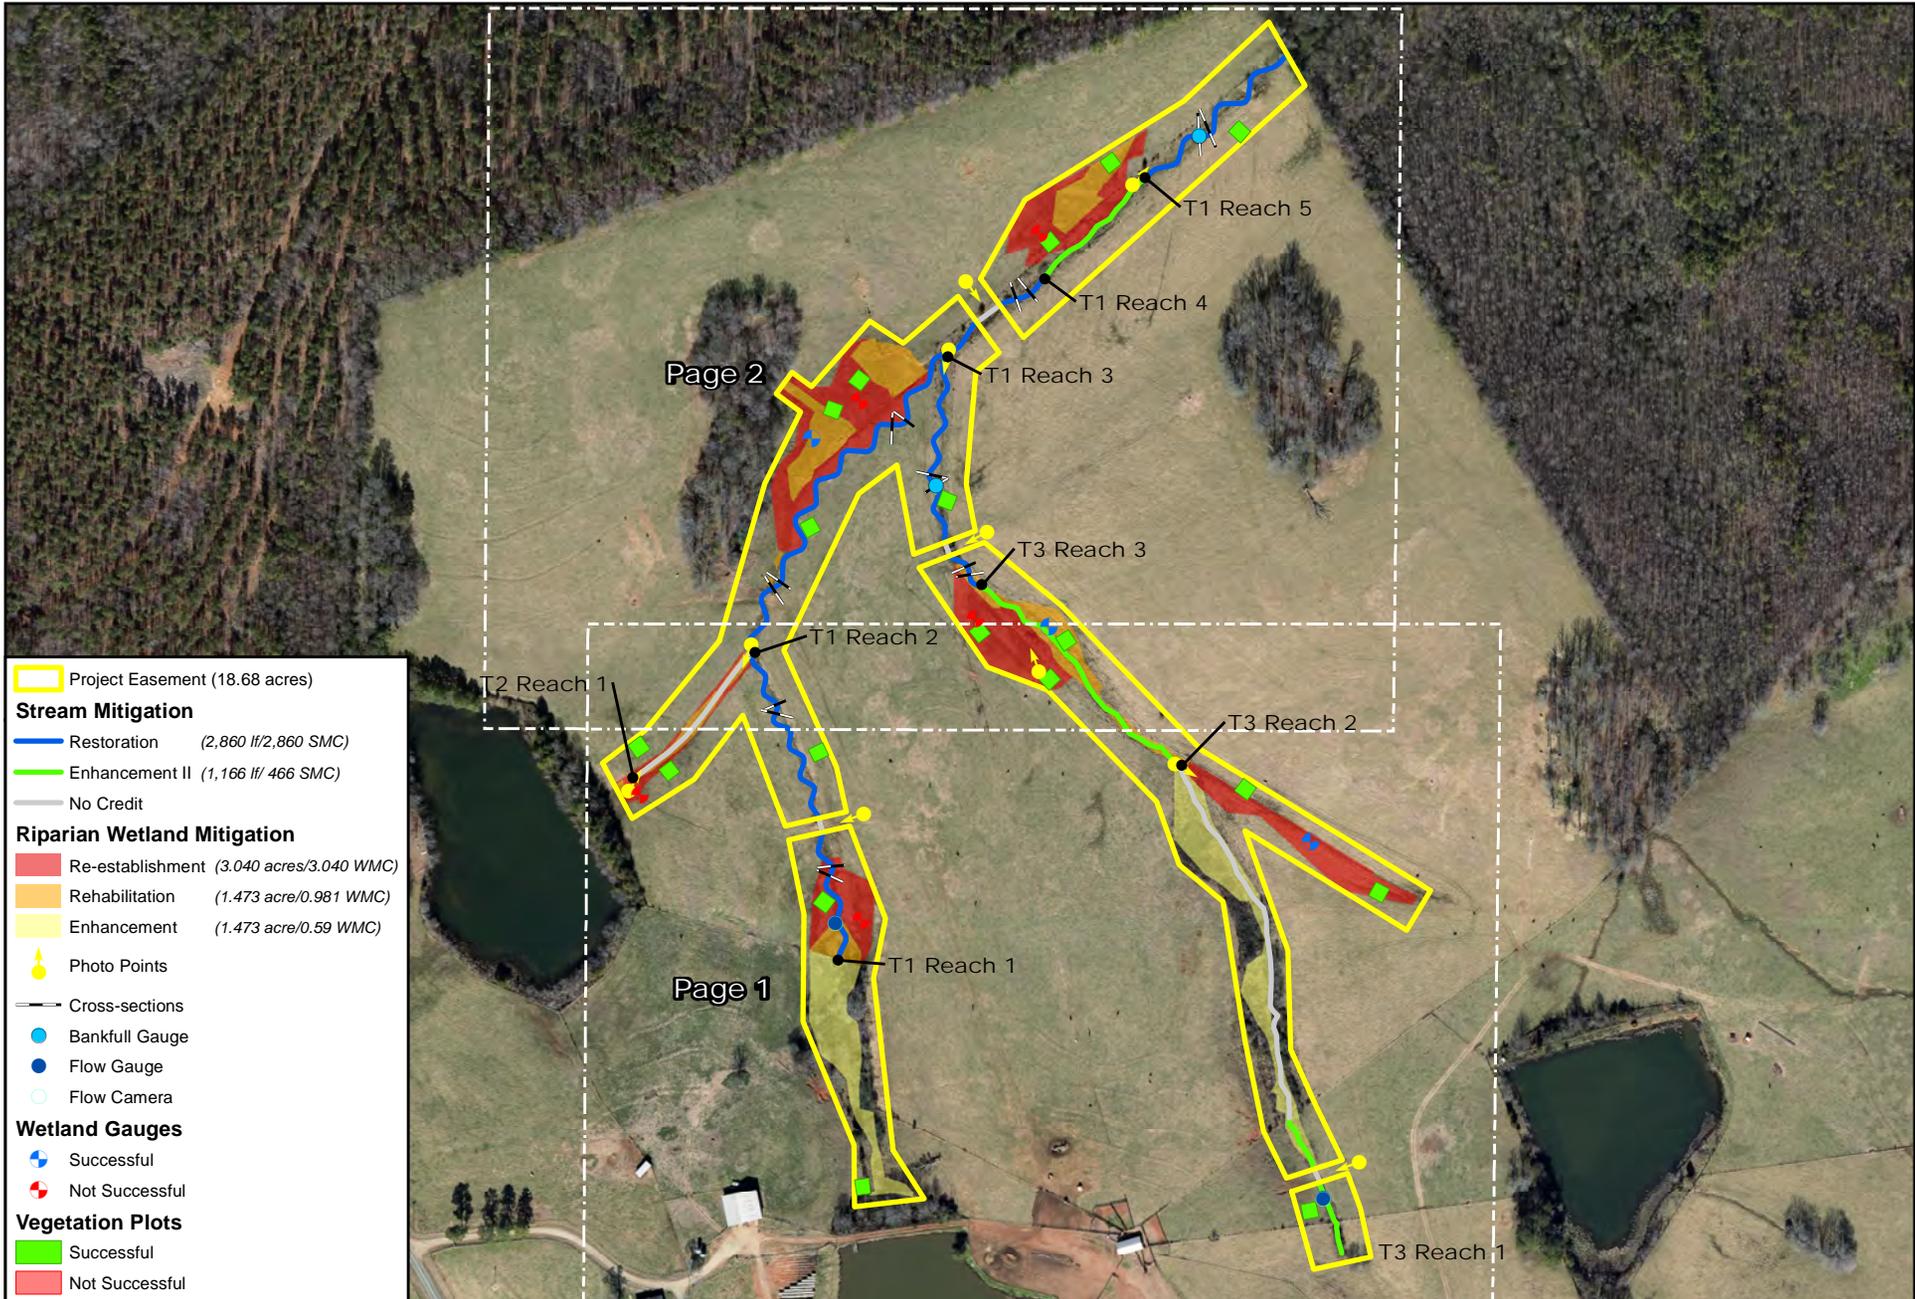
**CURRENT CONDITIONS PLANVIEW PAGE
HIP BONE CREEK RESTORATION SITE
CHATHAM COUNTY, NC**

Project Easement (18.68 acres)

Stream Mitigation

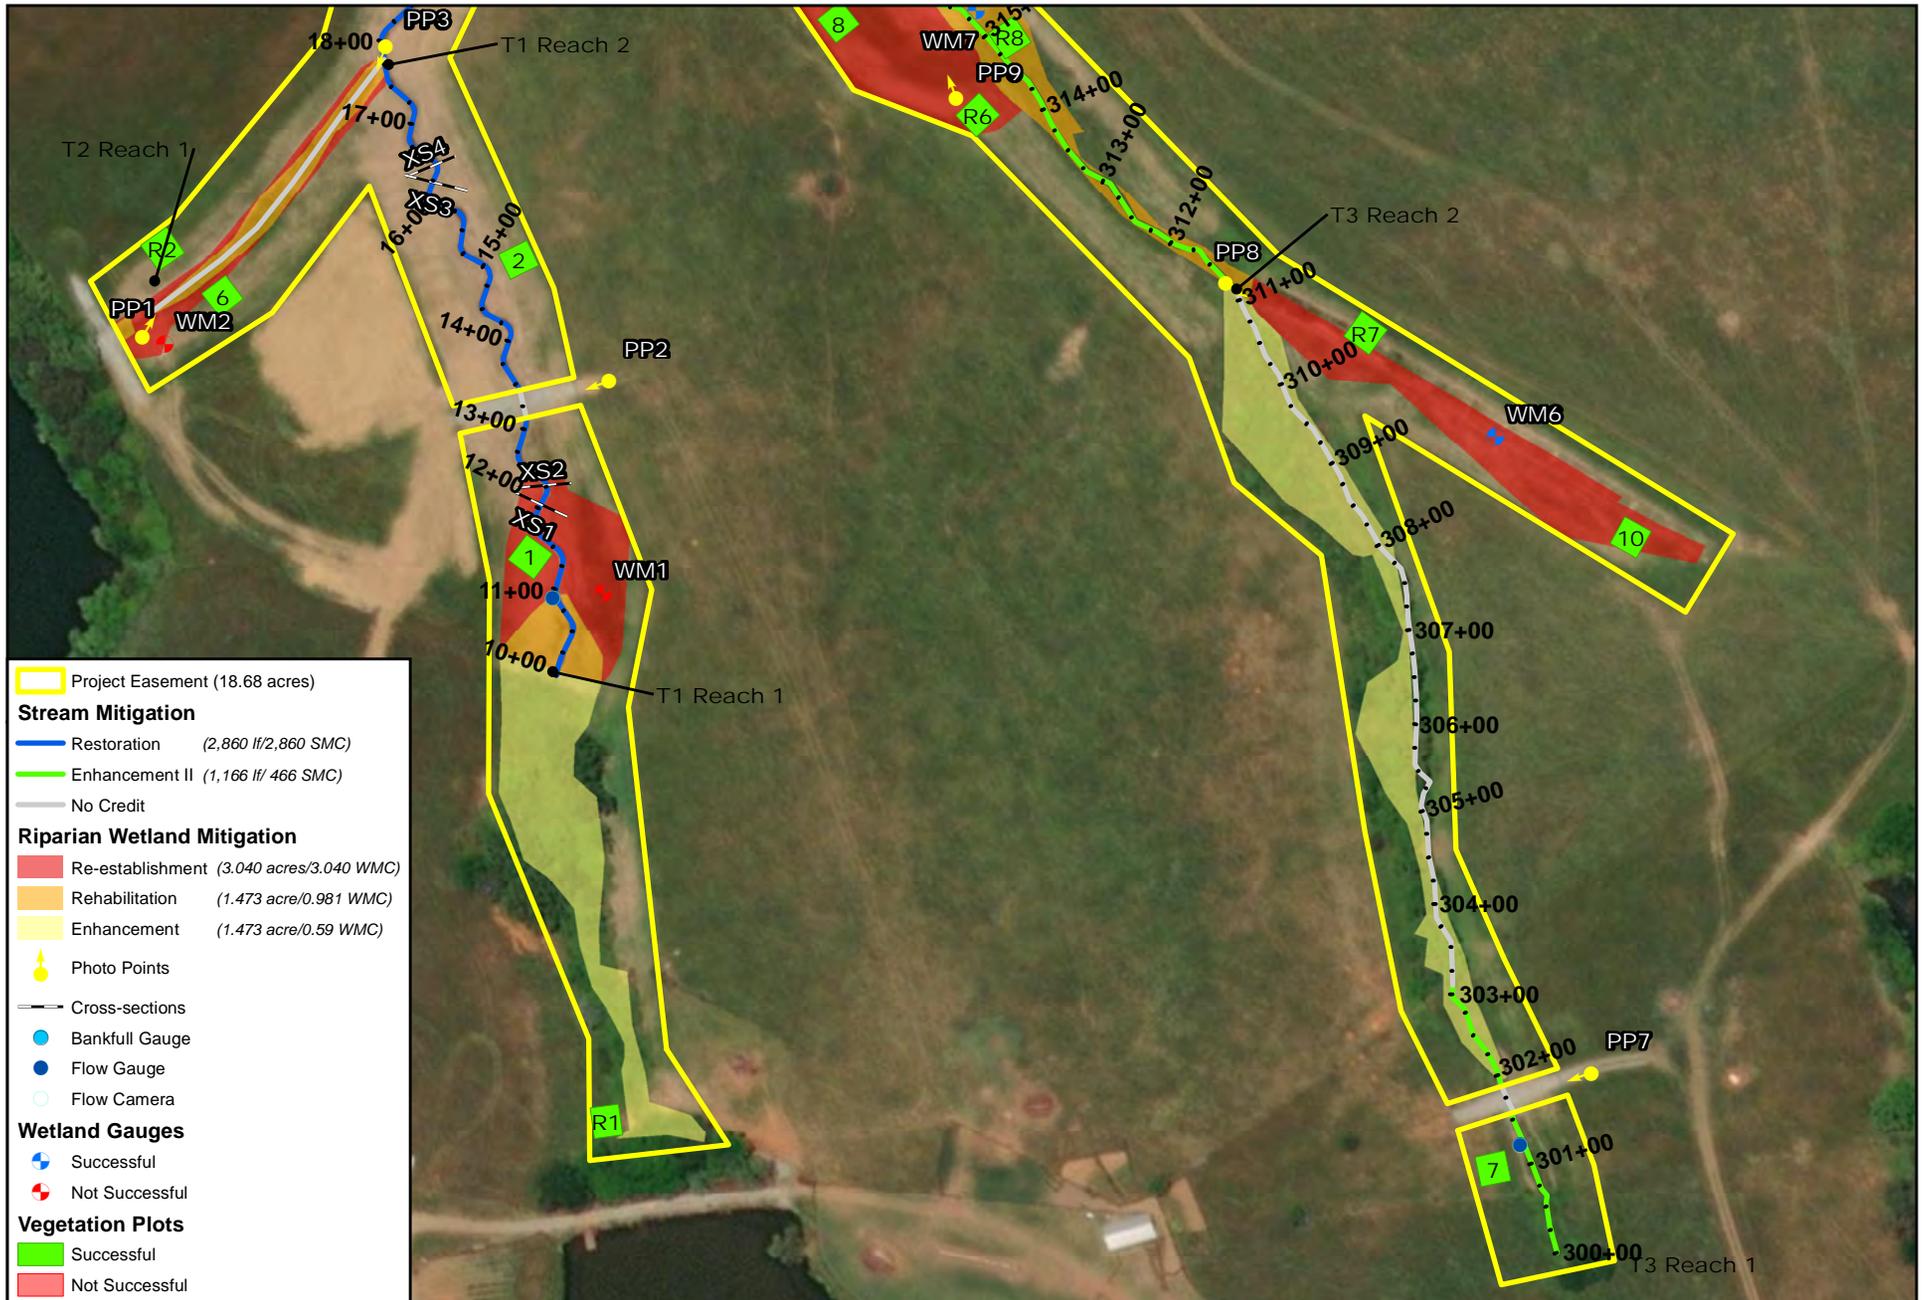
CURRENT CONDITIONS PLANVIEW PAGE
HIP BONE CREEK RESTORATION SITE
CHATHAM COUNTY, NC

Project Easement (18.68 acres)

Stream Mitigation

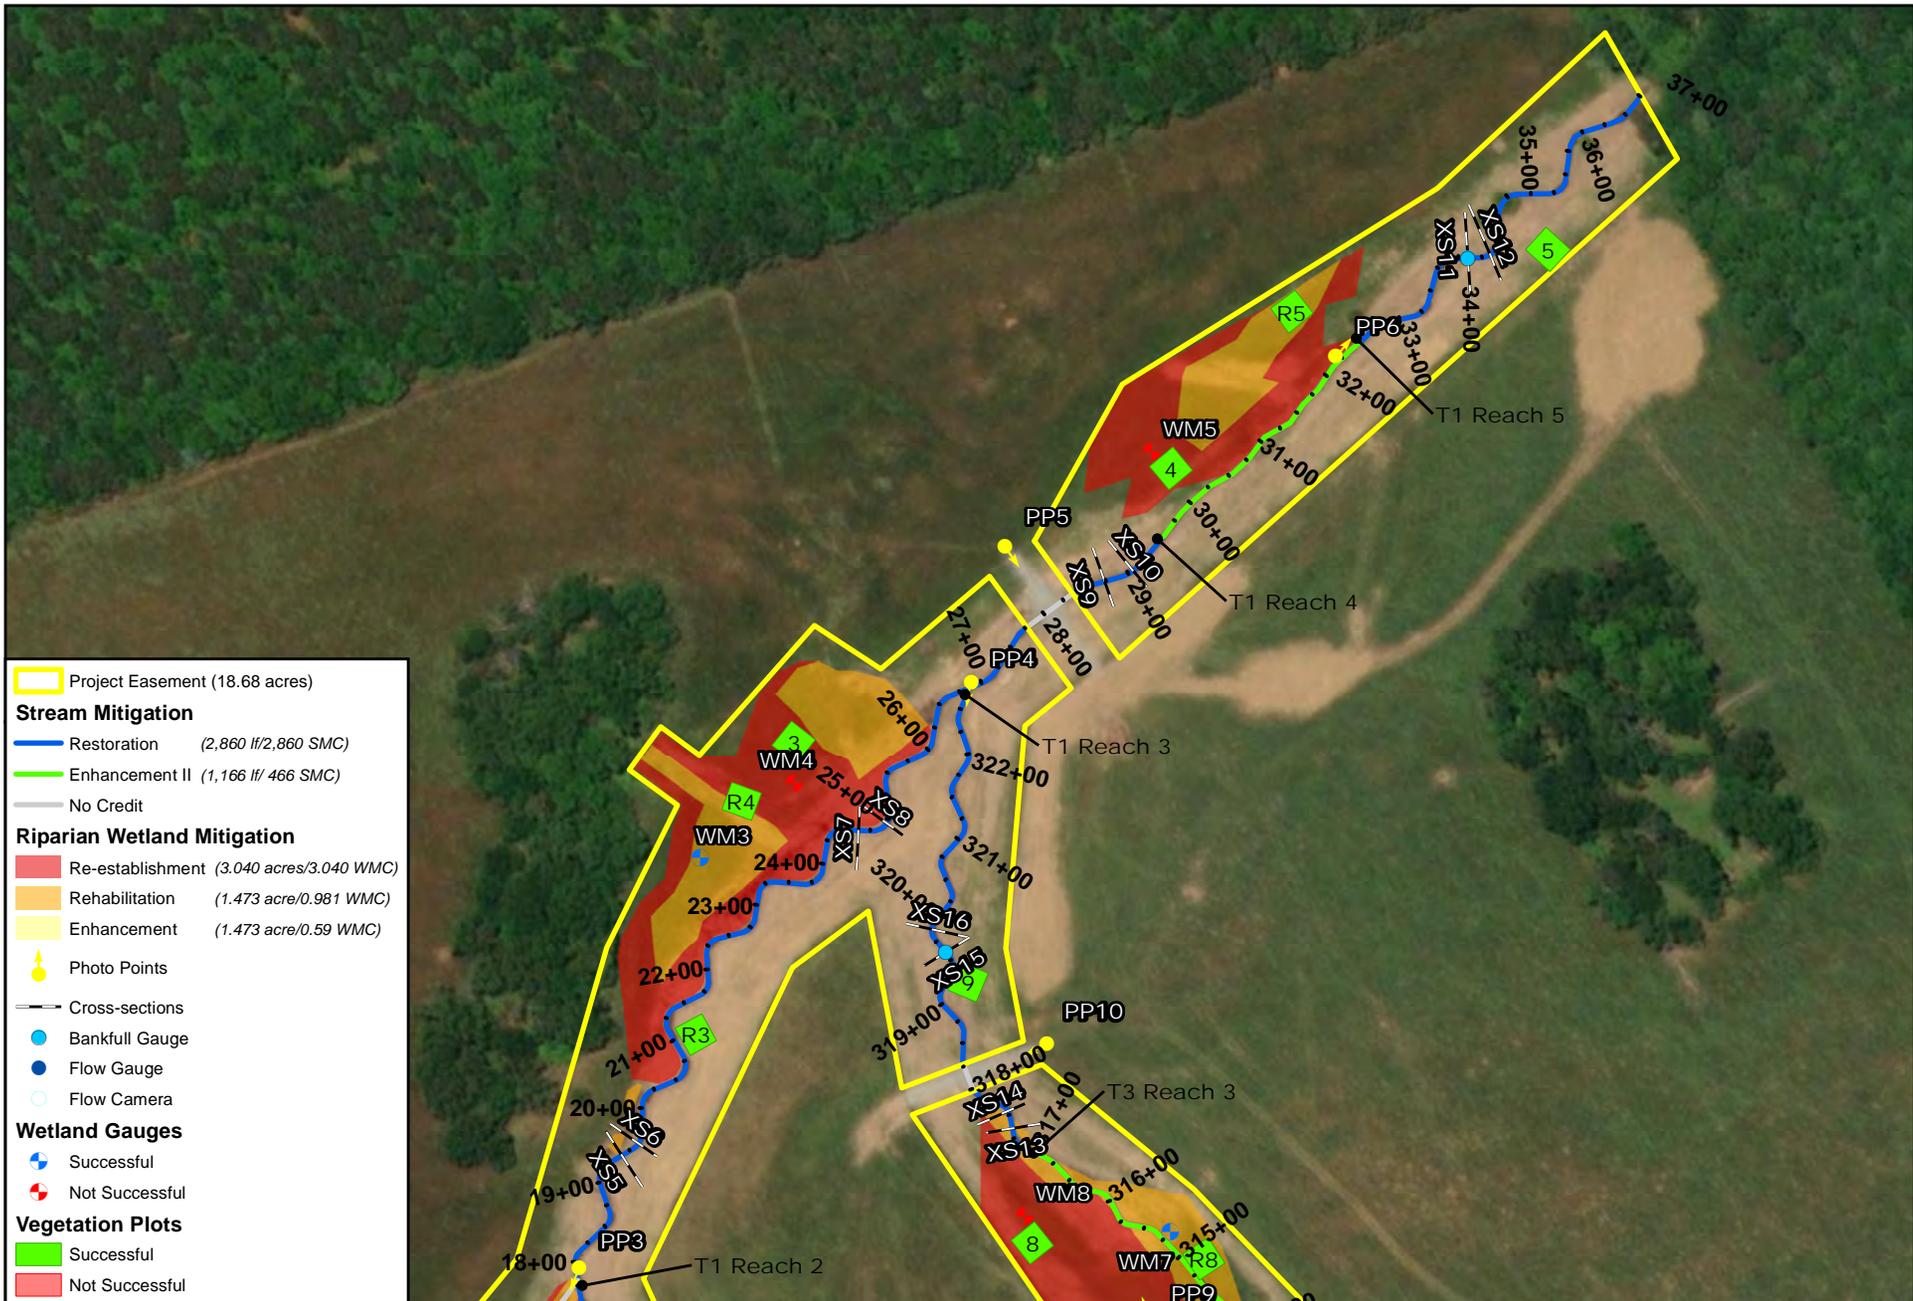
CURRENT CONDITIONS PLANVIEW PAGE
HIP BONE CREEK RESTORATION SITE
CHATHAM COUNTY, NC

Project Easement (18.68 acres)

Stream Mitigation

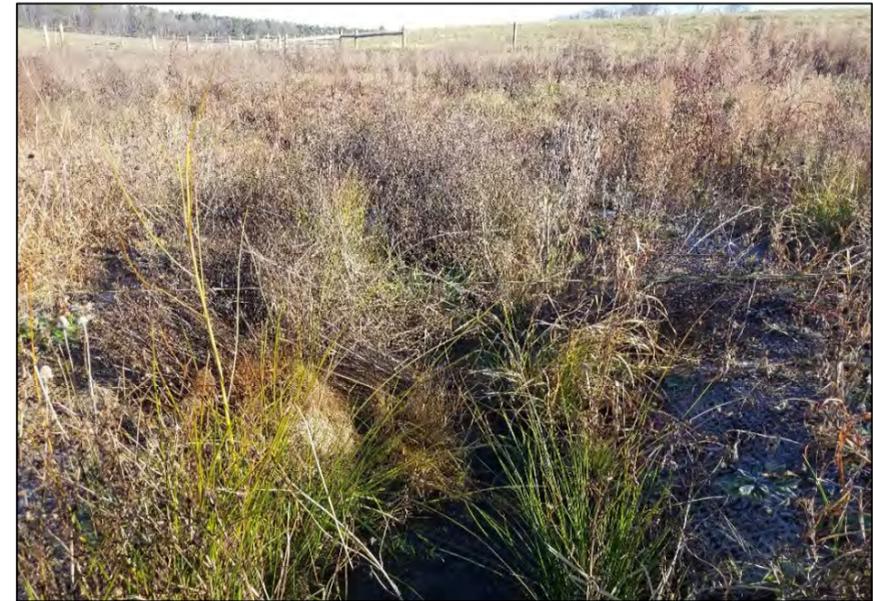
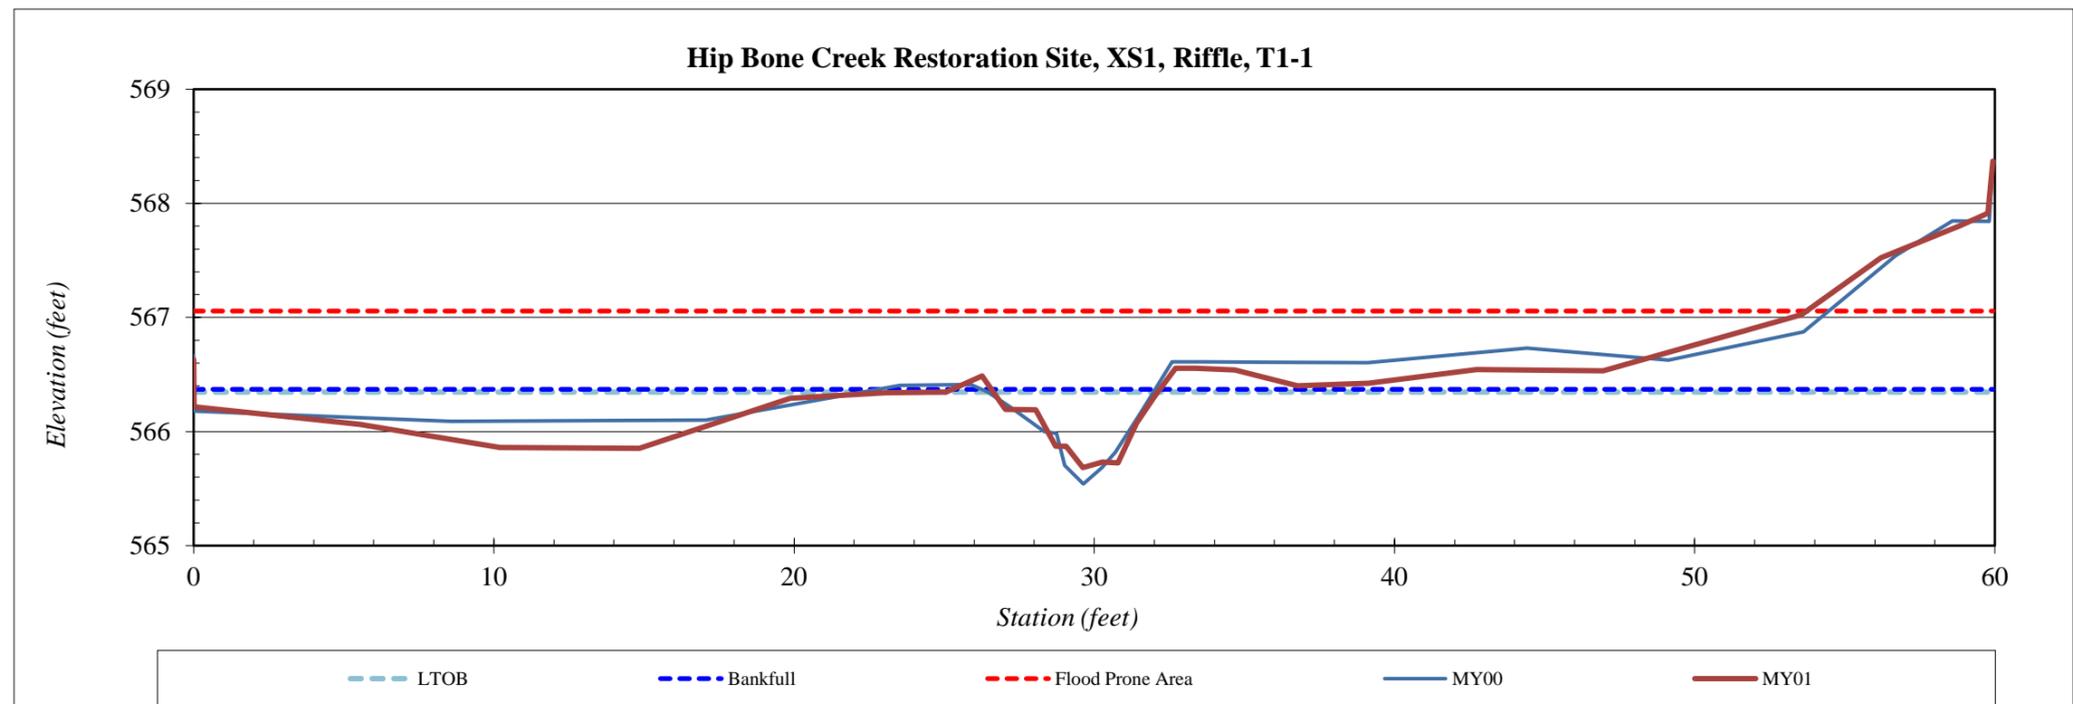
River Basin:	Cape Fear River
Site:	Hip Bone Creek Restoration Site
XS ID	XS1
Drainage Area (sq mi):	0.06
Date:	12/13/2021
Field Crew:	TS, KB

Station	Elevation
0.0	566.63
0.0	566.22
5.5	566.06
10.2	565.86
14.9	565.85
19.9	566.29
23.1	566.34
25.1	566.35
26.3	566.49
27.0	566.20
28.0	566.19
28.7	565.87
29.1	565.87
29.6	565.68
30.3	565.73
30.8	565.73
31.4	566.08
32.0	566.30
32.7	566.55
33.4	566.55
34.7	566.54
36.8	566.40
39.1	566.43
42.7	566.54
47.0	566.53
53.6	567.03
56.2	567.52
58.8	567.81
59.8	567.91
59.9	568.37

SUMMARY DATA	
Bankfull Elevation (ft) - Based on AB-Bankfull Area	566.37
Bankfull Cross-Sectional Area (sq ft):	2.1
LTOB Cross-Sectional Area (sq ft):	2.0
Bankfull Width (ft):	5.6
Flood Prone Area Elevation (ft):	567.06
Flood Prone Width (ft):	54
Max Depth at Bankfull (ft):	0.7
Mean Depth at Bankfull (ft):	0.4
W / D Ratio (ft/ft):	14.9
Entrenchment Ratio (ft/ft):	9.6
Bank Height Ratio (ft/ft):	1.0
Thalweg Elevation (ft):	565.68

The MY01 cross-section survey was completed on December 13, 2021. The MY01 survey found that the stream was functioning as designed with no problem areas identified. All 16 cross-sections had bank height ratios less than 1.2 and entrenchment ratios greater than 2.2.

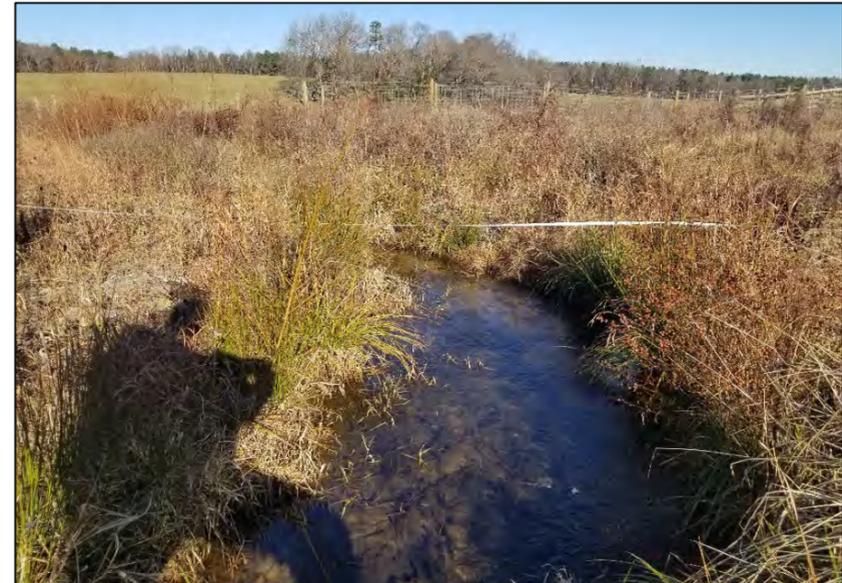
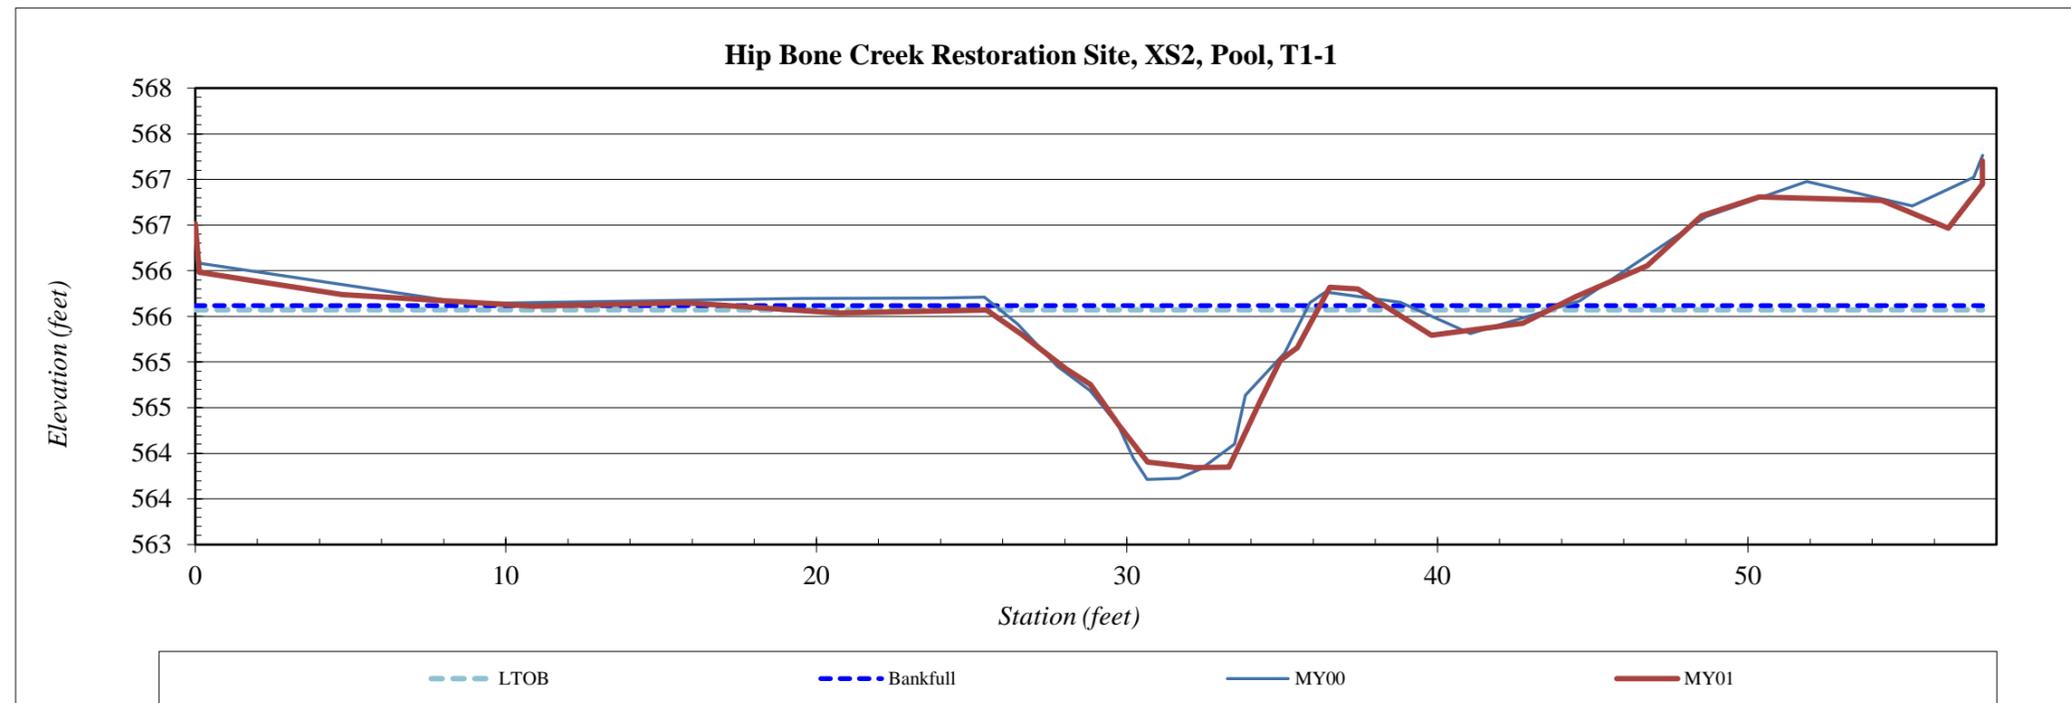
River Basin:	Cape Fear River
Site:	Hip Bone Creek Restoration Site
XS ID	XS2
Drainage Area (sq mi):	0.06
Date:	12/13/2021
Field Crew:	TS, KB

Station	Elevation
0.0	566.52
0.1	565.98
4.7	565.74
10.9	565.61
15.7	565.65
20.7	565.54
23.4	565.56
25.5	565.57
26.6	565.30
28.0	564.93
28.8	564.76
29.7	564.31
30.7	563.91
32.2	563.84
33.3	563.85
33.8	564.25
34.3	564.57
34.9	565.02
35.5	565.16
36.5	565.82
37.4	565.80
39.8	565.29
42.8	565.43
44.5	565.72
46.8	566.05
48.5	566.60
50.4	566.81
54.3	566.77
56.4	566.46
57.5	566.95
57.5	567.20

SUMMARY DATA	
Bankfull Elevation (ft) - Based on AB-Bankfull Area	565.62
Bankfull Cross-Sectional Area (sq ft):	10.9
LTOB Cross-Sectional Area (sq ft):	10.5
Bankfull Width (ft):	10.7
Flood Prone Area Elevation (ft):	---
Flood Prone Width (ft):	---
Max Depth at Bankfull (ft):	1.8
Mean Depth at Bankfull (ft):	1.0
W / D Ratio (ft/ft):	---
Entrenchment Ratio (ft/ft):	---
Bank Height Ratio (ft/ft):	1.0
Thalweg Elevation (ft):	563.84

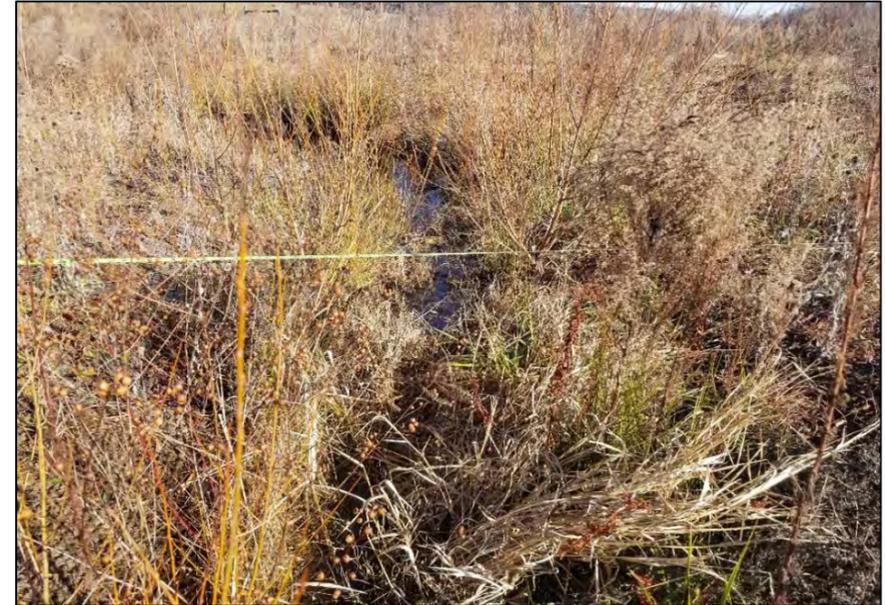
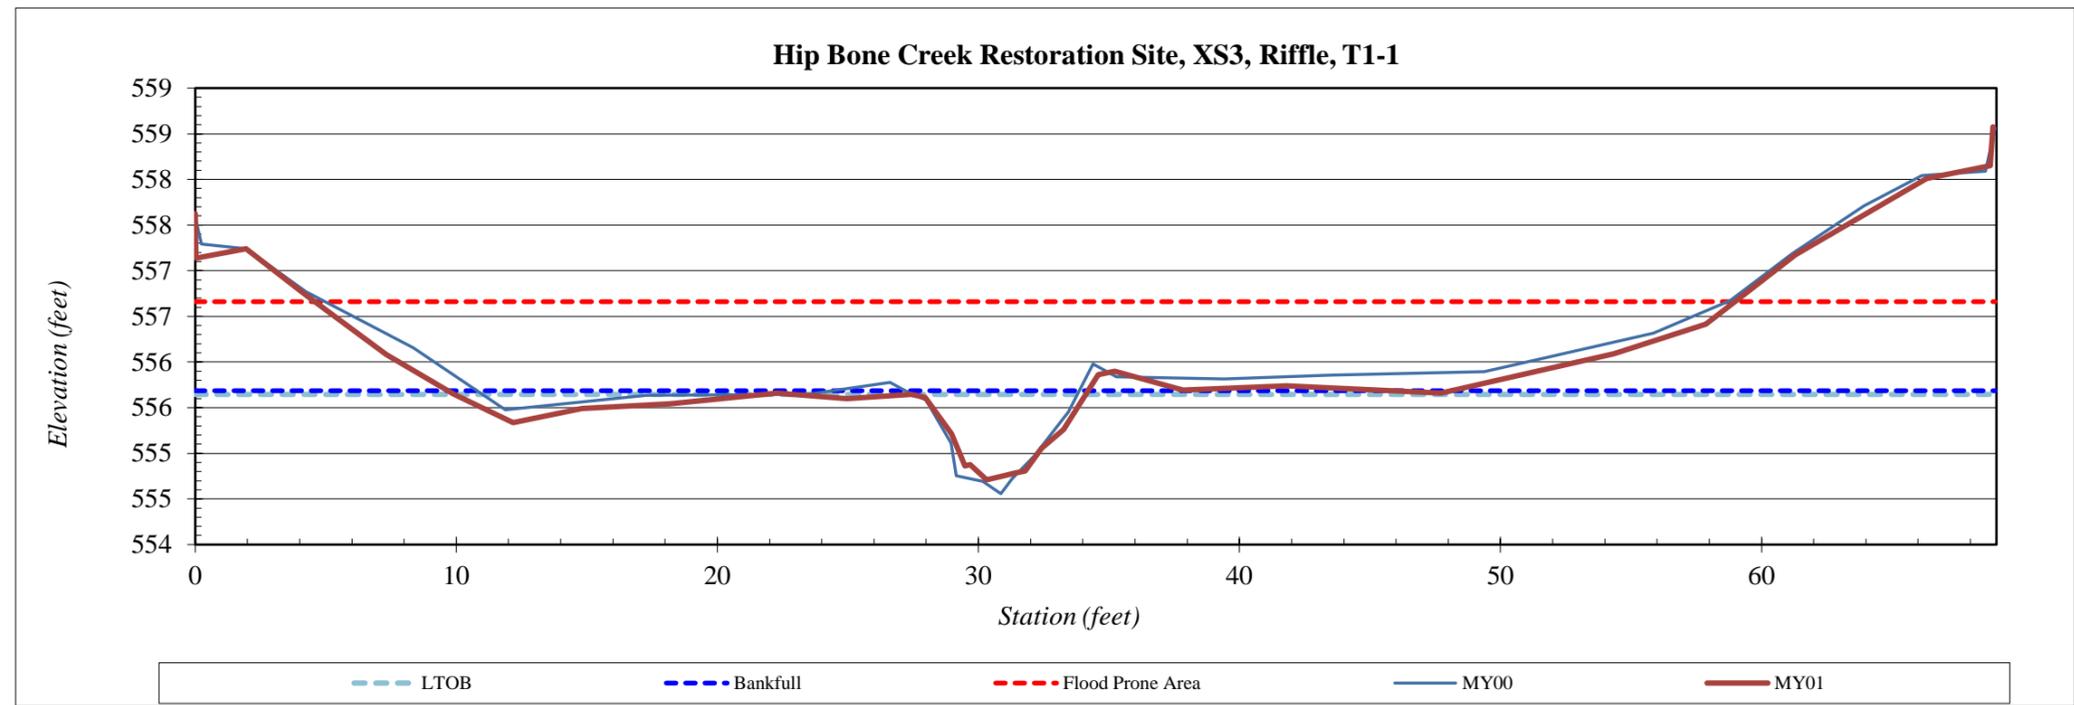
River Basin:	Cape Fear River
Site:	Hip Bone Creek Restoration Site
XS ID	XS3
Drainage Area (sq mi):	0.08
Date:	12/13/2021
Field Crew:	TS, KB

Station	Elevation
0.0	557.63
0.0	557.14
1.9	557.24
4.2	556.73
7.3	556.08
9.9	555.65
12.2	555.34
14.8	555.49
18.2	555.54
22.3	555.66
25.0	555.60
27.4	555.65
28.0	555.61
29.0	555.21
29.5	554.86
29.7	554.88
30.3	554.71
30.9	554.75
31.4	554.78
31.8	554.80
32.4	555.06
33.3	555.26
34.6	555.86
35.2	555.90
37.8	555.69
41.8	555.74
47.7	555.66
54.4	556.09
57.9	556.41
61.3	557.18
66.3	558.01
68.8	558.15
68.9	558.58

SUMMARY DATA	
Bankfull Elevation (ft) - Based on AB-Bankfull Area	555.69
Bankfull Cross-Sectional Area (sq ft):	3.9
LTOB Cross-Sectional Area (sq ft):	3.6
Bankfull Width (ft):	6.8
Flood Prone Area Elevation (ft):	556.66
Flood Prone Width (ft):	54
Max Depth at Bankfull (ft):	1.0
Mean Depth at Bankfull (ft):	0.6
W / D Ratio (ft/ft):	11.9
Entrenchment Ratio (ft/ft):	8.0
Bank Height Ratio (ft/ft):	1.0
Thalweg Elevation (ft):	554.71

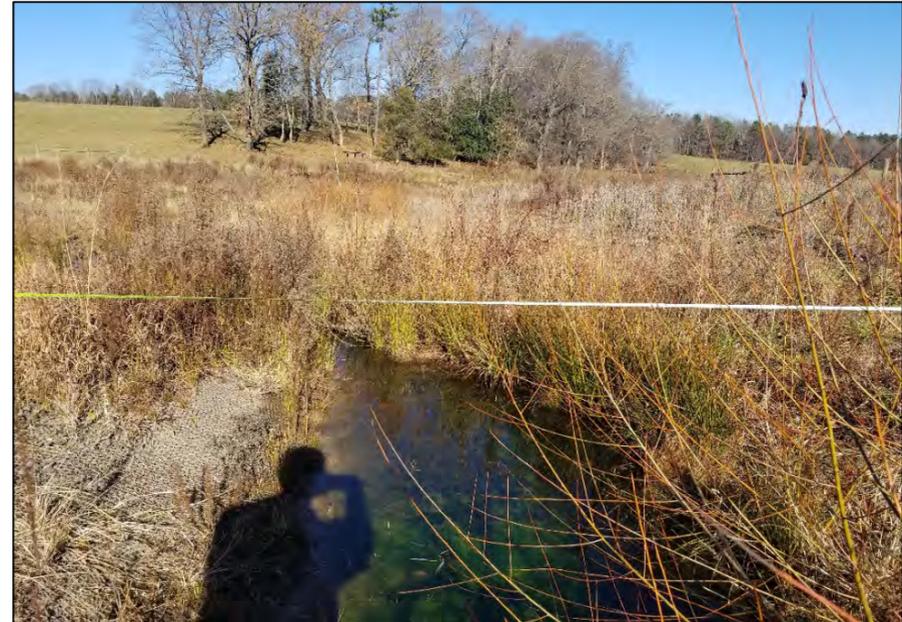
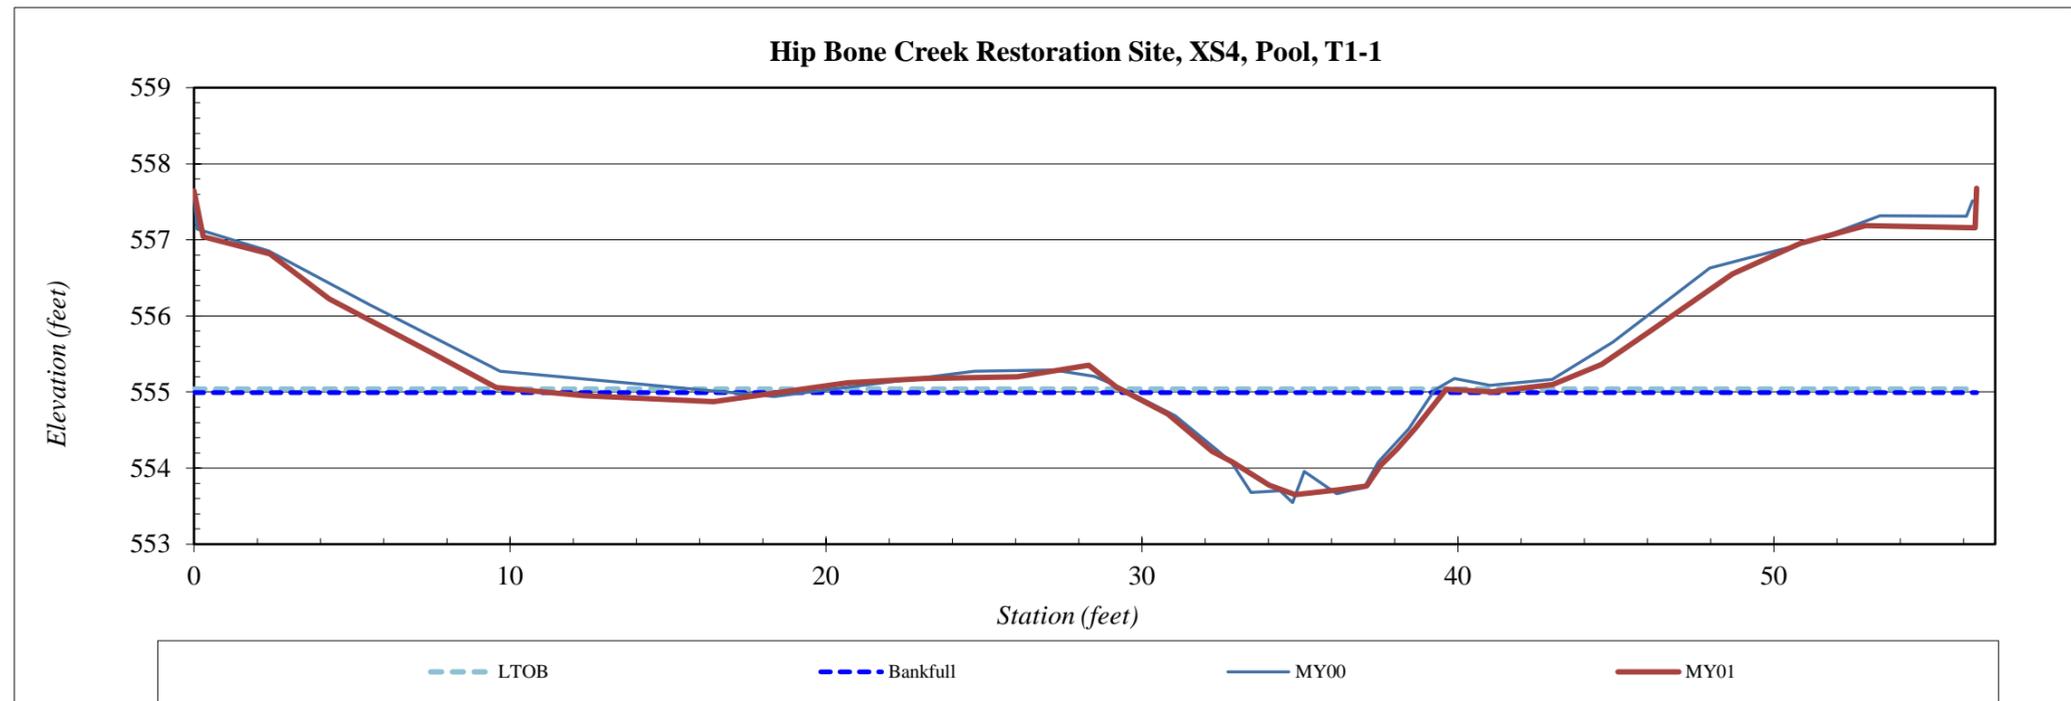
River Basin:	Cape Fear River
Site:	Hip Bone Creek Restoration Site
XS ID	XS4
Drainage Area (sq mi):	0.08
Date:	12/13/2021
Field Crew:	TS, KB

Station	Elevation
0.0	557.64
0.3	557.04
2.4	556.82
4.3	556.23
7.5	555.53
9.6	555.06
12.3	554.95
16.4	554.87
20.7	555.12
23.1	555.18
26.0	555.20
28.3	555.35
29.2	555.07
30.8	554.71
32.2	554.22
32.9	554.08
34.0	553.78
34.9	553.65
36.2	553.71
37.1	553.76
37.6	554.04
38.1	554.25
38.6	554.52
39.6	555.04
41.1	555.00
43.0	555.10
44.5	555.36
46.0	555.78
48.7	556.55
50.8	556.96
52.9	557.19
56.4	557.16
56.4	557.68

SUMMARY DATA	
Bankfull Elevation (ft) - Based on AB-Bankfull Area	554.99
Bankfull Cross-Sectional Area (sq ft):	8.1
LTOB Cross-Sectional Area (sq ft):	8.7
Bankfull Width (ft):	10.0
Flood Prone Area Elevation (ft):	---
Flood Prone Width (ft):	---
Max Depth at Bankfull (ft):	1.3
Mean Depth at Bankfull (ft):	0.8
W / D Ratio (ft/ft):	---
Entrenchment Ratio (ft/ft):	---
Bank Height Ratio (ft/ft):	1.0
Thalweg Elevation (ft):	553.65

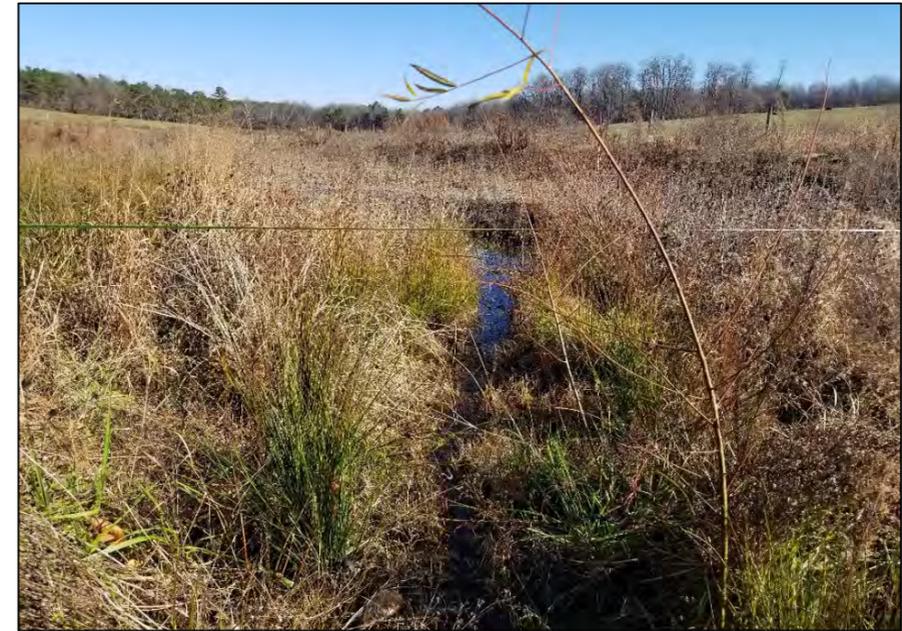
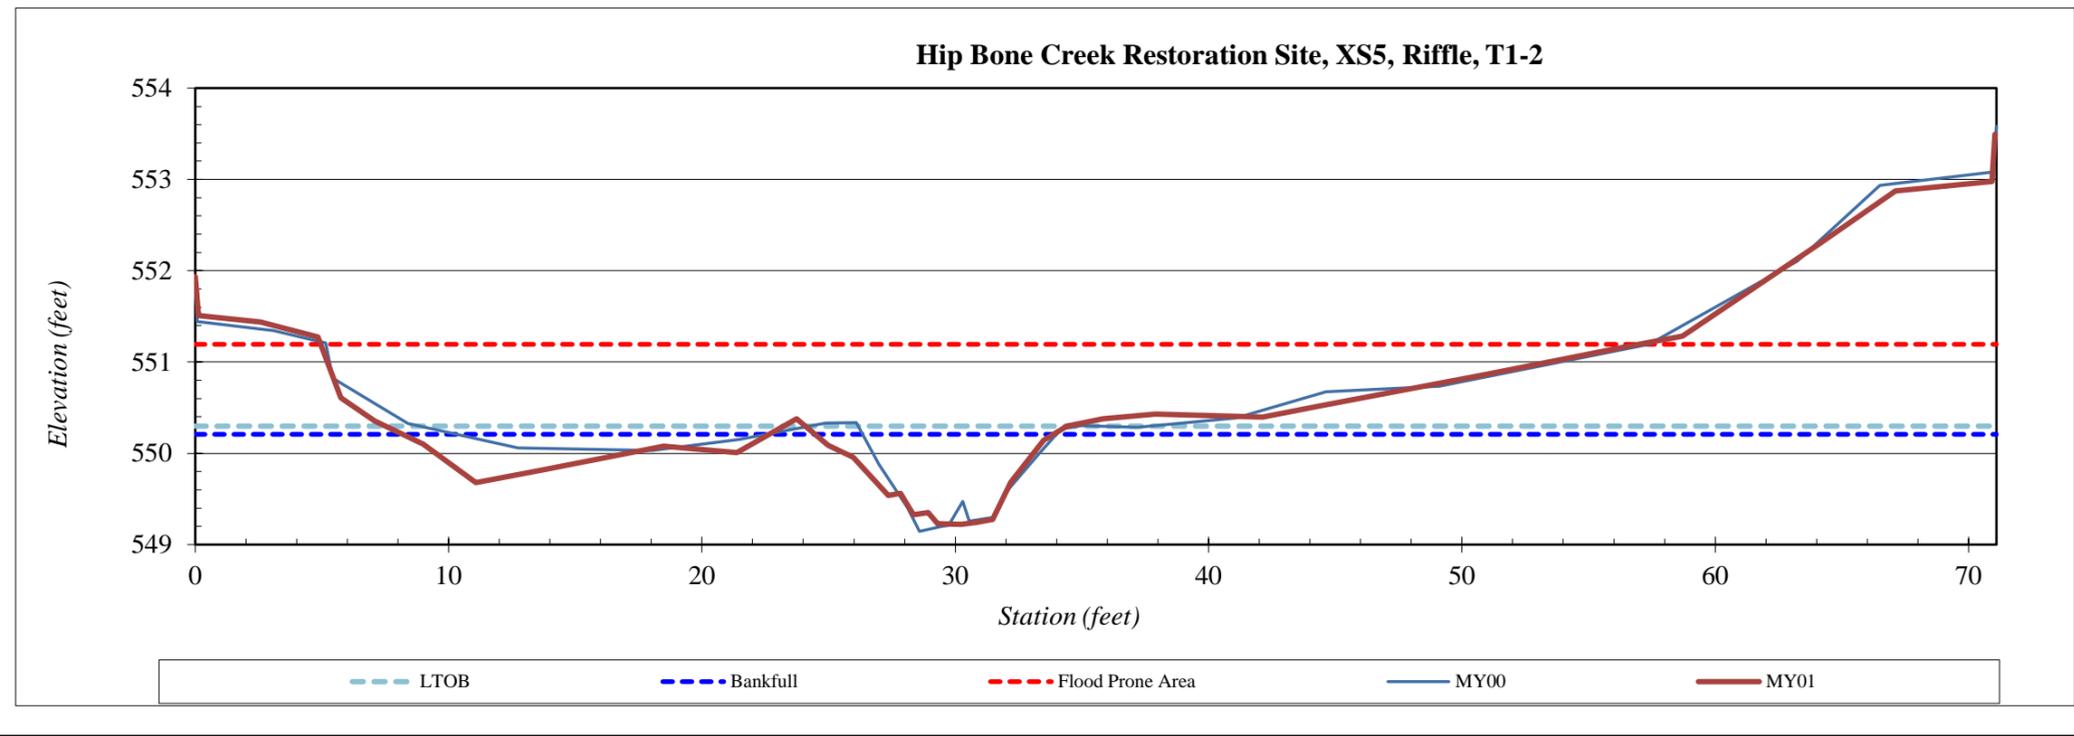
River Basin:	Cape Fear River
Site:	Hip Bone Creek Restoration Site
XS ID	XS5
Drainage Area (sq mi):	0.13
Date:	12/13/2021
Field Crew:	TS, KB

Station	Elevation
0.0	551.94
0.1	551.51
2.6	551.44
4.8	551.28
5.7	550.61
7.1	550.36
9.0	550.10
11.1	549.68
13.7	549.82
18.5	550.08
21.4	550.01
23.7	550.38
25.0	550.09
26.0	549.95
27.4	549.54
27.8	549.56
28.3	549.33
28.9	549.35
29.3	549.23
30.2	549.22
30.8	549.24
31.5	549.28
32.2	549.69
33.5	550.14
34.4	550.30
35.8	550.38
37.9	550.43
42.1	550.40
44.4	550.52
51.0	550.86
56.4	551.17
58.7	551.29
64.0	552.28
67.1	552.87
70.9	552.98
71.0	553.49

SUMMARY DATA	
Bankfull Elevation (ft) - Based on AB-Bankfull Area	550.21
Bankfull Cross-Sectional Area (sq ft):	5.4
LTOB Cross-Sectional Area (sq ft):	6.2
Bankfull Width (ft):	8.9
Flood Prone Area Elevation (ft):	551.19
Flood Prone Width (ft):	52
Max Depth at Bankfull (ft):	1.0
Mean Depth at Bankfull (ft):	0.6
W / D Ratio (ft/ft):	14.7
Entrenchment Ratio (ft/ft):	5.8
Bank Height Ratio (ft/ft):	1.1
Thalweg Elevation (ft):	549.22

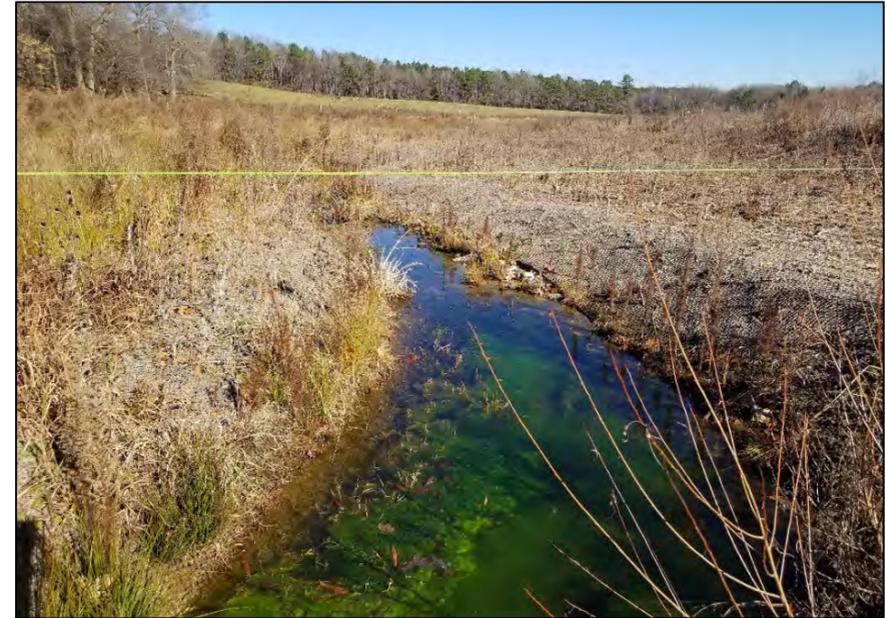
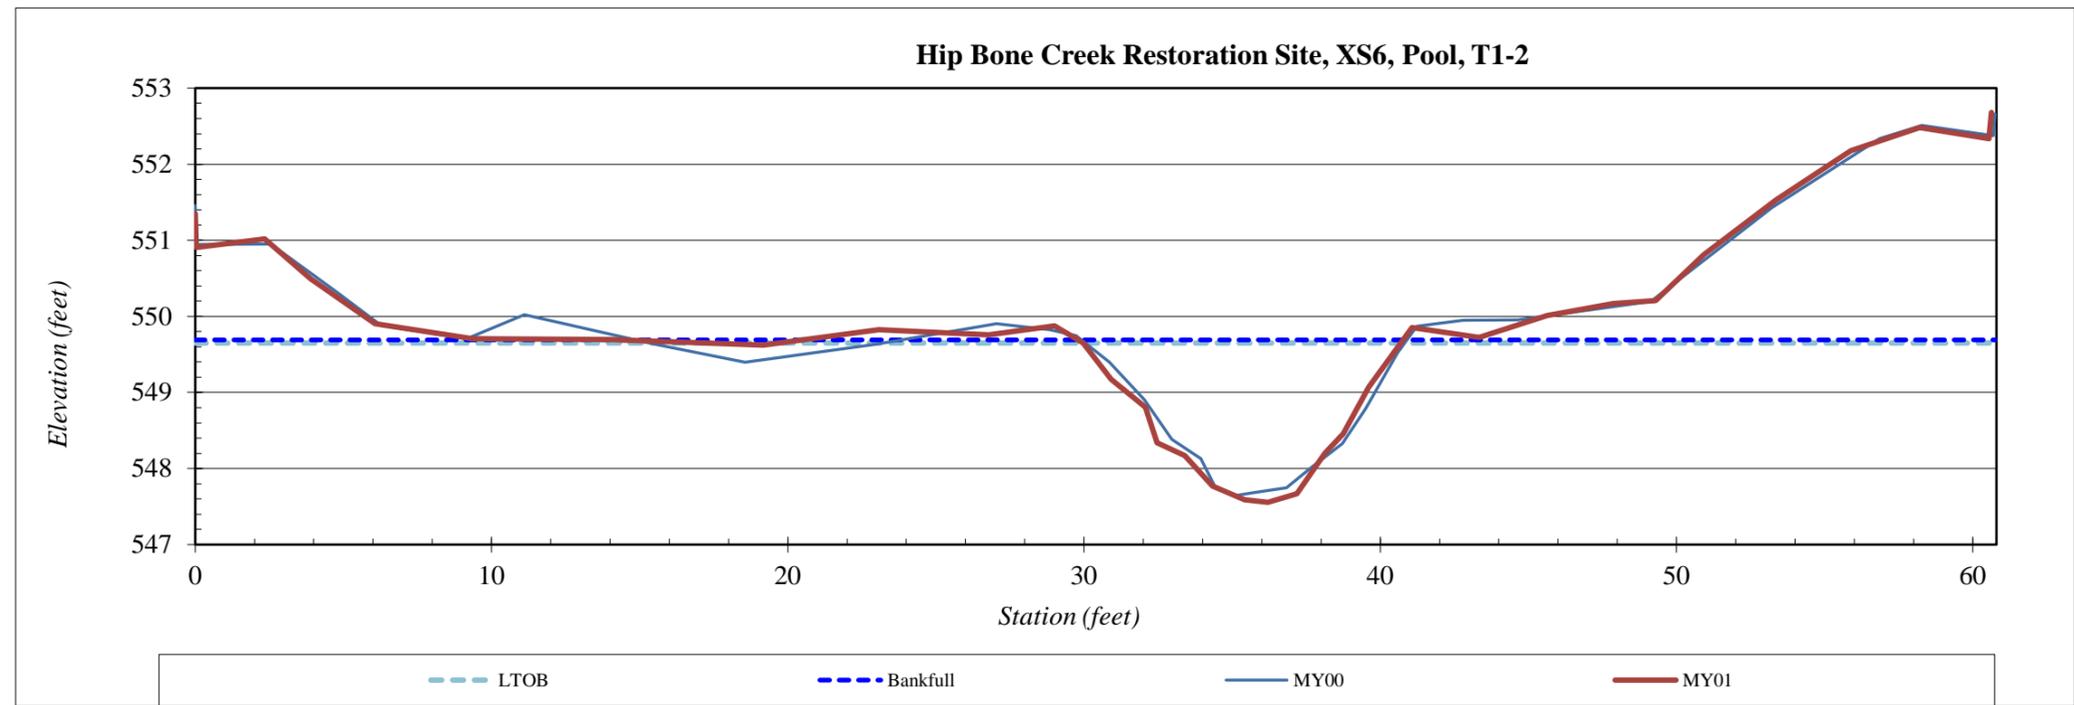
River Basin:	Cape Fear River
Site:	Hip Bone Creek Restoration Site
XS ID	XS6
Drainage Area (sq mi):	0.13
Date:	12/13/2021
Field Crew:	TS, KB

Station	Elevation
0.0	551.35
0.0	550.91
2.3	551.02
3.9	550.49
6.1	549.90
9.4	549.71
14.0	549.70
19.2	549.62
23.1	549.82
26.8	549.76
29.0	549.88
30.0	549.65
30.9	549.17
32.1	548.80
32.5	548.34
33.4	548.17
34.3	547.77
35.4	547.59
36.2	547.56
37.2	547.67
38.1	548.21
38.7	548.46
39.6	549.07
41.1	549.85
43.3	549.72
45.6	550.01
47.9	550.17
49.3	550.21
50.9	550.81
53.4	551.53
55.9	552.18
58.2	552.48
60.5	552.34
60.6	552.68

SUMMARY DATA	
Bankfull Elevation (ft) - Based on AB-Bankfull Area	549.69
Bankfull Cross-Sectional Area (sq ft):	14.0
LTOB Cross-Sectional Area (sq ft):	13.6
Bankfull Width (ft):	10.8
Flood Prone Area Elevation (ft):	---
Flood Prone Width (ft):	---
Max Depth at Bankfull (ft):	2.1
Mean Depth at Bankfull (ft):	1.3
W / D Ratio (ft/ft):	---
Entrenchment Ratio (ft/ft):	---
Bank Height Ratio (ft/ft):	1.0
Thalweg Elevation (ft):	547.56
