MY01 MONITORING REPORT

Hip Bone Creek Restoration Site
Chatham County
Cape Fear River Basin - 03040101

DMS Project #100059

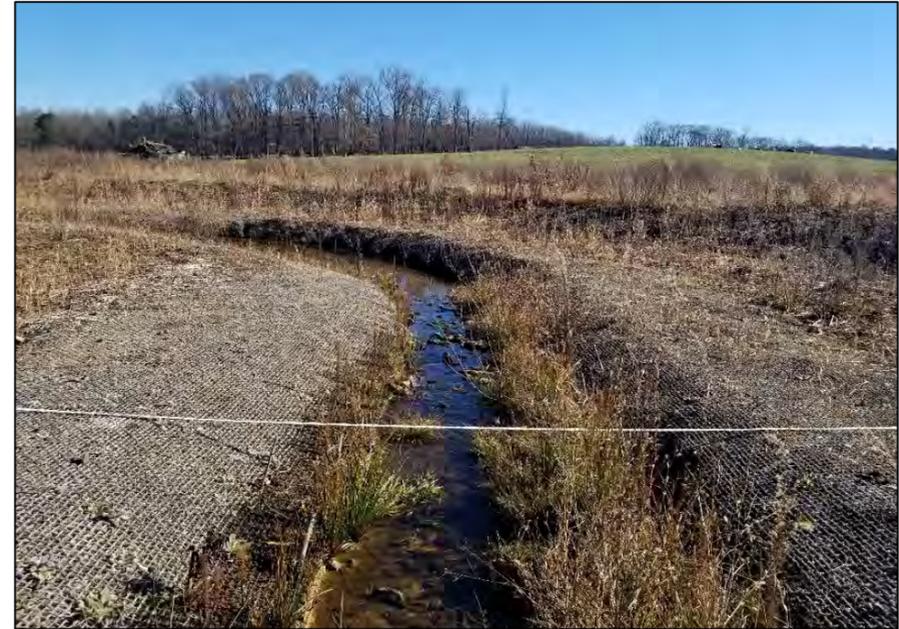
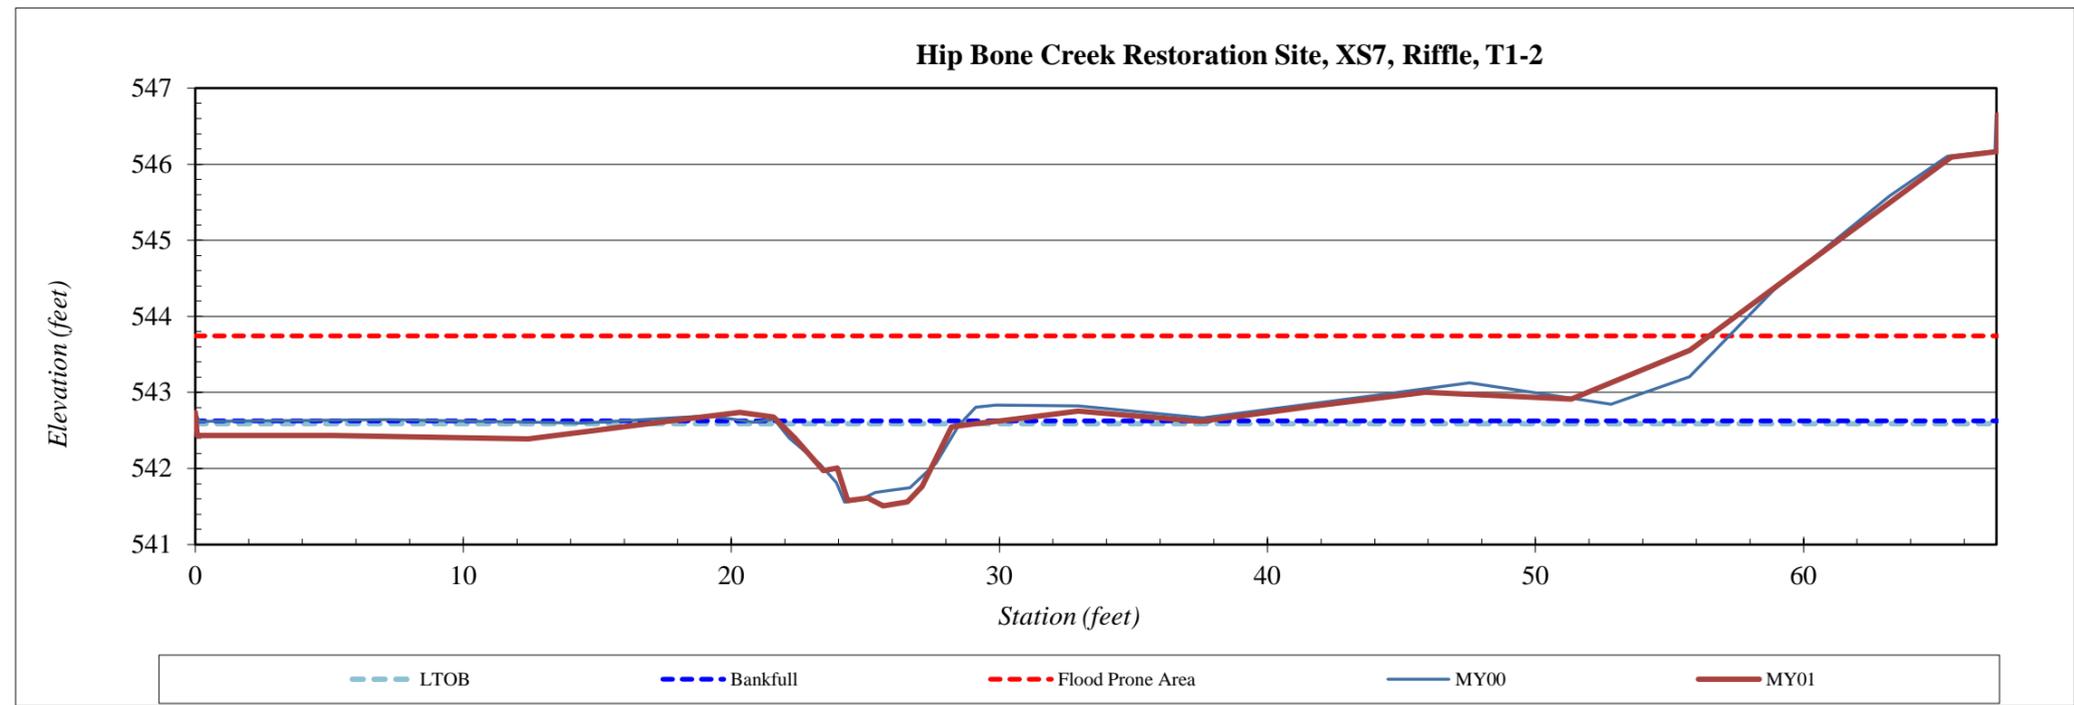
River Basin:	Cape Fear River
Site:	Hip Bone Creek Restoration Site
XS ID	XS7
Drainage Area (sq mi):	0.14
Date:	12/13/2021
Field Crew:	TS, KB

Station	Elevation
0.0	542.74
0.1	542.44
5.1	542.44
12.4	542.39
17.5	542.61
20.3	542.74
21.6	542.68
22.4	542.40
23.4	541.97
24.0	542.00
24.3	541.58
25.1	541.61
25.7	541.51
26.6	541.56
27.1	541.77
28.2	542.54
29.2	542.59
30.2	542.63
33.0	542.76
37.5	542.62
41.8	542.82
45.9	543.00
51.3	542.91
55.8	543.55
59.9	544.64
65.5	546.09
67.2	546.17
67.2	546.65

SUMMARY DATA	
Bankfull Elevation (ft) - Based on AB-Bankfull Area	542.63
Bankfull Cross-Sectional Area (sq ft):	4.6
LTOB Cross-Sectional Area (sq ft):	4.4
Bankfull Width (ft):	6.5
Flood Prone Area Elevation (ft):	543.74
Flood Prone Width (ft):	56
Max Depth at Bankfull (ft):	1.1
Mean Depth at Bankfull (ft):	0.7
W / D Ratio (ft/ft):	9.1
Entrenchment Ratio (ft/ft):	8.7
Bank Height Ratio (ft/ft):	1.0
Thalweg Elevation (ft):	541.51

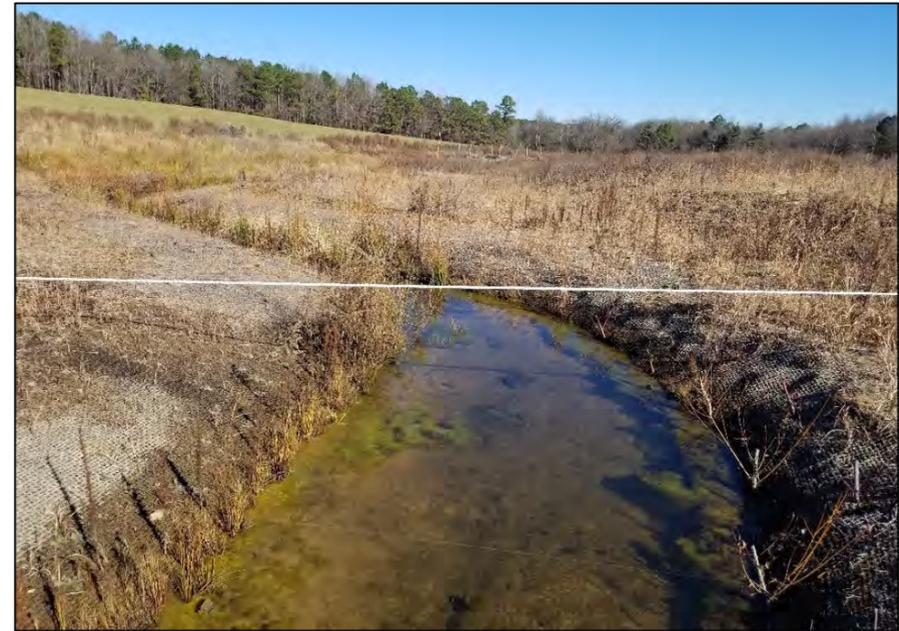
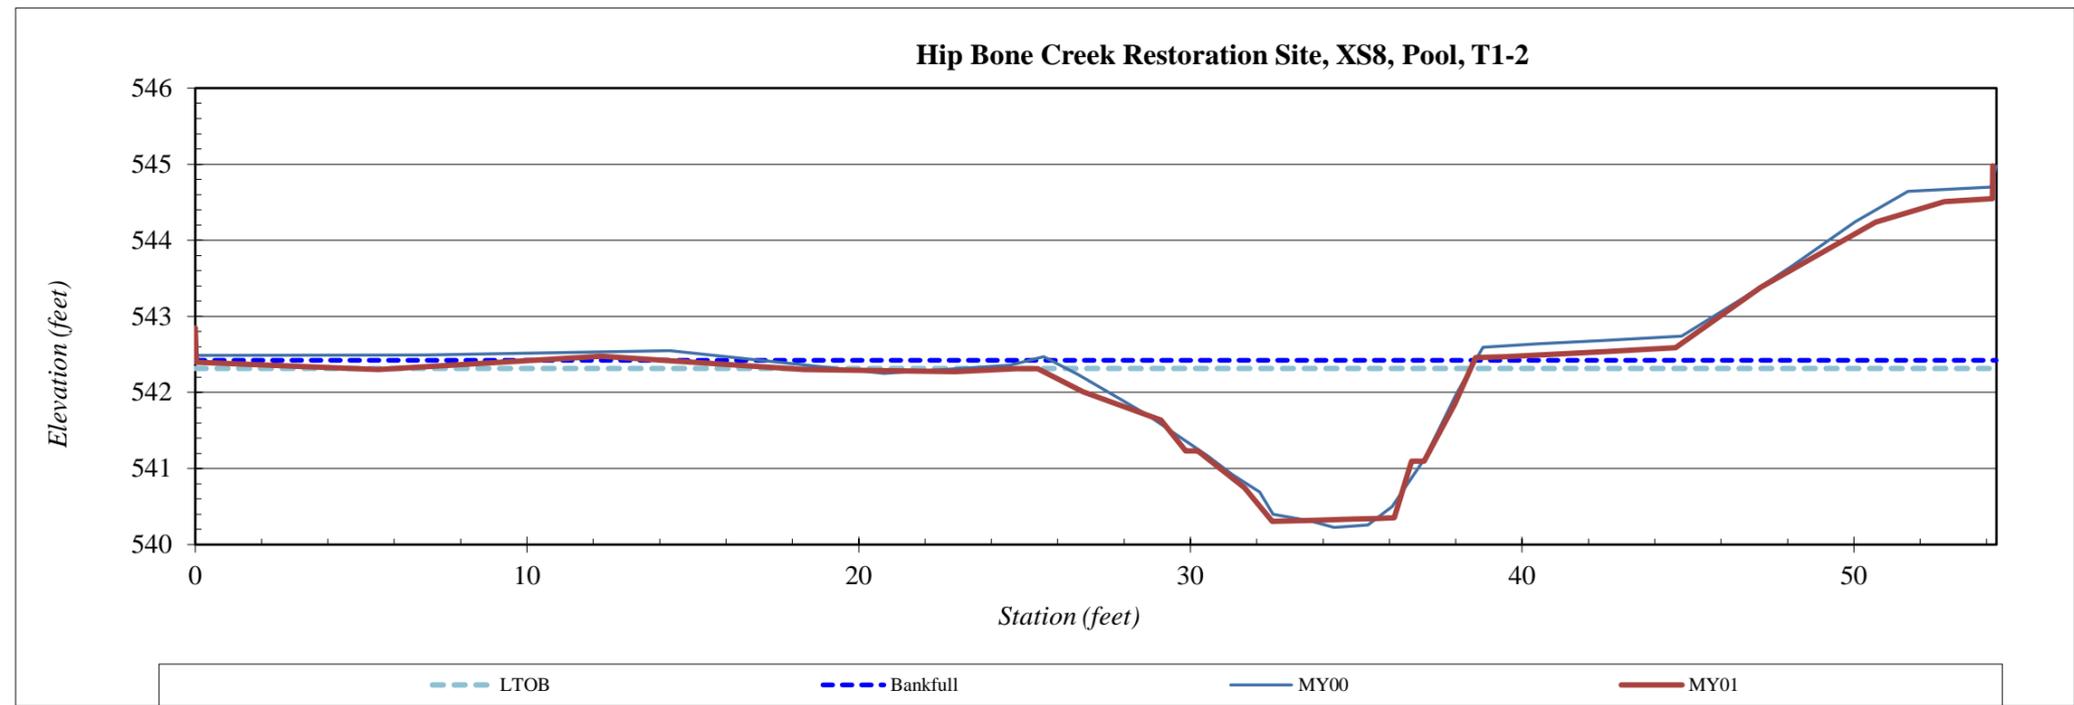
River Basin:	Cape Fear River
Site:	Hip Bone Creek Restoration Site
XS ID	XS8
Drainage Area (sq mi):	0.14
Date:	12/13/2021
Field Crew:	TS, KB

Station	Elevation
0.0	542.85
0.0	542.40
5.5	542.30
12.2	542.47
18.4	542.30
22.9	542.27
24.8	542.31
25.4	542.32
26.8	542.01
29.1	541.64
29.9	541.23
30.2	541.23
31.6	540.75
32.5	540.31
33.8	540.32
34.9	540.34
35.6	540.34
36.2	540.35
36.7	541.10
37.0	541.10
38.0	541.84
38.6	542.46
39.5	542.47
42.5	542.54
44.6	542.59
47.2	543.38
50.7	544.24
52.7	544.51
54.2	544.55
54.2	544.98

SUMMARY DATA	
Bankfull Elevation (ft) - Based on AB-Bankfull Area	542.42
Bankfull Cross-Sectional Area (sq ft):	16.7
LTOB Cross-Sectional Area (sq ft):	15.3
Bankfull Width (ft):	13.2
Flood Prone Area Elevation (ft):	---
Flood Prone Width (ft):	---
Max Depth at Bankfull (ft):	2.1
Mean Depth at Bankfull (ft):	1.3
W / D Ratio (ft/ft):	---
Entrenchment Ratio (ft/ft):	---
Bank Height Ratio (ft/ft):	0.9
Thalweg Elevation (ft):	540.31

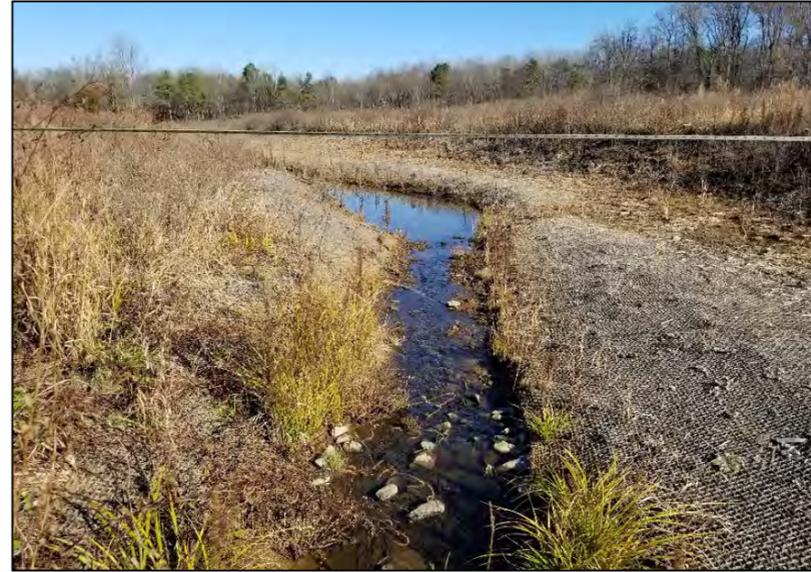
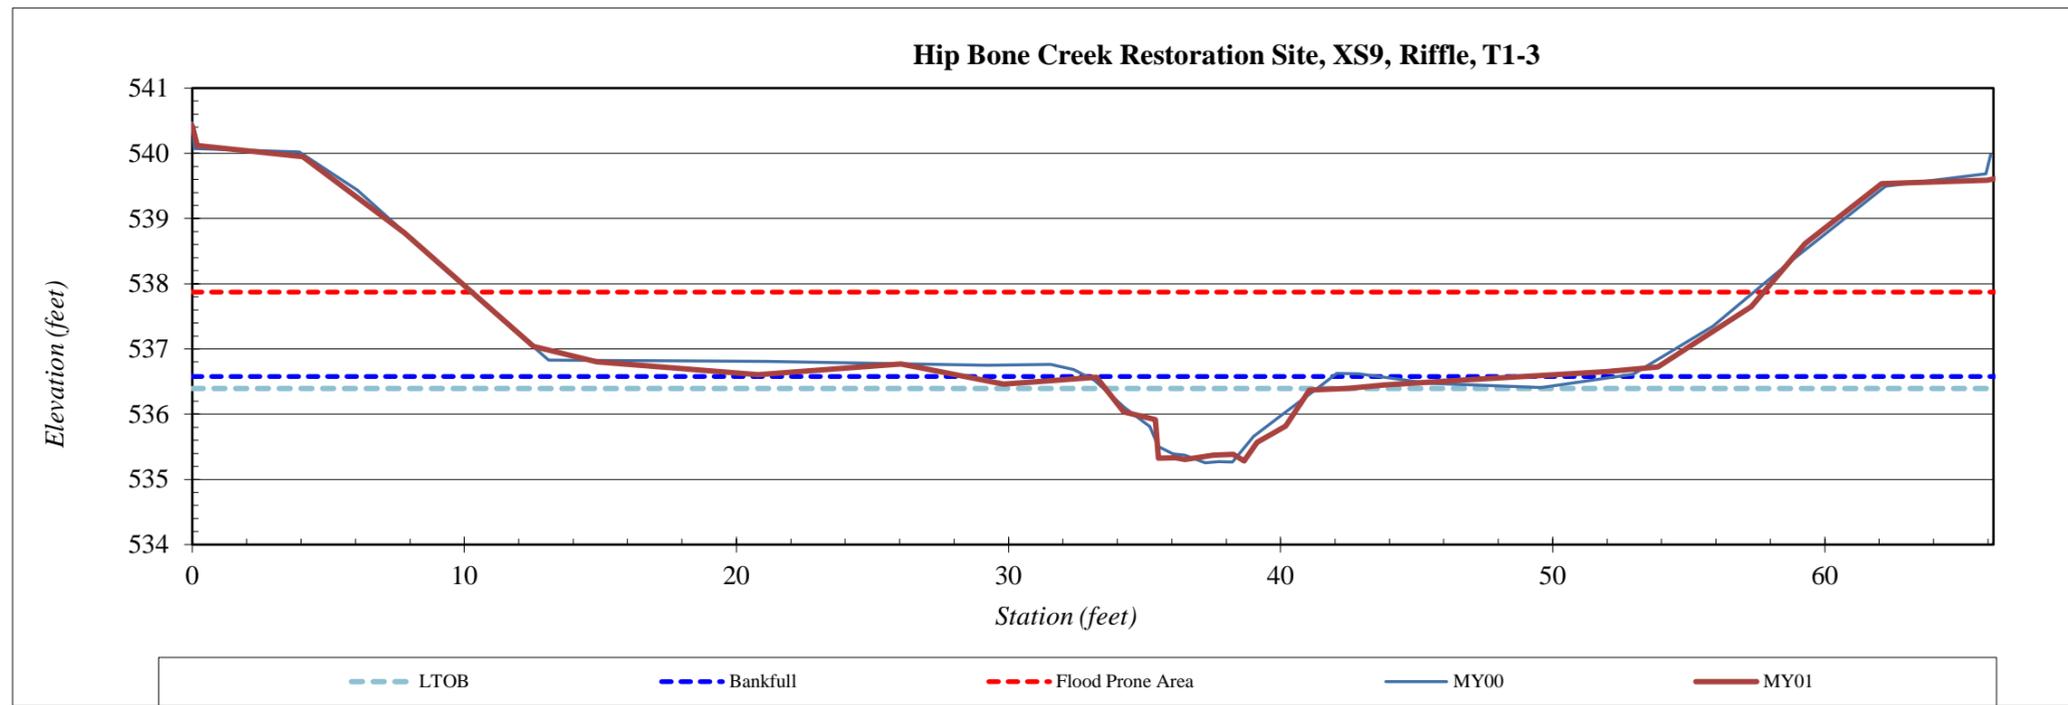
River Basin:	Cape Fear River
Site:	Hip Bone Creek Restoration Site
XS ID	XS9
Drainage Area (sq mi):	0.19
Date:	12/13/2021
Field Crew:	TS, KB

Station	Elevation
0.0	540.42
0.2	540.12
4.1	539.95
7.8	538.78
12.5	537.04
14.9	536.80
20.8	536.61
26.1	536.77
29.8	536.46
31.6	536.51
32.2	536.53
33.2	536.57
34.2	536.03
35.4	535.92
35.5	535.33
36.1	535.33
36.5	535.31
37.1	535.34
37.5	535.37
38.3	535.38
38.7	535.28
39.1	535.57
40.2	535.82
41.1	536.37
42.5	536.39
43.8	536.45
46.8	536.53
52.0	536.65
53.9	536.72
57.3	537.65
59.3	538.62
62.1	539.53
66.0	539.59
66.3	539.62

SUMMARY DATA	
Bankfull Elevation (ft) - Based on AB-Bankfull Area	536.58
Bankfull Cross-Sectional Area (sq ft):	7.2
LTOB Cross-Sectional Area (sq ft):	5.5
Bankfull Width (ft):	10.3
Flood Prone Area Elevation (ft):	537.87
Flood Prone Width (ft):	47
Max Depth at Bankfull (ft):	1.3
Mean Depth at Bankfull (ft):	0.7
W / D Ratio (ft/ft):	14.7
Entrenchment Ratio (ft/ft):	4.6
Bank Height Ratio (ft/ft):	0.9
Thalweg Elevation (ft):	535.28

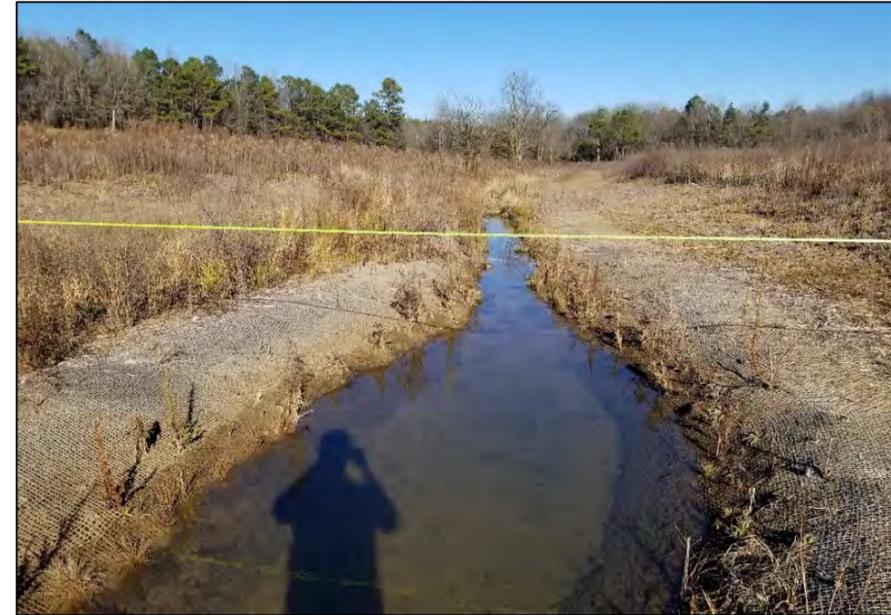
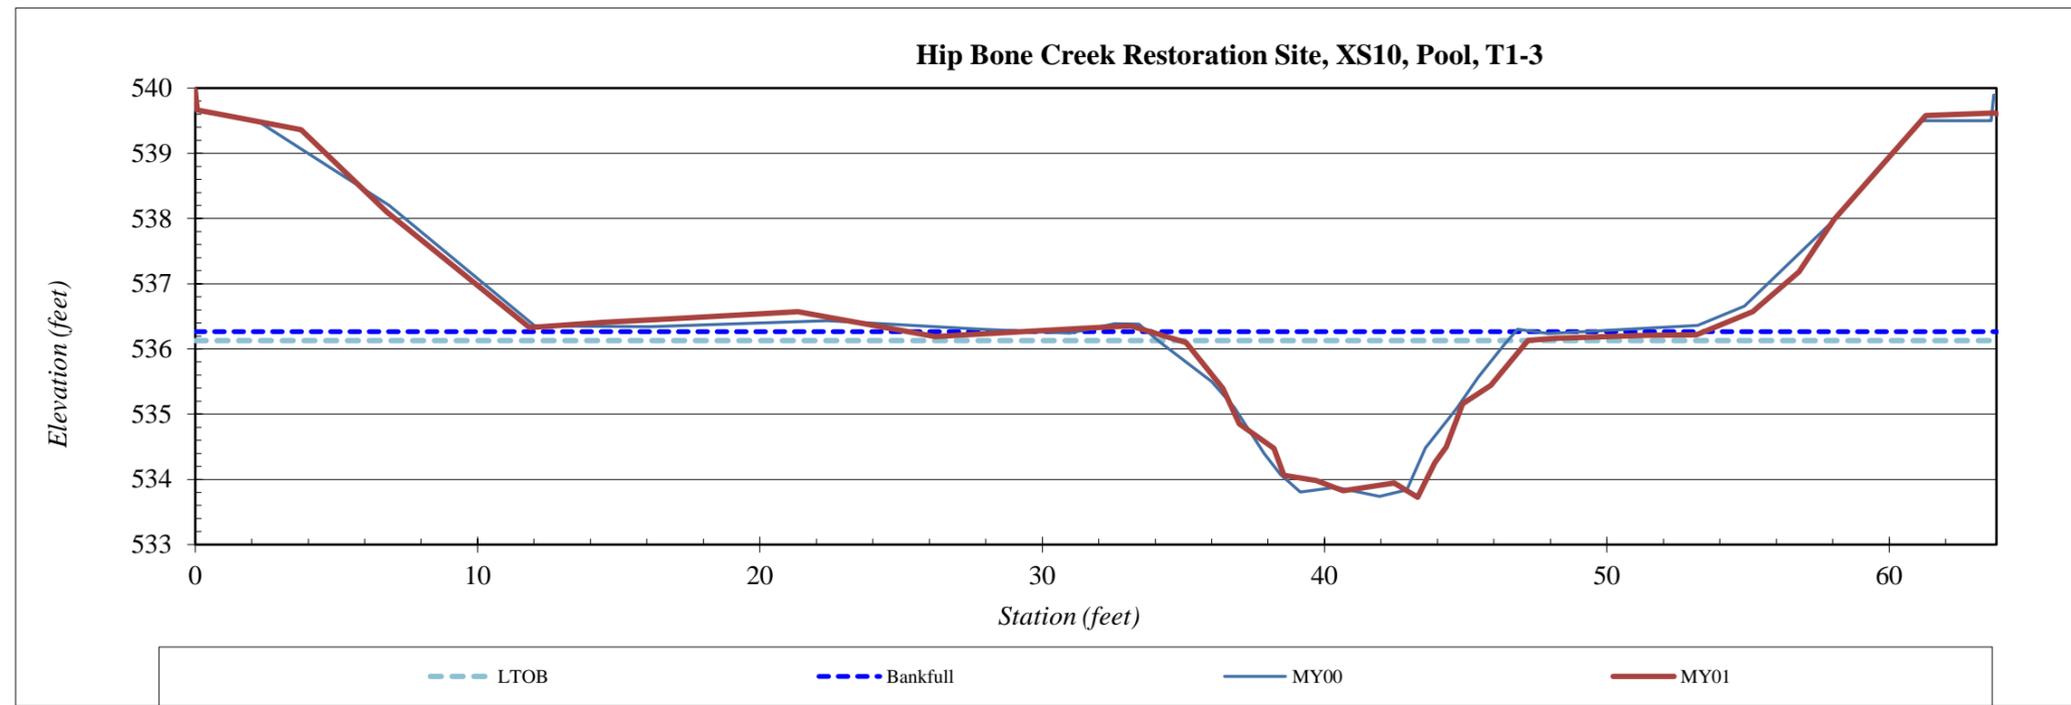
River Basin:	Cape Fear River
Site:	Hip Bone Creek Restoration Site
XS ID	XS10
Drainage Area (sq mi):	0.19
Date:	12/13/2021
Field Crew:	TS, KB

Station	Elevation
0.0	539.97
0.1	539.67
3.7	539.36
6.8	538.10
11.8	536.33
14.4	536.41
17.3	536.47
21.3	536.57
26.2	536.19
31.4	536.32
33.1	536.36
35.1	536.10
36.4	535.40
37.0	534.85
38.2	534.48
38.6	534.06
39.7	533.98
40.7	533.83
42.5	533.94
43.3	533.73
43.9	534.26
44.3	534.49
44.9	535.16
45.9	535.44
47.2	536.13
48.2	536.16
51.5	536.21
53.2	536.22
55.2	536.57
56.8	537.19
58.0	537.98
61.3	539.58
63.7	539.62
63.8	539.61

SUMMARY DATA	
Bankfull Elevation (ft) - Based on AB-Bankfull Area	536.27
Bankfull Cross-Sectional Area (sq ft):	20.0
LTOB Cross-Sectional Area (sq ft):	18.1
Bankfull Width (ft):	14.4
Flood Prone Area Elevation (ft):	---
Flood Prone Width (ft):	---
Max Depth at Bankfull (ft):	2.5
Mean Depth at Bankfull (ft):	1.4
W / D Ratio (ft/ft):	---
Entrenchment Ratio (ft/ft):	---
Bank Height Ratio (ft/ft):	0.9
Thalweg Elevation (ft):	533.73

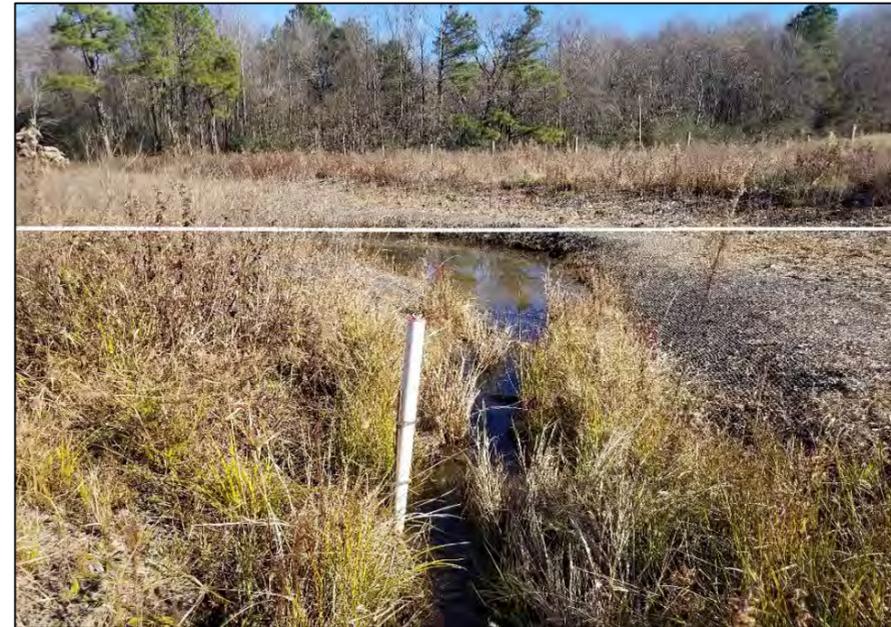
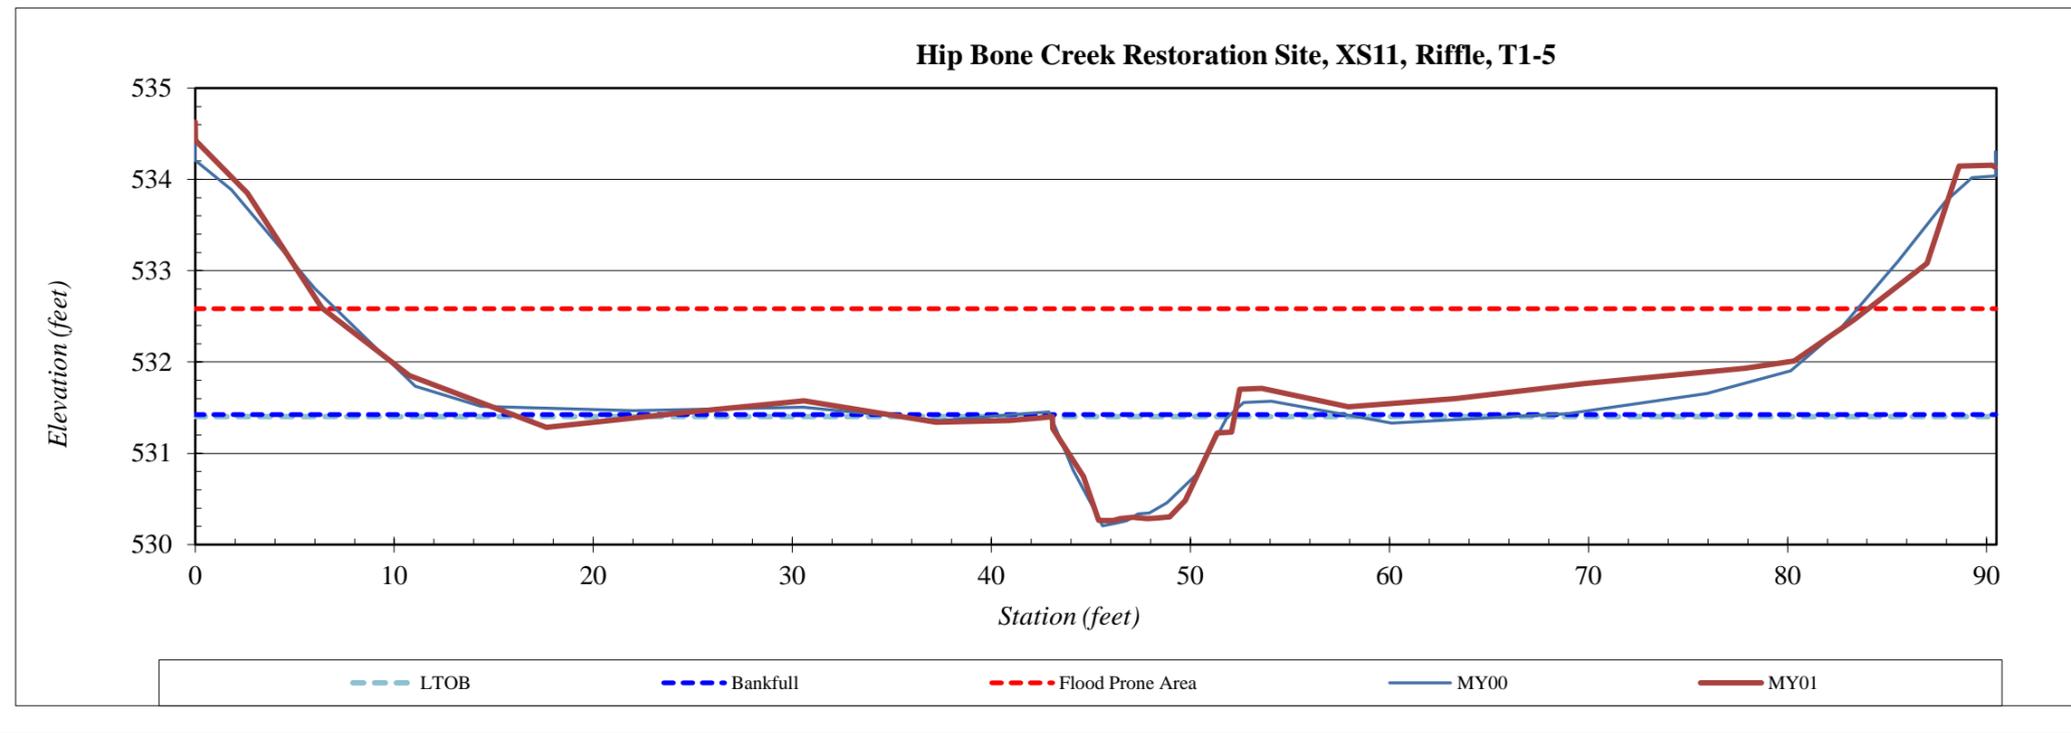
River Basin:	Cape Fear River
Site:	Hip Bone Creek Restoration Site
XS ID	XS11
Drainage Area (sq mi):	0.25
Date:	12/13/2021
Field Crew:	TS, KB

Station	Elevation
0.0	534.85
0.0	534.65
2.6	534.07
6.4	532.81
10.7	532.07
17.6	531.51
24.5	531.66
30.6	531.79
37.2	531.56
40.9	531.58
42.5	531.61
43.1	531.62
43.1	531.49
44.6	530.96
45.4	530.49
45.6	530.48
46.1	530.48
46.5	530.50
47.1	530.52
47.8	530.50
48.2	530.51
49.0	530.52
49.7	530.70
51.3	531.44
52.1	531.45
52.5	531.92
53.6	531.93
57.9	531.73
63.3	531.82
69.7	531.98
77.9	532.15
80.3	532.23
83.3	532.68
87.0	533.30
88.6	534.37
90.4	534.38

SUMMARY DATA	
Bankfull Elevation (ft) - Based on AB-Bankfull Area	531.42
Bankfull Cross-Sectional Area (sq ft):	7.3
LTOB Cross-Sectional Area (sq ft):	7.1
Bankfull Width (ft):	9.2
Flood Prone Area Elevation (ft):	532.58
Flood Prone Width (ft):	78
Max Depth at Bankfull (ft):	1.2
Mean Depth at Bankfull (ft):	0.8
W / D Ratio (ft/ft):	11.5
Entrenchment Ratio (ft/ft):	8.5
Bank Height Ratio (ft/ft):	1.0
Thalweg Elevation (ft):	530.26

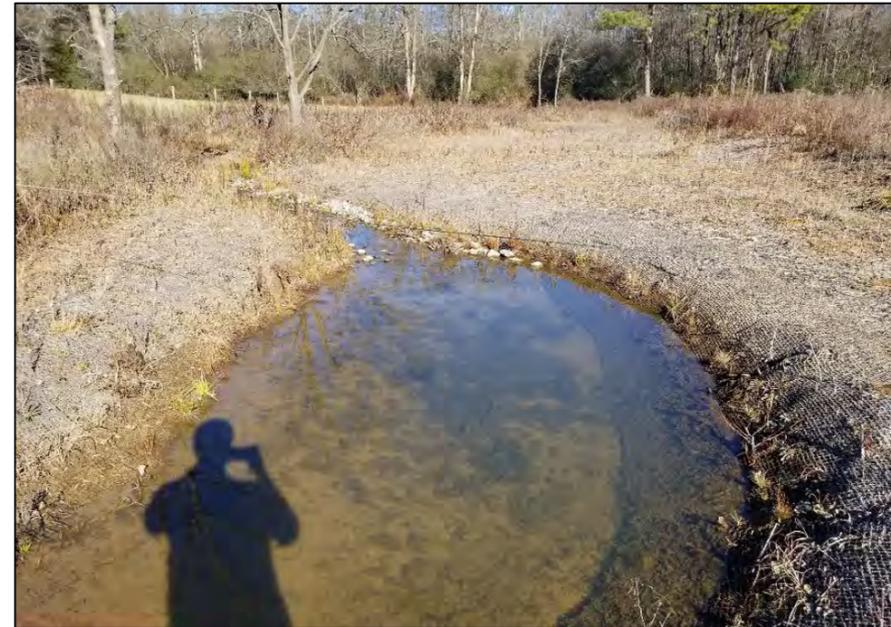
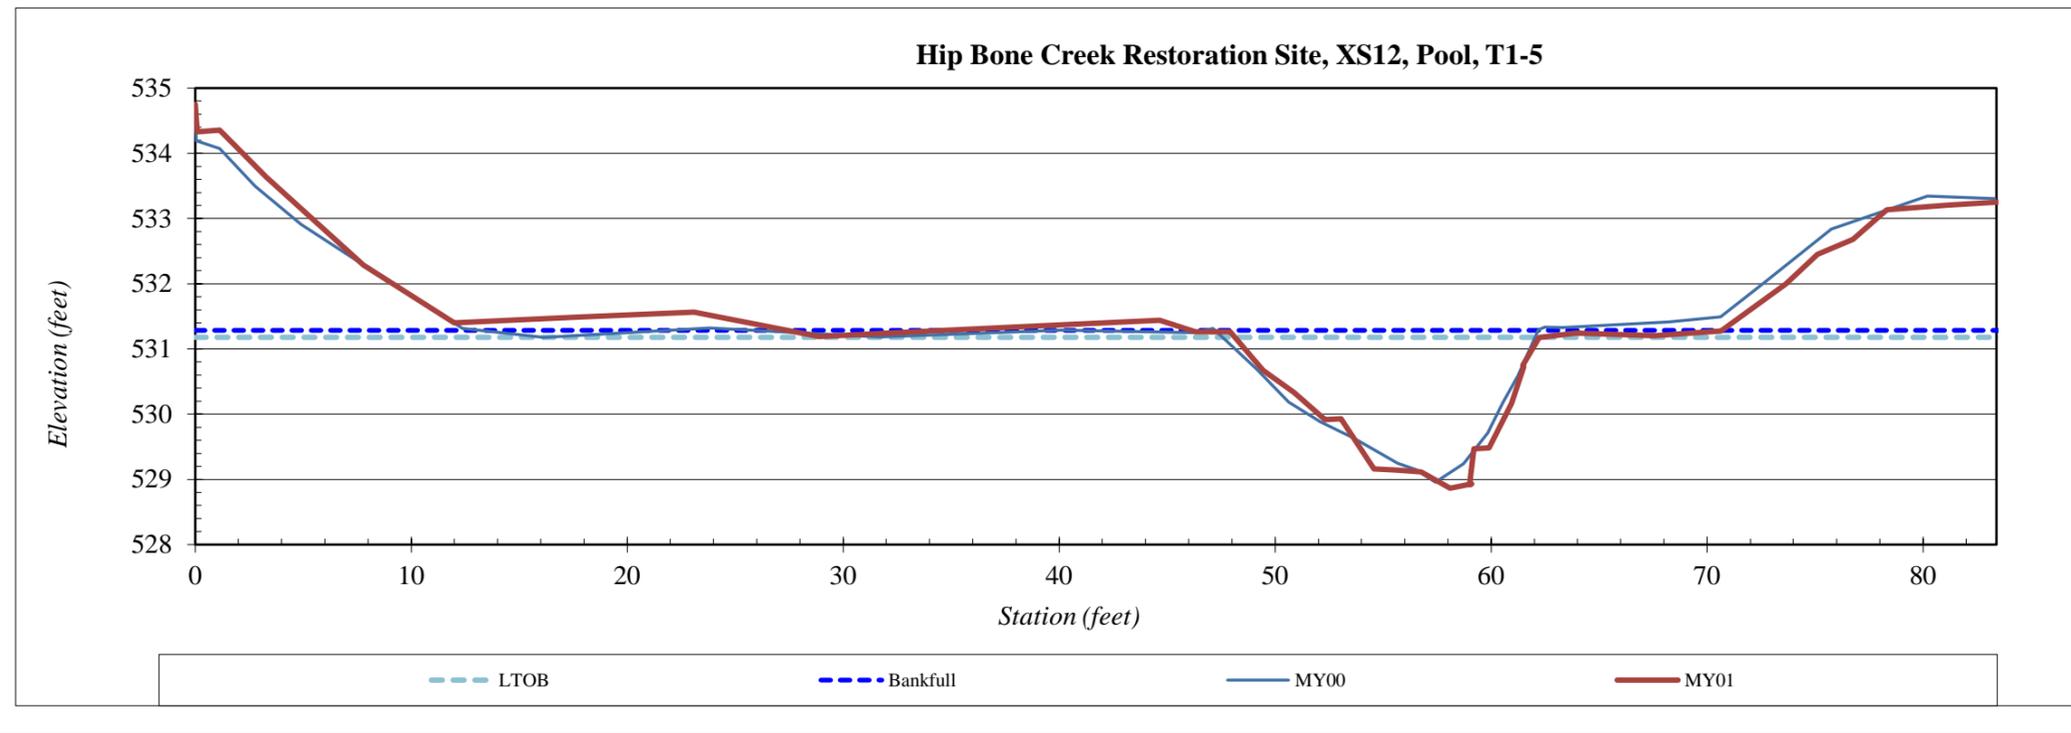
River Basin:	Cape Fear River
Site:	Hip Bone Creek Restoration Site
XS ID	XS12
Drainage Area (sq mi):	0.25
Date:	12/13/2021
Field Crew:	TS, KB

Station	Elevation
0.0	534.97
0.1	534.55
1.1	534.57
3.3	533.86
7.8	532.51
12.0	531.62
17.5	531.71
23.1	531.79
28.9	531.41
34.5	531.51
40.4	531.60
44.7	531.66
46.3	531.48
47.9	531.48
49.5	530.89
50.9	530.55
52.3	530.13
53.1	530.15
54.6	529.38
55.7	529.36
56.8	529.33
58.1	529.09
59.1	529.15
59.0	529.14
59.0	529.14
59.2	529.69
59.9	529.71
60.9	530.38
61.5	530.94
61.5	530.97
62.2	531.40
63.9	531.46
67.6	531.42
70.6	531.50
87.1	532.22
87.1	532.67

SUMMARY DATA	
Bankfull Elevation (ft) - Based on AB-Bankfull Area	531.29
Bankfull Cross-Sectional Area (sq ft):	20.8
LTOB Cross-Sectional Area (sq ft):	19.3
Bankfull Width (ft):	14.3
Flood Prone Area Elevation (ft):	---
Flood Prone Width (ft):	---
Max Depth at Bankfull (ft):	2.4
Mean Depth at Bankfull (ft):	1.5
W / D Ratio (ft/ft):	---
Entrenchment Ratio (ft/ft):	---
Bank Height Ratio (ft/ft):	1.0
Thalweg Elevation (ft):	528.87

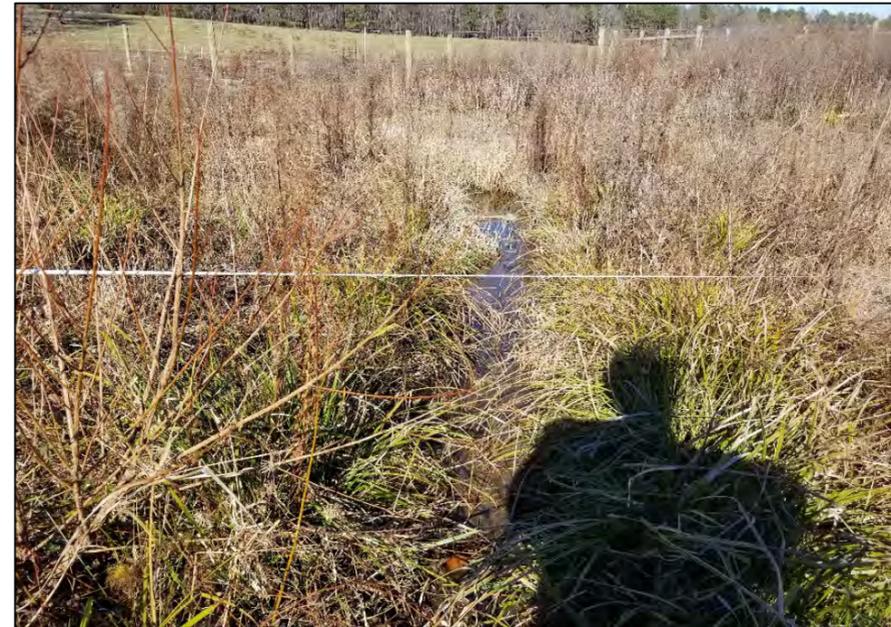
River Basin:	Cape Fear River
Site:	Hip Bone Creek Restoration Site
XS ID	XS13
Drainage Area (sq mi):	0.05
Date:	12/13/2021
Field Crew:	TS, KB

Station	Elevation
0.0	551.07
0.0	550.48
2.3	550.39
4.7	549.94
7.4	549.25
11.3	548.60
14.1	548.69
19.6	548.74
22.1	548.64
24.1	548.83
24.8	548.82
26.0	548.76
26.6	548.40
27.0	548.05
27.2	548.02
27.7	547.96
28.1	547.93
28.8	548.00
29.4	547.98
29.6	547.98
30.2	548.51
31.3	548.59
32.2	548.95
33.3	548.91
35.3	548.82
39.5	548.94
43.7	548.95
48.6	549.19
52.0	549.77
55.3	550.19
57.2	550.65
58.7	550.79
58.8	551.23

SUMMARY DATA	
Bankfull Elevation (ft) - Based on AB-Bankfull Area	548.84
Bankfull Cross-Sectional Area (sq ft):	3.4
LTOB Cross-Sectional Area (sq ft):	2.9
Bankfull Width (ft):	6.0
Flood Prone Area Elevation (ft):	549.75
Flood Prone Width (ft):	47
Max Depth at Bankfull (ft):	0.9
Mean Depth at Bankfull (ft):	0.6
W / D Ratio (ft/ft):	10.5
Entrenchment Ratio (ft/ft):	7.8
Bank Height Ratio (ft/ft):	0.9
Thalweg Elevation (ft):	547.93

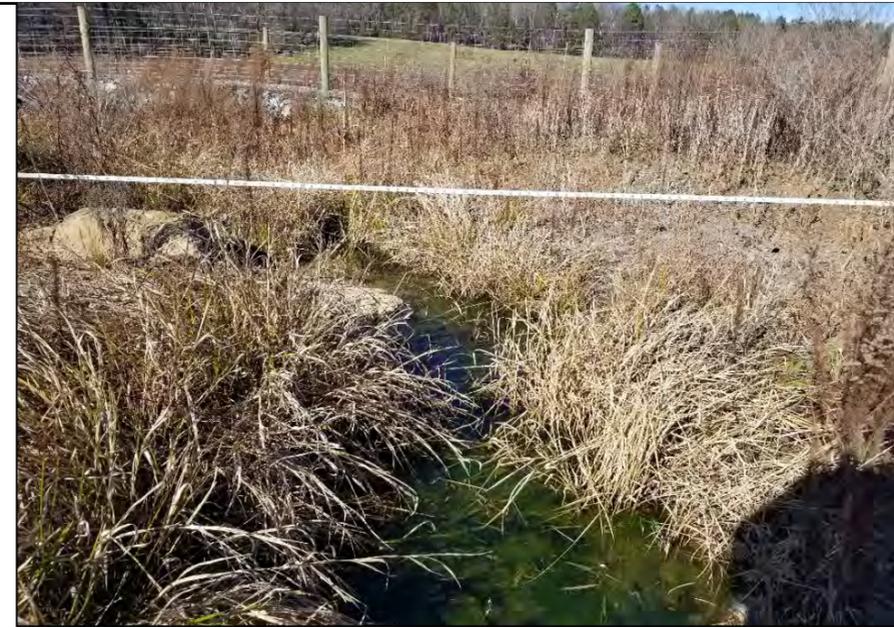
River Basin:	Cape Fear River
Site:	Hip Bone Creek Restoration Site
XS ID	XS14
Drainage Area (sq mi):	0.05
Date:	12/13/2021
Field Crew:	TS, KB

Station	Elevation
0.0	550.48
0.2	549.93
2.8	549.89
4.9	549.78
6.3	549.01
9.6	548.53
12.7	548.37
15.1	548.25
18.3	548.37
21.5	548.20
25.7	548.28
29.1	548.20
31.5	548.42
33.3	548.32
34.1	548.28
34.9	547.91
35.2	547.77
36.0	547.39
36.8	547.20
37.8	547.34
38.5	547.54
38.6	547.68
39.0	547.85
39.5	548.06
40.3	548.19
41.1	548.15
42.6	548.27
45.3	548.40
47.8	548.91
49.4	549.63
51.1	549.68
54.6	549.74
54.6	550.08

SUMMARY DATA	
Bankfull Elevation (ft) - Based on AB-Bankfull Area	548.36
Bankfull Cross-Sectional Area (sq ft):	4.3
LTOB Cross-Sectional Area (sq ft):	3.2
Bankfull Width (ft):	6.3
Flood Prone Area Elevation (ft):	---
Flood Prone Width (ft):	---
Max Depth at Bankfull (ft):	1.2
Mean Depth at Bankfull (ft):	0.7
W / D Ratio (ft/ft):	---
Entrenchment Ratio (ft/ft):	---
Bank Height Ratio (ft/ft):	0.9
Thalweg Elevation (ft):	547.20

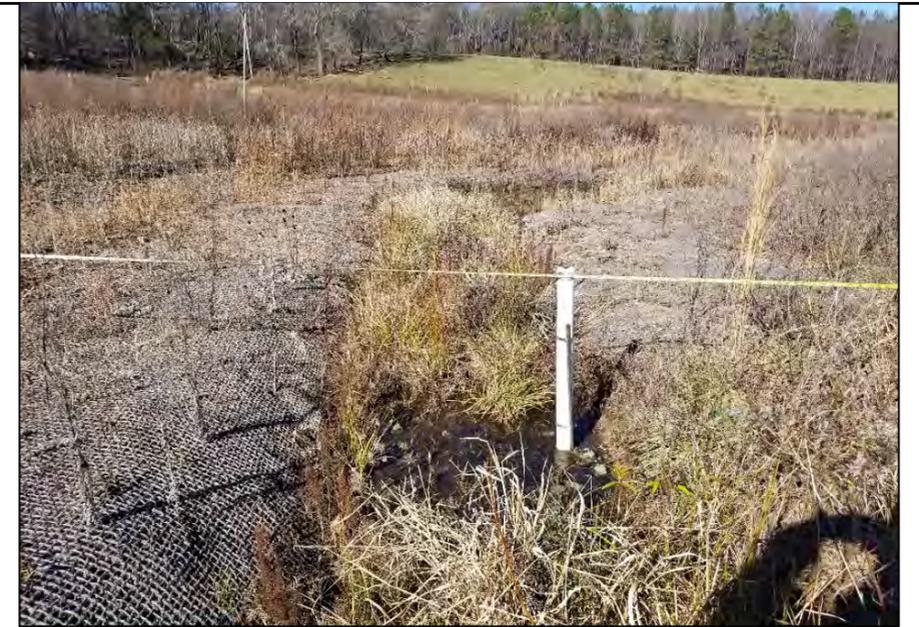
River Basin:	Cape Fear River
Site:	Hip Bone Creek Restoration Site
XS ID	XS15
Drainage Area (sq mi):	0.06
Date:	12/13/2021
Field Crew:	TS, KB

Station	Elevation
0.0	546.50
0.0	546.18
0.8	546.17
3.1	545.96
5.3	545.11
9.3	544.97
13.1	544.84
18.1	544.93
22.1	544.78
23.5	544.71
24.1	544.69
25.0	544.23
25.5	544.07
26.0	543.97
26.5	543.95
27.2	543.93
27.5	543.88
27.9	543.86
28.9	543.82
29.5	544.15
30.0	544.45
30.3	544.67
31.8	544.54
34.5	544.45
38.5	544.40
43.0	544.22
46.2	544.41
49.5	545.09
52.2	545.35
53.8	545.92
56.5	545.82
56.6	546.44

SUMMARY DATA	
Bankfull Elevation (ft) - Based on AB-Bankfull Area	544.71
Bankfull Cross-Sectional Area (sq ft):	3.9
LTOB Cross-Sectional Area (sq ft):	3.6
Bankfull Width (ft):	6.6
Flood Prone Area Elevation (ft):	545.60
Flood Prone Width (ft):	49
Max Depth at Bankfull (ft):	0.9
Mean Depth at Bankfull (ft):	0.6
W / D Ratio (ft/ft):	11.4
Entrenchment Ratio (ft/ft):	7.4
Bank Height Ratio (ft/ft):	1.0
Thalweg Elevation (ft):	543.82

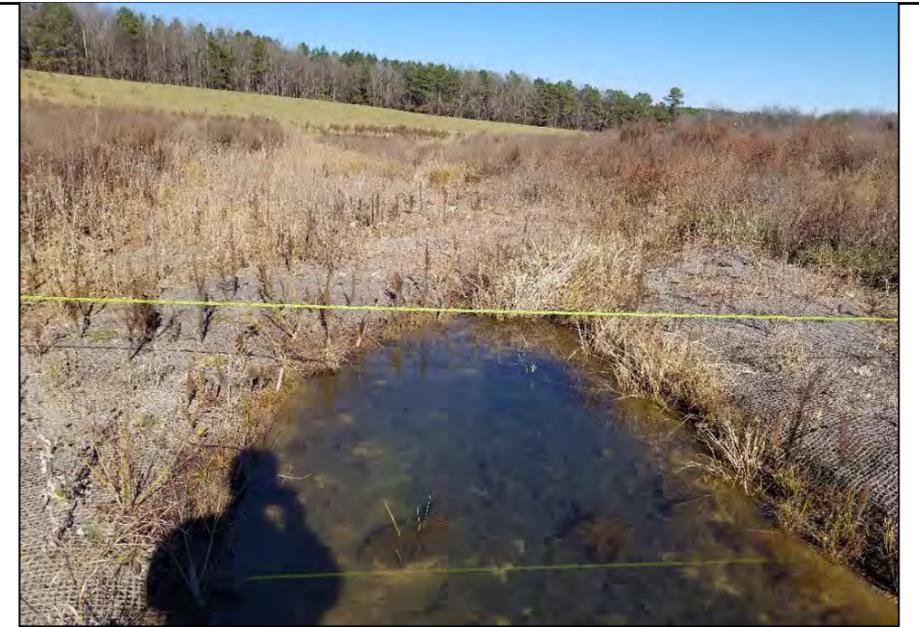
River Basin:	Cape Fear River
Site:	Hip Bone Creek Restoration Site
XS ID	XS16
Drainage Area (sq mi):	0.06
Date:	12/13/2021
Field Crew:	TS, KB

Station	Elevation
0.0	545.72
0.1	545.36
2.1	545.40
7.0	545.39
11.9	545.13
13.0	545.14
14.0	545.20
15.5	545.20
17.8	544.79
19.9	544.31
21.6	544.30
22.8	544.28
22.9	544.27
23.8	543.98
24.1	543.97
24.8	543.57
25.5	543.39
26.4	542.96
27.0	542.66
28.3	542.67
29.0	542.67
30.2	543.13
31.4	543.34
32.0	543.53
32.6	543.86
33.9	544.20
35.0	544.19
36.7	544.37
39.7	544.38
43.0	544.36
47.0	544.34
51.3	544.22
55.6	544.27
64.9	545.53
66.4	545.71
66.4	546.25

SUMMARY DATA	
Bankfull Elevation (ft) - Based on AB-Bankfull Area	544.11
Bankfull Cross-Sectional Area (sq ft):	8.6
LTOB Cross-Sectional Area (sq ft):	9.5
Bankfull Width (ft):	10.2
Flood Prone Area Elevation (ft):	---
Flood Prone Width (ft):	---
Max Depth at Bankfull (ft):	1.4
Mean Depth at Bankfull (ft):	0.8
W / D Ratio (ft/ft):	---
Entrenchment Ratio (ft/ft):	---
Bank Height Ratio (ft/ft):	1.1
Thalweg Elevation (ft):	542.66

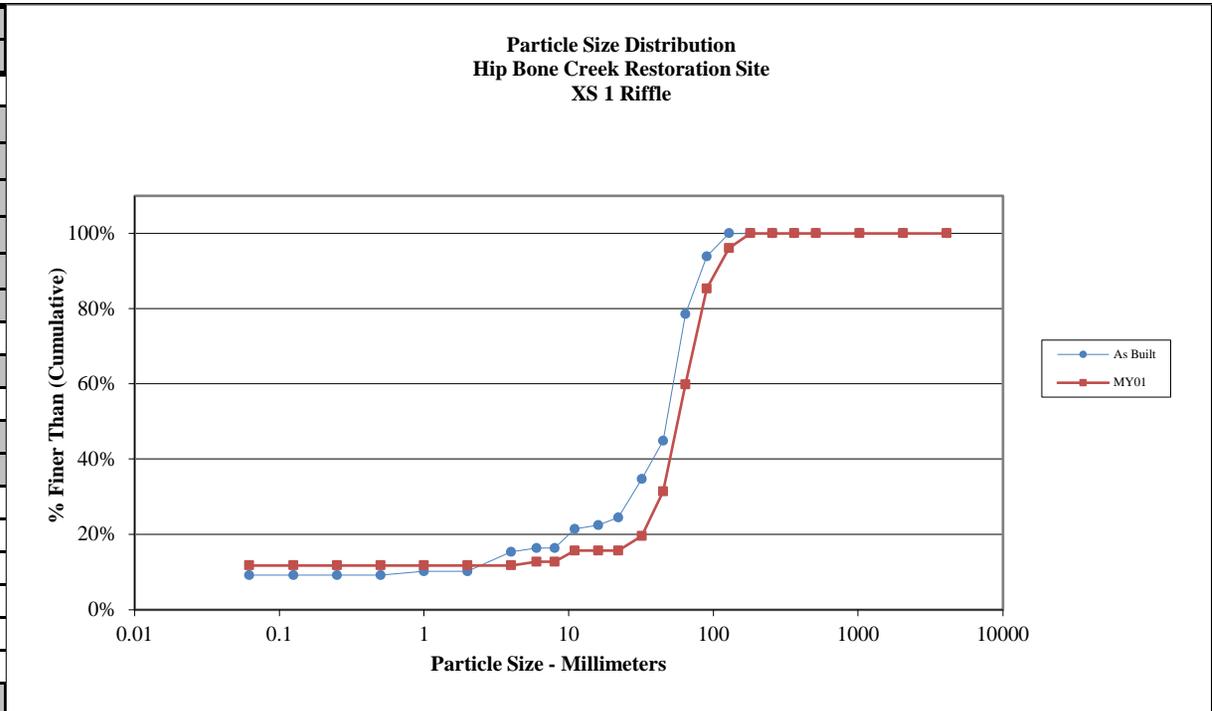
Cross-Section 1 Riffle - MY-01			
Particle	Millimeter		Count
Silt/Clay	< 0.062	S/C	12
Very Fine	.062 - .125	S	
Fine	.125 - .25	A	
Medium	.25 - .50	N	
Coarse	.50 - 1	D	
Very Coarse	1 - 2	S	
Very Fine	2 - 4		
Fine	4 - 5.7	G	1
Fine	5.7 - 8	R	
Medium	8 - 11.3	A	3
Medium	11.3 - 16	V	
Coarse	16 - 22.6	E	
Coarse	22.6 - 32	L	4
Very Coarse	32 - 45	S	12
Very Coarse	45 - 64		29
Small	64 - 90	C	26
Small	90 - 128	O	11
Large	128 - 180	B	4
Large	180 - 256	L	
Small	256 - 362	B	
Small	362 - 512	L	
Medium	512 - 1024	D	
Lrg- Very Lrg	1024 - 2048	R	
Bedrock	>2048	BDRK	
		Total	102
Note:

Size (mm)	
D16	23
D35	47
D50	57
D65	69
D84	88
D95	120

Size Distribution	
mean	45.0
dispersion	2.0
skewness	-0.13

Type	
silt/clay	12%
sand	0%
gravel	48%
cobble	40%
boulder	0%
bedrock	0%
hardpan	0%
wood/det	0%
artificial	0%

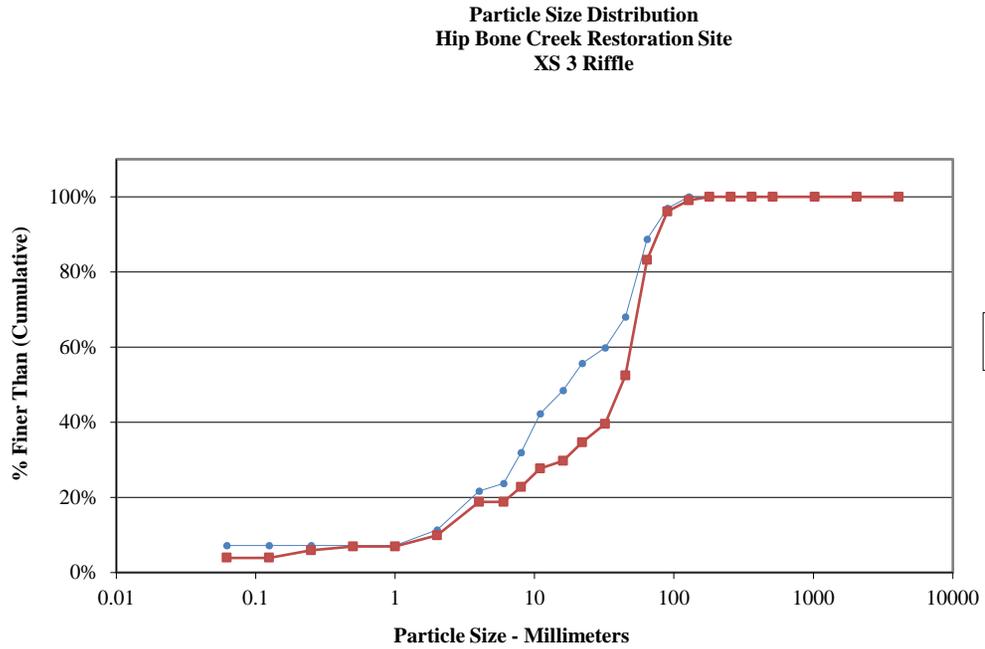
Cross-Section 3 Riffle - MY-01			
Particle	Millimeter		Count
Silt/Clay	< 0.062	S/C	4
Very Fine	.062 - .125	S	
Fine	.125 - .25	A	2
Medium	.25 - .50	N	1
Coarse	.50 - 1	D	
Very Coarse	1 - 2	S	3
Very Fine	2 - 4		9
Fine	4 - 5.7	G	
Fine	5.7 - 8	R	4
Medium	8 - 11.3	A	5
Medium	11.3 - 16	V	2
Coarse	16 - 22.6	E	5
Coarse	22.6 - 32	L	5
Very Coarse	32 - 45	S	13
Very Coarse	45 - 64		31
Small	64 - 90	C	13
Small	90 - 128	O	3
Large	128 - 180	B	1
Large	180 - 256	L	
Small	256 - 362	B	
Small	362 - 512	L	
Medium	512 - 1024	D	
Lrg- Very Lrg	1024 - 2048	R	
Bedrock	>2048	BDRK	
		Total	101

Size (mm)	
D16	3.2
D35	23
D50	42
D65	52
D84	65
D95	88

Size Distribution	
mean	14.4
dispersion	7.3
skewness	-0.41

Type	
silt/clay	4%
sand	6%
gravel	73%
cobble	17%
boulder	0%
bedrock	0%
hardpan	0%
wood/det	0%
artificial	0%

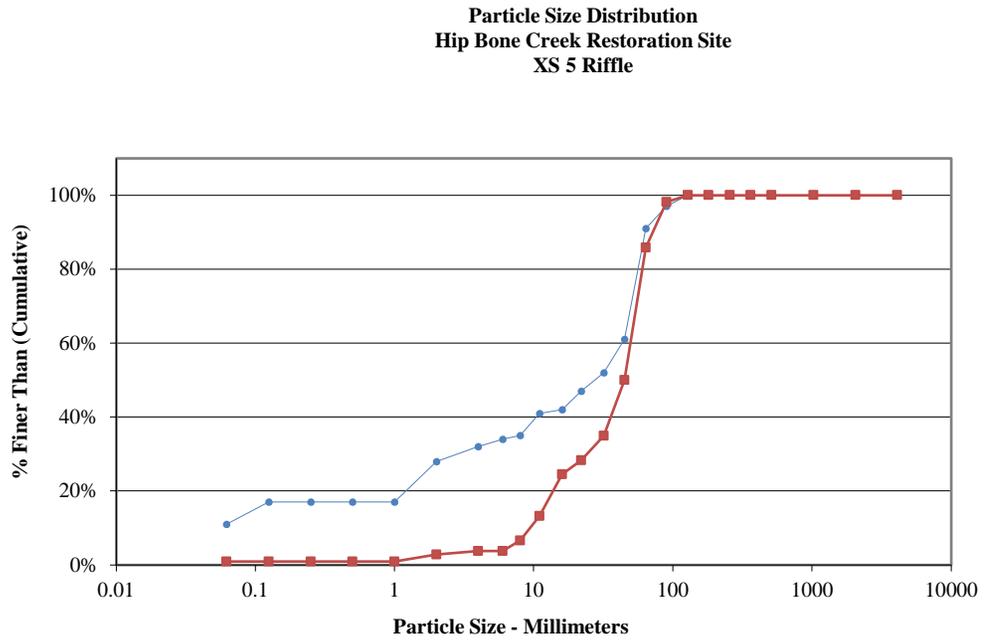
Cross-Section 5 Riffle - MY-01			
Particle	Millimeter		Count
Silt/Clay	< 0.062	S/C	1
Very Fine	.062 - .125	S	
Fine	.125 - .25	A	
Medium	.25 - .50	N	
Coarse	.50 - 1	D	
Very Coarse	1 - 2	S	2
Very Fine	2 - 4		1
Fine	4 - 5.7	G	
Fine	5.7 - 8	R	3
Medium	8 - 11.3	A	7
Medium	11.3 - 16	V	12
Coarse	16 - 22.6	E	4
Coarse	22.6 - 32	L	7
Very Coarse	32 - 45	S	16
Very Coarse	45 - 64		38
Small	64 - 90	C	13
Small	90 - 128	O	2
Large	128 - 180	B	
Large	180 - 256	L	
Small	256 - 362	B	
Small	362 - 512	L	
Medium	512 - 1024	D	
Lrg- Very Lrg	1024 - 2048	R	
Bedrock	>2048	BDRK	
		Total	106
Note:

Size (mm)	
D16	12
D35	32
D50	45
D65	52
D84	63
D95	83

Size Distribution	
mean	27.5
dispersion	2.6
skewness	-0.25

Type	
silt/clay	1%
sand	2%
gravel	83%
cobble	14%
boulder	0%
bedrock	0%
hardpan	0%
wood/det	0%
artificial	0%

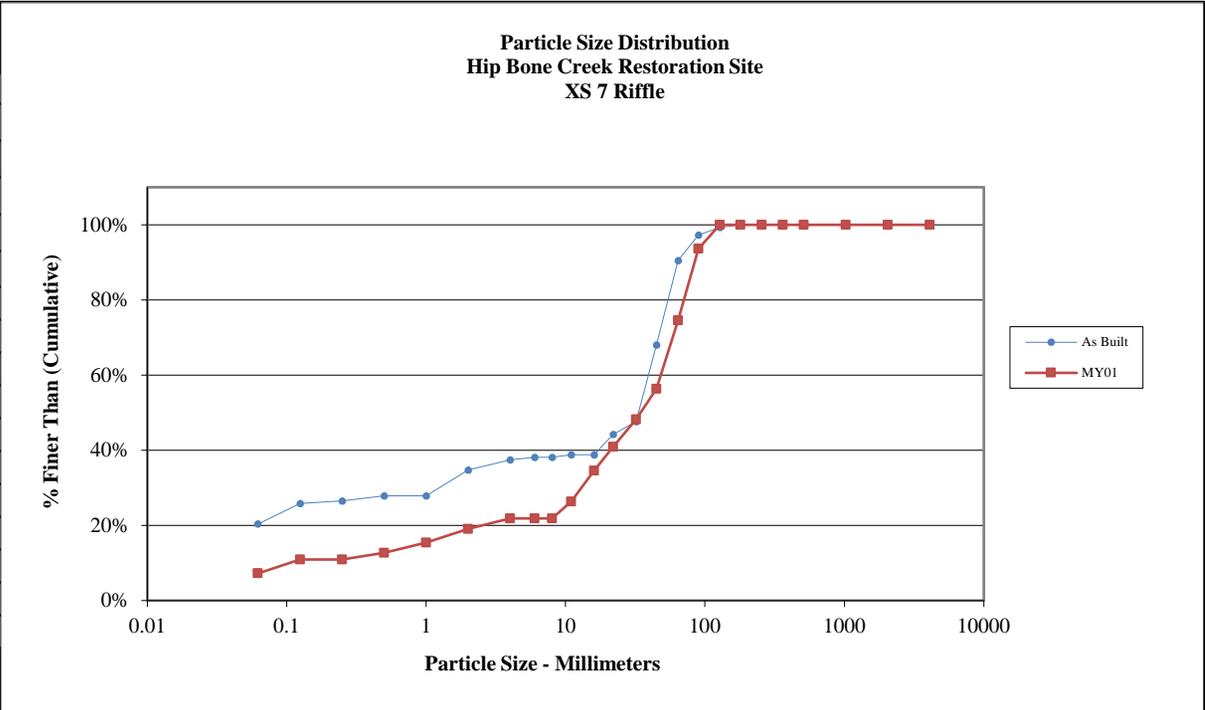
Cross-Section 7 Riffle -MY-01			
Particle	Millimeter		Count
Silt/Clay	< 0.062	S/C	8
Very Fine	.062 - .125	S	4
Fine	.125 - .25	A	
Medium	.25 - .50	N	2
Coarse	.50 - 1	D	3
Very Coarse	1 - 2	S	4
Very Fine	2 - 4		3
Fine	4 - 5.7	G	
Fine	5.7 - 8	R	
Medium	8 - 11.3	A	5
Medium	11.3 - 16	V	9
Coarse	16 - 22.6	E	7
Coarse	22.6 - 32	L	8
Very Coarse	32 - 45	S	9
Very Coarse	45 - 64		20
Small	64 - 90	C	21
Small	90 - 128	O	7
Large	128 - 180	B	
Large	180 - 256	L	
Small	256 - 362	B	
Small	362 - 512	L	
Medium	512 - 1024	D	
Lrg- Very Lrg	1024 - 2048	R	
Bedrock	>2048	BDRK	
		Total	110

Size (mm)	
D16	1.1
D35	16
D50	35
D65	53
D84	76
D95	97

Size Distribution	
mean	9.1
dispersion	17.0
skewness	-0.43

Type	
silt/clay	7%
sand	12%
gravel	55%
cobble	25%
boulder	0%
bedrock	0%
hardpan	0%
wood/det	0%
artificial	0%

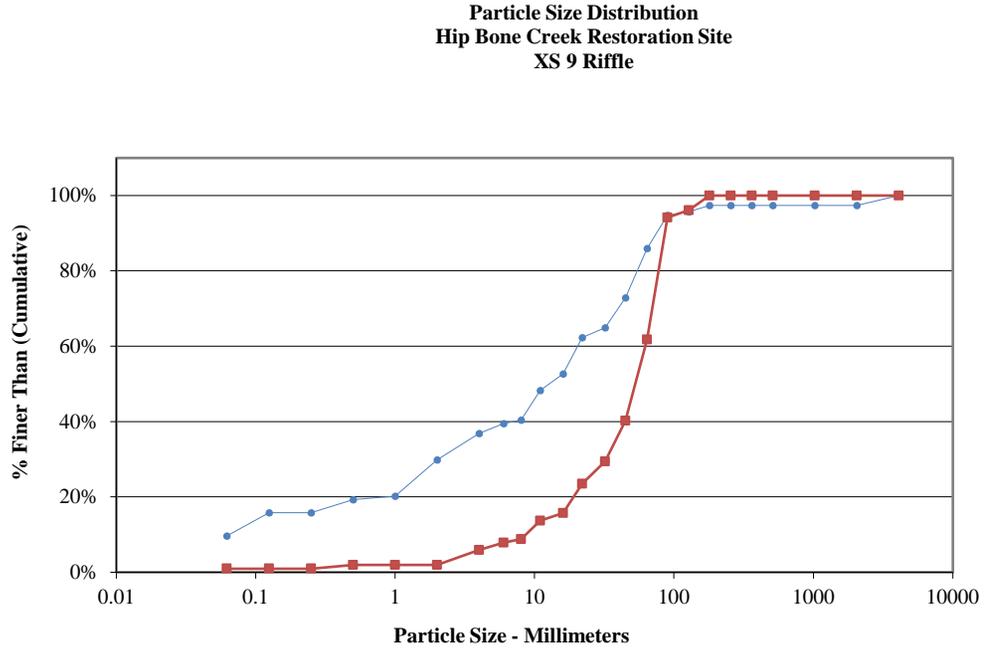
Cross-Section 9 Riffle - MY-01			
Particle	Millimeter		Count
Silt/Clay	< 0.062	S/C	1
Very Fine	.062 - .125	S	
Fine	.125 - .25	A	
Medium	.25 - .50	N	1
Coarse	.50 - 1	D	
Very Coarse	1 - 2	S	
Very Fine	2 - 4		4
Fine	4 - 5.7	G	2
Fine	5.7 - 8	R	1
Medium	8 - 11.3	A	5
Medium	11.3 - 16	V	2
Coarse	16 - 22.6	E	8
Coarse	22.6 - 32	L	6
Very Coarse	32 - 45	S	11
Very Coarse	45 - 64		22
Small	64 - 90	C	33
Small	90 - 128	O	2
Large	128 - 180	B	4
Large	180 - 256	L	
Small	256 - 362	B	
Small	362 - 512	L	
Medium	512 - 1024	D	
Lrg- Very Lrg	1024 - 2048	R	
Bedrock	>2048	BDRK	
		Total	102

Size (mm)	
D16	16
D35	38
D50	53
D65	66
D84	81
D95	110

Size Distribution	
mean	36.0
dispersion	2.4
skewness	-0.20

Type	
silt/clay	1%
sand	1%
gravel	60%
cobble	38%
boulder	0%
bedrock	0%
hardpan	0%
wood/det	0%
artificial	0%
