MY01 MONITORING REPORT

Hip Bone Creek Restoration Site
Chatham County
Cape Fear River Basin - 03040101

DMS Project #100059

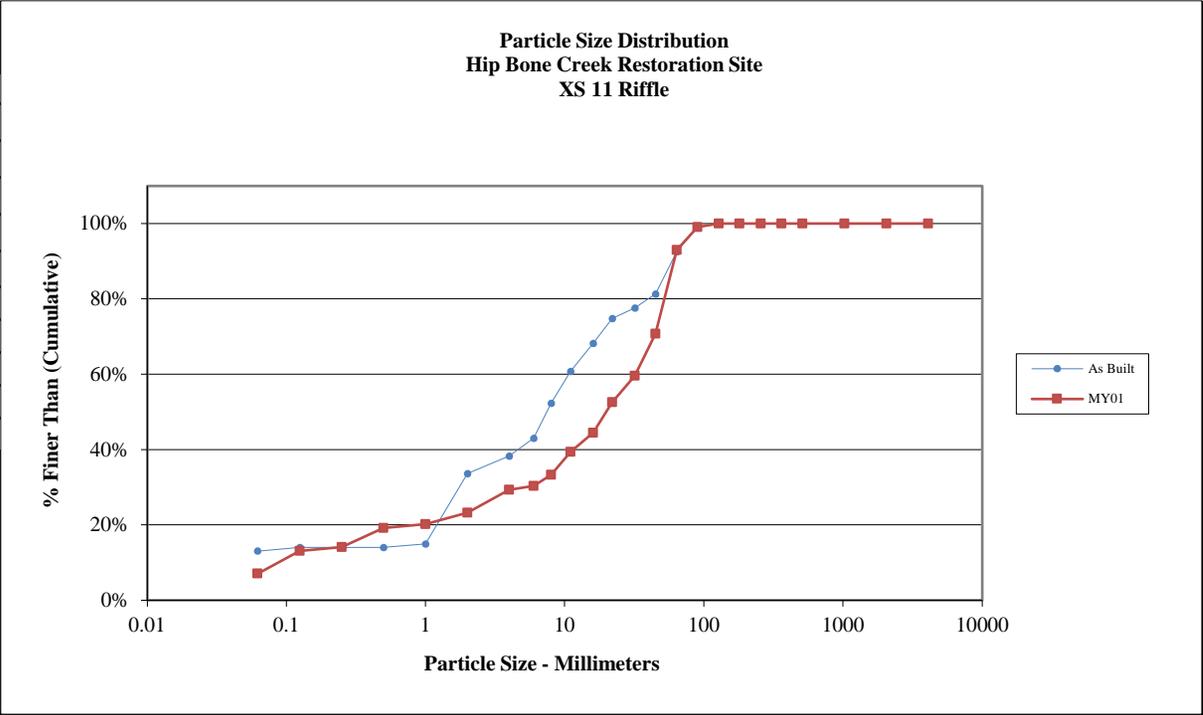
Cross-Section 11 Riffle - MY-01			
Particle	Millimeter		Count
Silt/Clay	< 0.062	S/C	7
Very Fine	.062 - .125	S	6
Fine	.125 - .25	A	1
Medium	.25 - .50	N	5
Coarse	.50 - 1	D	1
Very Coarse	1 - 2	S	3
Very Fine	2 - 4		6
Fine	4 - 5.7	G	1
Fine	5.7 - 8	R	3
Medium	8 - 11.3	A	6
Medium	11.3 - 16	V	5
Coarse	16 - 22.6	E	8
Coarse	22.6 - 32	L	7
Very Coarse	32 - 45	S	11
Very Coarse	45 - 64		22
Small	64 - 90	C	6
Small	90 - 128	O	1
Large	128 - 180	B	
Large	180 - 256	L	
Small	256 - 362	B	
Small	362 - 512	L	
Medium	512 - 1024	D	
Lrg- Very Lrg	1024 - 2048	R	
Bedrock	>2048	BDRK	
		Total	99

Size (mm)	
D16	0.32
D35	8.7
D50	20
D65	38
D84	56
D95	72

Size Distribution	
mean	4.2
dispersion	32.7
skewness	-0.45

Type	
silt/clay	7%
sand	16%
gravel	70%
cobble	7%
boulder	0%
bedrock	0%
hardpan	0%
wood/det	0%
artificial	0%

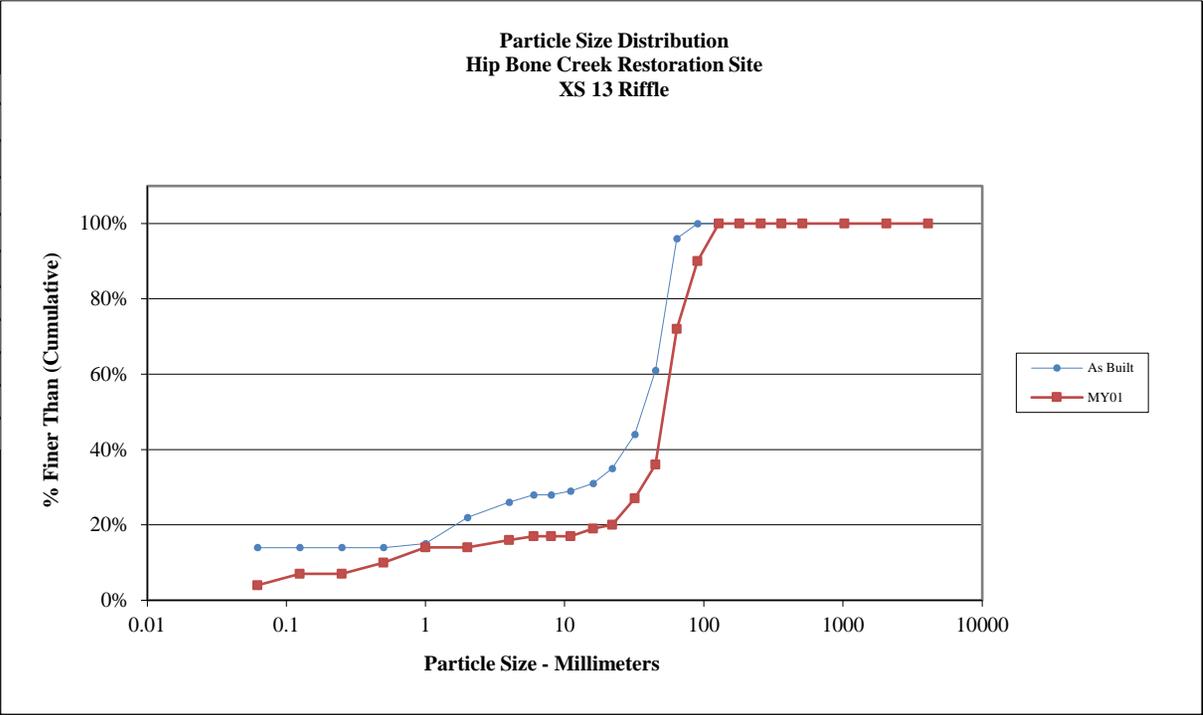
Cross-Section 13 Riffle - MY-01			
Particle	Millimeter		Count
Silt/Clay	< 0.062	S/C	4
Very Fine	.062 - .125	S	3
Fine	.125 - .25	A	
Medium	.25 - .50	N	3
Coarse	.50 - 1	D	4
Very Coarse	1 - 2	S	
Very Fine	2 - 4		2
Fine	4 - 5.7	G	1
Fine	5.7 - 8	R	
Medium	8 - 11.3	A	
Medium	11.3 - 16	V	2
Coarse	16 - 22.6	E	1
Coarse	22.6 - 32	L	7
Very Coarse	32 - 45	S	9
Very Coarse	45 - 64		36
Small	64 - 90	C	18
Small	90 - 128	O	10
Large	128 - 180	B	
Large	180 - 256	L	
Small	256 - 362	B	
Small	362 - 512	L	
Medium	512 - 1024	D	
Lrg- Very Lrg	1024 - 2048	R	
Bedrock	>2048	BDRK	
		Total	100

Size (mm)	
D16	4
D35	43
D50	52
D65	60
D84	80
D95	110

Size Distribution	
mean	17.9
dispersion	7.3
skewness	-0.41

Type	
silt/clay	4%
sand	10%
gravel	58%
cobble	28%
boulder	0%
bedrock	0%
hardpan	0%
wood/det	0%
artificial	0%

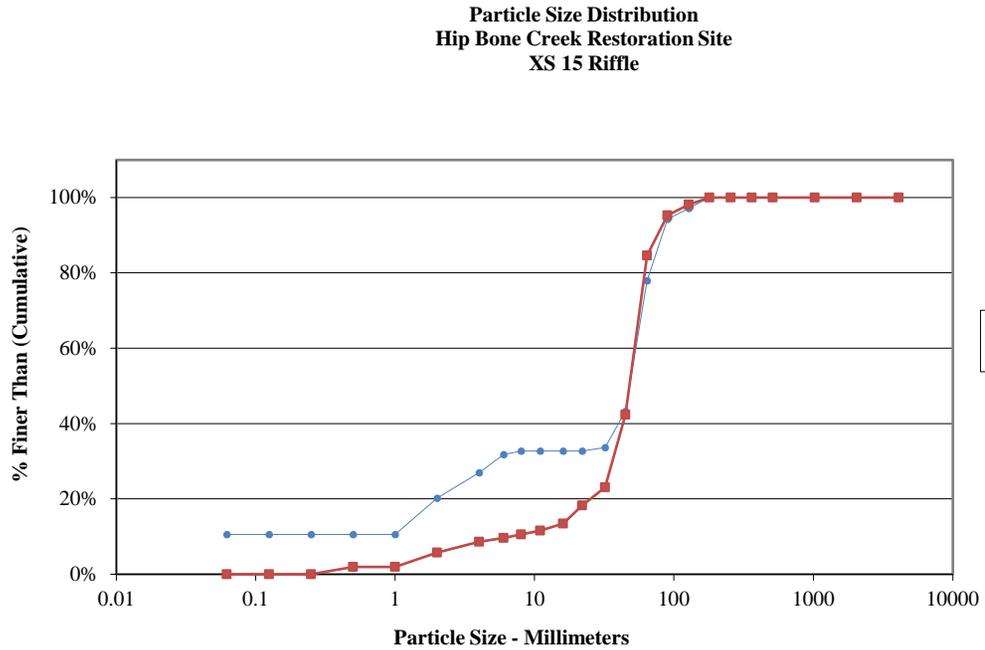
Cross-Section 15 Riffle - MY-01			
Particle	Millimeter		Count
Silt/Clay	< 0.062	S/C	
Very Fine	.062 - .125	S	
Fine	.125 - .25	A	
Medium	.25 - .50	N	2
Coarse	.50 - 1	D	
Very Coarse	1 - 2	S	4
Very Fine	2 - 4		3
Fine	4 - 5.7	G	1
Fine	5.7 - 8	R	1
Medium	8 - 11.3	A	1
Medium	11.3 - 16	V	2
Coarse	16 - 22.6	E	5
Coarse	22.6 - 32	L	5
Very Coarse	32 - 45	S	20
Very Coarse	45 - 64		44
Small	64 - 90	C	11
Small	90 - 128	O	3
Large	128 - 180	B	2
Large	180 - 256	L	
Small	256 - 362	B	
Small	362 - 512	L	
Medium	512 - 1024	D	
Lrg- Very Lrg	1024 - 2048	R	
Bedrock	>2048	BDRK	
		Total	104

Size (mm)	
D16	19
D35	40
D50	48
D65	54
D84	64
D95	89

Size Distribution	
mean	34.9
dispersion	1.9
skewness	-0.19

Type	
silt/clay	0%
sand	6%
gravel	79%
cobble	15%
boulder	0%
bedrock	0%
hardpan	0%
wood/det	0%
artificial	0%

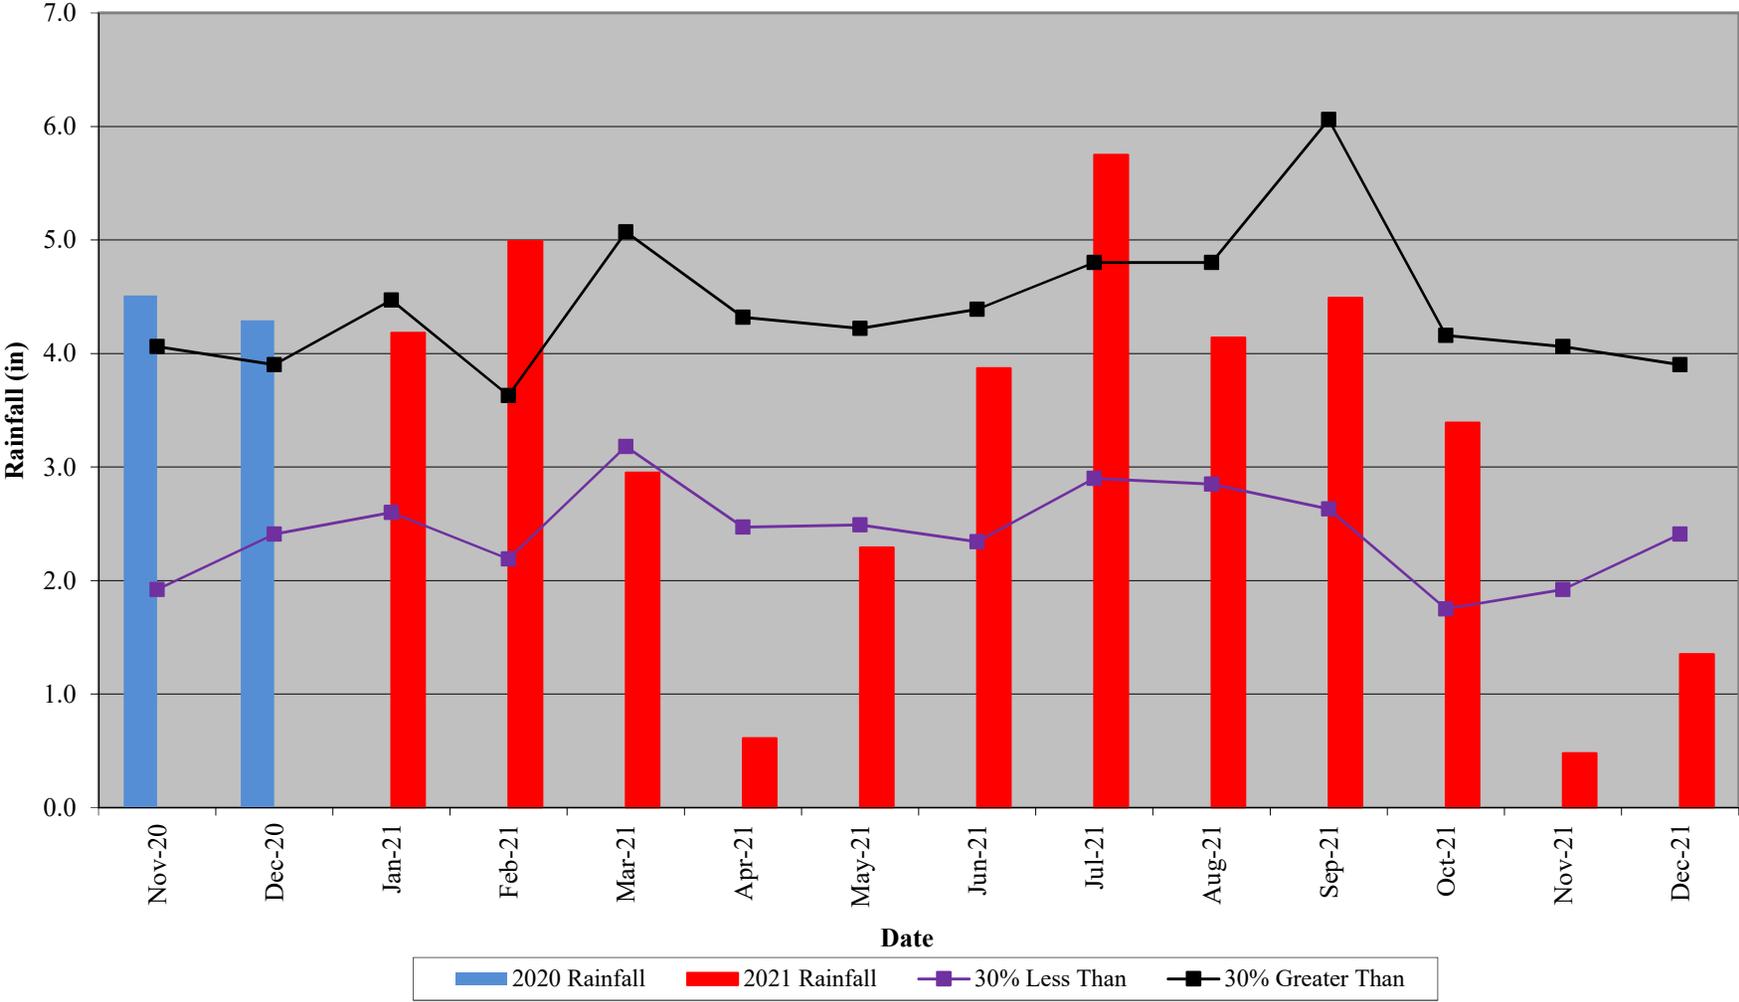
**Hip Bone Creek Restoration Site
30-70 Percentile Graph
WETS Station Name: Siler City 2N**

Table 10. Rainfall Summary, Hip Bone Creek Restoration Site (ID-100059)							
	MY1 2021	MY2 2022	MY3 2023	MY4 2024	MY5 2025	MY6 2026	MY7 2027
Annual Precip Total	38.49						
WETS 30th Percentile	29.73						
WETS 70th Percentile	53.88						
Normal	Y

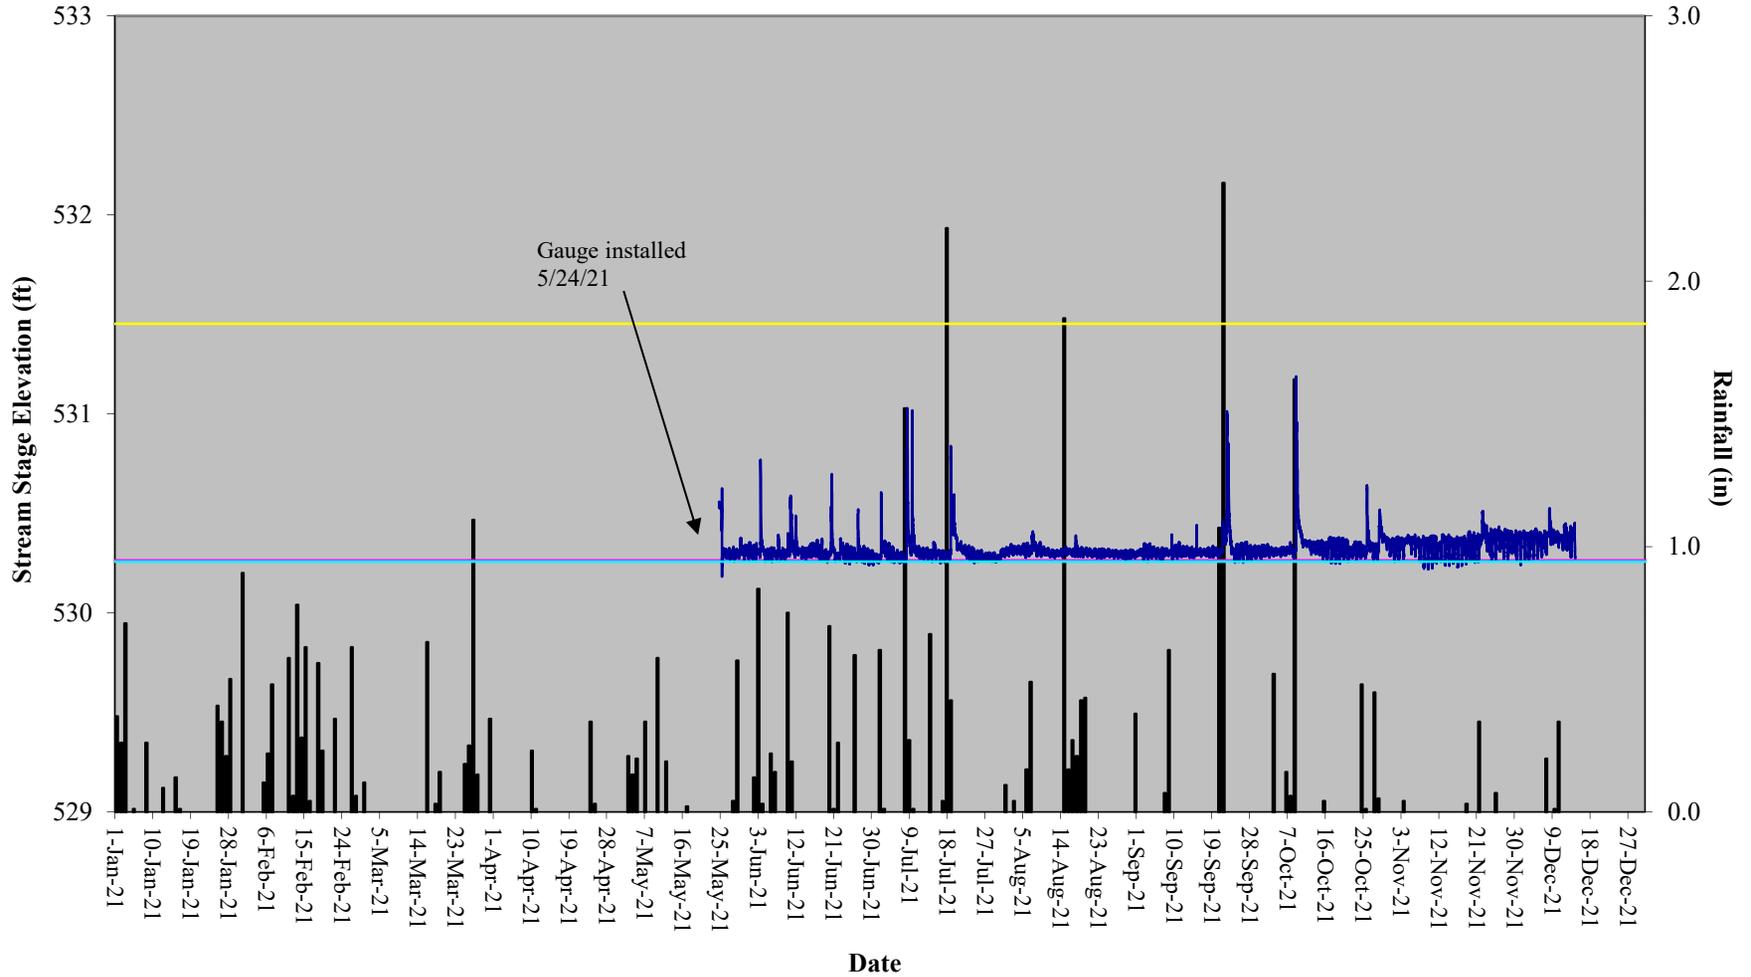
Hip Bone Creek Restoration Site Hydrograph Stream Gauge T1-5

Table 11. Overbank Events , Hip Bone Creek Restoration Site (ID-100059)							
Gage ID	MY1 2021	MY2 2022	MY3 2023	MY4 2024	MY5 2025	MY6 2026	MY7 2027
T1-5	none						
T3-3	none

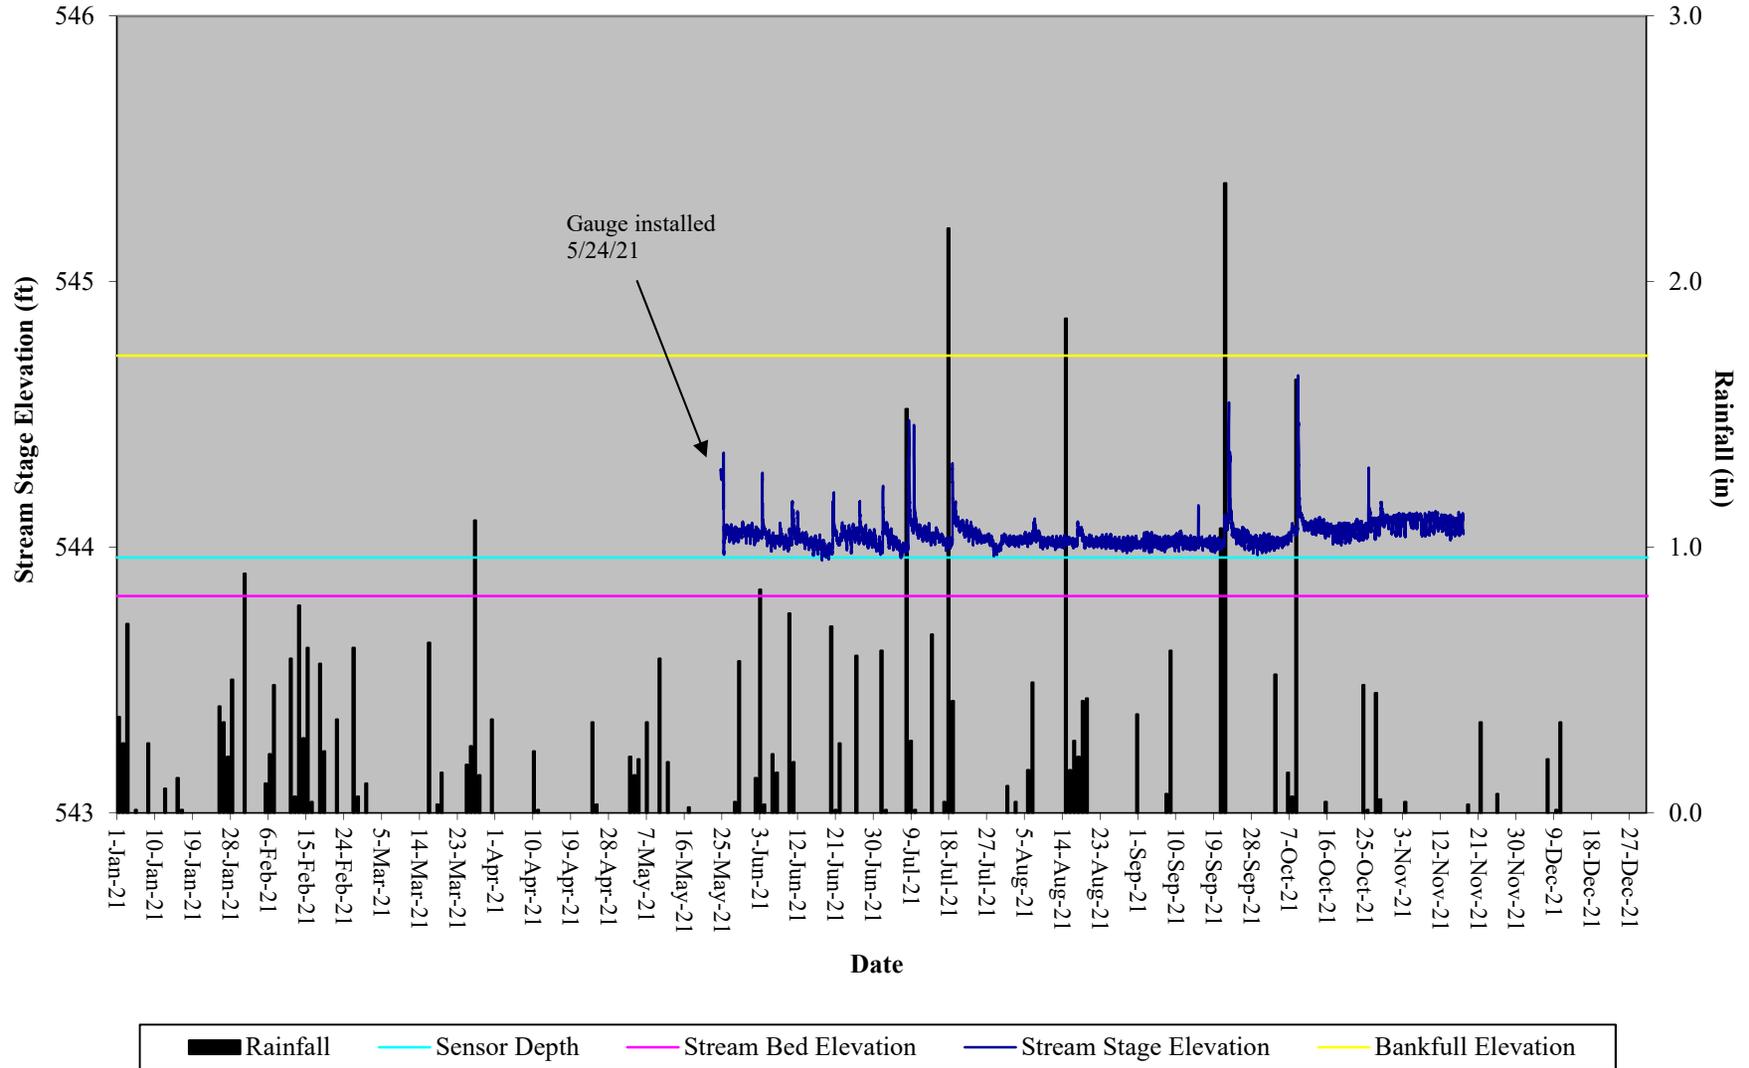
Hip Bone Creek Restoration Site Hydrograph Stream Gauge T3-3

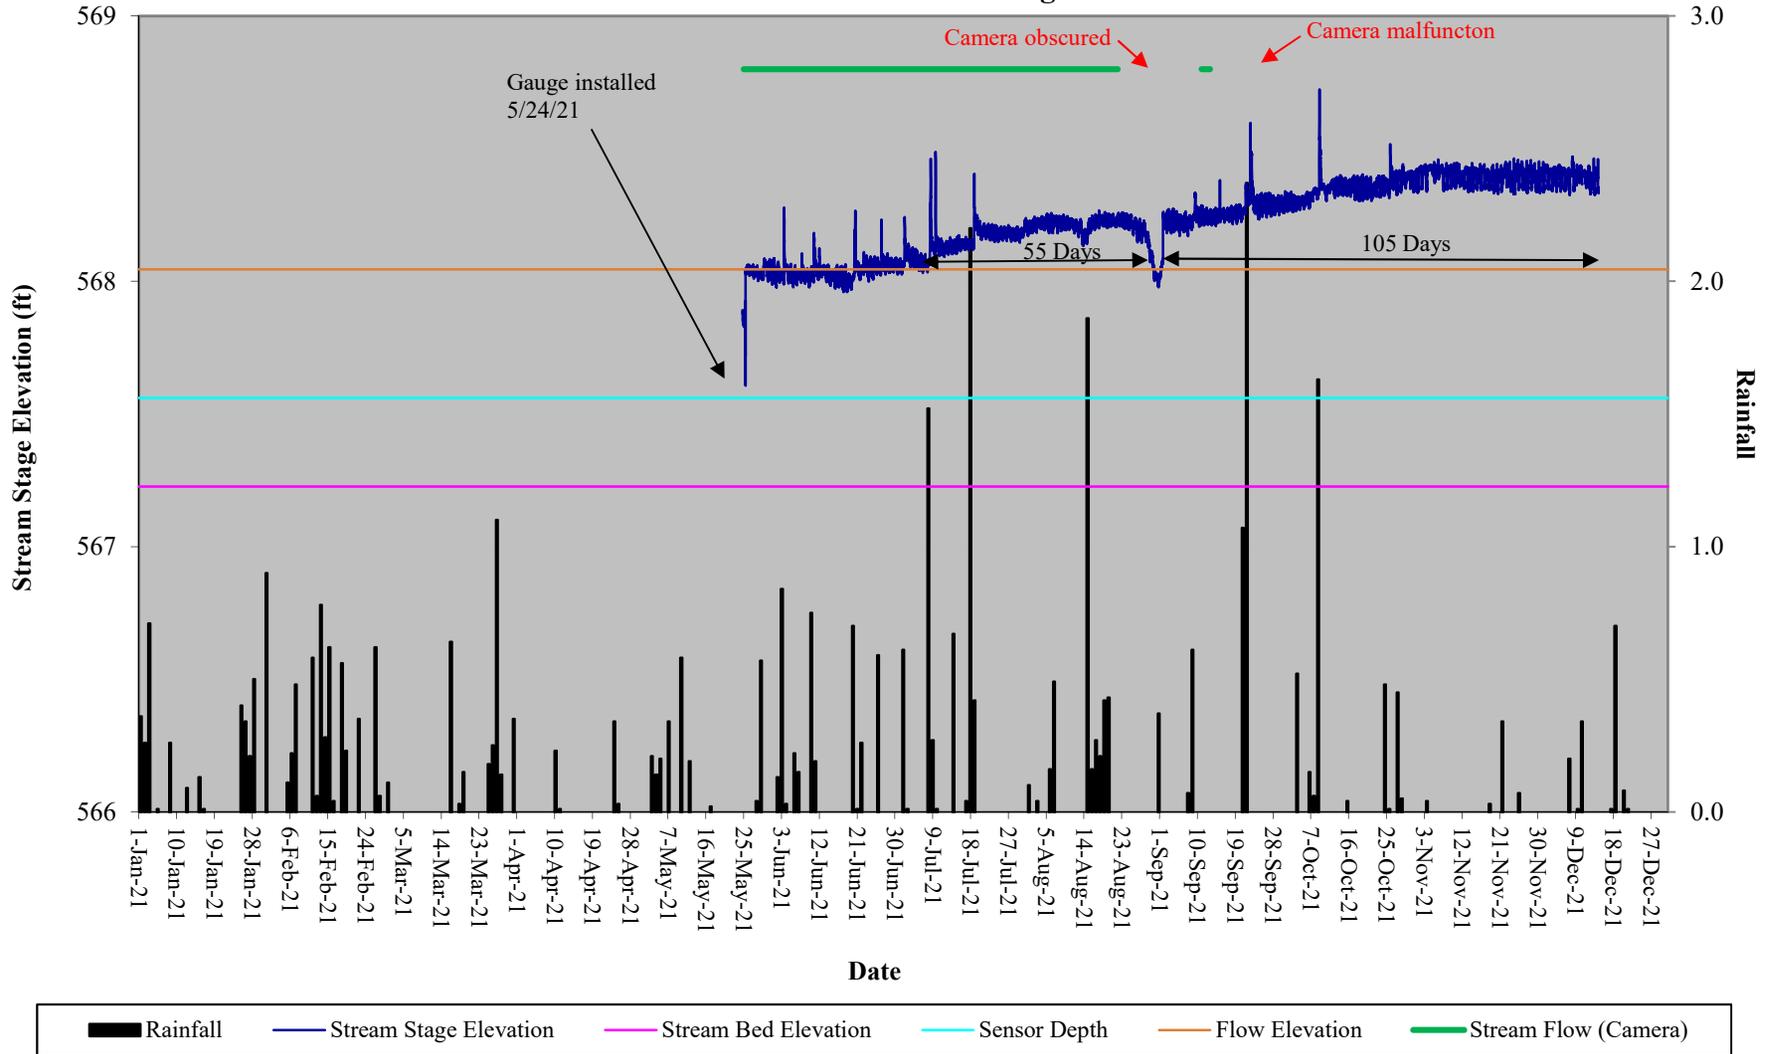
Hip Bone Creek Restoration Site Hydrograph T1-1 Stream Flow Gauge

Table 12. Stream Flow Criteria Attainment, Hip Bone Creek Restoration Site (ID-100059)							
	Greater than 30 Days of Flow/Max Consecutive Days						
Reach	MY1 2021	MY2 2022	MY3 2023	MY4 2024	MY5 2025	MY6 2026	MY7 2027
T1-1 (Gauge)	Yes/105						
T1-1 (Camera)	Yes/90						
T3-1 (Gauge)	Yes/205						
T3-1 (Camera)	Yes/39

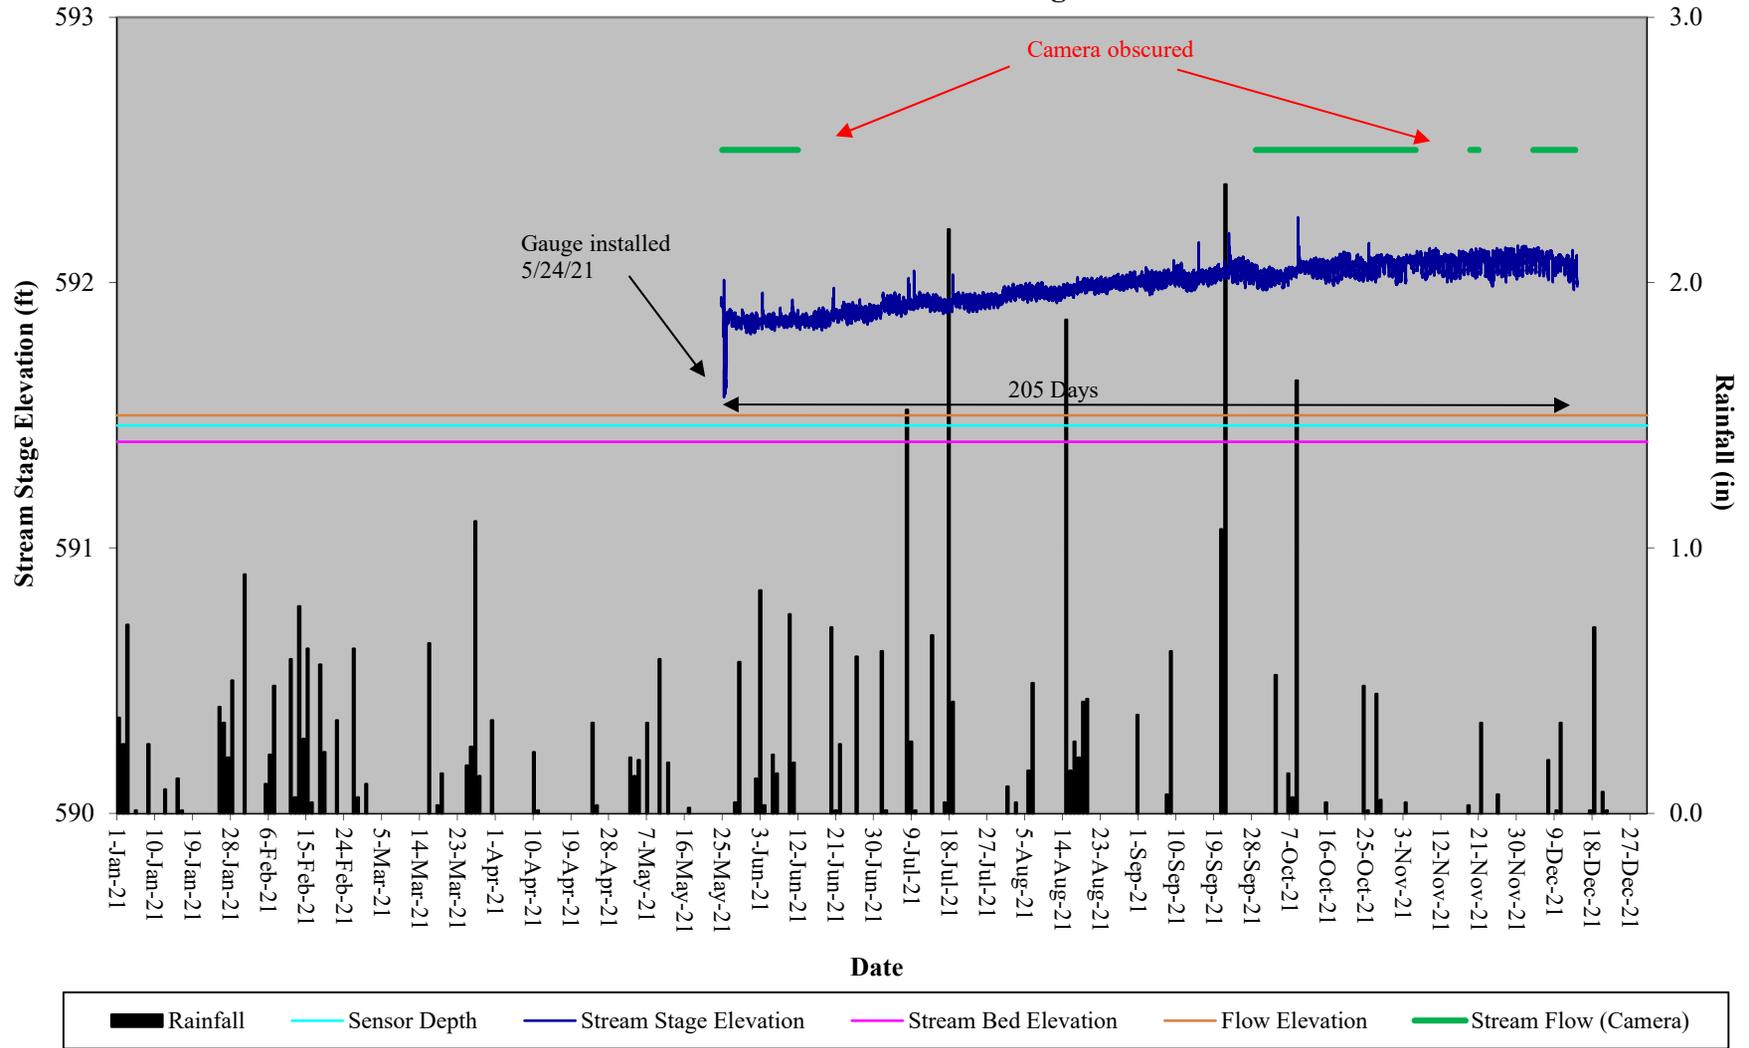
Hip Bone Creek Restoration Site Hydrograph T3-1 Stream Flow Gauge

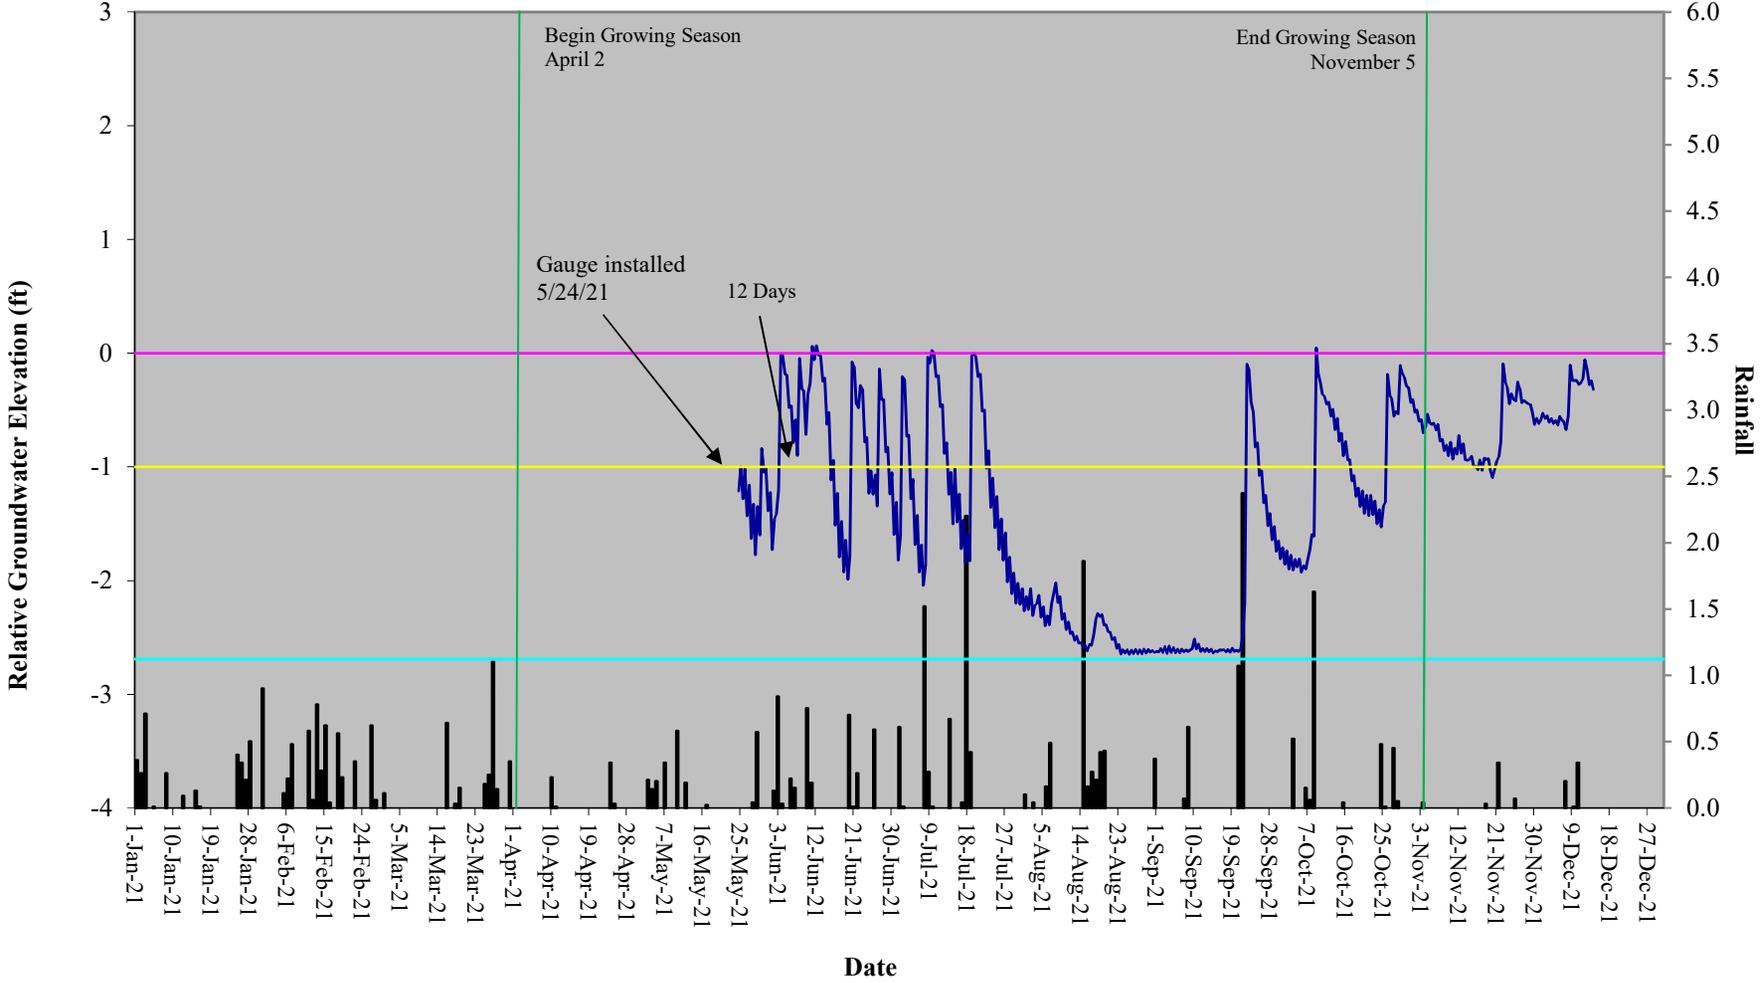
Hip Bone Creek Restoration Site Hydrograph Wetland Gauge 1

Table 12. Stream Flow Criteria Attainment, Hip Bone Creek Restoration Site (ID-100059)							
	Performance Standard: 12 % WETS Station: Siler City 2N Growing Season: 4/2 to 11/5 (217 days)						
	Max. Consecutive Hydroperiod (%)						
Monitoring Gauge	MY1 2021	MY2 2022	MY3 2023	MY4 2024	MY5 2025	MY6 2026	MY7 2027
WM-1	5.5%						
WM-2	6.0%						
WM-3	30.9%						
WM-4	5.1%						
WM-5	3.2%						
WM-6	19.8%						
WM-7	28.1%						
WM-8	2.3%

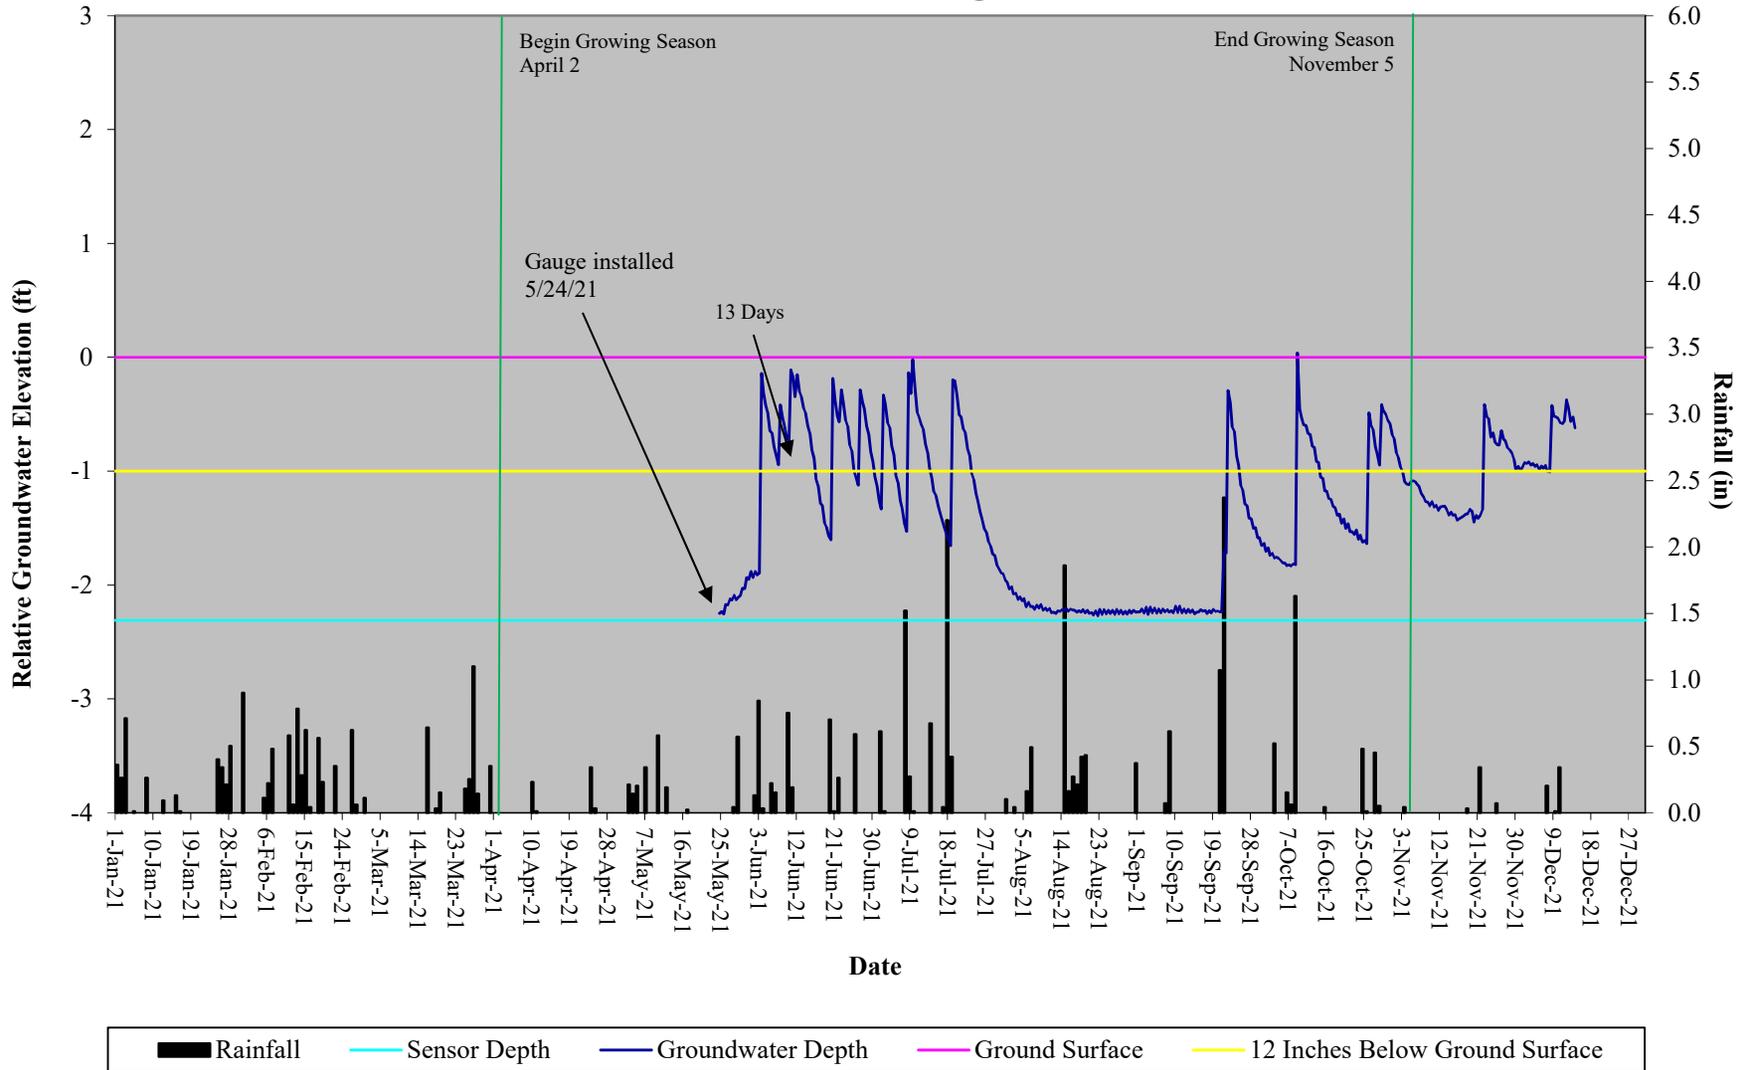
Hip Bone Creek Restoration Site Hydrograph Wetland Gauge 2

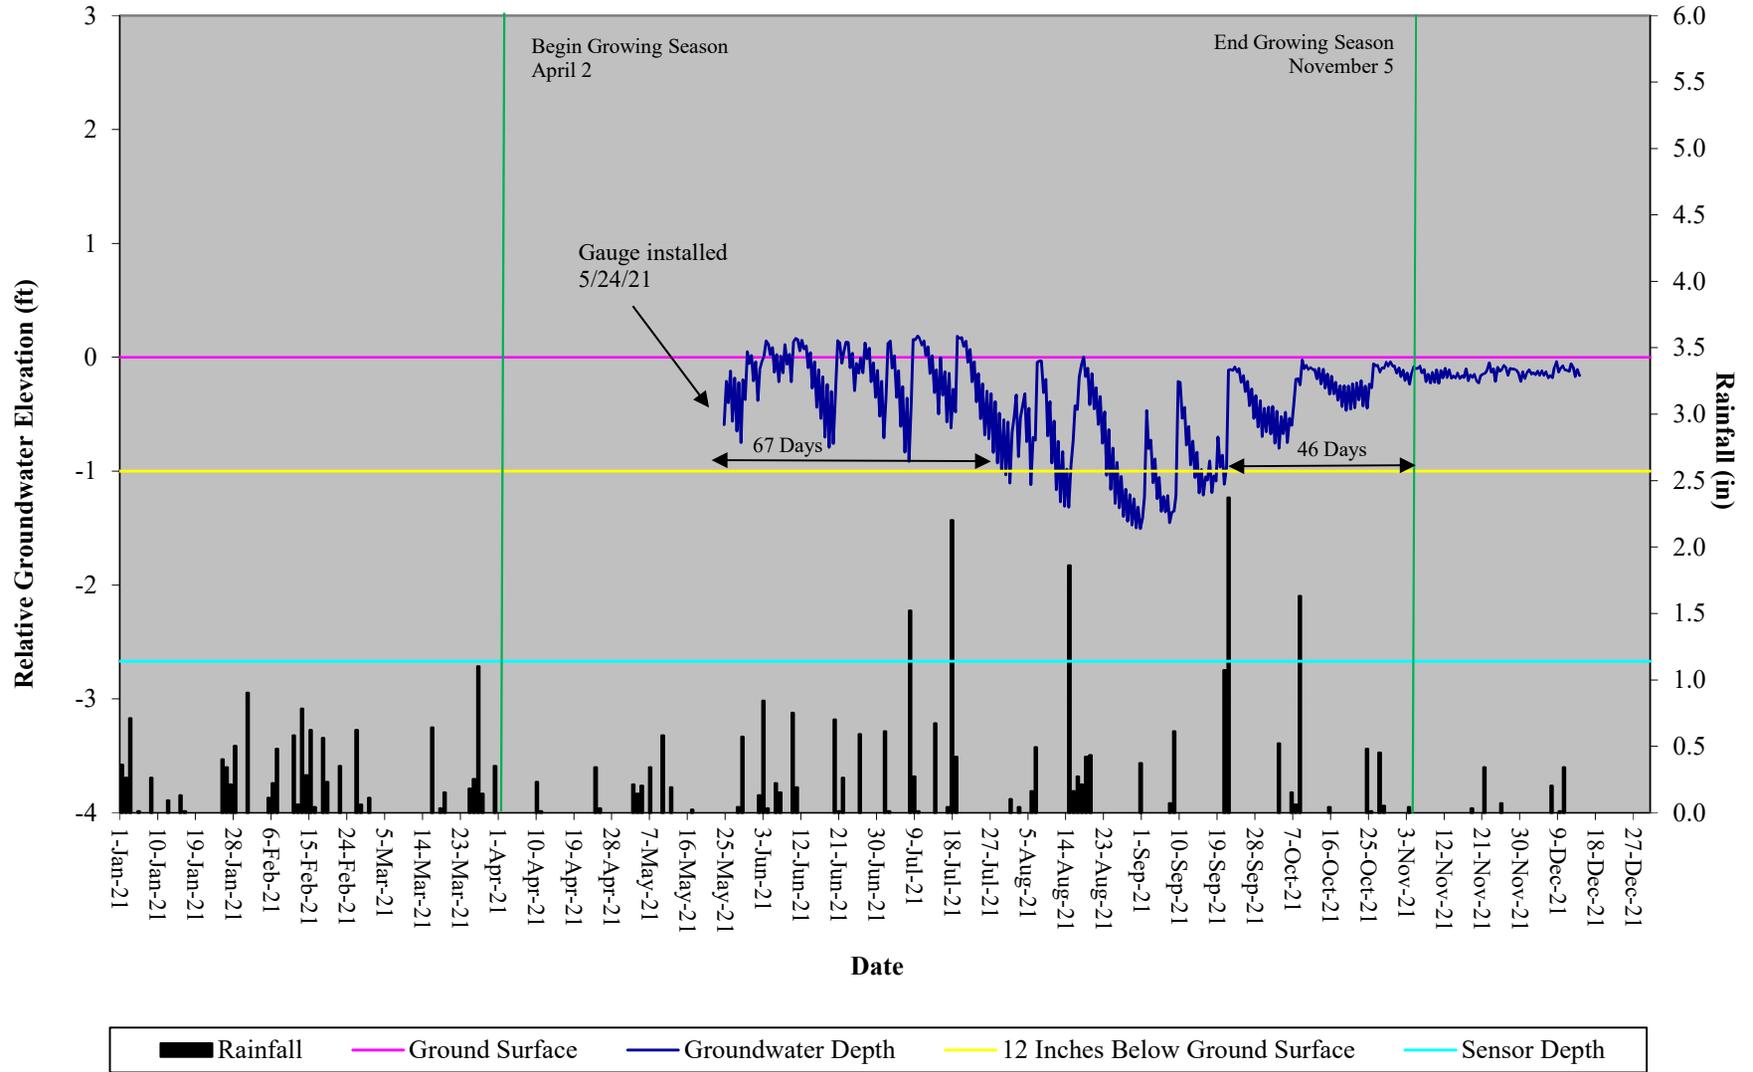
Hip Bone Creek Restoration Site Hydrograph Wetland Gauge 3

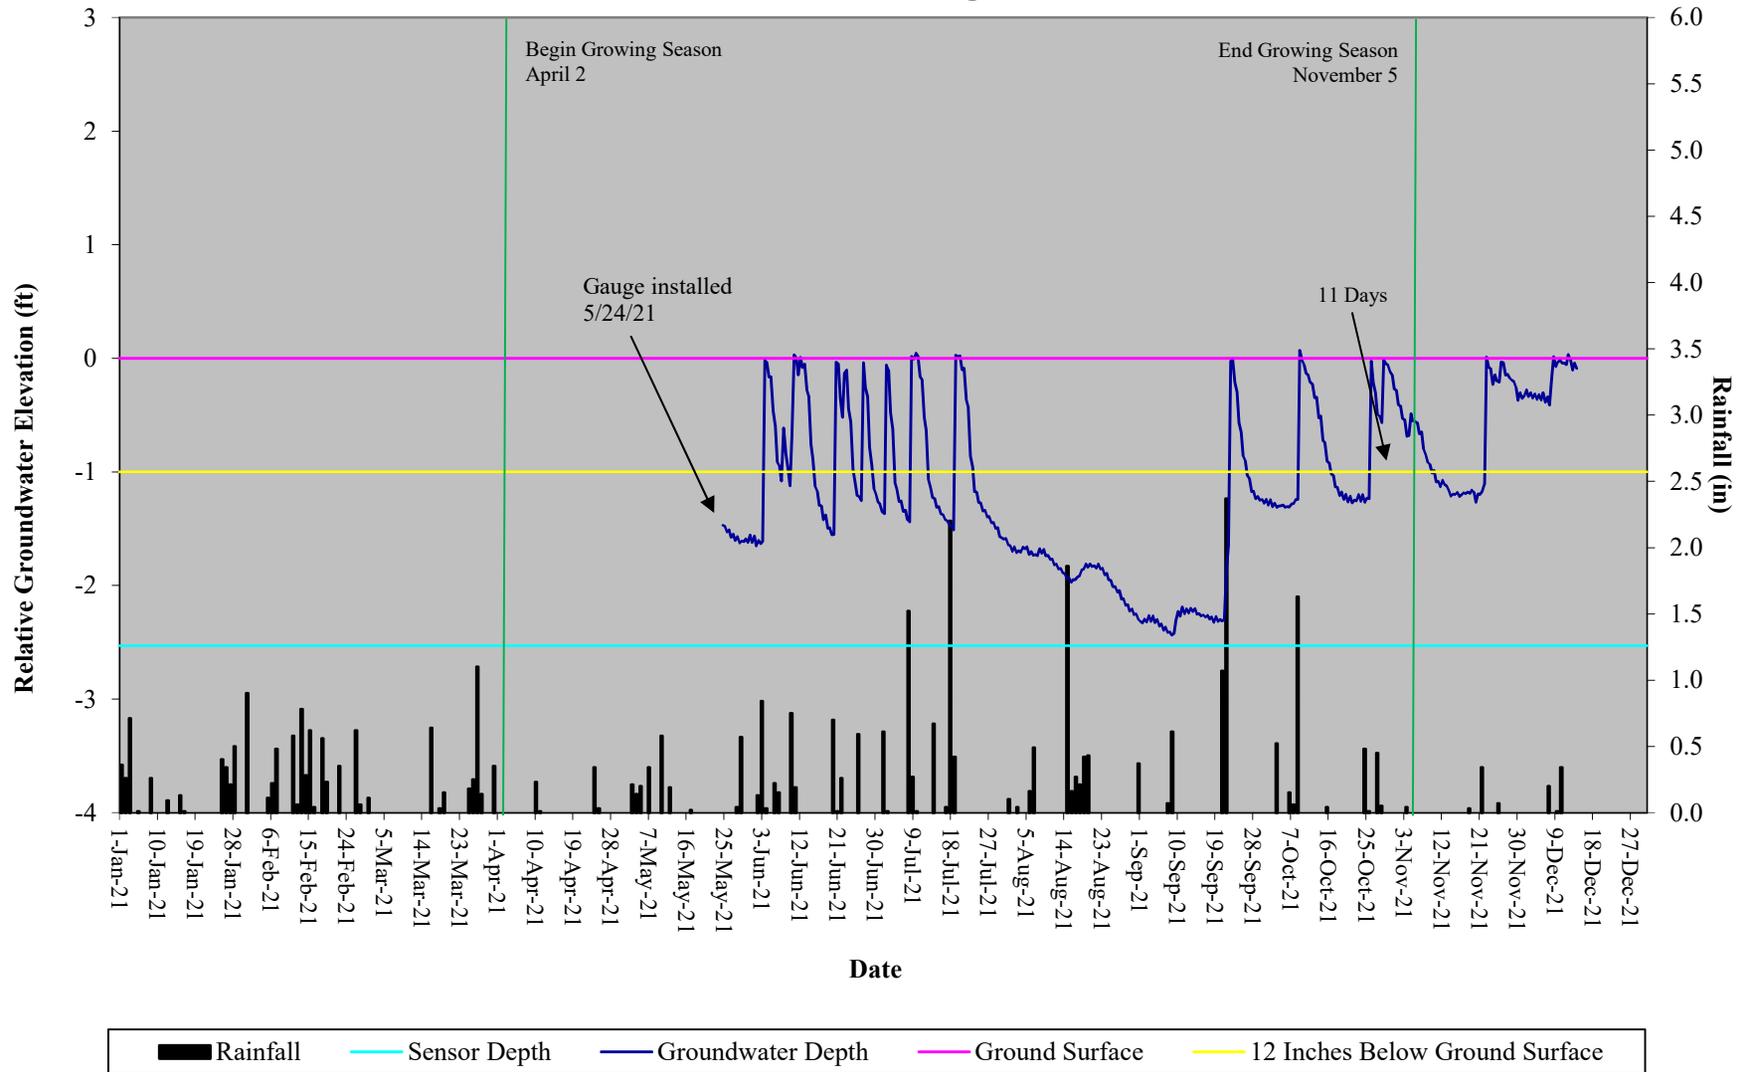
Hip Bone Creek Restoration Site Hydrograph Wetland Gauge 4

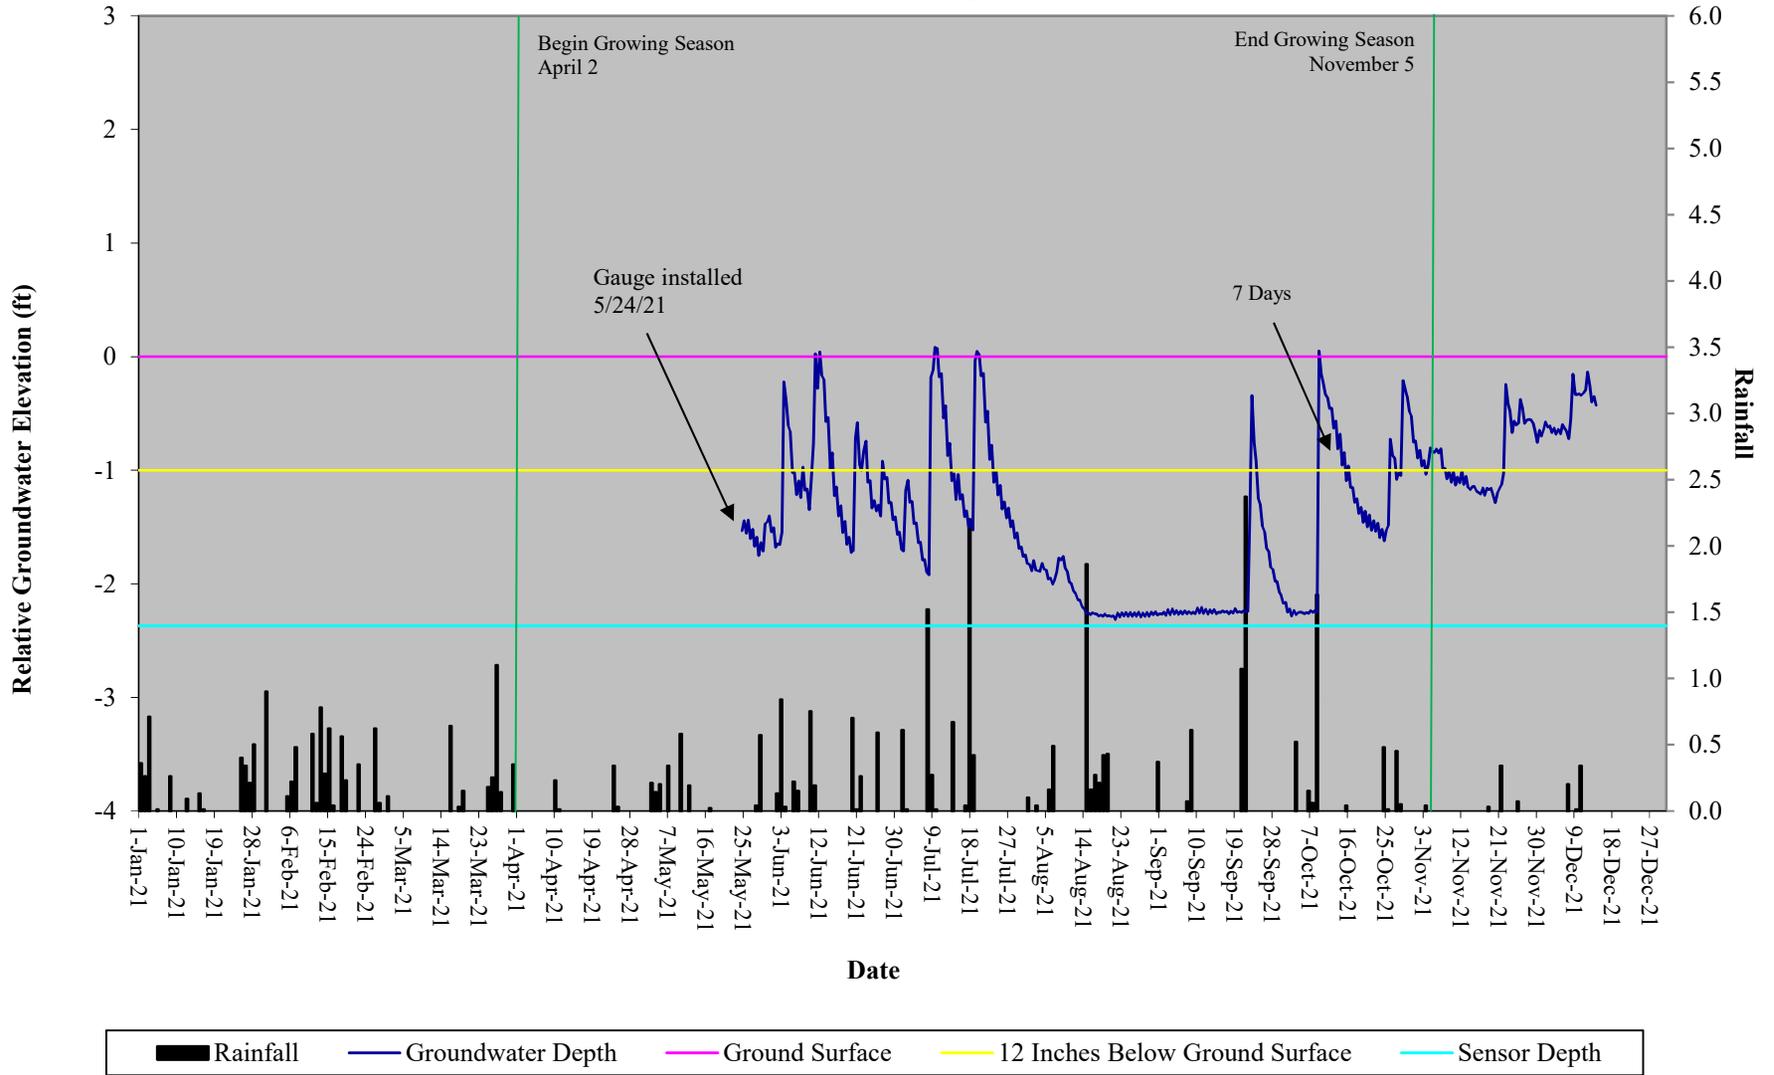
Hip Bone Creek Restoration Site Hydrograph Wetland Gauge 5
