MY01 MONITORING REPORT

Hip Bone Creek Restoration Site
Chatham County
Cape Fear River Basin - 03040101

DMS Project #100059

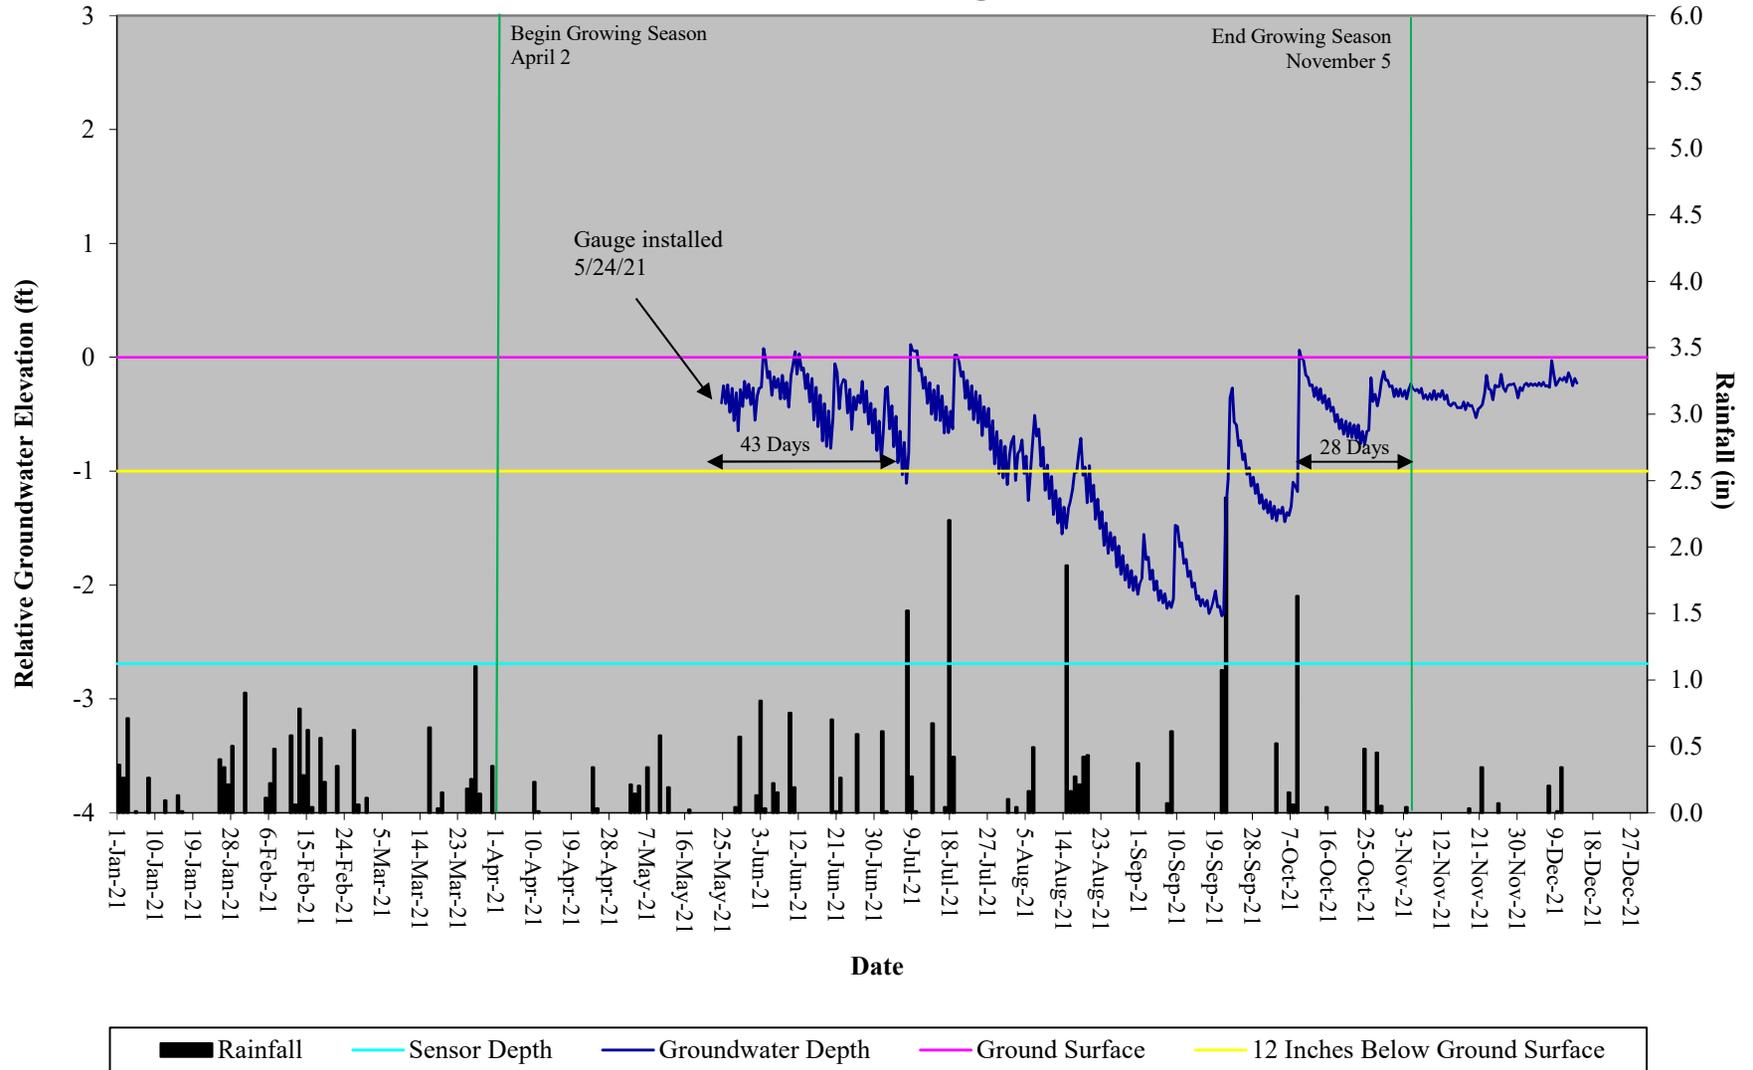
Hip Bone Creek Restoration Site Hydrograph Wetland Gauge 6

Table 12. Stream Flow Criteria Attainment, Hip Bone Creek Restoration Site (ID-100059)							
	Performance Standard: 12 % WETS Station: Siler City 2N Growing Season: 4/2 to 11/5 (217 days)						
	Max. Consecutive Hydroperiod (%)						
Monitoring Gauge	MY1 2021	MY2 2022	MY3 2023	MY4 2024	MY5 2025	MY6 2026	MY7 2027
WM-1	5.5%						
WM-2	6.0%						
WM-3	30.9%						
WM-4	5.1%						
WM-5	3.2%						
WM-6	19.8%						
WM-7	28.1%						
WM-8	2.3%

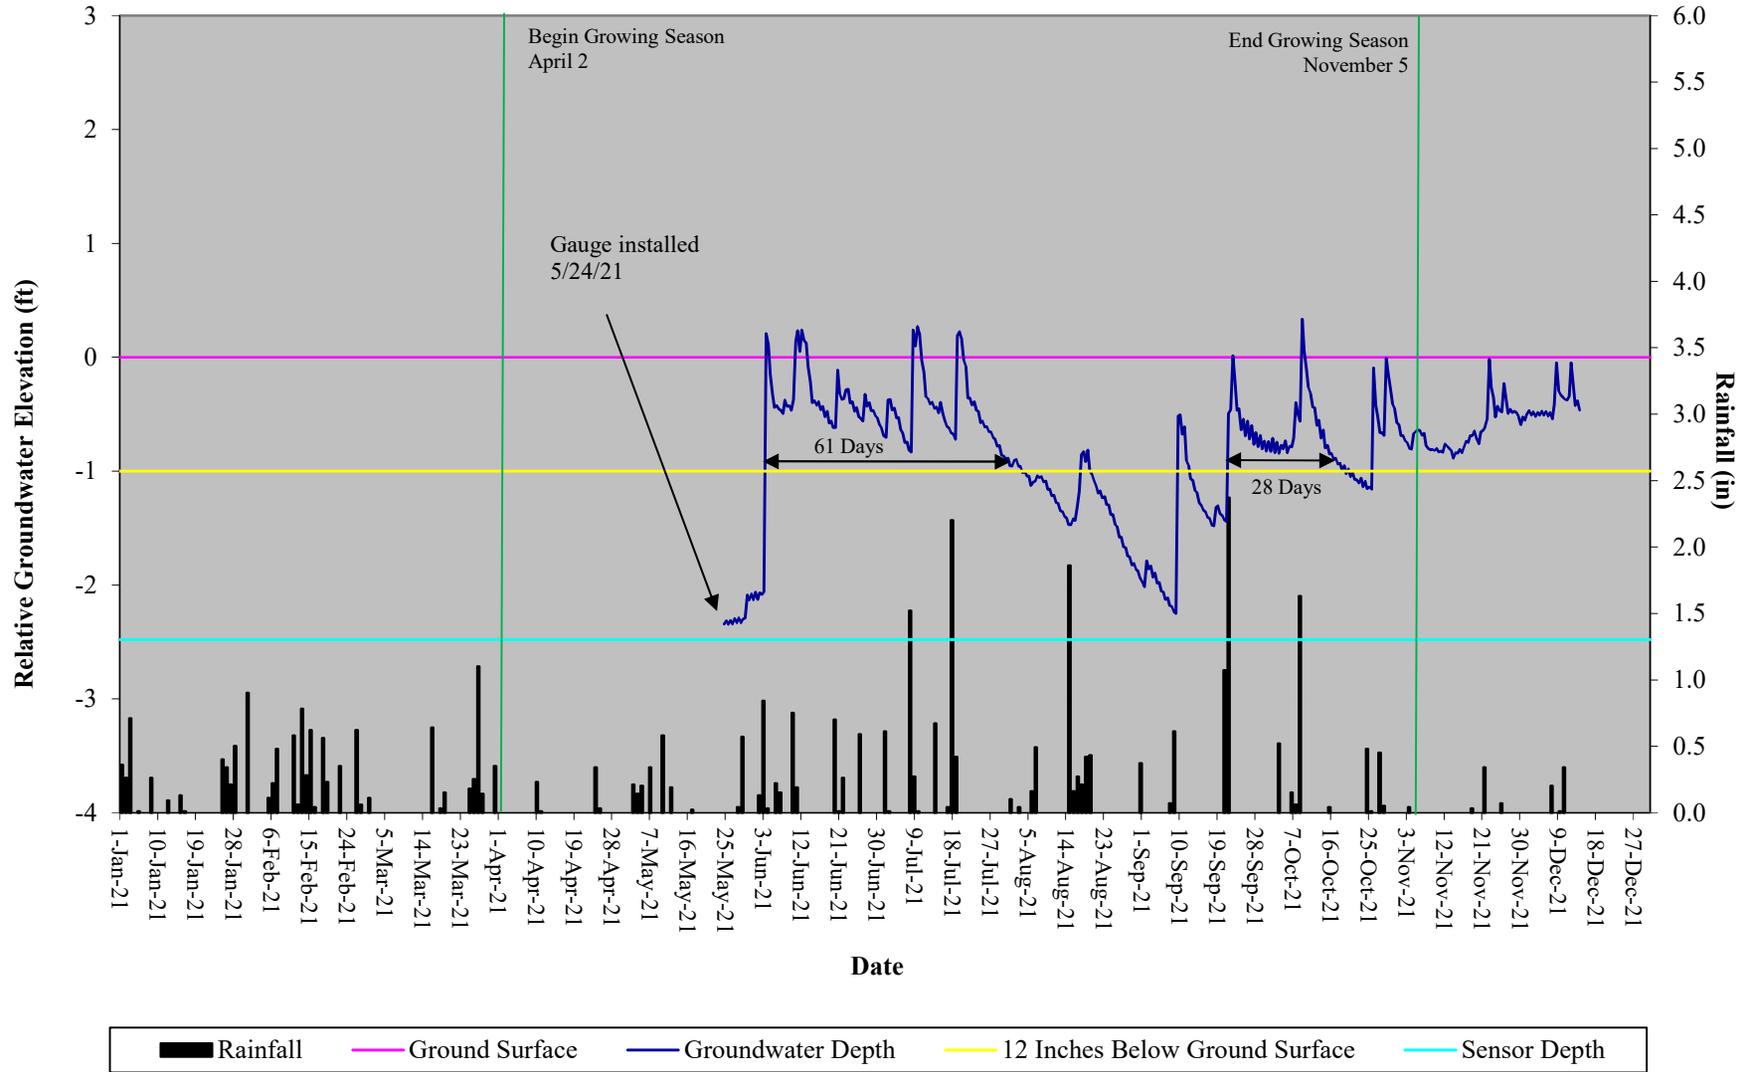
Hip Bone Creek Restoration Site Hydrograph Wetland Gauge 7

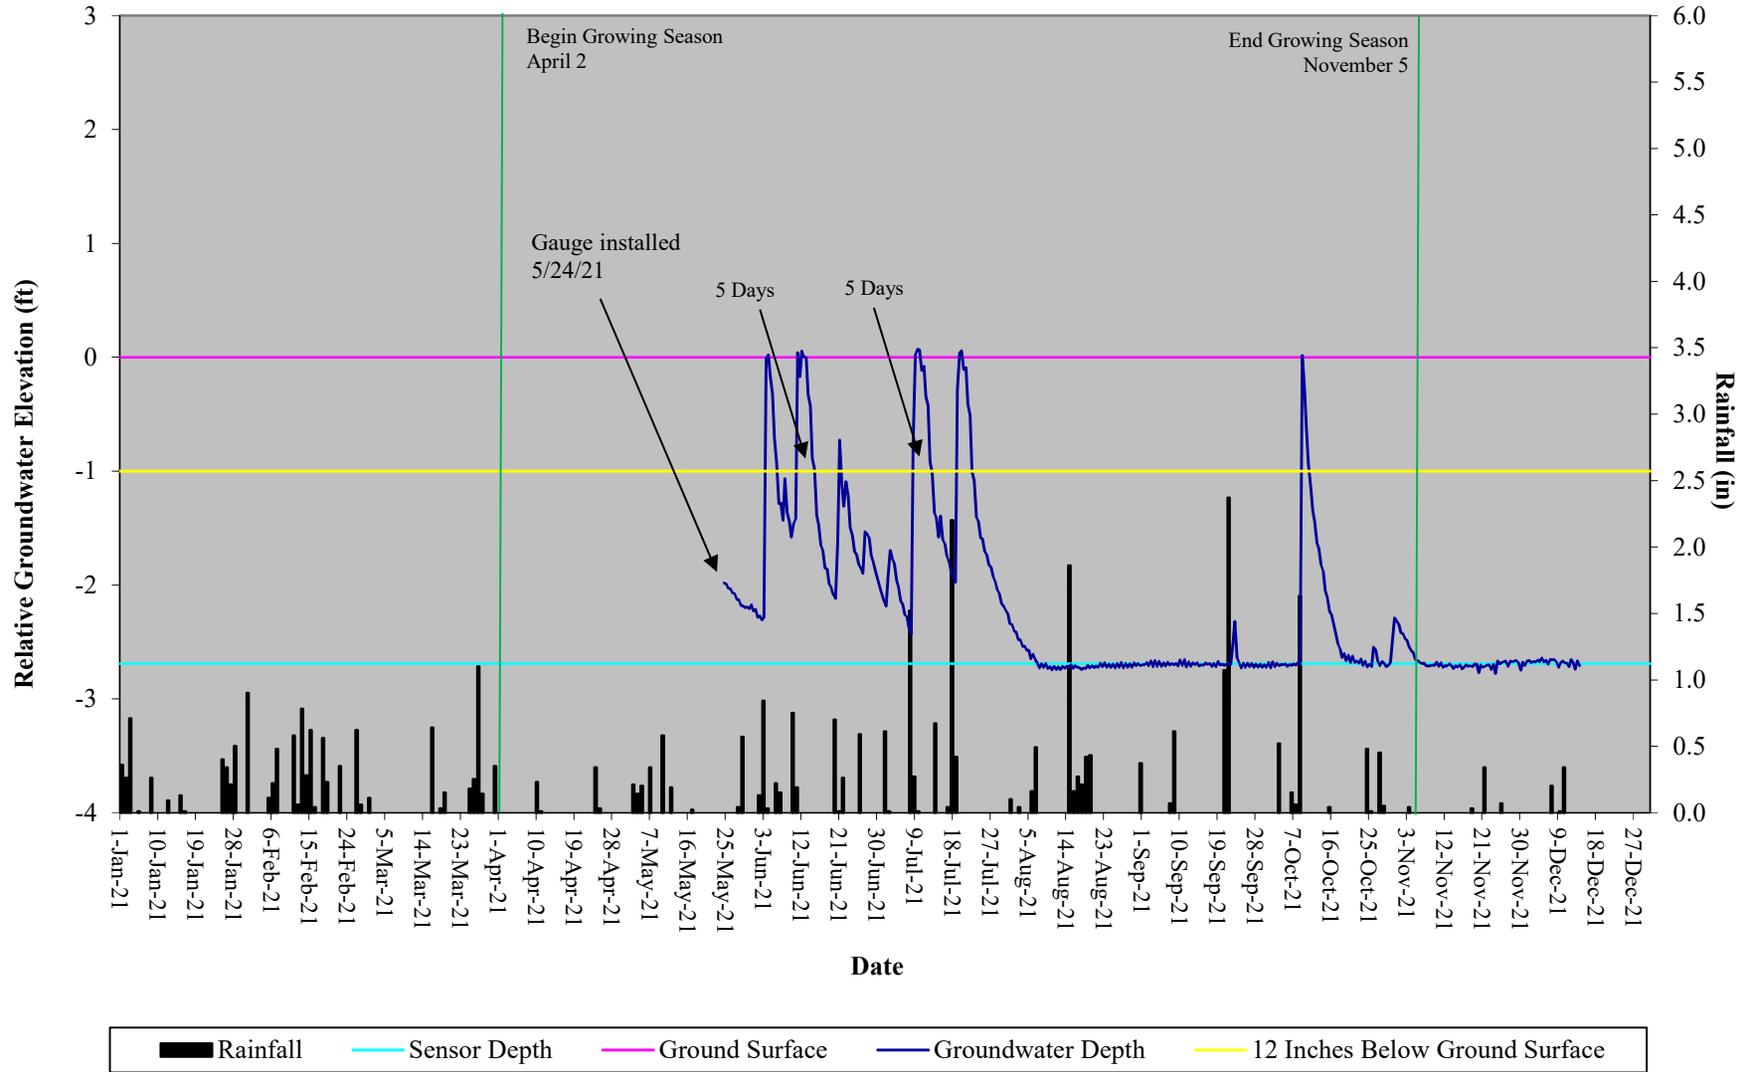
Hip Bone Creek Restoration Site Hydrograph Wetland Gauge 8

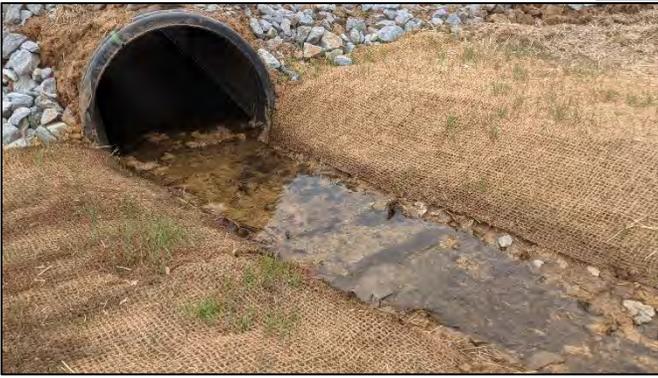
T1-1 Culvert – 4/15/2021

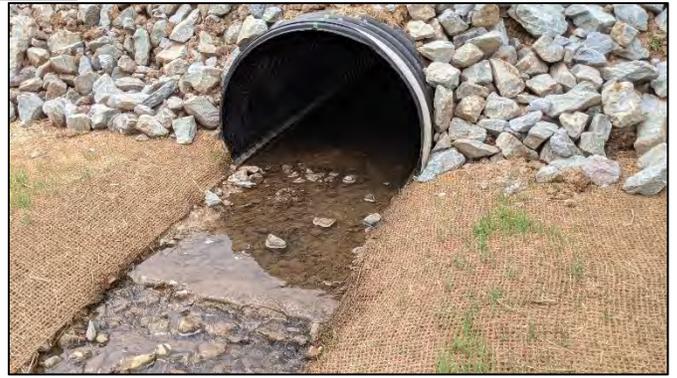
T1-3 Culvert – 4/15/2021

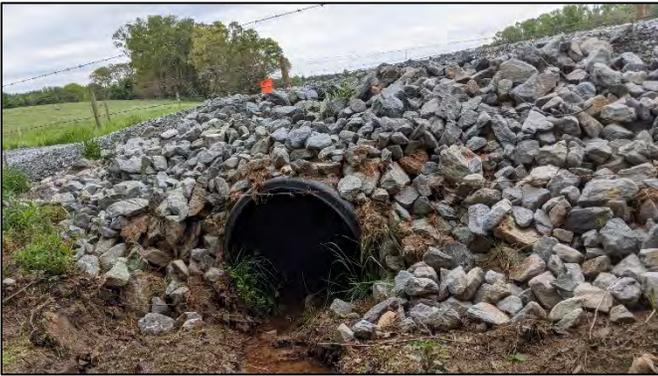
T2 Culvert – 4/15/2021

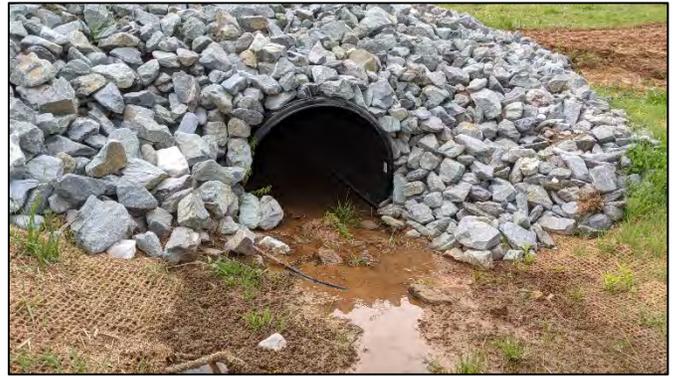
T3-1 Culvert – 1/27/2022

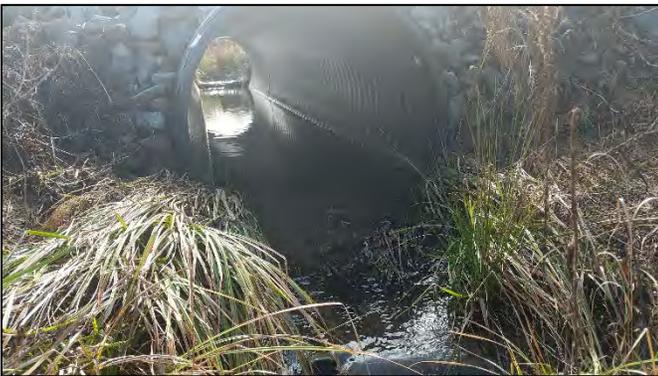
T3-3 Culvert – 4/15/2021
