FINAL MY1 (2021) MONITORING REPORT

SHAW'S RUN MITIGATION SITE

Columbus County, North Carolina Lumber River Basin Cataloging Unit 03040203

DMS Project No. 100055
Full Delivery Contract No. 7515
DMS RFP No. 16-007337
USACE Action ID No. SAW-2018-01169
DWR Project No. 2018-0866

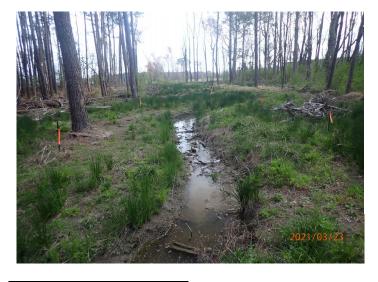
Site	Shaw's Run
Watershed:	Lumber River Basin, 03040203
XS ID	UT1, XS - 2, Pool
Feature	Pool
Date:	3/23/2021
Field Crew:	Harris, Perkinson

Station	Elevation
-0.3	90.9
1.3	91.0
3.9	91.0
5.6	90.9
7.1	90.9
7.9	90.7
8.6	90.5
9.3	90.2
10.1	89.9
10.8	89.7
11.4	89.6
12.2	89.7
13.0	89.7
13.7	89.9
14.1	90.2
14.6	90.9
15.3	91.2
16.2	91.4
17.4	91.4
18.7	91.5
20.1	91.5

SUMMARY DATA	
Bankfull Elevation:	90.9
Bank Hieght Ratio:	1.0
Thalweg Elevation:	89.6
LTOB Elevation:	90.9
LTOB Max Depth:	1.2
LTOB Cross Sectional Area:	5.7

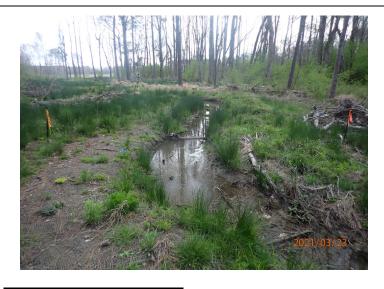
Site	Shaw's Run
Watershed:	Lumber River Basin, 03040203
XS ID	UT1, XS - 3, Pool
Feature	Pool
Date:	3/23/2021
Field Crew:	Harris, Perkinson

Elevation
92.6
92.6
92.5
92.4
92.1
91.9
91.1
90.9
90.8
90.7
90.8
91.1
91.4
91.7
92.1
92.2
92.3
92.5
92.6
92.7
92.6

SUMMARY DATA	
Bankfull Elevation:	92.1
Bank Hieght Ratio:	1.0
Thalweg Elevation:	90.7
LTOB Elevation:	92.1
LTOB Max Depth:	1.4
LTOB Cross Sectional Area:	6.1

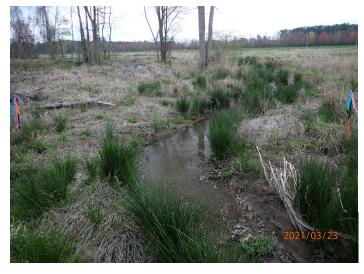
Site	Shaw's Run
Watershed:	Lumber River Basin, 03040203
XS ID	UT1, XS - 4, Riffle
Feature	Riffle
Date:	3/23/2021
Field Crew:	Harris, Perkinson

Station	Elevation
-0.1	92.8
2.7	92.8
4.9	92.7
6.4	92.6
7.6	92.2
8.3	92.0
8.8	91.8
9.3	91.5
9.9	91.5
10.8	91.3
11.1	91.5
11.7	91.8
12.4	92.1
13.3	92.1
14.1	92.4
14.7	92.4
15.9	92.4
17.3	92.5
19.3	92.6

SUMMARY DATA	
Bankfull Elevation:	92.2
Bank Hieght Ratio:	1.0
Thalweg Elevation:	91.3
LTOB Elevation:	92.2
LTOB Max Depth:	0.9
LTOB Cross Sectional Area:	2.5

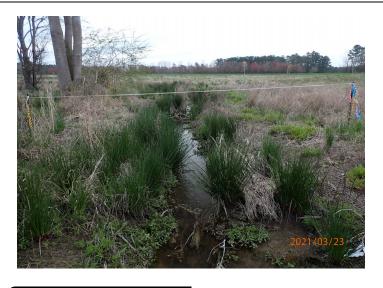
Site	Shaw's Run
Watershed:	Lumber River Basin, 03040203
XS ID	UT1, XS - 5, Pool
Feature	Pool
Date:	3/23/2021
Field Crew:	Harris, Perkinson

SUMMARY DATA	
Bankfull Elevation:	93.8
Bank Hieght Ratio:	1.0
Thalweg Elevation:	92.6
LTOB Elevation:	93.8
LTOB Max Depth:	1.2
LTOB Cross Sectional Area:	5.6

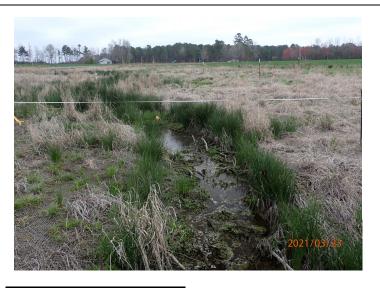
Site	Shaw's Run
Watershed:	Lumber River Basin, 03040203
XS ID	UT1, XS -6, Riffle
Feature	Riffle
Date:	3/23/2021
Field Crew:	Harris, Perkinson

Station	Elevation
0.0	94.2
1.5	94.2
3.5	94.2
4.7	94.2
5.4	94.1
5.9	93.9
6.5	93.7
7.1	93.5
7.4	93.3
8.2	93.3
9.1	93.3 93.3
9.7	93.3
10.5	93.4
11.0	93.6
11.7	93.7
12.3	93.9
12.8	94.1
13.5	94.3
15.0	94.3
16.8	94.5
19.1	94.33
	<u> </u>

SUMMARY DATA	
Bankfull Elevation:	94.2
Bank Hieght Ratio:	1.0
Thalweg Elevation:	93.3
LTOB Elevation:	94.2
LTOB Max Depth:	0.9
LTOB Cross Sectional Area:	4.8

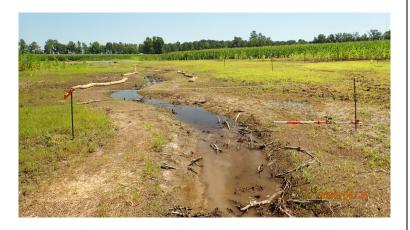
Site	Shaw's Run
Watershed:	Lumber River Basin, 03040203
XS ID	UT1, XS - 7, Pool
Feature	Pool
Date:	3/23/2021
Field Crew:	Harris, Perkinson

Station	Elevation
0.2	95.7
2.5	95.8
4.3	95.8
5.8	95.6
6.8	95.3
7.1	94.8
7.7	94.4
8.2	94.3
8.7	94.1
9.1	94.1
9.5	94.2
10.0	94.4
10.5	94.4
10.9	94.8
11.3	94.9
11.9	95.1
12.7	95.5
13.3	95.6
13.9	95.7
15.3	95.7
17.0	95.7
18.7	95.7
20.3	95.7

SUMMARY DATA	
Bankfull Elevation:	95.5
Bank Hieght Ratio:	1.0
Thalweg Elevation:	94.1
LTOB Elevation:	95.6
LTOB Max Depth:	1.5
LTOB Cross Sectional Area:	5.6

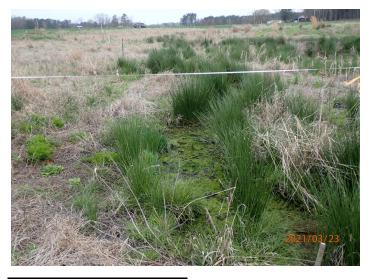
Site	Shaw's Run
Watershed:	Lumber River Basin, 03040203
XS ID	UT1, XS -8, Riffle
Feature	Riffle
Date:	3/23/2021
Field Crew:	Harris, Perkinson

Station	Elevation
0.7	95.7
2.7	95.5
5.1	95.5
6.4	95.6
7.2 7.7	95.3
7.7	95.0
8.2	94.9
8.6	94.6
9.2	94.6
9.7	94.7
10.1	94.8
10.5	94.9
11.1	95.1
11.7	95.4
12.5	95.3
13.6	95.5
14.4	95.7
15.4	95.7
16.9	95.8
18.6	96.0

SUMMARY DATA	
Bankfull Elevation:	95.5
Bank Hieght Ratio:	1.0
Thalweg Elevation:	94.6
LTOB Elevation:	95.6
LTOB Max Depth:	1.0
LTOB Cross Sectional Area:	3.2

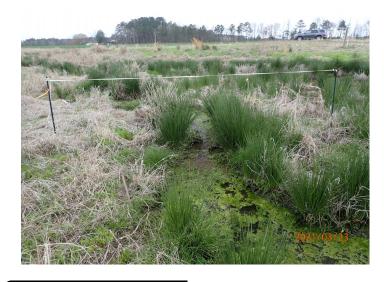
Site	Shaw's Run
Watershed:	Lumber River Basin, 03040203
XS ID	UT2, XS - 9, Pool
Feature	Pool
Date:	3/23/2021
Field Crew:	Harris, Perkinson

Station	Elevation
0.0	94.6
2.1	94.4
3.7	94.5
4.9	94.5
5.7	94.4
6.1	94.1
6.7	93.6
7.3	93.3
7.7	93.4
8.3	93.6
8.7	93.7
9.0	93.8
9.4	94.1
9.9	94.4
10.4	94.6
11.0	94.6
11.9	94.6
13.3	94.7
14.9	94.8

SUMMARY DATA	
Bankfull Elevation:	94.4
Bank Hieght Ratio:	1.0
Thalweg Elevation:	93.3
LTOB Elevation:	94.4
LTOB Max Depth:	1.1
LTOB Cross Sectional Area:	2.4

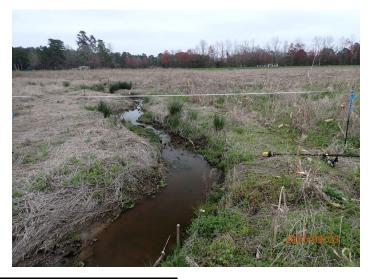
Site	Shaw's Run
Watershed:	Lumber River Basin, 03040203
XS ID	UT2, XS -10, Riffle
Feature	Riffle
Date:	3/23/2021
Field Crew:	Harris, Perkinson

Elevation
94.7
94.6
94.5
94.5
94.4
94.4
94.2
94.0
94.0
94.1
94.0
94.2
94.4
94.3
94.5
94.6
94.6
94.8
94.7
I I

SUMMARY DATA	
Bankfull Elevation:	94.6
Bank Hieght Ratio:	1.1
Thalweg Elevation:	94.0
LTOB Elevation:	94.6
LTOB Max Depth:	0.6
LTOB Cross Sectional Area:	1.8
