FINAL
Baseline Monitoring Document and As-Built Baseline Report
Thomas Creek Restoration Project

Wake County, North Carolina

DMS Project ID No. 96074, DEQ Contract No. 5549

Submission Date: October 2016

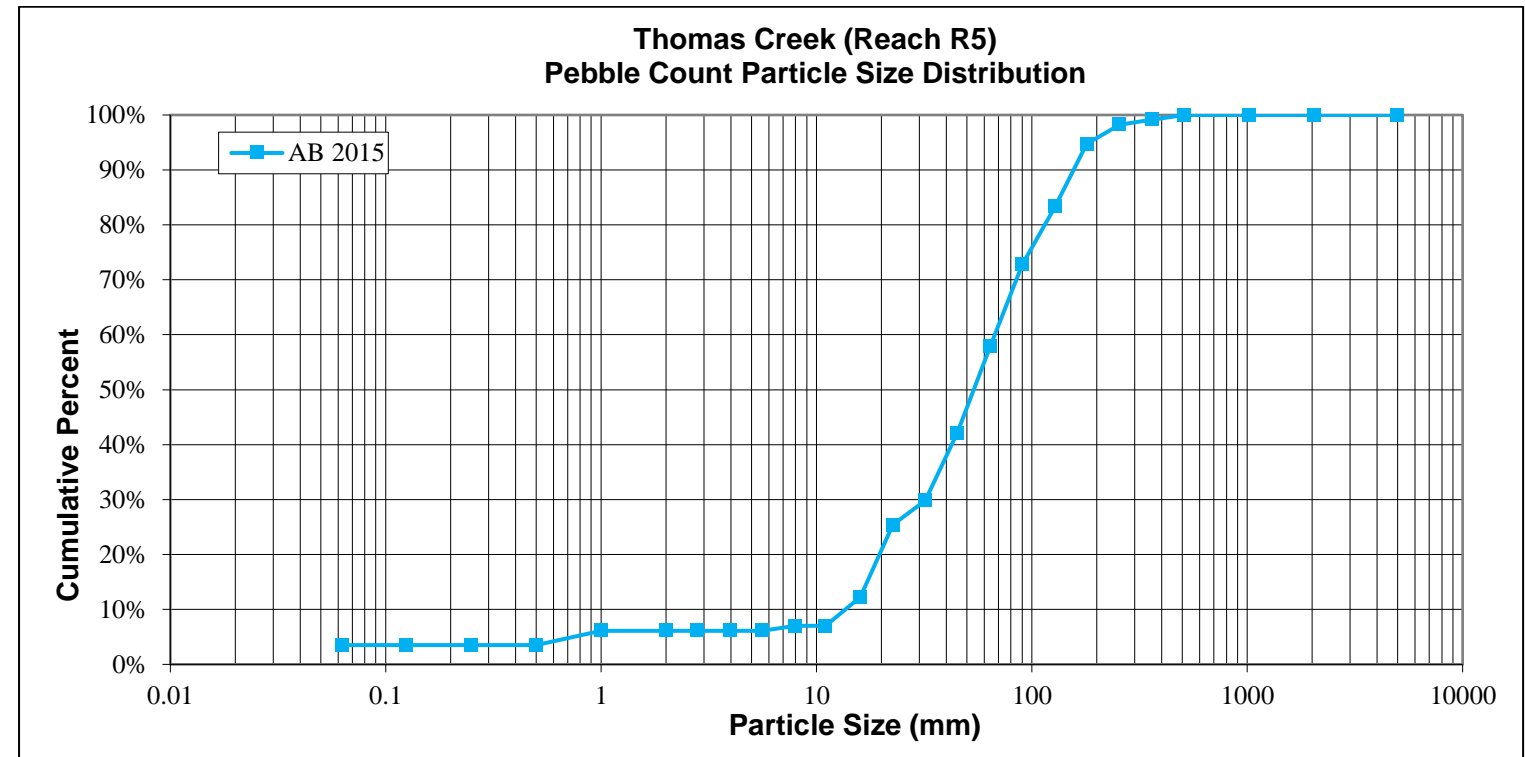
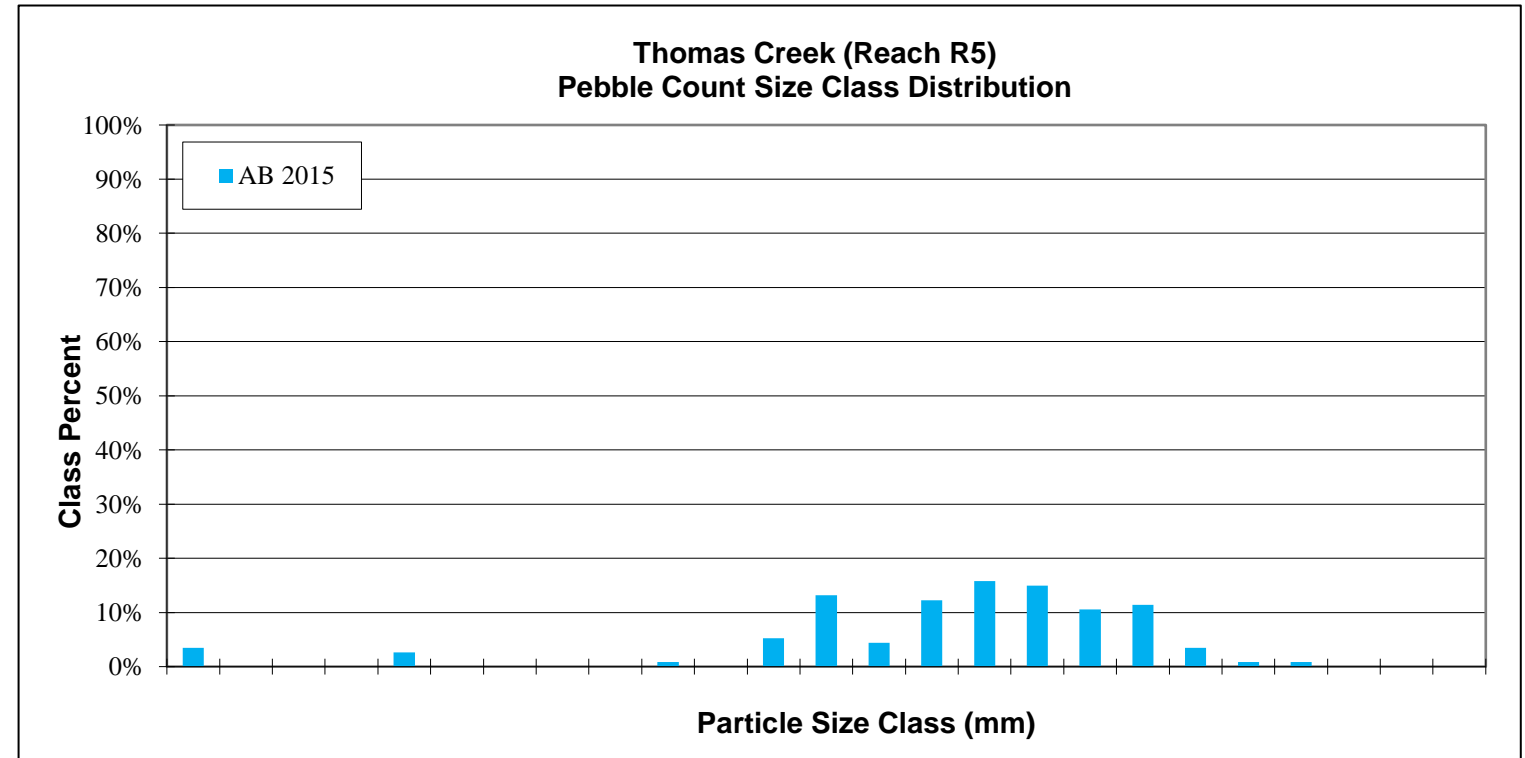
Pebble Count; As-built Survey
Thomas Creek Mitigation Project, DMS# 96074

SITE OR PROJECT:	Thomas Creek
REACH/LOCATION:	Reach R5 (Station 37+00)
FEATURE:	Rock Riffle
DATE:	6-Nov-15

Summary Data			
Channel materials			
D16 =	17.6	D84 =	130.6
D35 =	36.9	D95 =	184.8
D50 =	53.7	D100 =	362 - 512

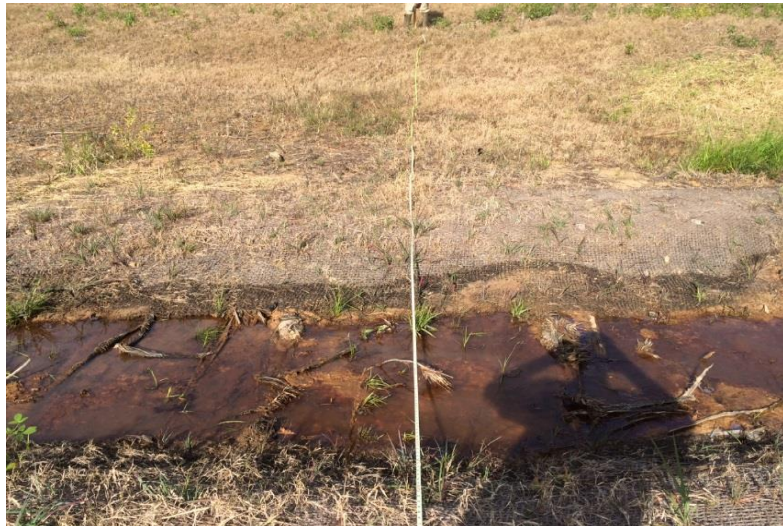
Looking at the Left Bank

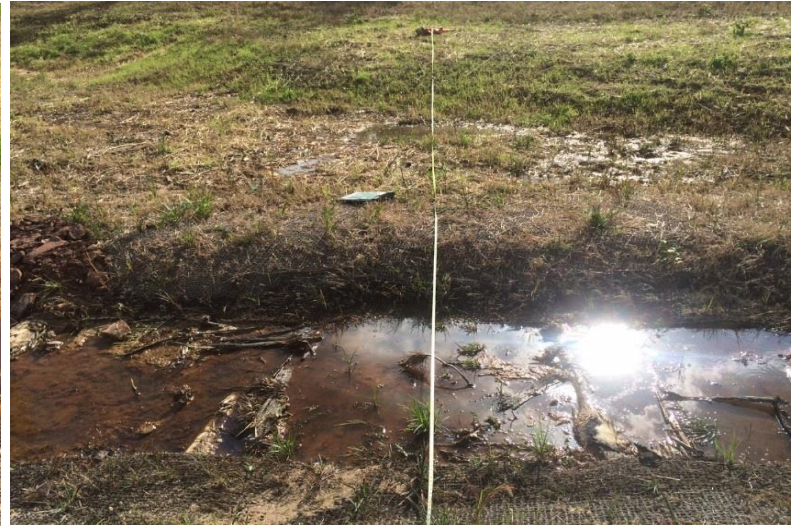
Looking at the Right Bank

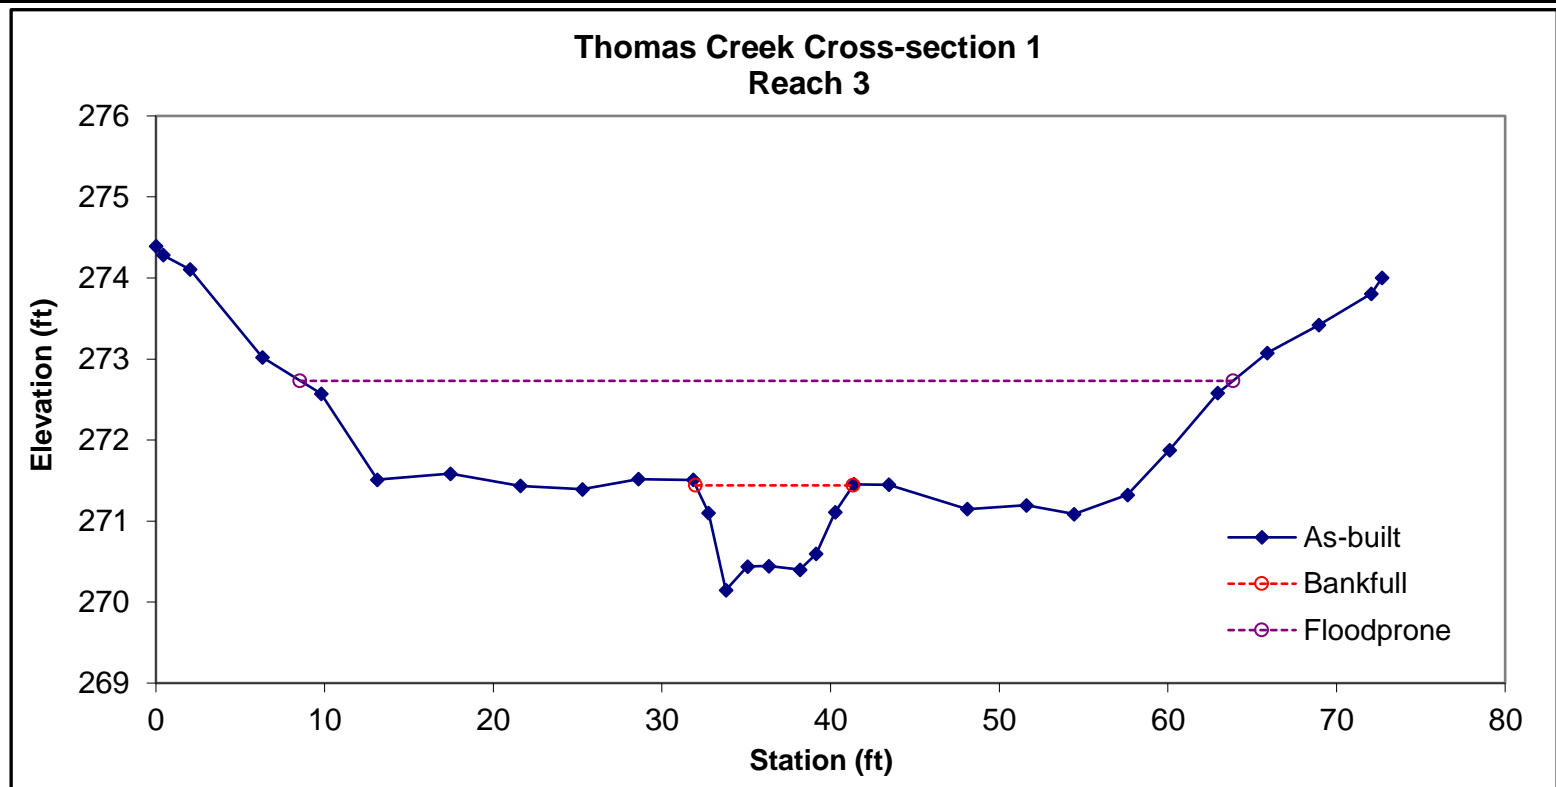
Permanent Cross-section 1
(As-Built Data - Collected Oct/Nov 2015)

Feature	Stream Type	BKF Area	BKF Width	BKF Depth	Max BKF Depth	W/D	BH Ratio	ER	BKF Elev	TOB Elev
Riffle	C	7.3	9.34	0.78	1.29	11.9	1	5.9	271.44	271.45

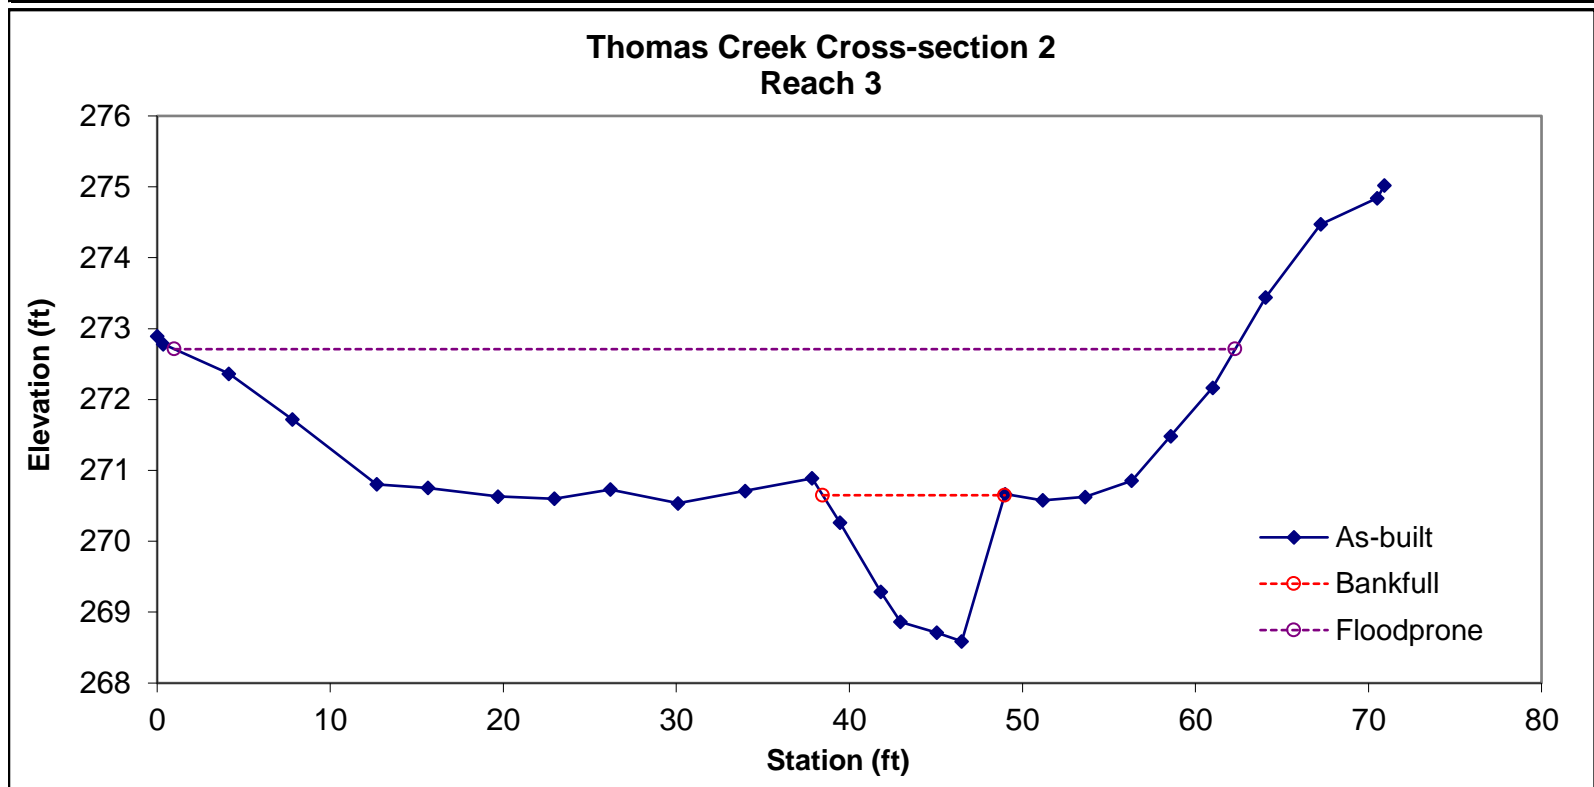
Permanent Cross-section 2
(As-Built Data - Collected Oct/Nov 2015)

Feature	Stream Type	BKF Area	BKF Width	BKF Depth	Max BKF Depth	W/D	BH Ratio	ER	BKF Elev	TOB Elev
Pool		13.4	10.51	1.27	2.06	8.25	1	5.8	270.65	270.67

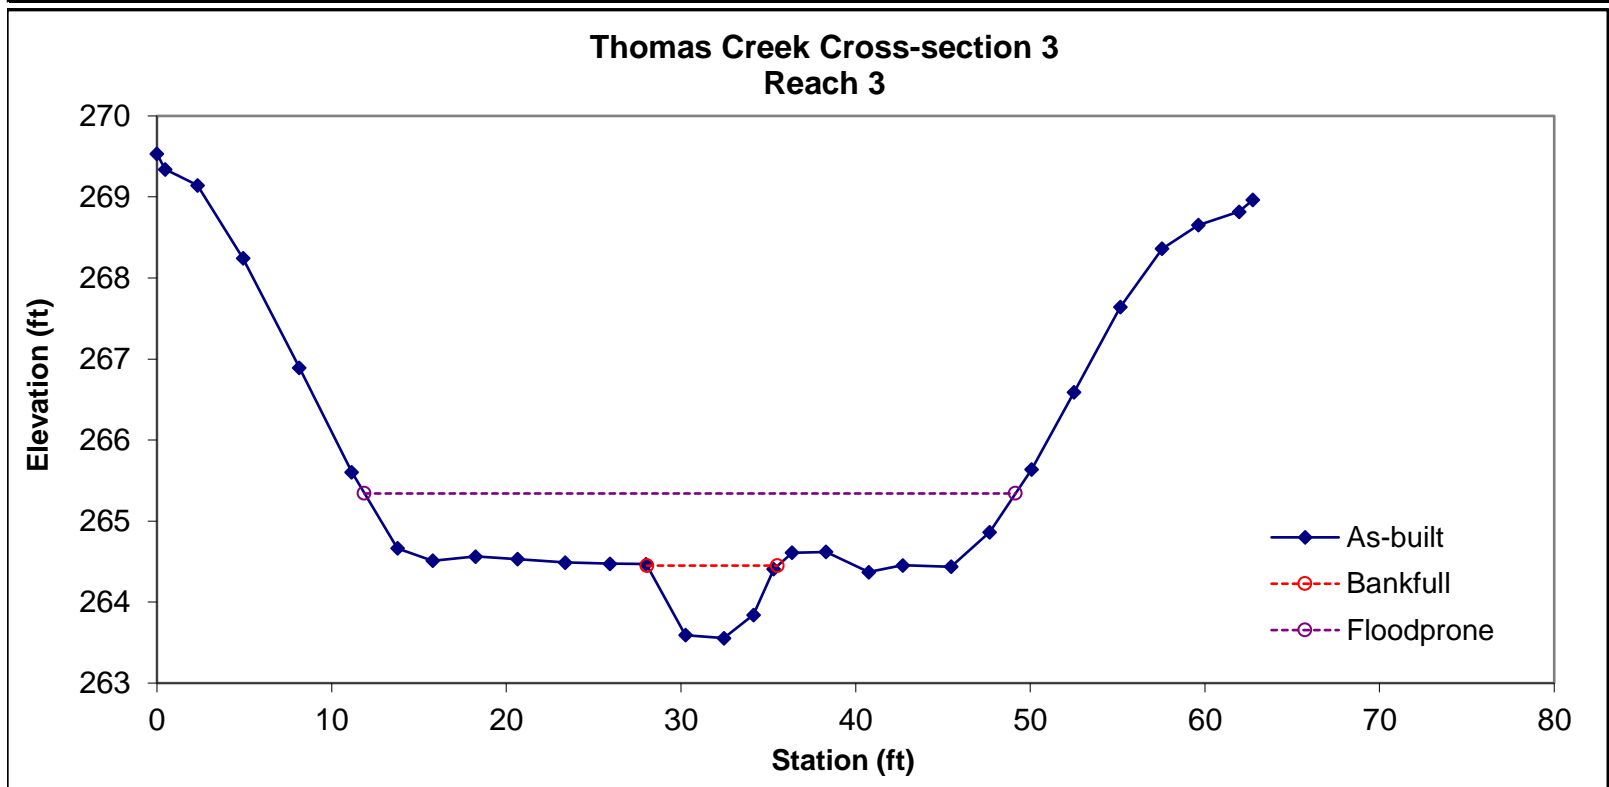
Permanent Cross-section 3
(As-Built Data - Collected Oct/Nov 2015)

Feature	Stream Type	BKF Area	BKF Width	BKF Depth	Max BKF Depth	W/D	BH Ratio	ER	BKF Elev	TOB Elev
Riffle	C	4.5	7.47	0.61	0.89	12.34	1	5	264.45	264.47

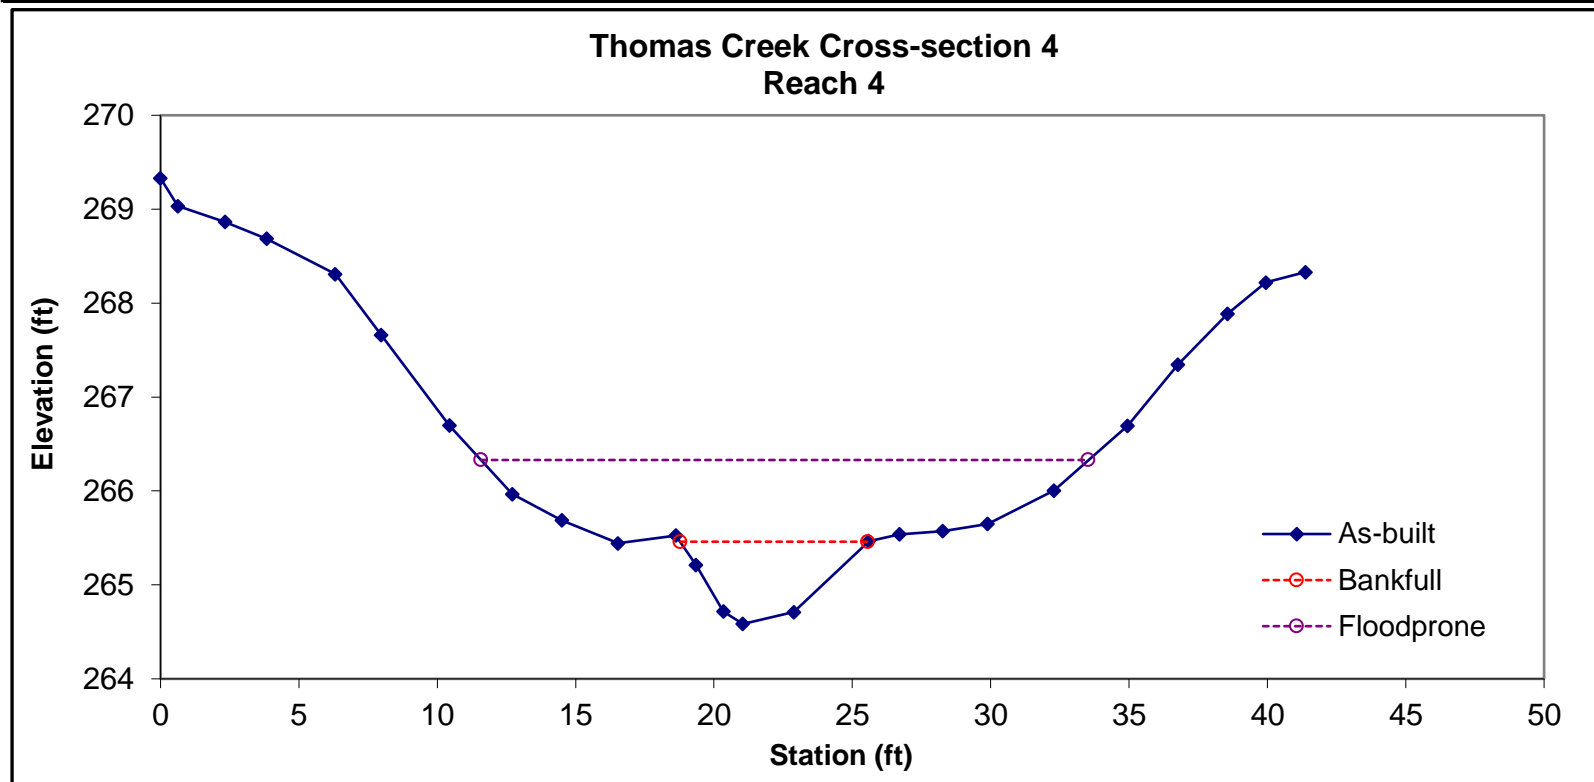
Permanent Cross-section 4
(As-Built Data - Collected Oct/Nov 2015)

Feature	Stream Type	BKF Area	BKF Width	BKF Depth	Max BKF Depth	W/D	BH Ratio	ER	BKF Elev	TOB Elev
Riffle	C	3.6	6.78	0.53	0.87	12.74	1	3.2	265.46	265.47

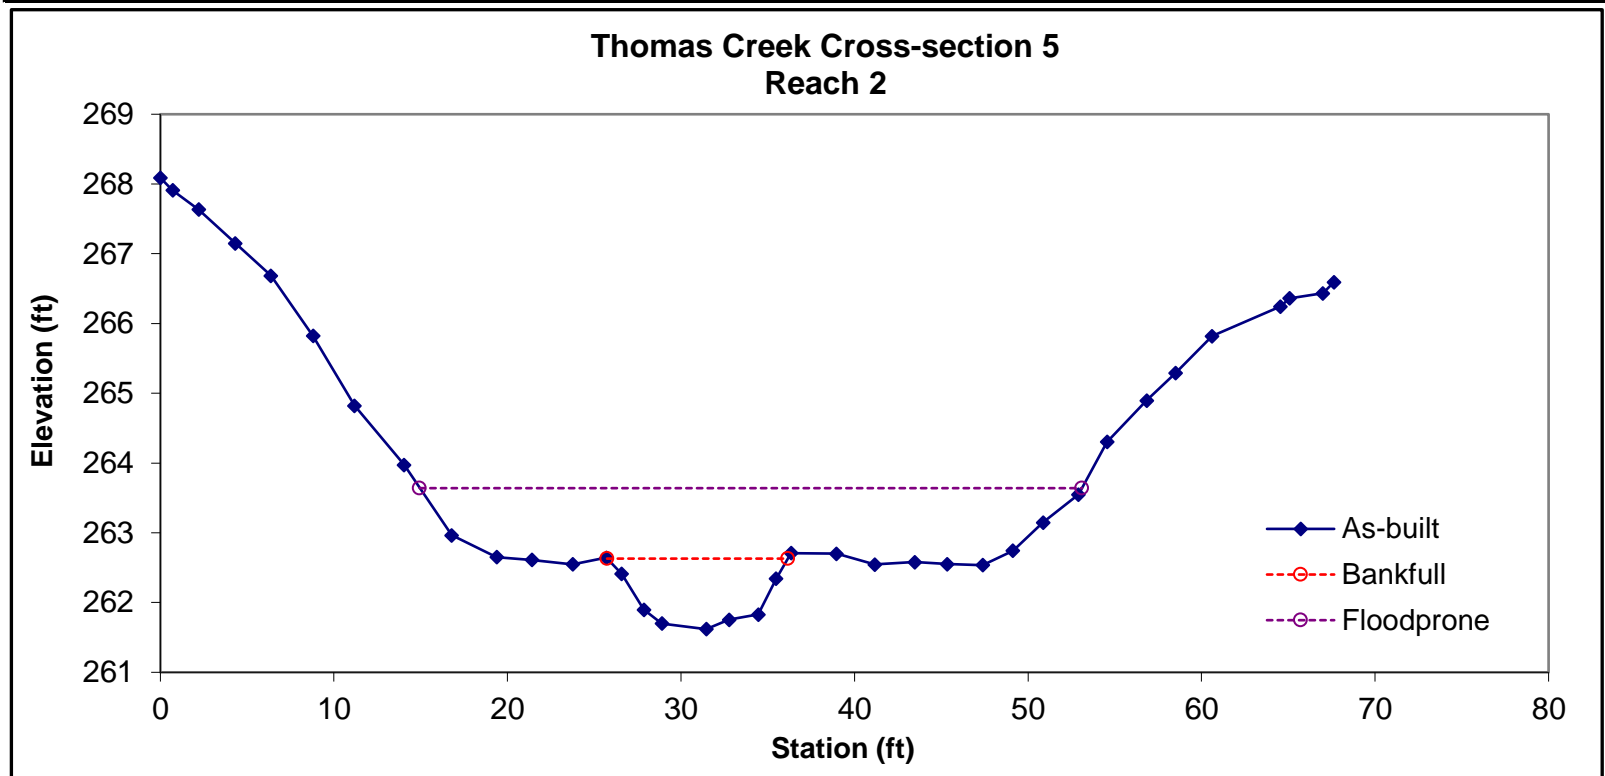
Permanent Cross-section 5
(As-Built Data - Collected Oct/Nov 2015)

Feature	Stream Type	BKF Area	BKF Width	BKF Depth	Max BKF Depth	W/D	BH Ratio	ER	BKF Elev	TOB Elev
Riffle	C	7.4	10.42	0.71	1.01	14.77	1	3.7	262.63	262.64

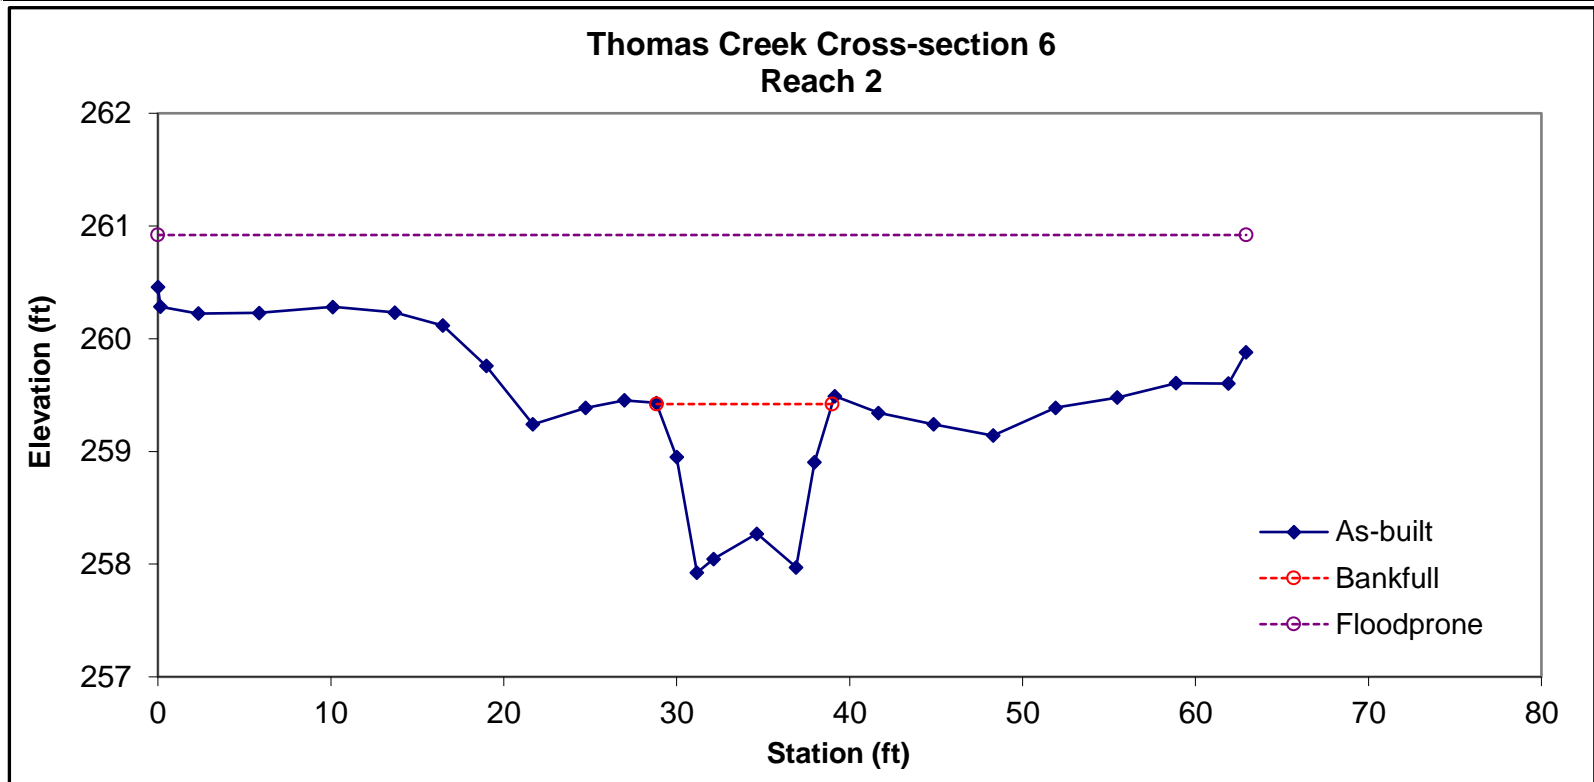
Permanent Cross-section 6
(As-Built Data - Collected Oct/Nov 2015)

Feature	Stream Type	BKF Area	BKF Width	BKF Depth	Max BKF Depth	W/D	BH Ratio	ER	BKF Elev	TOB Elev
Riffle	C	10.2	10.15	1.01	1.5	10.08	1	6.2	259.42	259.43

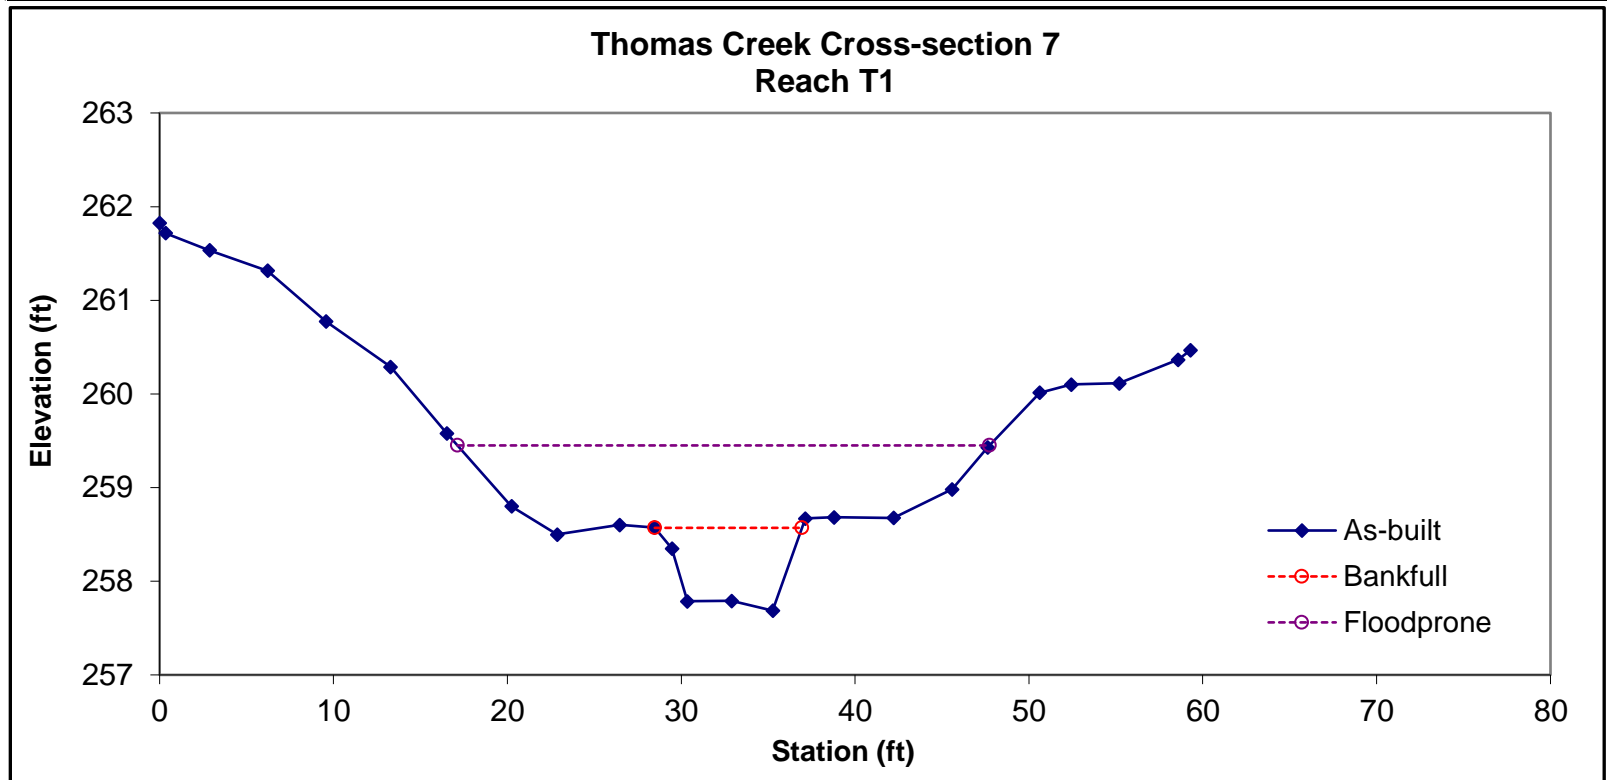
Permanent Cross-section 7
(As-Built Data - Collected Oct/Nov 2015)

Feature	Stream Type	BKF Area	BKF Width	BKF Depth	Max BKF Depth	W/D	BH Ratio	ER	BKF Elev	TOB Elev
Riffle	C	5.3	8.46	0.62	0.88	13.64	1	3.6	258.57	258.57

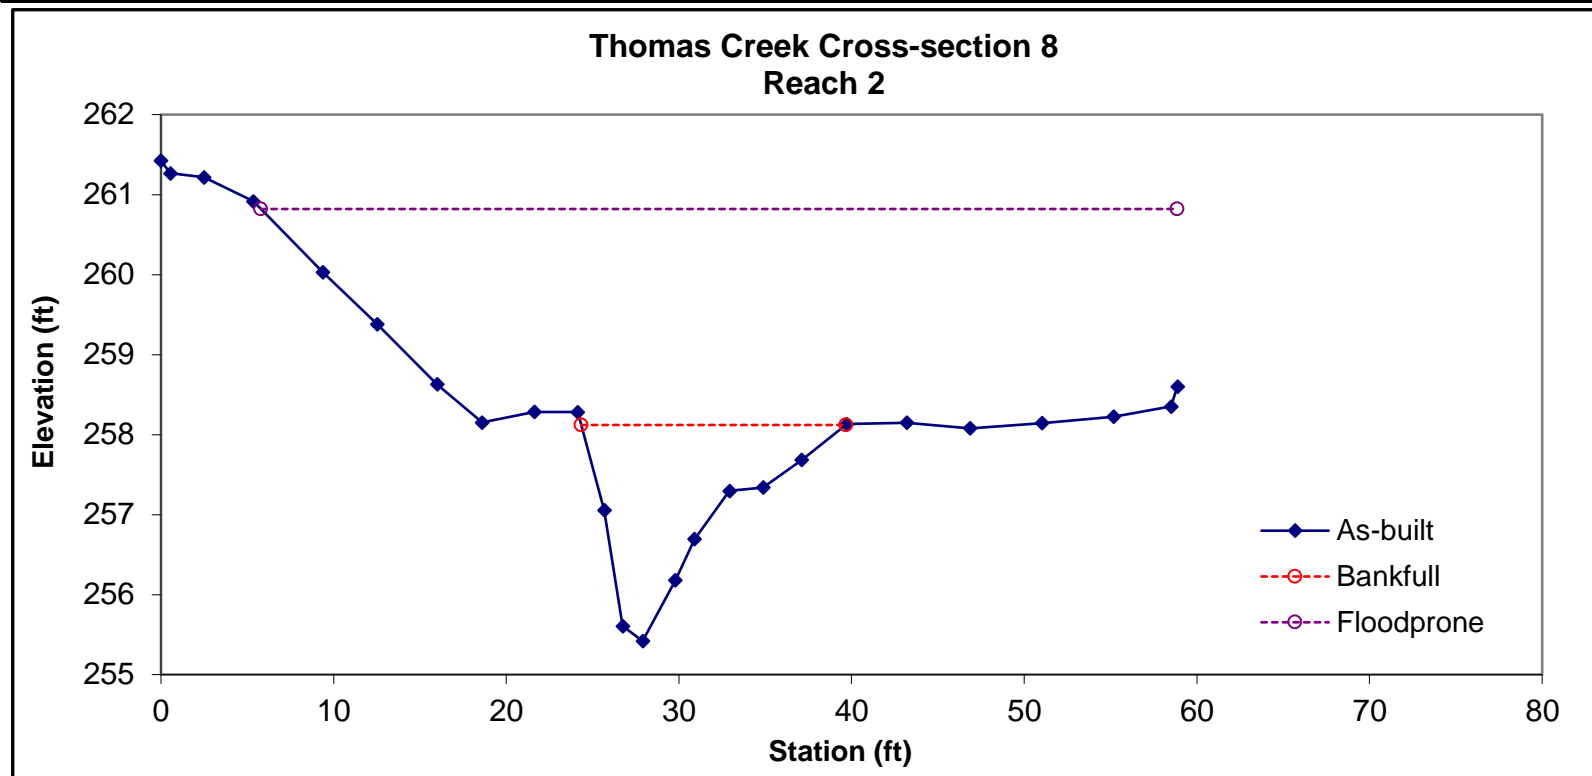
Permanent Cross-section 8
(As-Built Data - Collected Oct/Nov 2015)

Feature	Stream Type	BKF Area	BKF Width	BKF Depth	Max BKF Depth	W/D	BH Ratio	ER	BKF Elev	TOB Elev
Pool		17.6	15.33	1.15	2.7	13.32	1	3.5	258.12	258.13

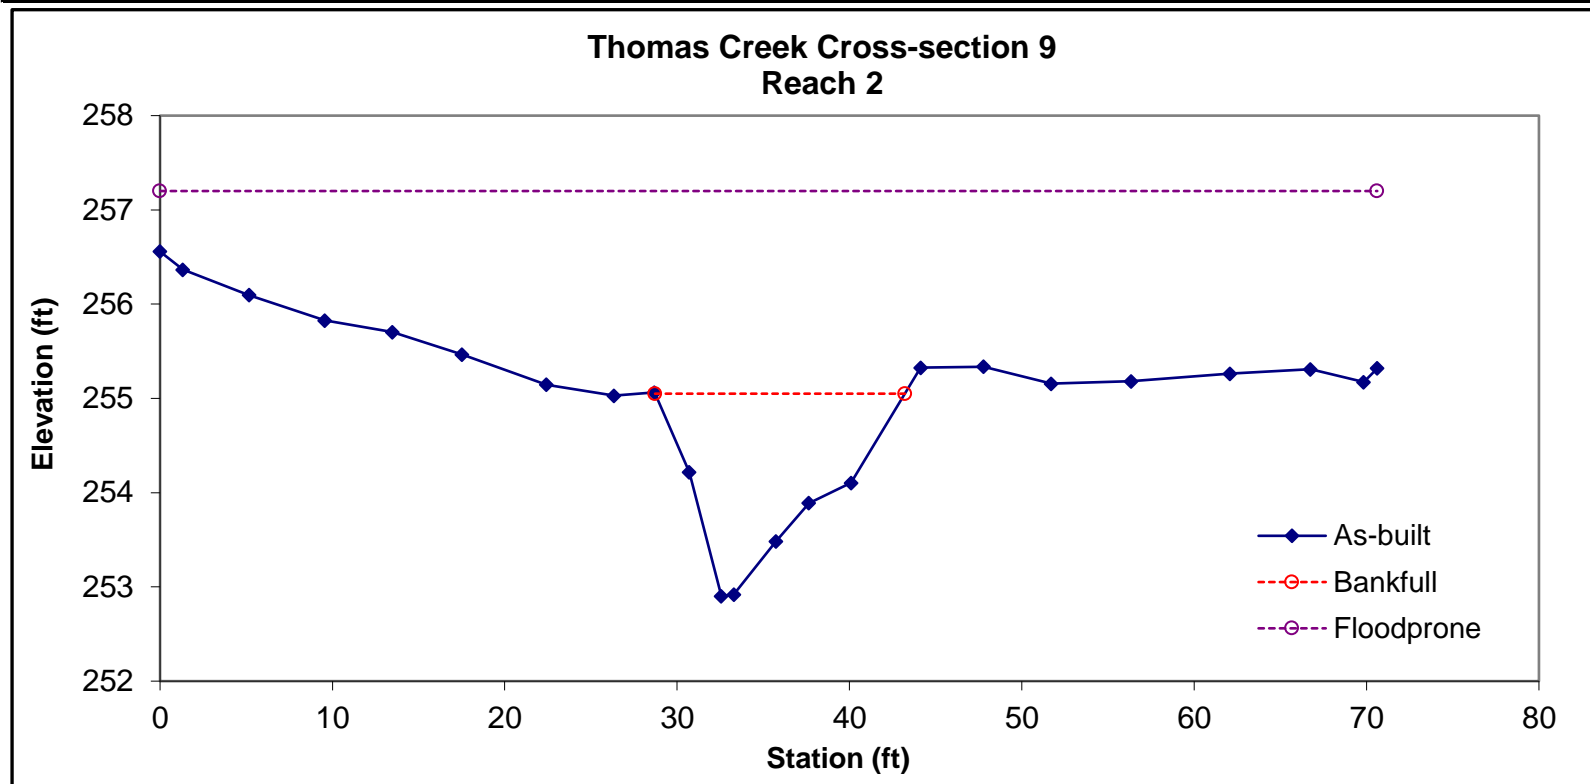
Permanent Cross-section 9
(As-Built Data - Collected Oct/Nov 2015)

Feature	Stream Type	BKF Area	BKF Width	BKF Depth	Max BKF Depth	W/D	BH Ratio	ER	BKF Elev	TOB Elev
Pool		16.3	14.5	1.13	2.15	12.87	1	4.9	255.05	255.06

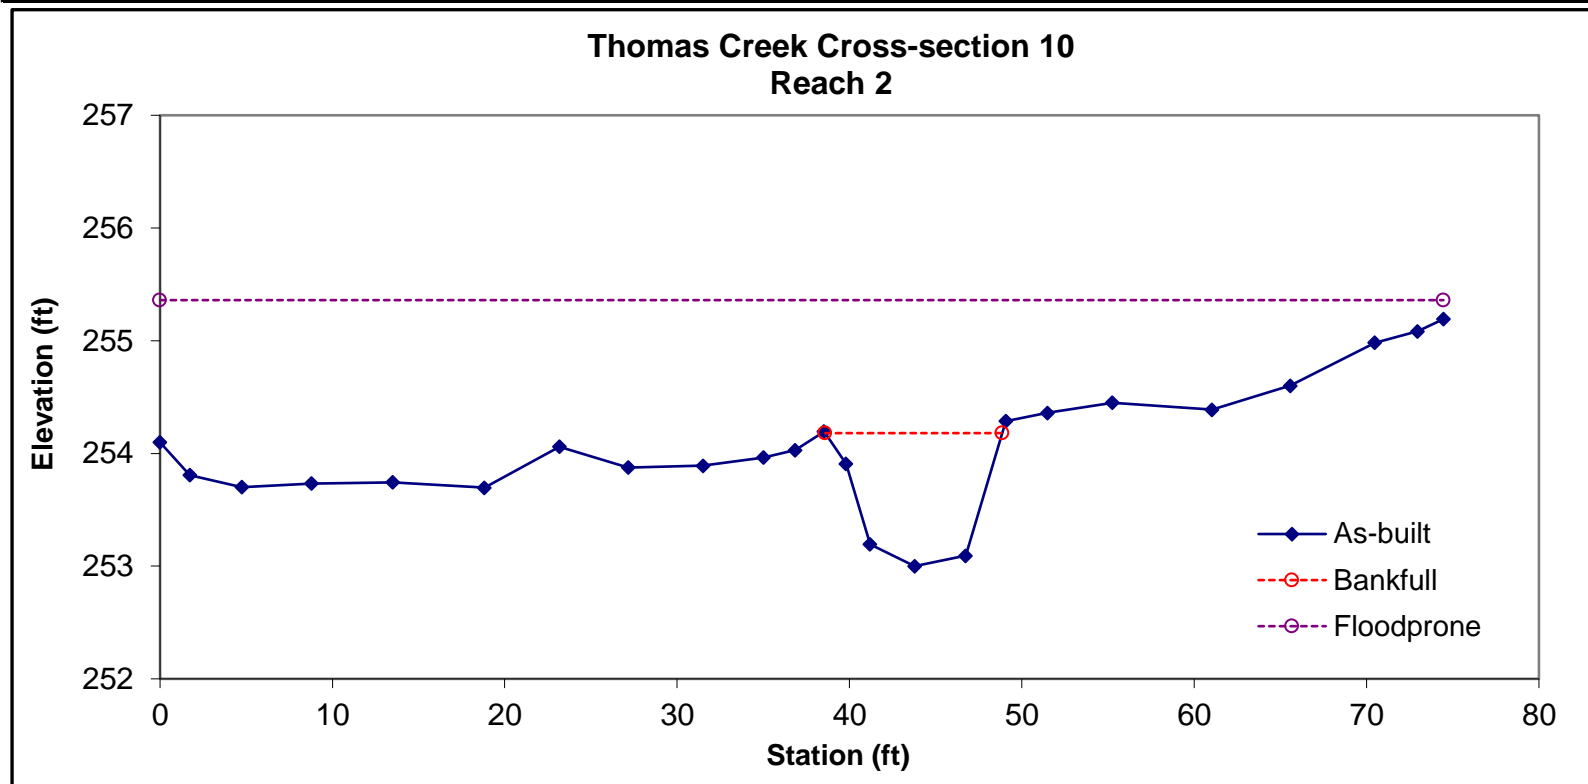
Feature	Stream Type	BKF Area	BKF Width	BKF Depth	Max BKF Depth	W/D	BH Ratio	ER	BKF Elev	TOB Elev
Riffle	C	8.4	10.27	0.81	1.18	12.64	1	7.2	254.18	254.19

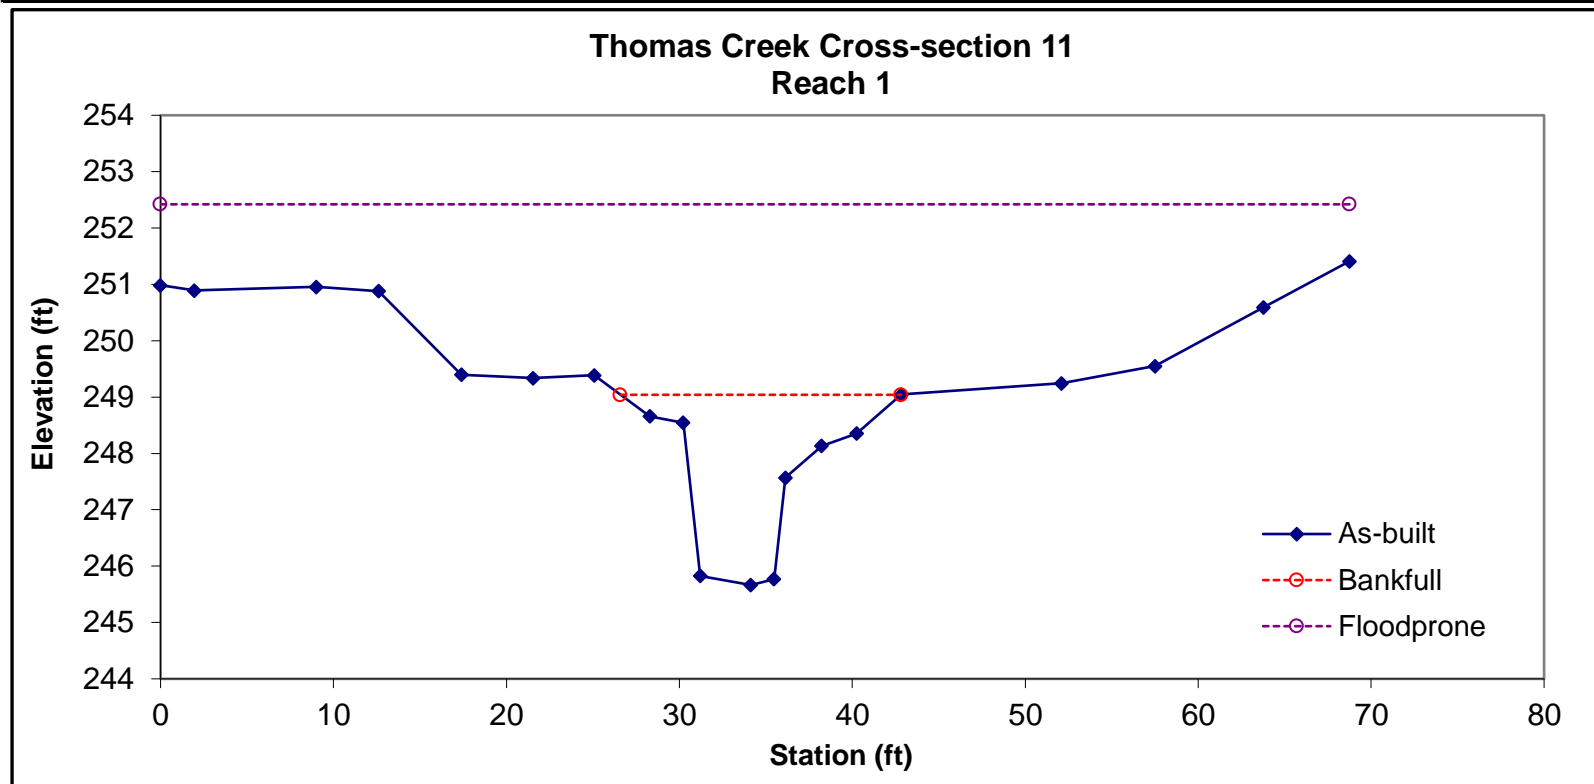
Permanent Cross-section 11
(As-Built Data - Collected Oct/Nov 2015)

Feature	Stream Type	BKF Area	BKF Width	BKF Depth	Max BKF Depth	W/D	BH Ratio	ER	BKF Elev	TOB Elev
Pool		23.7	16.24	1.46	3.38	11.14	1	4.2	249.04	249.04

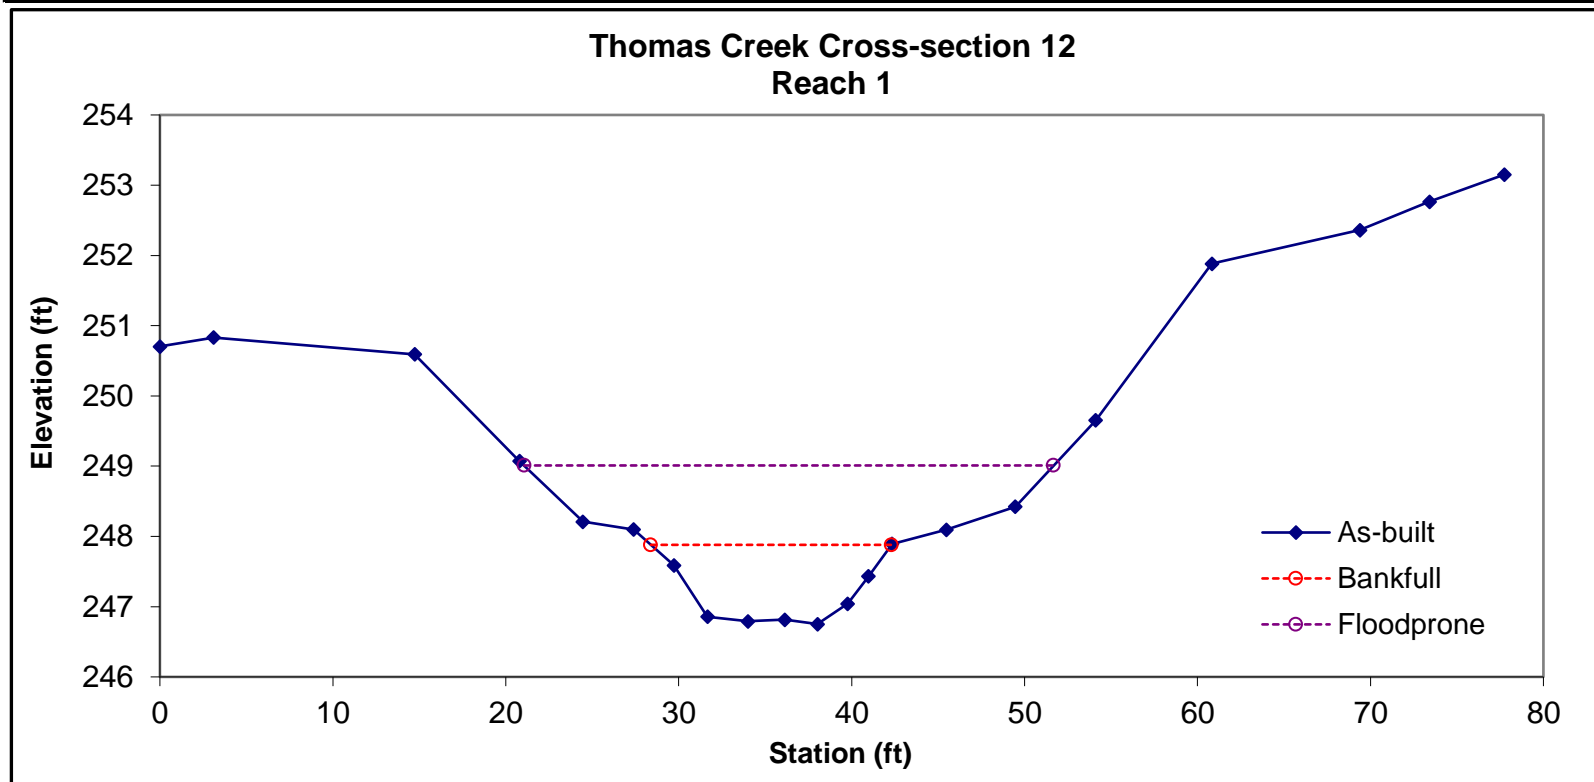
Permanent Cross-section 12
(As-Built Data - Collected Oct/Nov 2015)

Feature	Stream Type	BKF Area	BKF Width	BKF Depth	Max BKF Depth	W/D	BH Ratio	ER	BKF Elev	TOB Elev
Riffle	C	11.1	13.91	0.8	1.13	17.43	1	2.2	247.88	247.89

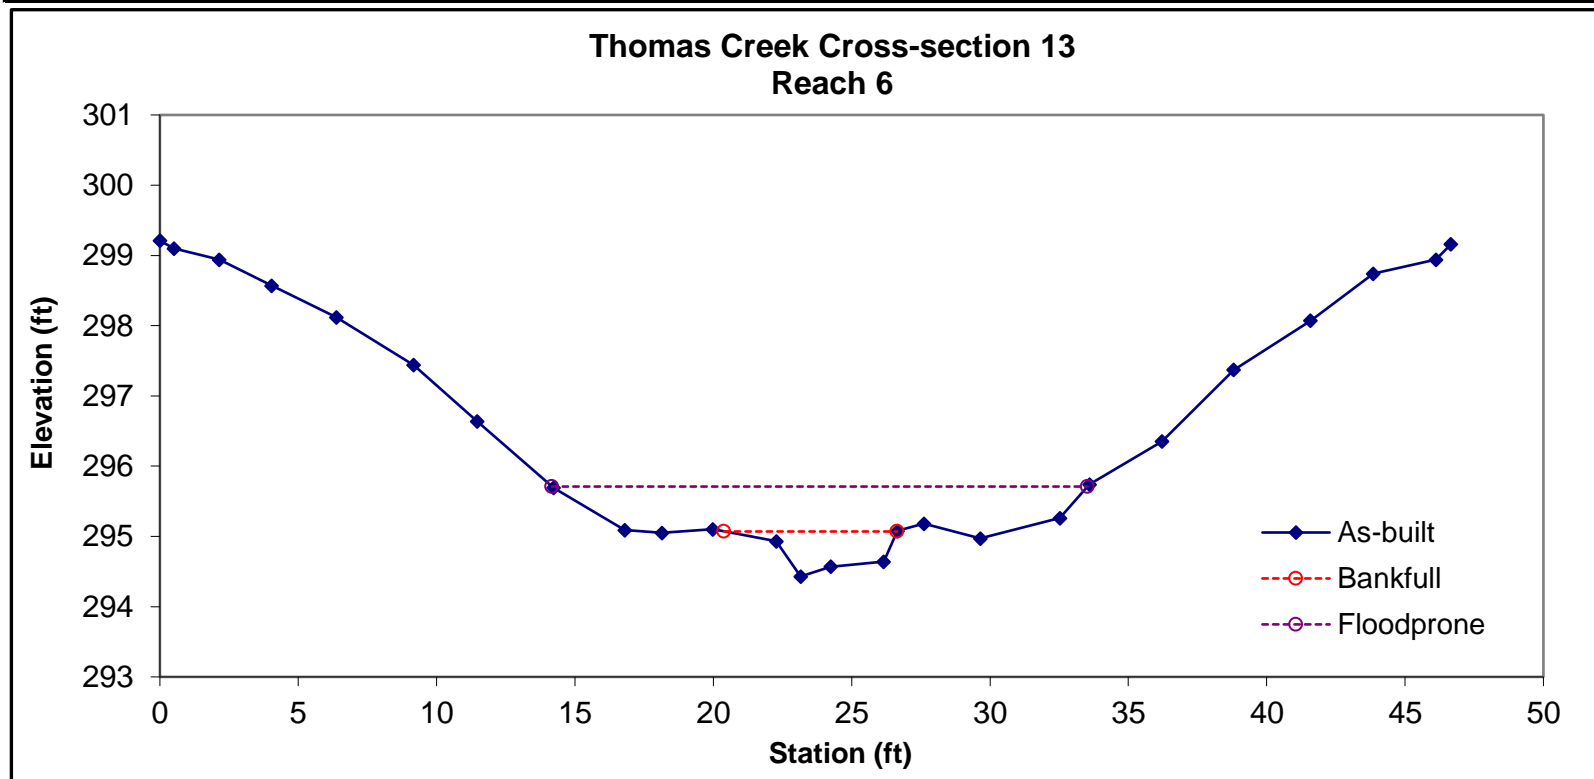
Permanent Cross-section 13
(As-Built Data - Collected Oct/Nov 2015)

Feature	Stream Type	BKF Area	BKF Width	BKF Depth	Max BKF Depth	W/D	BH Ratio	ER	BKF Elev	TOB Elev
Riffle	C	2.1	6.26	0.33	0.64	18.72	1	3.1	295.07	295.08

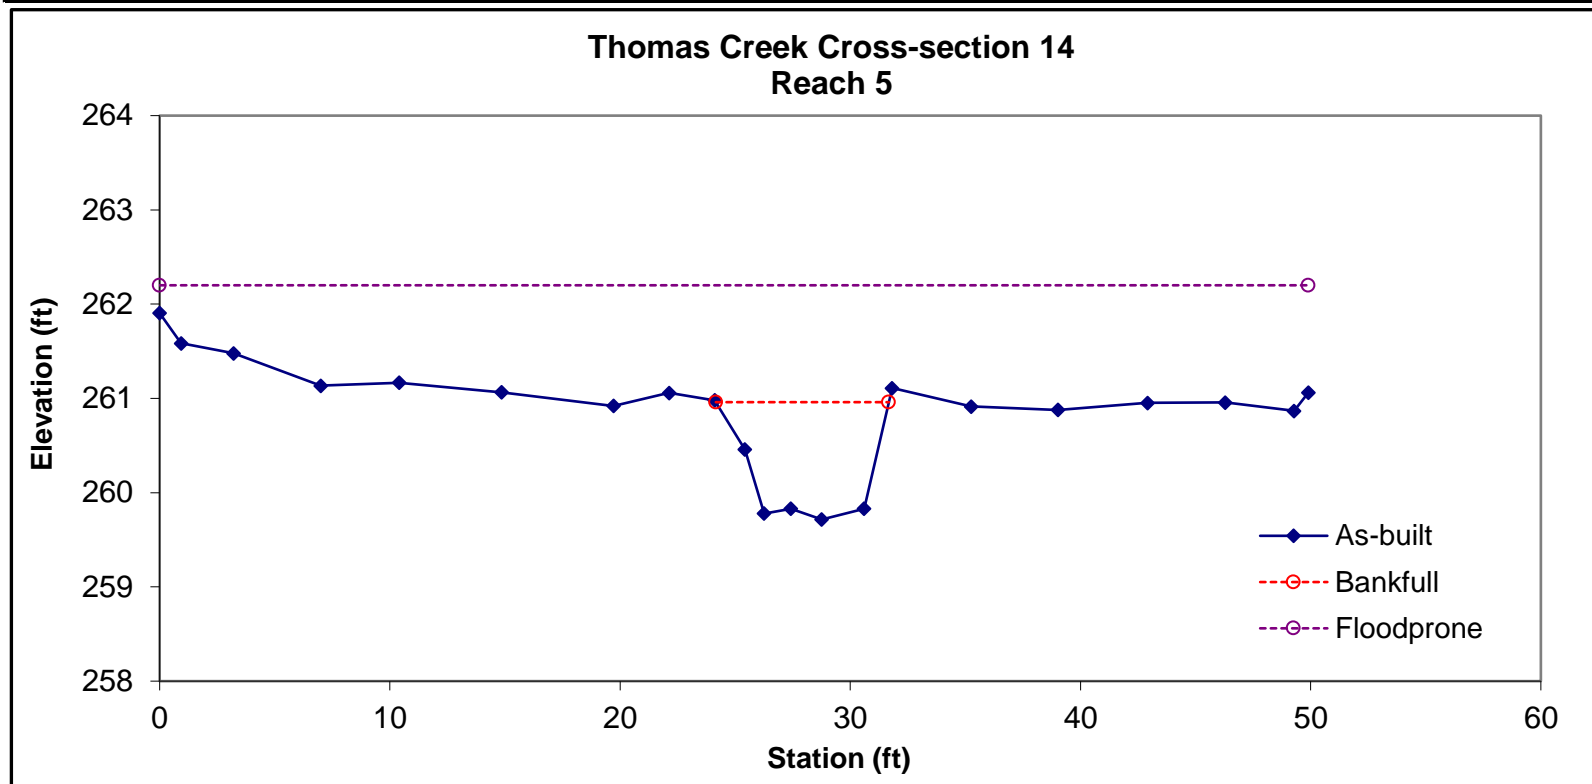
Permanent Cross-section 14
(As-Built Data - Collected Oct/Nov 2015)

Feature	Stream Type	BKF Area	BKF Width	BKF Depth	Max BKF Depth	W/D	BH Ratio	ER	BKF Elev	TOB Elev
Riffle	E	6.8	7.52	0.9	1.24	8.38	1	6.6	260.96	260.98

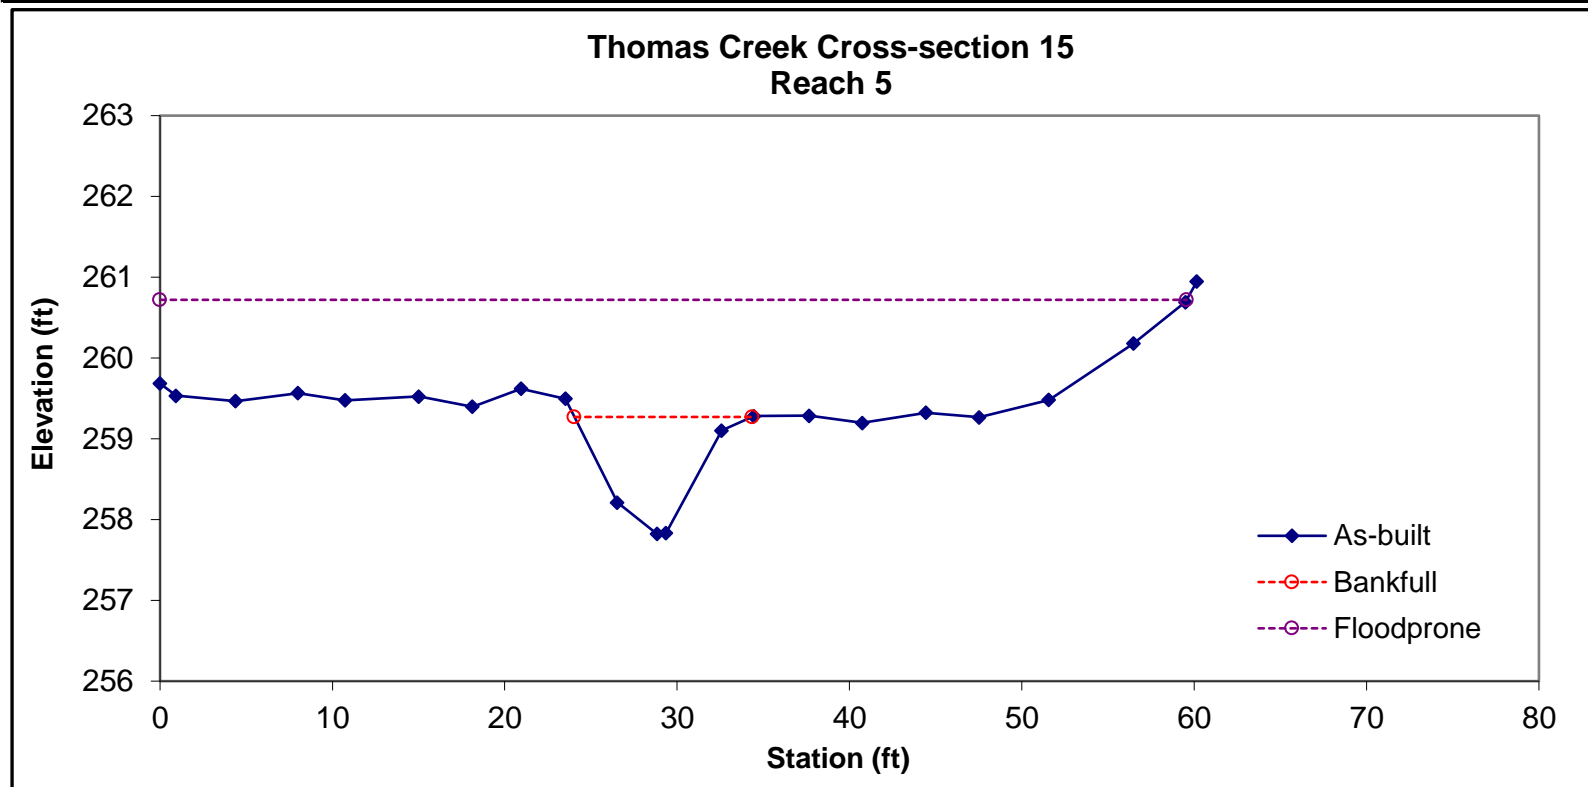
Permanent Cross-section 15
(As-Built Data - Collected Oct/Nov 2015)

Feature	Stream Type	BKF Area	BKF Width	BKF Depth	Max BKF Depth	W/D	BH Ratio	ER	BKF Elev	TOB Elev
Pool		7.7	10.3	0.75	1.45	13.81	1	5.8	259.27	259.28
