FINAL
Baseline Monitoring Document and As-Built Baseline Report
Thomas Creek Restoration Project

Wake County, North Carolina

DMS Project ID No. 96074, DEQ Contract No. 5549

Submission Date: October 2016

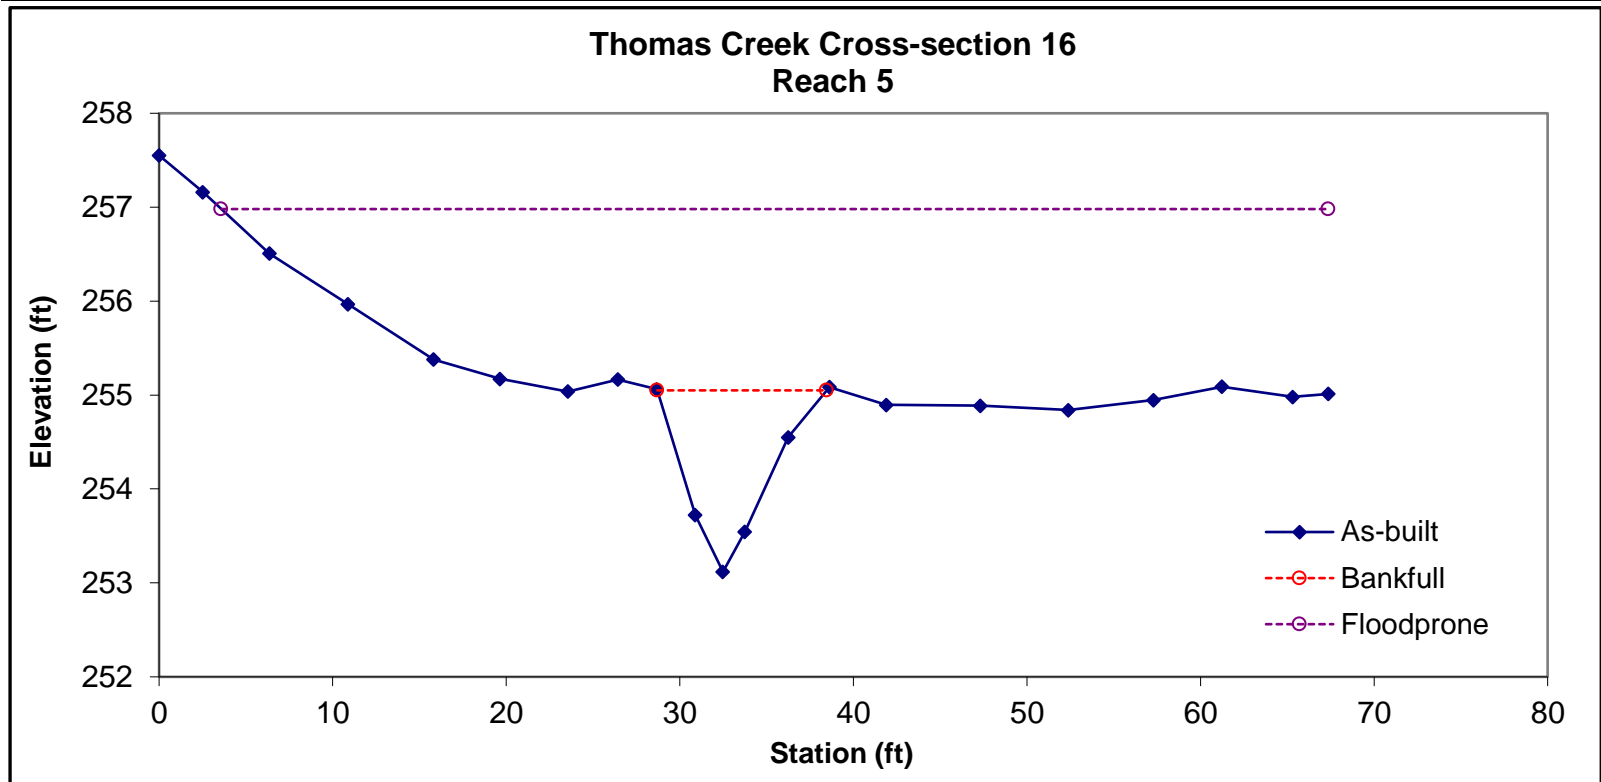
Permanent Cross-section 16
(As-Built Data - Collected Oct/Nov 2015)

Feature	Stream Type	BKF Area	BKF Width	BKF Depth	Max BKF Depth	W/D	BH Ratio	ER	BKF Elev	TOB Elev
Pool		7.3	9.34	0.78	1.29	11.9	1	5.9	271.44	271.45

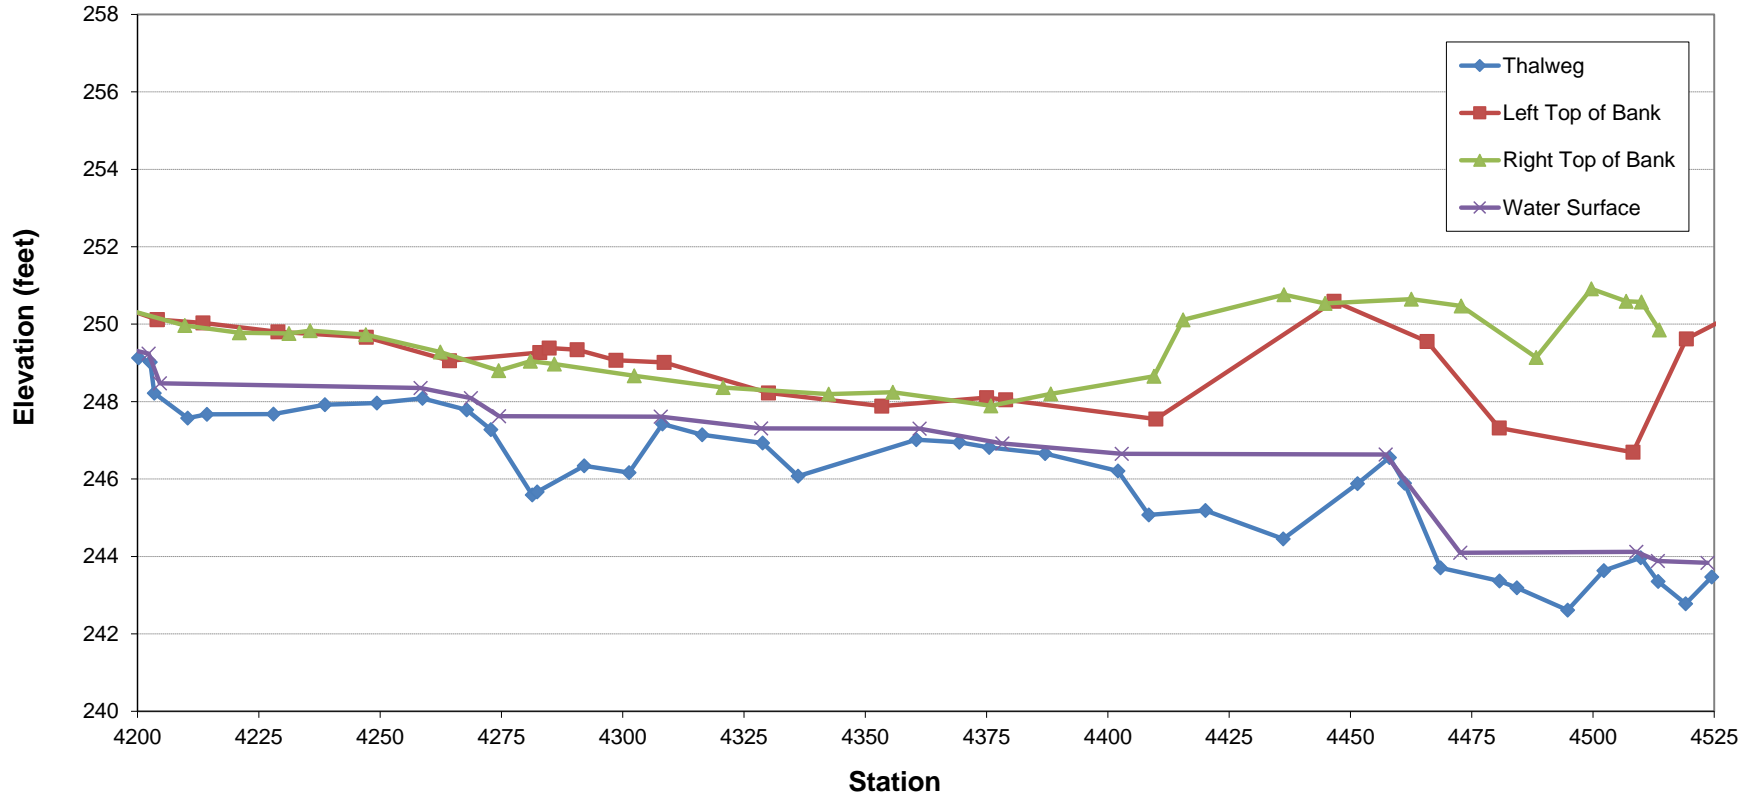
Thomas Creek - Reach 1
As-built Station 42+00 to 45+25
(Data Collected December 2015)

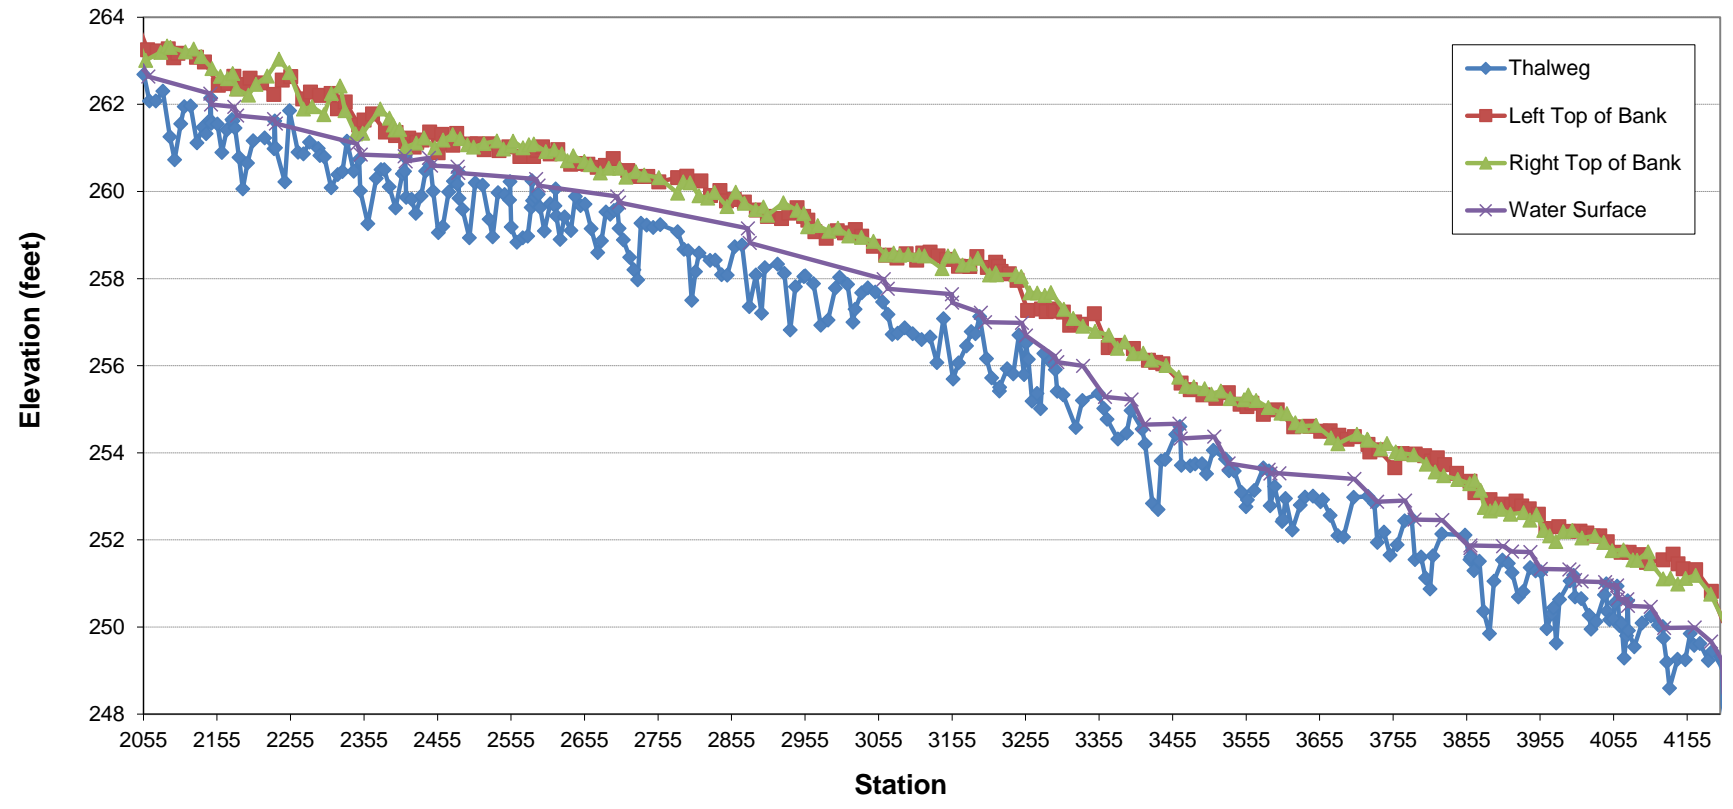
Thomas Creek - Reach 2
As-built Station 20+55 to 42+00
(Data Collected December 2015)

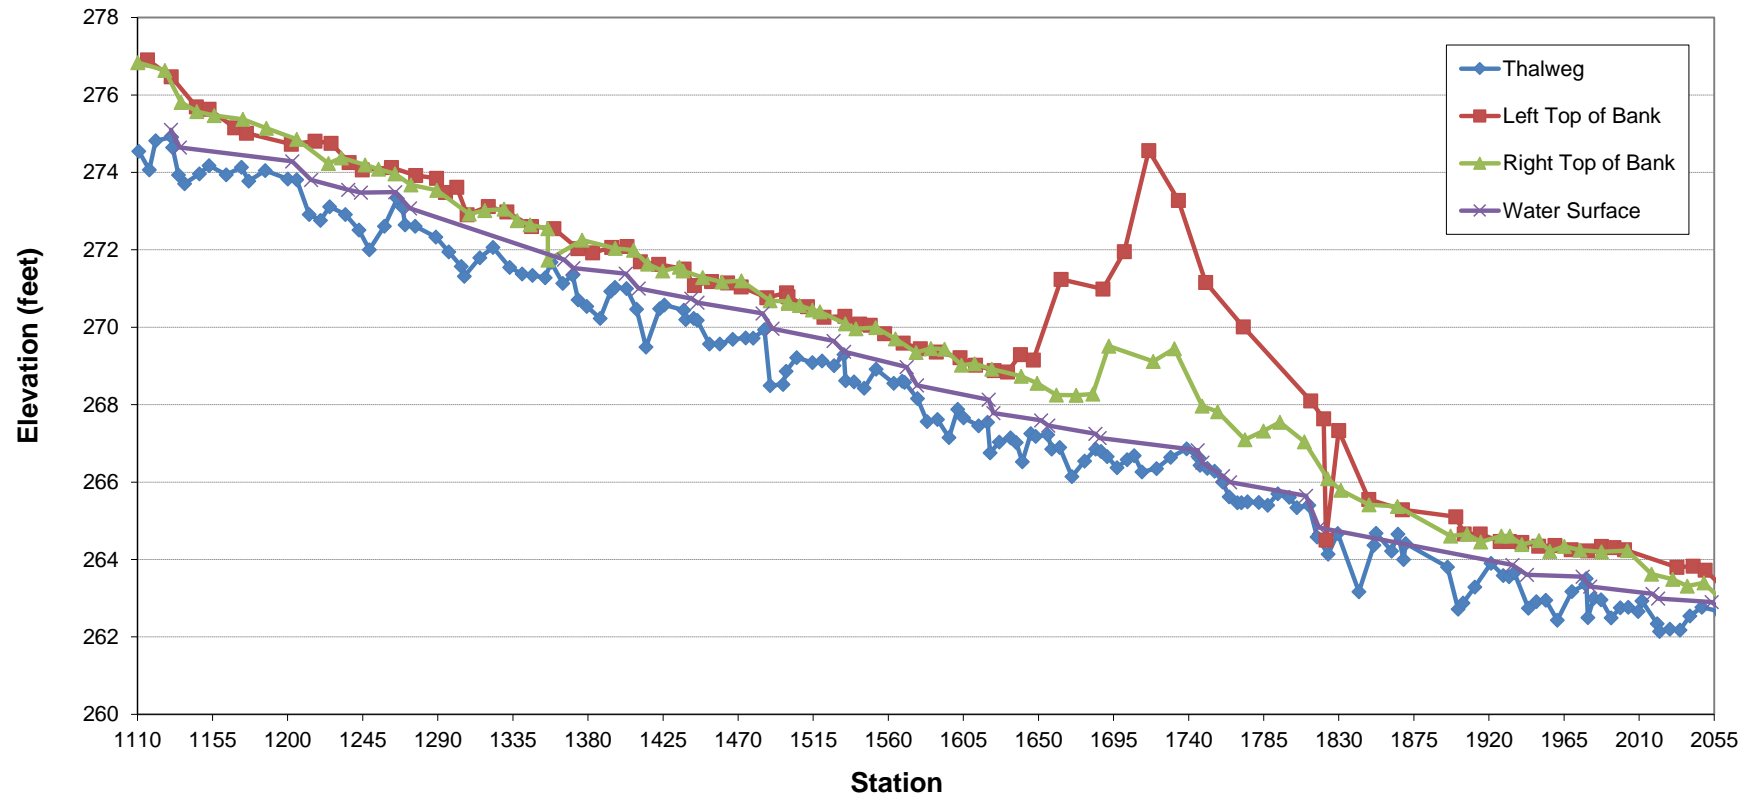
Thomas Creek - Reach 3
As-built Station 11+10 to 20+55
(Data Collected Oct/Nov 2015)

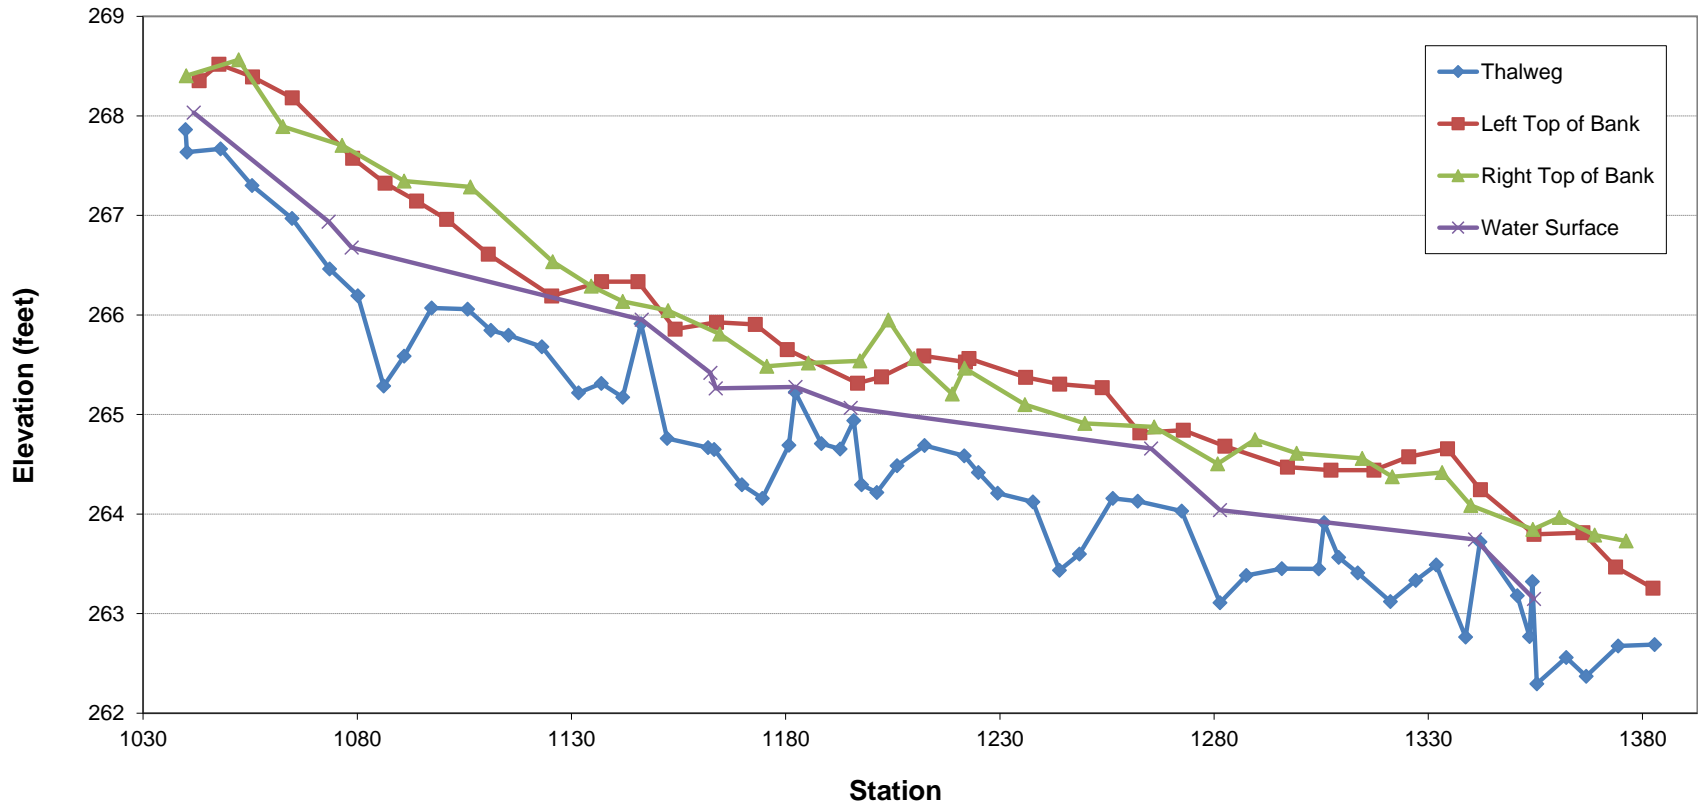
Thomas Creek - Reach 4
As-built Station 10+39 to 13+83
(Data Collected - Oct/Nov 2015)

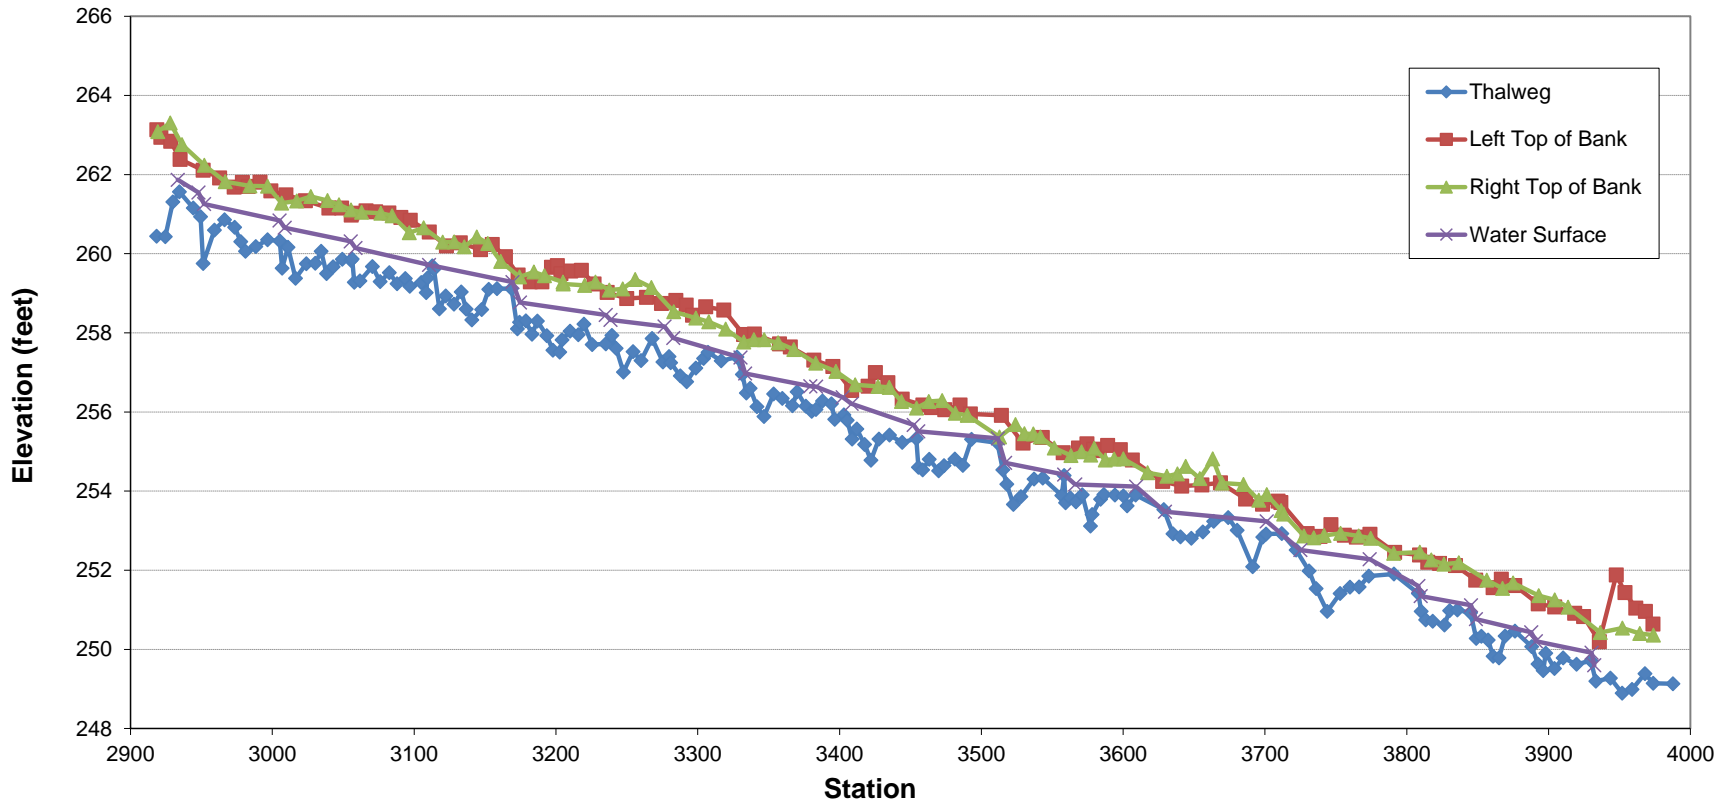
Thomas Creek - Reach 5
As-built Station 29+18 to 39+88
(Data Collected - Oct/Nov 2015)

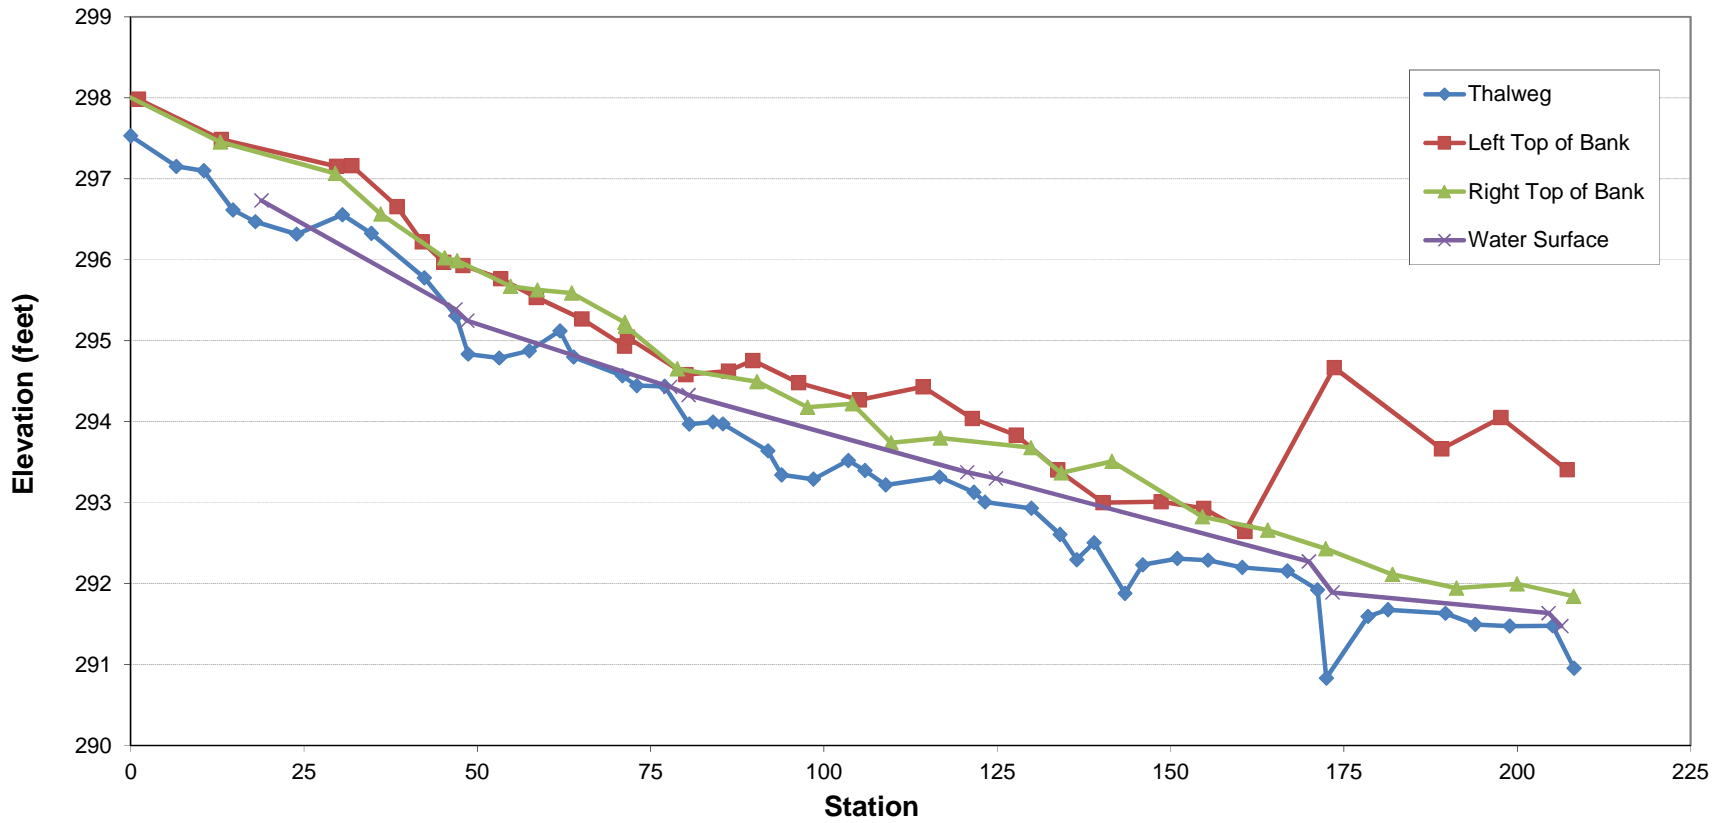
Thomas Creek - Reach 6
As-built Station 10+00 to 12+08
(Data Collected - Oct/Nov 2015)

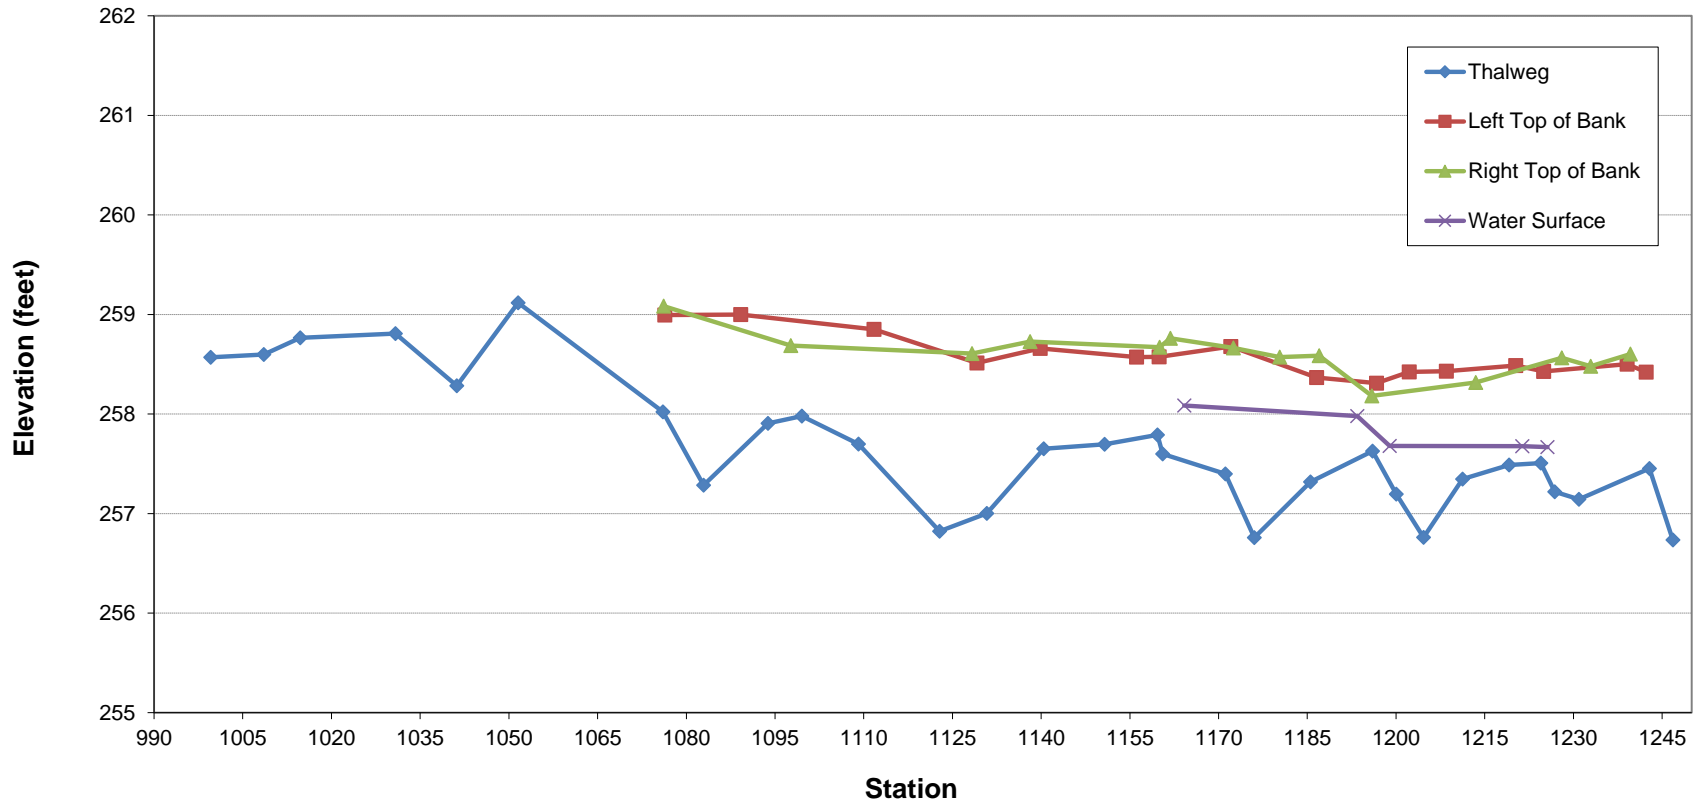
Thomas Creek - T1
As-built Station 10+00 to 12+47
(Data Collected - Oct/Nov 2015)

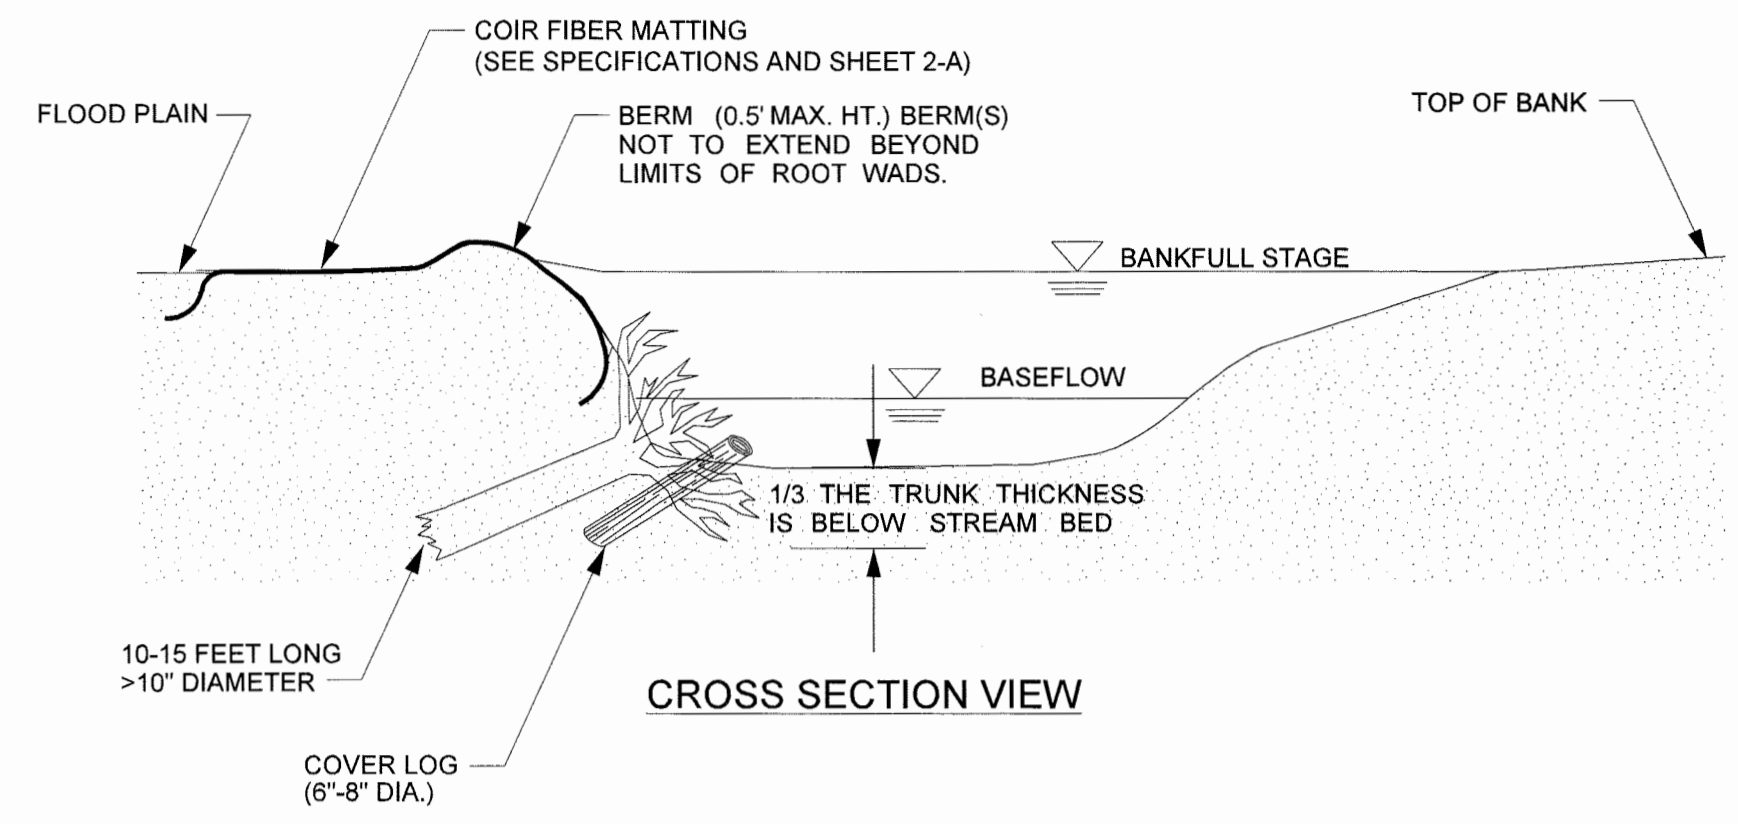
ROOT WADS WITHOUT TRANSPLANTS
USE IF TRANSPLANTS ARE NOT AVAILABLE ON-SITE

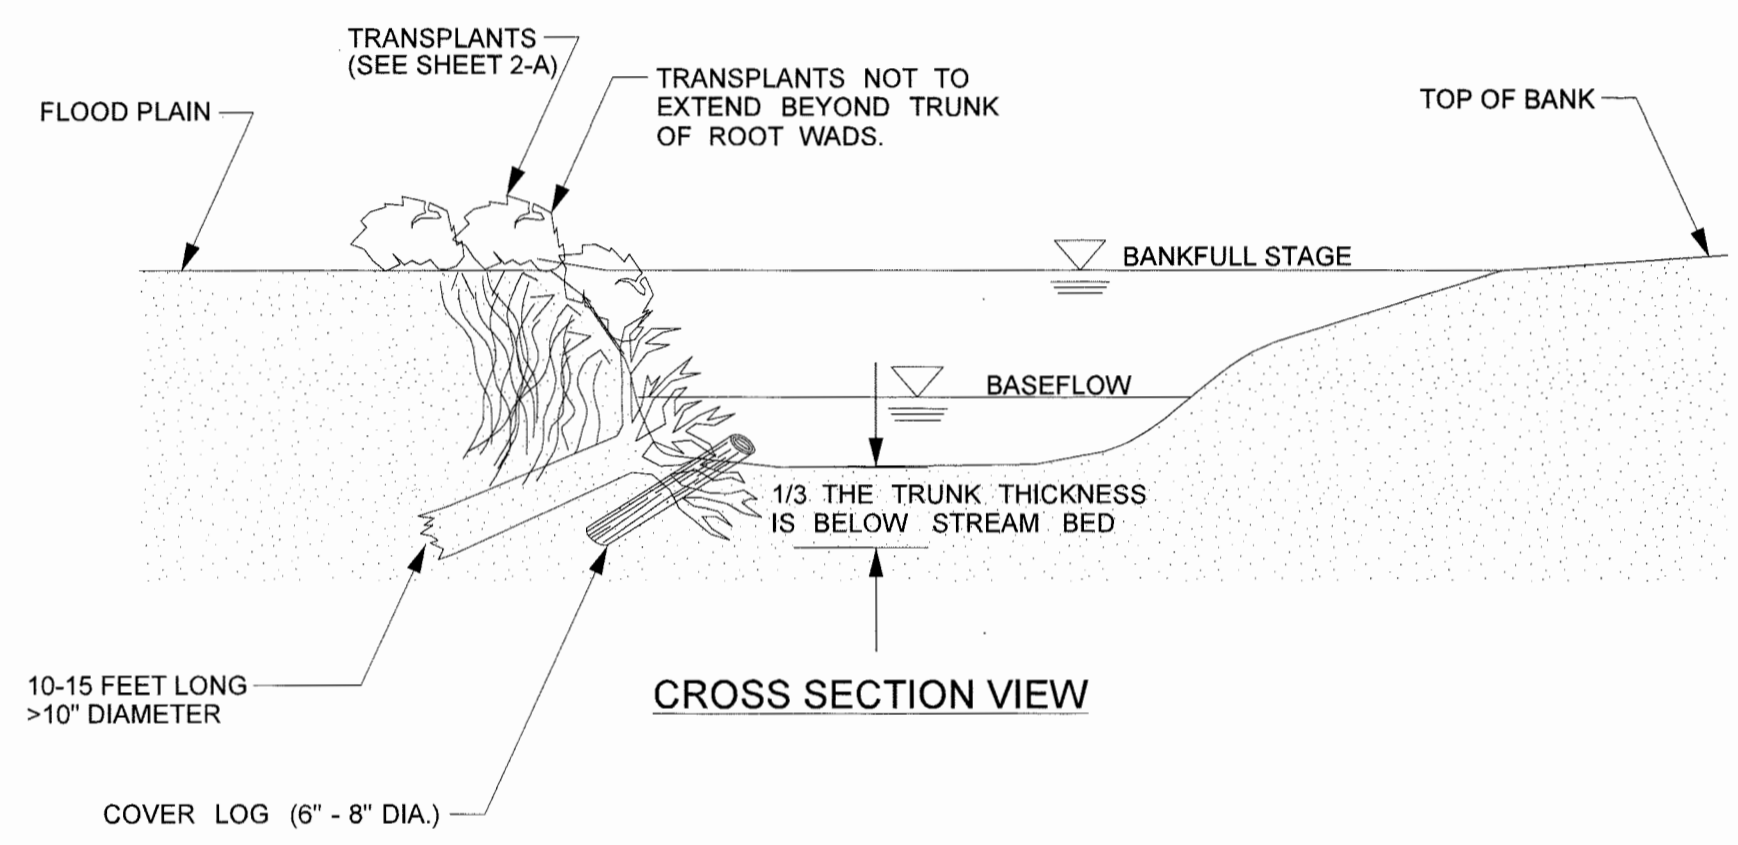
ROOT WADS WITH TRANSPLANTS
USE IF TRANSPLANTS ARE AVAILABLE ON-SITE

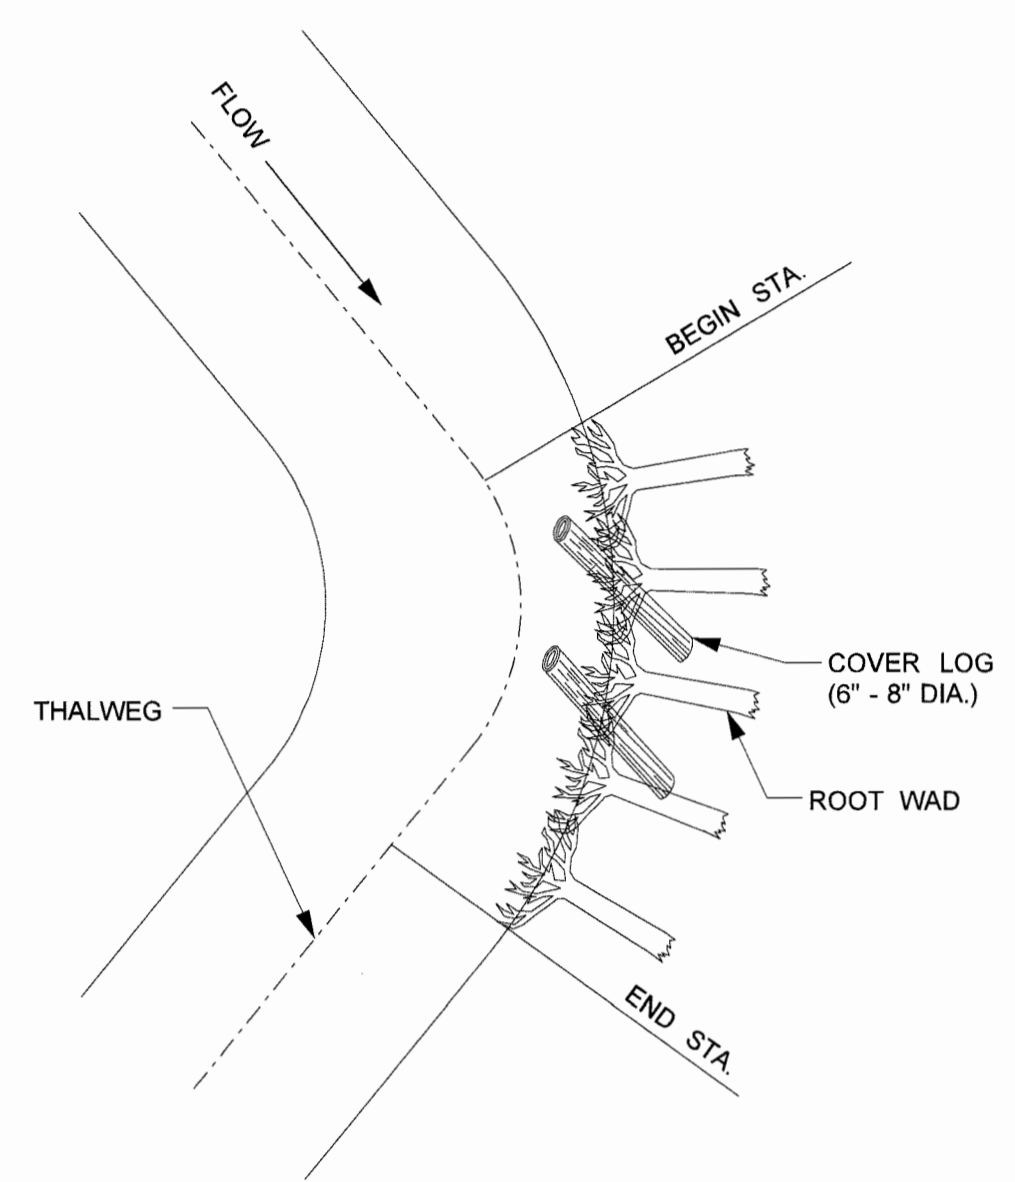
PLAN VIEW

- NOTES:**
1. INSTALLATION USING THE TRENCHING METHOD REQUIRES THAT A TRENCH BE EXCAVATED FOR THE LOG PORTION OF THE ROOT WAD. ONE-THIRD OF THE ROOT WAD SHOULD REMAIN BELOW NORMAL BASE FLOW CONDITIONS OR CHANNEL BOTTOM.
 2. THE NUMBER OF ROOTWADS ESTIMATED MAY VARY DEPENDING ON THE ROOTMASS SIZE. IN GENERAL, ROOTWADS SHOULD PROTECT THE OUTER MEANDER BEND AS SHOWN. SEE STRUCTURE TABLE FOR APPROXIMATE STATION AND LOCATION.
 3. INSTALL COVER LOGS BETWEEN ROOTWADS TO PROVIDE HABITAT ONLY WHEN AVAILABLE FROM ON-SITE HARVESTING.

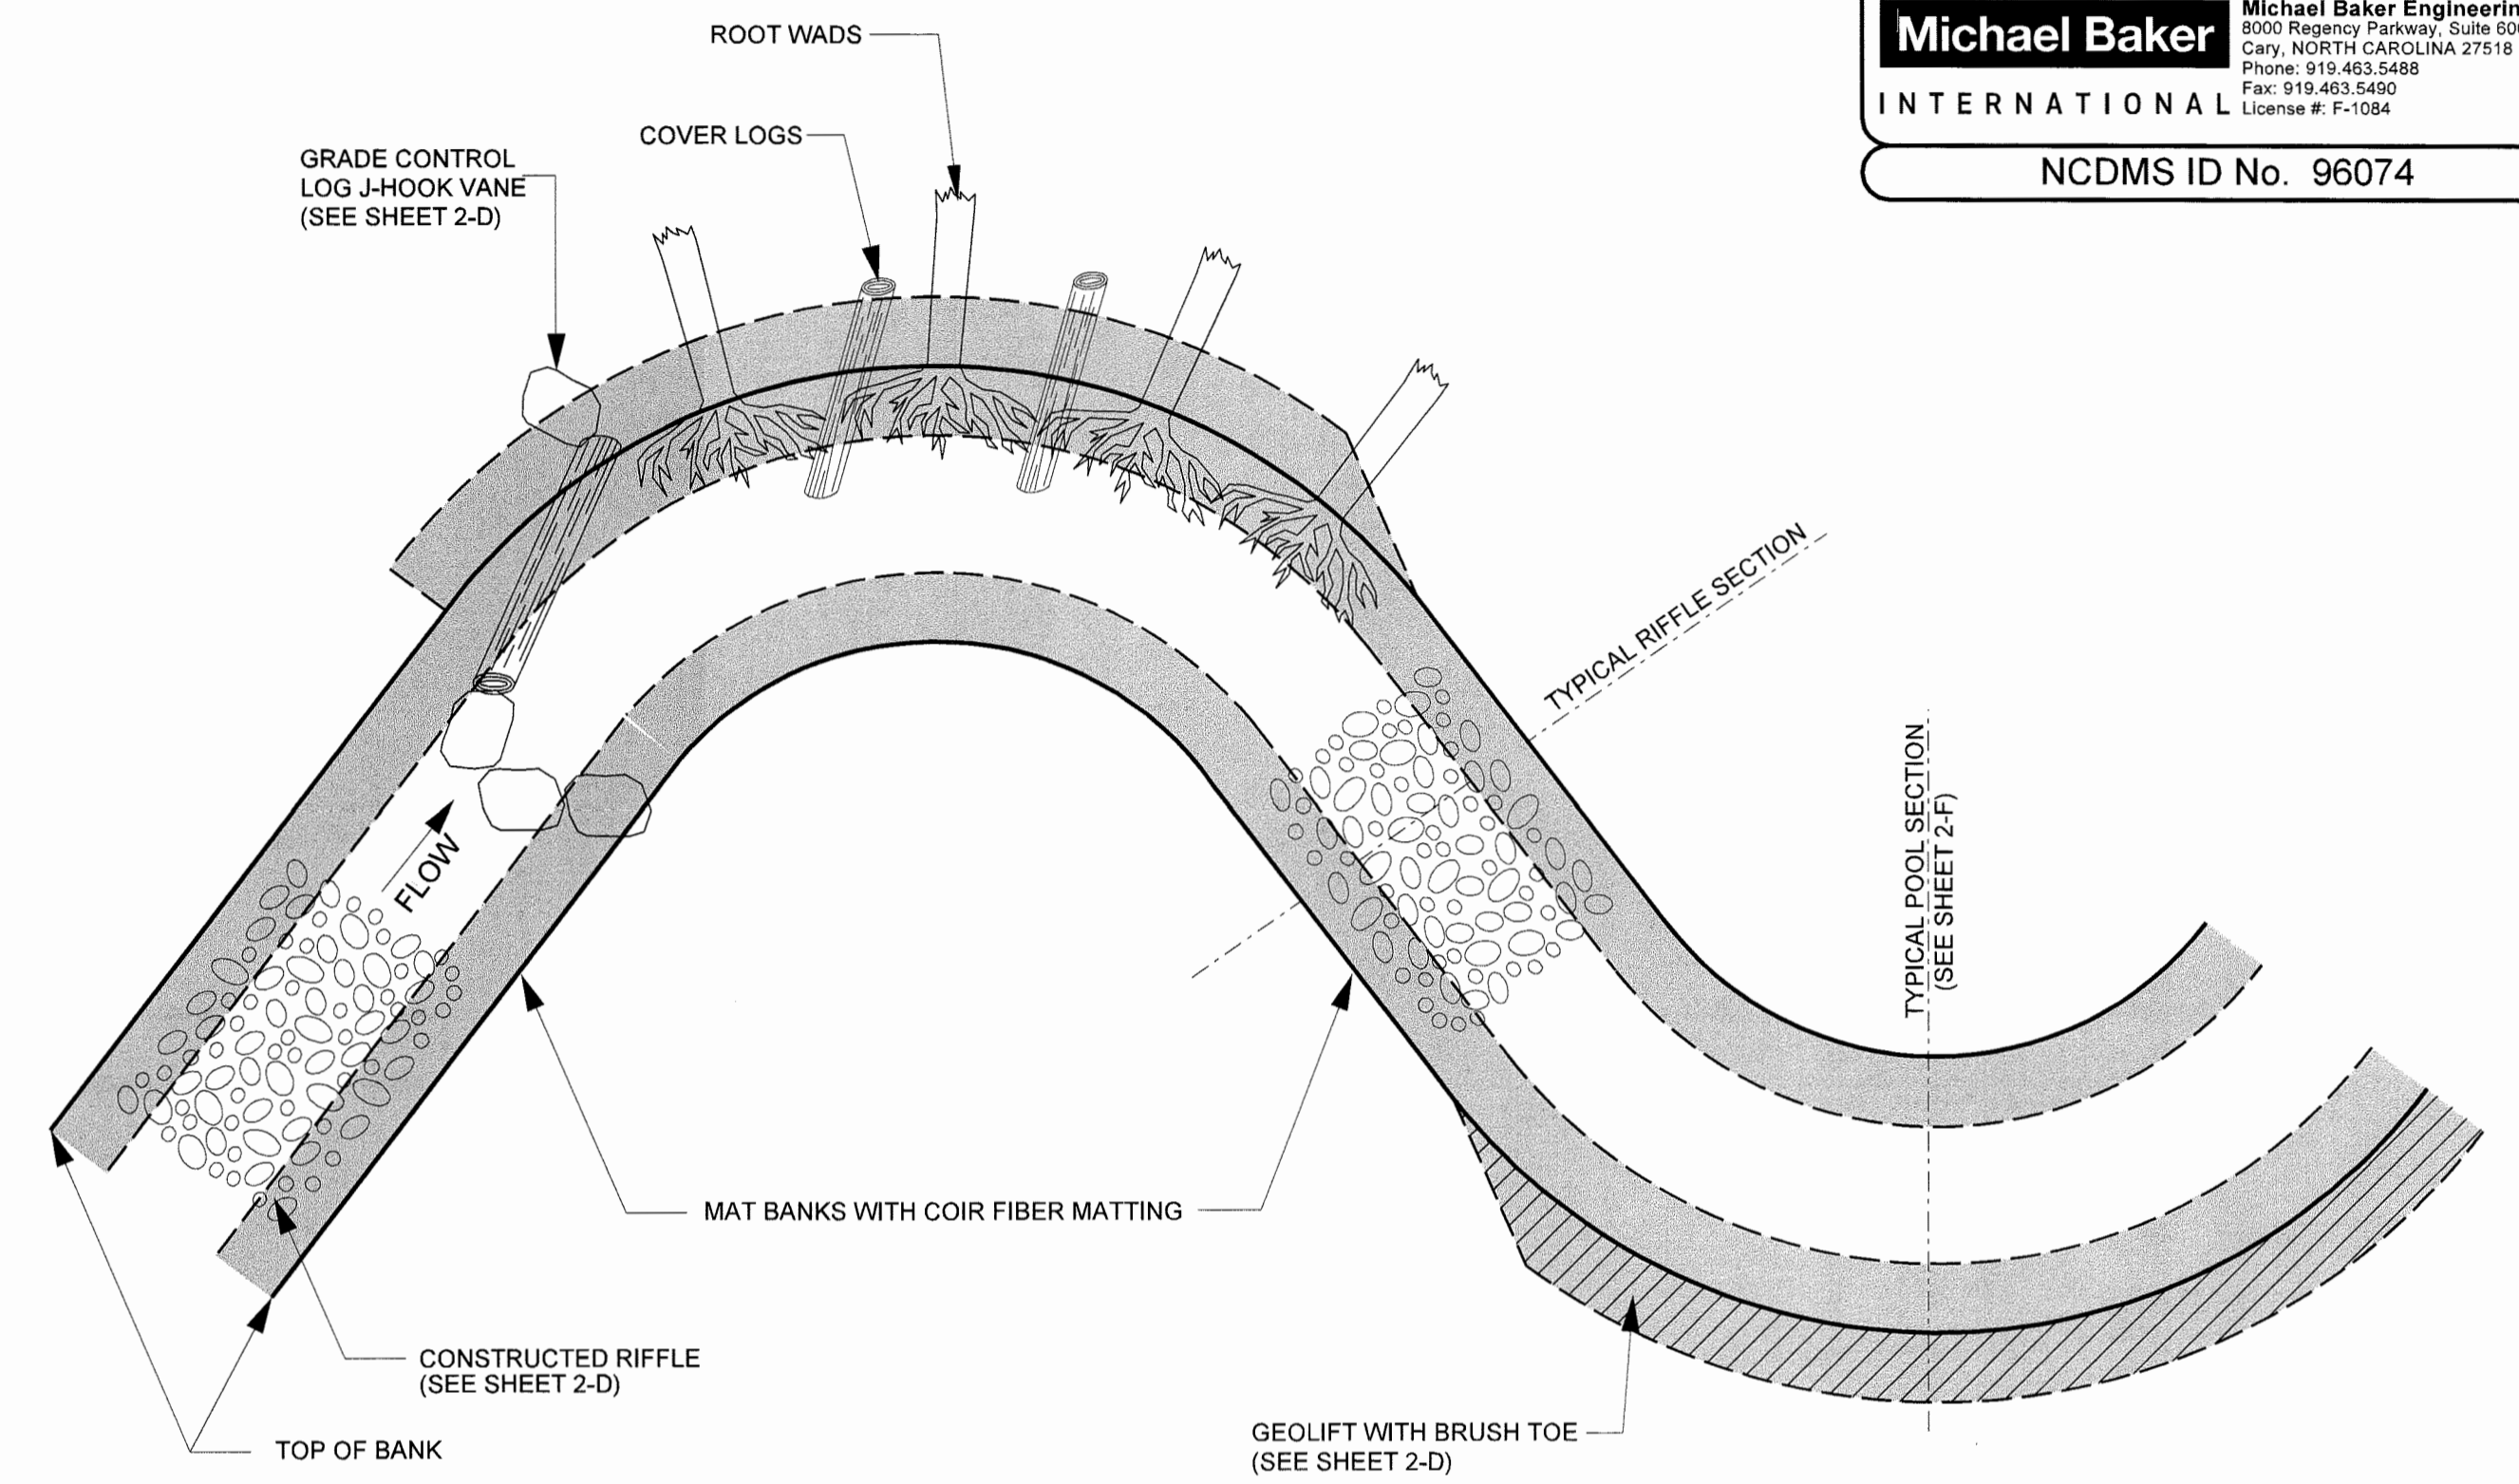
TYPICAL STRUCTURE PLACEMENT

- STRUCTURE NOTES:**
1. GENERALLY CONSTRUCTED RIFFLES, ROOT WADS, LOG VANES AND COIR FIBER MATTING WILL BE INSTALLED IN THE LOCATION AND SEQUENCE AS SHOWN.
 2. ANY CHANGES TO NUMBER OR LOCATION OF STRUCTURES DURING CONSTRUCTION MUST BE APPROVED BY THE DESIGN ENGINEER.
 3. COIR FIBER MATTING TO BE INSTALLED ON ALL RESTORED STREAMBANKS, FLOODPLAIN BENCHING, AND TERRACE SLOPES AS DESCRIBED IN THE TECHNICAL SPECIFICATIONS.

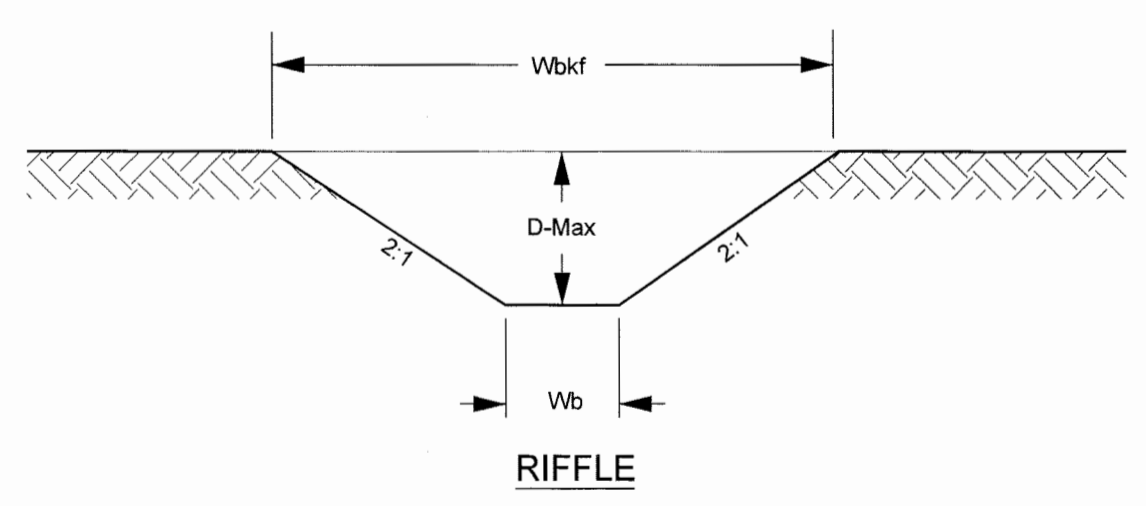
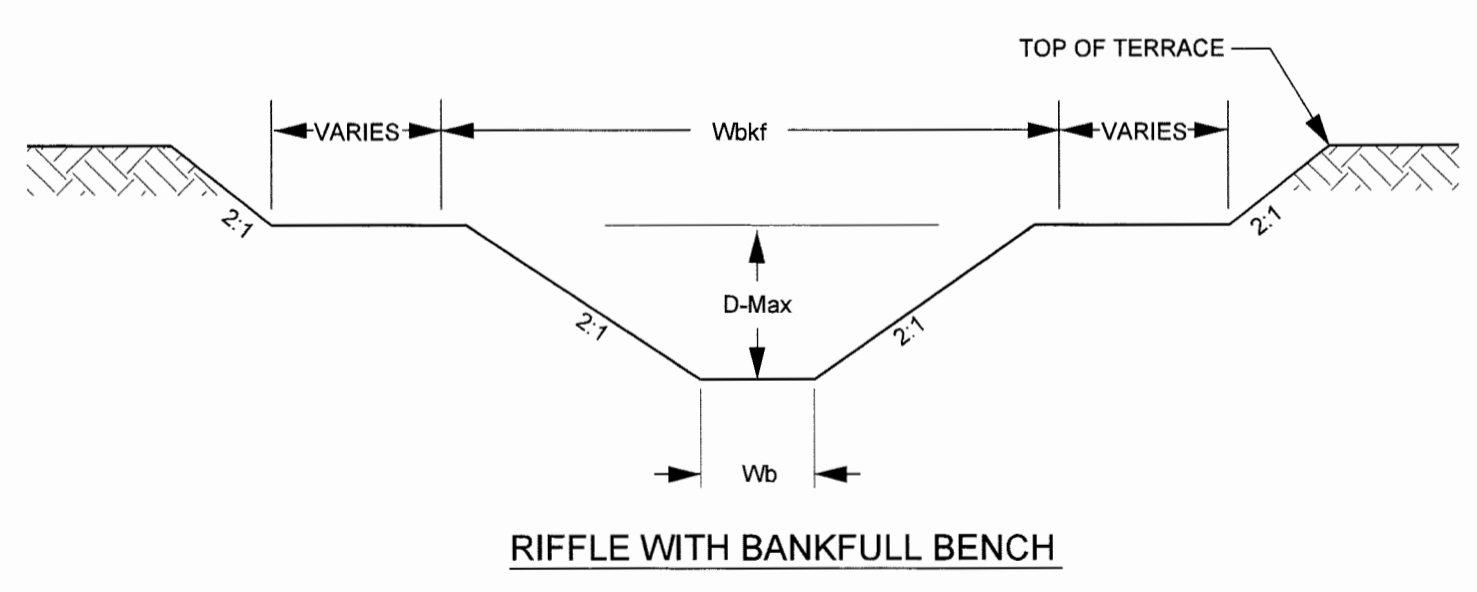
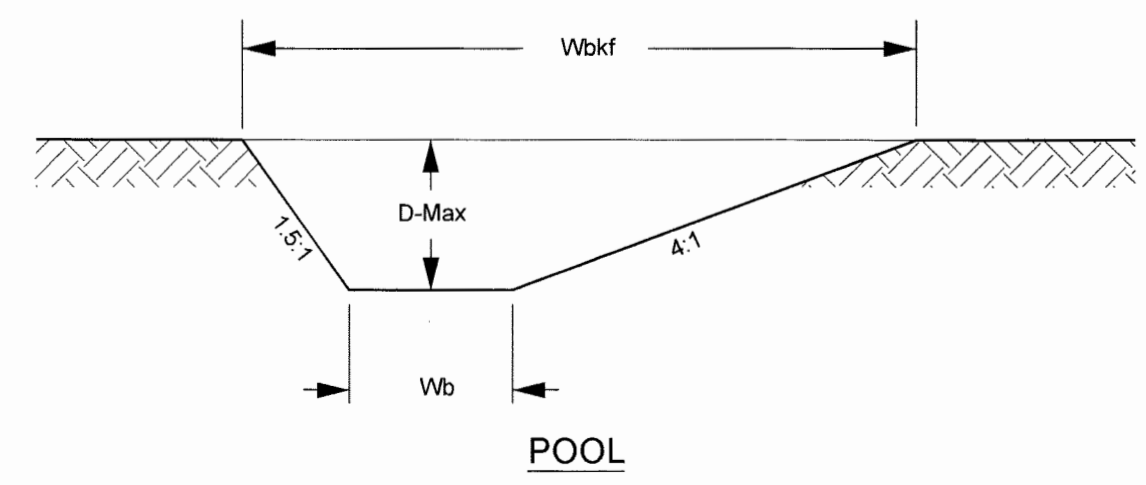
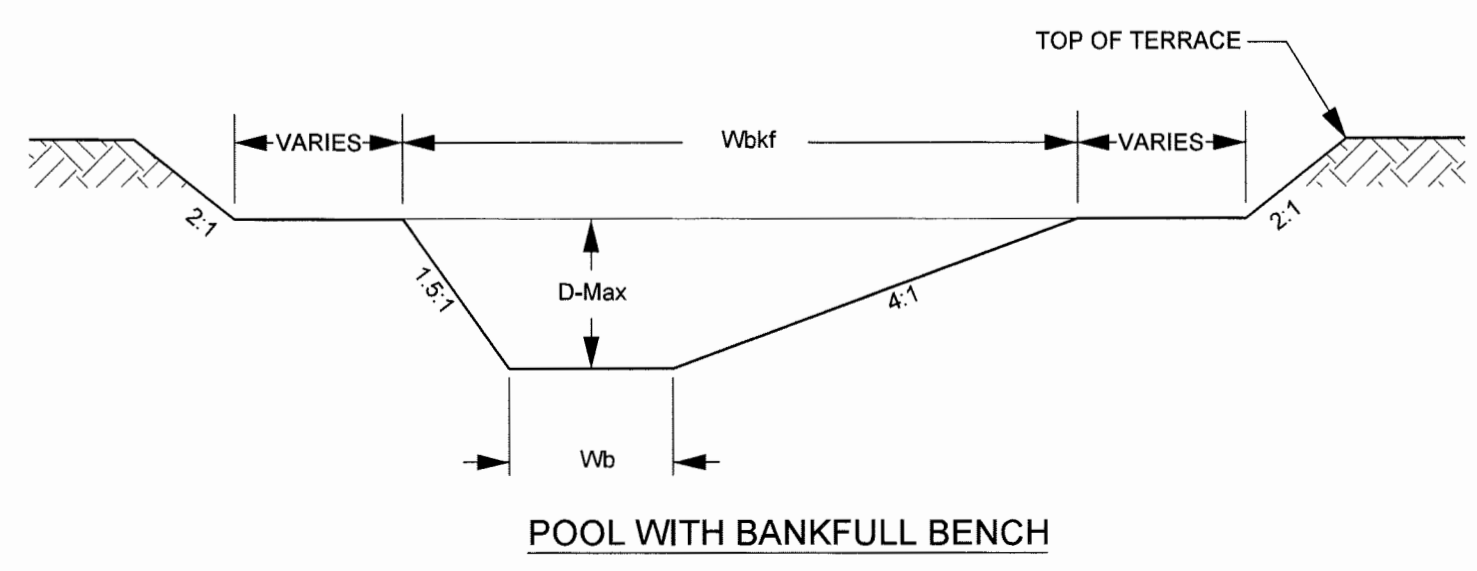
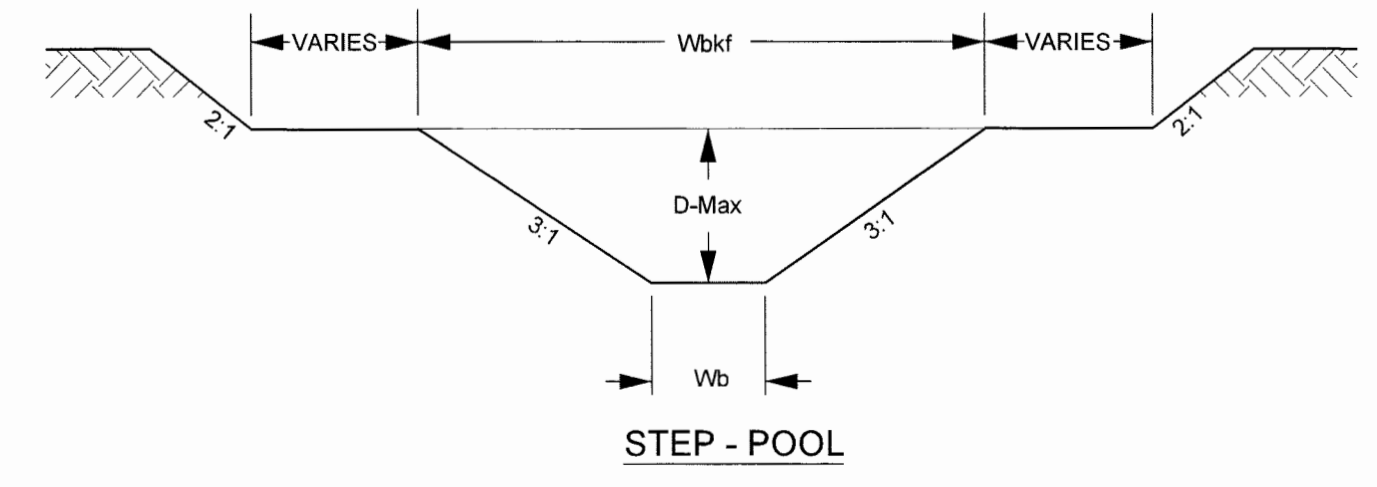
TYPICAL RIFFLE, POOL, AND BANKFULL BENCH CROSS-SECTIONS

R1		R2-Top		R2-Bottom *	
RIFFLE	POOL	RIFFLE	POOL	RIFFLE	POOL
12.5	17.5	9.2	12.0	10.4	13.7
1.1	2.4	0.8	1.7	1.0	1.9
14.0	12.4	14.0	11.6	14.0	11.7
11.2	24.7	6.0	12.5	7.7	16.1
8.2	3.1	6.0	2.7	5.5	3.3

WIDTH OF BANKFULL (Wbkf)
MAXIMUM DEPTH (D-Max)
WIDTH TO DEPTH RATIO (Wbkf / D)
BANKFULL AREA (Abkf)
BOTTOM WIDTH (Wb)
