FINAL
Baseline Monitoring Document and As-Built Baseline Report
Thomas Creek Restoration Project

Wake County, North Carolina

DMS Project ID No. 96074, DEQ Contract No. 5549

Submission Date: October 2016

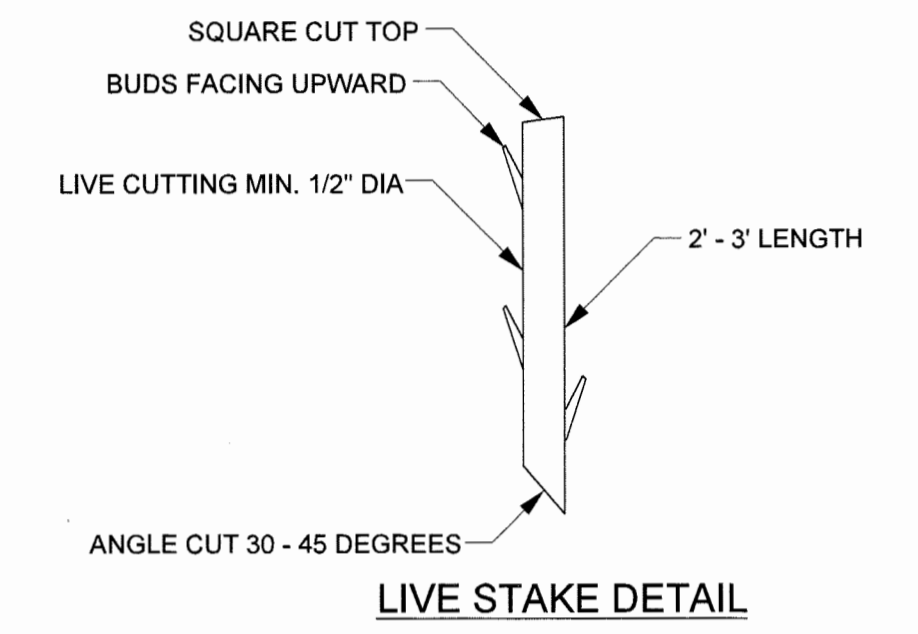
LIVE STAKING

- NOTES:**
1. STAKES SHOULD BE CUT AND INSTALLED ON THE SAME DAY.
 2. DO NOT INSTALL STAKES THAT HAVE BEEN SPLIT.
 3. STAKES MUST BE INSTALLED WITH BUDS POINTING UPWARDS.
 4. STAKES SHOULD BE INSTALLED PERPENDICULAR TO BANK.
 5. STAKES SHOULD BE 1/2 TO 2 INCHES IN DIAMETER AND 2 TO 3 FT LONG.
 6. STAKES SHOULD BE INSTALLED LEAVING 1/5 OF STAKE ABOVE GROUND.

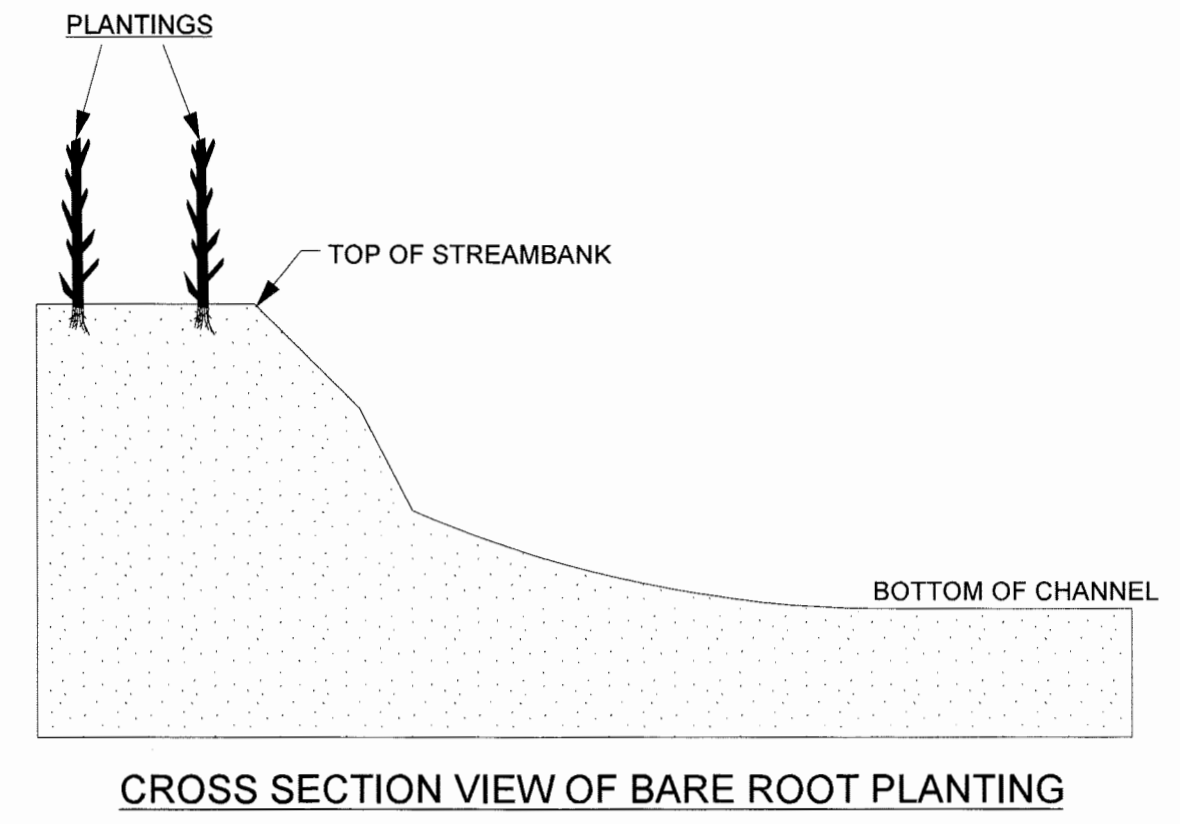
PLANTING SPECIFICATIONS

- NOTES:**
1. PLANT BARE ROOT SHRUBS AND TREES TO THE WIDTH OF THE BUFFER/PLANTING ZONE AS SHOWN ON THE PLANS.
 2. ALLOW FOR 8-10 FEET BETWEEN PLANTINGS, DEPENDING ON SIZE.
 3. LOOSEN COMPACTED SOIL.
 4. PLANT IN HOLES MADE BY A MATTOCK, DIBBLE, PLANTING BAR, OR OTHER APPROVED MEANS.
 5. PLANT IN HOLES DEEP AND WIDE ENOUGH TO ALLOW THE ROOTS TO SPREAD OUT AND DOWN WITHOUT J-ROOTING.
 6. KEEP ROOTS MOIST WHILE DISTRIBUTING OR WAITING TO PLANT BY MEANS OF WET CANVAS, BURLAP, OR STRAW.
 7. HEEL-IN PLANTS IN MOIST SOIL OR SAWDUST IF NOT PROMPTLY PLANTED UPON ARRIVAL TO PROJECT SITE.

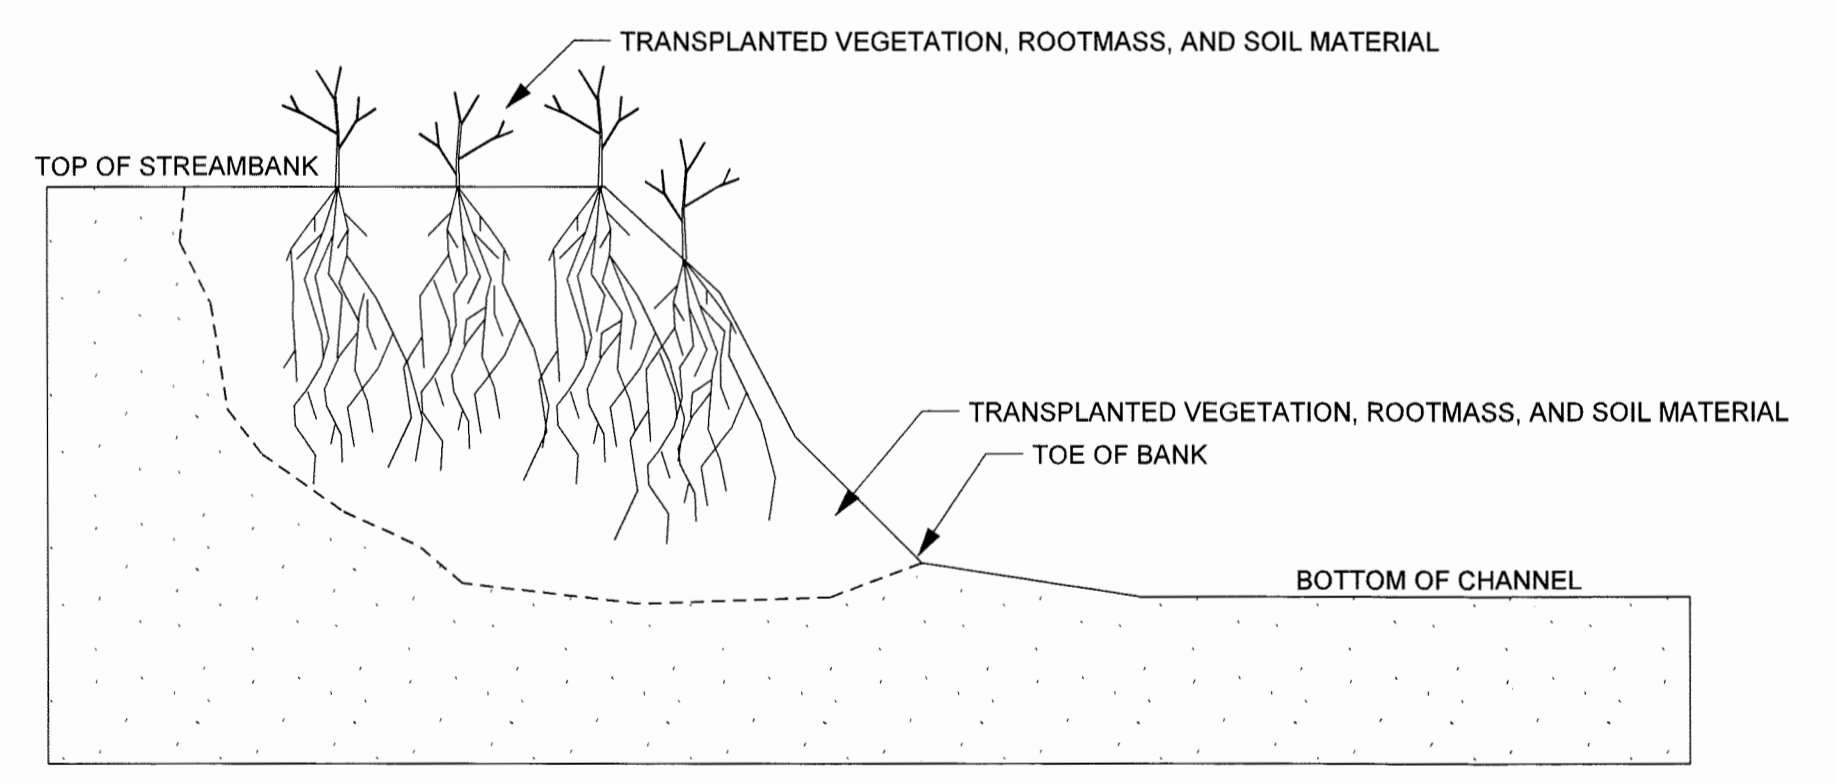
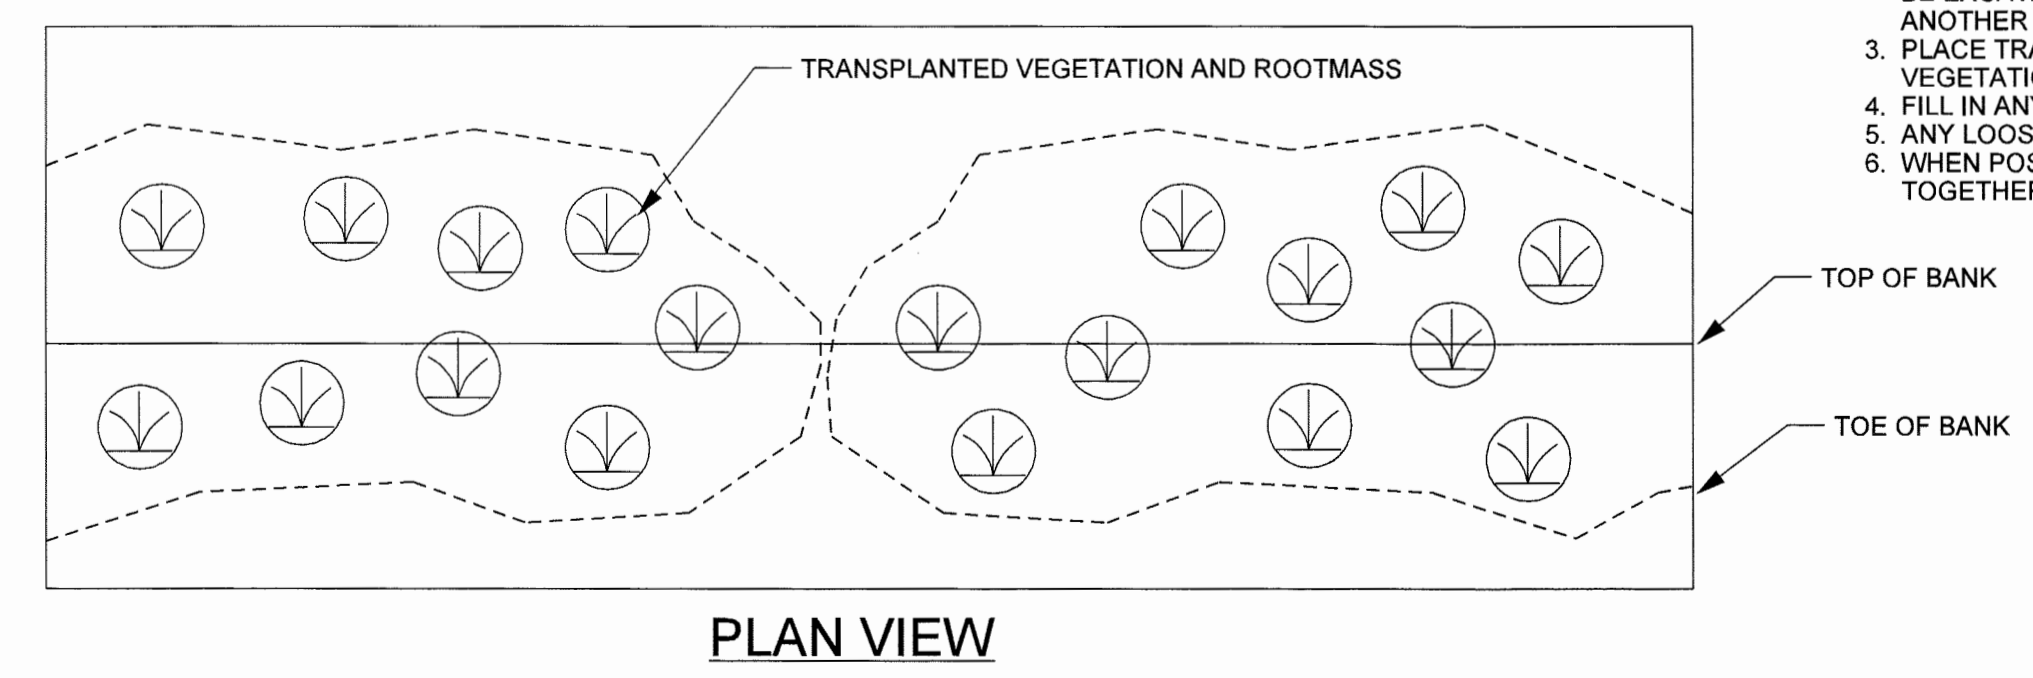
TRANSPLANTED VEGETATION

- NOTES:**
1. EXCAVATE A HOLE IN THE BANK TO BE STABILIZED THAT WILL ACCOMMODATE THE SIZE OF TRANSPLANT TO BE PLACED. BEGIN EXCAVATION AT THE TOE OF THE BANK.
 2. EXCAVATE THE ENTIRE ROOT MASS AND AS MUCH ADDITIONAL SOIL MATERIAL AS POSSIBLE. IF ENTIRE ROOT MASS CAN NOT BE EXCAVATED AT ONCE, THE TRANSPLANT IS TOO LARGE AND ANOTHER SHOULD BE SELECTED.
 3. PLACE TRANSPLANT IN THE BANK TO BE STABILIZED SO THAT VEGETATION IS ORIENTATED VERTICALLY.
 4. FILL IN ANY HOLES AROUND THE TRANSPLANT AND COMPACT.
 5. ANY LOOSE SOIL LEFT IN THE STREAM SHOULD BE REMOVED.
 6. WHEN POSSIBLE, PLACE MULTIPLE TRANSPLANTS CLOSE TOGETHER SUCH THAT THEY TOUCH.

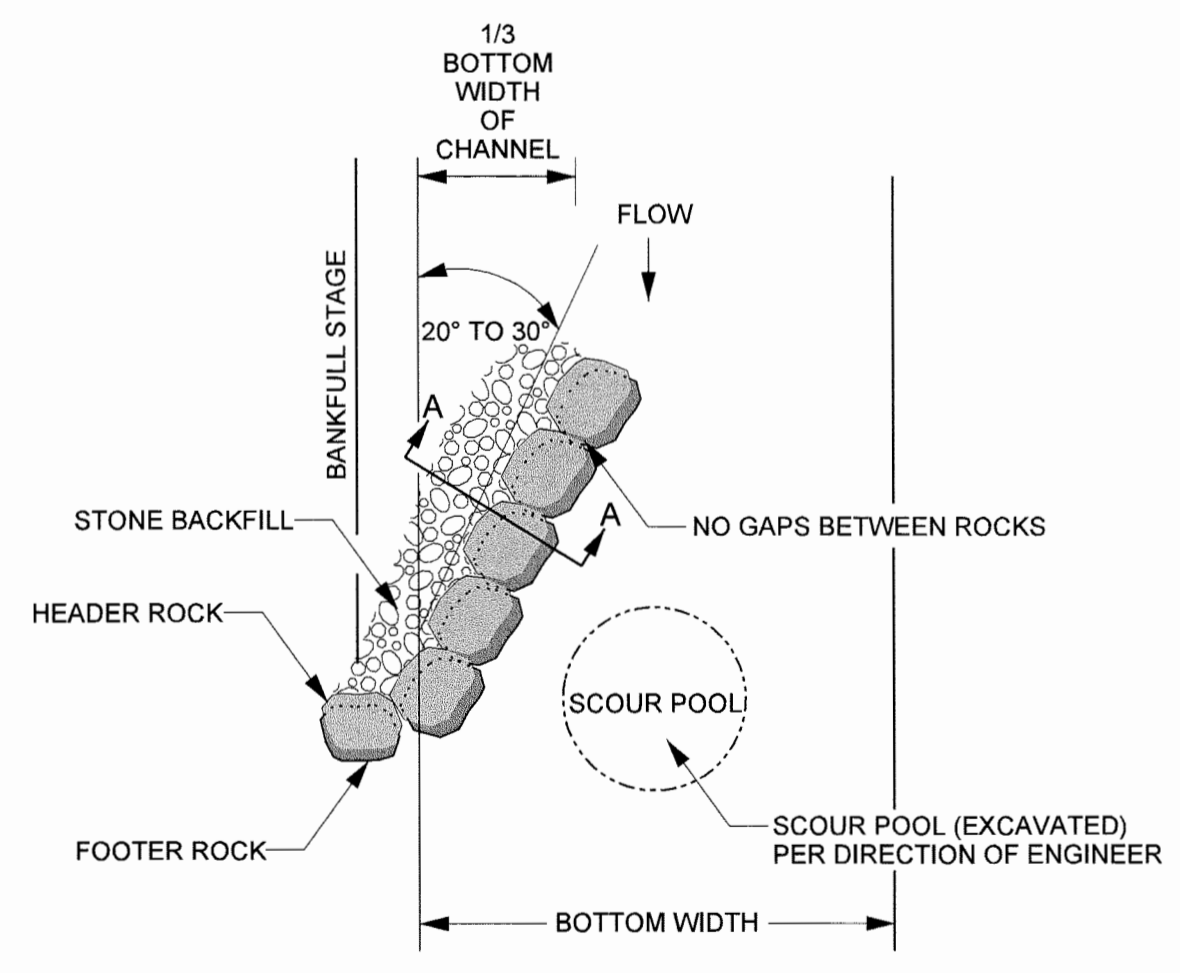
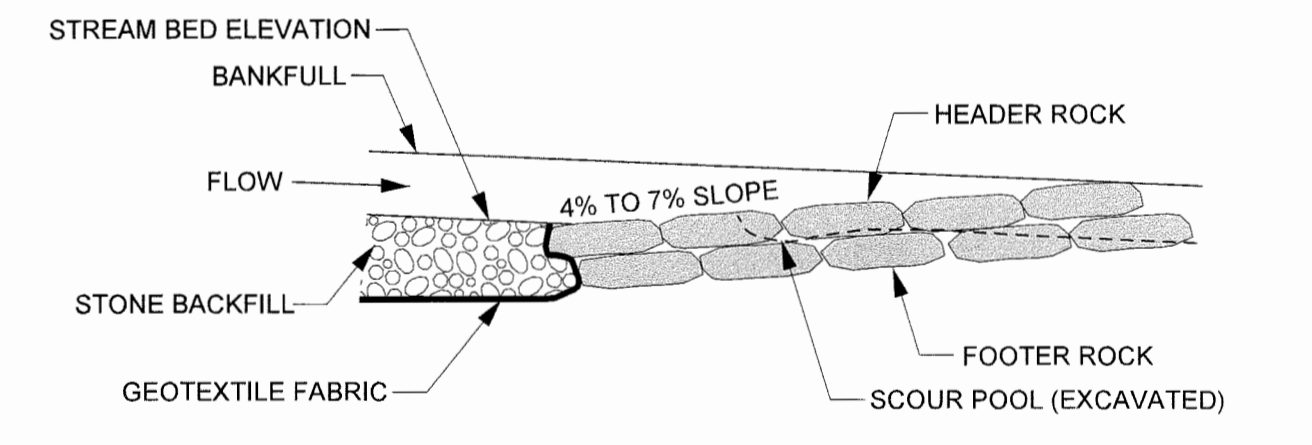
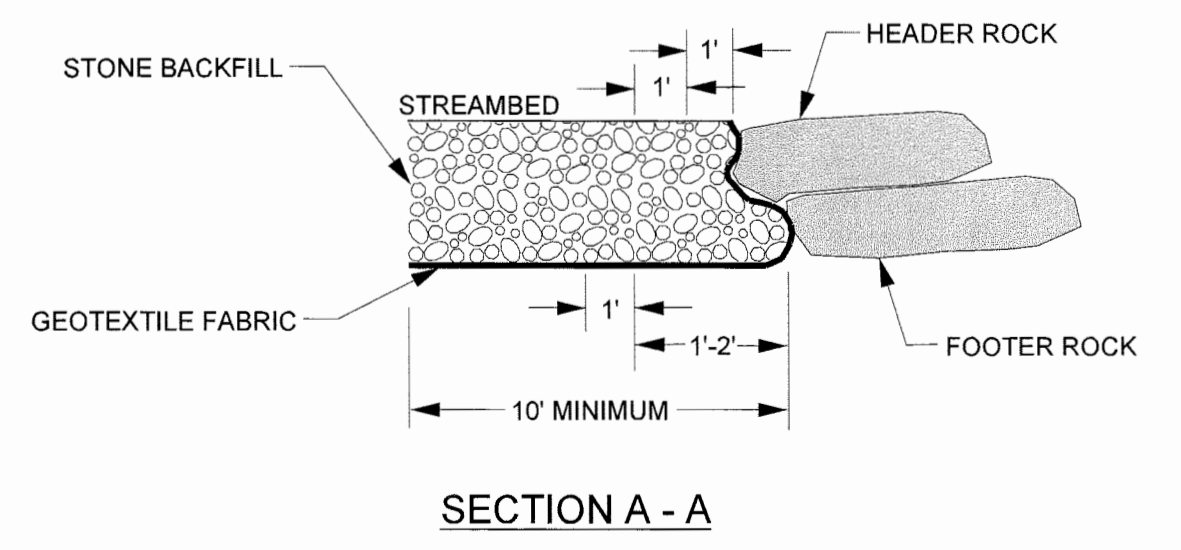
ROCK VANE

- NOTES FOR ALL VANE STRUCTURES:**
1. INSTALL GEOTEXTILE FABRIC BEGINNING AT THE TOP OF THE HEADER ROCKS AND EXTEND DOWNWARD TO THE DEPTH OF THE BOTTOM FOOTER ROCK, AND THEN UPSTREAM TO A MINIMUM OF TEN FEET.
 2. DIG A TRENCH BELOW THE BED FOR FOOTER ROCKS AND PLACE FILL ON UPSTREAM SIDE OF VANE ARM, BETWEEN THE ARM AND STREAMBANK.
 3. START AT BANK AND PLACE FOOTER ROCKS FIRST AND THEN HEADER (TOP) ROCK.
 4. CONTINUE WITH STRUCTURE, FOLLOWING ANGLE AND SLOPE SPECIFICATIONS.
 5. AN EXTRA ROCK CAN BE PLACED IN SCOUR POOL FOR HABITAT IMPROVEMENT.
 6. USE HAND PLACED STONE TO FILL GAPS ON UPSTREAM SIDE OF HEADER AND FOOTER ROCKS.
 7. AFTER ALL STONE BACKFILL HAS BEEN PLACED, FILL IN THE UPSTREAM SIDE OF THE STRUCTURE WITH ON-SITE ALLUVIUM TO THE ELEVATION OF THE TOP OF THE HEADER ROCK.
 8. START SLOPE AT 2/3 TO 1 TIMES THE BANKFULL STAGE.

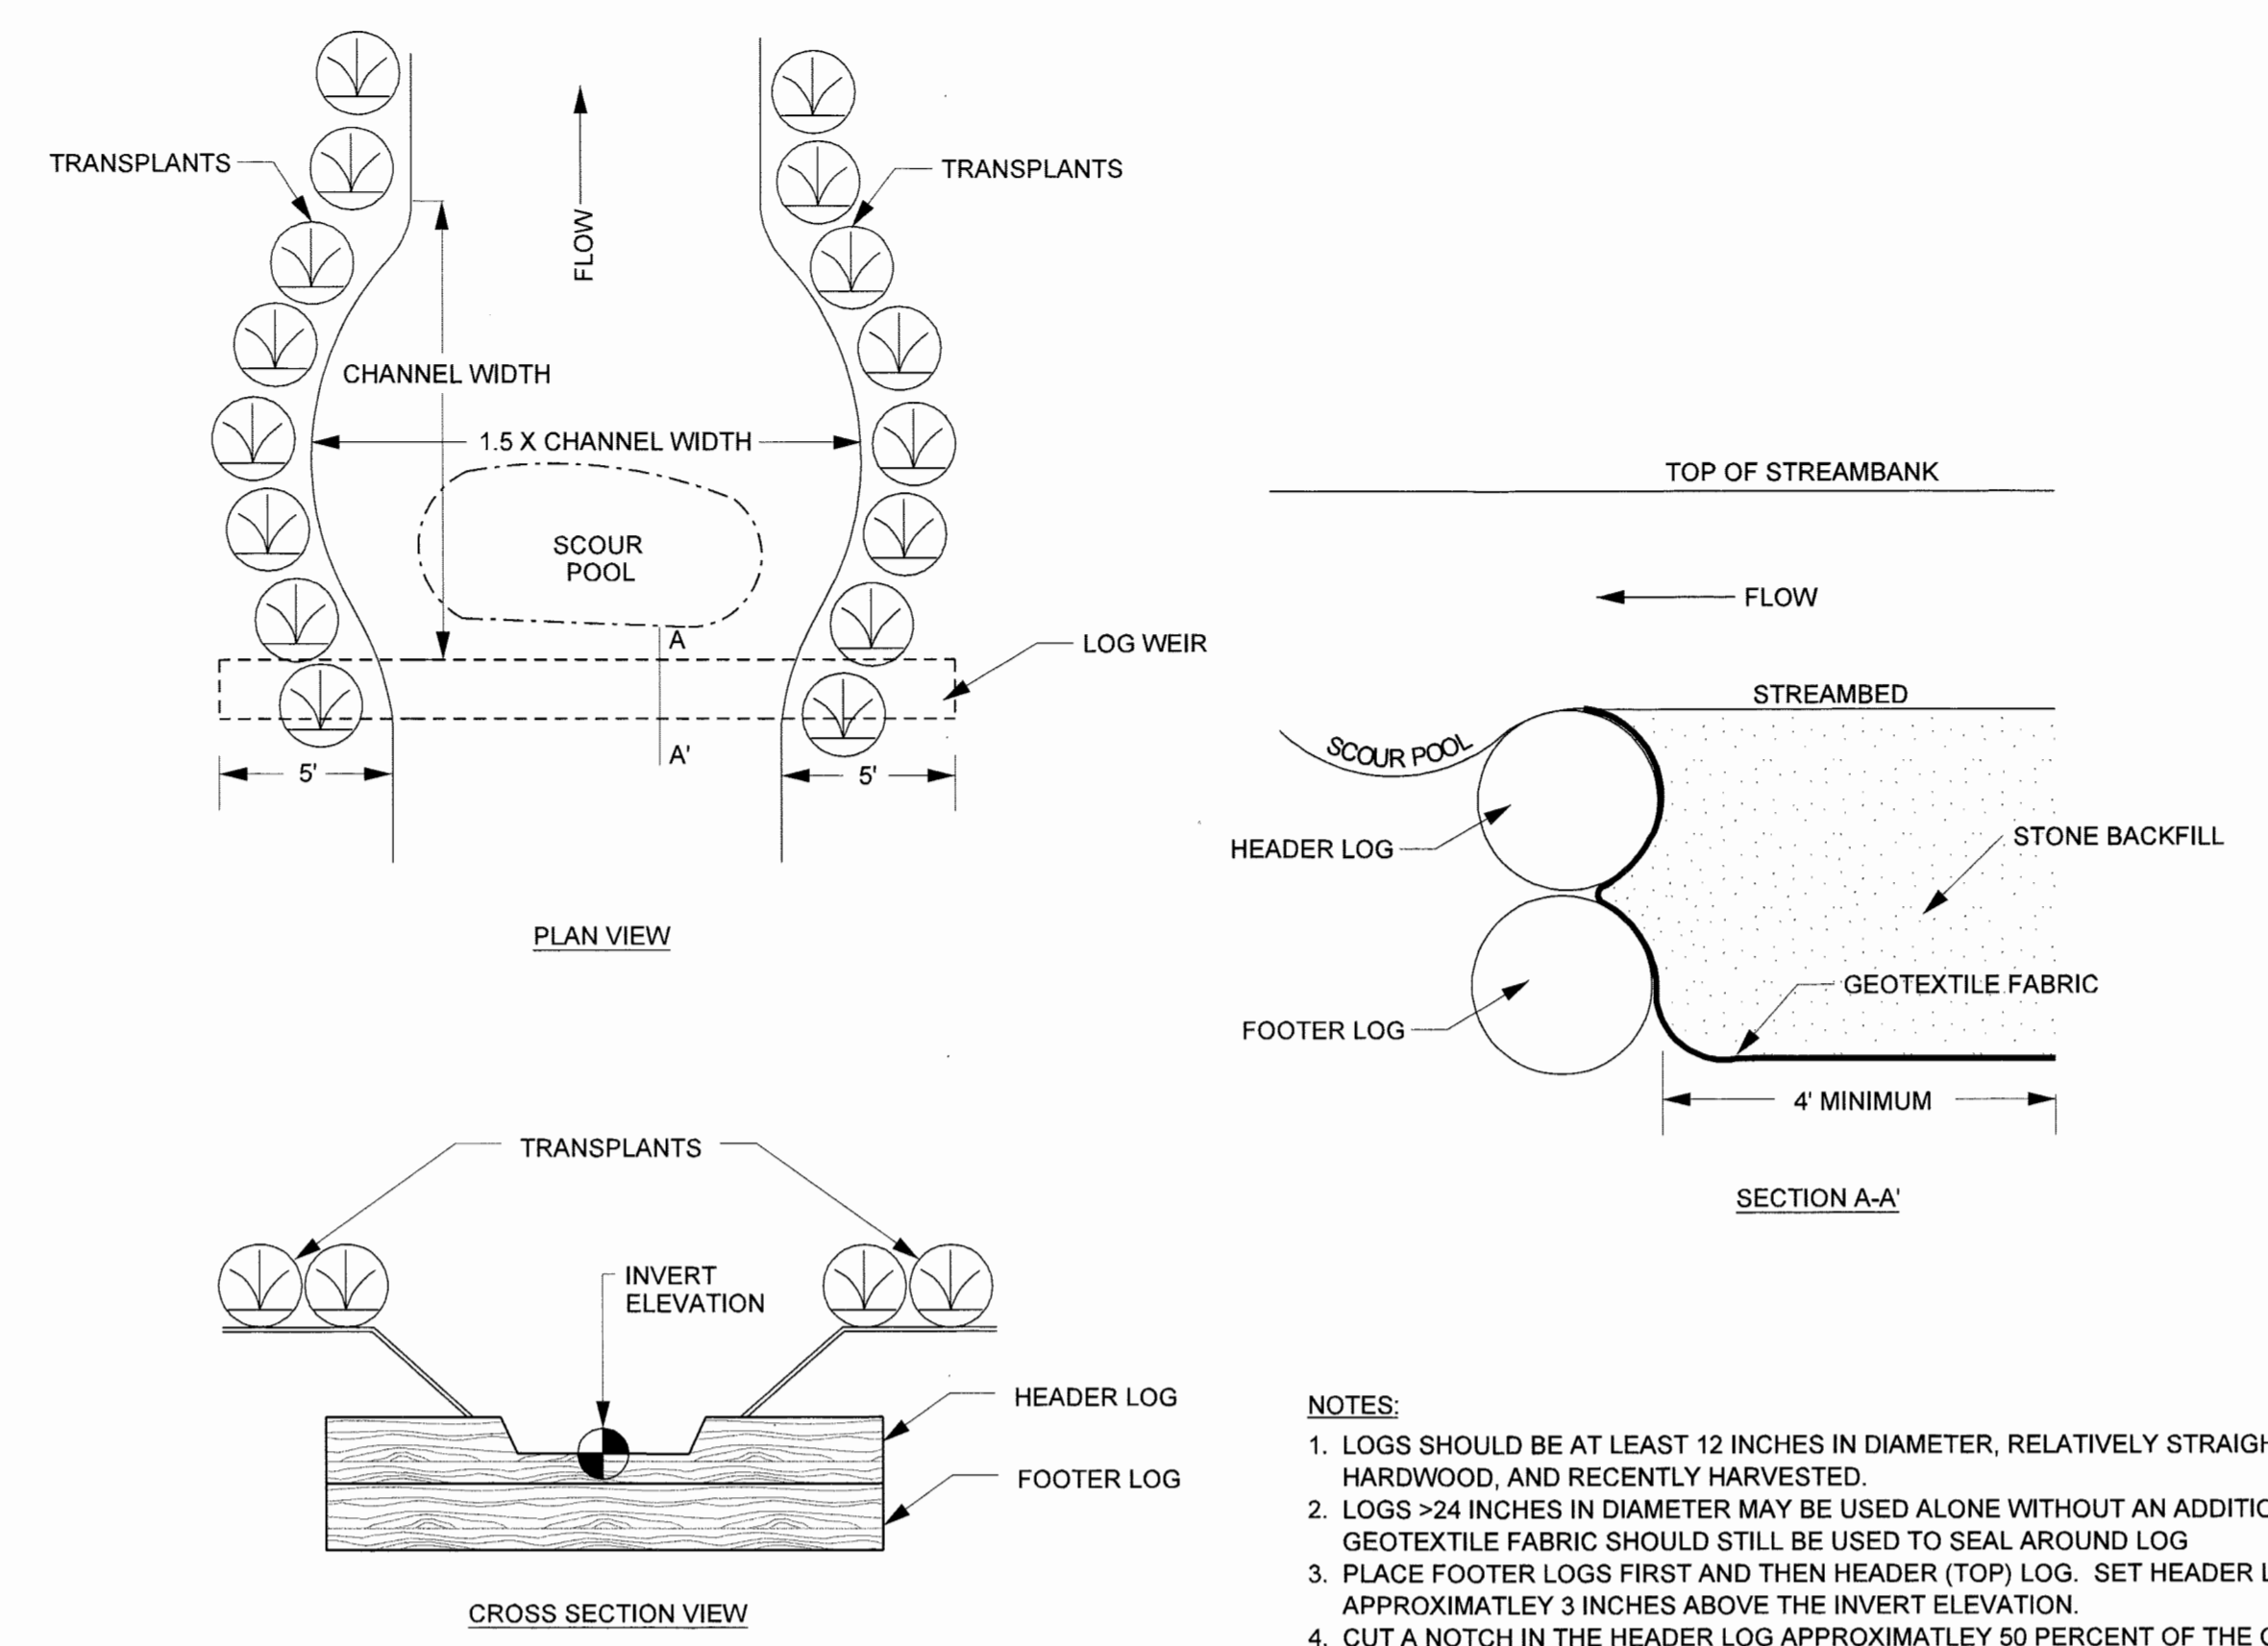
LOG WEIR

- NOTES:**
- LOGS SHOULD BE AT LEAST 12 INCHES IN DIAMETER, RELATIVELY STRAIGHT, HARDWOOD, AND RECENTLY HARVESTED.
 - LOGS >24 INCHES IN DIAMETER MAY BE USED ALONE WITHOUT AN ADDITIONAL LOG. GEOTEXTILE FABRIC SHOULD STILL BE USED TO SEAL AROUND LOG
 - PLACE FOOTER LOGS FIRST AND THEN HEADER (TOP) LOG. SET HEADER LOG APPROXIMATELY 3 INCHES ABOVE THE INVERT ELEVATION.
 - CUT A NOTCH IN THE HEADER LOG APPROXIMATELY 50 PERCENT OF THE CHANNEL BOTTOM WIDTH AND EXTENDING DOWN TO THE INVERT ELEVATION.
 - USE GEOTEXTILE FABRIC TO SEAL GAPS BETWEEN LOGS.
 - PLACE TRANSPLANTS FROM TOE OF STREAMBANK TO TOP OF STREAMBANK.

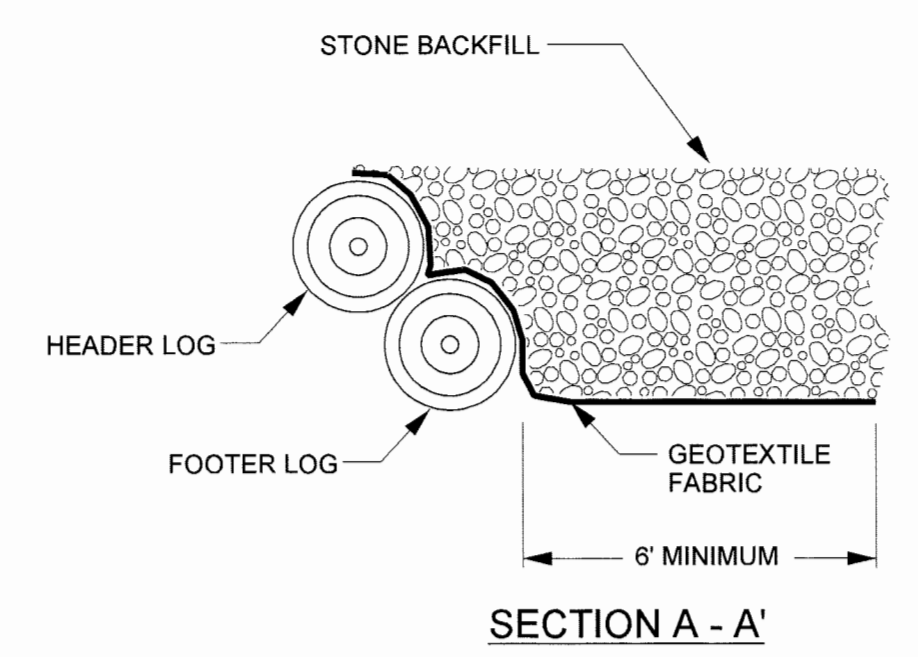
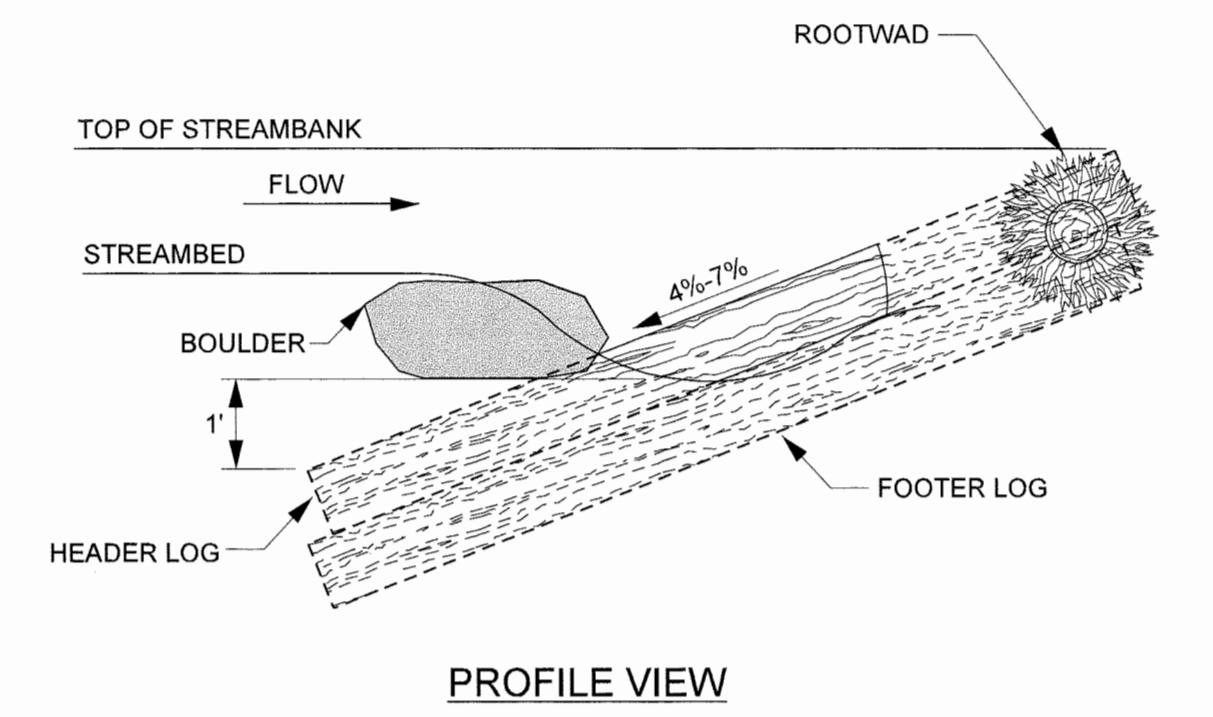
LOG VANE

- NOTES:**
- LOGS SHOULD BE AT LEAST 10" IN DIAMETER, RELATIVELY STRAIGHT, HARDWOOD, AND RECENTLY HARVESTED.
 - BOULDERS MUST BE OF SUFFICIENT SIZE TO ANCHOR LOGS.
 - SOIL SHOULD BE COMPACTED WELL AROUND BURIED PORTIONS OF LOGS.
 - ROOTWADS SHOULD BE PLACED BENEATH THE HEADER LOG AND PLACED SO THAT IT LOCKS THE HEADER LOG INTO THE BANK. SEE ROOTWAD DETAIL.
 - BOULDER SHOULD BE PLACED ON TOP OF HEADER LOG FOR ANCHORING.
 - GEOTEXTILE FABRIC SHOULD BE NAILED TO THE LOG BELOW THE BACKFILL.
 - TRANSPLANTS CAN BE USED INSTEAD OF ROOTWADS, PER DIRECTION OF ENGINEER.

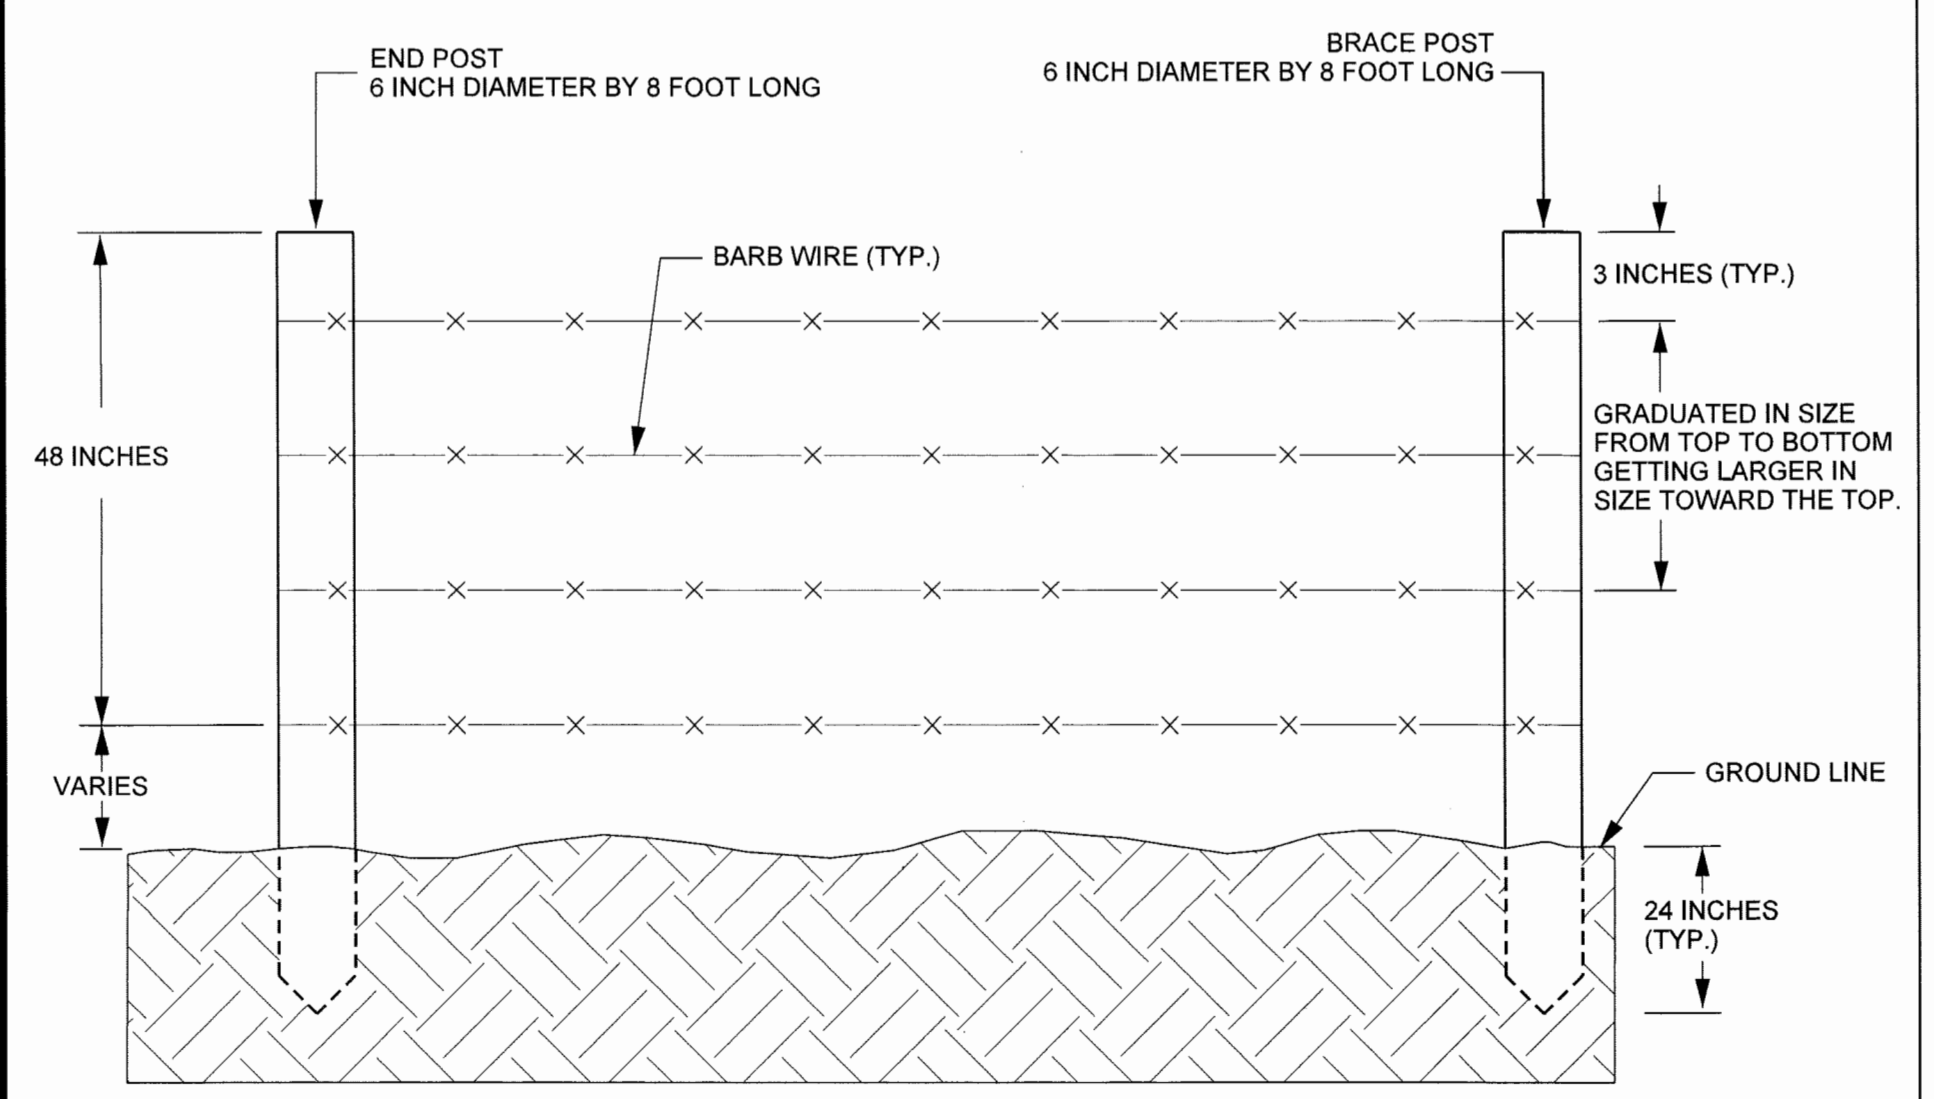
BARB WIRE FIELD FENCE

- NOTE:**
- END POSTS SHALL BE INSTALLED AT A SPACING OF 10-15 FEET.

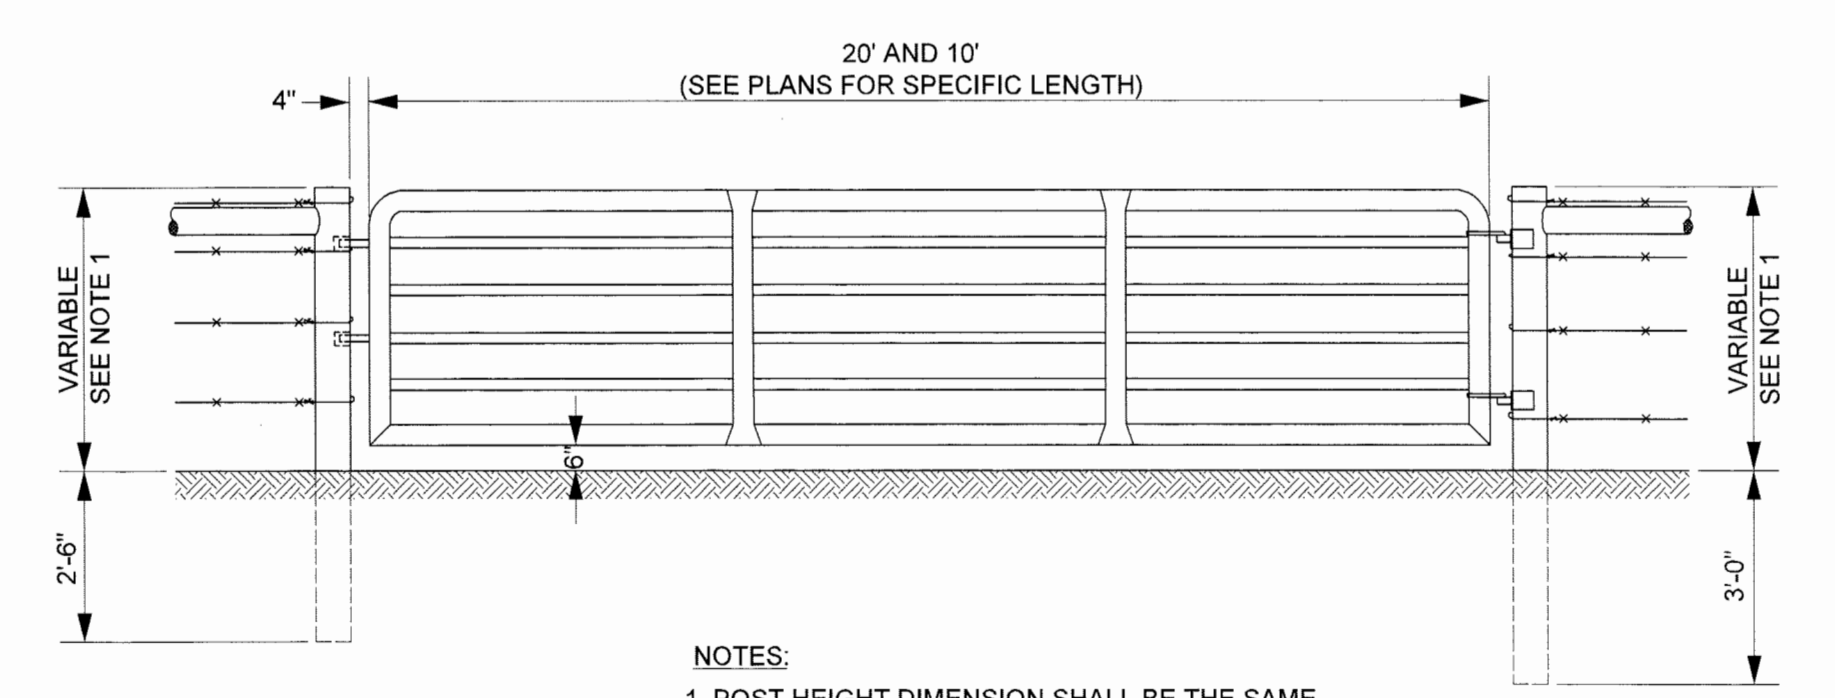
STEEL FRAME GATES

- NOTES:**
- POST HEIGHT DIMENSION SHALL BE THE SAME AS REQUIRED FOR THE ADJACENT FENCE.
 - CONSTRUCT AN END OR STRESS PANEL AS REQUIRED IN THE SPECIFICATION, ON EACH SIDE OF GATE.
 - HINGES AND LOCKS SHALL BE INSTALLED AS SPECIFIED BY GATE MANUFACTURER.

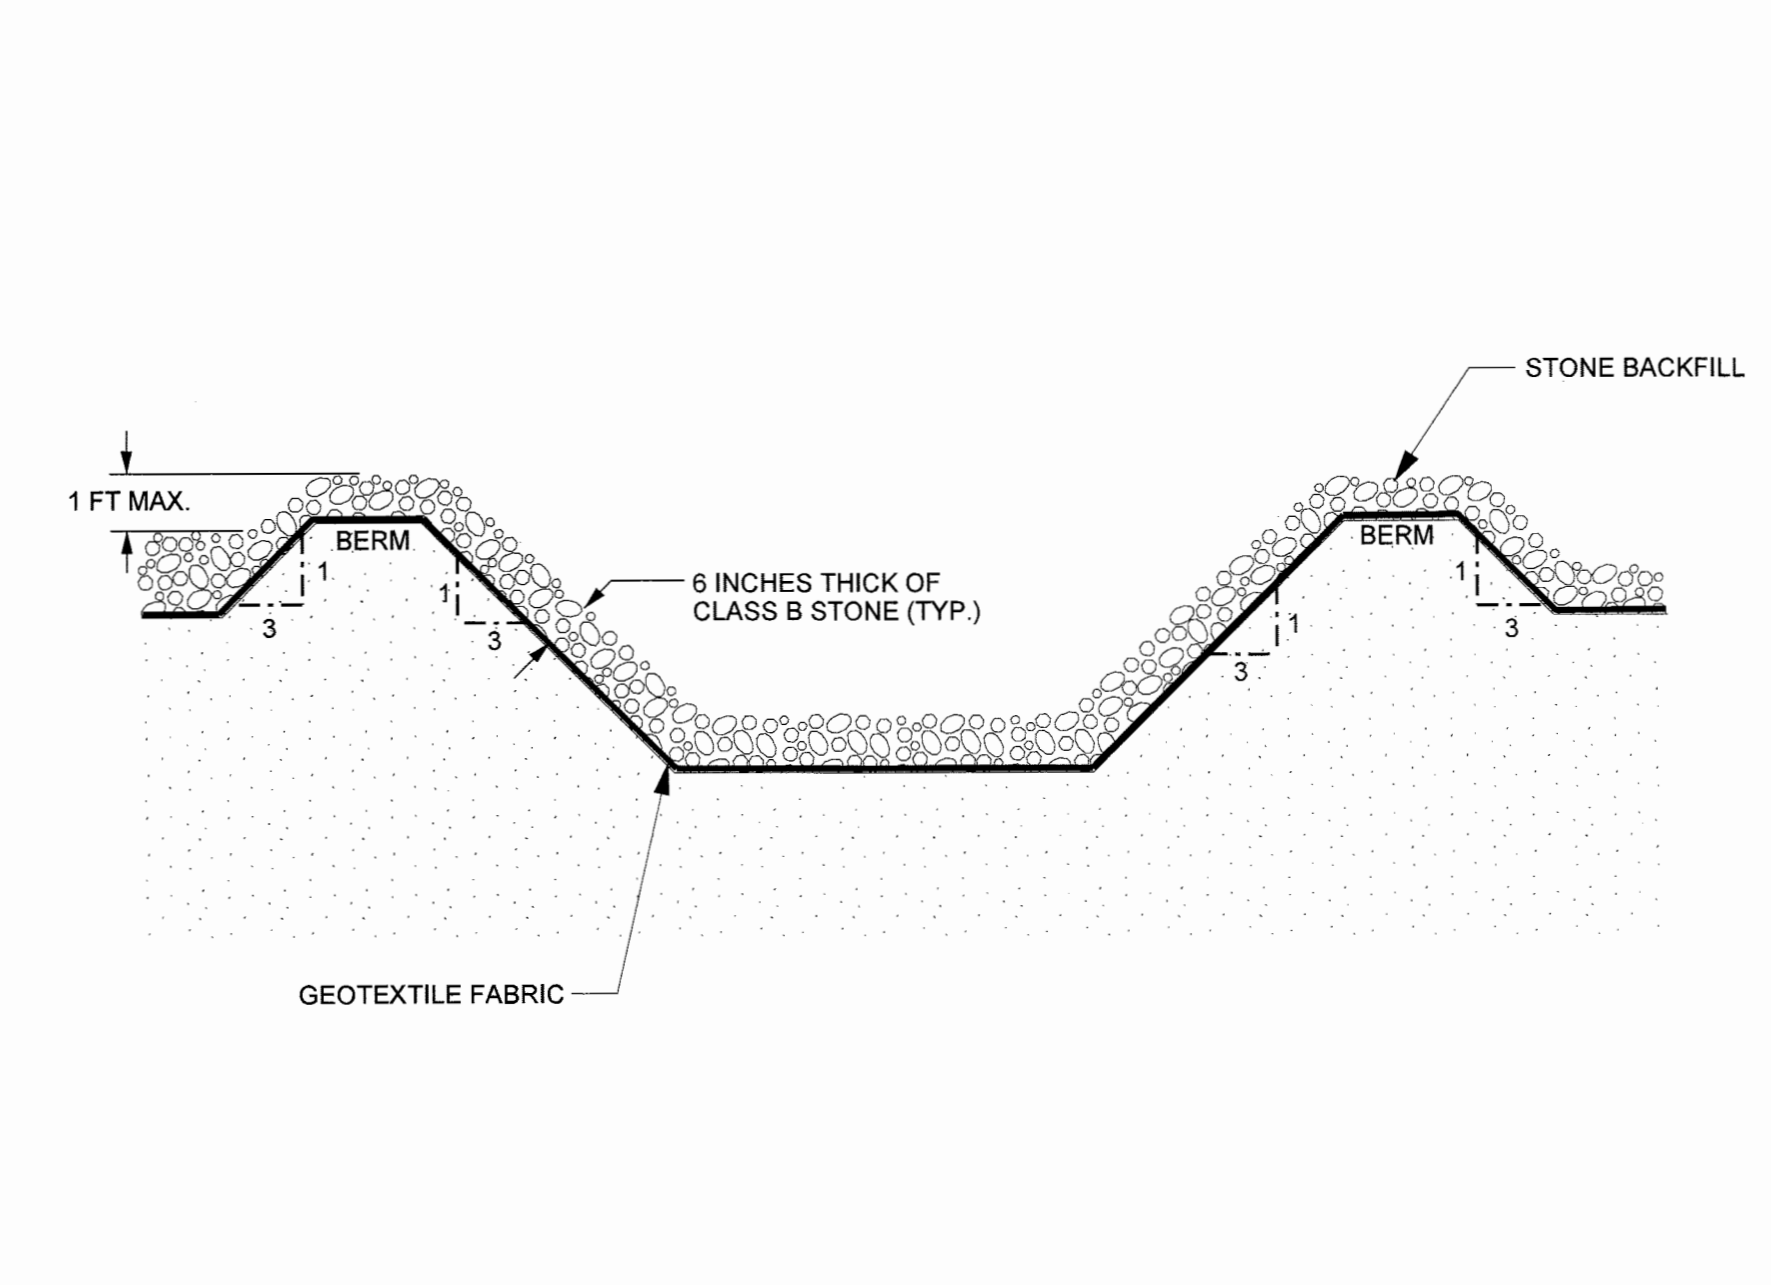
PERMANENT FORD STREAM CROSSING

- NOTES:**
- CONSTRUCT STREAM CROSSING WHEN FLOW IS LOW.
 - HAVE ALL NECESSARY MATERIALS AND EQUIPMENT ON-SITE BEFORE WORK BEGINS.
 - MINIMIZE CLEARING AND EXCAVATION OF STREAMBANKS. DO NOT EXCAVATE CHANNEL BOTTOM. COMPLETE ONE SIDE BEFORE STARTING ON THE OTHER SIDE.
 - INSTALL STREAM CROSSING AT RIGHT ANGLE TO THE FLOW.
 - GRADE SLOPES TO A 3:1 SLOPE. TRANSPLANT SOD FROM ORIGINAL STREAMBANK ONTO SIDE SLOPES.
 - MAINTAIN CROSSING SO THAT RUNOFF IN THE CONSTRUCTION ROAD DOES NOT ENTER EXISTING CHANNEL.
 - A STABILIZED PAD OF STONE BACKFILL, 6 INCHES THICK, LINED WITH GEOTEXTILE FABRIC, SHALL BE USED OVER THE BERM AND ACCESS SLOPES.
 - WIDTH OF THE CROSSING SHALL BE SUFFICIENT TO ACCOMMODATE THE LARGEST VEHICLE CROSSING THE CHANNEL.
 - CONTRACTOR SHALL DETERMINE AN APPROPRIATE RAMP ANGLE ACCORDING TO EQUIPMENT UTILIZED.

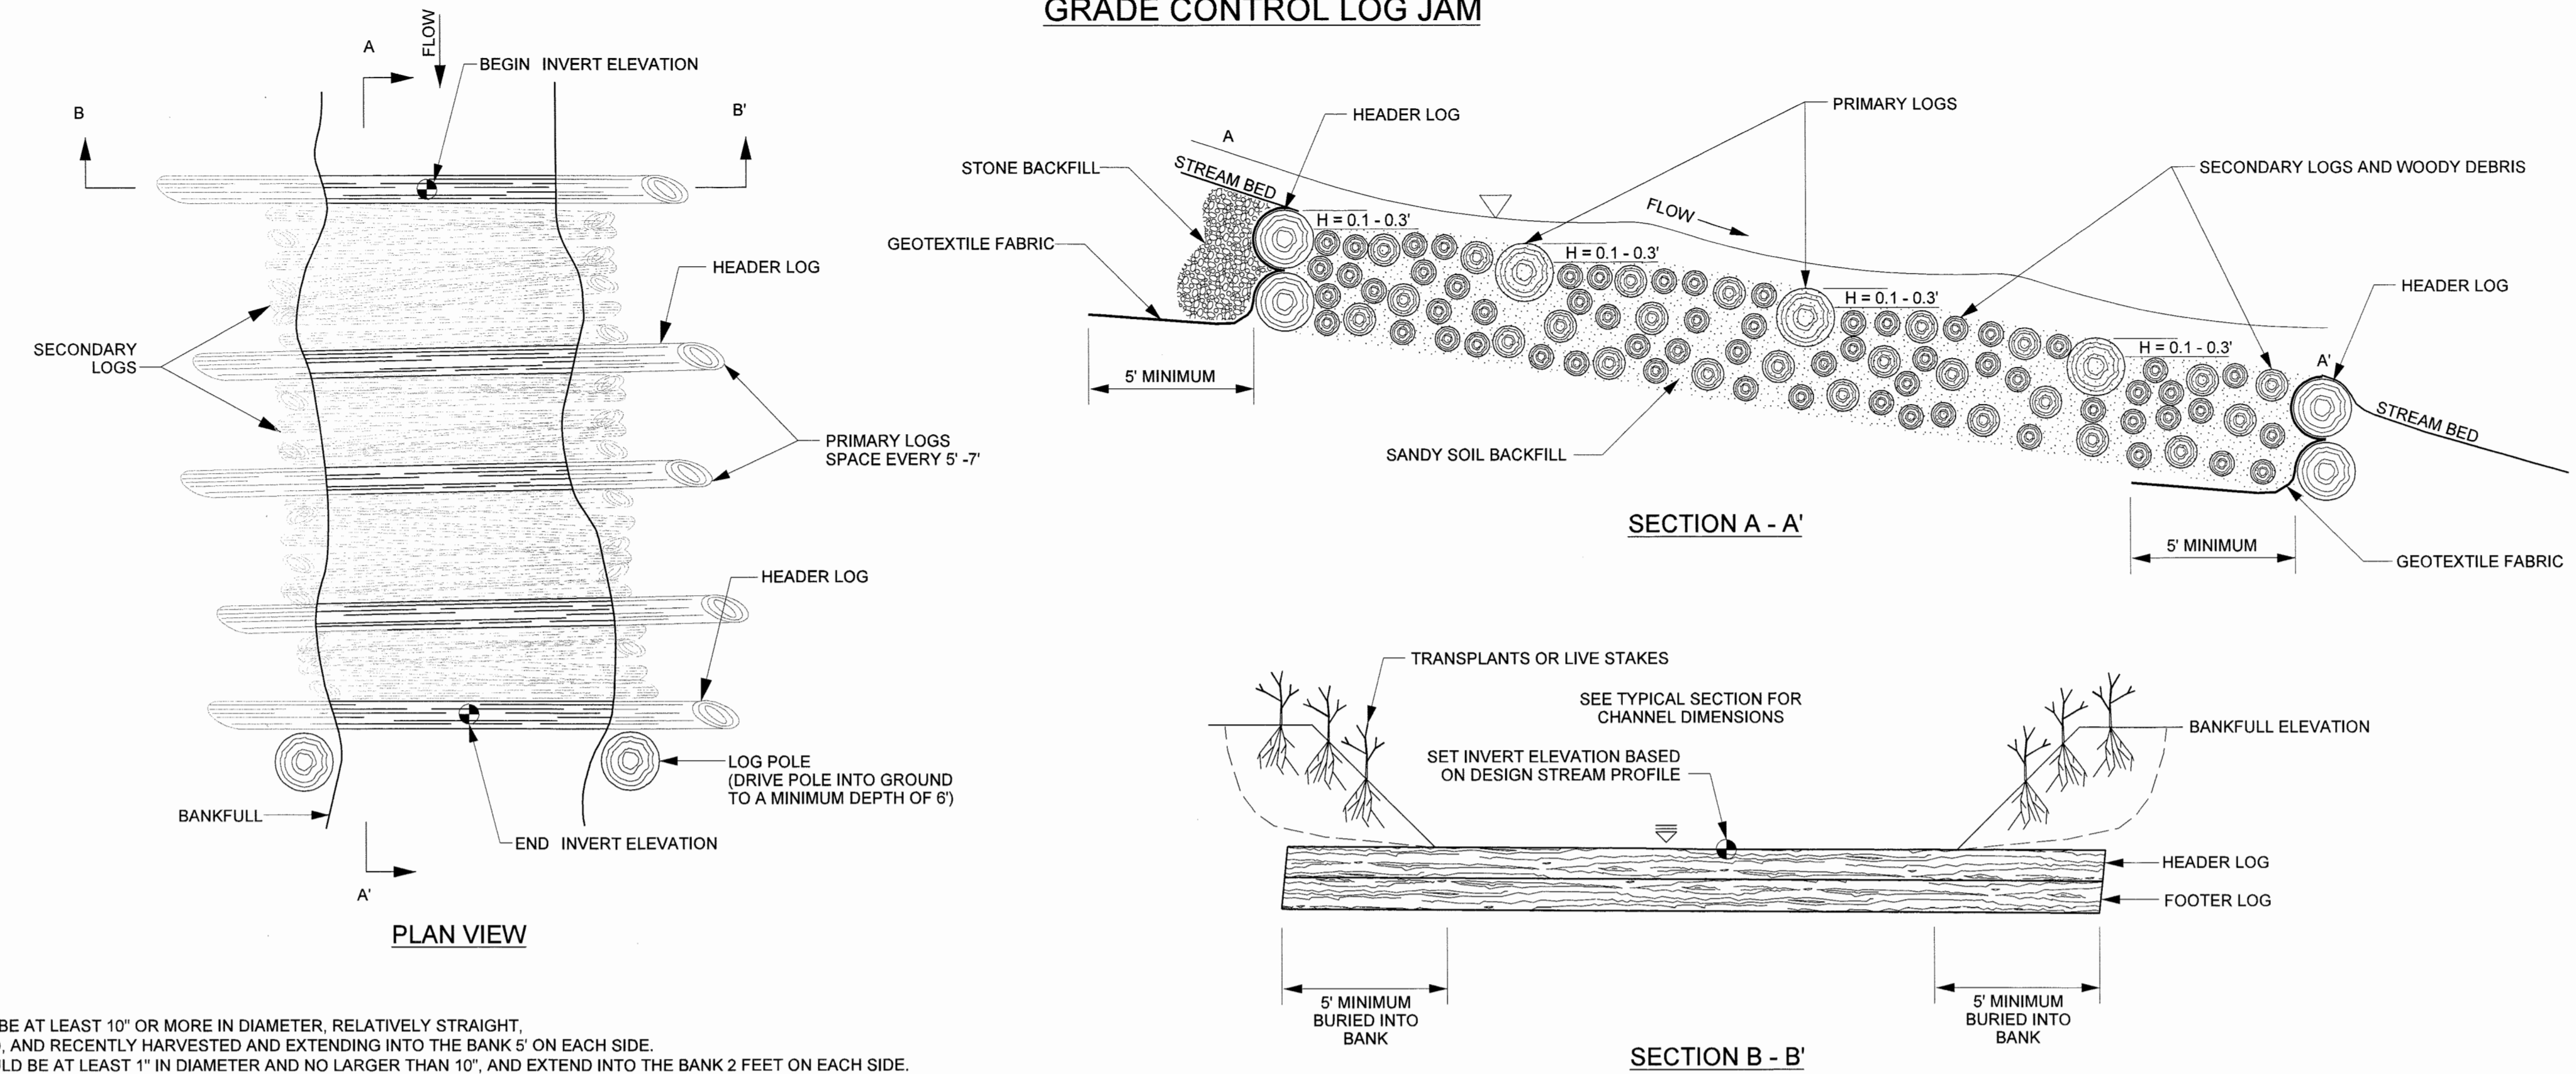
GRADE CONTROL LOG JAM

- NOTES:**
1. PRIMARY LOGS SHOULD BE AT LEAST 10" OR MORE IN DIAMETER, RELATIVELY STRAIGHT, HARDWOOD PREFERRED, AND RECENTLY HARVESTED AND EXTENDING INTO THE BANK 5' ON EACH SIDE.

2. SECONDARY LOGS SHOULD BE AT LEAST 1" IN DIAMETER AND NO LARGER THAN 10", AND EXTEND INTO THE BANK 2 FEET ON EACH SIDE. WOOD MATERIAL SHALL BE VARYING DIAMETER TO ALLOW MATERIAL TO BE COMPACTED.
