FINAL
Baseline Monitoring Document and As-Built Baseline Report
Thomas Creek Restoration Project

Wake County, North Carolina

DMS Project ID No. 96074, DEQ Contract No. 5549

Submission Date: October 2016

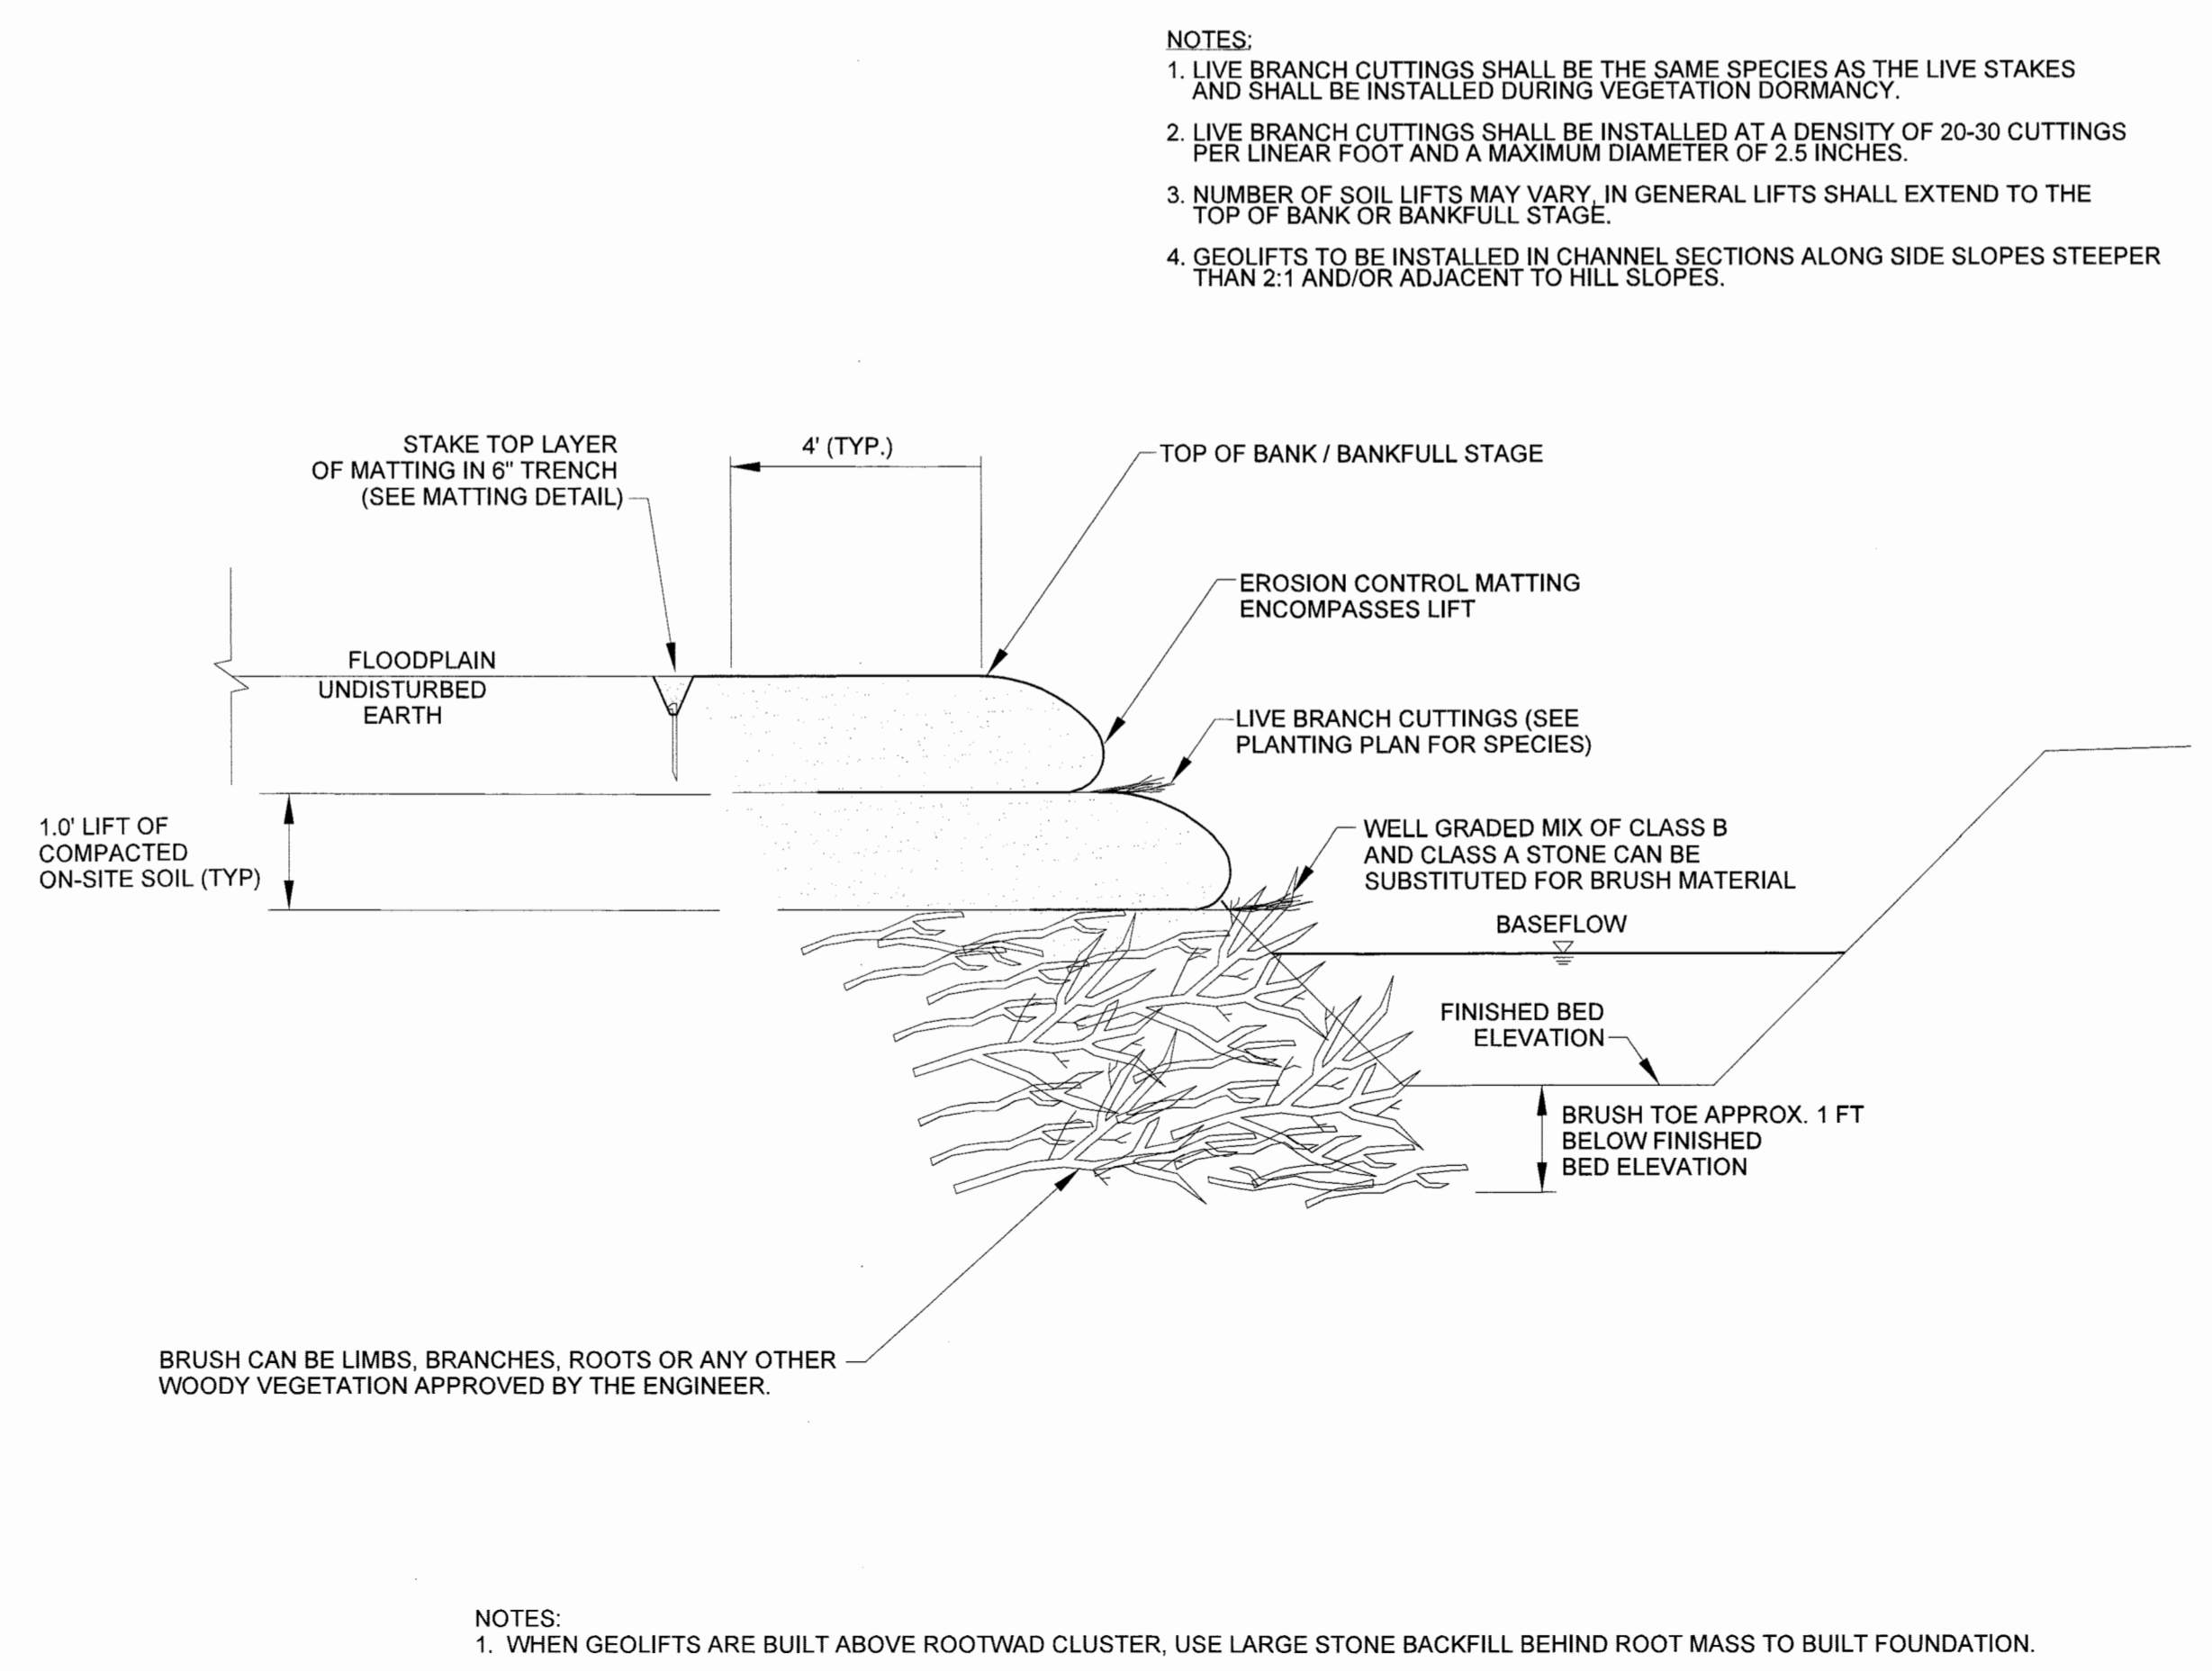
GEOLIFT WITH BRUSH TOE

- NOTES:**
1. WHEN GEOLIFTS ARE BUILT ABOVE ROOTWAD CLUSTER, USE LARGE STONE BACKFILL BEHIND ROOT MASS TO BUILT FOUNDATION.

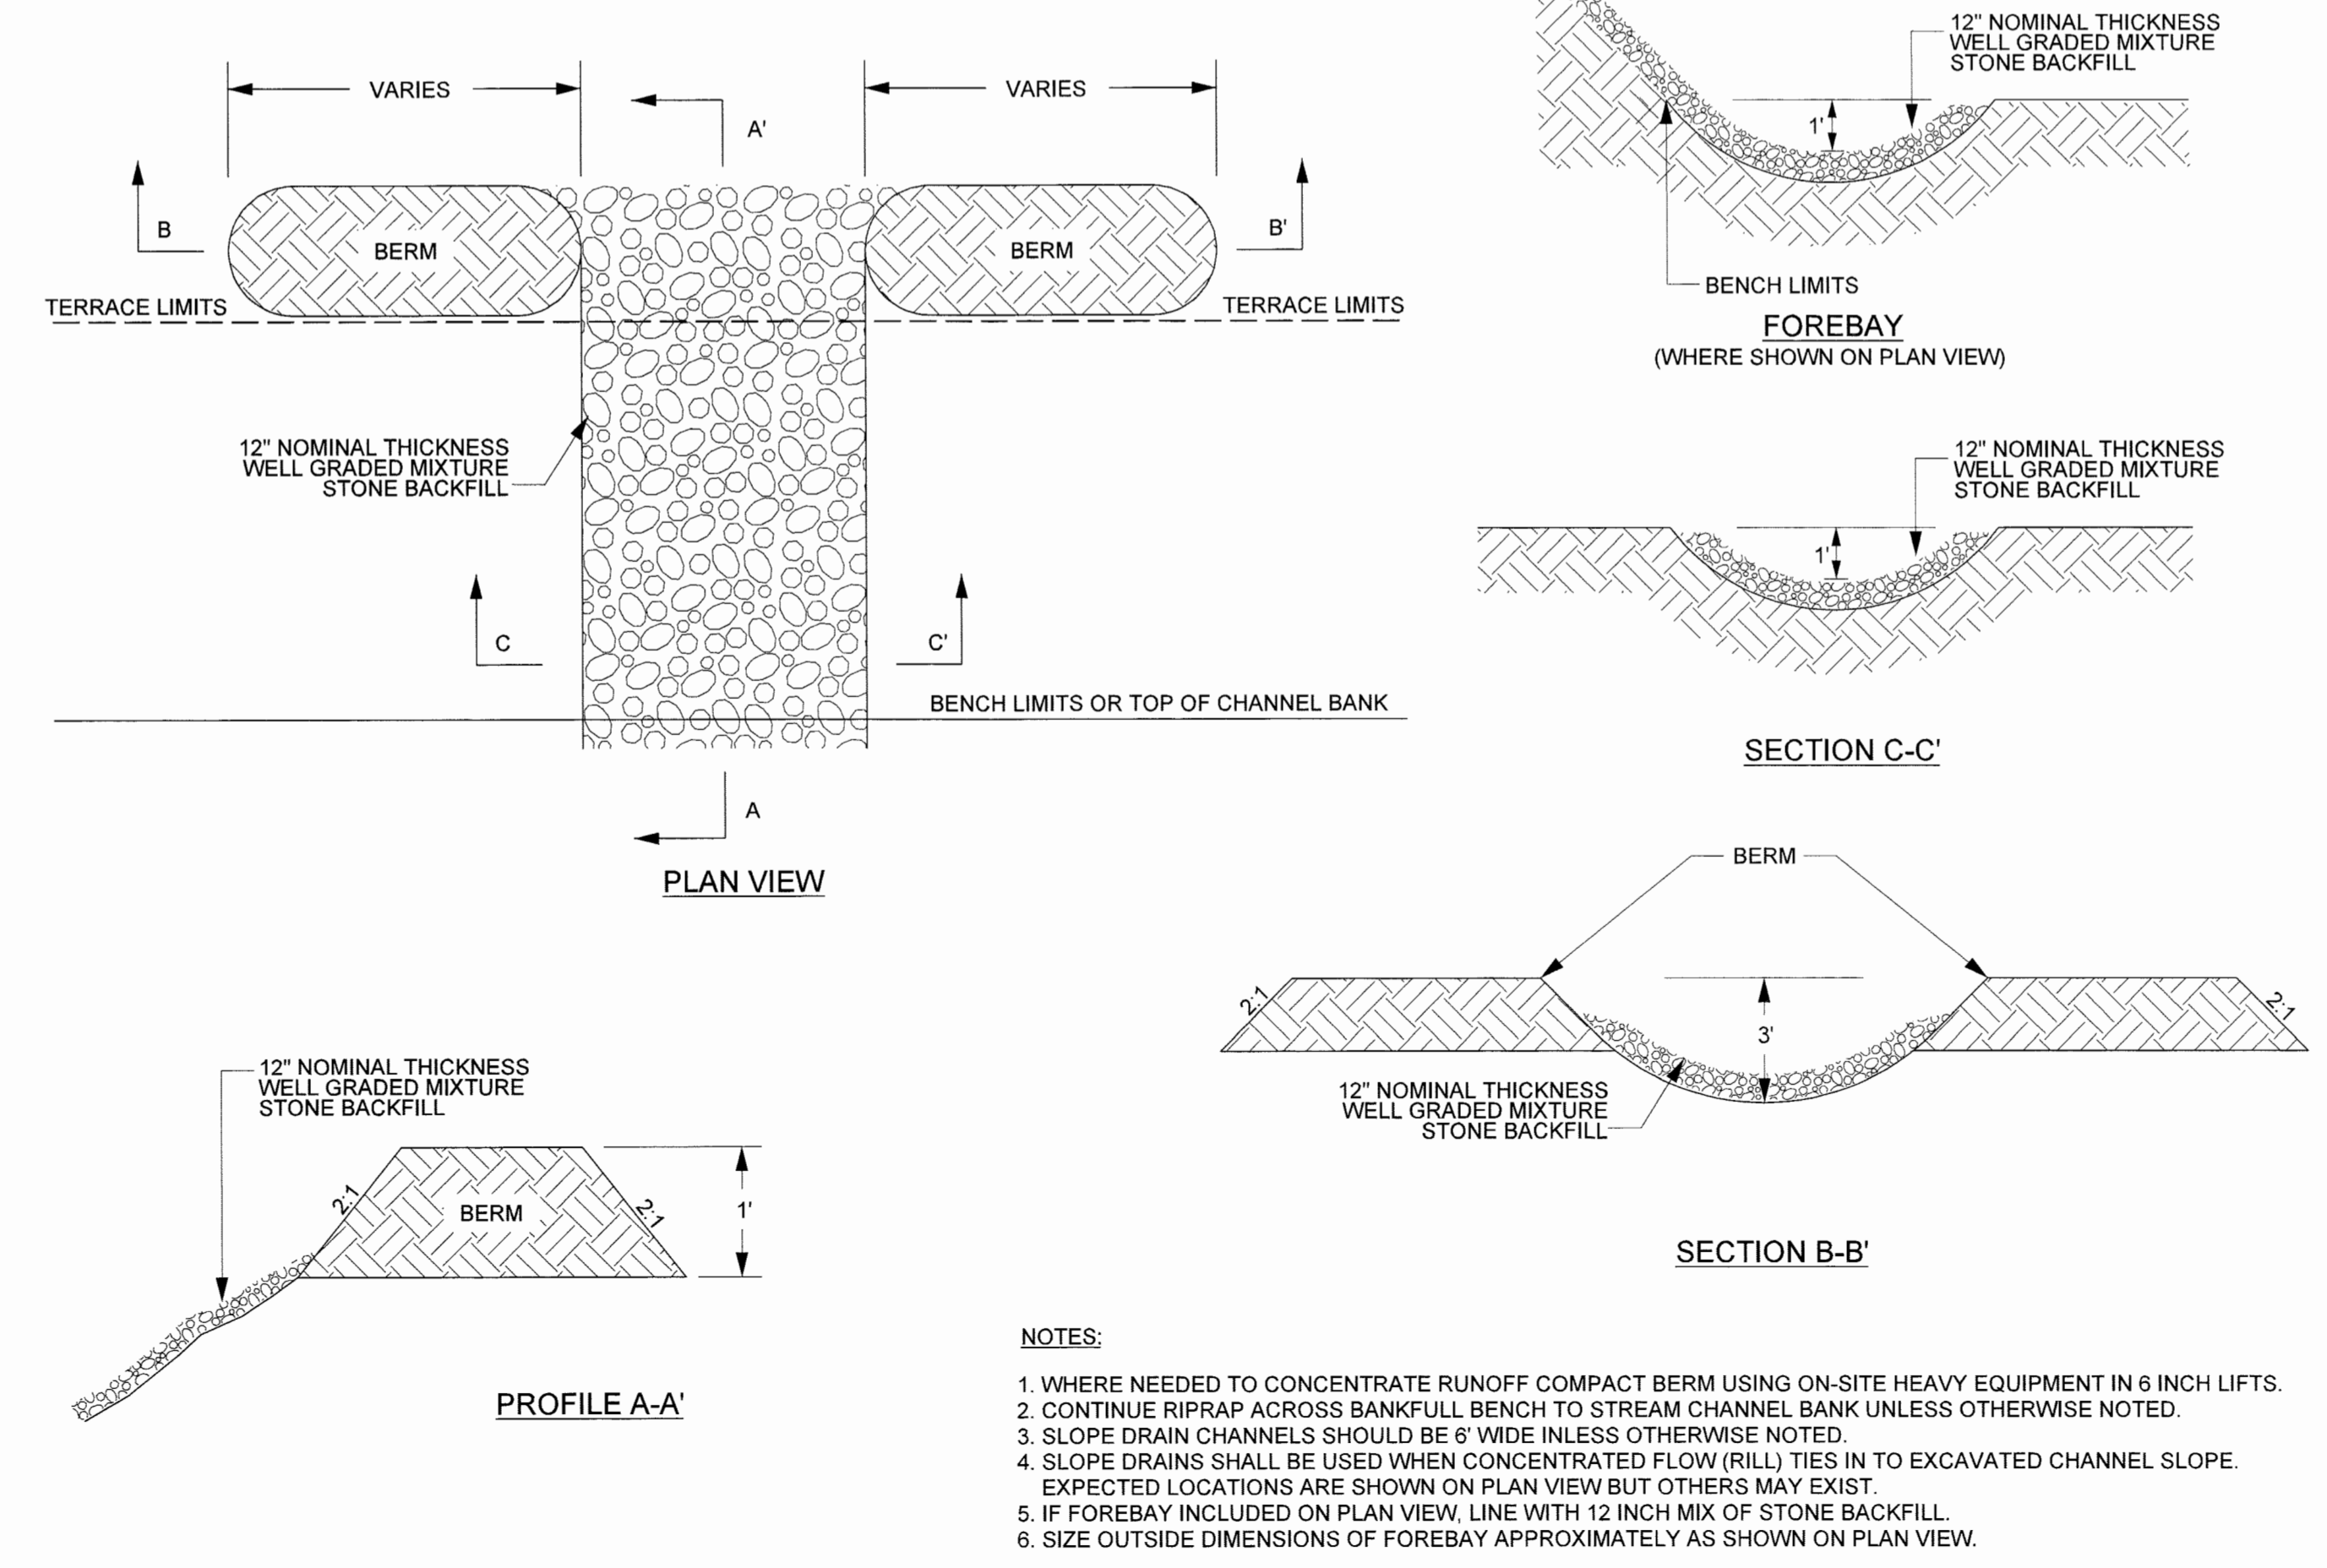
- NOTES:**
1. WHERE NEEDED TO CONCENTRATE RUNOFF COMPACT BERM USING ON-SITE HEAVY EQUIPMENT IN 6 INCH LIFTS.
 2. CONTINUE RIPRAP ACROSS BANKFULL BENCH TO STREAM CHANNEL BANK UNLESS OTHERWISE NOTED.
 3. SLOPE DRAIN CHANNELS SHOULD BE 6' WIDE UNLESS OTHERWISE NOTED.
 4. SLOPE DRAINS SHALL BE USED WHEN CONCENTRATED FLOW (RILL) TIES IN TO EXCAVATED CHANNEL SLOPE. EXPECTED LOCATIONS ARE SHOWN ON PLAN VIEW BUT OTHERS MAY EXIST.
 5. IF FOREBAY INCLUDED ON PLAN VIEW, LINE WITH 12 INCH MIX OF STONE BACKFILL.
 6. SIZE OUTSIDE DIMENSIONS OF FOREBAY APPROXIMATELY AS SHOWN ON PLAN VIEW.

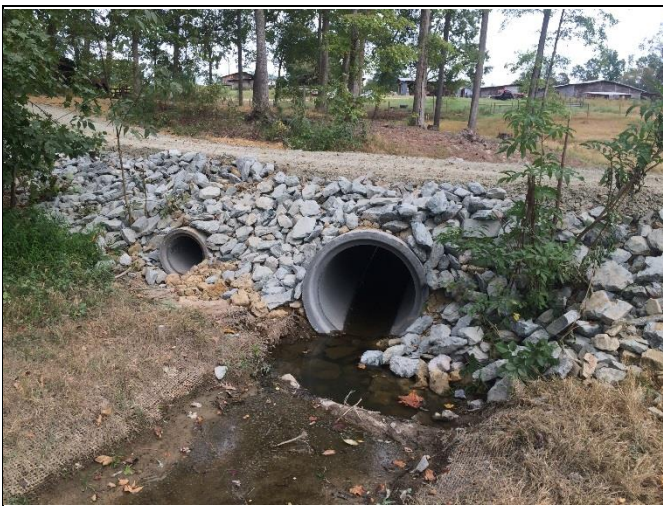
Reach 3, view downstream at pipe crossing, Station 18+50

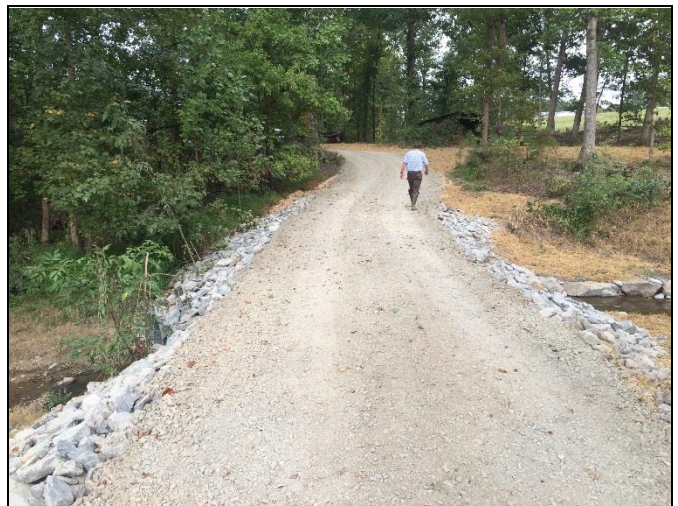
Reach 3, stream crossing, Station 18+80

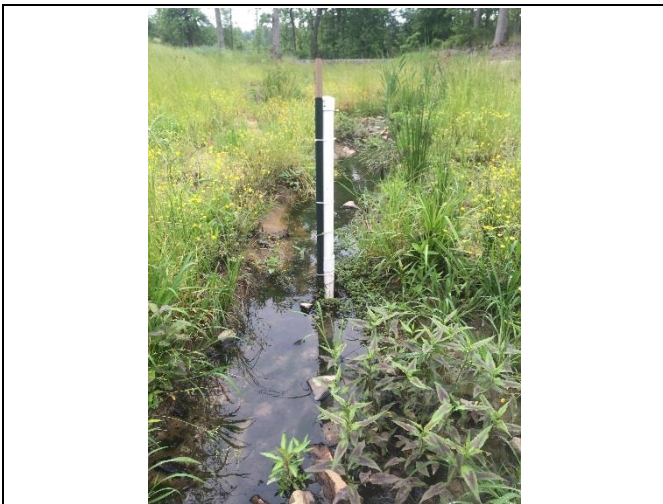
Reach 2, Flow Gauge #1 at Station 20+75

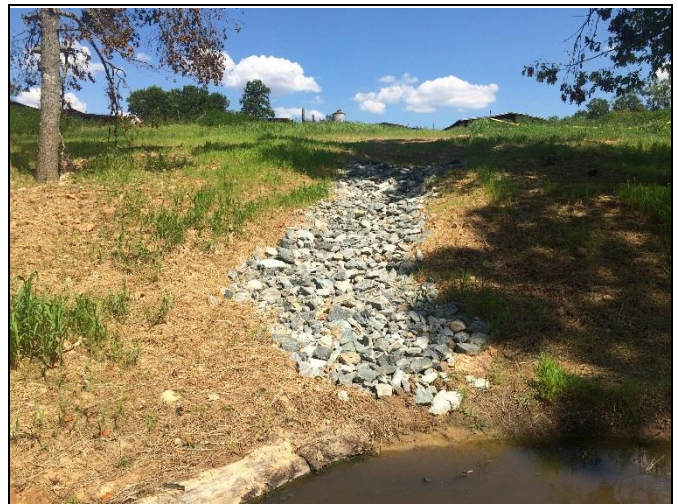
Reach 2, view of stabilized drainage on left bank at Station 20+80

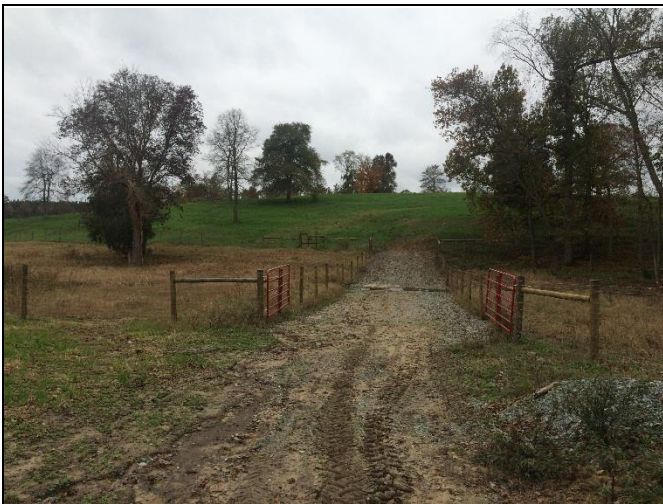
Reach 2, view of crossing at Station 27+75

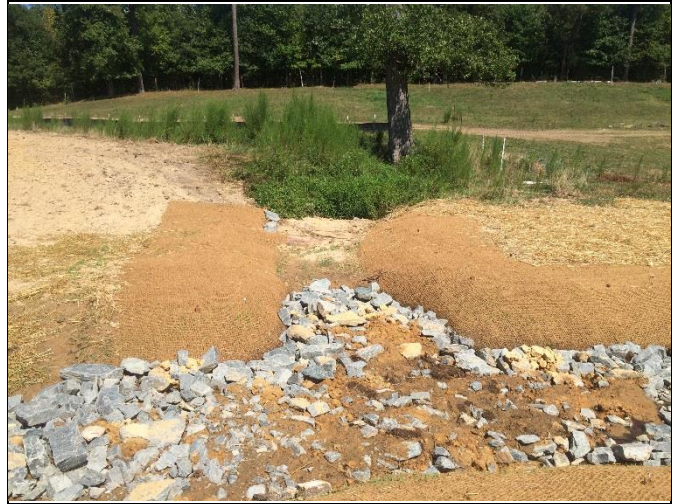
Reach 2, view of drainage on left bank at Station 32+90

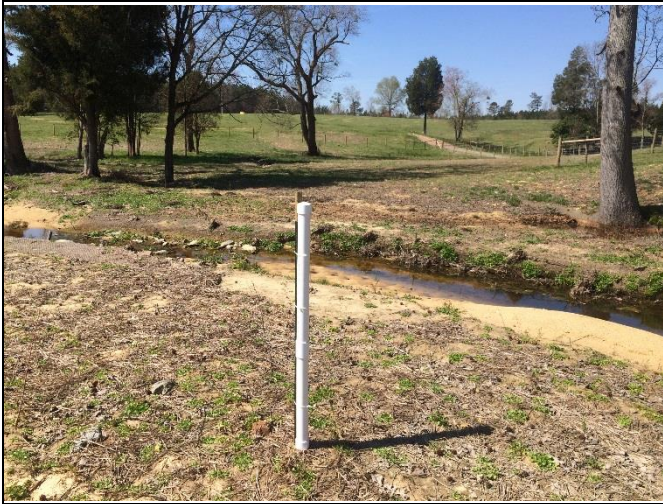
Reach 2, Crest Gauge at Station 38+75

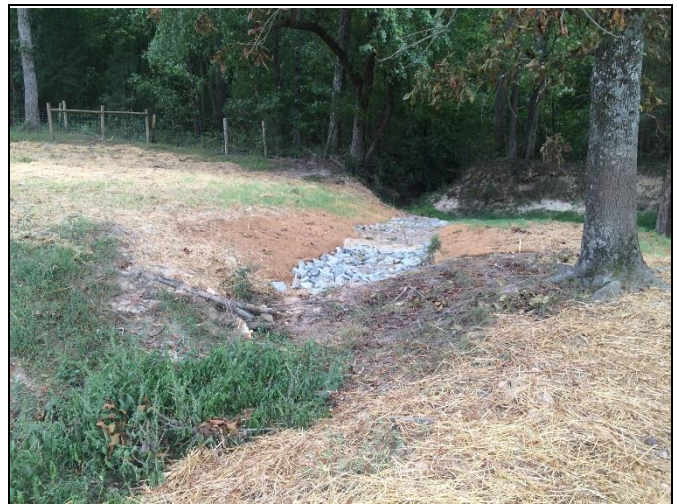
Reach 1, view of drainage on left bank at Station 44+00

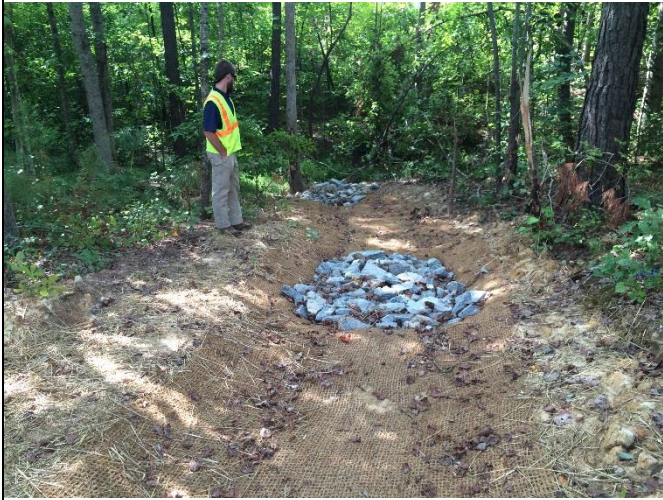
Reach 7, view of stabilized drainage at Station 13+50

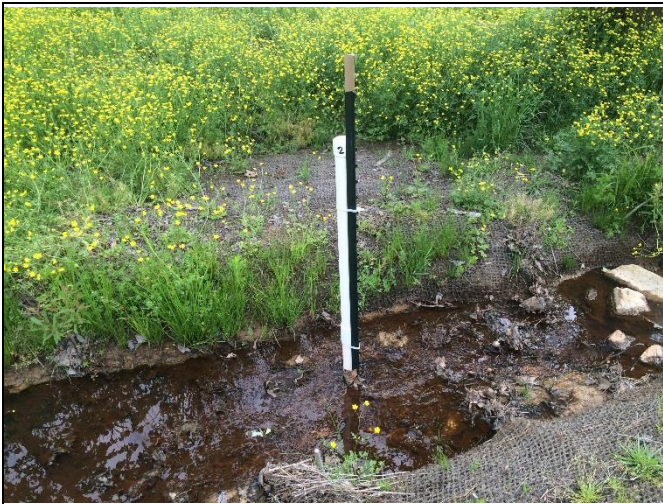
Reach 5, Flow Gauge #2 at Station 33+90

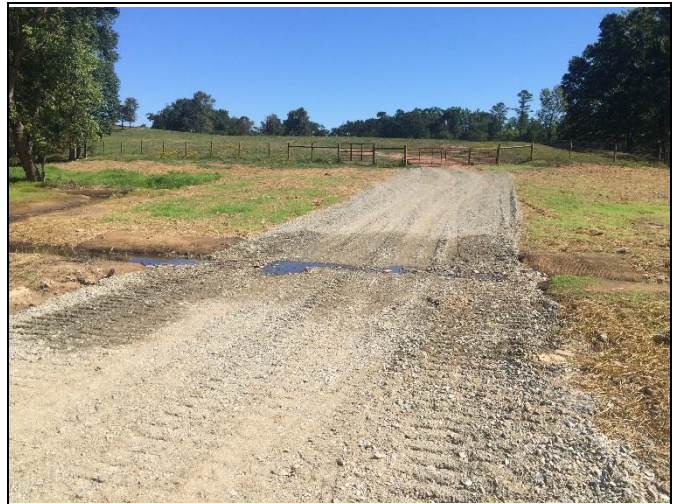
Reach 5, Rock Crossing at Station 35+00
