MONITORING YEAR 0 ANNUAL REPORT

BANNER FARM MITIGATION SITE

Henderson County, NC
French Broad River Basin
HUC 06010105

DMS Project No. 100062

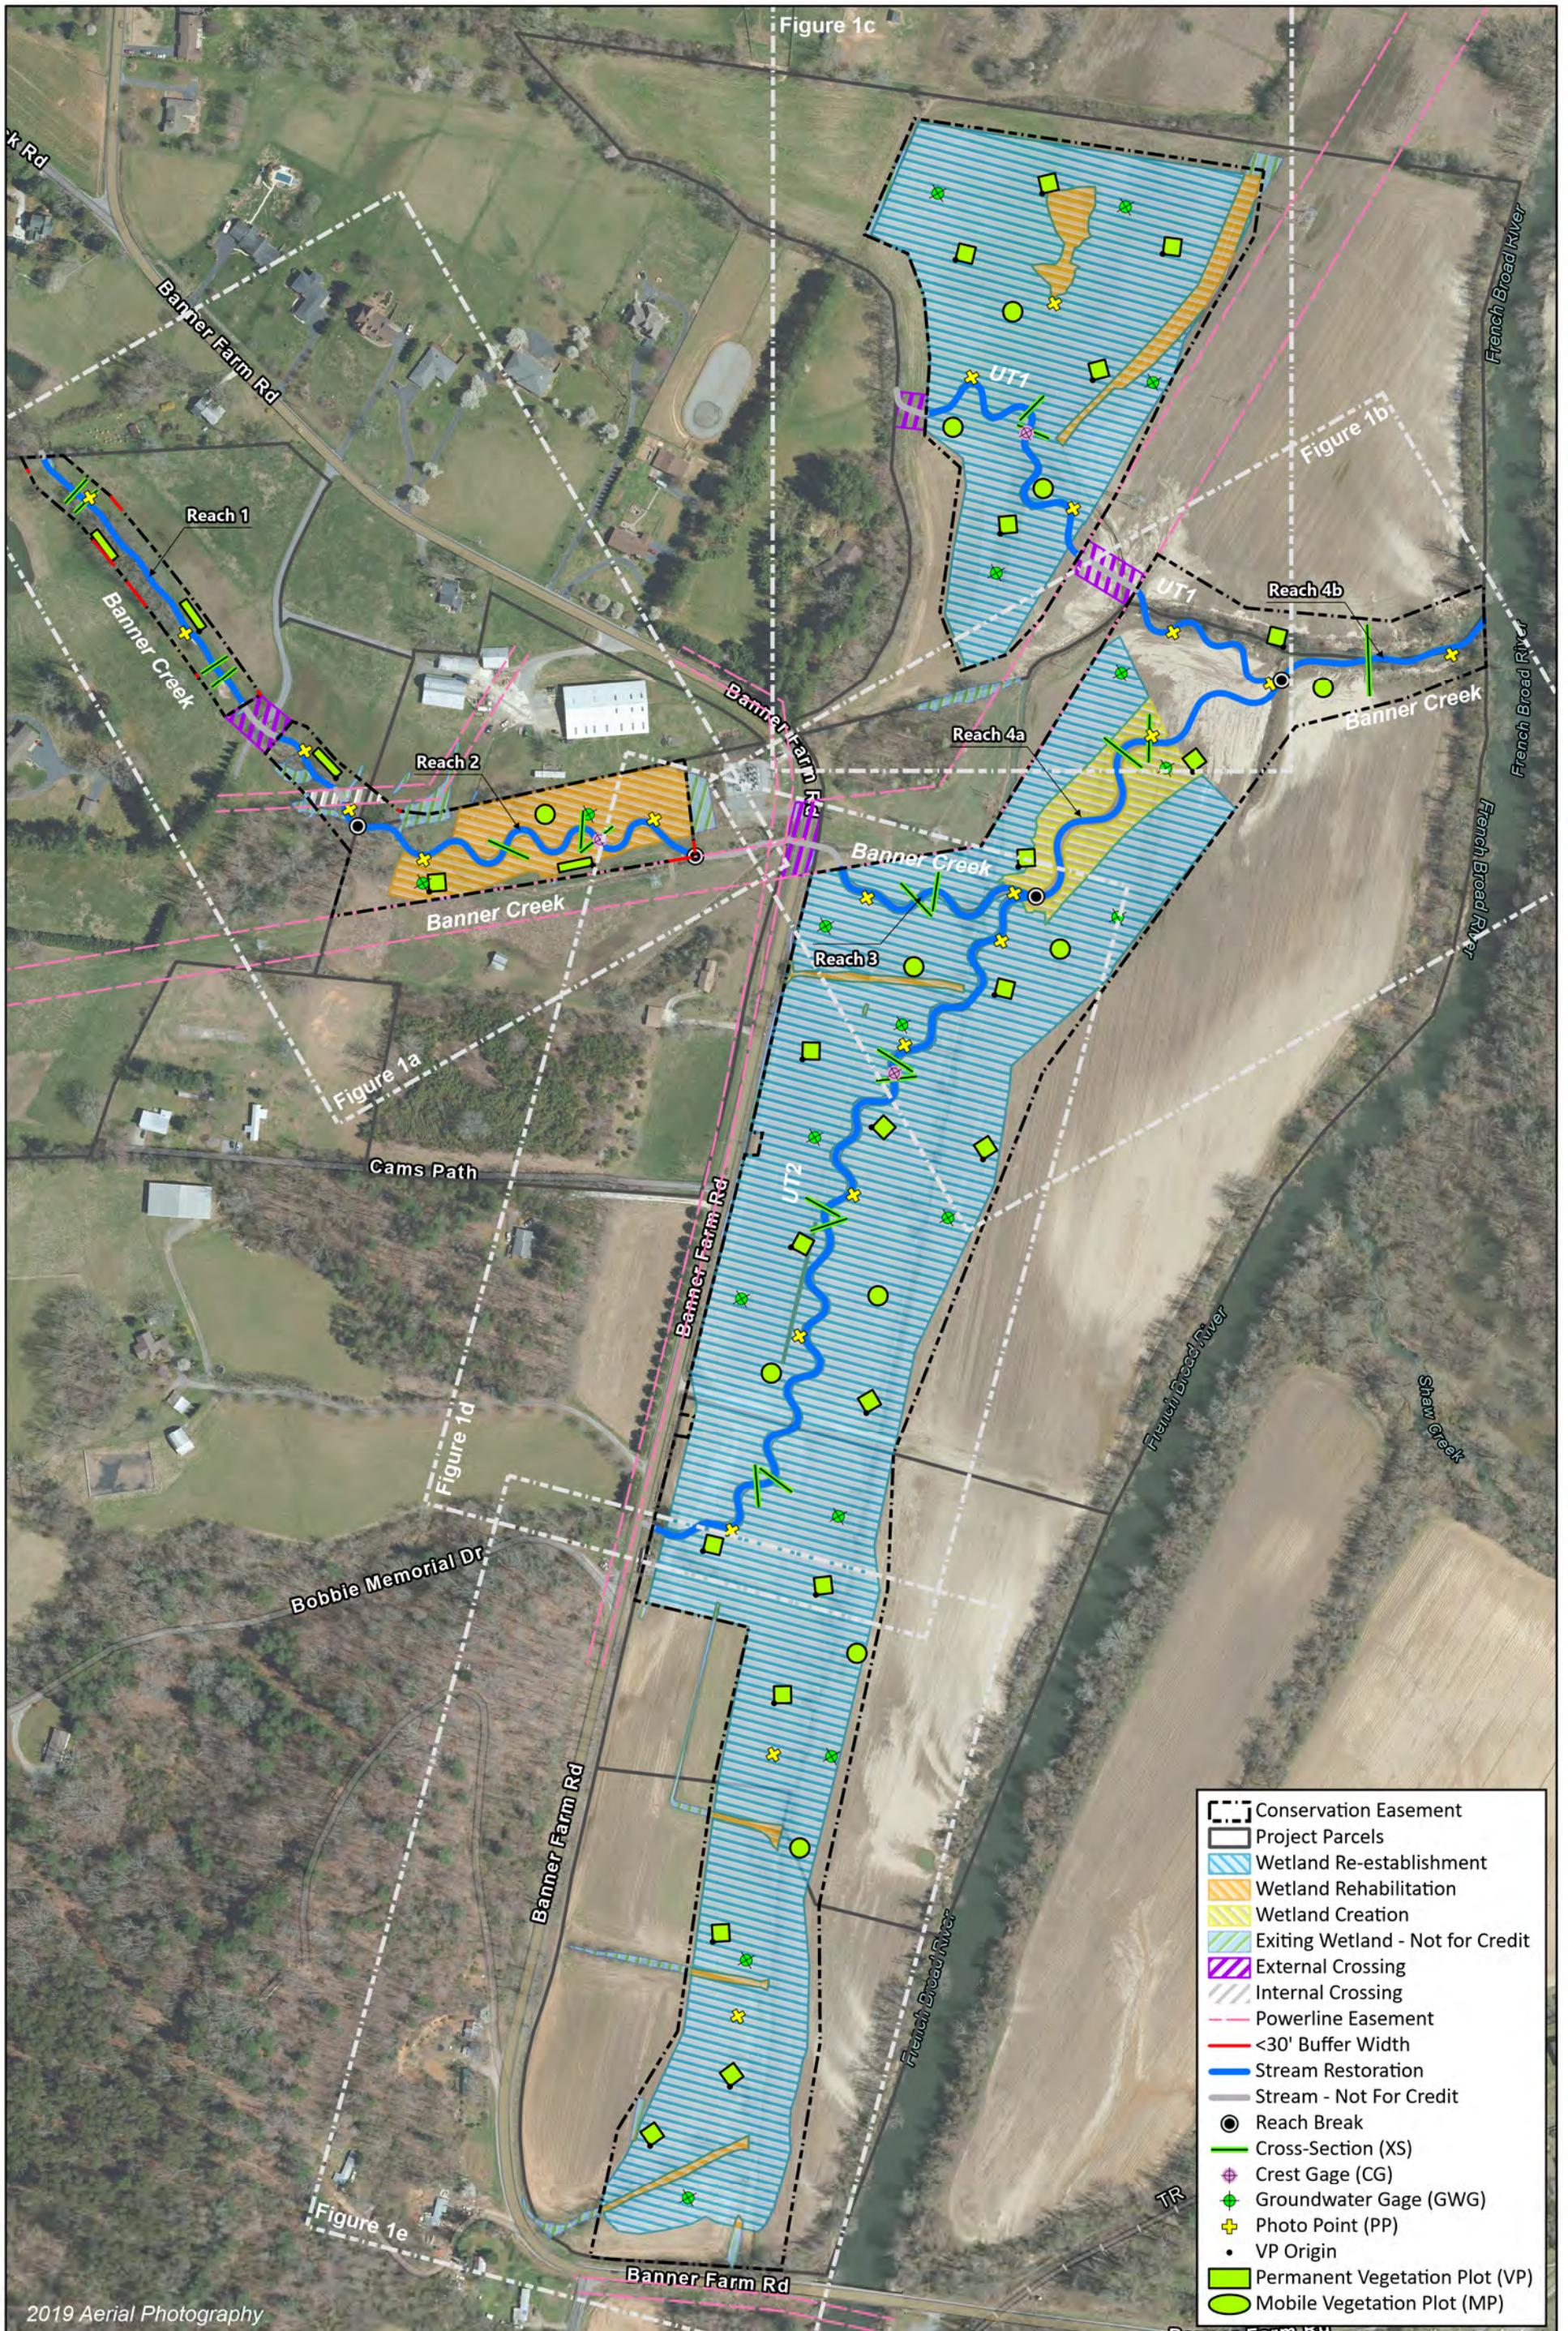
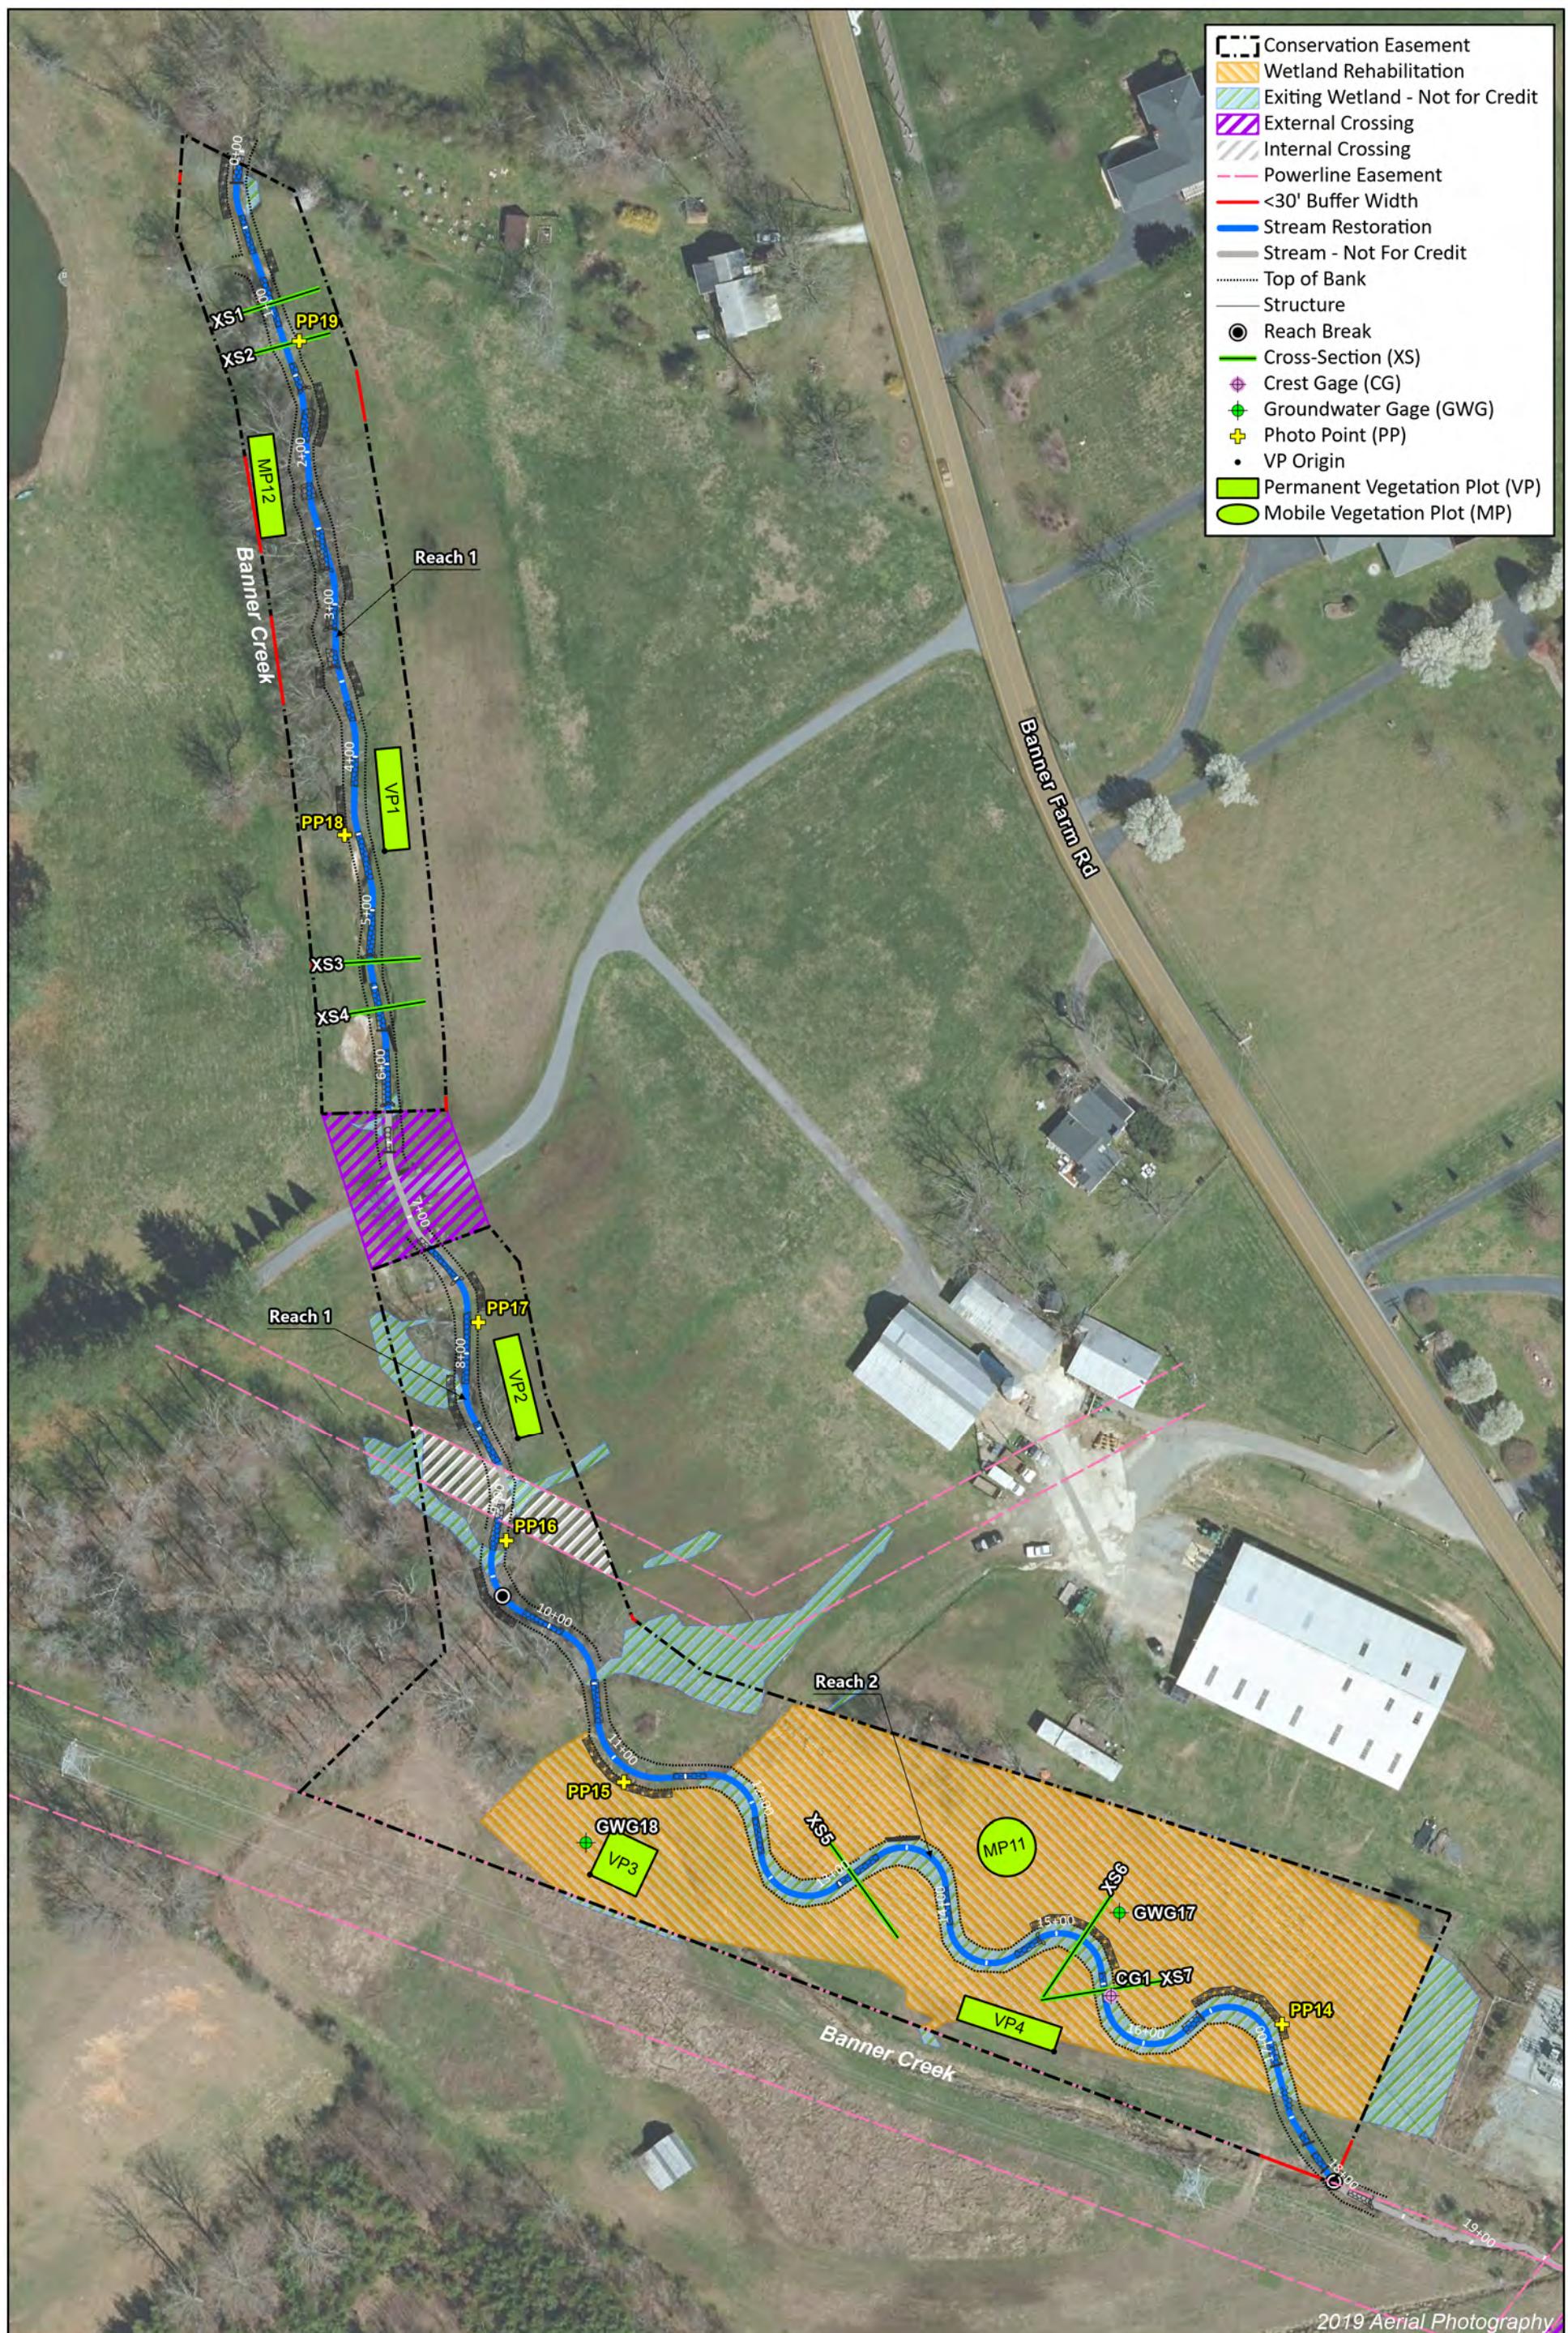
Figure 1a Monitoring Plan View Map
Banner Farm Mitigation Site
DMS Project No. 100062
Monitoring Year 0 - 2022
Henderson County, NC

□ Conservation Easement
▨ Wetland Rehabilitation
▨ Existing Wetland - Not for Credit
▨ External Crossing
▨ Internal Crossing
- Powerline Easement
— <30' Buffer Width
— Stream Restoration
— Stream - Not For Credit
— Top of Bank
— Structure
● Reach Break
— Cross-Section (XS)
◆ Crest Gage (CG)
◆ Groundwater Gage (GWG)
◆ Photo Point (PP)
• VP Origin
■ Permanent Vegetation Plot (VP)
○ Mobile Vegetation Plot (MP)

Figure 1a-e	Monitoring Plan View Maps
-------------	---------------------------

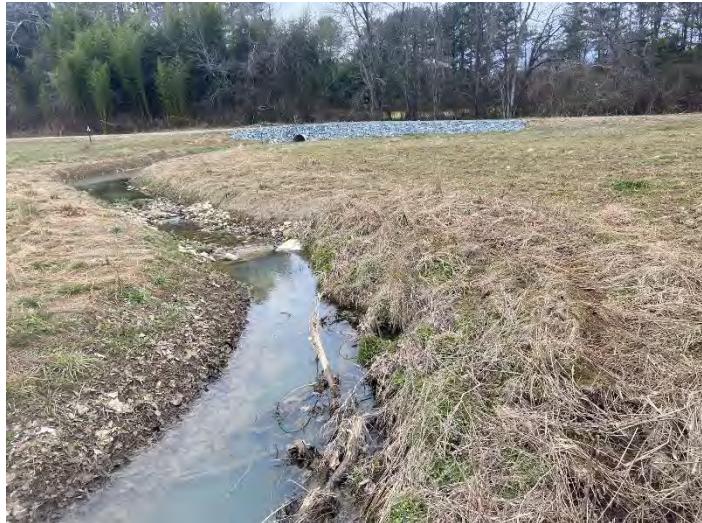
Photo Point 1 – UT1, view upstream (02/16/2022)

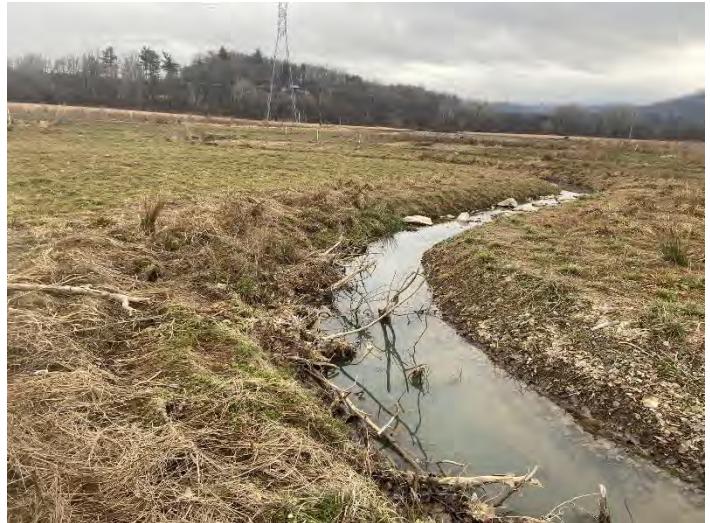
Photo Point 1 – UT1, view downstream (02/16/2022)

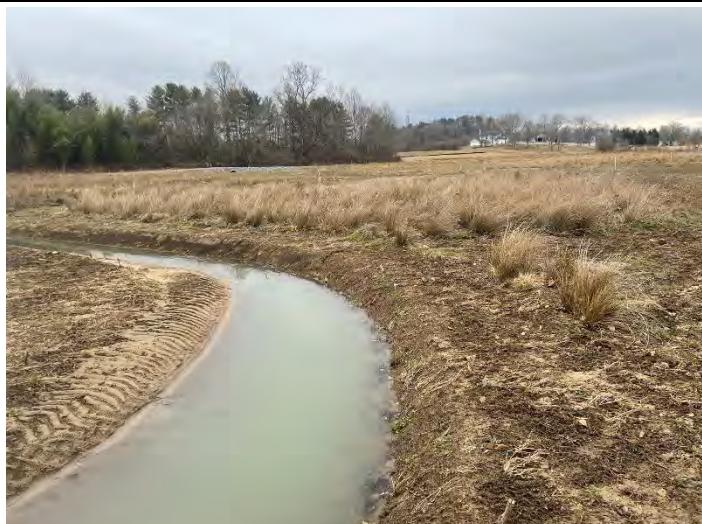
Photo Point 2 – UT1, view upstream (02/16/2022)

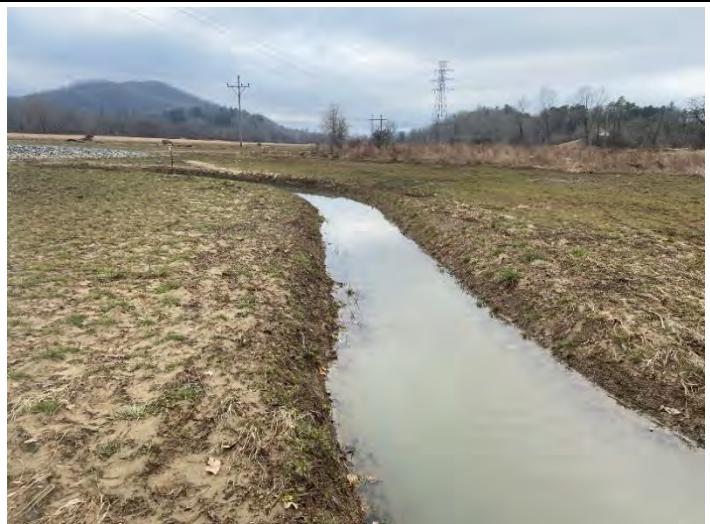
Photo Point 2 – UT1, view downstream (02/16/2022)

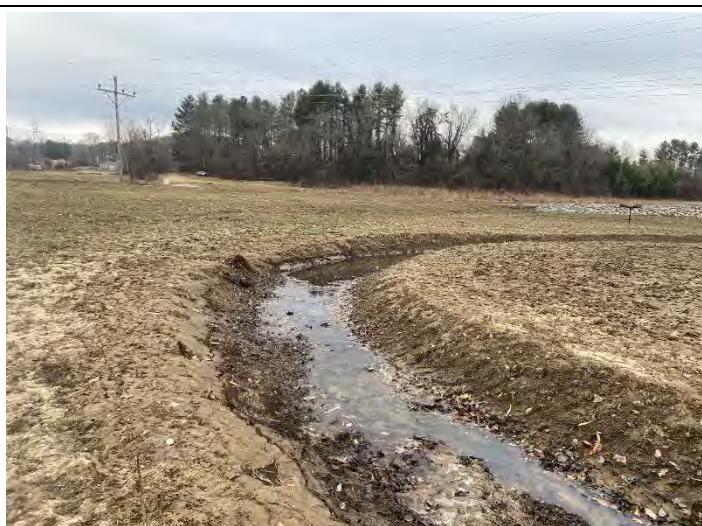
Photo Point 3 – UT1, view upstream (02/16/2022)

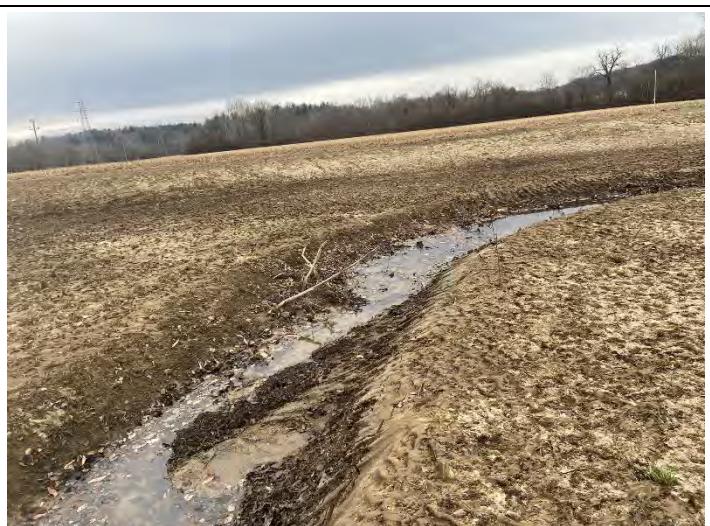
Photo Point 3 – UT1, view downstream (02/16/2022)

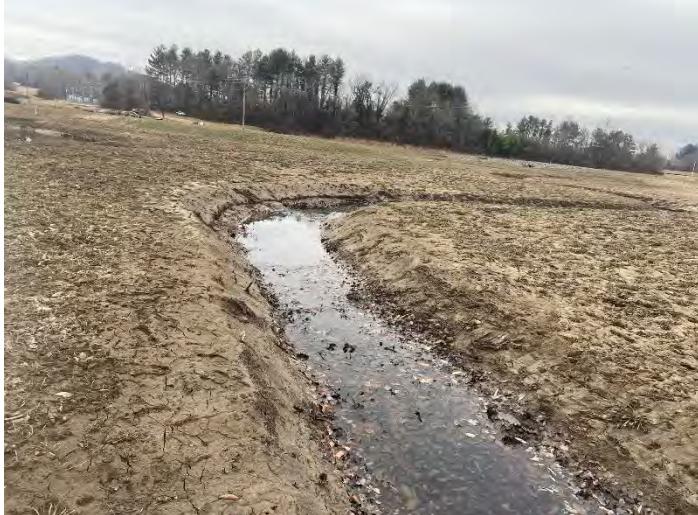
Photo Point 4 – UT1, view upstream (02/16/2022)

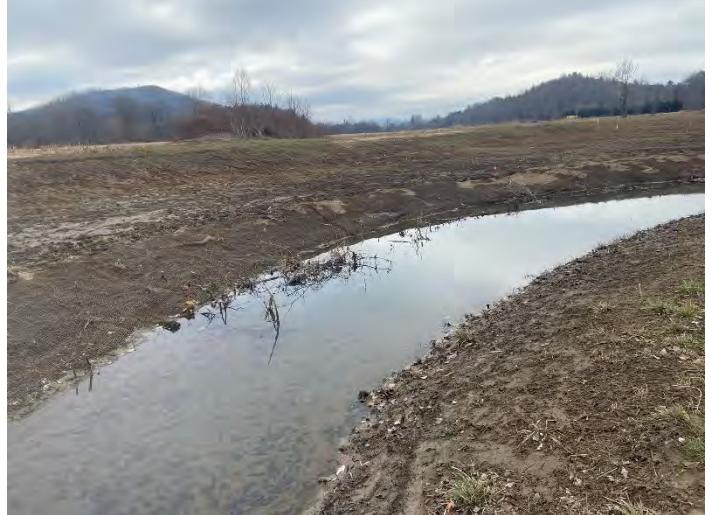
Photo Point 4 – Banner Creek R4a, view upstream (02/16/2022)

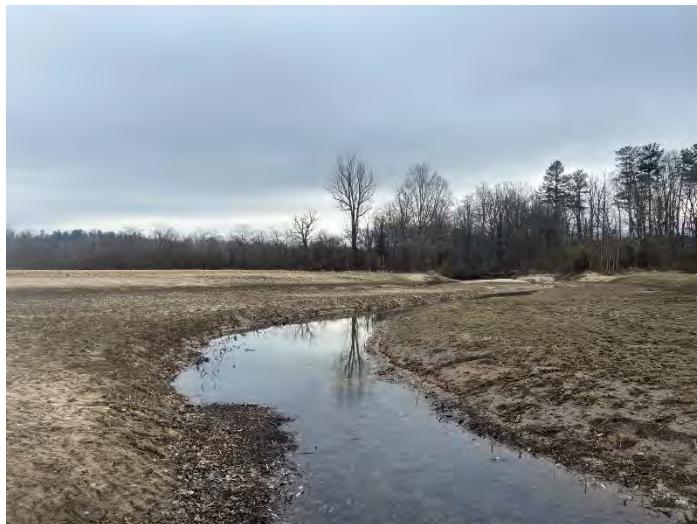
Photo Point 4 – Banner Creek R4b, view downstream (02/16/2022)

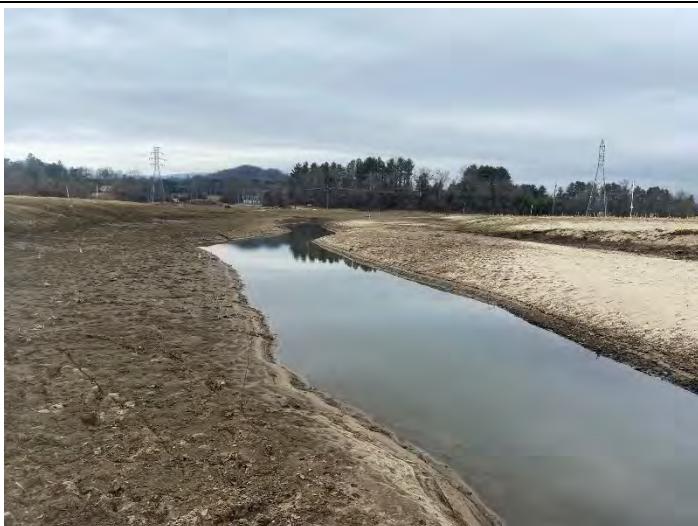
Photo Point 5 – Banner Creek R4b, view upstream (02/16/2022)

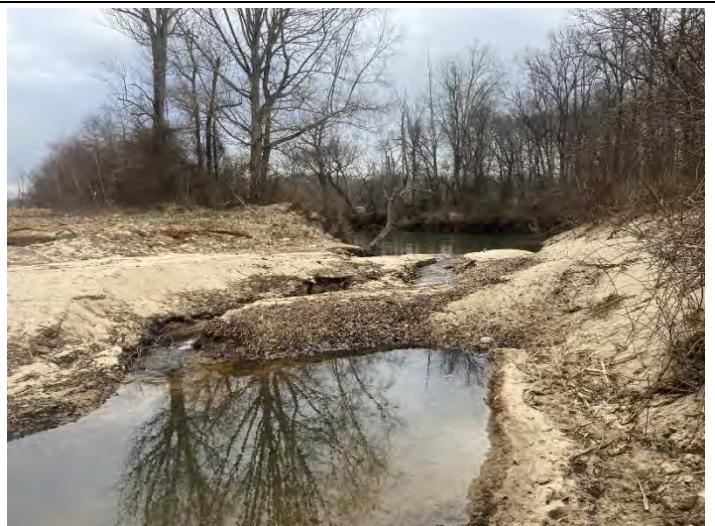
Photo Point 5 – Banner Creek R4b, view downstream (02/16/2022)

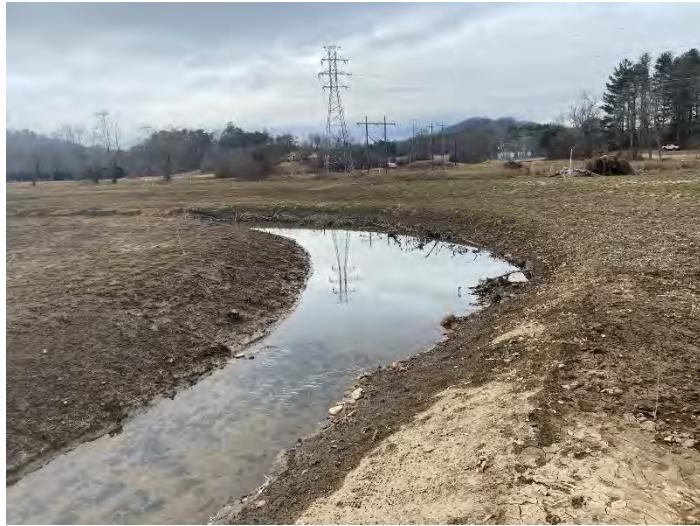
Photo Point 6 – Banner Creek R4a, view upstream (02/16/2022)

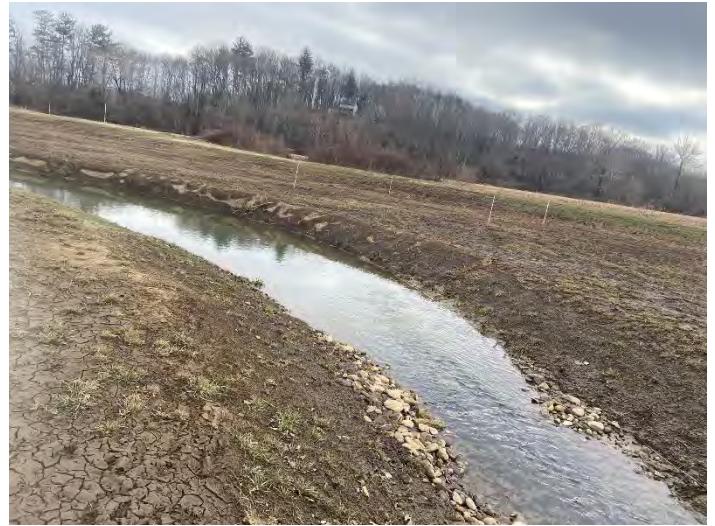
Photo Point 6 – Banner Creek R4a, view downstream (02/16/2022)

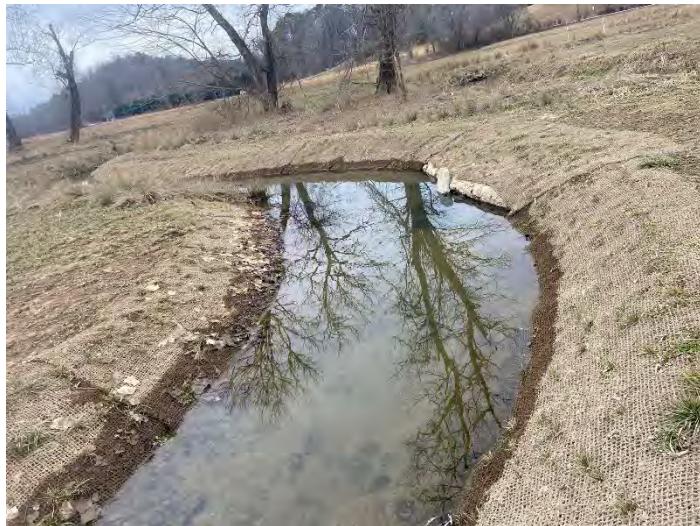
Photo Point 7 – UT2, view upstream (02/16/2022)

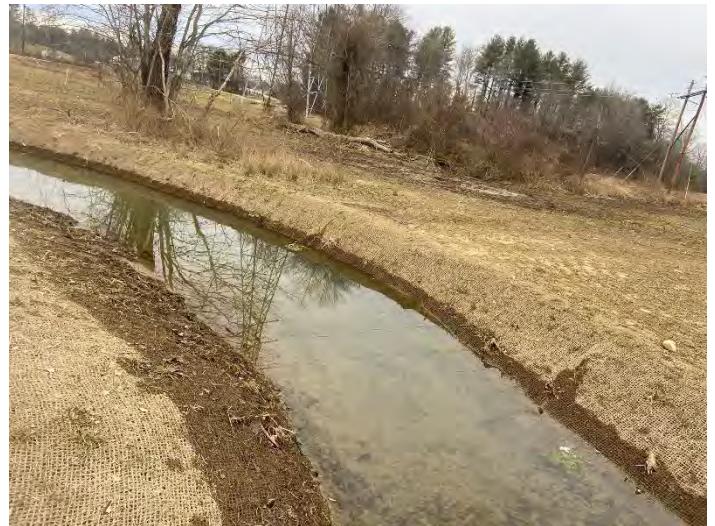
Photo Point 7 – Banner Creek R3, view upstream (02/16/2022)

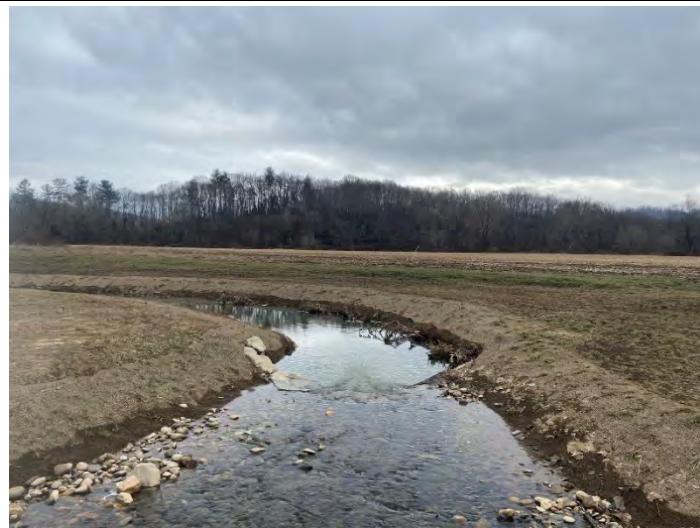
Photo Point 7 – Banner Creek R4a, view downstream (02/16/2022)

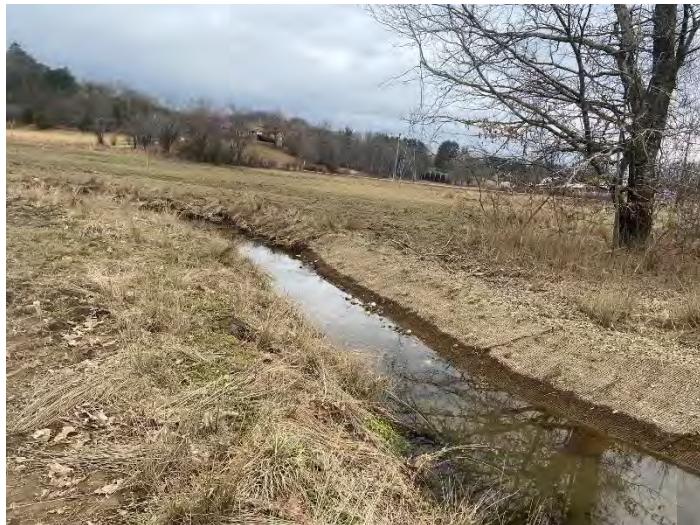
Photo Point 8 – UT2, view upstream (02/16/2022)

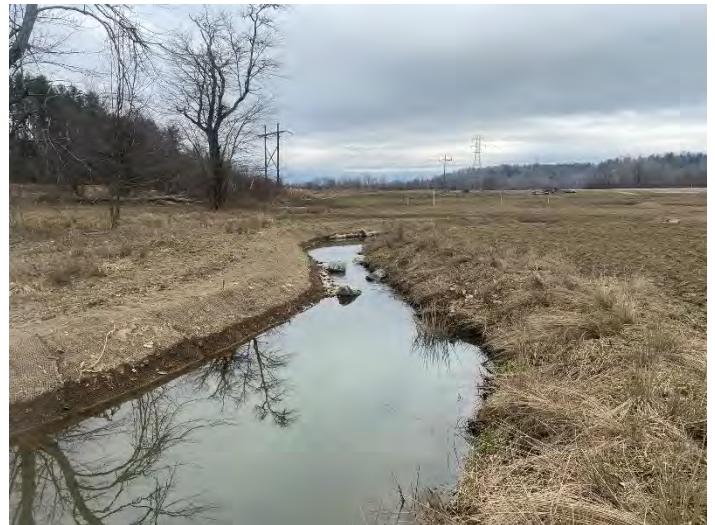
Photo Point 8 – UT2, view downstream (02/16/2022)

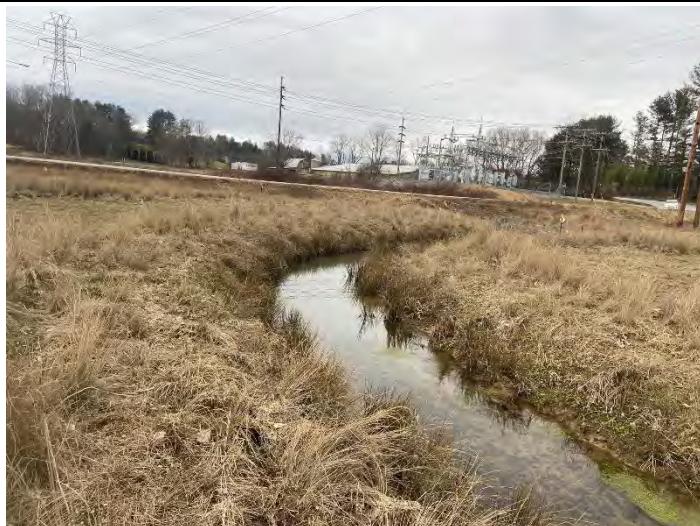
Photo Point 9 – Banner Creek R3, view upstream (02/16/2022)

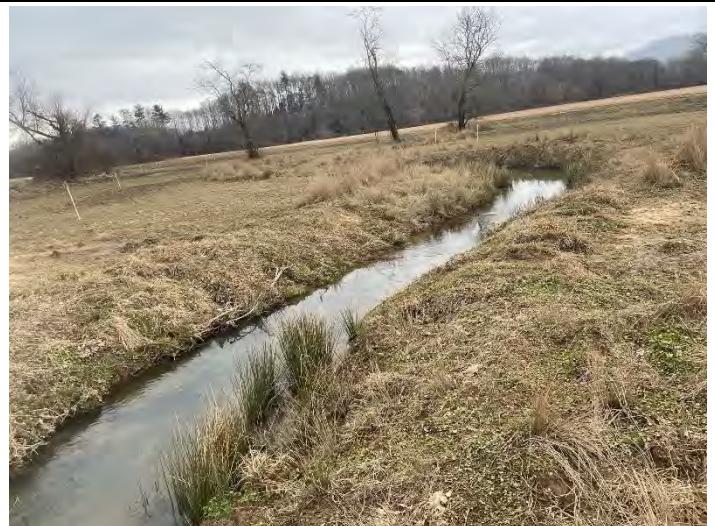
Photo Point 9 – Banner Creek R3, view downstream (02/16/2022)

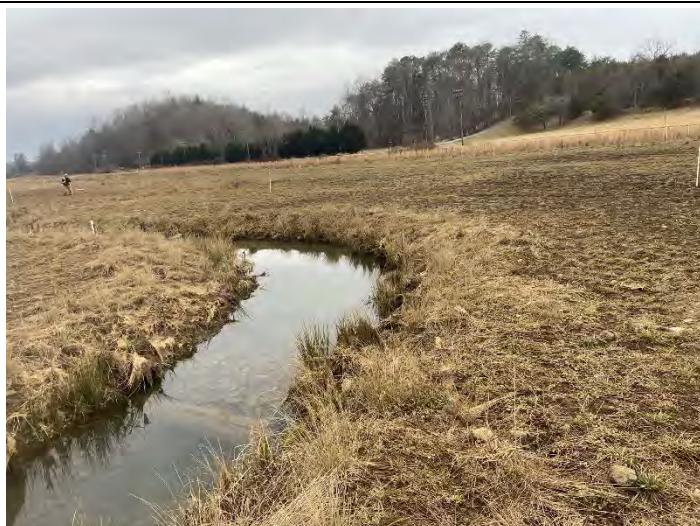
Photo Point 10 – UT2, view upstream (02/16/2022)

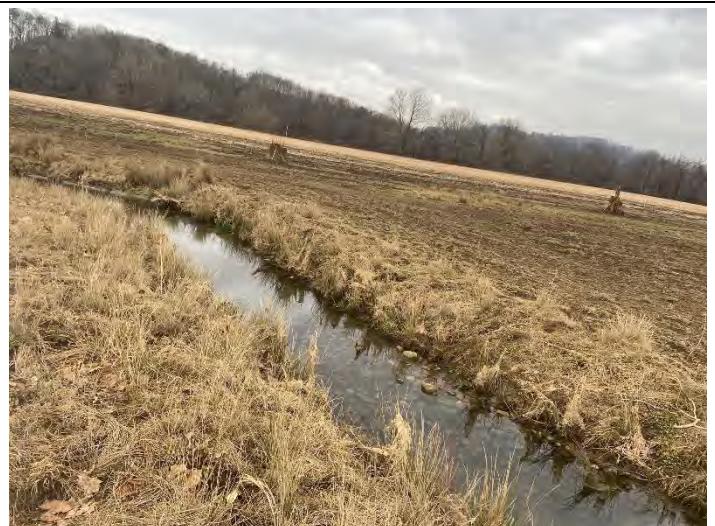
Photo Point 10 – UT2, view downstream (02/16/2022)

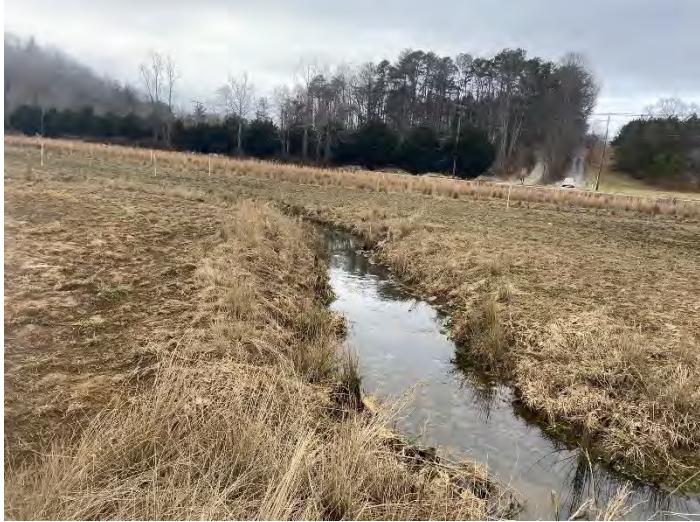
Photo Point 11 – UT2, view upstream (02/16/2022)

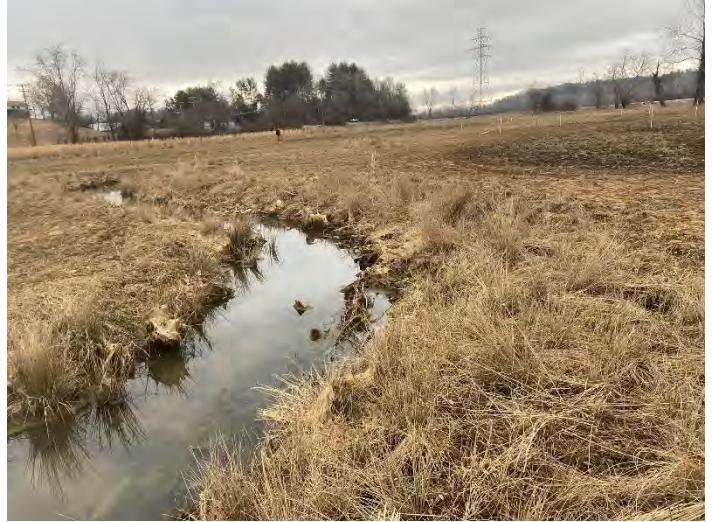
Photo Point 11 – UT2, view downstream (02/16/2022)

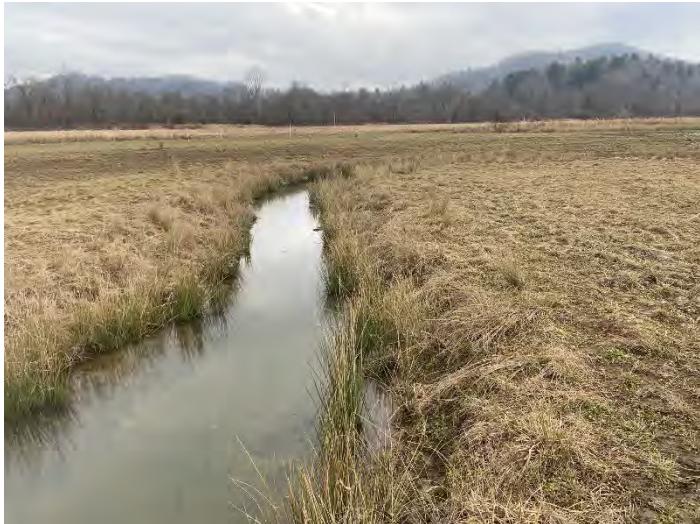
Photo Point 12 – UT2, view upstream (02/16/2022)

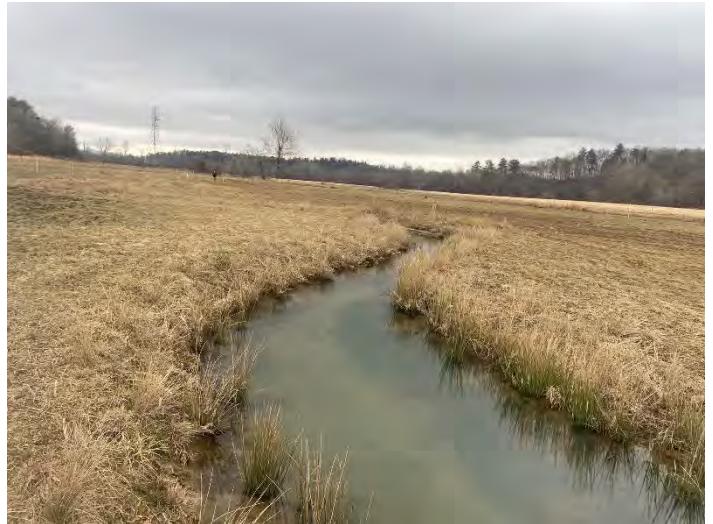
Photo Point 12 – UT2, view downstream (02/16/2022)

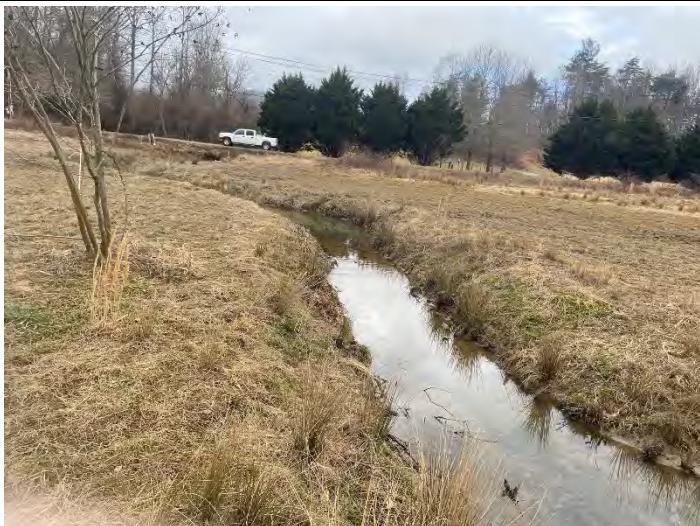
Photo Point 13 – UT2, view upstream (02/16/2022)

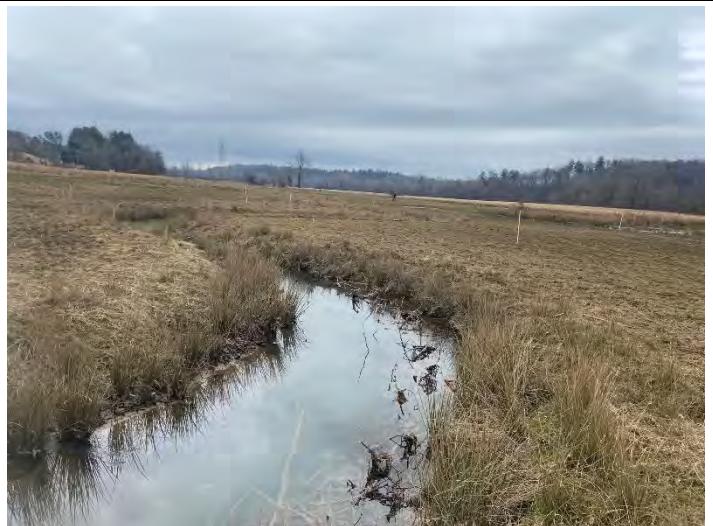
Photo Point 13 – UT2, view downstream (02/16/2022)

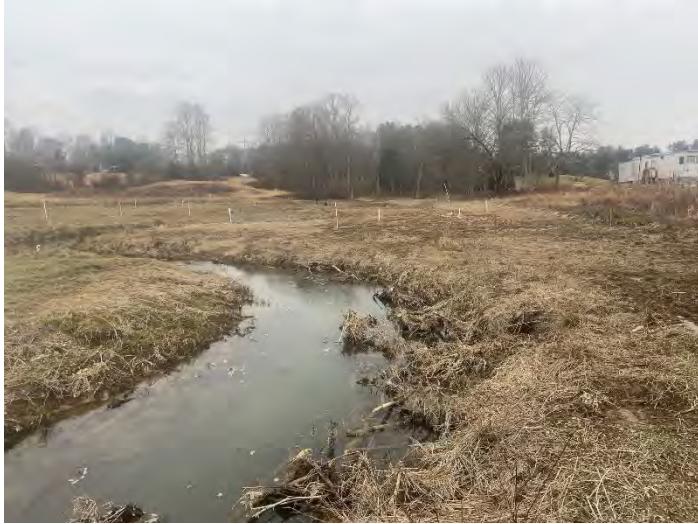
Photo Point 14 – Banner Creek R2, view upstream (02/16/2022)

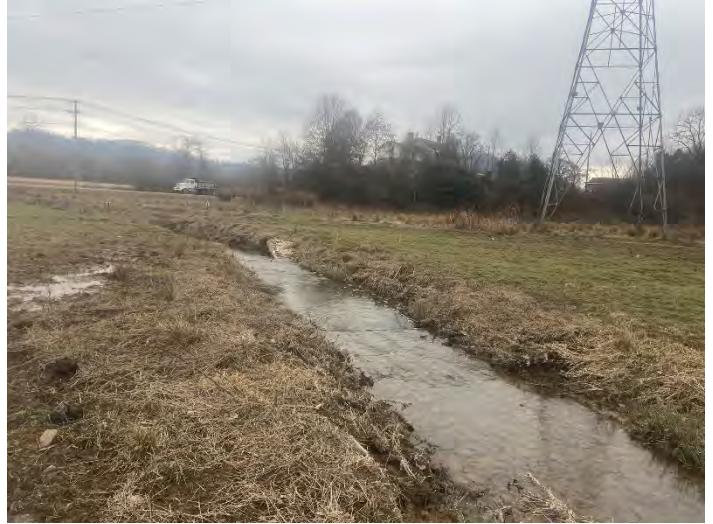
Photo Point 14 – Banner Creek R2, view downstream (02/16/2022)

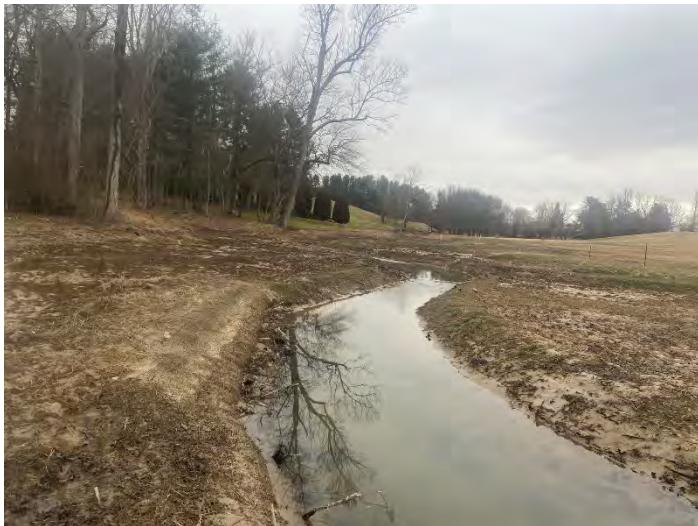
Photo Point 15 – Banner Creek R2, view upstream (02/16/2022)

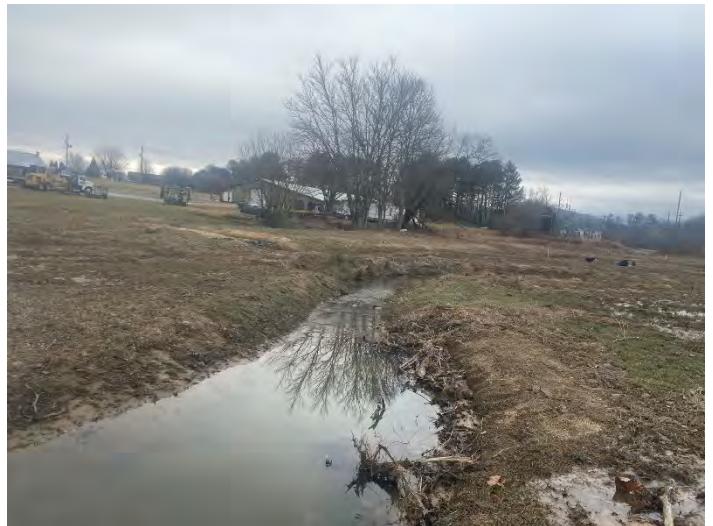
Photo Point 15 – Banner Creek R2, view downstream (02/16/2022)

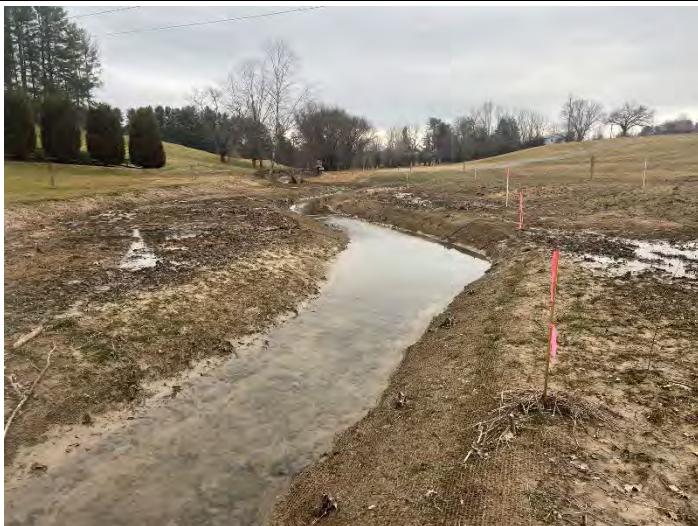
Photo Point 16 – Banner Creek R1, view upstream (02/16/2022)

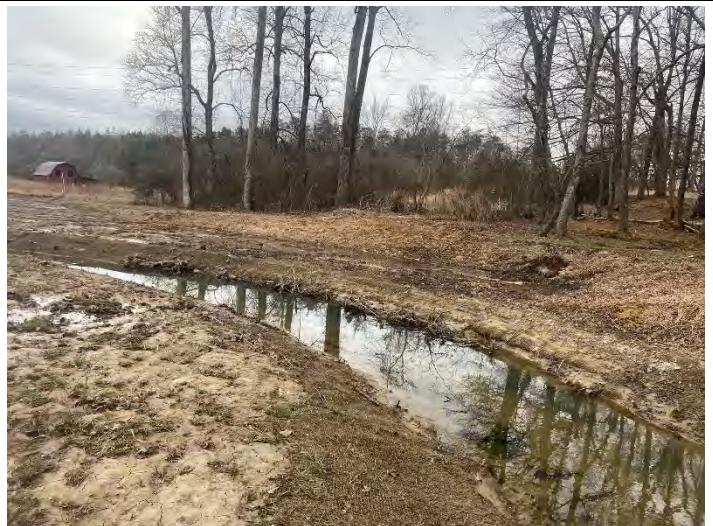
Photo Point 16 – Banner Creek R1, view downstream (02/16/2022)

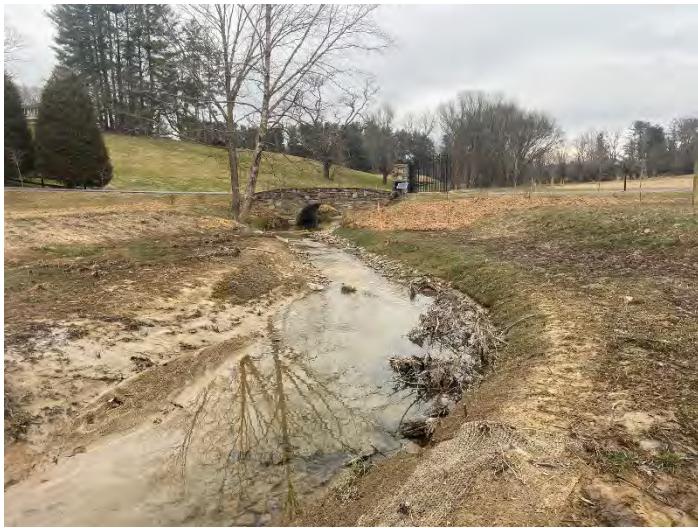
Photo Point 17 – Banner Creek R1, view upstream (02/16/2022)

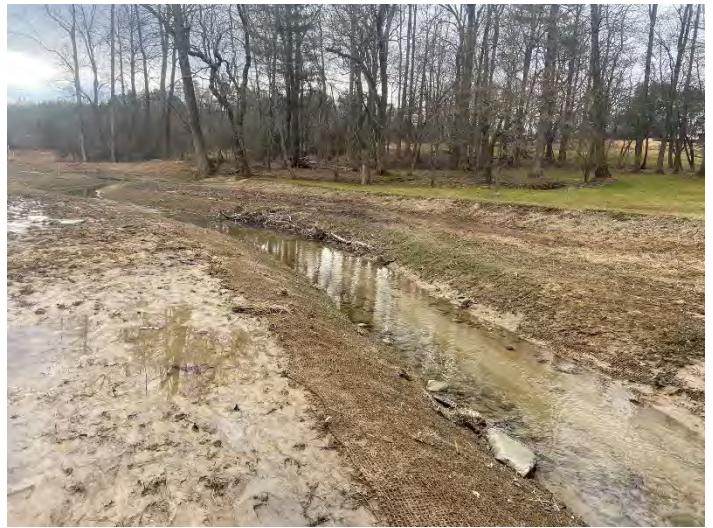
Photo Point 17 – Banner Creek R1, view downstream (02/16/2022)

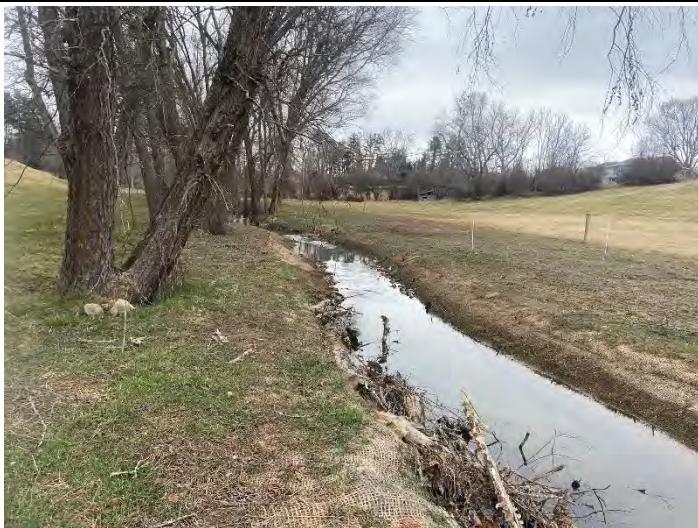
Photo Point 18 – Banner Creek R1, view upstream (02/16/2022)

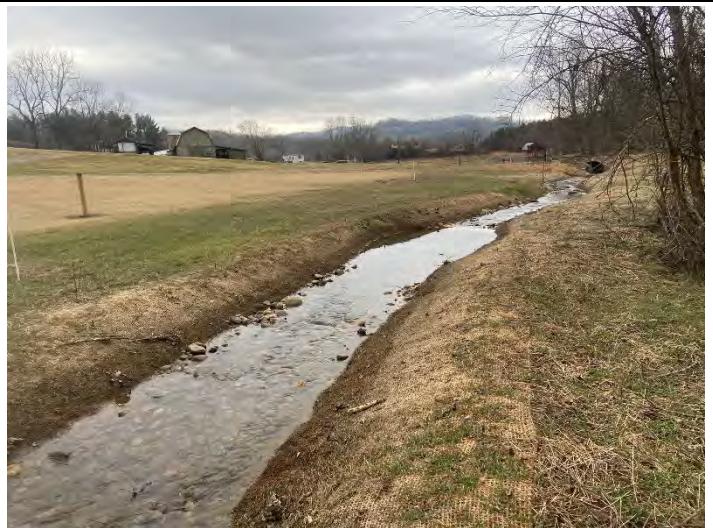
Photo Point 18 – Banner Creek R1, view downstream (02/16/2022)

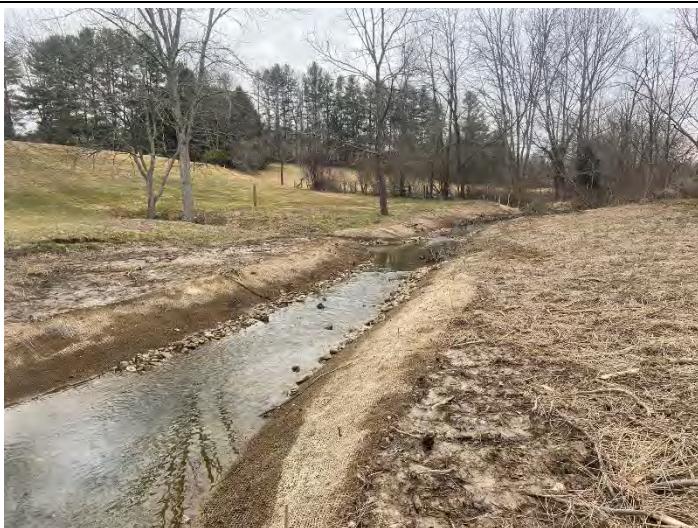
Photo Point 19 – Banner Creek R1, view upstream (02/16/2022)

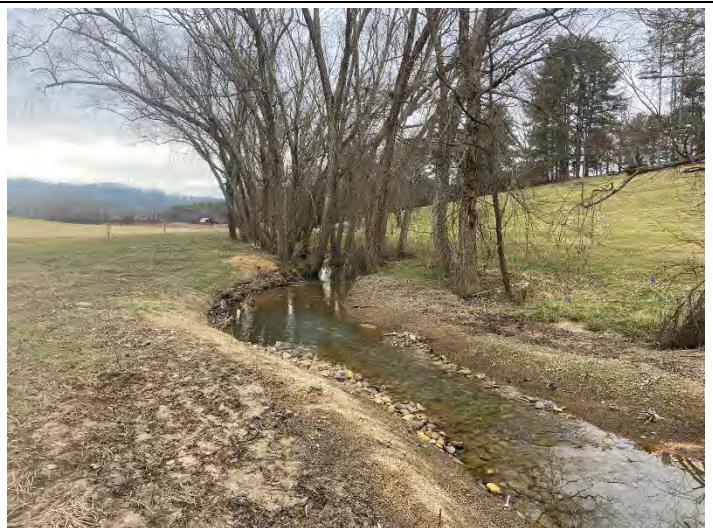
Photo Point 19 – Banner Creek R1, view downstream (02/16/2022)
