MONITORING YEAR 0 ANNUAL REPORT

BANNER FARM MITIGATION SITE

Henderson County, NC
French Broad River Basin
HUC 06010105

DMS Project No. 100062

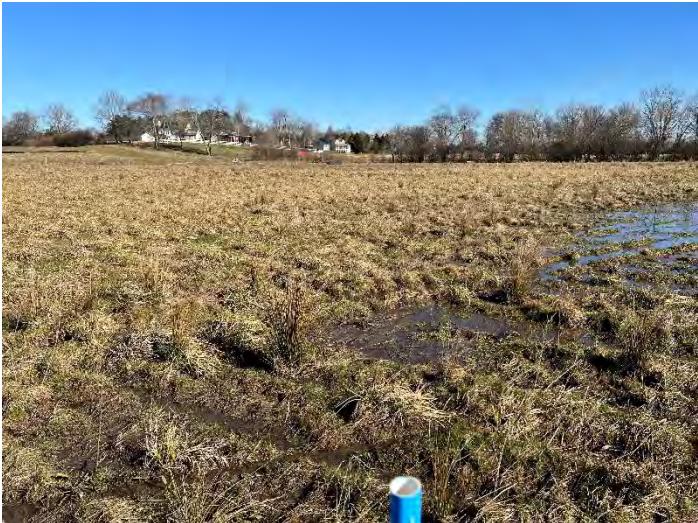
Photo Point 20 –
wetland rehabilitation/re-establishment area, view north (03/02/2022)

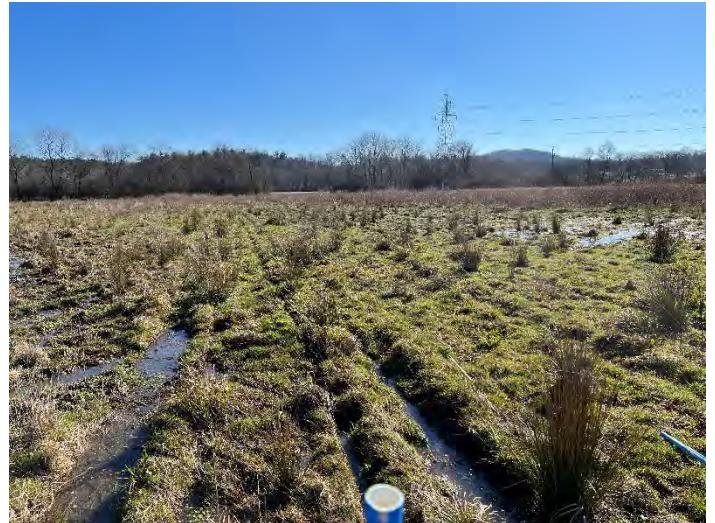
Photo Point 20 –
wetland rehabilitation/re-establishment area, view east (03/02/2022)

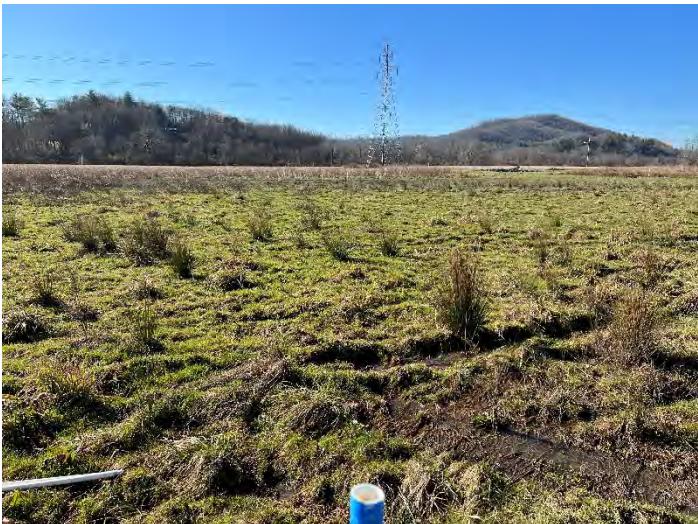
Photo Point 20 –
wetland re-establishment area, view south (03/02/2022)

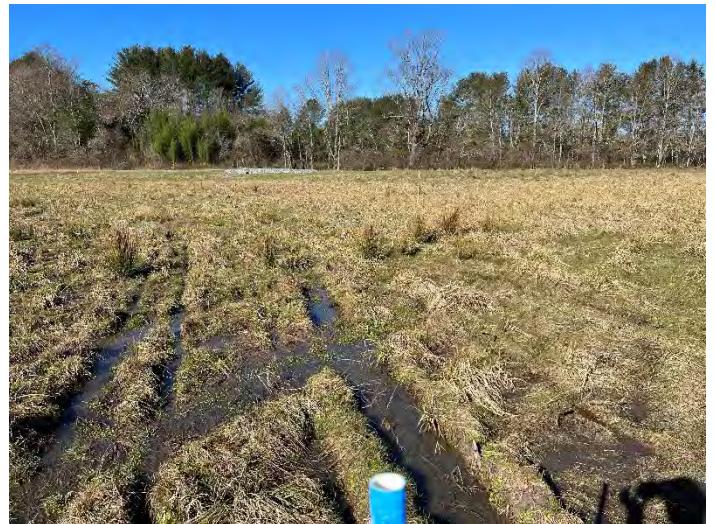
Photo Point 20 –
wetland re-establishment area, view west (03/02/2022)

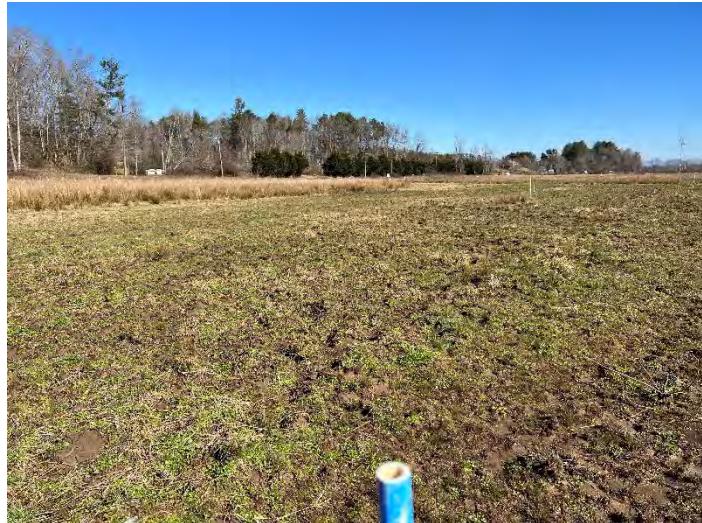
Photo Point 21 –
wetland re-establishment area, view north (03/02/2022)

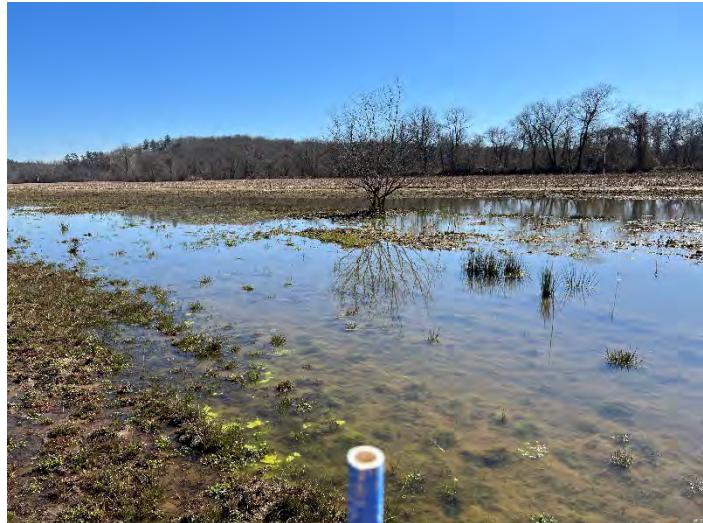
Photo Point 21 –
wetland re-establishment area, view east (03/02/2022)

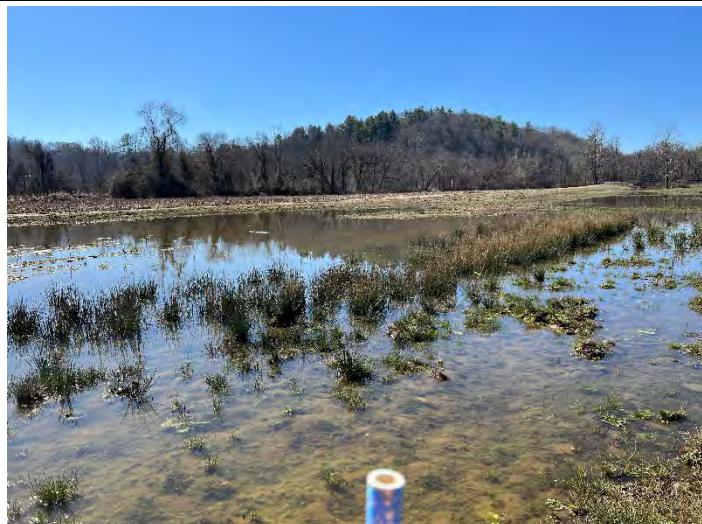
Photo Point 21 –
wetland re-establishment area, view south (03/02/2022)

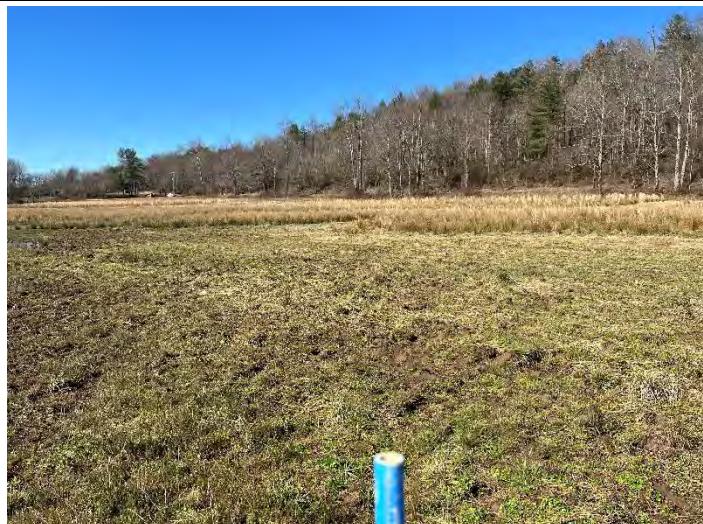
Photo Point 21 –
wetland re-establishment area, view west (03/02/2022)

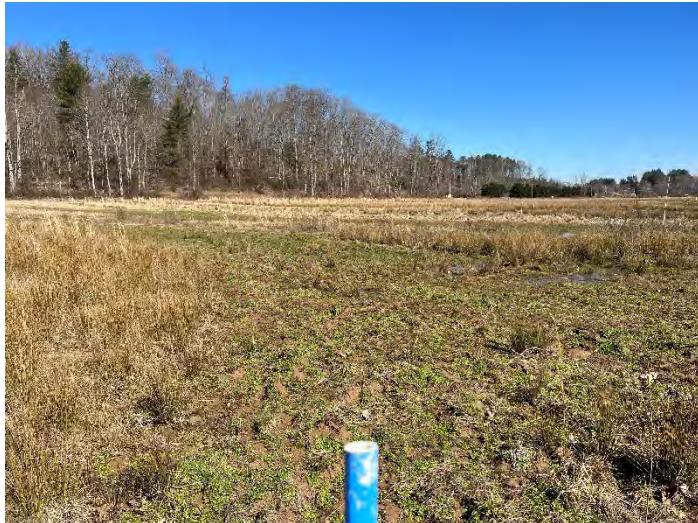
Photo Point 22 –
wetland re-establishment area, view north (03/02/2022)

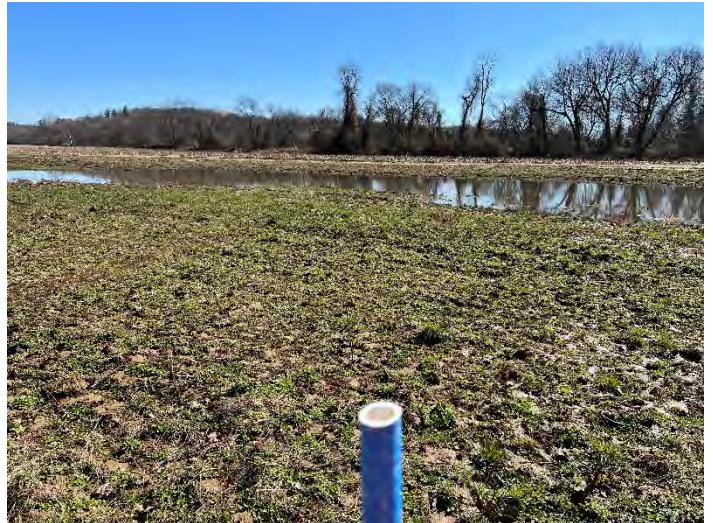
Photo Point 22 –
wetland re-establishment area, view east (03/02/2022)

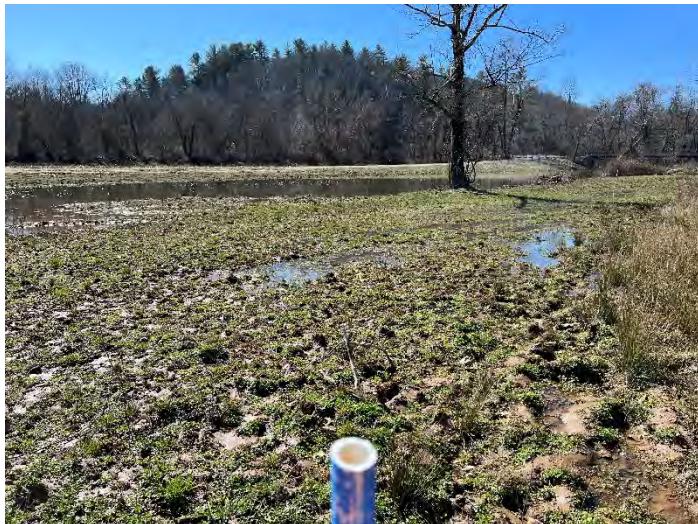
Photo Point 22 –
wetland re-establishment area, view south (03/02/2022)

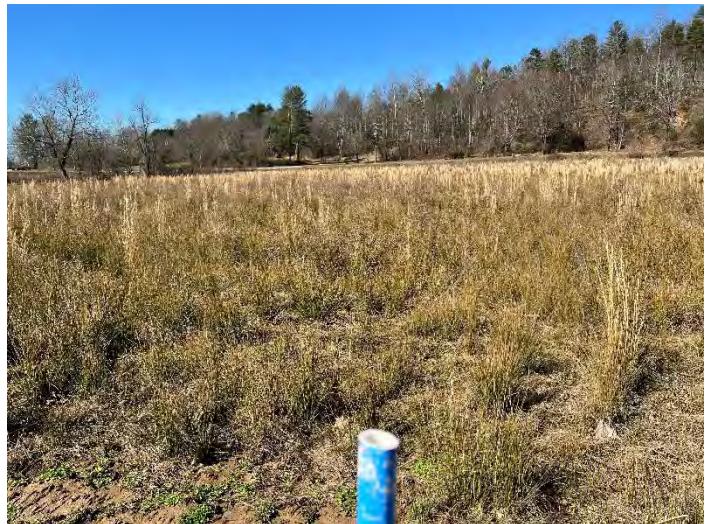
Photo Point 22 –
wetland re-establishment area, view west (03/02/2022)

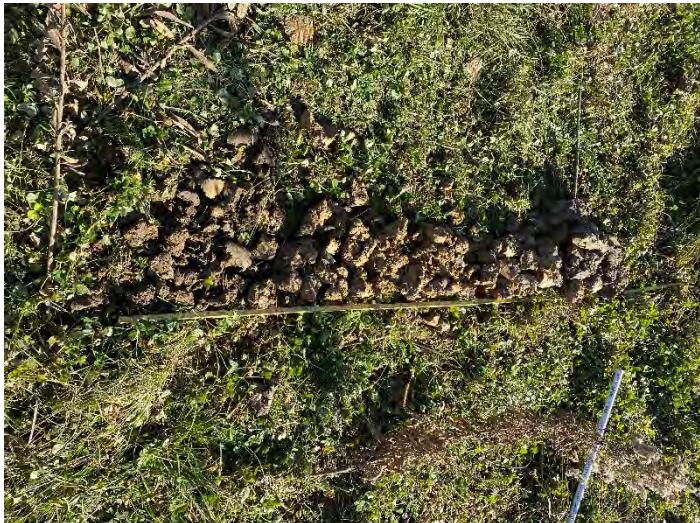
GWG 1 Soil Profile – (12/02/2021)

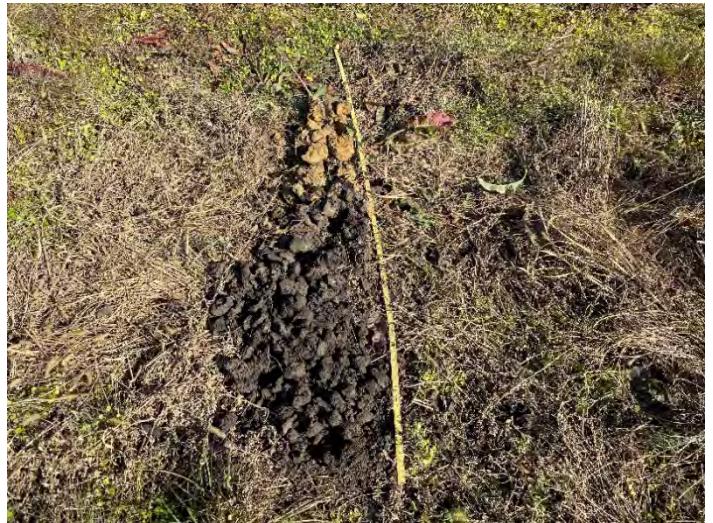
GWG 2 Soil Profile – (12/02/2021)

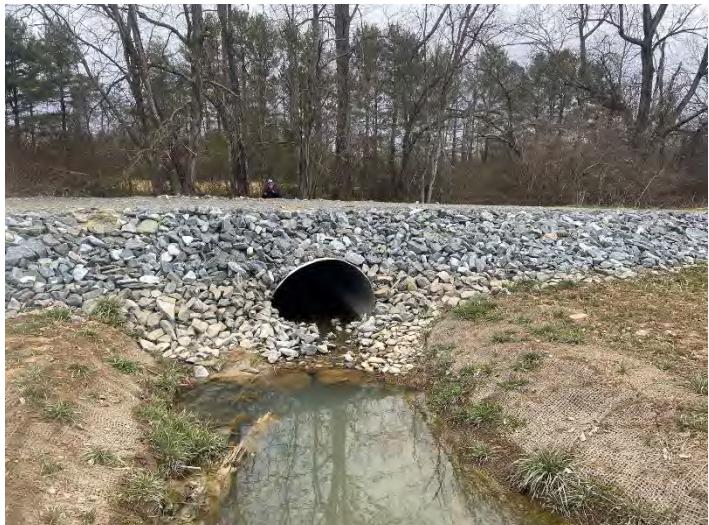
Culvert Crossing – Upper UT1, view upstream (02/16/2022)

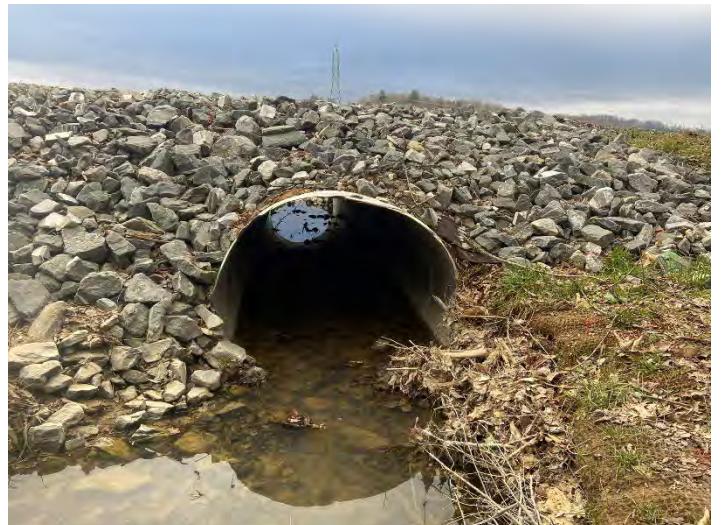
Culvert Crossing – Upper UT1, view downstream (02/16/2022)

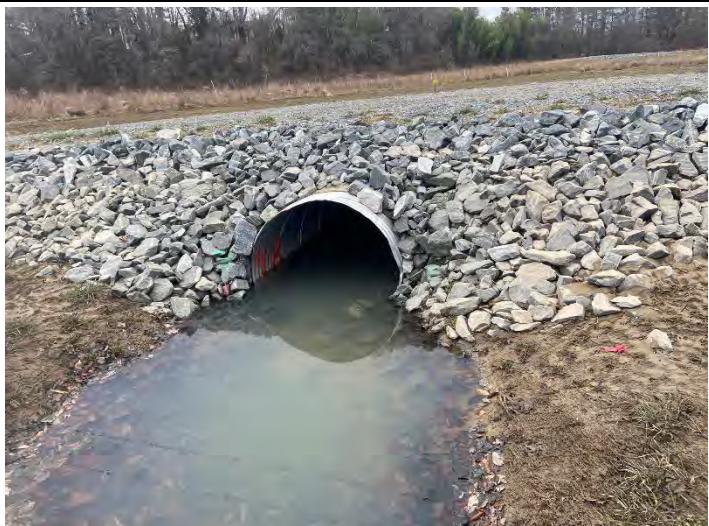
Culvert Crossing – Lower UT1, view upstream (02/16/2022)

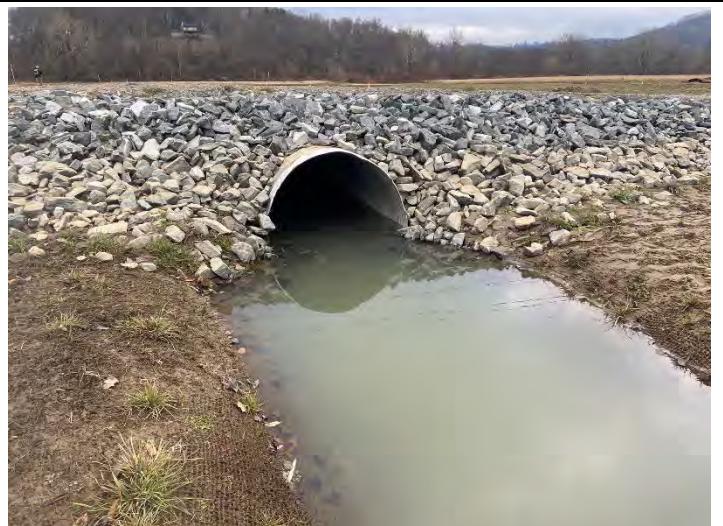
Culvert Crossing – Lower UT1, view downstream (02/16/2022)

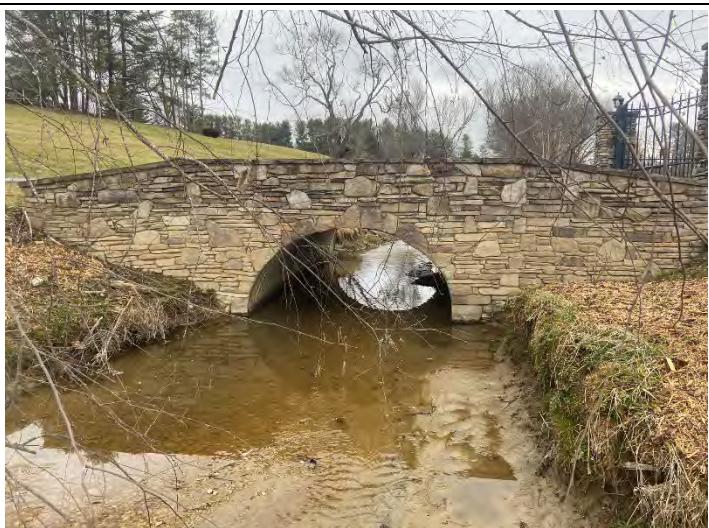
Culvert Crossing – Banner Creek R1, view upstream (02/16/2022)

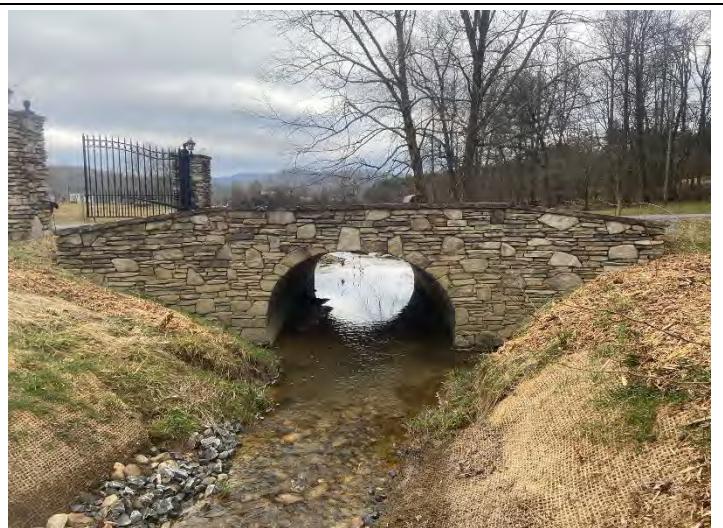
Culvert Crossing – Banner Creek R1, view downstream (02/16/2022)

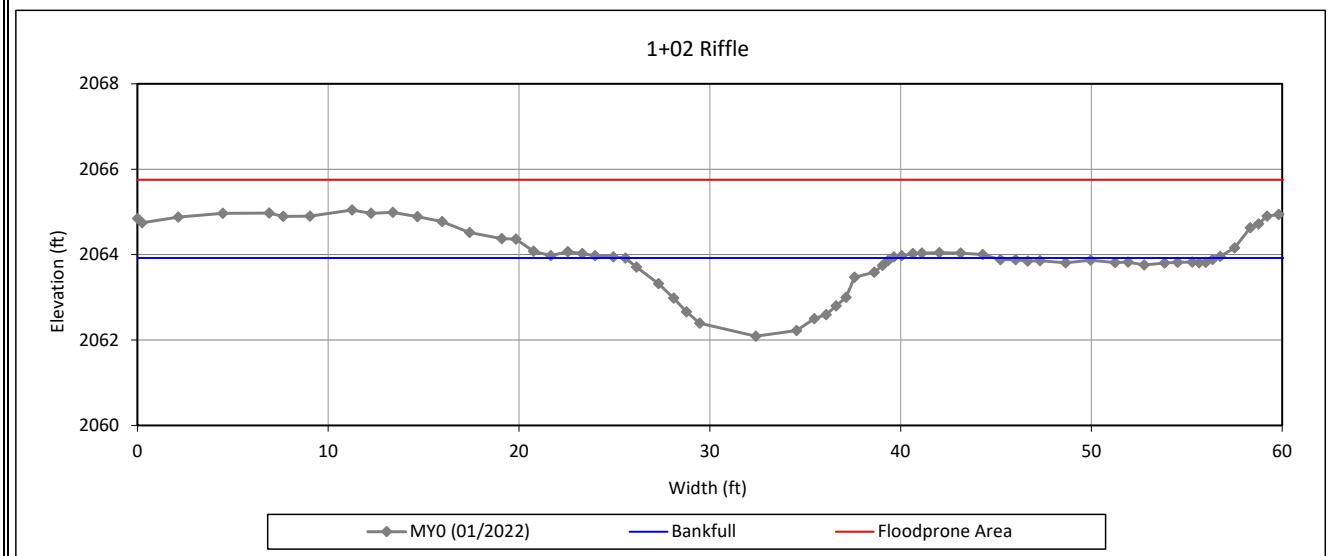
Cross-Section 1-Banner Creek Reach 1

Bankfull Dimensions

15.9	x-section area (ft.sq.)
14.0	width (ft)
1.1	mean depth (ft)
1.8	max depth (ft)
14.7	wetted perimeter (ft)
1.1	hydraulic radius (ft)
12.3	width-depth ratio
61.7	W flood prone area (ft)
4.4	entrenchment ratio
1.0	low bank height ratio

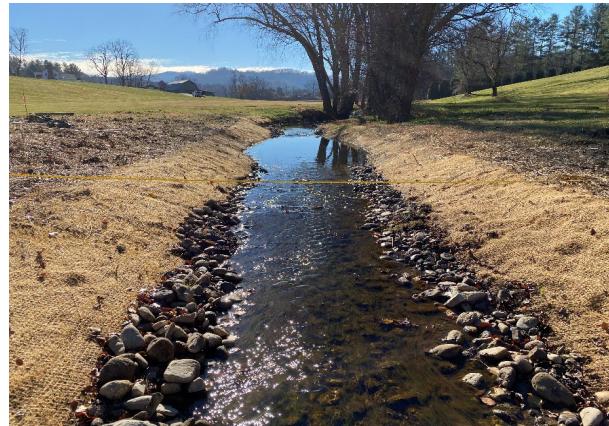
View Downstream

Survey Date: 01/2022

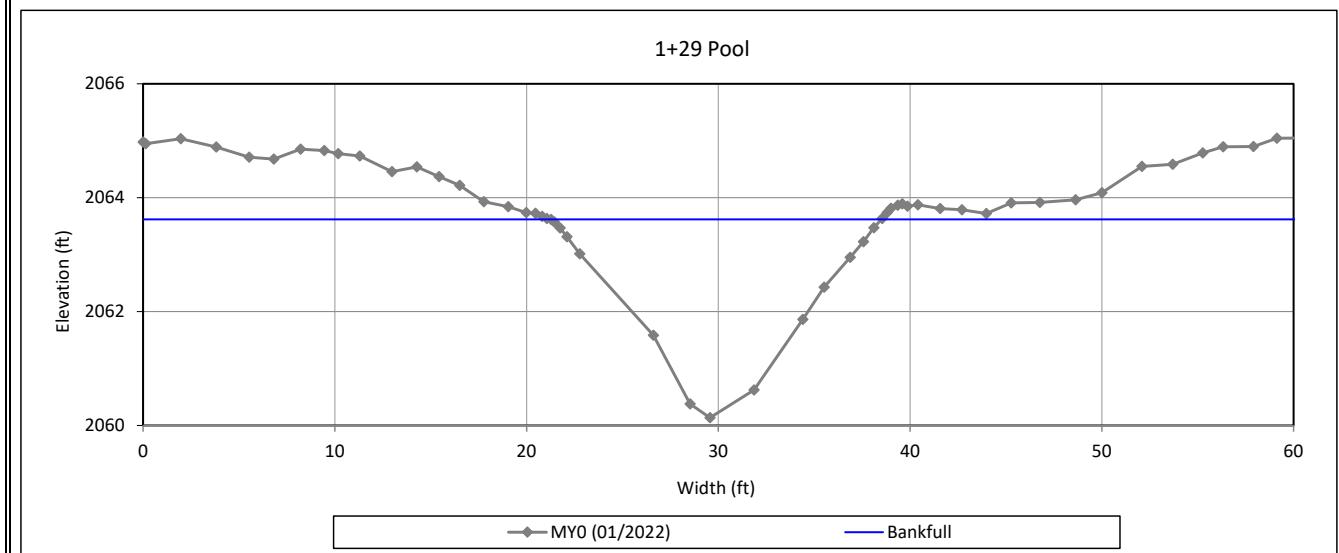
Cross-Section 2-Banner Creek Reach 1

Bankfull Dimensions

31.0	x-section area (ft.sq.)
17.2	width (ft)
1.8	mean depth (ft)
3.5	max depth (ft)
18.7	wetted perimeter (ft)
1.7	hydraulic radius (ft)
9.6	width-depth ratio

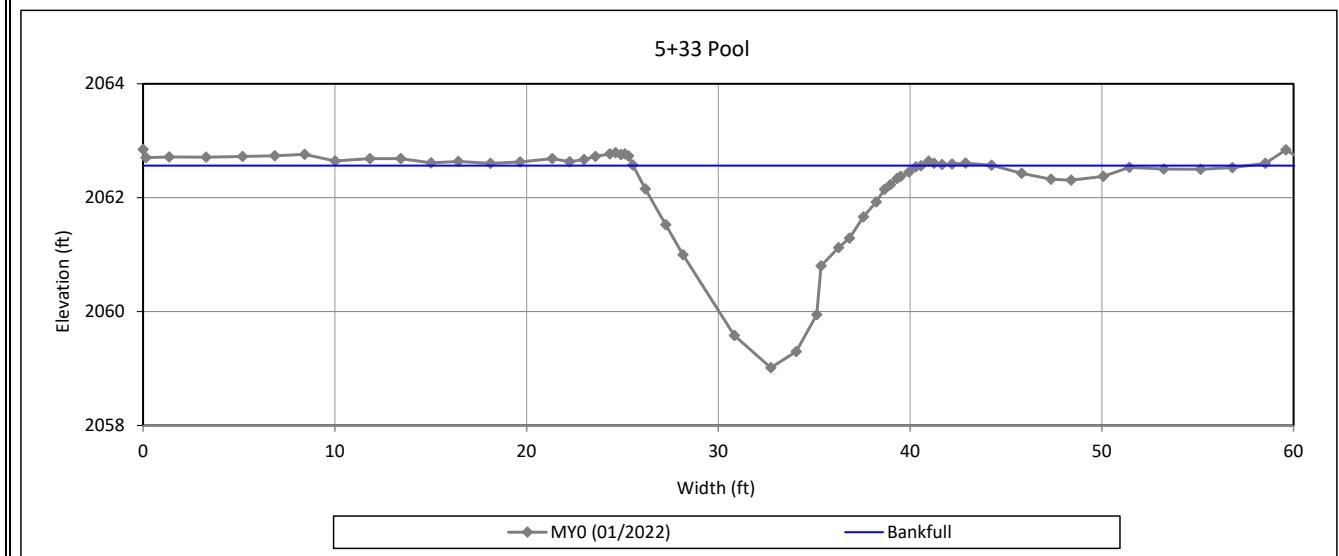
Cross-Section 3-Banner Creek Reach 1

Bankfull Dimensions

26.6	x-section area (ft.sq.)
15.0	width (ft)
1.8	mean depth (ft)
3.5	max depth (ft)
17.1	wetted perimeter (ft)
1.6	hydraulic radius (ft)
8.5	width-depth ratio

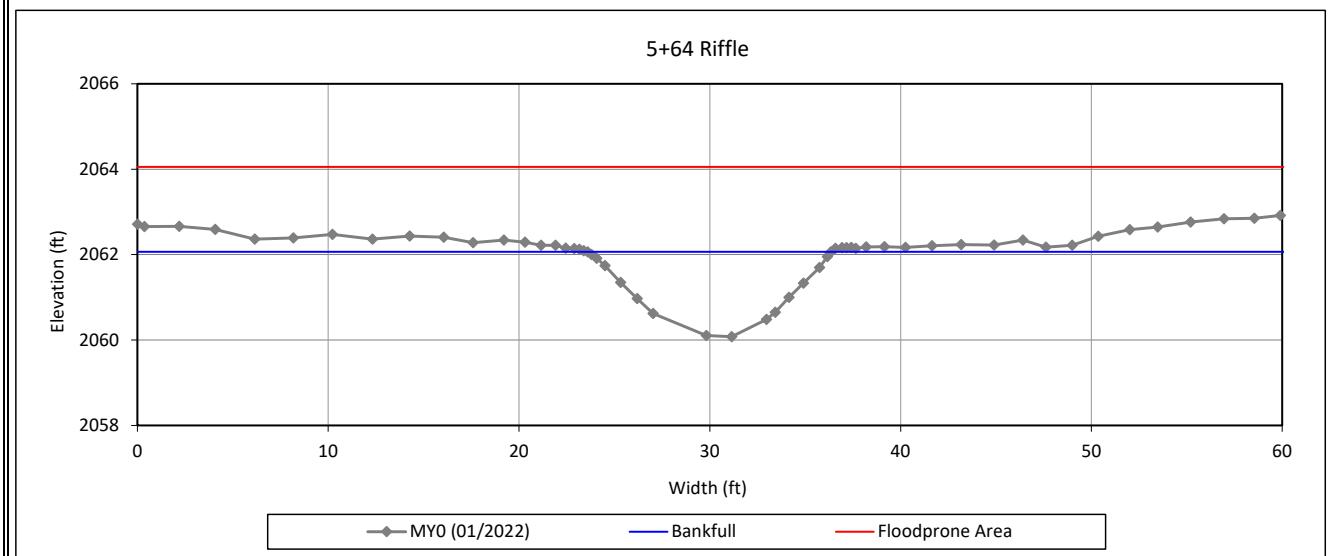
Cross-Section 4-Banner Creek Reach 1

Bankfull Dimensions

15.9	x-section area (ft.sq.)
12.8	width (ft)
1.2	mean depth (ft)
2.0	max depth (ft)
13.5	wetted perimeter (ft)
1.2	hydraulic radius (ft)
10.2	width-depth ratio
60.5	W flood prone area (ft)
4.7	entrenchment ratio
1.0	low bank height ratio

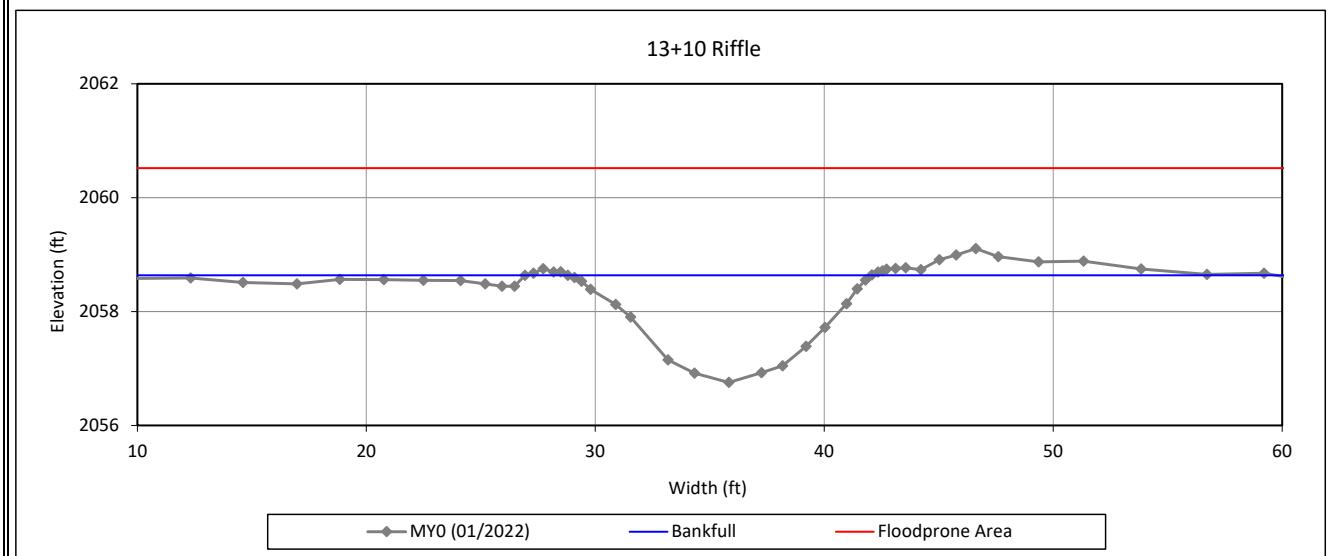
Cross-Section 5-Banner Creek Reach 2

Bankfull Dimensions

14.6	x-section area (ft.sq.)
13.3	width (ft)
1.1	mean depth (ft)
1.9	max depth (ft)
13.9	wetted perimeter (ft)
1.1	hydraulic radius (ft)
12.0	width-depth ratio
85.8	W flood prone area (ft)
6.5	entrenchment ratio
1.0	low bank height ratio

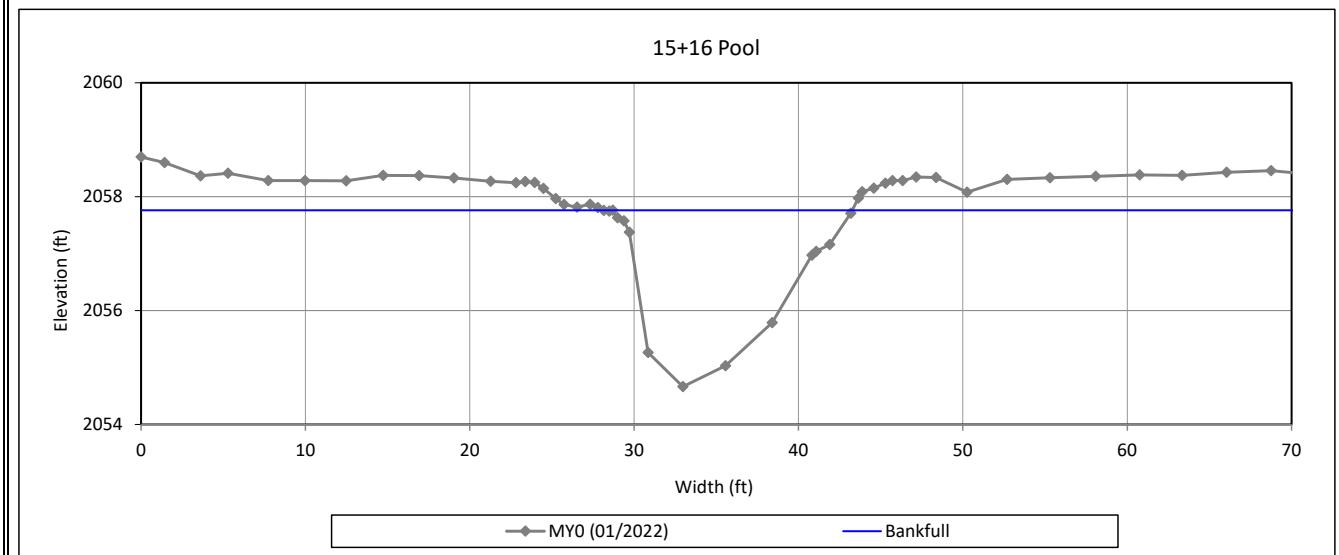
Cross-Section 6-Banner Creek Reach 2

Bankfull Dimensions

26.5	x-section area (ft.sq.)
14.6	width (ft)
1.8	mean depth (ft)
3.1	max depth (ft)
16.5	wetted perimeter (ft)
1.6	hydraulic radius (ft)
8.0	width-depth ratio

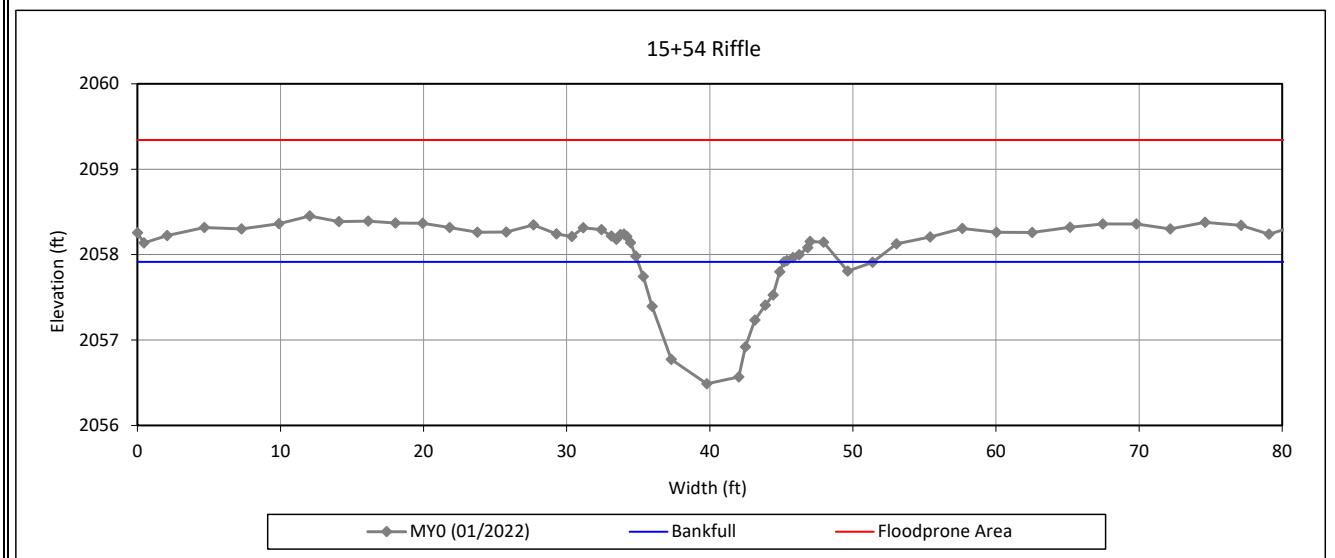
Cross-Section 7-Banner Creek Reach 2

Bankfull Dimensions

9.6	x-section area (ft.sq.)
10.2	width (ft)
0.9	mean depth (ft)
1.4	max depth (ft)
10.8	wetted perimeter (ft)
0.9	hydraulic radius (ft)
10.9	width-depth ratio
80.8	W flood prone area (ft)
7.9	entrenchment ratio
1.0	low bank height ratio

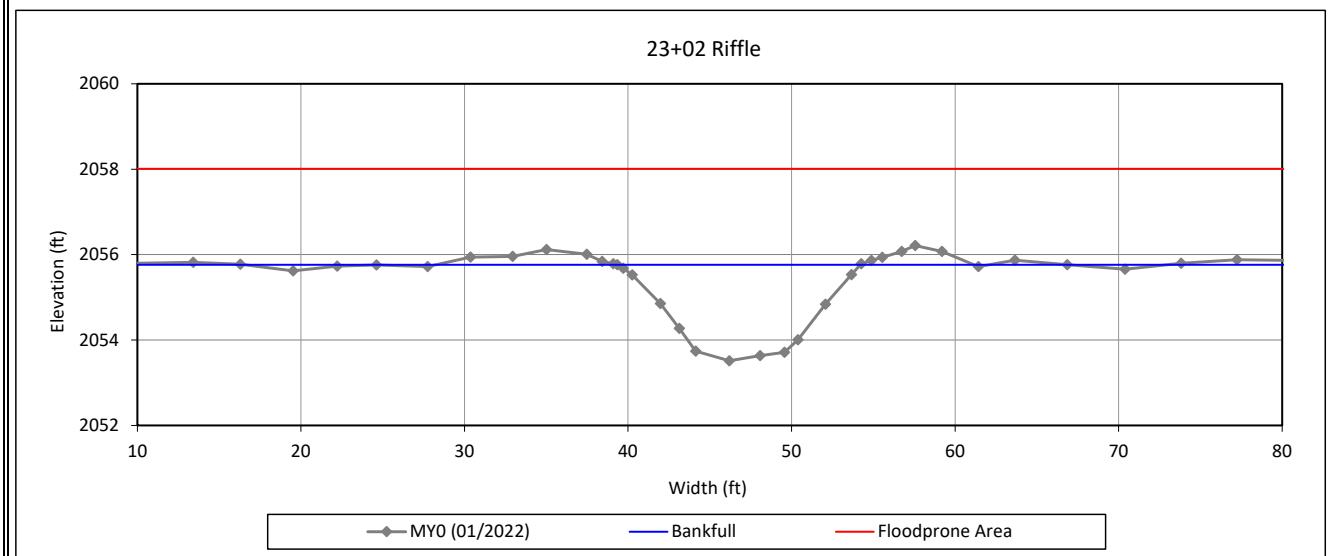
Cross-Section 8-Banner Creek Reach 3

Bankfull Dimensions

20.6	x-section area (ft.sq.)
14.9	width (ft)
1.4	mean depth (ft)
2.2	max depth (ft)
15.7	wetted perimeter (ft)
1.3	hydraulic radius (ft)
10.7	width-depth ratio
87.5	W flood prone area (ft)
5.9	entrenchment ratio
1.0	low bank height ratio

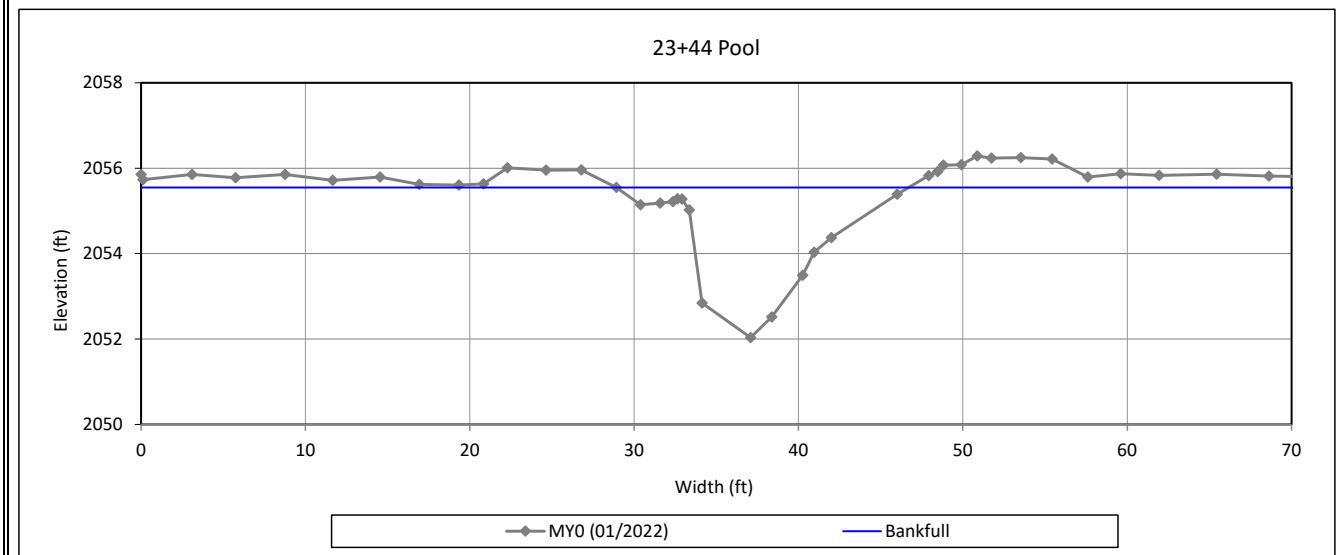
Cross-Section 9-Banner Creek Reach 3

Bankfull Dimensions

26.2	x-section area (ft.sq.)
17.8	width (ft)
1.5	mean depth (ft)
3.5	max depth (ft)
20.3	wetted perimeter (ft)
1.3	hydraulic radius (ft)
12.1	width-depth ratio

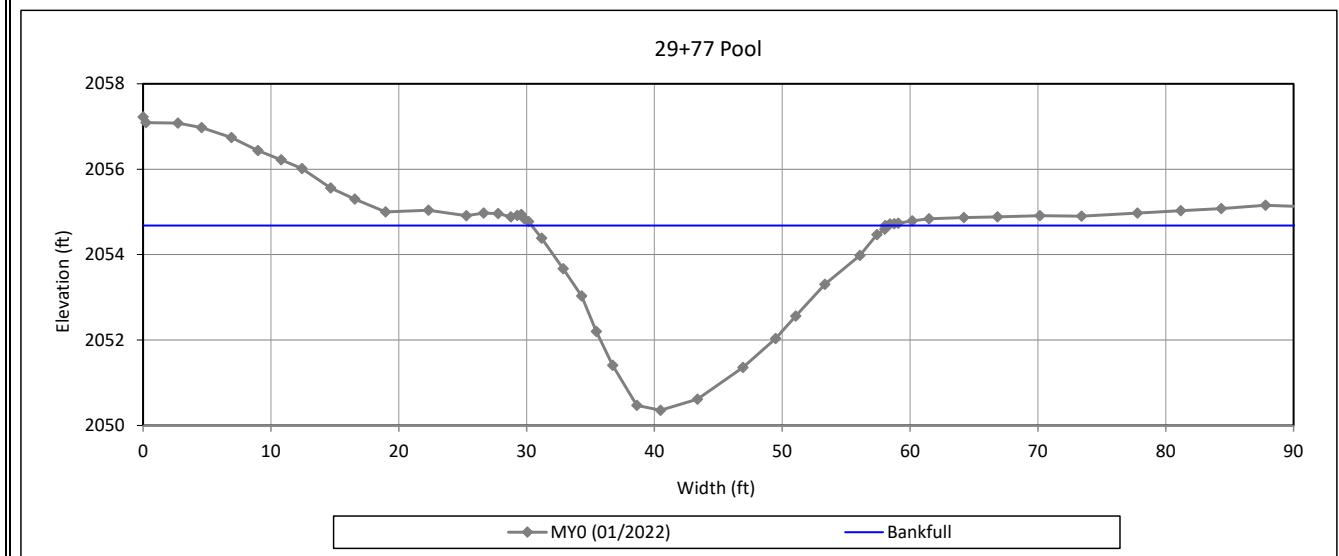
Cross-Section 10-Banner Creek Reach 4a

Bankfull Dimensions

68.4	x-section area (ft.sq.)
27.7	width (ft)
2.5	mean depth (ft)
4.3	max depth (ft)
29.3	wetted perimeter (ft)
2.3	hydraulic radius (ft)
11.2	width-depth ratio

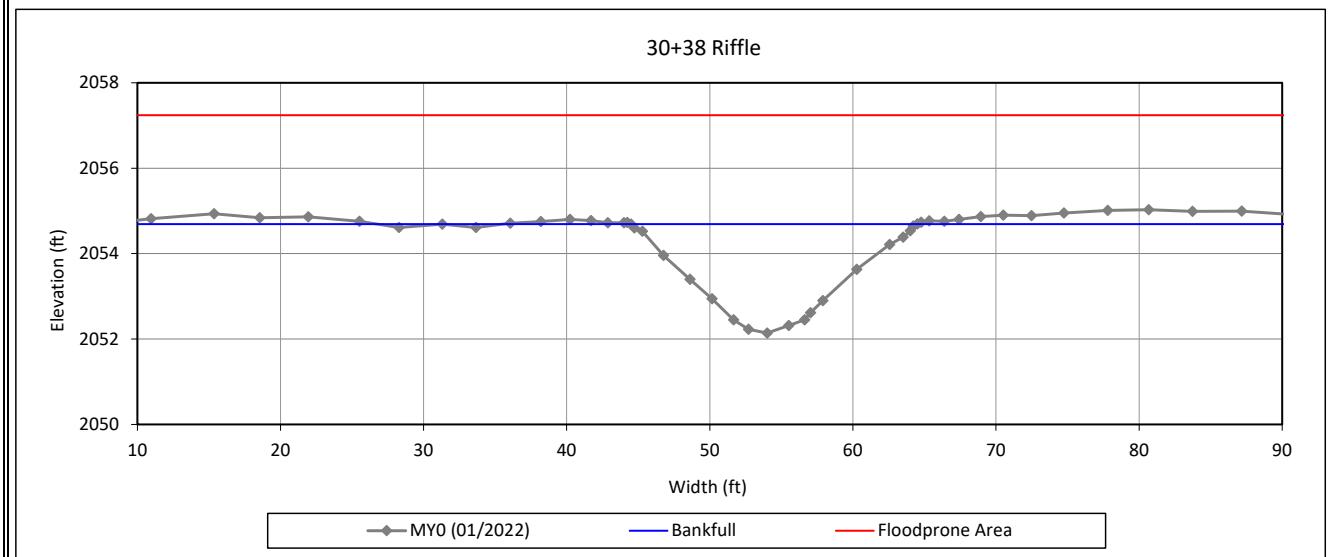
Cross-Section 11-Banner Creek Reach 4a

Bankfull Dimensions

28.2	x-section area (ft.sq.)
20.0	width (ft)
1.4	mean depth (ft)
2.5	max depth (ft)
20.7	wetted perimeter (ft)
1.4	hydraulic radius (ft)
14.2	width-depth ratio
93.5	W flood prone area (ft)
4.7	entrenchment ratio
1.0	low bank height ratio

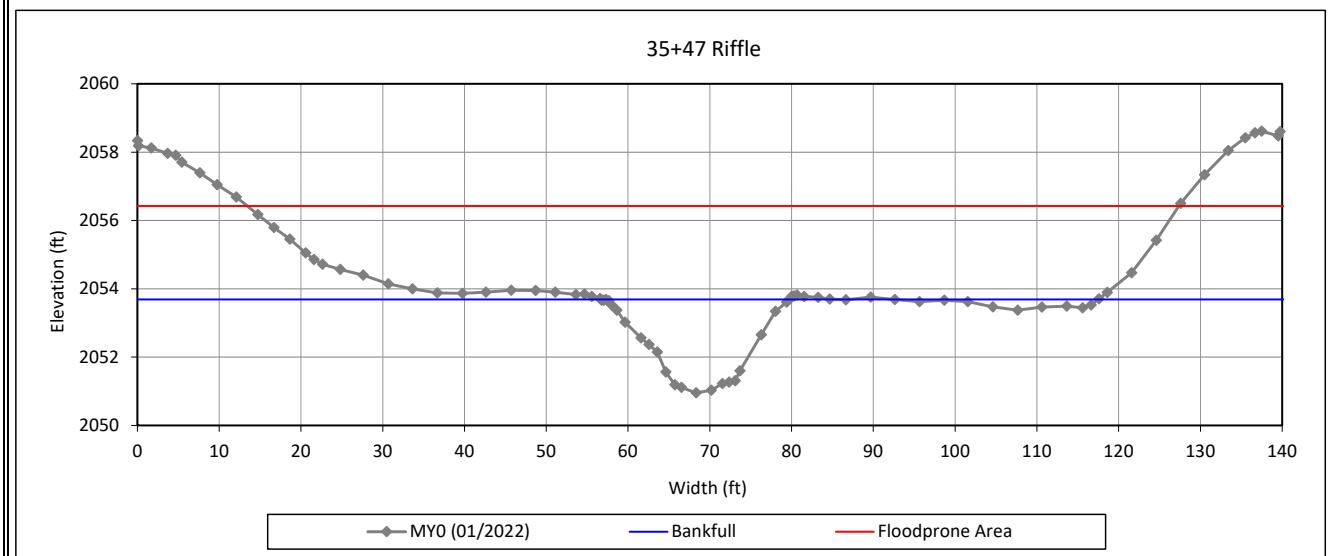
Cross-Section 12-Banner Creek Reach 4b

Bankfull Dimensions

35.5	x-section area (ft.sq.)
22.4	width (ft)
1.6	mean depth (ft)
2.7	max depth (ft)
23.3	wetted perimeter (ft)
1.5	hydraulic radius (ft)
14.2	width-depth ratio
114.0	W flood prone area (ft)
5.1	entrenchment ratio
1.0	low bank height ratio

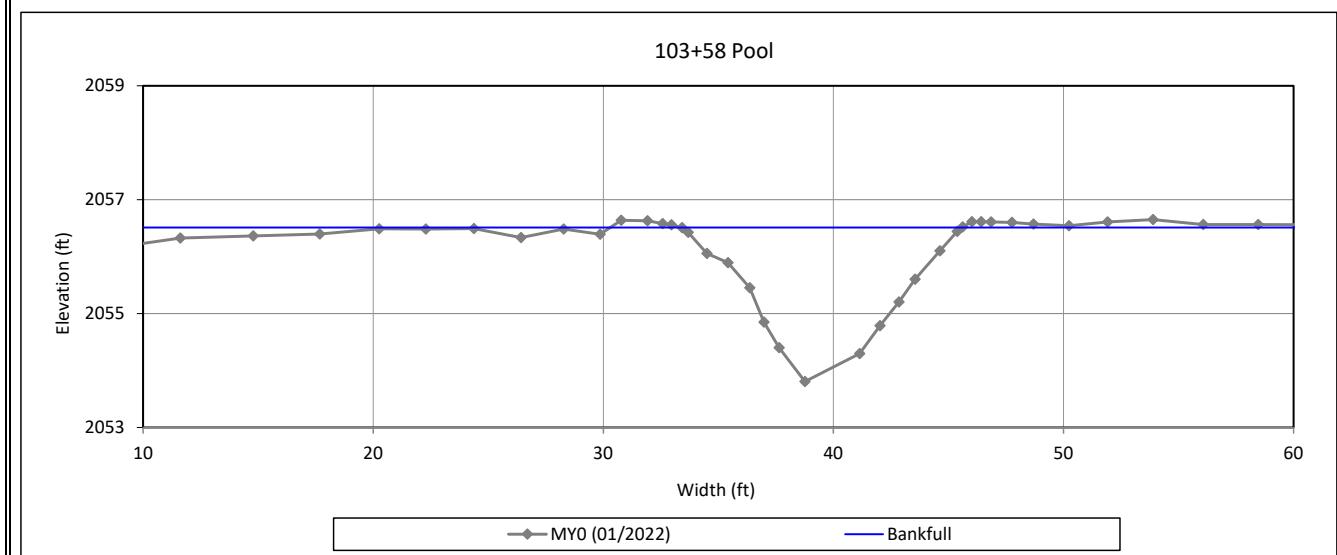
Cross-Section 13-UT1

Bankfull Dimensions

16.8	x-section area (ft.sq.)
12.2	width (ft)
1.4	mean depth (ft)
2.7	max depth (ft)
13.5	wetted perimeter (ft)
1.2	hydraulic radius (ft)
8.8	width-depth ratio

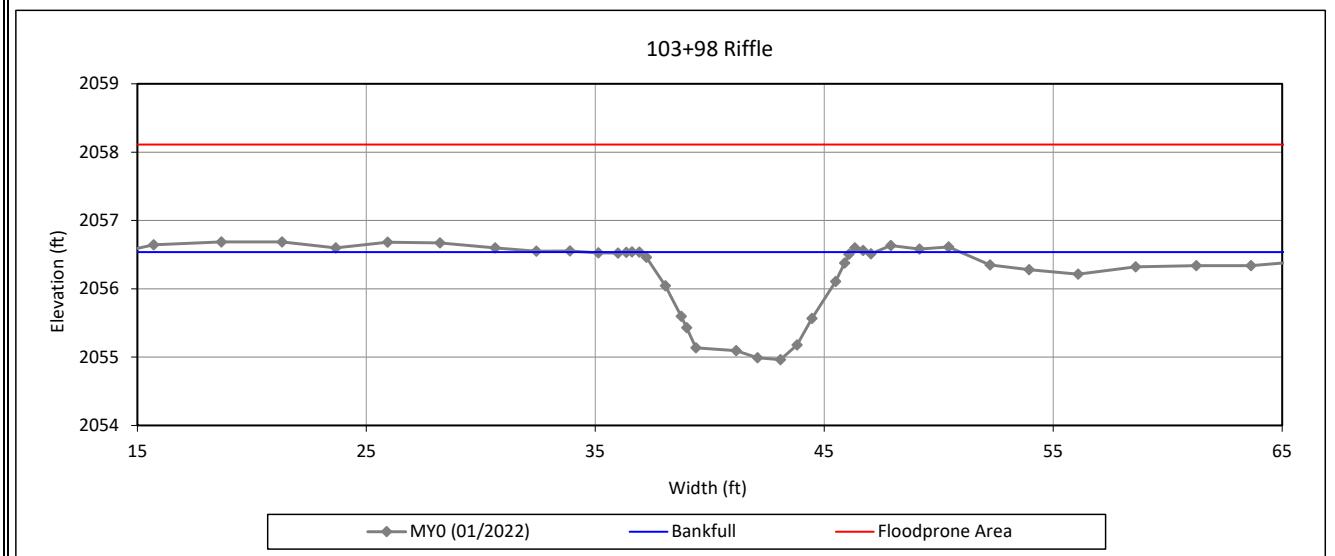
Cross-Section 14-UT1

Bankfull Dimensions

9.6	x-section area (ft.sq.)
9.2	width (ft)
1.0	mean depth (ft)
1.6	max depth (ft)
10.0	wetted perimeter (ft)
1.0	hydraulic radius (ft)
8.9	width-depth ratio
66.4	W flood prone area (ft)
7.2	entrenchment ratio
1.0	low bank height ratio

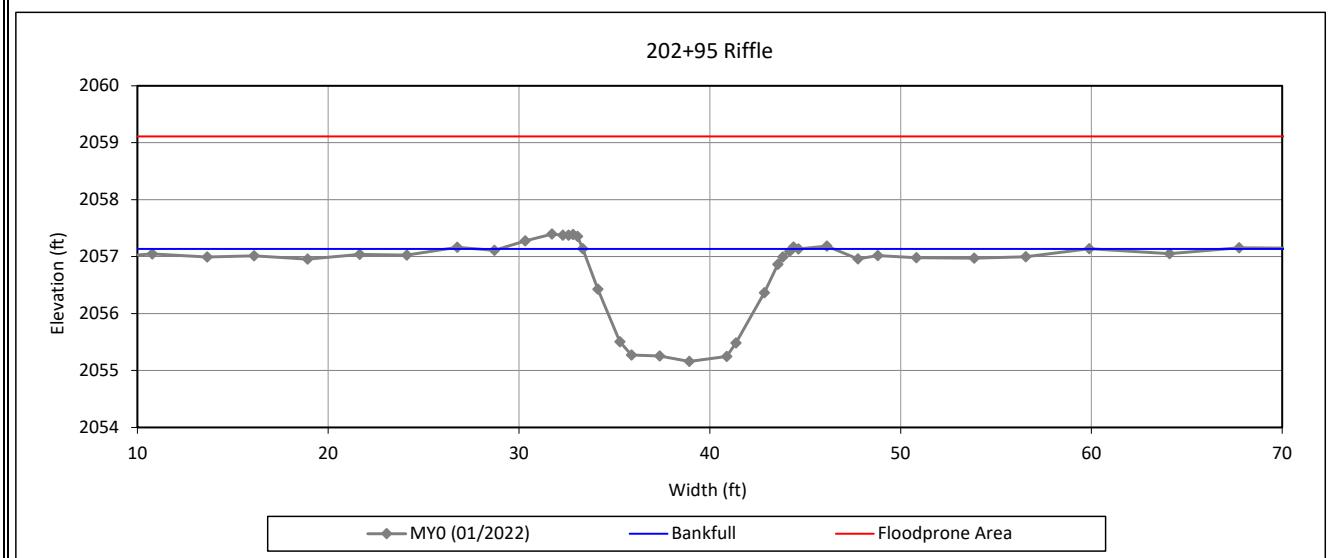
Cross-Section 15-UT2

Bankfull Dimensions

15.4	x-section area (ft.sq.)
11.0	width (ft)
1.4	mean depth (ft)
2.0	max depth (ft)
12.1	wetted perimeter (ft)
1.3	hydraulic radius (ft)
7.8	width-depth ratio
81.9	W flood prone area (ft)
7.5	entrenchment ratio
1.0	low bank height ratio

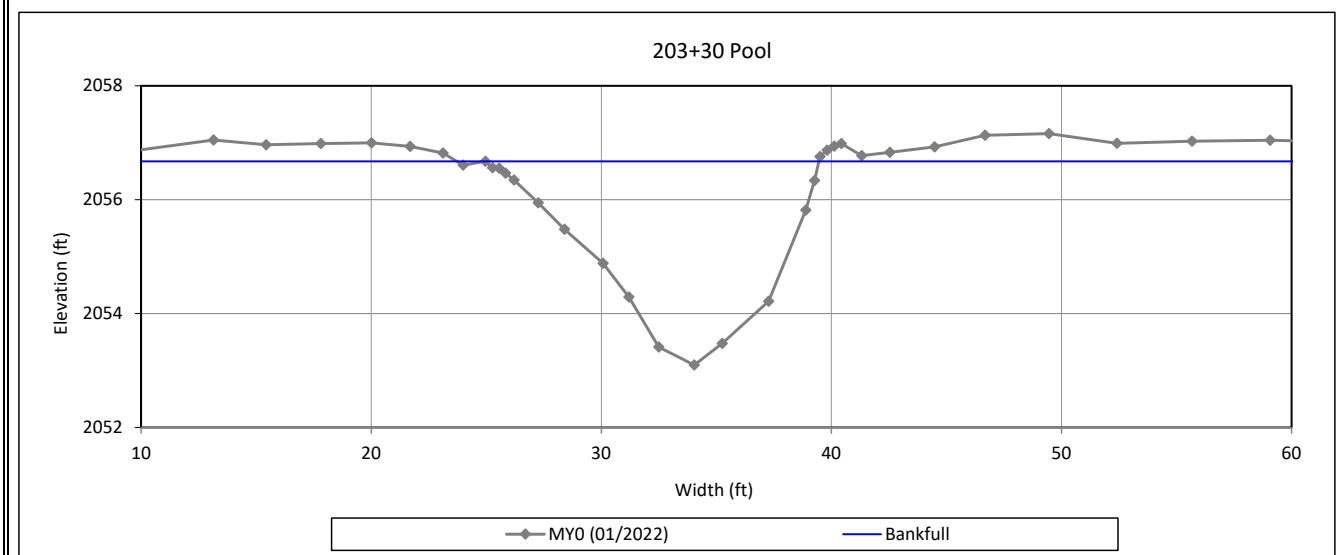
Cross-Section 16-UT2

Bankfull Dimensions

28.4	x-section area (ft.sq.)
14.5	width (ft)
2.0	mean depth (ft)
3.6	max depth (ft)
16.6	wetted perimeter (ft)
1.7	hydraulic radius (ft)
7.4	width-depth ratio

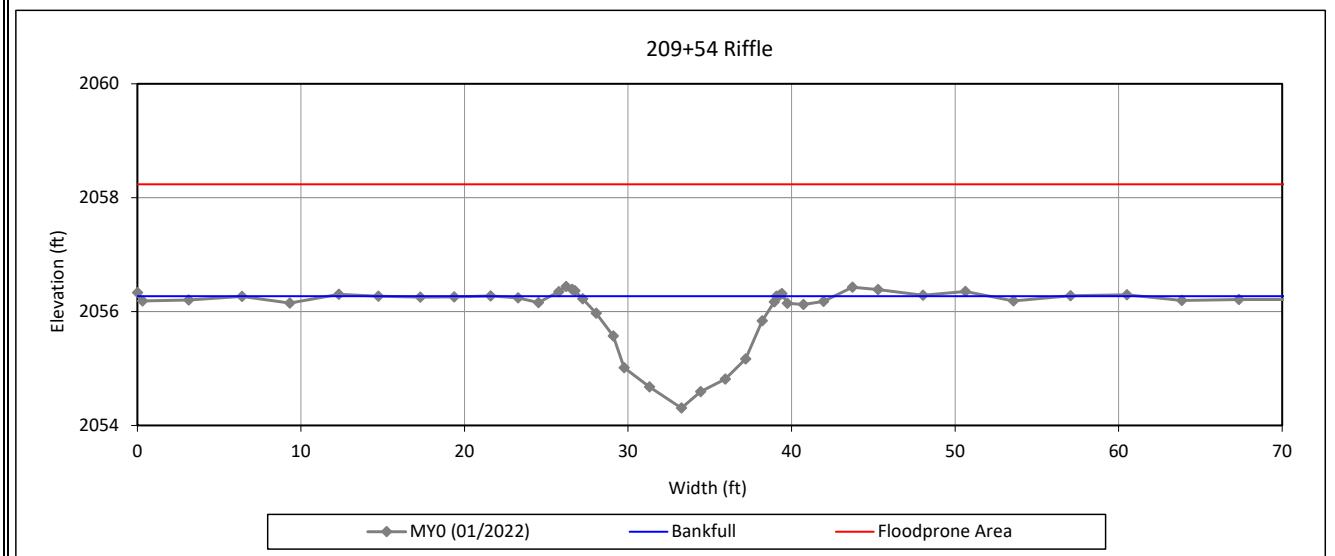
Cross-Section 17-UT2

Bankfull Dimensions

- 14.1 x-section area (ft.sq.)
- 12.0 width (ft)
- 1.2 mean depth (ft)
- 2.0 max depth (ft)
- 12.8 wetted perimeter (ft)
- 1.1 hydraulic radius (ft)
- 10.2 width-depth ratio
- 74.8 W flood prone area (ft)
- 6.2 entrenchment ratio
- 1.0 low bank height ratio

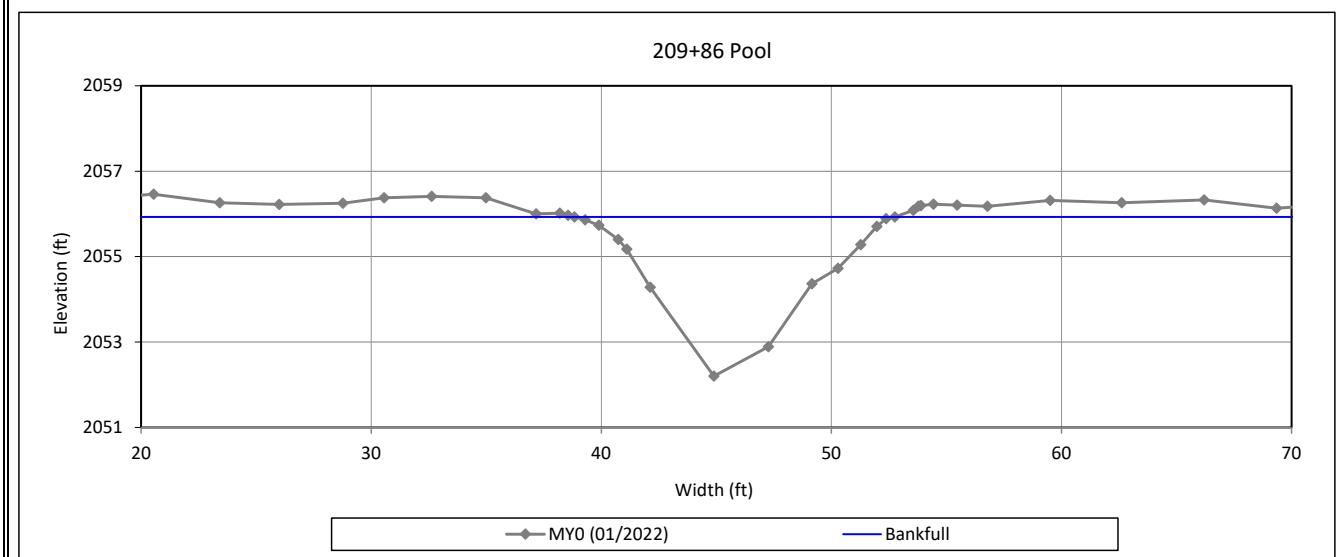
Cross-Section 18-UT2

Bankfull Dimensions

24.5	x-section area (ft.sq.)
13.9	width (ft)
1.8	mean depth (ft)
3.7	max depth (ft)
16.1	wetted perimeter (ft)
1.5	hydraulic radius (ft)
7.9	width-depth ratio
