MONITORING YEAR 0 ANNUAL REPORT

BANNER FARM MITIGATION SITE

Henderson County, NC
French Broad River Basin
HUC 06010105

DMS Project No. 100062

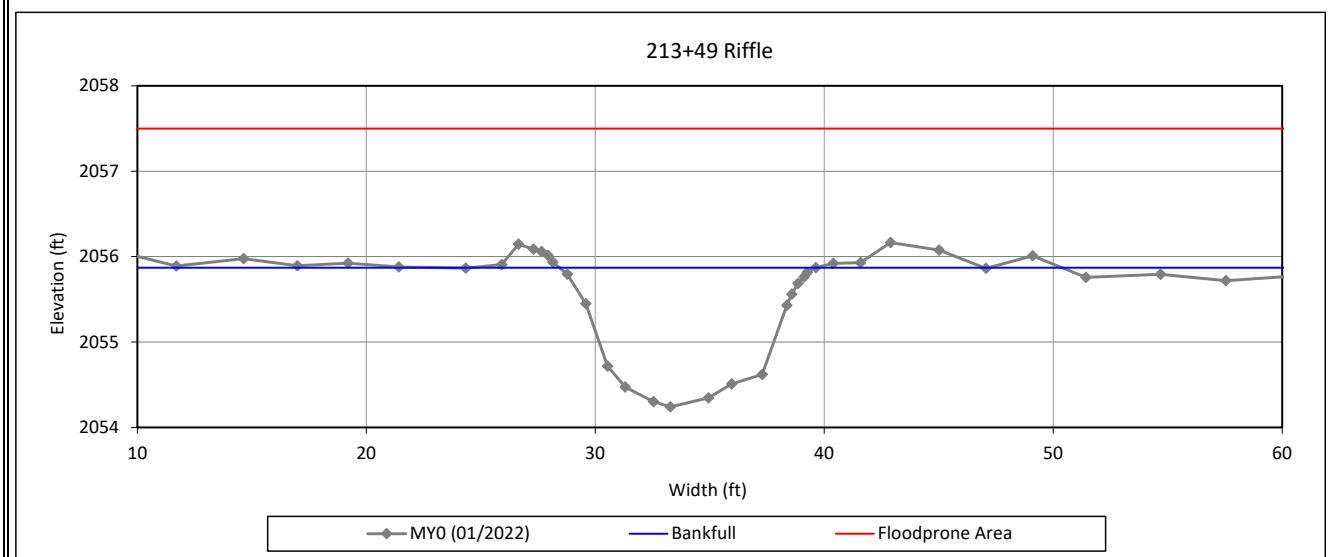
Cross-Section 19-UT2

Bankfull Dimensions

11.9	x-section area (ft.sq.)
11.2	width (ft)
1.1	mean depth (ft)
1.6	max depth (ft)
12.0	wetted perimeter (ft)
1.0	hydraulic radius (ft)
10.5	width-depth ratio
79.0	W flood prone area (ft)
7.1	entrenchment ratio
1.0	low bank height ratio

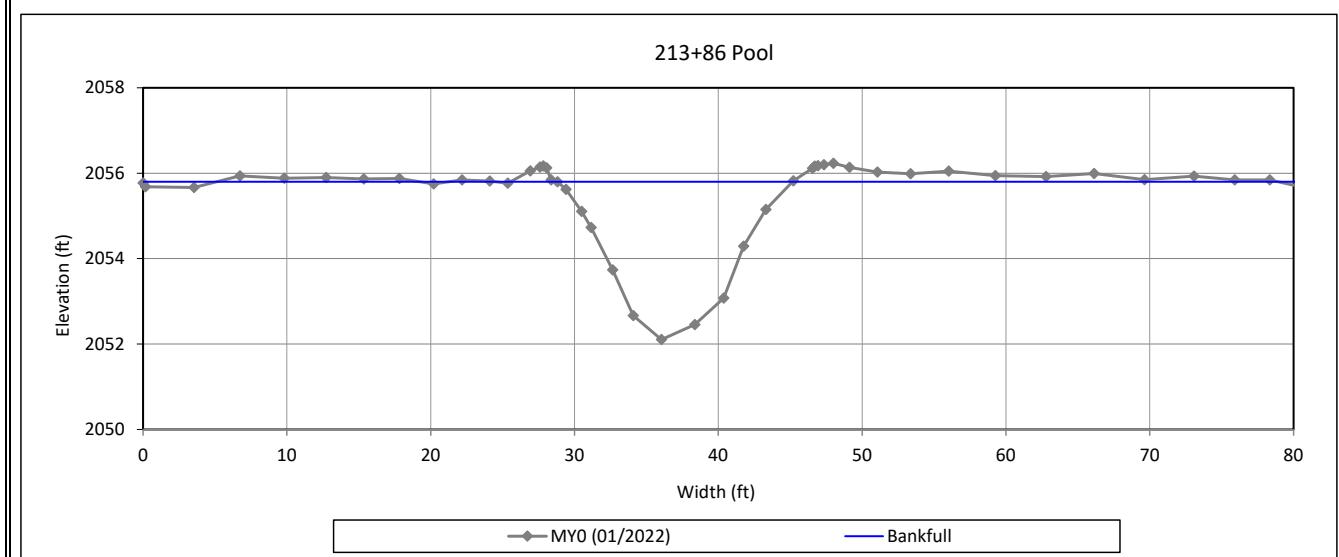
Cross-Section 20-UT2

Bankfull Dimensions

33.3	x-section area (ft.sq.)
16.3	width (ft)
2.0	mean depth (ft)
3.7	max depth (ft)
18.2	wetted perimeter (ft)
1.8	hydraulic radius (ft)
8.0	width-depth ratio

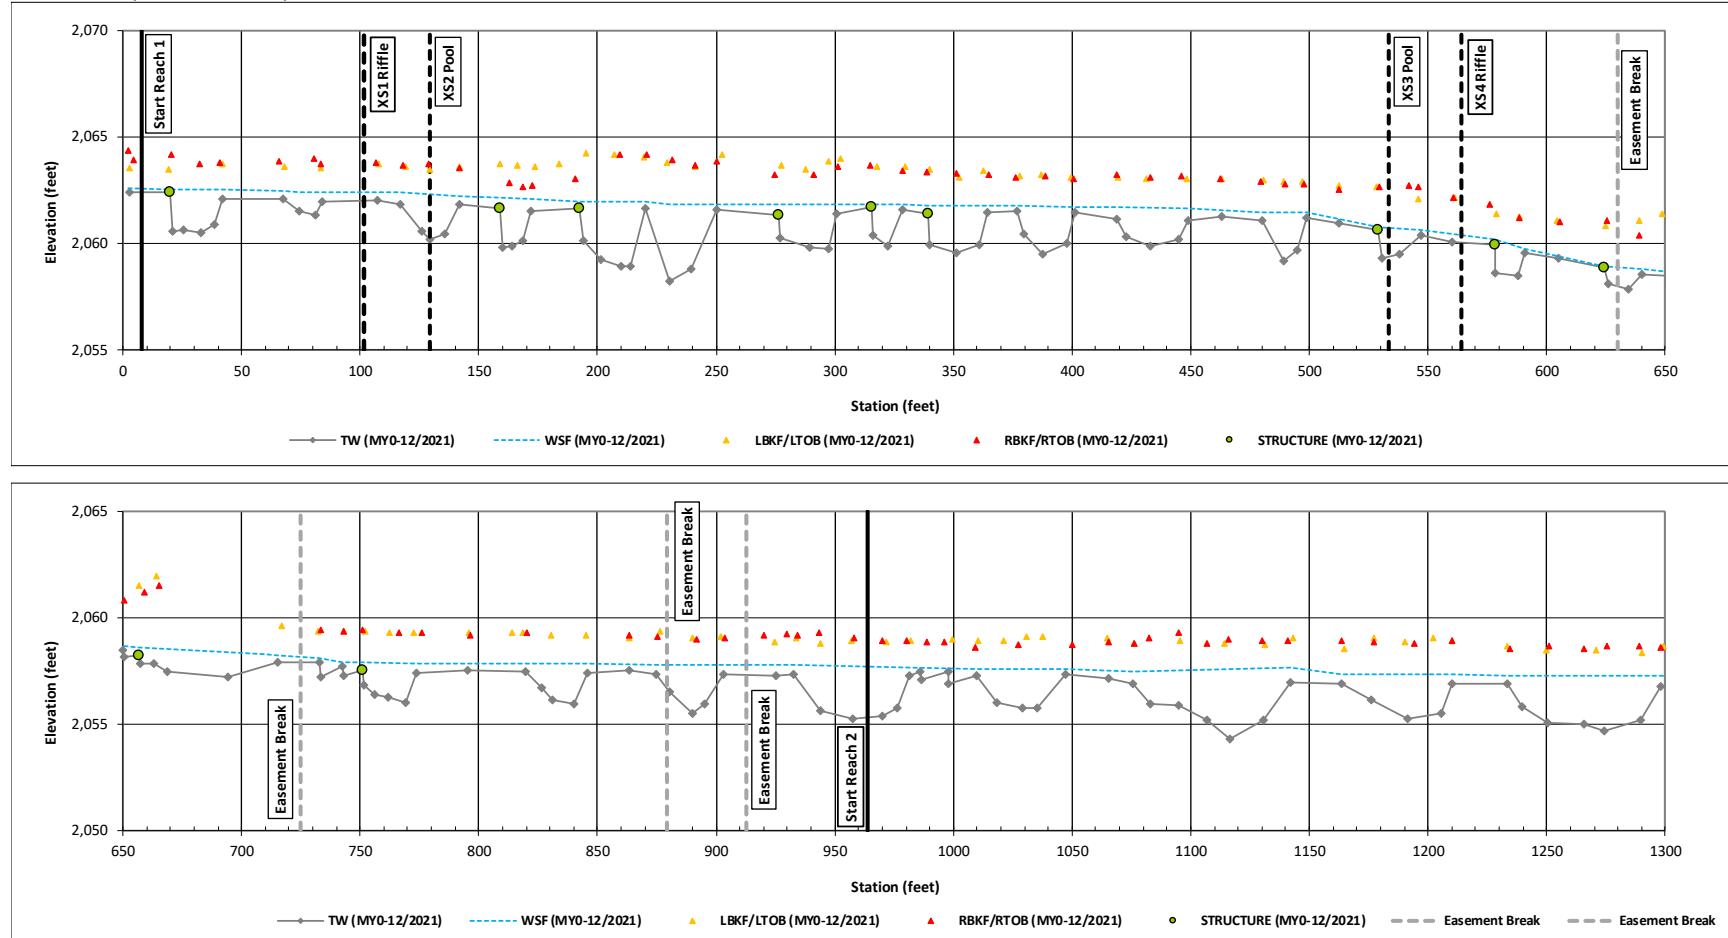
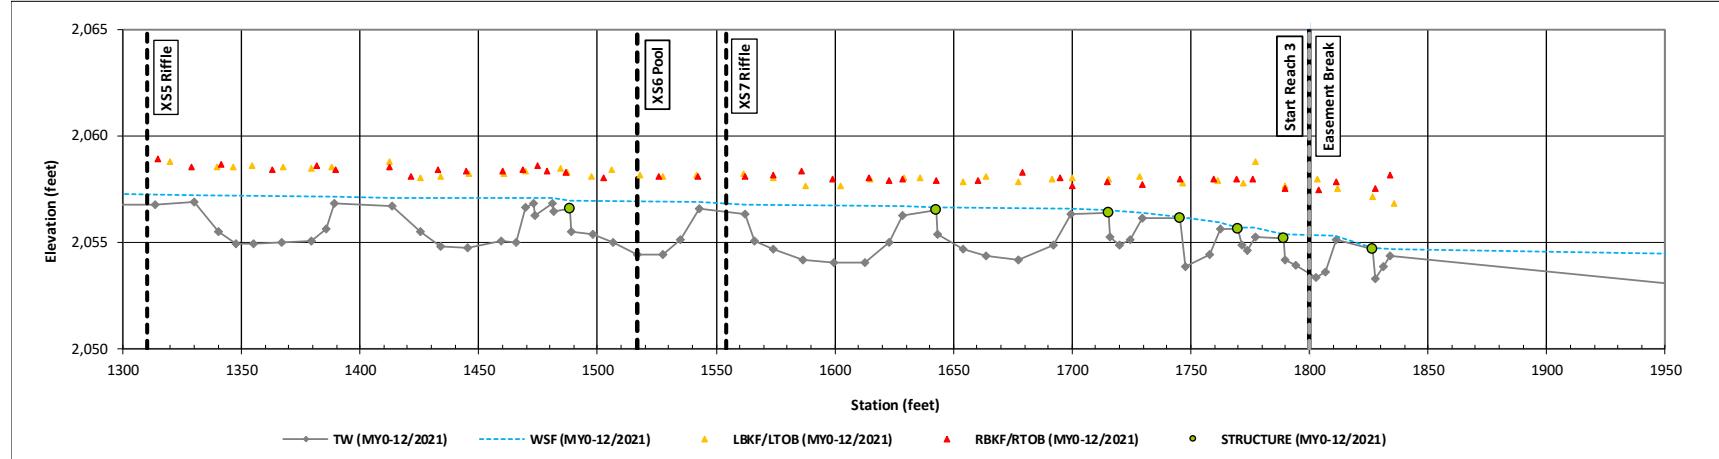
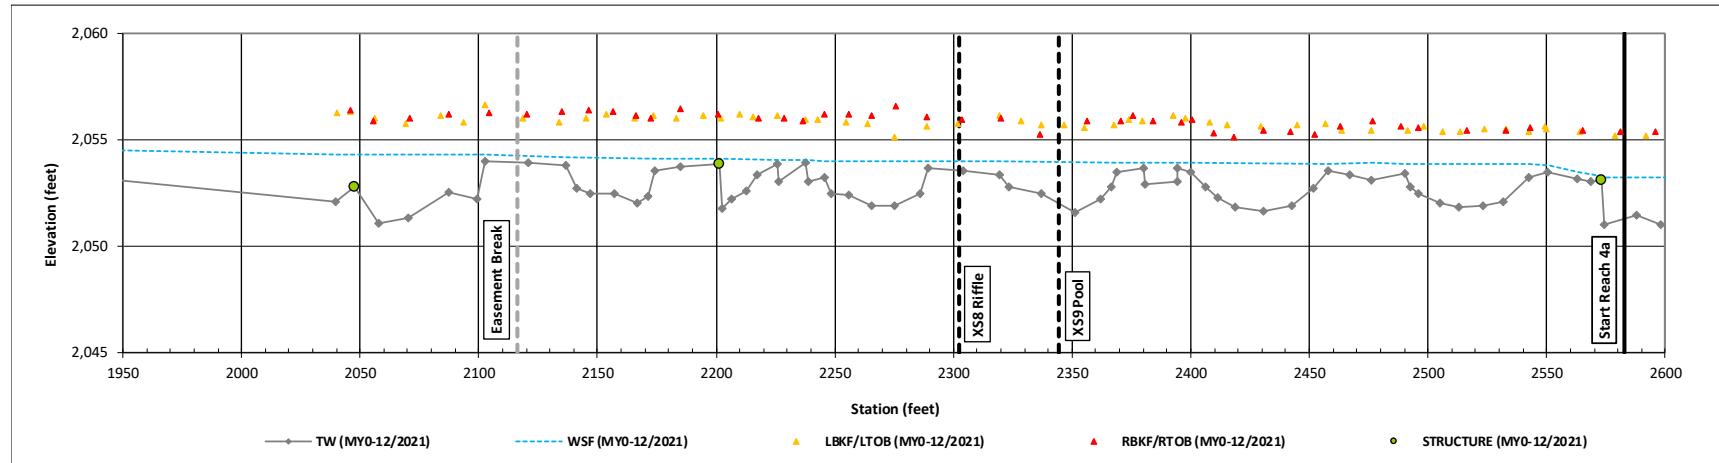
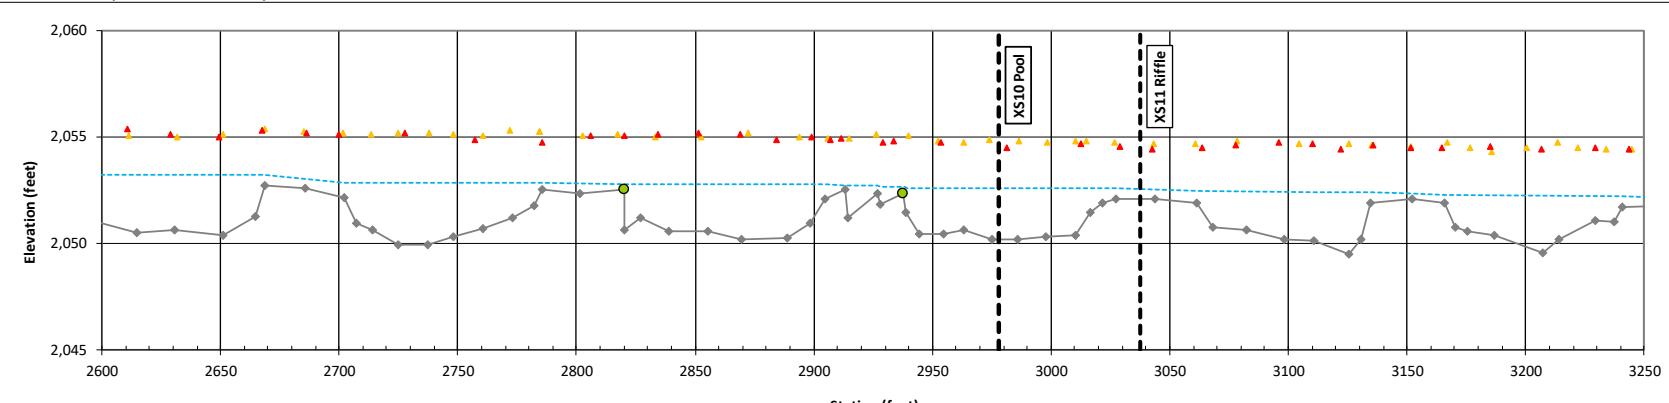
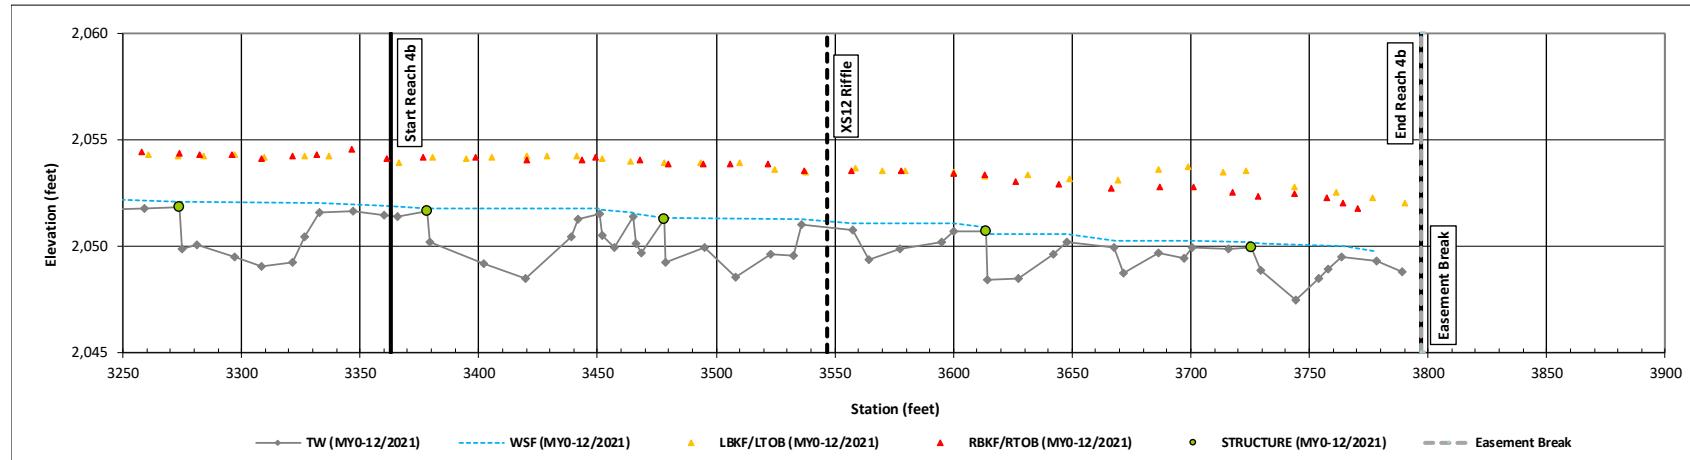
Banner Creek (STA 0+08 to 37+97)

Longitudinal Profile Plots

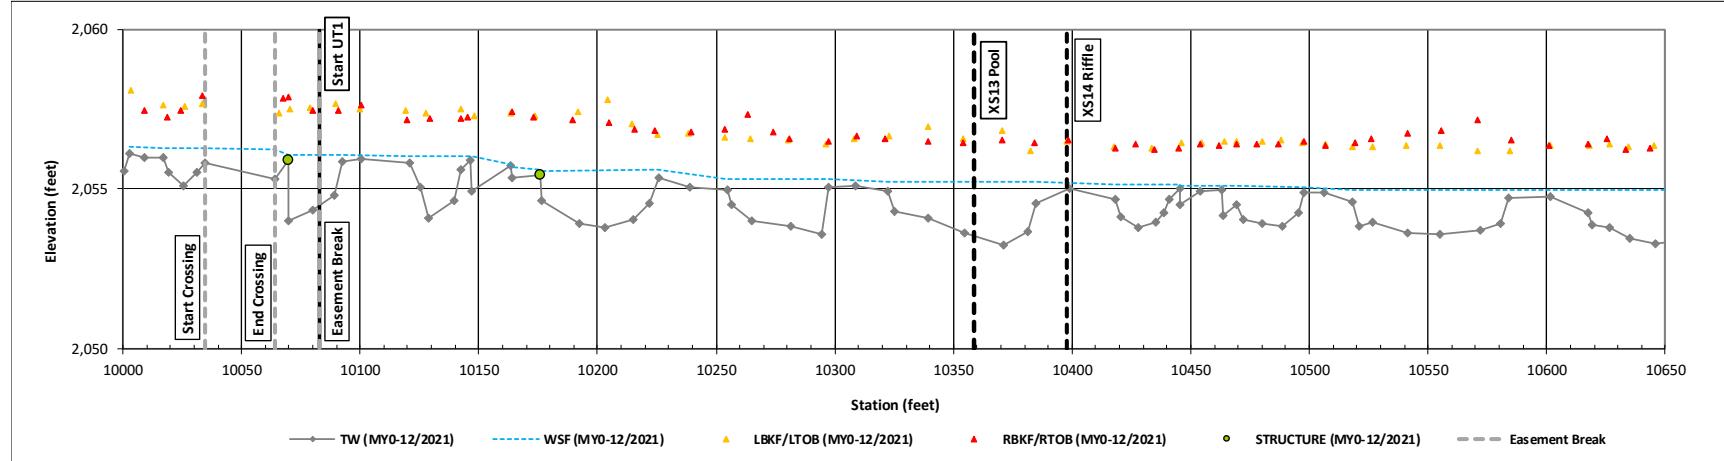
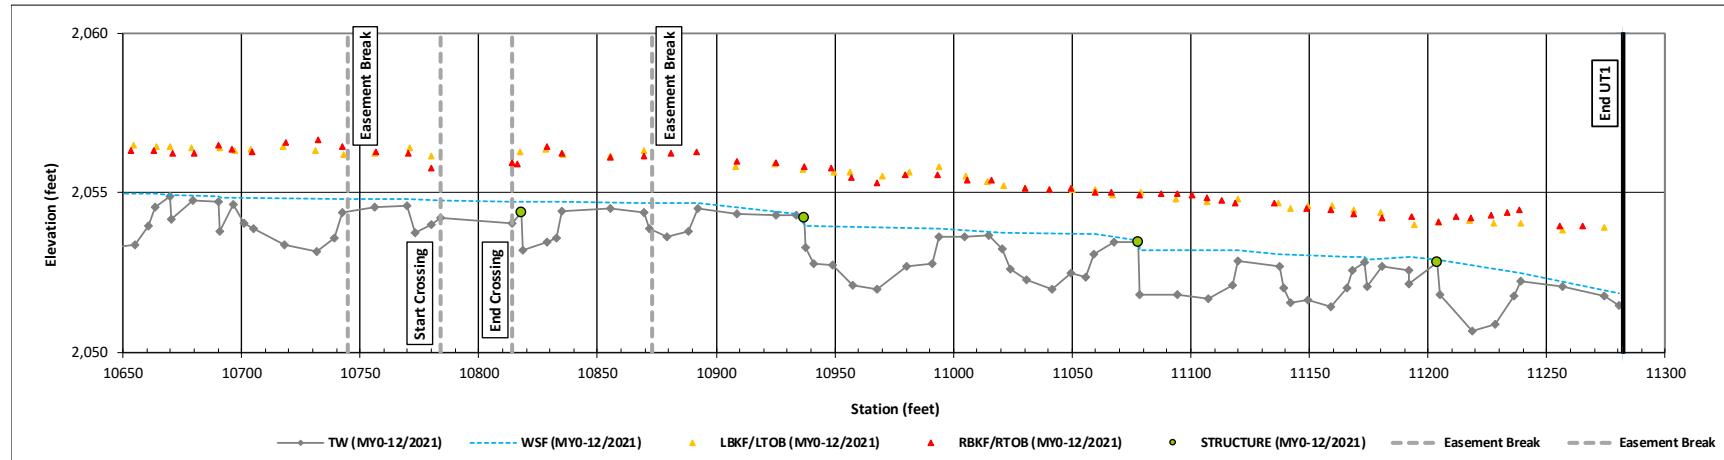
UT1 (STA 100+83 to 112+82)

Longitudinal Profile Plots

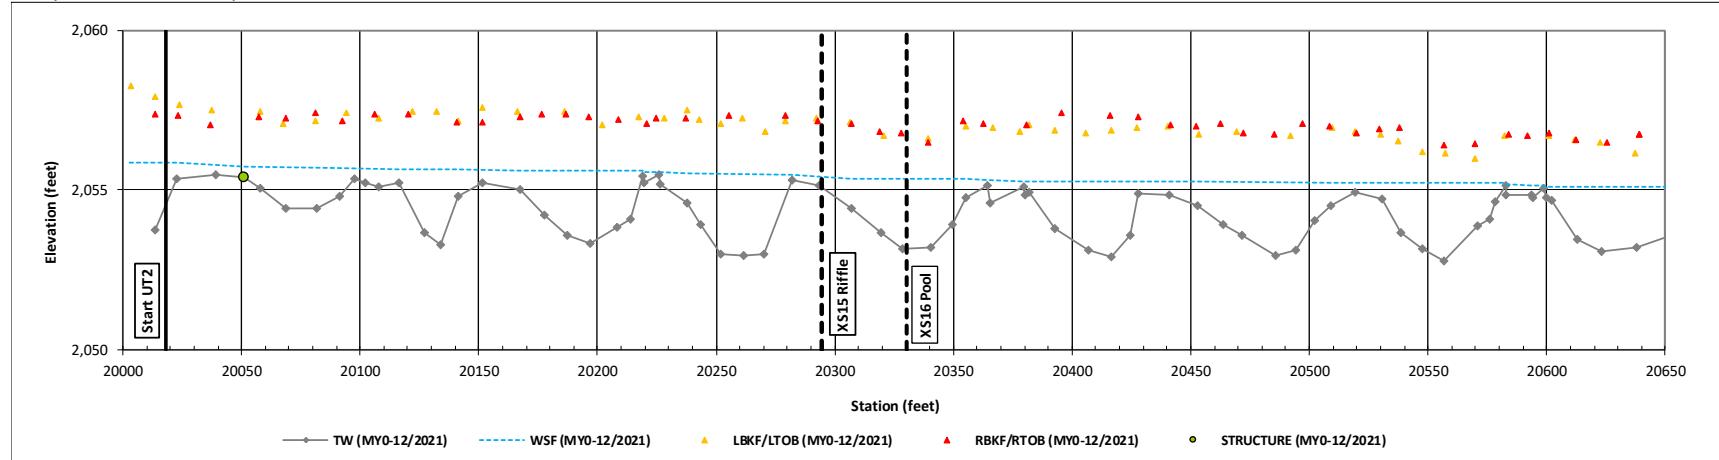
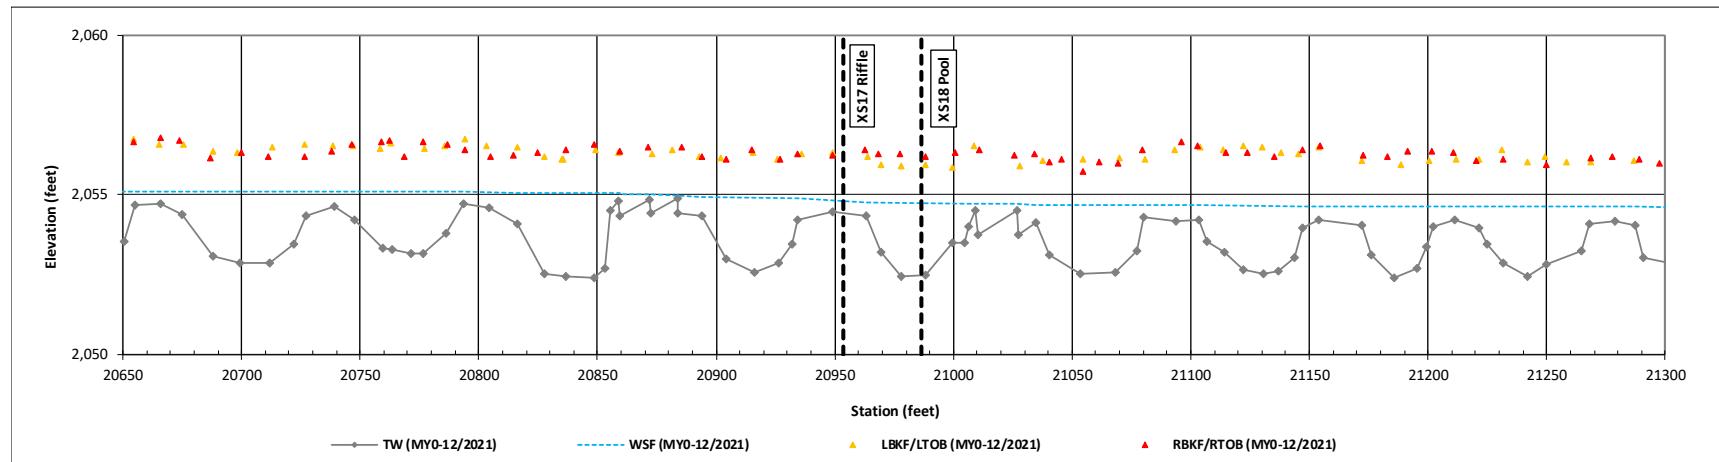
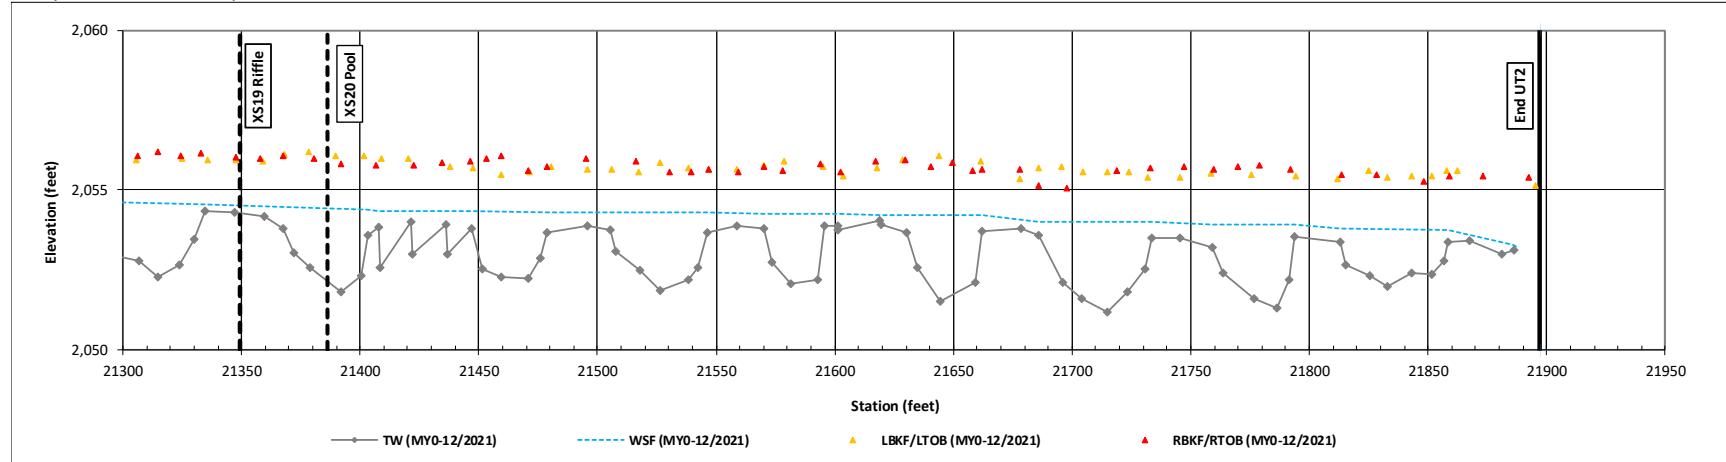
UT2 (STA 200+18 to 218+97)

Longitudinal Profile Plots

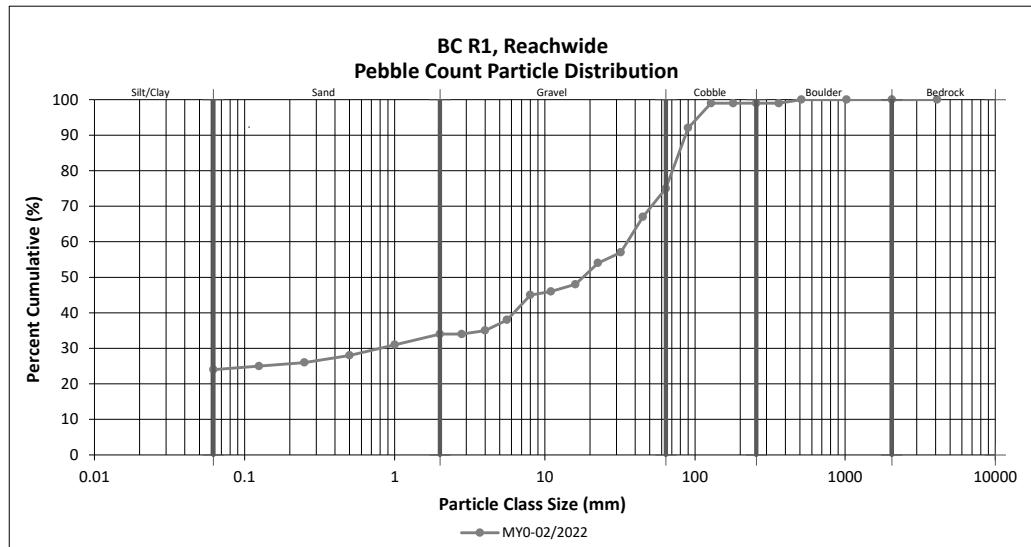
Particle Class	Diameter (mm)		Particle Count			Reach Summary		
	min	max	Riffle	Pool	Total	Class Percentage	Percent Cumulative	
SILT/CLAY	Silt/Clay	0.000	0.062		24	24	24	24
SAND	Very fine	0.062	0.125		1	1	1	25
	Fine	0.125	0.250		1	1	1	26
	Medium	0.25	0.50		2	2	2	28
	Coarse	0.5	1.0		3	3	3	31
	Very Coarse	1.0	2.0		3	3	3	34
	Very Fine	2.0	2.8					34
GRAVEL	Very Fine	2.8	4.0		1	1	1	35
	Fine	4.0	5.6		3	3	3	38
	Fine	5.6	8.0		7	7	7	45
	Medium	8.0	11.0		1	1	1	46
	Medium	11.0	16.0	1	1	2	2	48
	Coarse	16.0	22.6	3	3	6	6	54
	Coarse	22.6	32	3		3	3	57
	Very Coarse	32	45	10		10	10	67
	Very Coarse	45	64	8		8	8	75
	Small	64	90	17		17	17	92
COBBLE	Small	90	128	7		7	7	99
	Large	128	180					99
	Large	180	256					99
	Small	256	362					99
BOULDER	Small	362	512	1		1	1	100
	Medium	512	1024					100
	Large/Very Large	1024	2048					100
	Bedrock	2048	>2048					100
		Total	50	50	100	100	100

Reachwide	
Channel materials (mm)	
D ₁₆ =	Silt/Clay
D ₃₅ =	4.0
D ₅₀ =	18.0
D ₈₄ =	76.7
D ₉₅ =	104.7
D ₁₀₀ =	512.0

Sediment analysis results show riffles along most reaches have a median particle size classification of coarse gravel to small cobble. As expected, and noted in the Mitigation Plan (Wildlands, 2020), the Banner Creek Reach 4b riffle count is showing a finer median particle size of fine sand due to backwater and high sand loads from the French Broad River. Based on a DMS Technical Workgroup memo from 10/19/21 and concurrence received on 10/27/2021 from the DMS project manager for the Site, pebble counts will not be conducted during the remaining monitoring years unless requested by the IRT or deemed necessary by best professional judgement. Refer to Appendix A for the Visual Stream Morphology Stability Assessment Table and Stream Photographs. Refer to Appendix C for Stream Geomorphology Data. Refer to Appendix D for the DMS Technical Workgroup memo and the email confirmation from the DMS project manager (Reid, 2021).

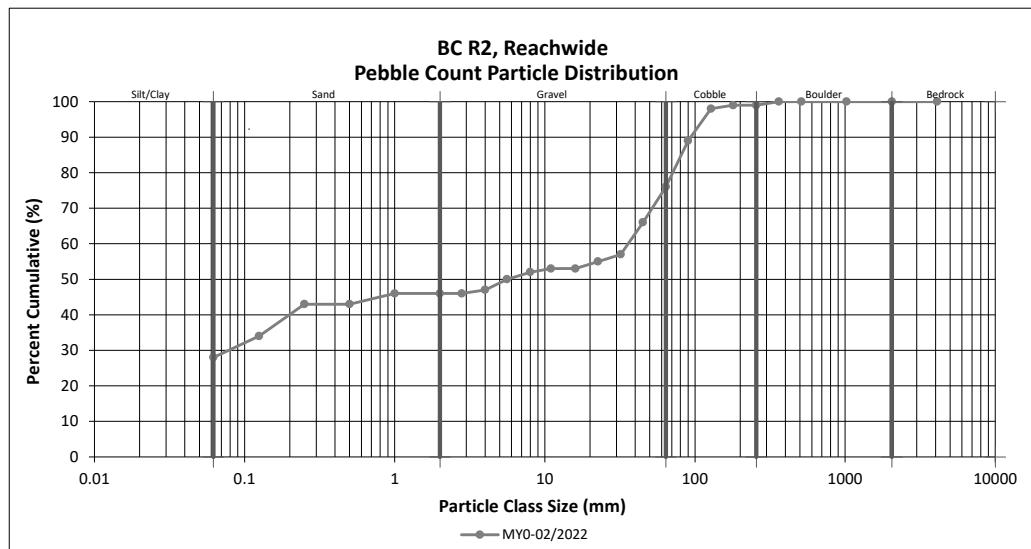
Particle Class	Diameter (mm)		Particle Count			Reach Summary		
	min	max	Riffle	Pool	Total	Class Percentage	Percent Cumulative	
SILT/CLAY	Silt/Clay	0.000	0.062	2	26	28	28	28
SAND	Very fine	0.062	0.125		6	6	6	34
	Fine	0.125	0.250	1	8	9	9	43
	Medium	0.25	0.50					43
	Coarse	0.5	1.0	2	1	3	3	46
	Very Coarse	1.0	2.0					46
	Very Fine	2.0	2.8					46
GRAVEL	Very Fine	2.8	4.0		1	1	1	47
	Fine	4.0	5.6		3	3	3	50
	Fine	5.6	8.0		2	2	2	52
	Medium	8.0	11.0	1		1	1	53
	Medium	11.0	16.0					53
	Coarse	16.0	22.6		2	2	2	55
	Coarse	22.6	32	2		2	2	57
	Very Coarse	32	45	8	1	9	9	66
	Very Coarse	45	64	10		10	10	76
	Small	64	90	13		13	13	89
COBBLE	Small	90	128	9		9	9	98
	Large	128	180	1		1	1	99
	Large	180	256					99
	Small	256	362	1		1	1	100
BOULDER	Small	362	512					100
	Medium	512	1024					100
	Large/Very Large	1024	2048					100
	Bedrock	2048	>2048					100
		Total	50	50	100	100	100

Reachwide	
Channel materials (mm)	
D ₁₆ =	Silt/Clay
D ₃₅ =	0.1
D ₅₀ =	5.6
D ₈₄ =	78.9
D ₉₅ =	113.8
D ₁₀₀ =	362.0

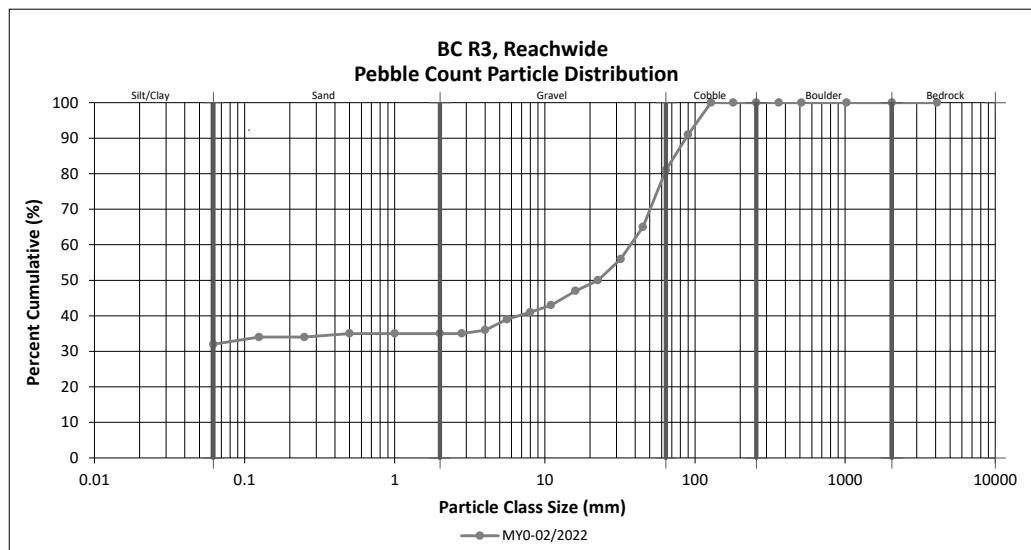
Particle Class	Diameter (mm)		Particle Count			Reach Summary		
	min	max	Riffle	Pool	Total	Class Percentage	Percent Cumulative	
SILT/CLAY	Silt/Clay	0.000	0.062	2	30	32	32	32
SAND	Very fine	0.062	0.125		2	2	2	34
	Fine	0.125	0.250					34
	Medium	0.25	0.50		1	1	1	35
	Coarse	0.5	1.0					35
	Very Coarse	1.0	2.0					35
	Very Fine	2.0	2.8					35
GRAVEL	Very Fine	2.8	4.0		1	1	1	36
	Fine	4.0	5.6		3	3	3	39
	Fine	5.6	8.0		2	2	2	41
	Medium	8.0	11.0		2	2	2	43
	Medium	11.0	16.0		4	4	4	47
	Coarse	16.0	22.6	1	2	3	3	50
	Coarse	22.6	32	6		6	6	56
	Very Coarse	32	45	7	2	9	9	65
	Very Coarse	45	64	16		16	16	81
	Small	64	90	9	1	10	10	91
COBBLE	Small	90	128	9		9	9	100
	Large	128	180					100
	Large	180	256					100
	Small	256	362					100
BOULDER	Small	362	512					100
	Medium	512	1024					100
	Large/Very Large	1024	2048					100
	Bedrock	2048	>2048					100
		Total	50	50	100	100	100

Reachwide	
Channel materials (mm)	
D ₁₆ =	Silt/Clay
D ₃₅ =	0.5
D ₅₀ =	22.6
D ₈₄ =	70.9
D ₉₅ =	105.3
D ₁₀₀ =	128.0

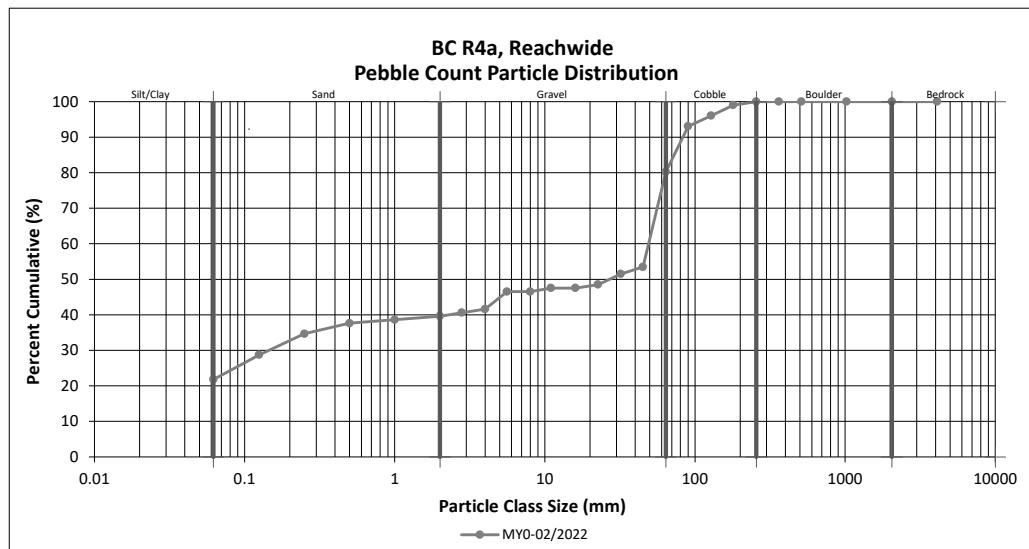
Particle Class	Diameter (mm)		Particle Count			Reach Summary		
	min	max	Riffle	Pool	Total	Class Percentage	Percent Cumulative	
SILT/CLAY	Silt/Clay	0.000	0.062		22	22	22	22
SAND	Very fine	0.062	0.125		7	7	7	29
	Fine	0.125	0.250		6	6	6	35
	Medium	0.25	0.50		3	3	3	38
	Coarse	0.5	1.0		1	1	1	39
	Very Coarse	1.0	2.0		1	1	1	40
	Very Fine	2.0	2.8		1	1	1	41
GRAVEL	Very Fine	2.8	4.0		1	1	1	42
	Fine	4.0	5.6		5	5	5	47
	Fine	5.6	8.0					47
	Medium	8.0	11.0		1	1	1	48
	Medium	11.0	16.0					48
	Coarse	16.0	22.6		1	1	1	49
	Coarse	22.6	32	2	1	3	3	51
	Very Coarse	32	45	2		2	2	53
	Very Coarse	45	64	27		27	27	80
	Small	64	90	13		13	13	93
COBBLE	Small	90	128	3		3	3	96
	Large	128	180	3		3	3	99
	Large	180	256	1		1	1	100
	Small	256	362					100
BOULDER	Small	362	512					100
	Medium	512	1024					100
	Large/Very Large	1024	2048					100
	Bedrock	2048	>2048					100
		Total	51	50	101	100	100

Reachwide	
Channel materials (mm)	
D ₁₆ =	Silt/Clay
D ₃₅ =	0.3
D ₅₀ =	26.9
D ₈₄ =	70.8
D ₉₅ =	113.2
D ₁₀₀ =	256.0

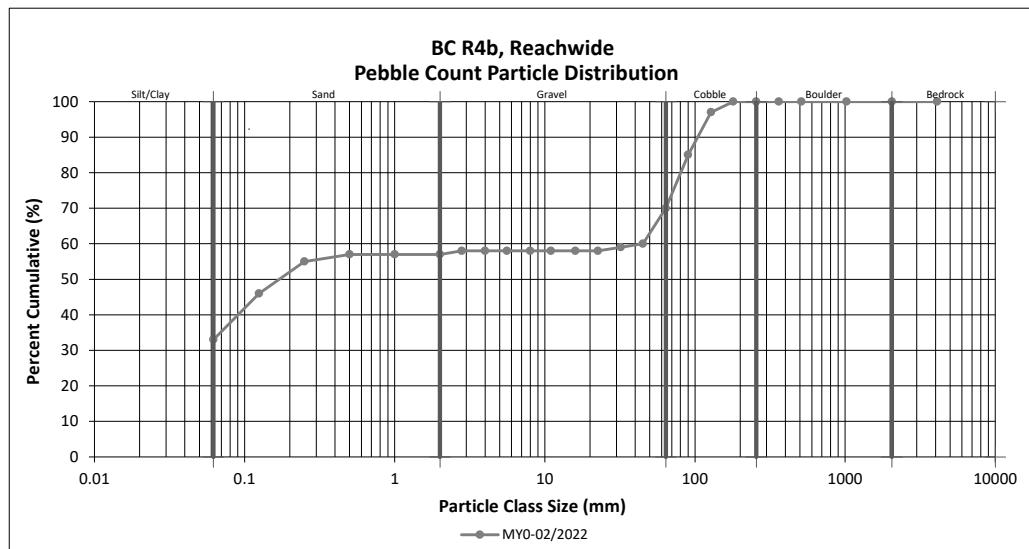
Particle Class	Diameter (mm)		Particle Count			Reach Summary		
	min	max	Riffle	Pool	Total	Class Percentage	Percent Cumulative	
SILT/CLAY	Silt/Clay	0.000	0.062	7	26	33	33	33
SAND	Very fine	0.062	0.125		13	13	13	46
	Fine	0.125	0.250	2	7	9	9	55
	Medium	0.25	0.50		2	2	2	57
	Coarse	0.5	1.0					57
	Very Coarse	1.0	2.0					57
	Very Fine	2.0	2.8		1	1	1	58
GRAVEL	Very Fine	2.8	4.0					58
	Fine	4.0	5.6					58
	Fine	5.6	8.0					58
	Medium	8.0	11.0					58
	Medium	11.0	16.0					58
	Coarse	16.0	22.6					58
	Coarse	22.6	32	1		1	1	59
	Very Coarse	32	45	1		1	1	60
	Very Coarse	45	64	10		10	10	70
	Small	64	90	14	1	15	15	85
COBBLE	Small	90	128	12		12	12	97
	Large	128	180	3		3	3	100
	Large	180	256					100
	Small	256	362					100
BOULDER	Small	362	512					100
	Medium	512	1024					100
	Large/Very Large	1024	2048					100
	Bedrock	2048	>2048					100
		Total	50	50	100	100	100

Reachwide	
Channel materials (mm)	
D ₁₆ =	Silt/Clay
D ₃₅ =	0.1
D ₅₀ =	0.2
D ₈₄ =	88.0
D ₉₅ =	120.7
D ₁₀₀ =	180.0

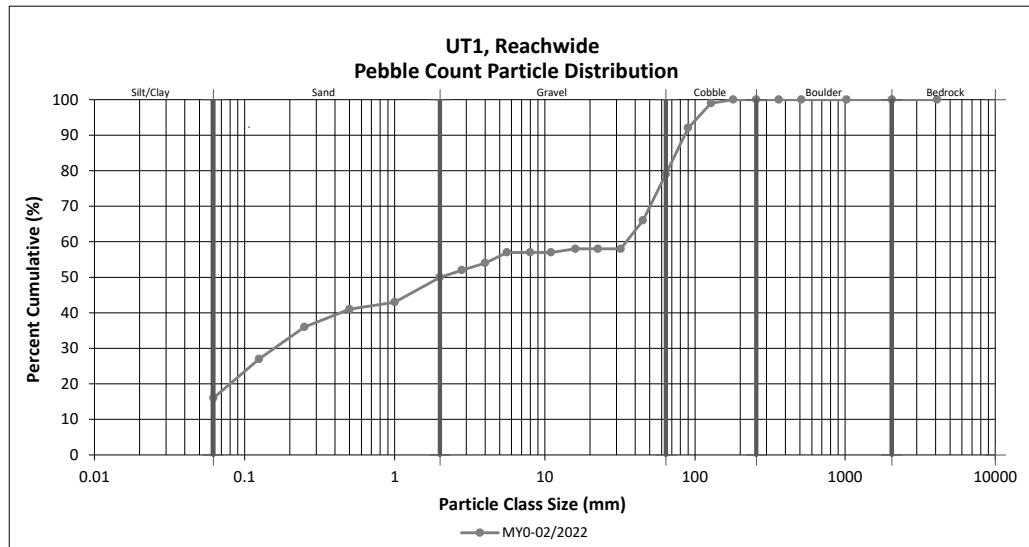
Particle Class	Diameter (mm)		Particle Count			Reach Summary		
	min	max	Riffle	Pool	Total	Class Percentage	Percent Cumulative	
SILT/CLAY	Silt/Clay	0.000	0.062		16	16	16	16
SAND	Very fine	0.062	0.125		11	11	11	27
	Fine	0.125	0.250		9	9	9	36
	Medium	0.25	0.50		5	5	5	41
	Coarse	0.5	1.0		2	2	2	43
	Very Coarse	1.0	2.0	4	3	7	7	50
	Very Fine	2.0	2.8	1	1	2	2	52
GRAVEL	Very Fine	2.8	4.0		2	2	2	54
	Fine	4.0	5.6	2	1	3	3	57
	Fine	5.6	8.0					57
	Medium	8.0	11.0					57
	Medium	11.0	16.0	1		1	1	58
	Coarse	16.0	22.6					58
	Coarse	22.6	32					58
	Very Coarse	32	45	8		8	8	66
	Very Coarse	45	64	13		13	13	79
	Small	64	90	13		13	13	92
COBBLE	Small	90	128	7		7	7	99
	Large	128	180	1		1	1	100
	Large	180	256					100
	Small	256	362					100
BOULDER	Small	362	512					100
	Medium	512	1024					100
	Large/Very Large	1024	2048					100
	Bedrock	2048	>2048					100
		Total	50	50	100	100	100

Reachwide	
Channel materials (mm)	
D ₁₆ =	Silt/Clay
D ₃₅ =	0.2
D ₅₀ =	2.0
D ₈₄ =	73.0
D ₉₅ =	104.7
D ₁₀₀ =	180.0

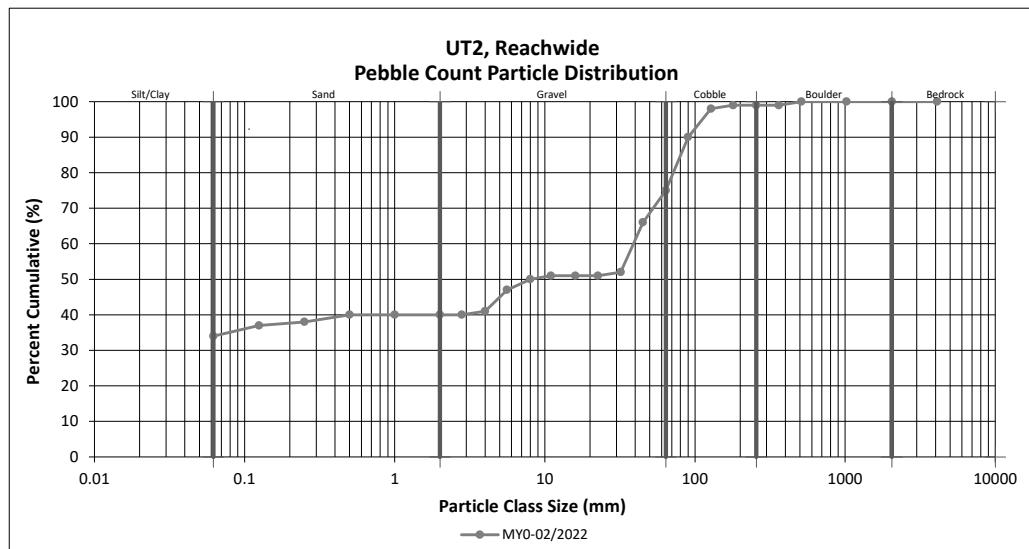
Particle Class	Diameter (mm)		Particle Count			Reach Summary	
	min	max	Riffle	Pool	Total	Class Percentage	Percent Cumulative
SILT/CLAY	Silt/Clay	0.000	0.062		34	34	34
SAND	Very fine	0.062	0.125		3	3	3
	Fine	0.125	0.250		1	1	37
	Medium	0.25	0.50		2	2	40
	Coarse	0.5	1.0				40
	Very Coarse	1.0	2.0				40
	Very Fine	2.0	2.8				40
GRAVEL	Very Fine	2.8	4.0		1	1	41
	Fine	4.0	5.6	1	5	6	47
	Fine	5.6	8.0		3	3	50
	Medium	8.0	11.0		1	1	51
	Medium	11.0	16.0				51
	Coarse	16.0	22.6				51
	Coarse	22.6	32	1		1	52
	Very Coarse	32	45	14		14	66
	Very Coarse	45	64	9		9	75
	Small	64	90	15		15	90
COBBLE	Small	90	128	8		8	98
	Large	128	180	1		1	99
	Large	180	256				99
	Small	256	362				99
BOULDER	Small	362	512	1		1	100
	Medium	512	1024				100
	Large/Very Large	1024	2048				100
	Bedrock	2048	>2048				100
		Total	50	50	100	100	100

Reachwide	
Channel materials (mm)	
D ₁₆ =	Silt/Clay
D ₃₅ =	0.1
D ₅₀ =	8.0
D ₈₄ =	78.5
D ₉₅ =	112.2
D ₁₀₀ =	512.0

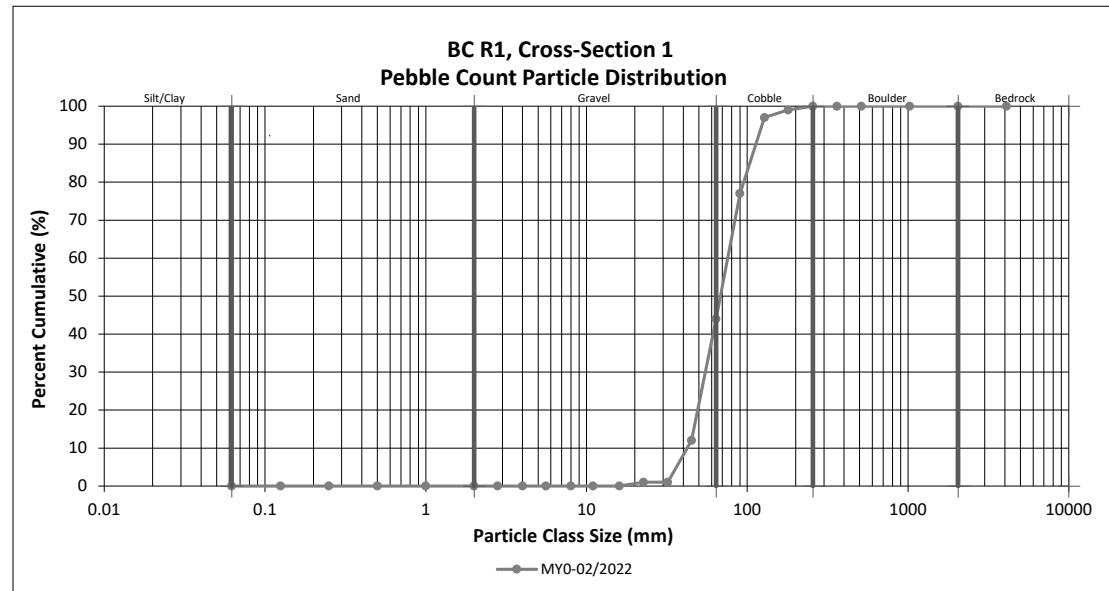
Particle Class	Diameter (mm)		Riffle 100-Count	Summary	
	min	max		Class Percentage	Percent Cumulative
SILT/CLAY	Silt/Clay	0.000	0.062		0
SAND	Very fine	0.062	0.125		0
	Fine	0.125	0.250		0
	Medium	0.25	0.50		0
	Coarse	0.5	1.0		0
	Very Coarse	1.0	2.0		0
GRAVEL	Very Fine	2.0	2.8		0
	Very Fine	2.8	4.0		0
	Fine	4.0	5.6		0
	Fine	5.6	8.0		0
	Medium	8.0	11.0		0
	Medium	11.0	16.0		0
	Coarse	16.0	22.6	1	1
	Coarse	22.6	32		1
	Very Coarse	32	45	11	11
	Very Coarse	45	64	32	44
COBBLE	Small	64	90	33	33
	Small	90	128	20	20
	Large	128	180	2	2
	Large	180	256	1	1
BOULDER	Small	256	362		100
	Small	362	512		100
	Medium	512	1024		100
	Large/Very Large	1024	2048		100
BEDROCK	Bedrock	2048	>2048		100
		Total	100	100	100

Cross-Section 1	
Channel materials (mm)	
$D_{16} =$	47.0
$D_{35} =$	58.0
$D_{50} =$	68.1
$D_{84} =$	101.8
$D_{95} =$	123.6
$D_{100} =$	256.0

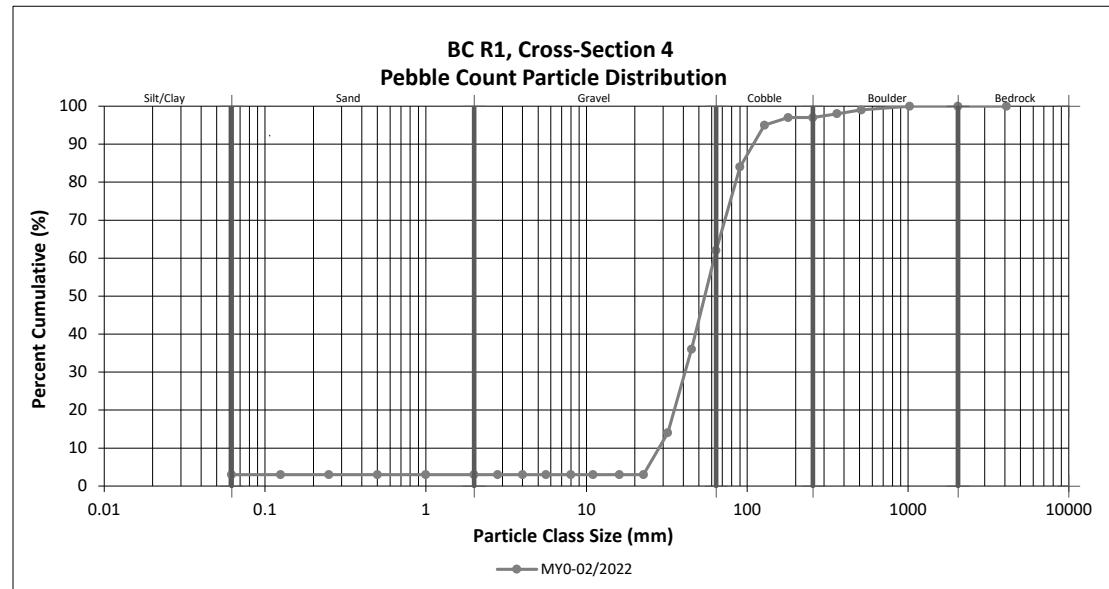
Particle Class	Diameter (mm)		Riffle 100-Count	Summary	
	min	max		Class Percentage	Percent Cumulative
SILT/CLAY	Silt/Clay	0.000	0.062	3	3
SAND	Very fine	0.062	0.125		3
	Fine	0.125	0.250		3
	Medium	0.25	0.50		3
	Coarse	0.5	1.0		3
	Very Coarse	1.0	2.0		3
GRAVEL	Very Fine	2.0	2.8		3
	Very Fine	2.8	4.0		3
	Fine	4.0	5.6		3
	Fine	5.6	8.0		3
	Medium	8.0	11.0		3
	Medium	11.0	16.0		3
	Coarse	16.0	22.6		3
	Coarse	22.6	32	11	14
	Very Coarse	32	45	22	36
	Very Coarse	45	64	26	62
COBBLE	Small	64	90	22	22
	Small	90	128	11	11
	Large	128	180	2	2
	Large	180	256		97
BOULDER	Small	256	362	1	1
	Small	362	512	1	1
	Medium	512	1024	1	1
	Large/Very Large	1024	2048		100
BEDROCK	Bedrock	2048	>2048		100
		Total	100	100	100

Cross-Section 4	
Channel materials (mm)	
$D_{16} =$	33.0
$D_{35} =$	44.3
$D_{50} =$	54.4
$D_{84} =$	90.0
$D_{95} =$	128.0
$D_{100} =$	1024.0

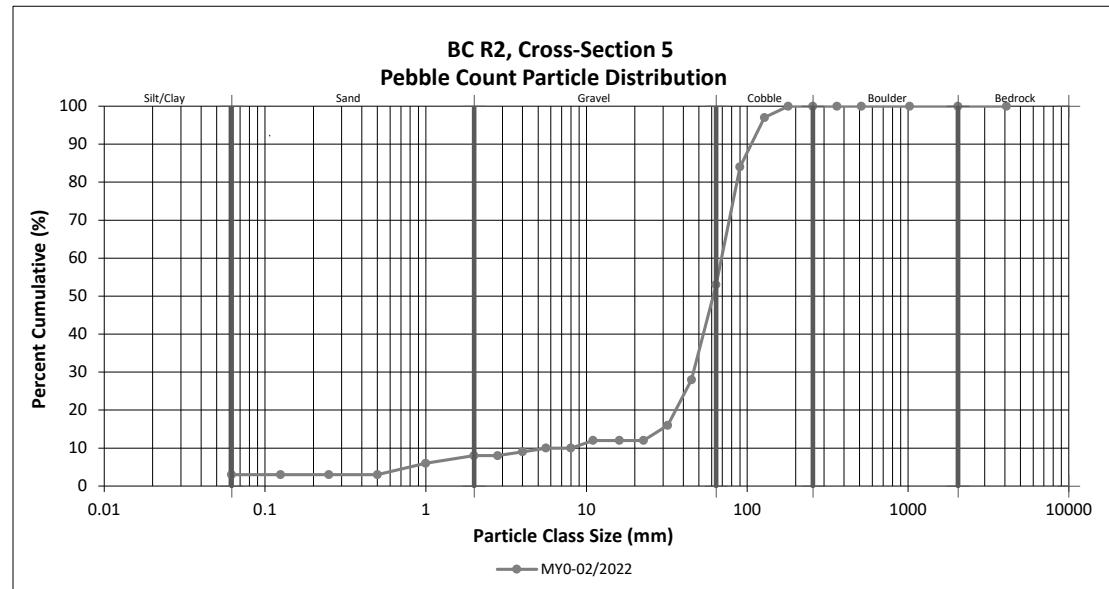
Particle Class	Diameter (mm)		Riffle 100-Count	Summary	
	min	max		Class Percentage	Percent Cumulative
SILT/CLAY	Silt/Clay	0.000	0.062	3	3
SAND	Very fine	0.062	0.125		3
	Fine	0.125	0.250		3
	Medium	0.25	0.50		3
	Coarse	0.5	1.0	3	6
	Very Coarse	1.0	2.0	2	8
GRAVEL	Very Fine	2.0	2.8		8
	Very Fine	2.8	4.0	1	9
	Fine	4.0	5.6	1	10
	Fine	5.6	8.0		10
	Medium	8.0	11.0	2	12
	Medium	11.0	16.0		12
	Coarse	16.0	22.6		12
	Coarse	22.6	32	4	16
	Very Coarse	32	45	12	28
	Very Coarse	45	64	25	53
COBBLE	Small	64	90	31	31
	Small	90	128	13	13
	Large	128	180	3	3
	Large	180	256		100
BOULDER	Small	256	362		100
	Small	362	512		100
	Medium	512	1024		100
	Large/Very Large	1024	2048		100
BEDROCK	Bedrock	2048	>2048		100
		Total	100	100	100

Cross-Section 5	
Channel materials (mm)	
$D_{16} =$	32.0
$D_{35} =$	49.7
$D_{50} =$	61.4
$D_{84} =$	90.0
$D_{95} =$	121.2
$D_{100} =$	180.0

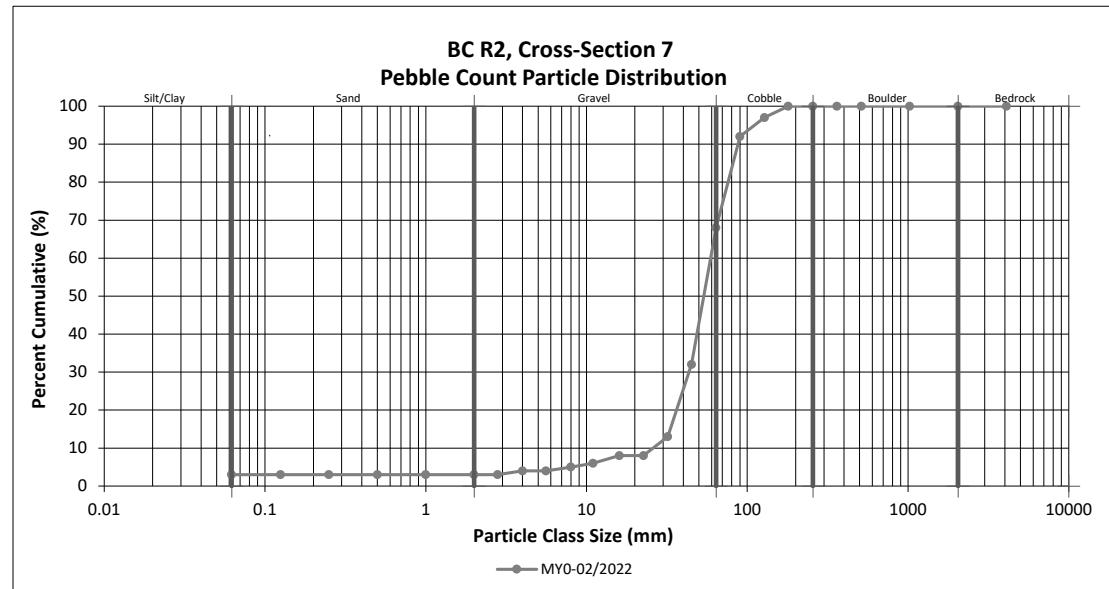
Particle Class	Diameter (mm)		Riffle 100-Count	Summary	
	min	max		Class Percentage	Percent Cumulative
SILT/CLAY	Silt/Clay	0.000	0.062	3	3
SAND	Very fine	0.062	0.125		3
	Fine	0.125	0.250		3
	Medium	0.25	0.50		3
	Coarse	0.5	1.0		3
	Very Coarse	1.0	2.0		3
GRAVEL	Very Fine	2.0	2.8		3
	Very Fine	2.8	4.0	1	1
	Fine	4.0	5.6		4
	Fine	5.6	8.0	1	1
	Medium	8.0	11.0	1	1
	Medium	11.0	16.0	2	2
	Coarse	16.0	22.6		8
	Coarse	22.6	32	5	13
	Very Coarse	32	45	19	32
	Very Coarse	45	64	36	68
COBBLE	Small	64	90	24	24
	Small	90	128	5	5
	Large	128	180	3	3
	Large	180	256		100
BOULDER	Small	256	362		100
	Small	362	512		100
	Medium	512	1024		100
	Large/Very Large	1024	2048		100
BEDROCK	Bedrock	2048	>2048		100
		Total	100	100	100

Cross-Section 7	
Channel materials (mm)	
$D_{16} =$	33.8
$D_{35} =$	46.3
$D_{50} =$	53.7
$D_{84} =$	80.3
$D_{95} =$	111.2
$D_{100} =$	180.0

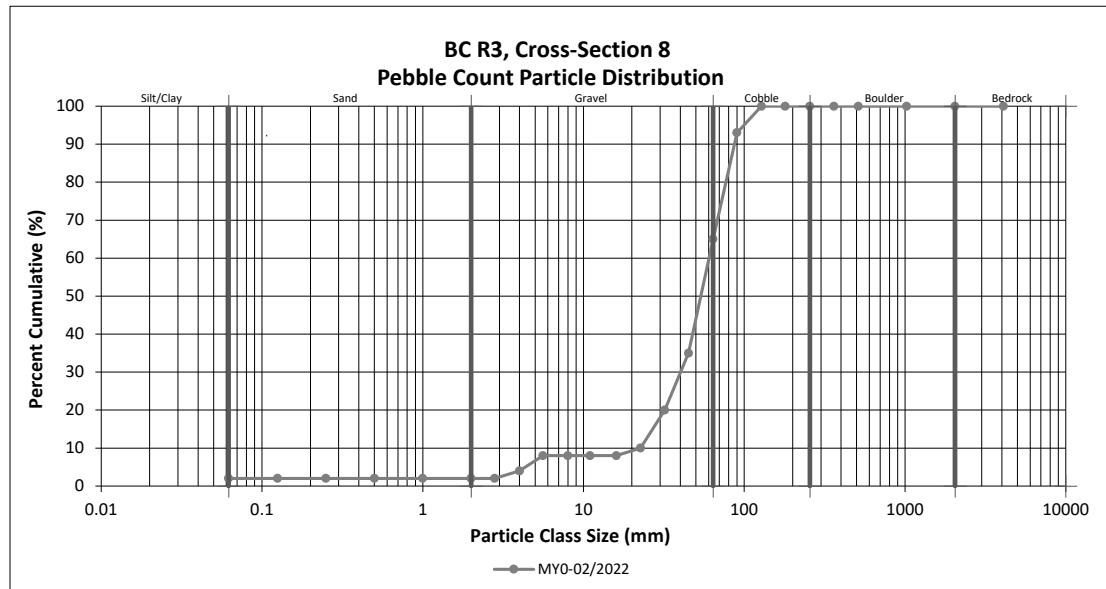
Riffle Pebble Count Plots

Cross-Section 8	
Channel materials (mm)	
$D_{16} =$	27.8
$D_{35} =$	45.0
$D_{50} =$	53.7
$D_{84} =$	80.7
$D_{95} =$	99.5
$D_{100} =$	128.0

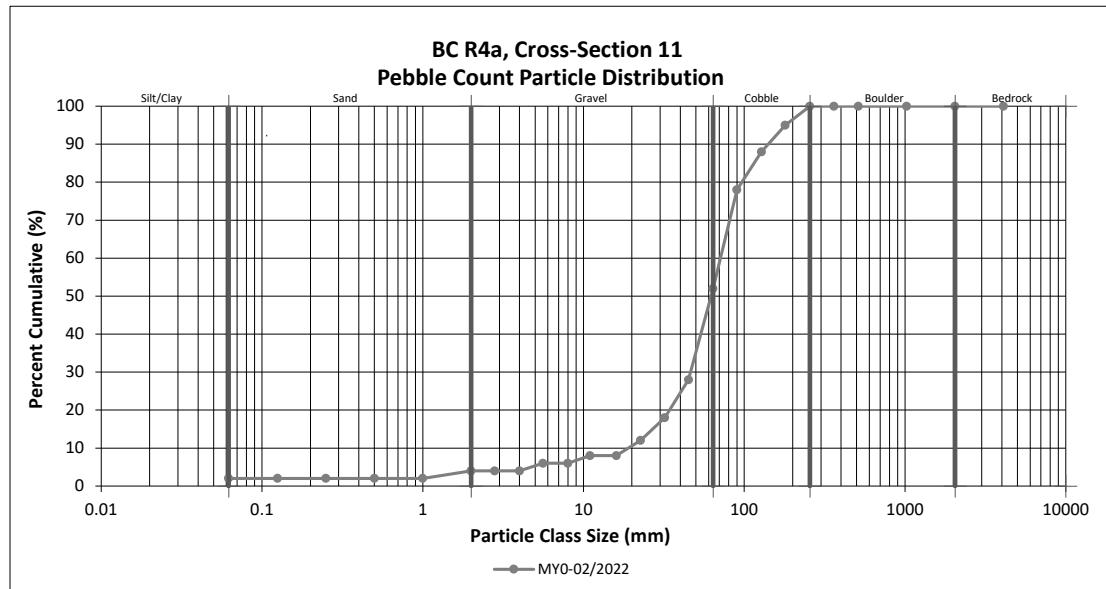
Riffle Pebble Count Plots

Cross-Section 11	
Channel materials (mm)	
$D_{16} =$	28.5
$D_{35} =$	49.9
$D_{50} =$	62.1
$D_{84} =$	111.2
$D_{95} =$	180.0
$D_{100} =$	256.0

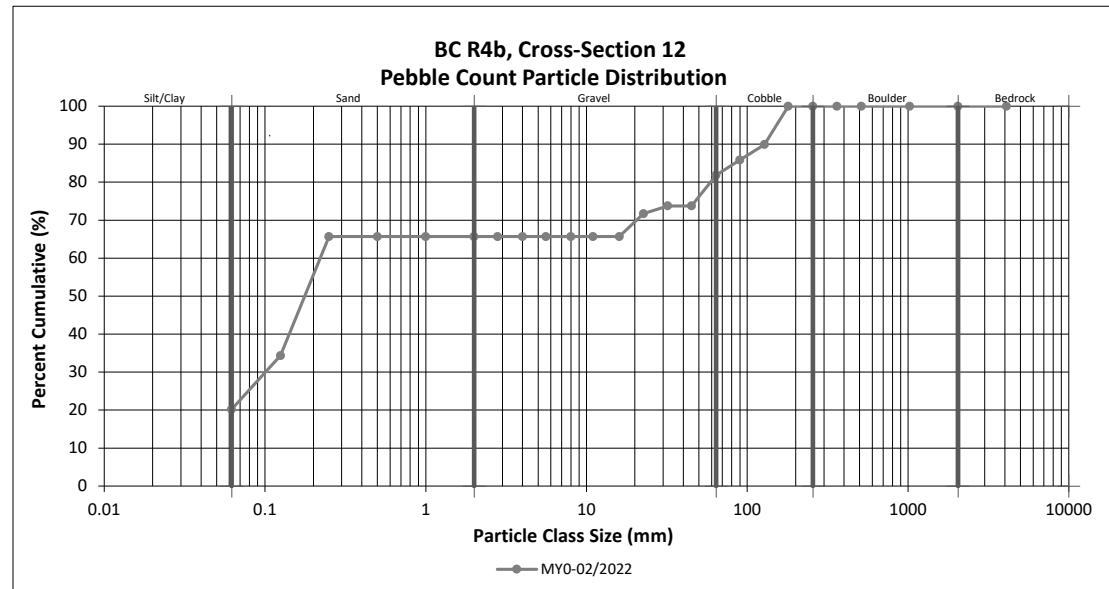
Riffle Pebble Count Plots

Cross-Section 12	
Channel materials (mm)	
D ₁₆ =	Silt/Clay
D ₃₅ =	0.1
D ₅₀ =	0.2
D ₈₄ =	76.9
D ₉₅ =	152.0
D ₁₀₀ =	180.0
