MONITORING YEAR 0 ANNUAL REPORT

BANNER FARM MITIGATION SITE

Henderson County, NC
French Broad River Basin
HUC 06010105

DMS Project No. 100062

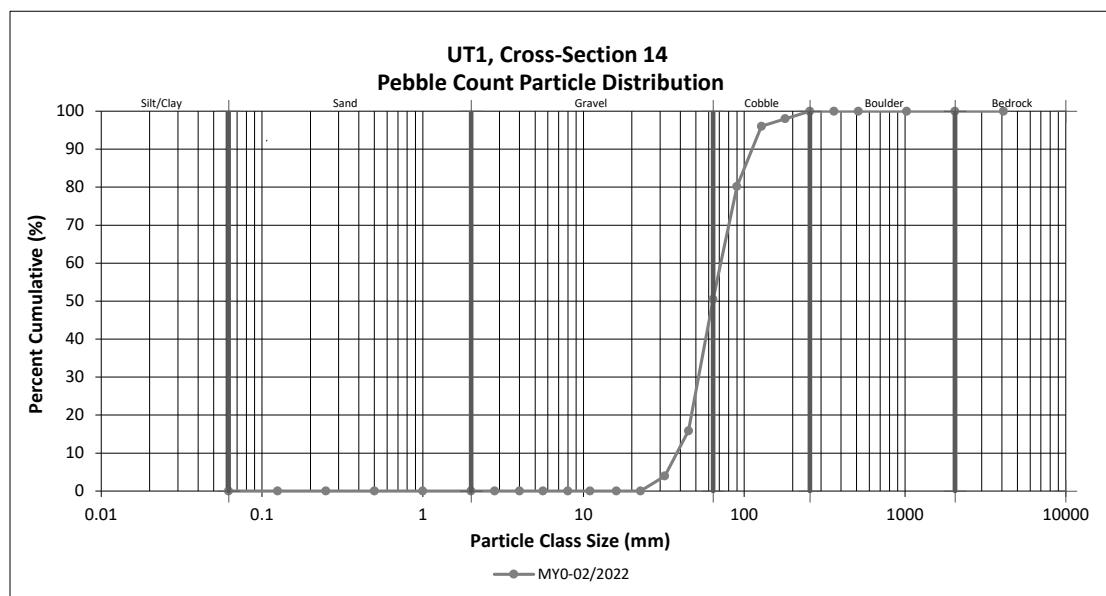
Riffle Pebble Count Plots

Cross-Section 14	
Channel materials (mm)	
$D_{16} =$	45.1
$D_{35} =$	54.7
$D_{50} =$	63.7
$D_{84} =$	97.9
$D_{95} =$	125.1
$D_{100} =$	256.0

Sediment analysis results show riffles along most reaches have a median particle size classification of coarse gravel to small cobble. As expected, and noted in the Mitigation Plan (Wildlands, 2020), the Banner Creek Reach 4b riffle count is showing a finer median particle size of fine sand due to backwater and high sand loads from the French Broad River. Based on a DMS Technical Workgroup memo from 10/19/21 and concurrence received on 10/27/2021 from the DMS project manager for the Site, pebble counts will not be conducted during the remaining monitoring years unless requested by the IRT or deemed necessary by best professional judgement. Refer to Appendix A for the Visual Stream Morphology Stability Assessment Table and Stream Photographs. Refer to Appendix C for Stream Geomorphology Data. Refer to Appendix D for the DMS Technical Workgroup memo and the email confirmation from the DMS project manager (Reid, 2021).

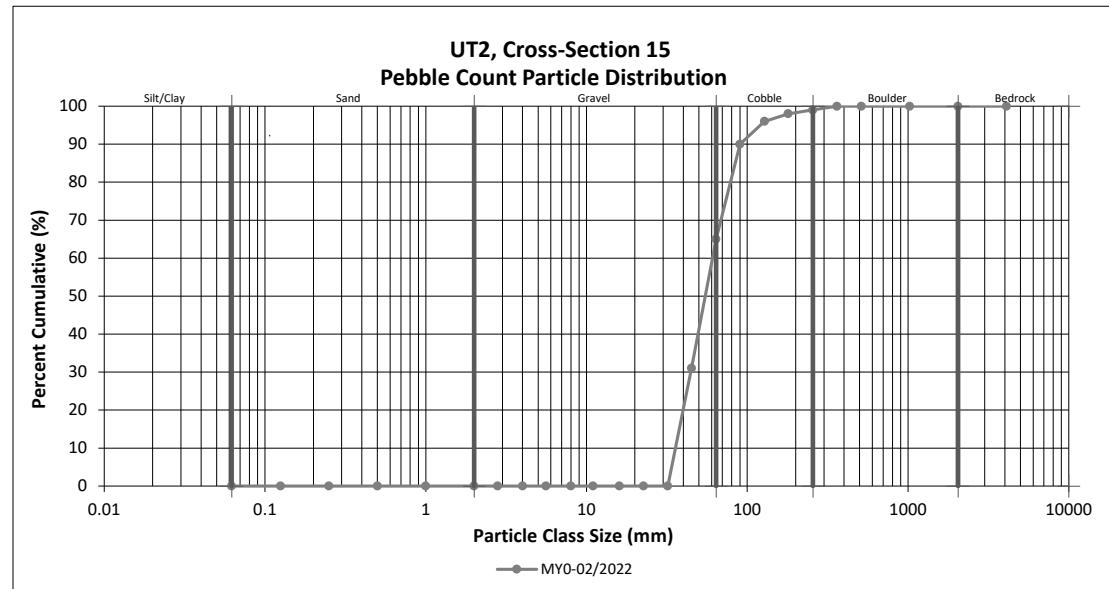
Riffle Pebble Count Plots

Cross-Section 15	
Channel materials (mm)	
$D_{16} =$	38.2
$D_{35} =$	46.9
$D_{50} =$	54.8
$D_{84} =$	82.9
$D_{95} =$	120.7
$D_{100} =$	362.0

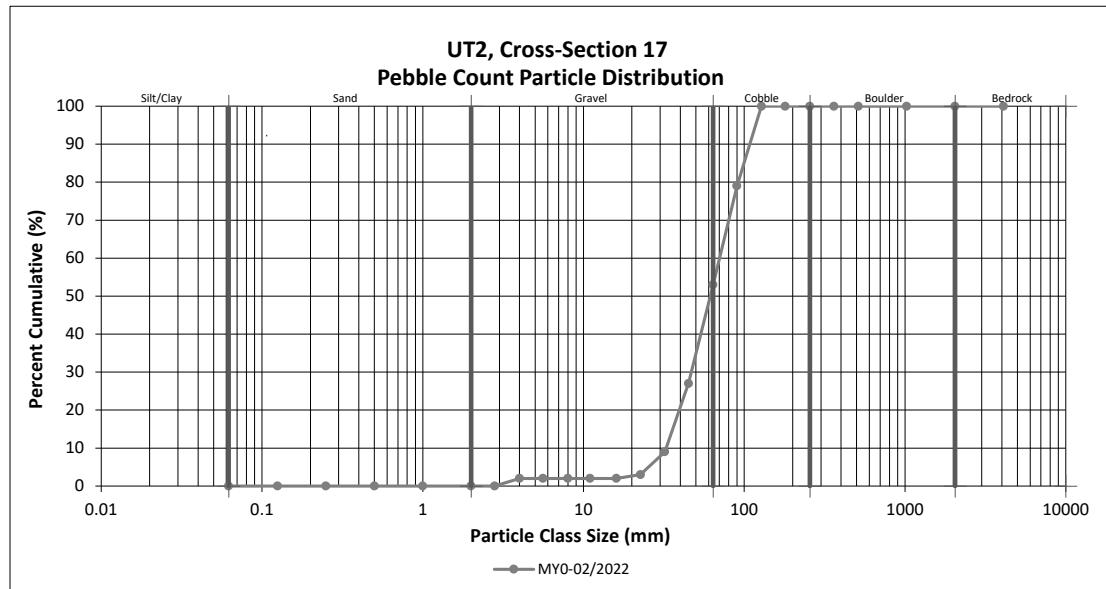
Riffle Pebble Count Plots

Cross-Section 17	
Channel materials (mm)	
$D_{16} =$	36.5
$D_{35} =$	50.2
$D_{50} =$	61.5
$D_{84} =$	97.9
$D_{95} =$	117.7
$D_{100} =$	128.0

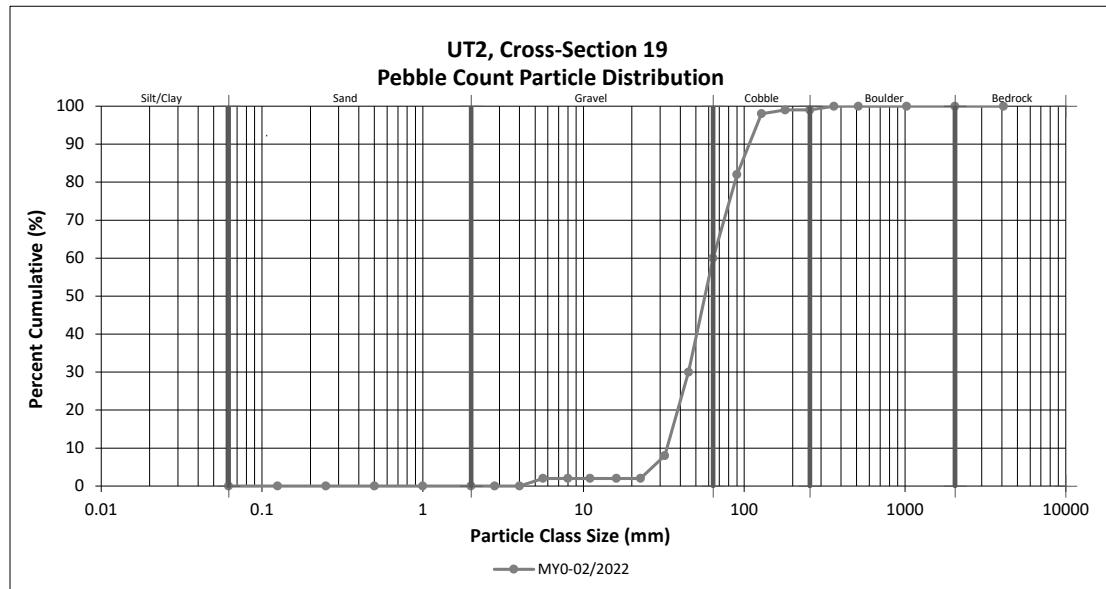
Cross-Section 19	
Channel materials (mm)	
$D_{16} =$	36.2
$D_{35} =$	47.7
$D_{50} =$	56.9
$D_{84} =$	94.1
$D_{95} =$	119.8
$D_{100} =$	362.0

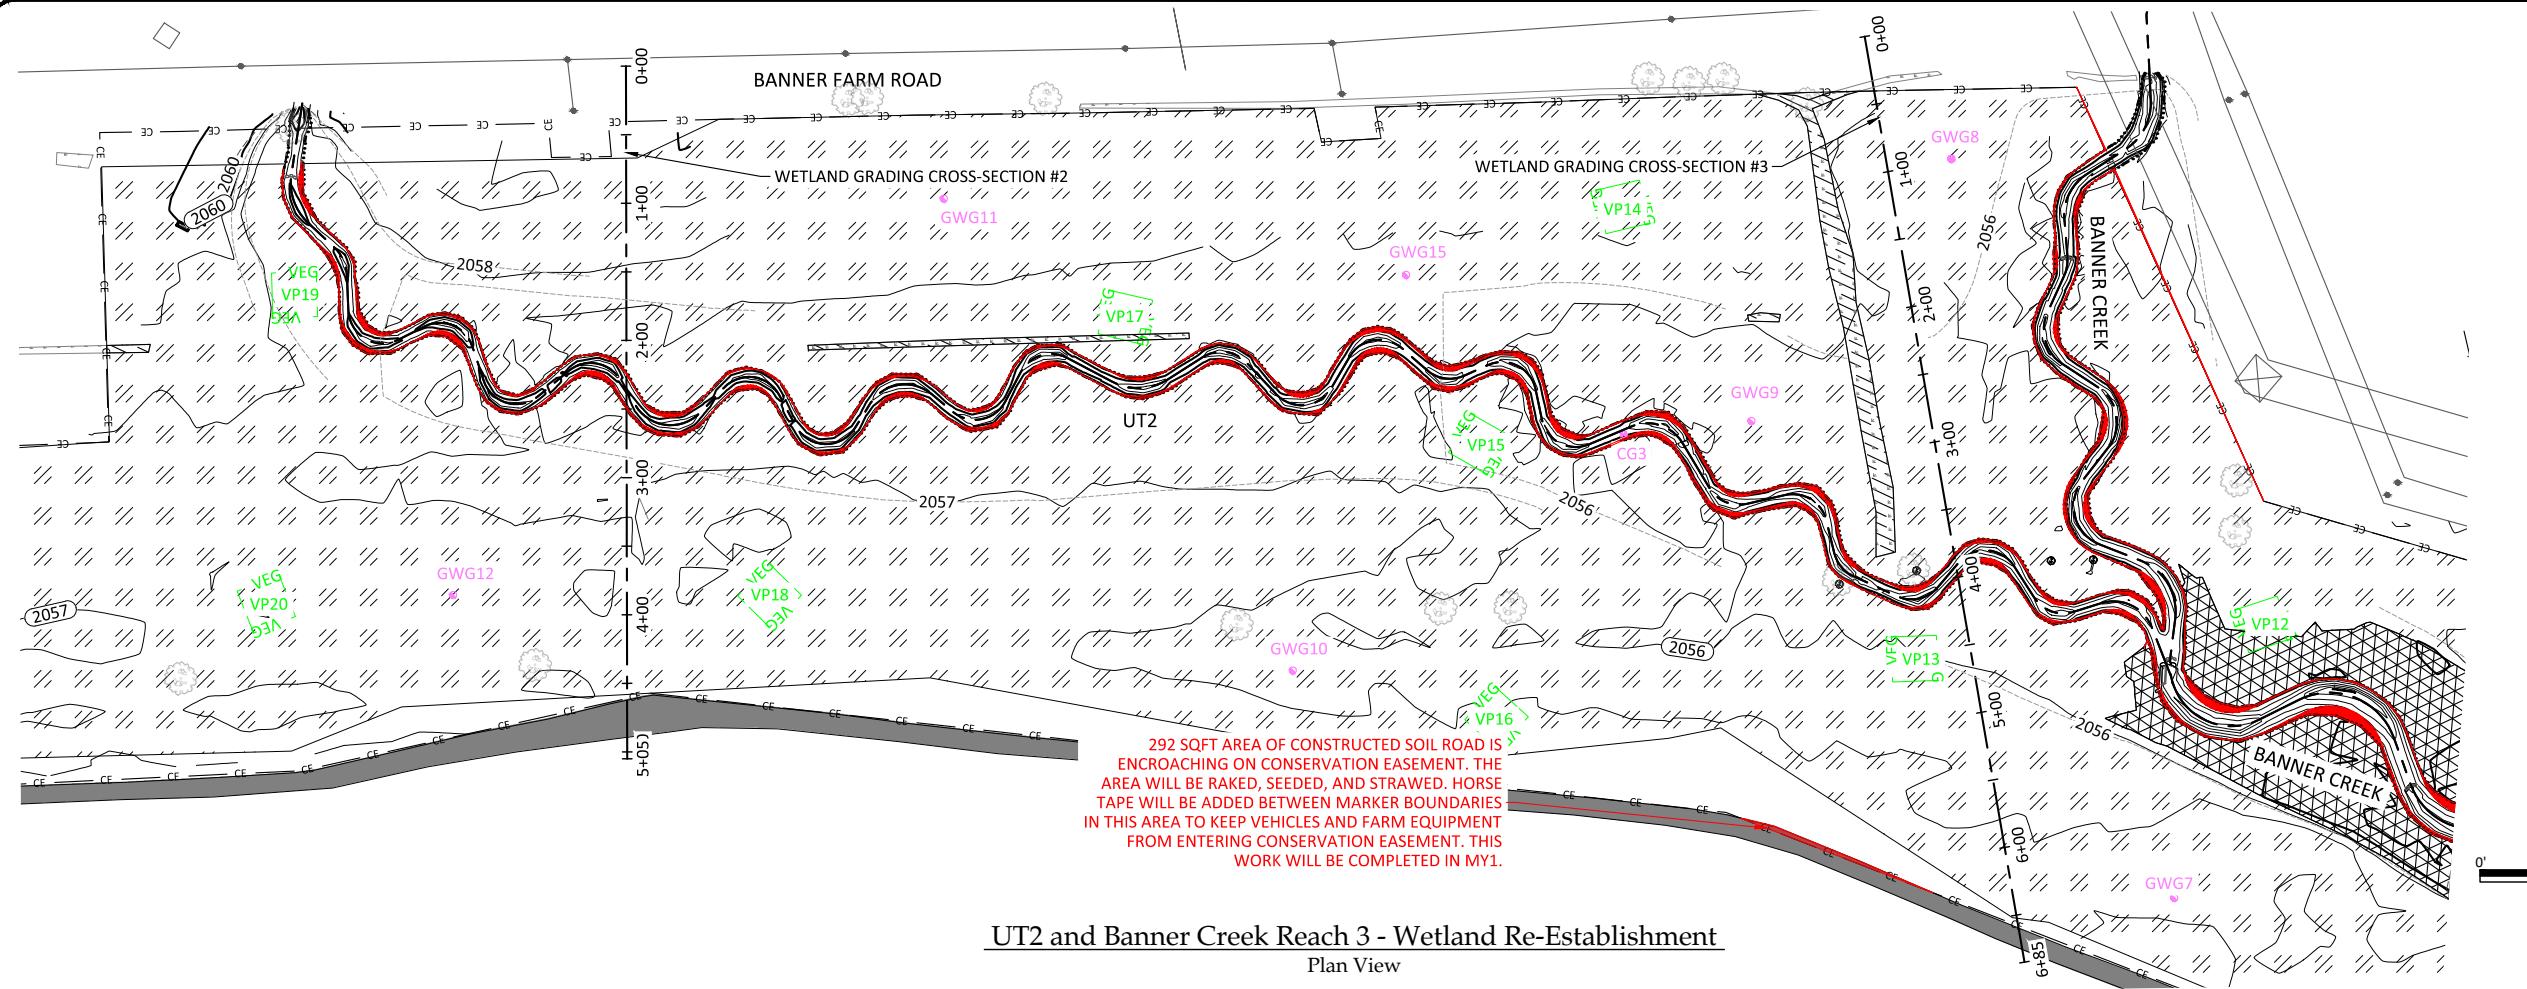
2.2

UT2 and Banner Creek Reach 3 - Wetland Re-Establishment

Plan View

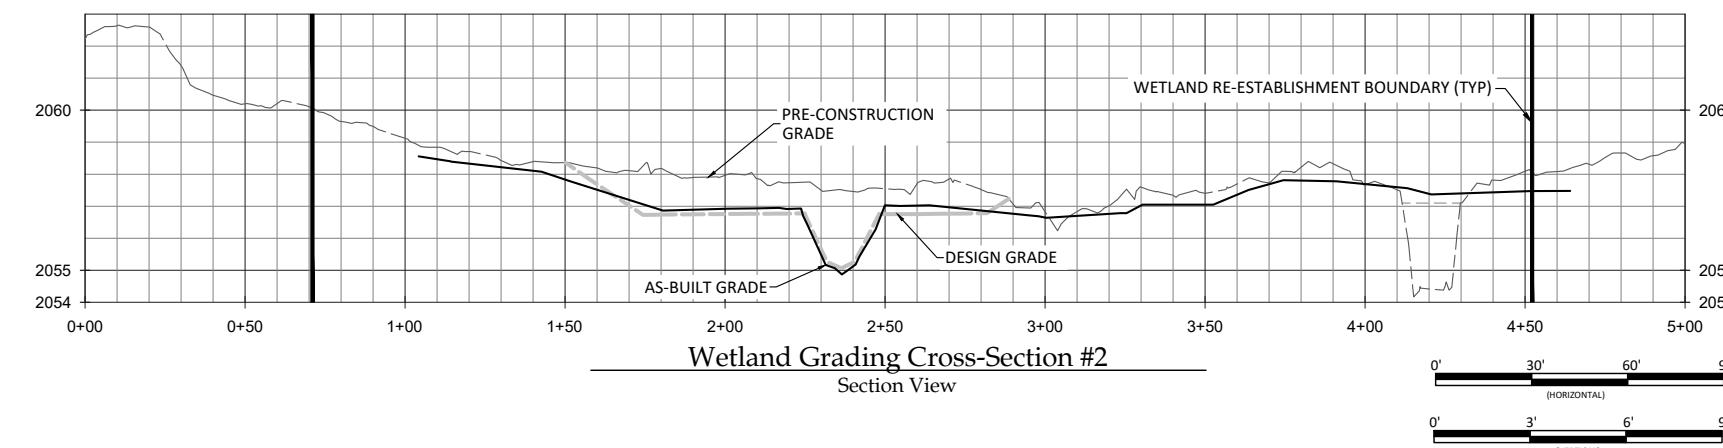
Wetland Grading Cross-Section #2

Section View

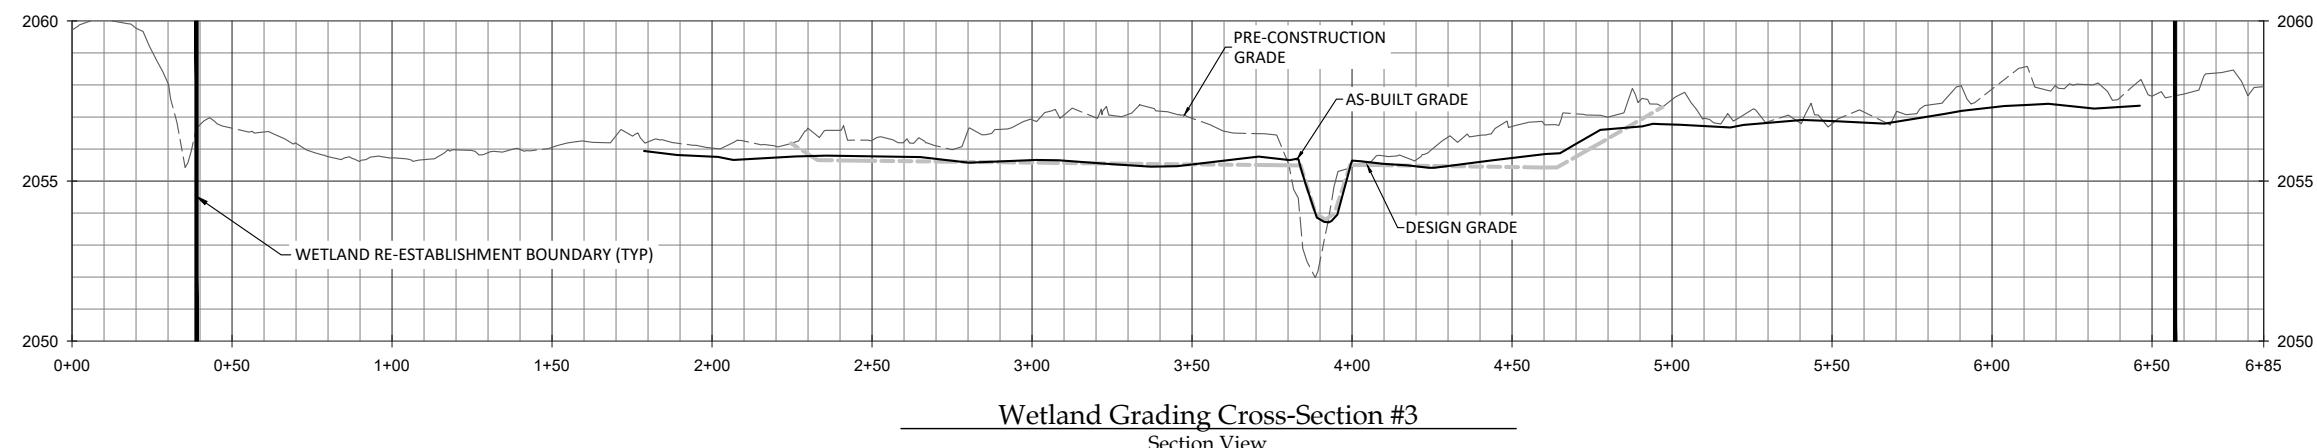
Wetland Grading Cross-Section #3

Section View

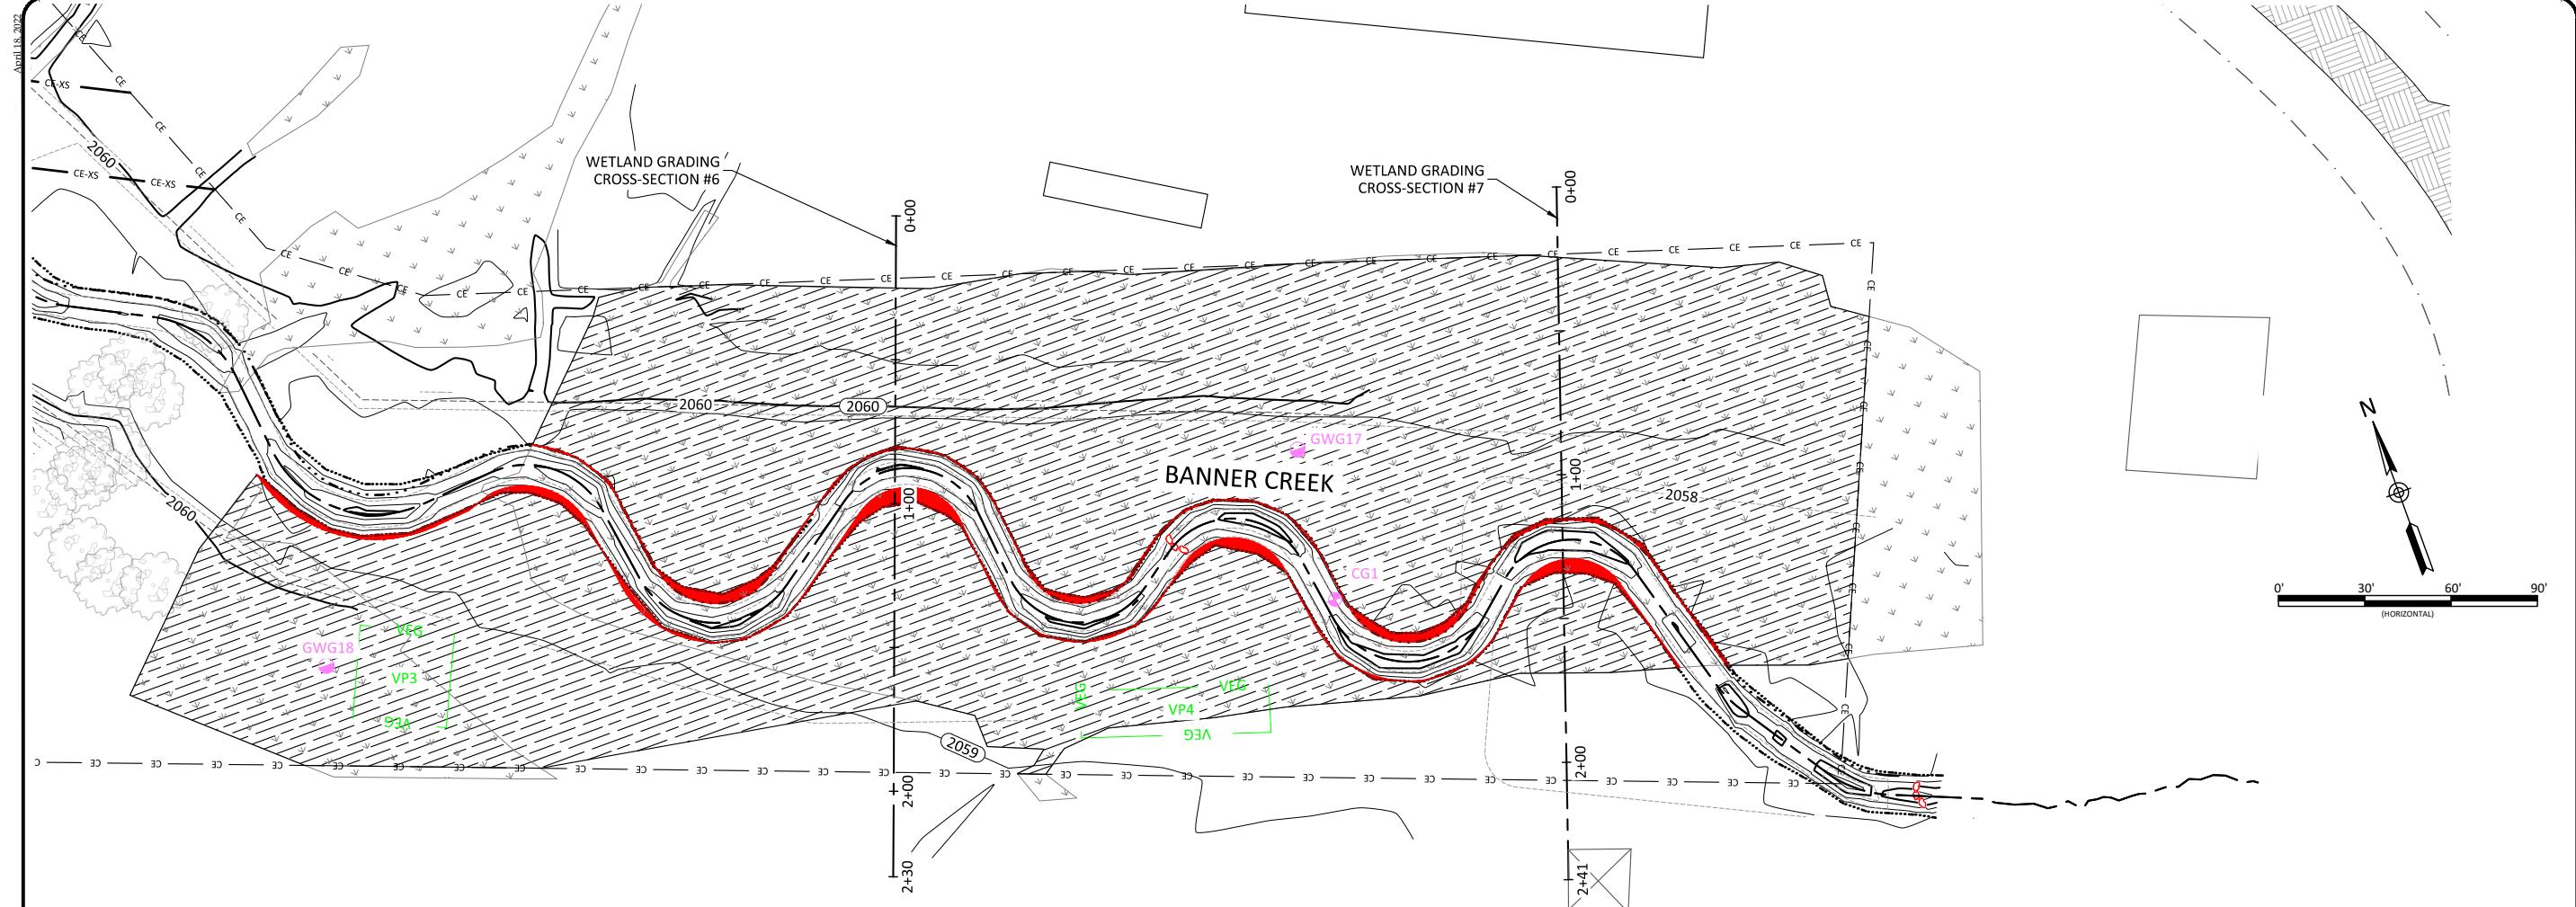
2.4

Banner Creek Reach 2 - Wetland Rehabilitation
Plan View

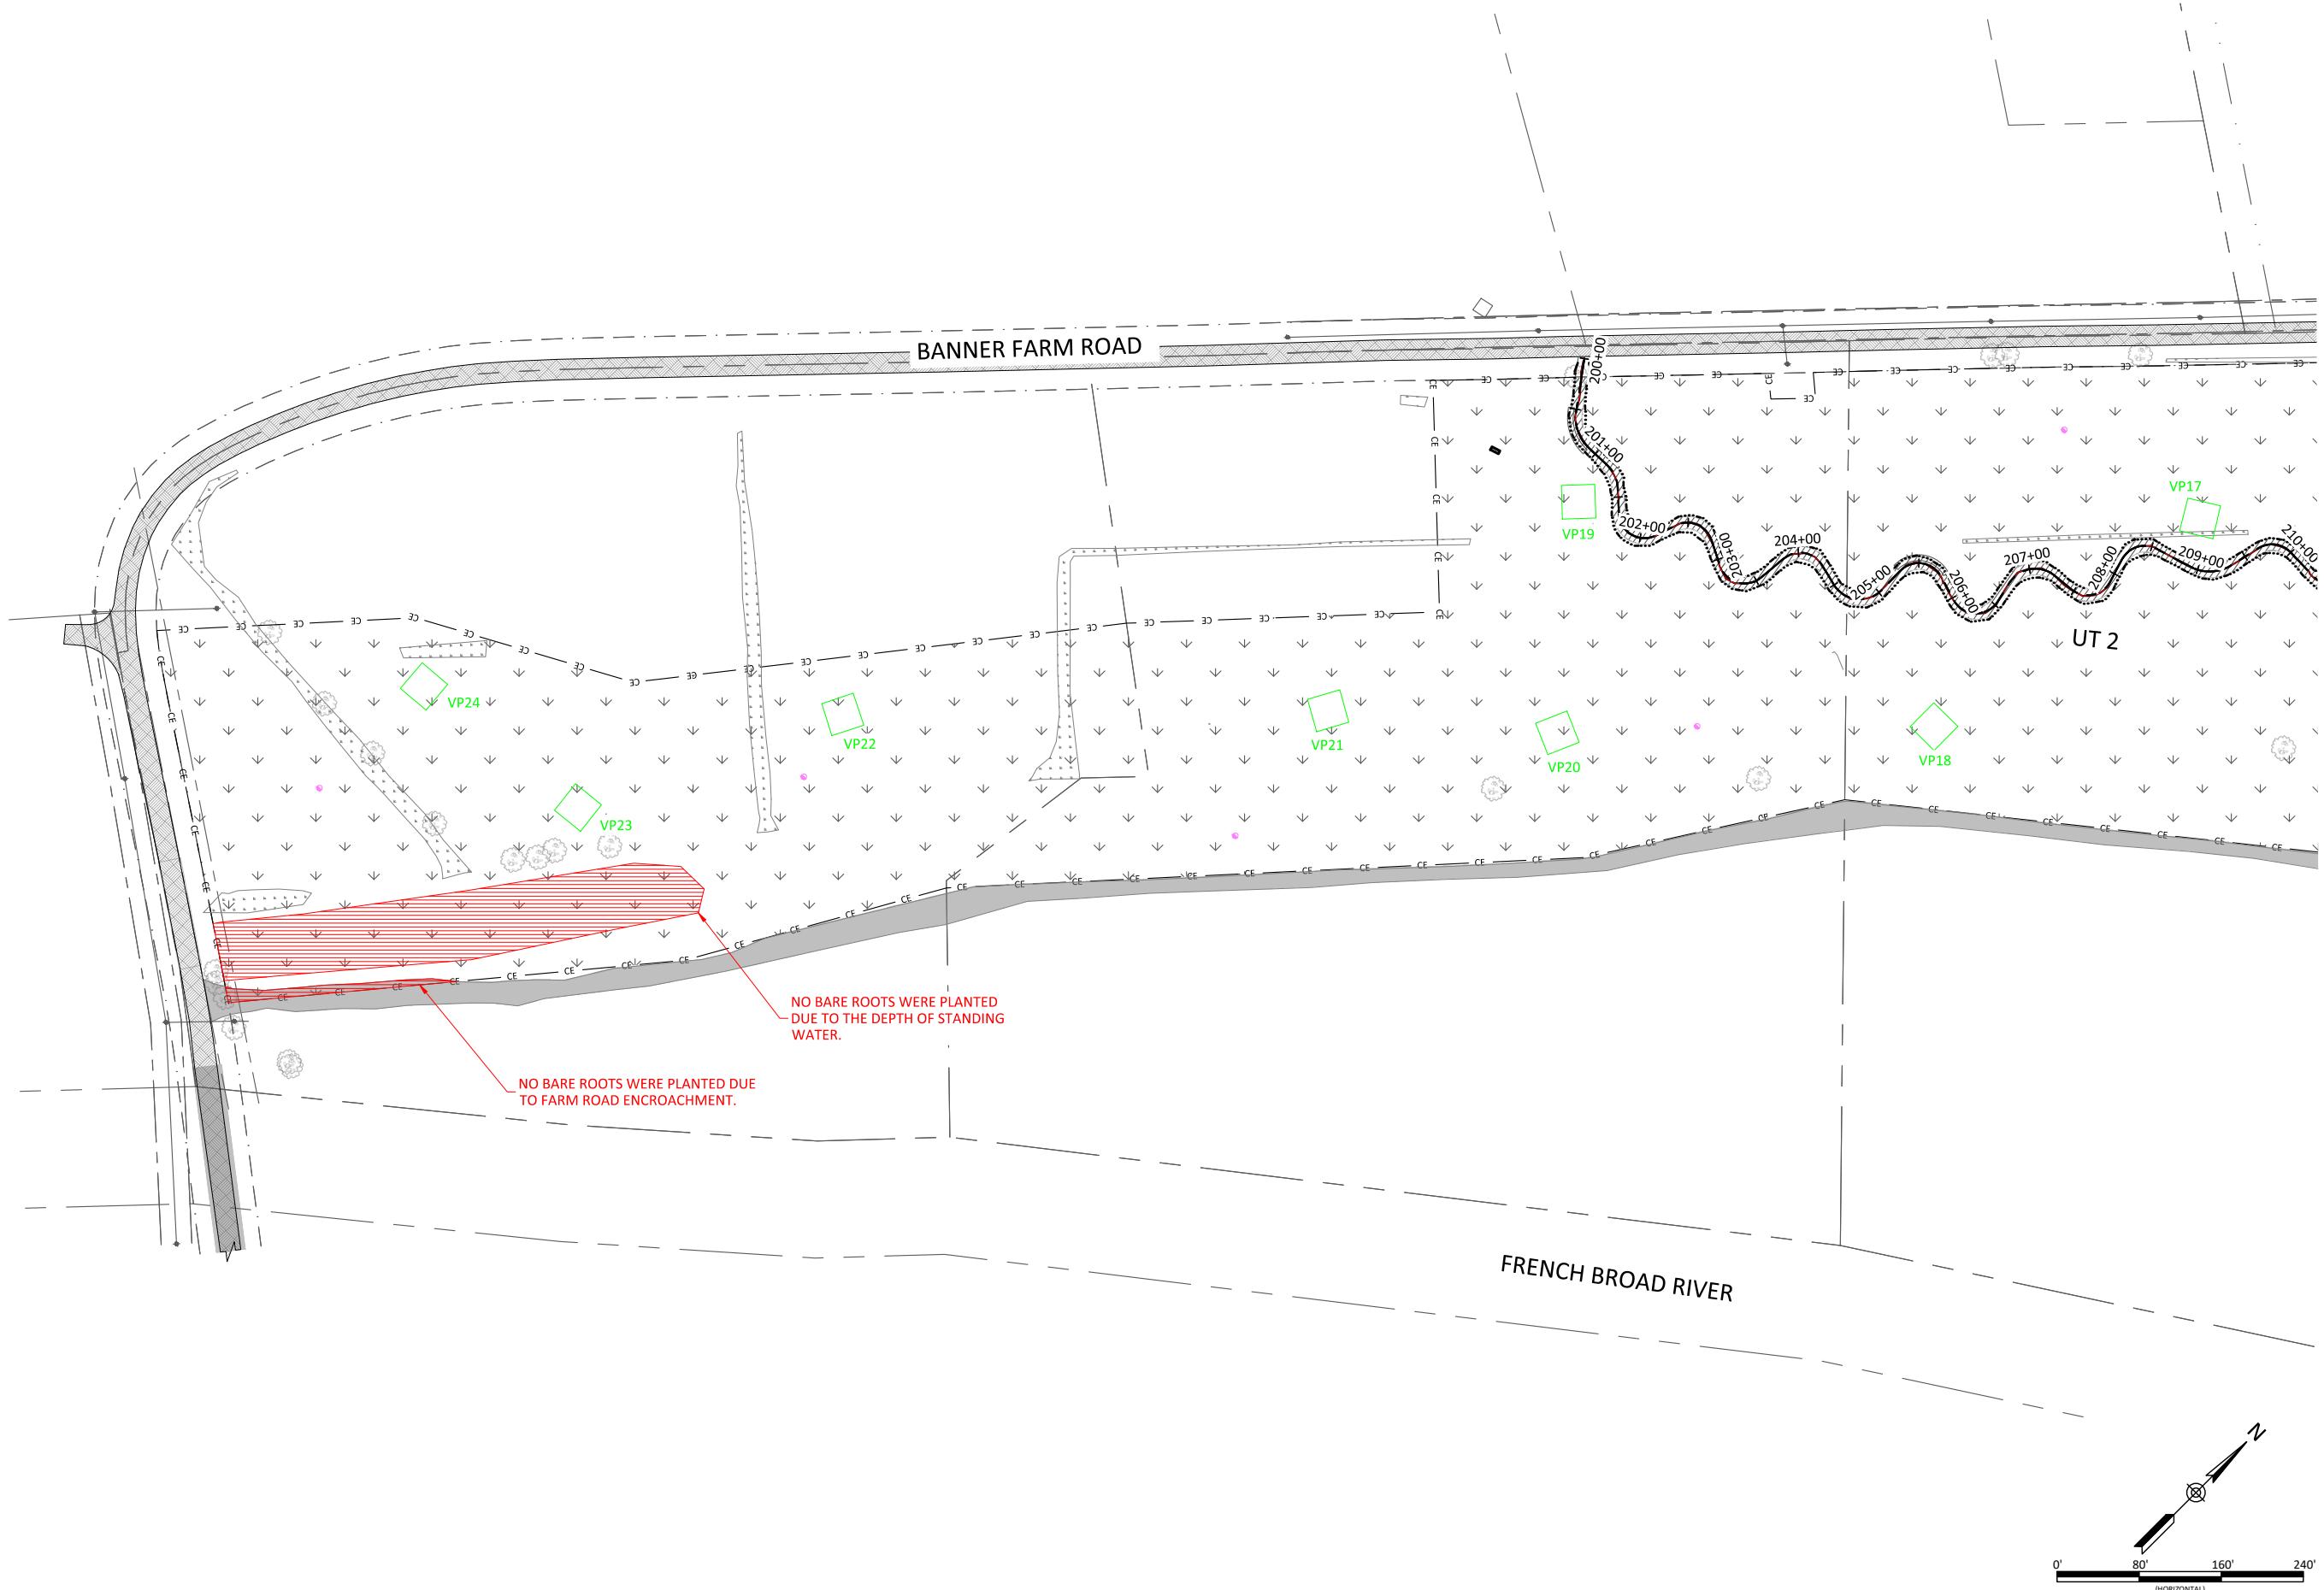
Sheet 3.3

Planting Overview
Planting Plan

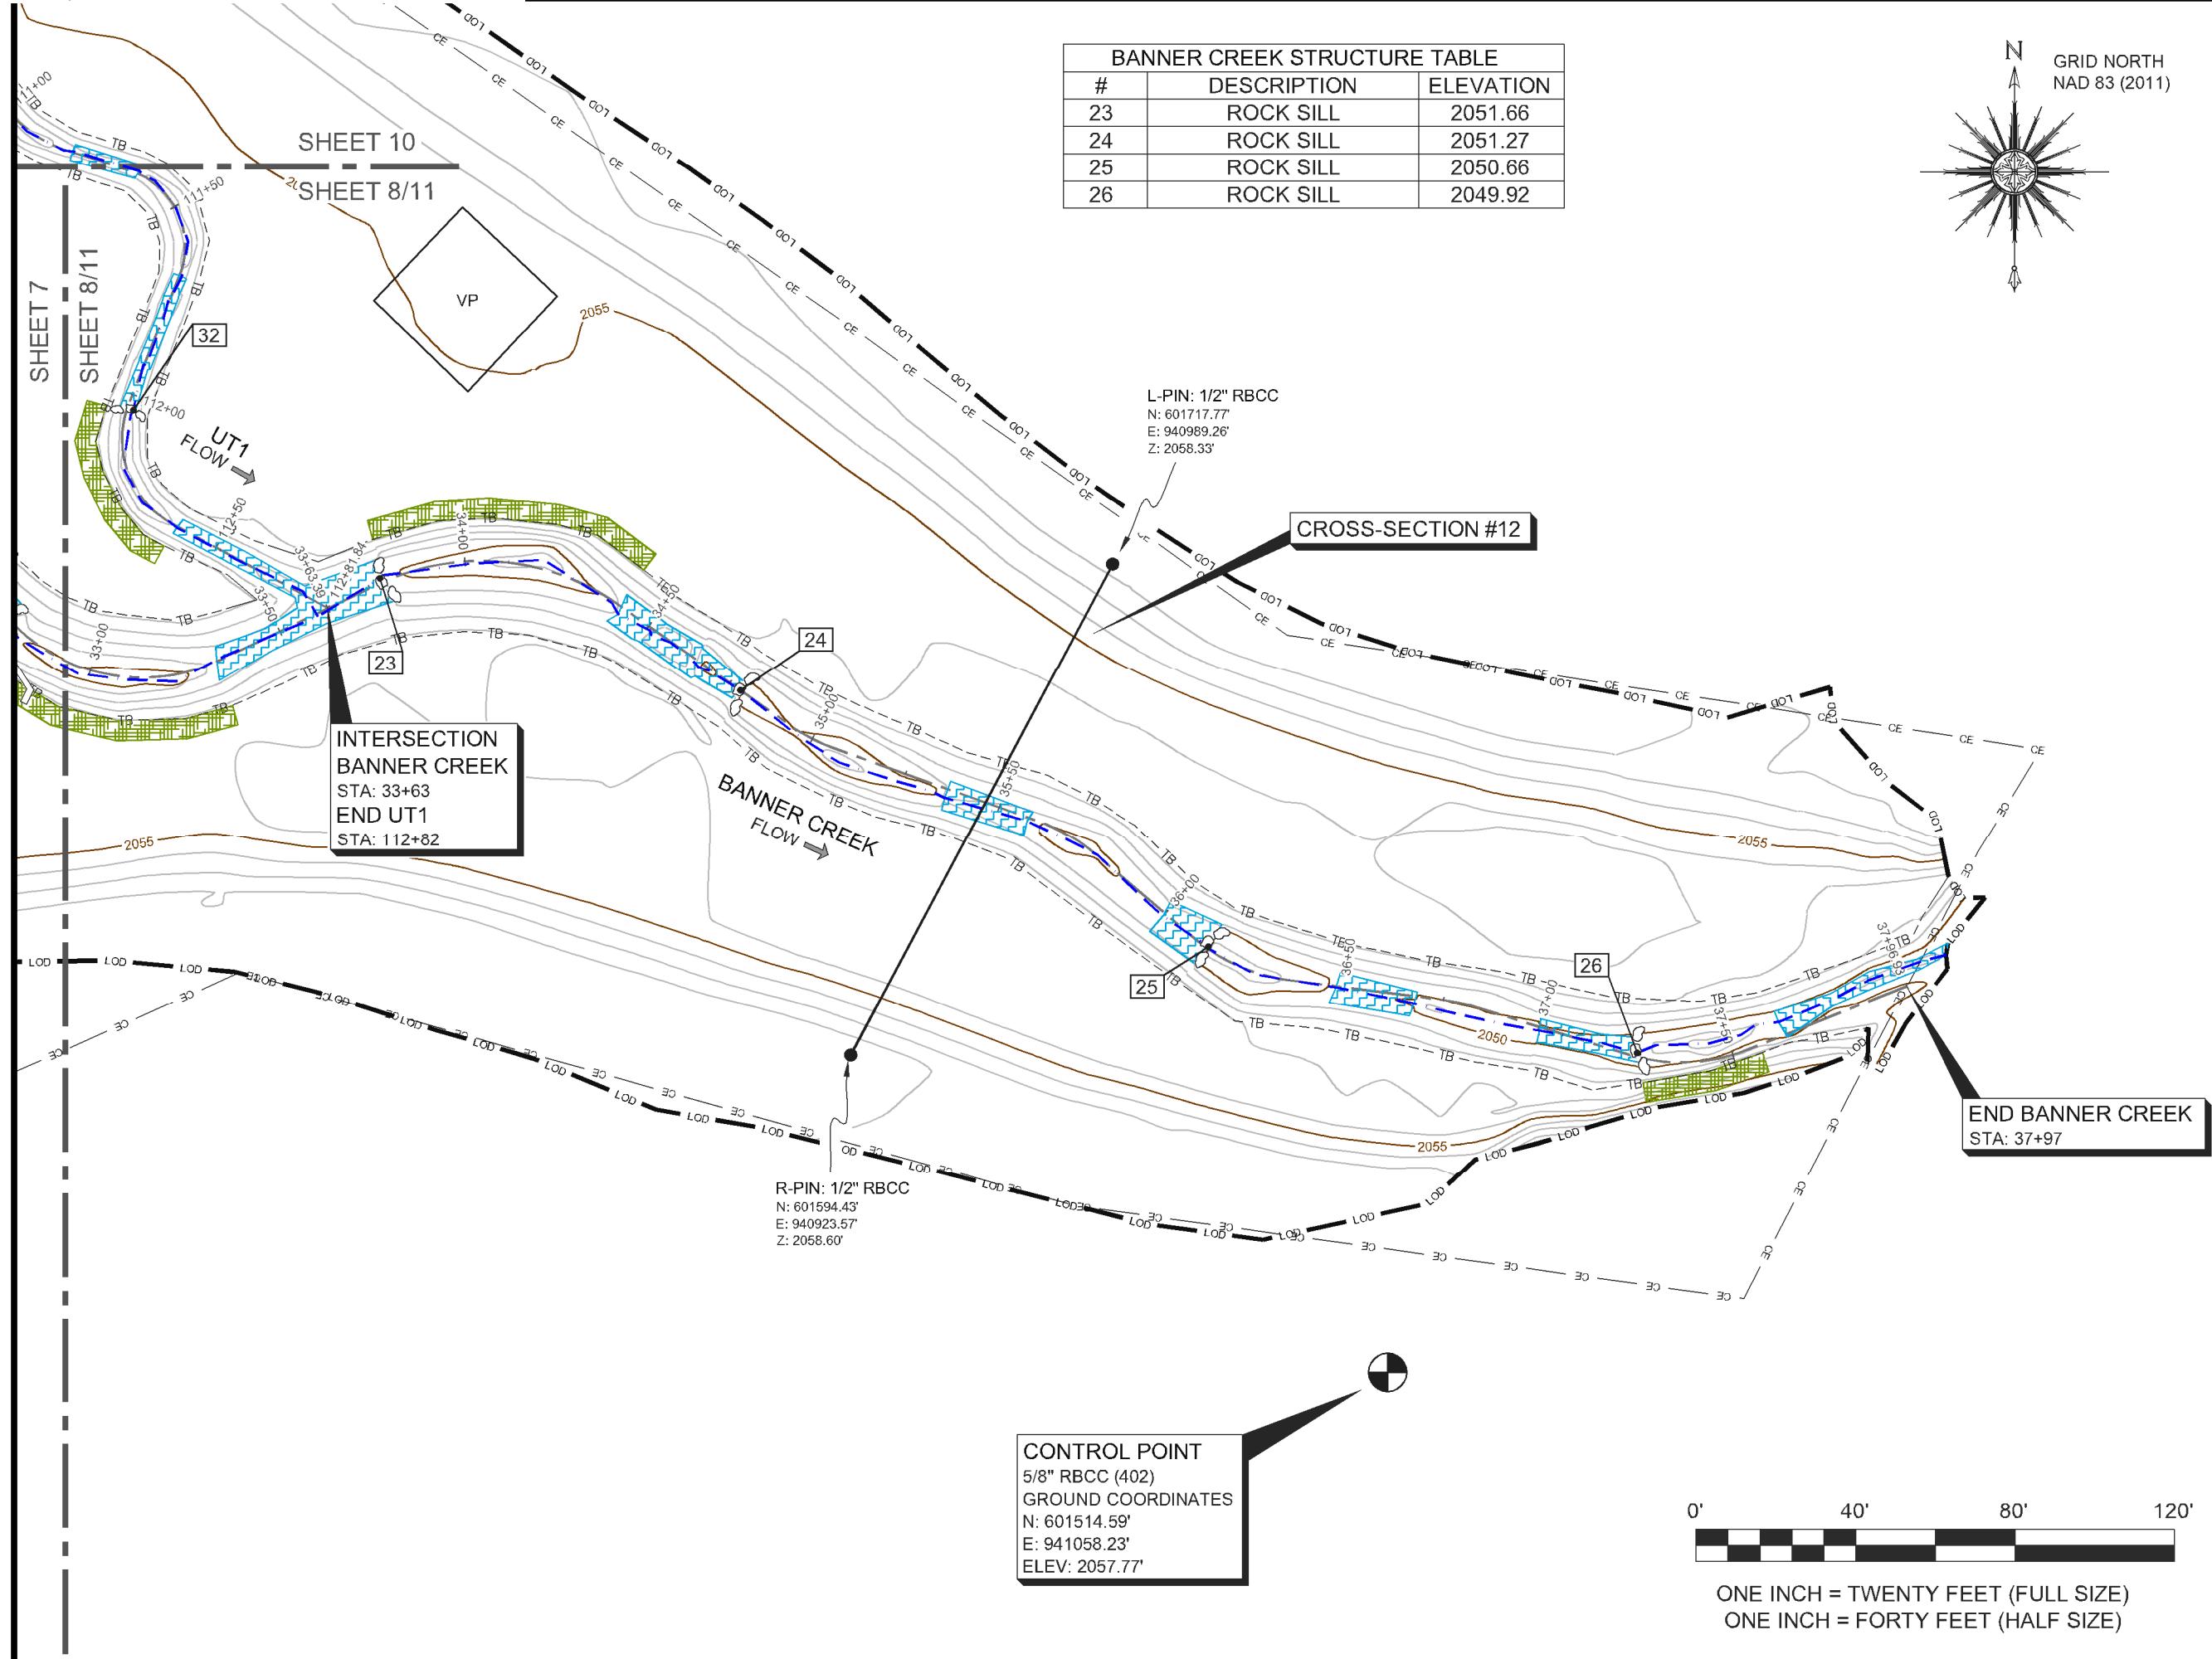
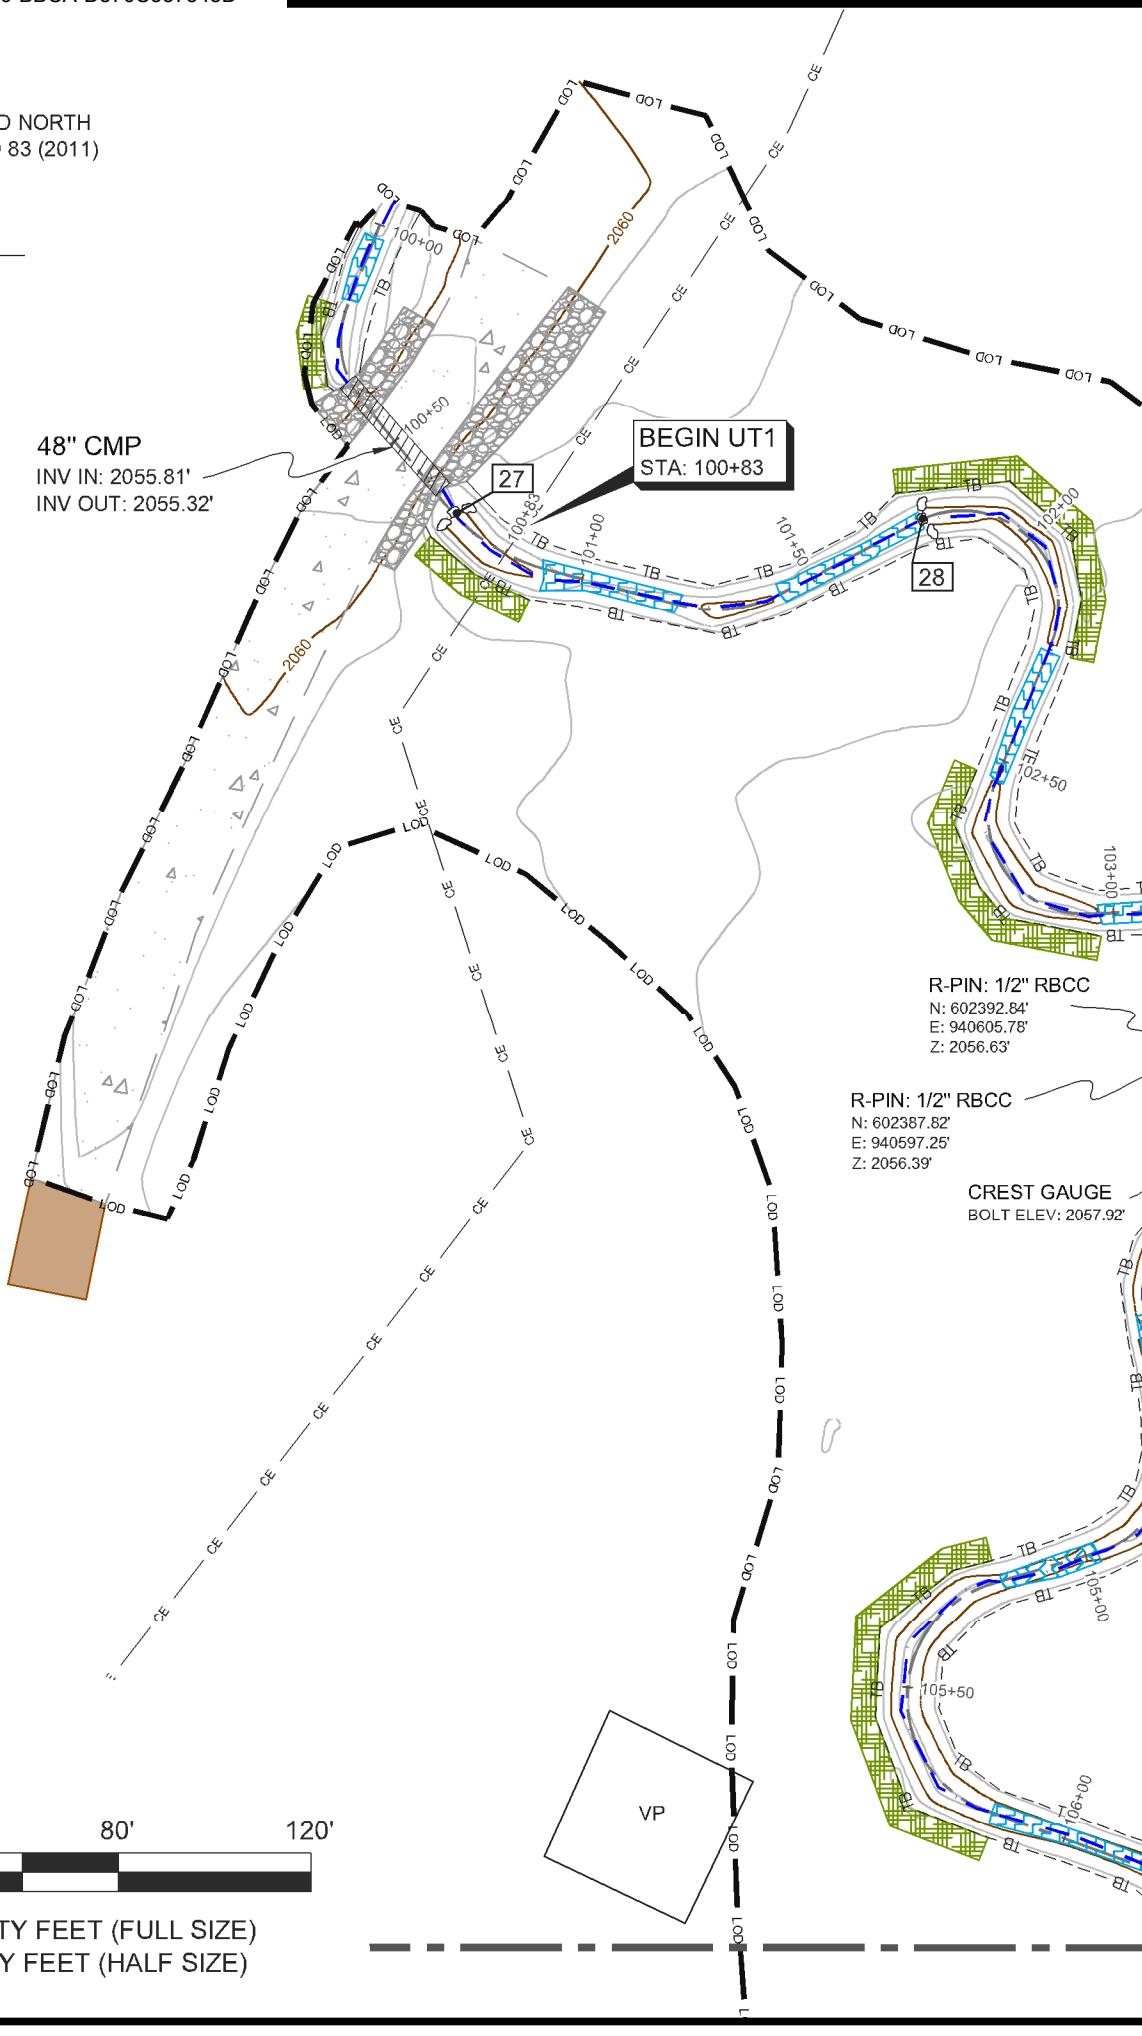
GRID NORTH
NAD 83 (2011)48" CMP
INV IN: 2055.81'
INV OUT: 2055.32'

UT1 STRUCTURE TABLE		
#	DESCRIPTION	ELEVATION
27	ROCK SILL	2055.92
28	ROCK SILL	2055.42

NOTE: SEE SHEET 1 FOR
SURVEYOR'S NOTES, LEGEND &
STATEMENT OF CERTIFICATIONELEVATION DATUM: NAVD 88
CONTOUR INTERVAL: 1 FOOTTHIS IS A TOPOGRAPHIC
SURVEY FOR INFORMATIONAL
AND DESIGN PURPOSES
ONLY. IT SHOULD NOT BE
USED FOR CONVEYANCE OR
LEGAL PURPOSES.AN AS-BUILT SURVEY FOR:
**WILDLANDS
ENGINEERING, INC**SPO FILE NOS. 45-DN, 45-DO,
45-DP, 45-DQ
DMS SITE ID NO. 100062PROJECT:
**BANNER FARMS
MITIGATION SITE**SHEET TITLE:
BEGIN UT1
