MONITORING YEAR 0 ANNUAL REPORT

BANNER FARM MITIGATION SITE

Henderson County, NC
French Broad River Basin
HUC 06010105

DMS Project No. 100062

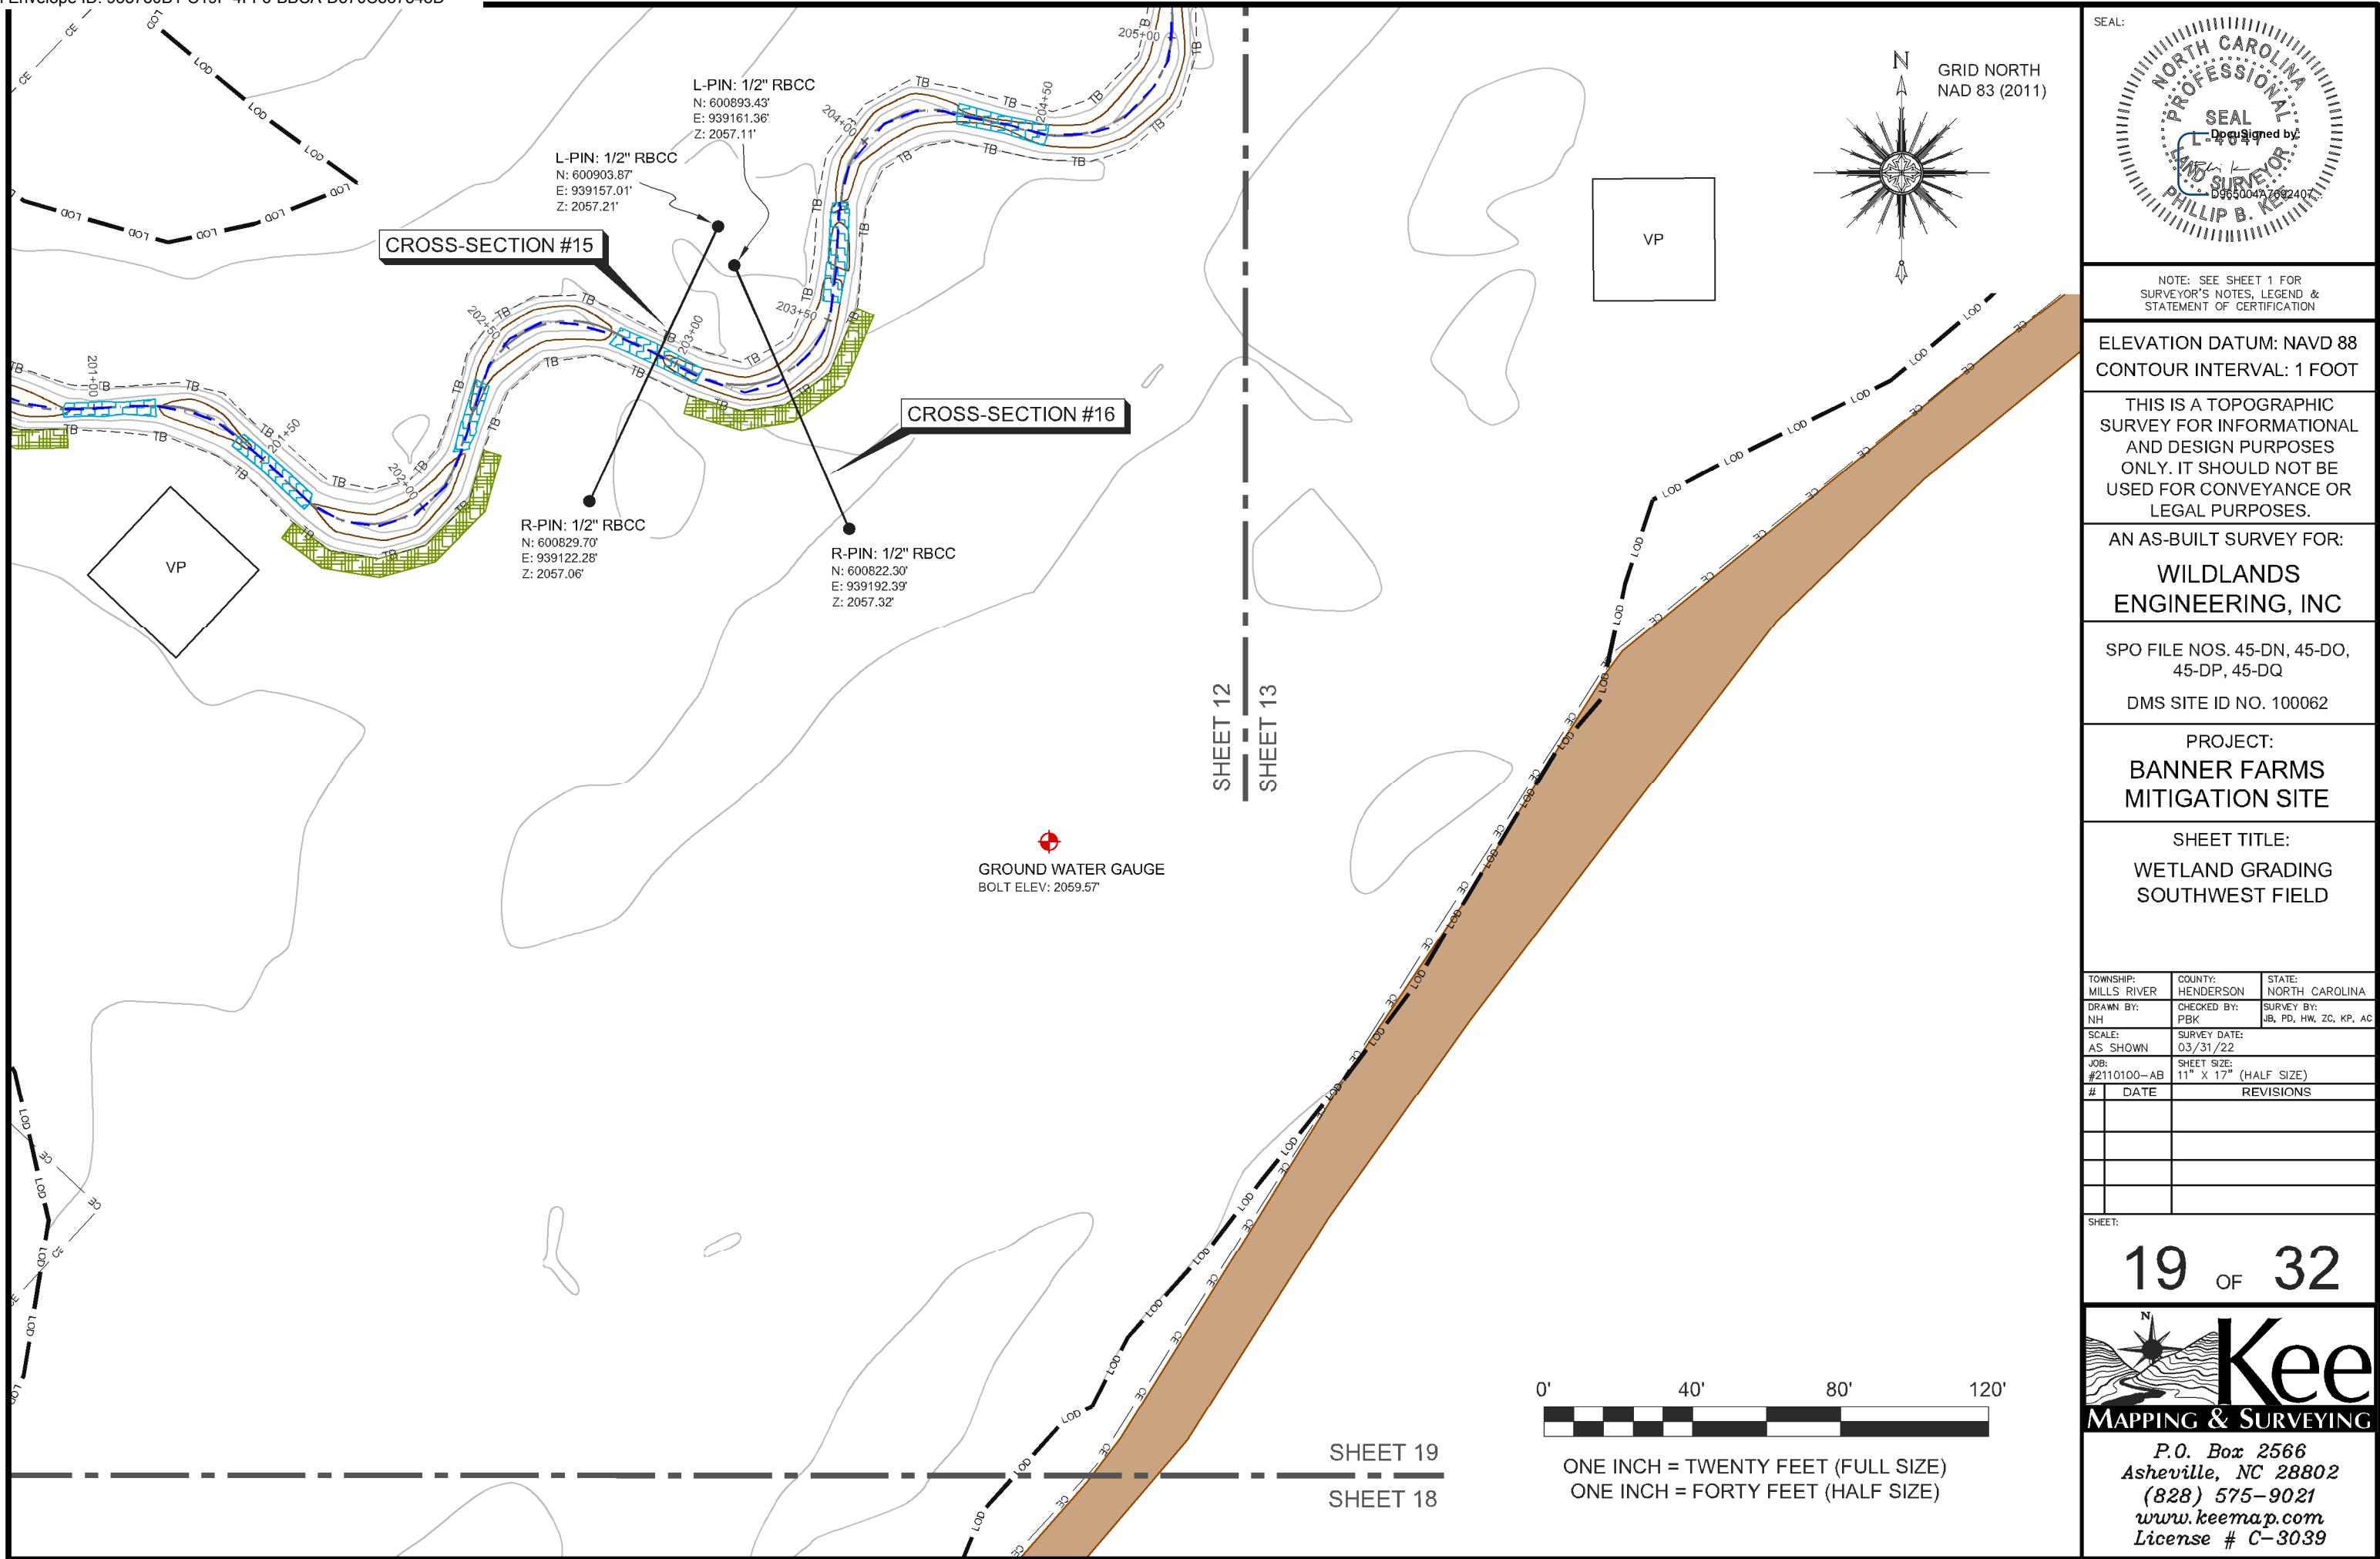
NOTE: SEE SHEET 1 FOR
SURVEYOR'S NOTES, LEGEND &
STATEMENT OF CERTIFICATIONELEVATION DATUM: NAVD 88
CONTOUR INTERVAL: 1 FOOTTHIS IS A TOPOGRAPHIC
SURVEY FOR INFORMATIONAL
AND DESIGN PURPOSES
ONLY. IT SHOULD NOT BE
USED FOR CONVEYANCE OR
LEGAL PURPOSES.AN AS-BUILT SURVEY FOR:
**WILDLANDS
ENGINEERING, INC**SPO FILE NOS. 45-DN, 45-DO,
45-DP, 45-DQ
DMS SITE ID NO. 100062PROJECT:
**BANNER FARMS
MITIGATION SITE**SHEET TITLE:
**WETLAND GRADING
SOUTHWEST FIELD**

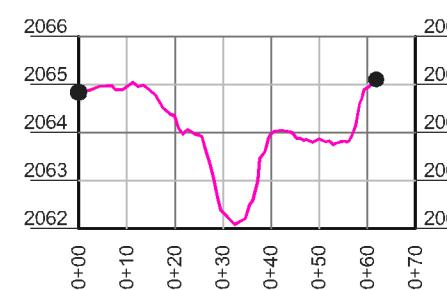
CROSS-SECTION #1 - BANNER CREEK
HORIZONTAL SCALE: 1" = 20' FULL SIZE, 1" = 40' HALF SIZE
VERTICAL SCALE: 1" = 2' FULL SIZE, 1" = 4' HALF SIZE

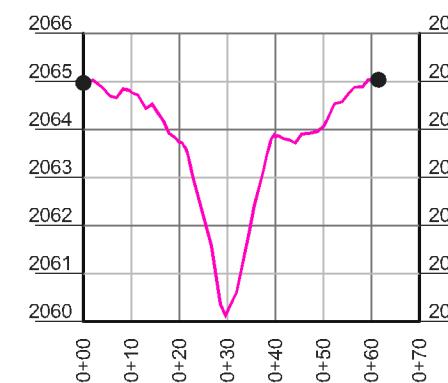
CROSS-SECTION #2 - BANNER CREEK
HORIZONTAL SCALE: 1" = 20' FULL SIZE, 1" = 40' HALF SIZE
VERTICAL SCALE: 1" = 2' FULL SIZE, 1" = 4' HALF SIZE

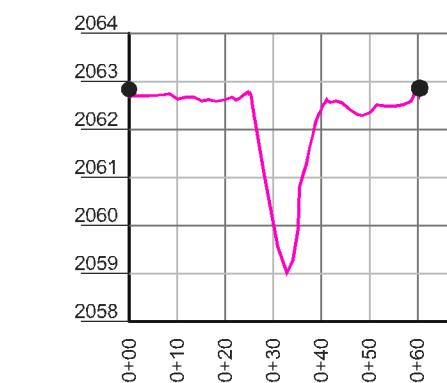
CROSS-SECTION #3 - BANNER CREEK
HORIZONTAL SCALE: 1" = 20' FULL SIZE, 1" = 40' HALF SIZE
VERTICAL SCALE: 1" = 2' FULL SIZE, 1" = 4' HALF SIZE

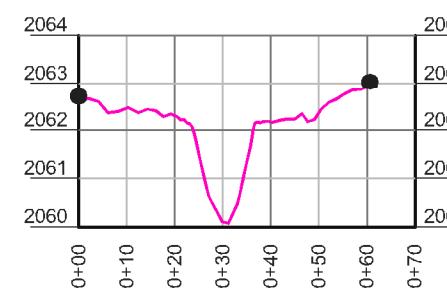
CROSS-SECTION #4 - BANNER CREEK
HORIZONTAL SCALE: 1" = 20' FULL SIZE, 1" = 40' HALF SIZE
VERTICAL SCALE: 1" = 2' FULL SIZE, 1" = 4' HALF SIZE

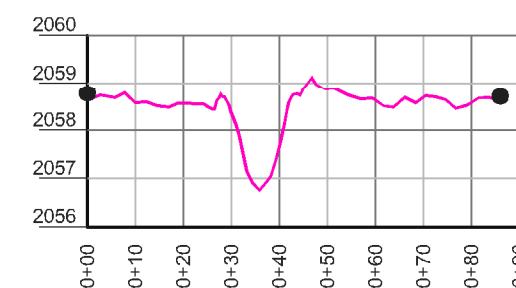
CROSS-SECTION #5 - BANNER CREEK
HORIZONTAL SCALE: 1" = 20' FULL SIZE, 1" = 40' HALF SIZE
VERTICAL SCALE: 1" = 2' FULL SIZE, 1" = 4' HALF SIZE

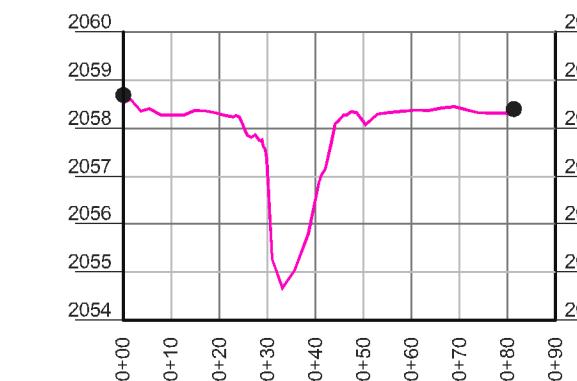
CROSS-SECTION #6 - BANNER CREEK
HORIZONTAL SCALE: 1" = 20' FULL SIZE, 1" = 40' HALF SIZE
VERTICAL SCALE: 1" = 2' FULL SIZE, 1" = 4' HALF SIZE

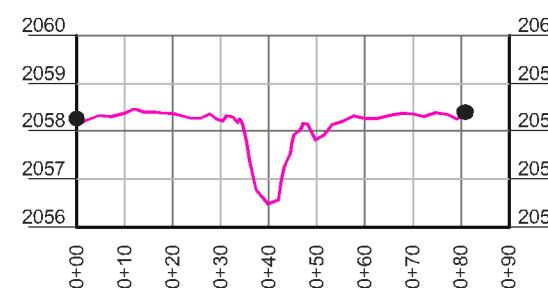
CROSS-SECTION #7 - BANNER CREEK
HORIZONTAL SCALE: 1" = 20' FULL SIZE, 1" = 40' HALF SIZE
VERTICAL SCALE: 1" = 2' FULL SIZE, 1" = 4' HALF SIZE

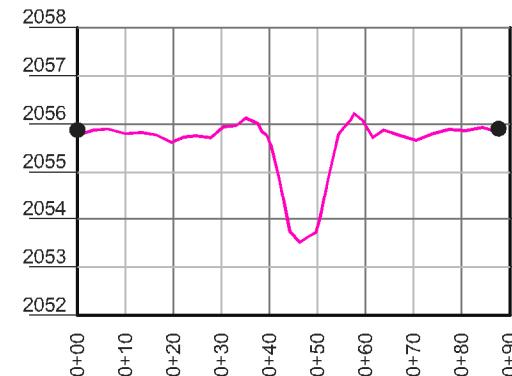
CROSS-SECTION #8 - BANNER CREEK
HORIZONTAL SCALE: 1" = 20' FULL SIZE, 1" = 40' HALF SIZE
VERTICAL SCALE: 1" = 2' FULL SIZE, 1" = 4' HALF SIZE

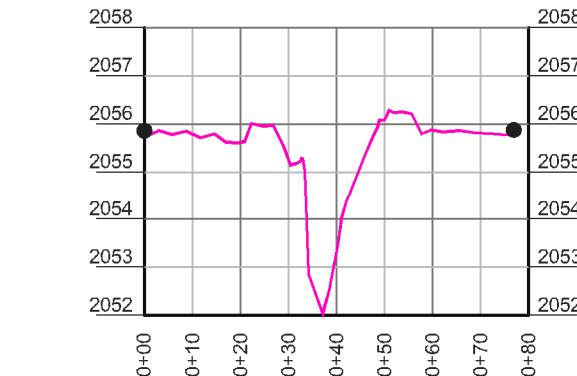
CROSS-SECTION #9 - BANNER CREEK
HORIZONTAL SCALE: 1" = 20' FULL SIZE, 1" = 40' HALF SIZE
VERTICAL SCALE: 1" = 2' FULL SIZE, 1" = 4' HALF SIZE

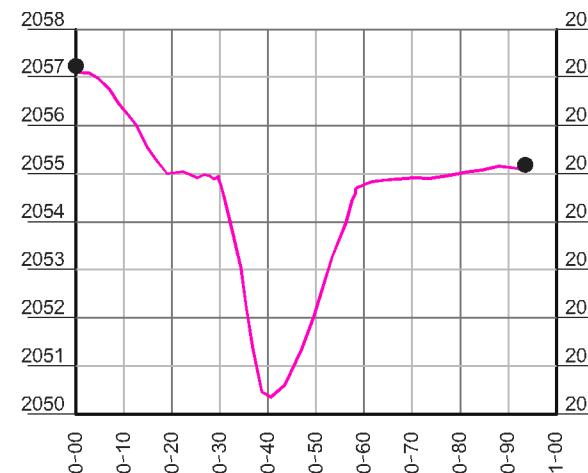
CROSS-SECTION #10 -BANNER CREEK

HORIZONTAL SCALE: 1" = 20' FULL SIZE, 1" = 40' HALF SIZE
VERTICAL SCALE: 1" = 2' FULL SIZE, 1" = 4' HALF SIZE

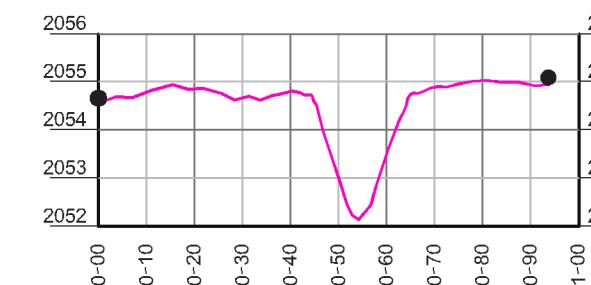
CROSS-SECTION #11 -BANNER CREEK

HORIZONTAL SCALE: 1" = 20' FULL SIZE, 1" = 40' HALF SIZE
VERTICAL SCALE: 1" = 2' FULL SIZE, 1" = 4' HALF SIZE

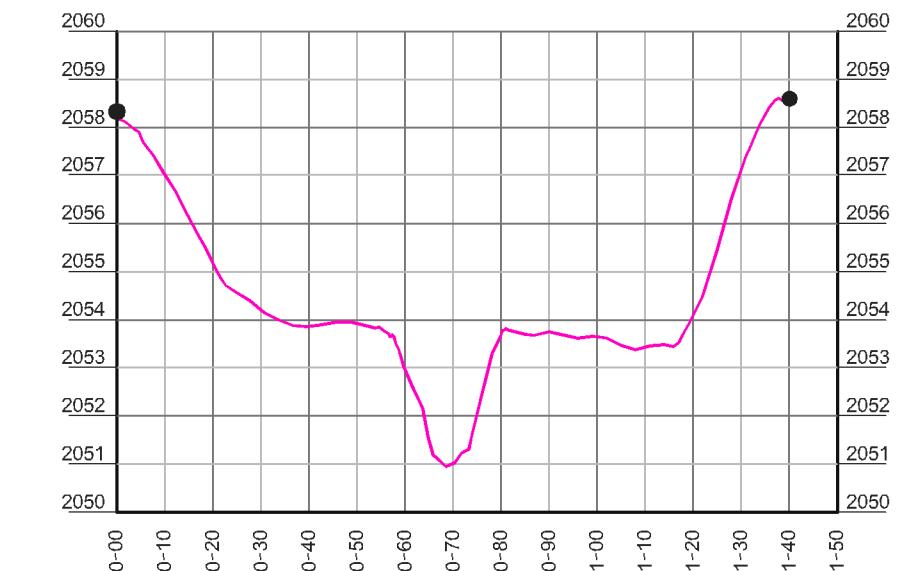
CROSS-SECTION #12 -BANNER CREEK

HORIZONTAL SCALE: 1" = 20' FULL SIZE, 1" = 40' HALF SIZE
VERTICAL SCALE: 1" = 2' FULL SIZE, 1" = 4' HALF SIZE

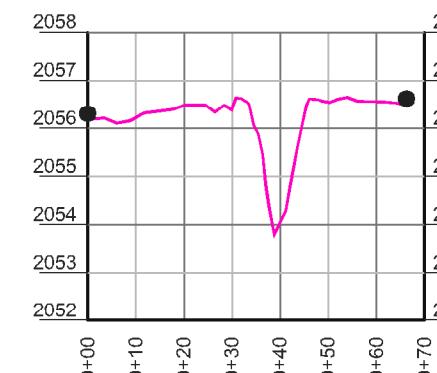
CROSS-SECTION #13 -UT1

HORIZONTAL SCALE: 1" = 20' FULL SIZE, 1" = 40' HALF SIZE
VERTICAL SCALE: 1" = 2' FULL SIZE, 1" = 4' HALF SIZE

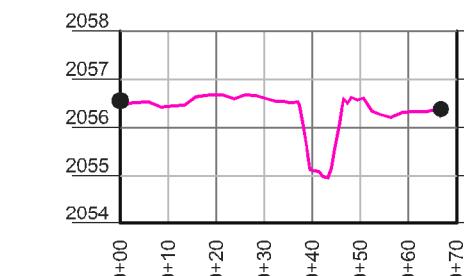
CROSS-SECTION #14 -UT1

HORIZONTAL SCALE: 1" = 20' FULL SIZE, 1" = 40' HALF SIZE
VERTICAL SCALE: 1" = 2' FULL SIZE, 1" = 4' HALF SIZE

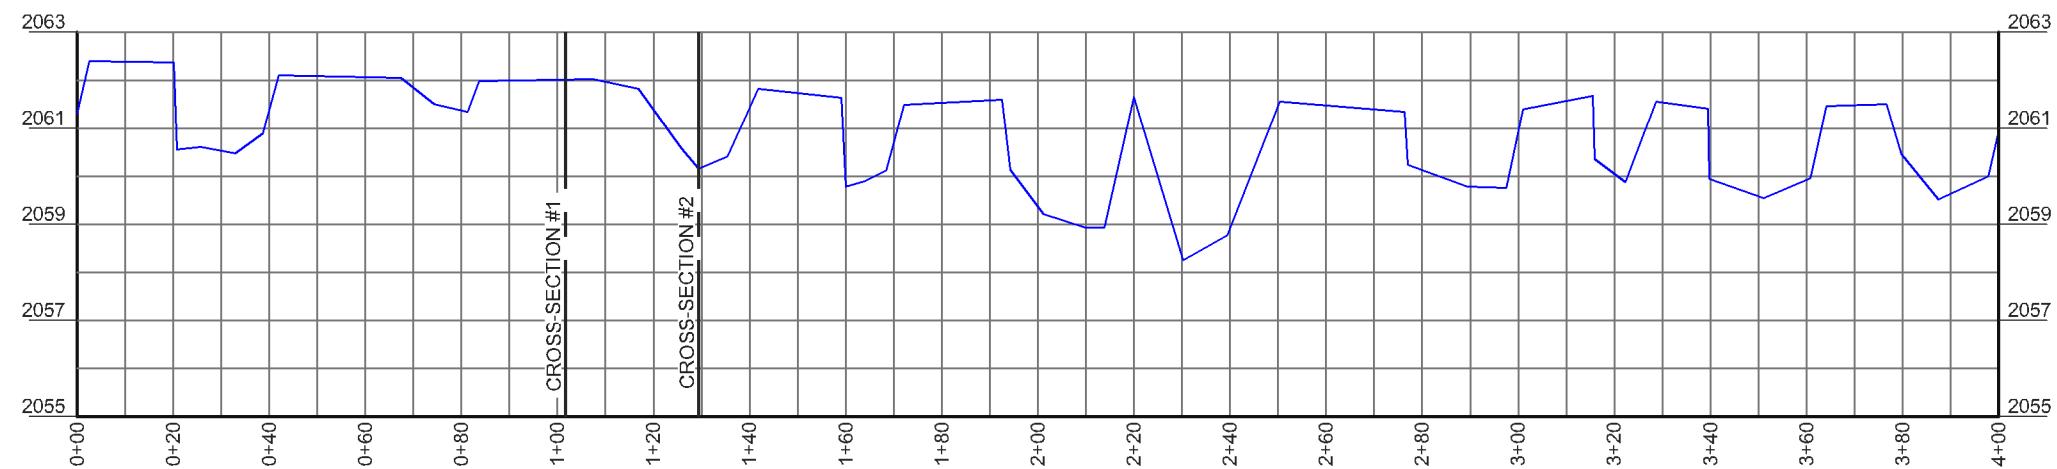
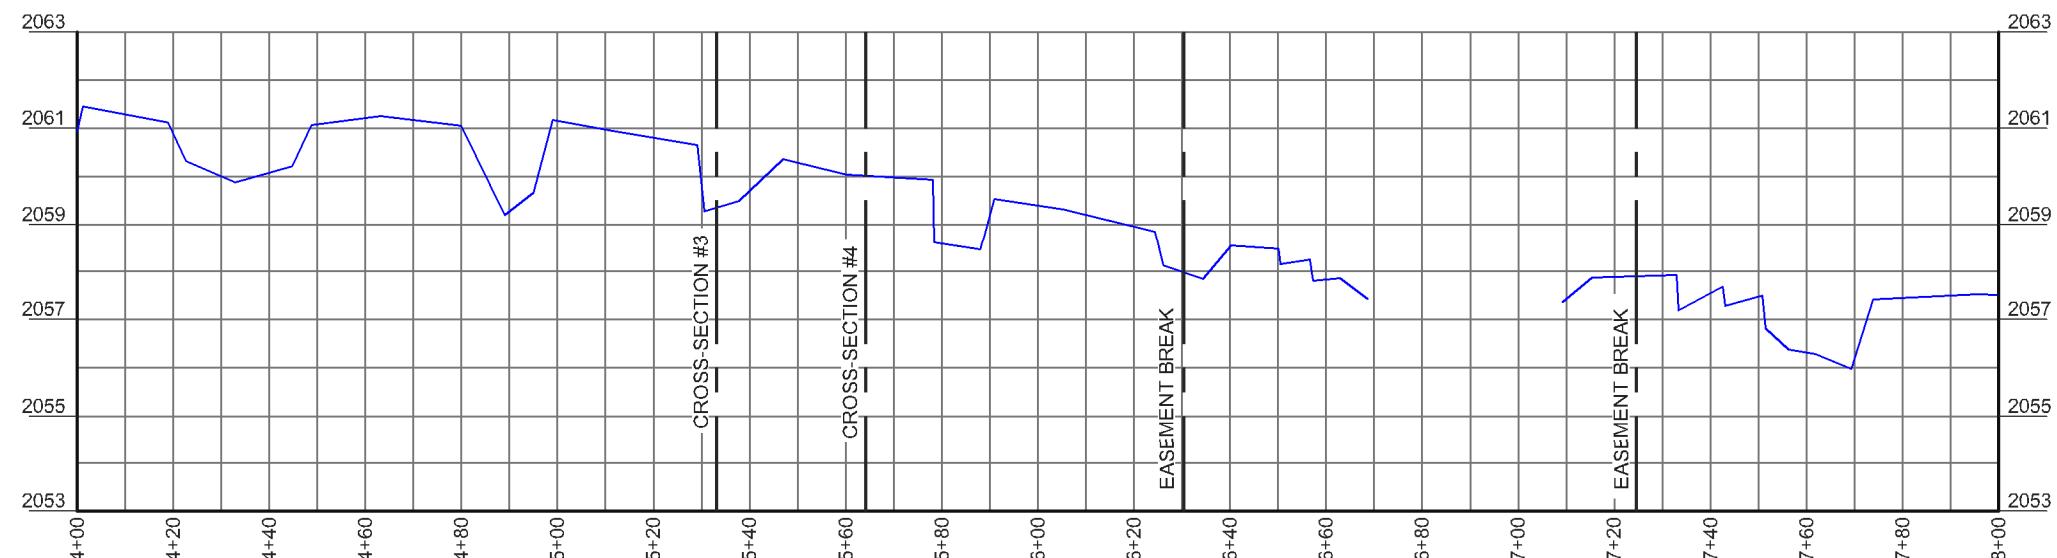
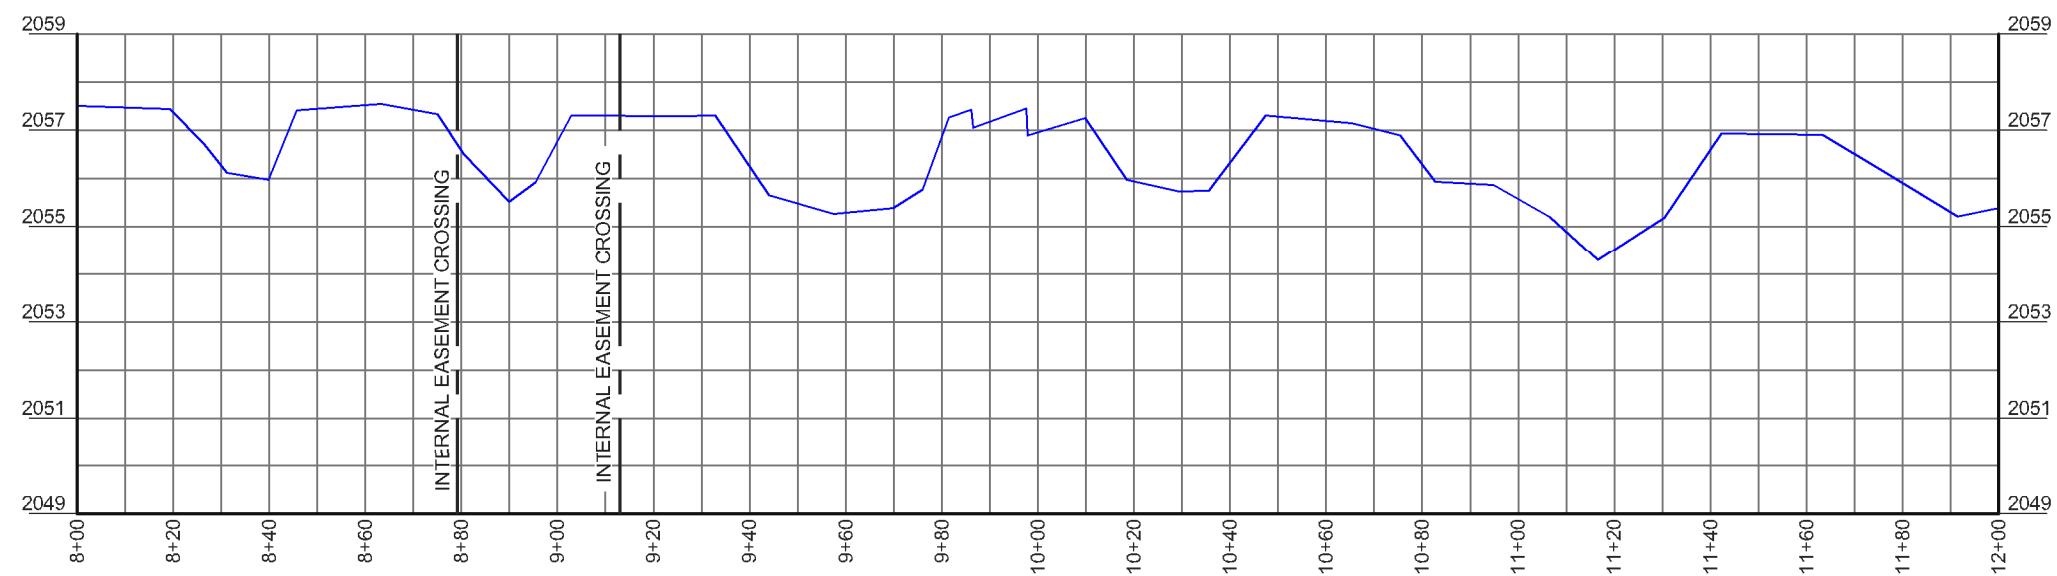
LONGITUDINAL PROFILE- BANNER CREEK
HORIZONTAL SCALE: 1" = 20' FULL SIZE, 1" = 40' HALF SIZE
VERTICAL SCALE: 1" = 2' FULL SIZE, 1" = 4' HALF SIZE

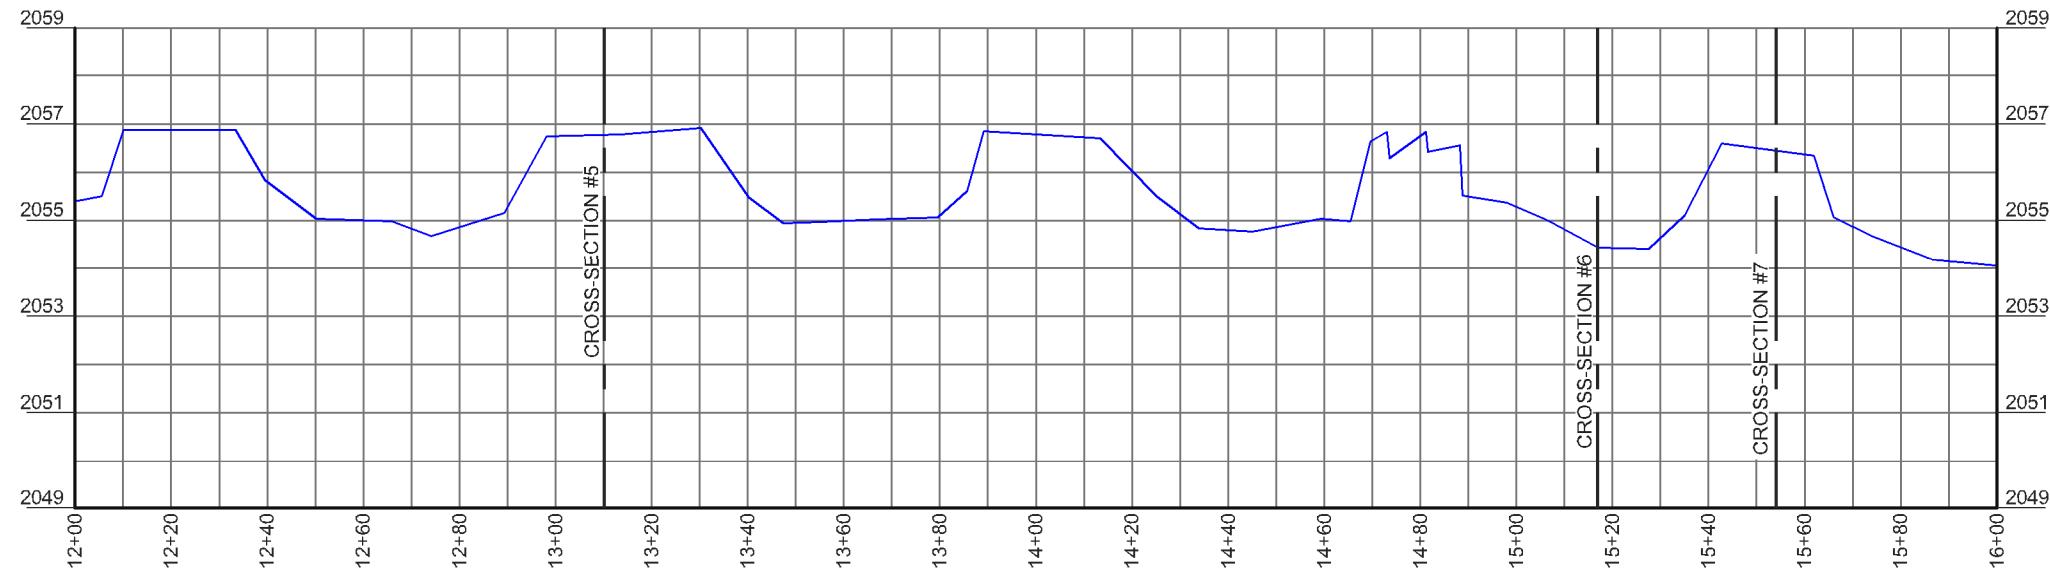
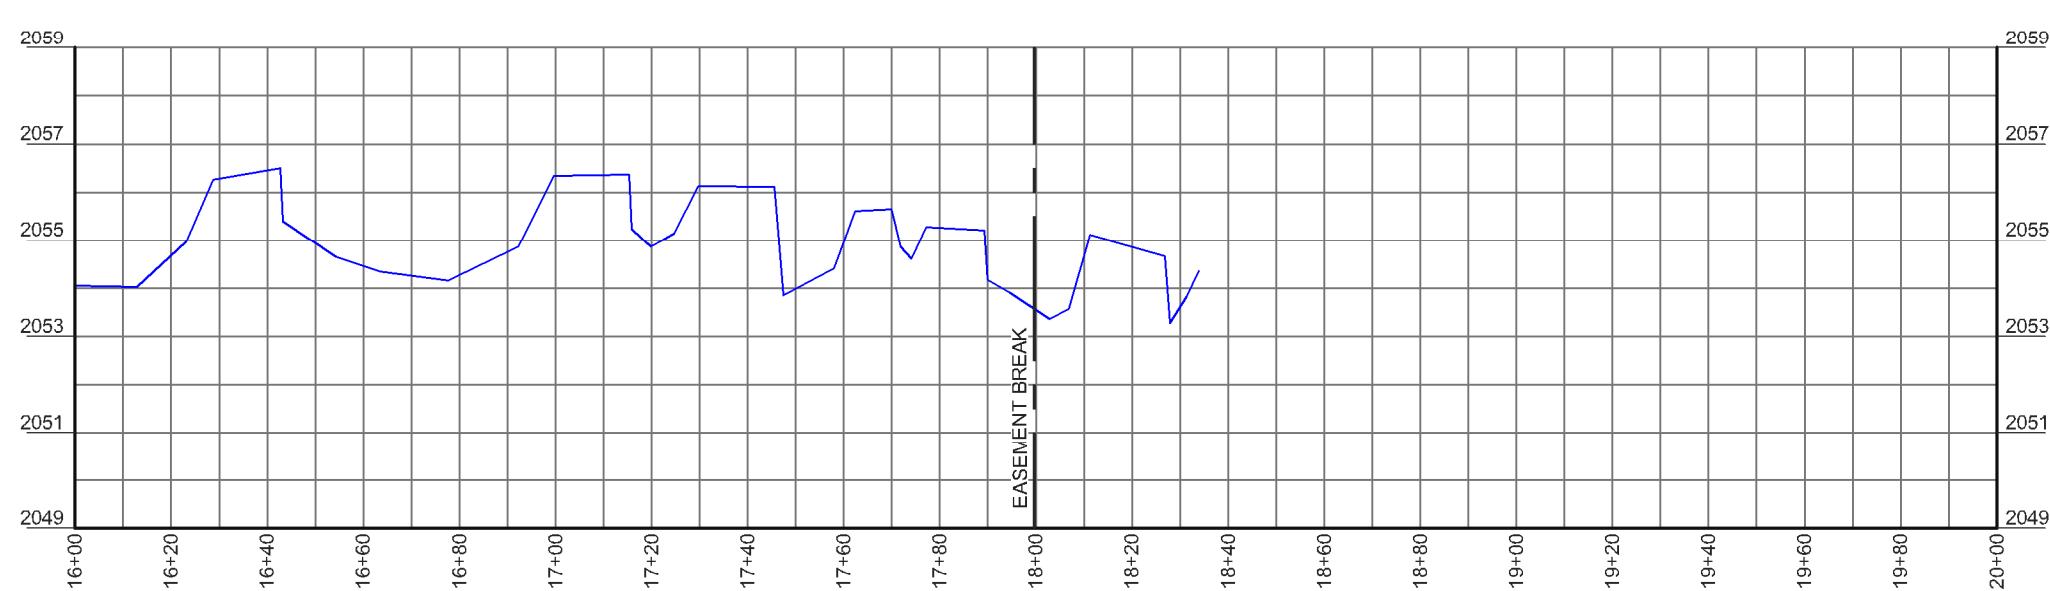
LONGITUDINAL PROFILE- BANNER CREEK
HORIZONTAL SCALE: 1" = 20' FULL SIZE, 1" = 40' HALF SIZE
VERTICAL SCALE: 1" = 2' FULL SIZE, 1" = 4' HALF SIZE

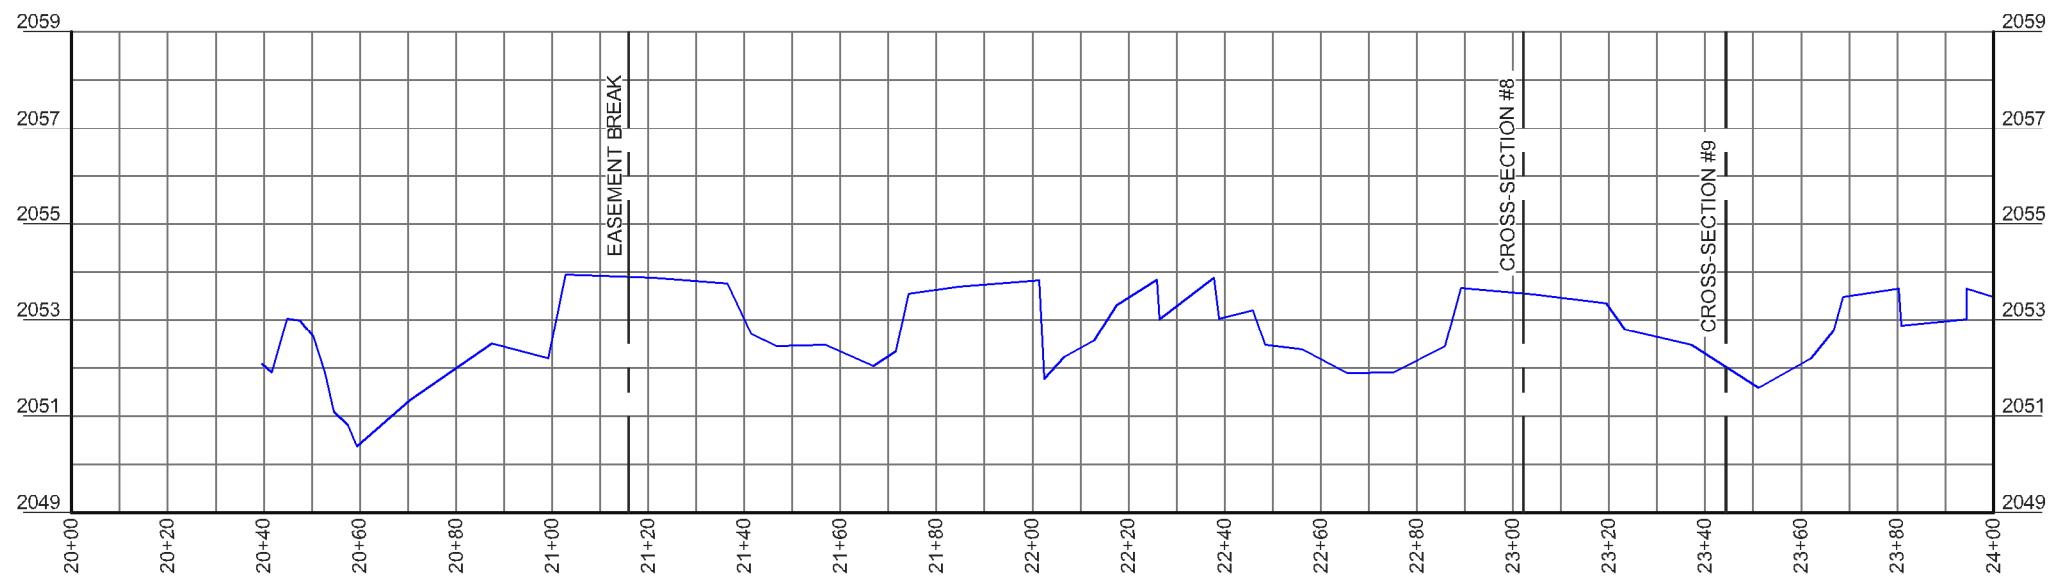
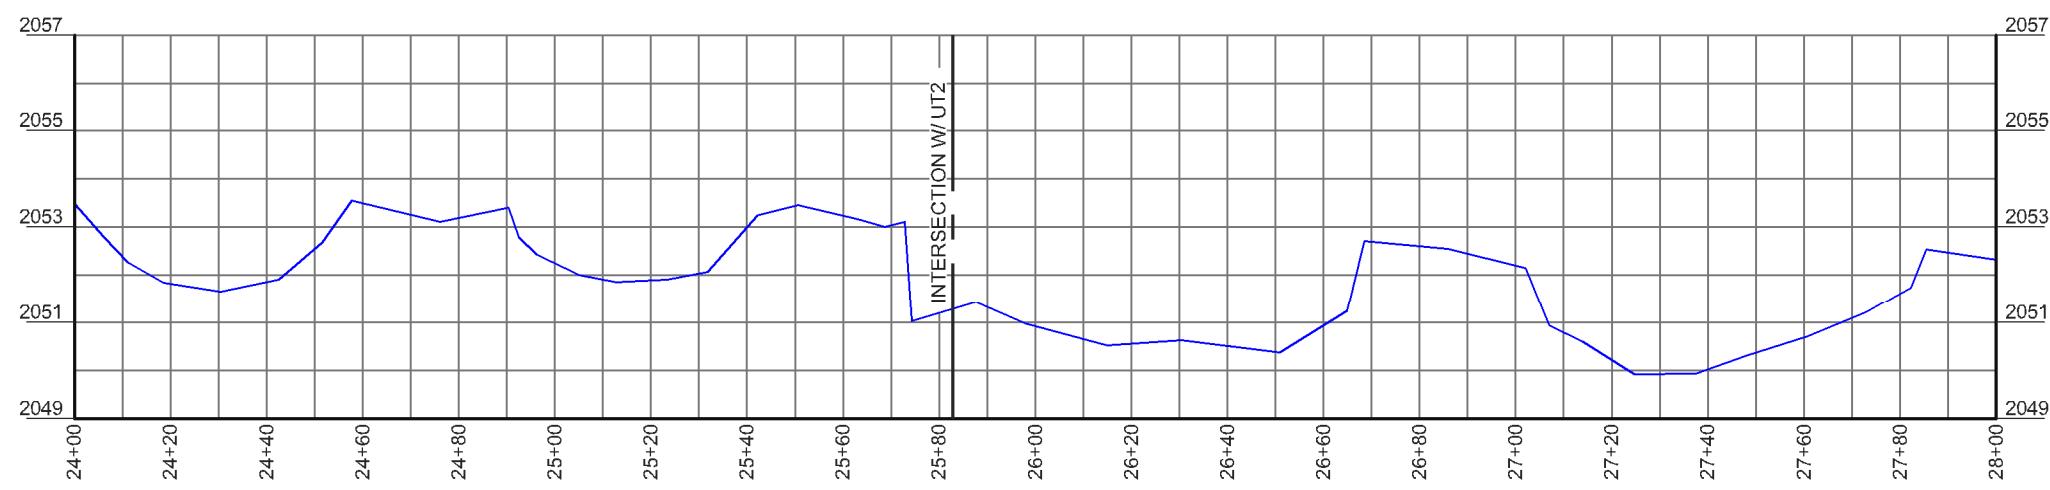
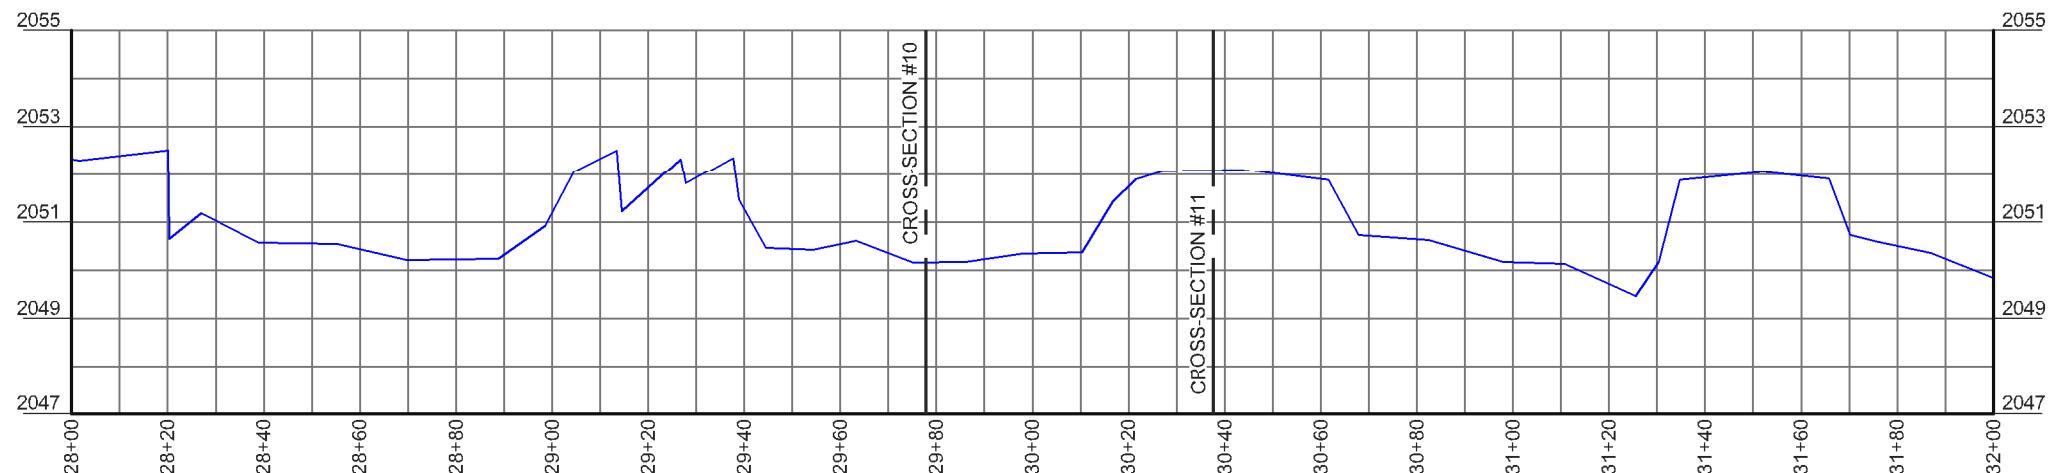
LONGITUDINAL PROFILE- BANNER CREEK

HORIZONTAL SCALE: 1" = 20' FULL SIZE, 1" = 40' HALF SIZE

NOTE: SEE SHEET 1 FOR
SURVEYOR'S NOTES, LEGEND &
STATEMENT OF CERTIFICATIONELEVATION DATUM: NAVD 88
CONTOUR INTERVAL: 1 FOOTTHIS IS A TOPOGRAPHIC
SURVEY FOR INFORMATIONAL
AND DESIGN PURPOSES
ONLY. IT SHOULD NOT BE
USED FOR CONVEYANCE OR
LEGAL PURPOSES.AN AS-BUILT SURVEY FOR:
**WILDLANDS
ENGINEERING, INC**SPO FILE NOS. 45-DN, 45-DO,
45-DP, 45-DQ
DMS SITE ID NO. 100062PROJECT:
**BANNER FARMS
MITIGATION SITE**SHEET TITLE:
LONGITUDINAL PROFILE:
BANNER CREEK
STA: 20+00-32+00

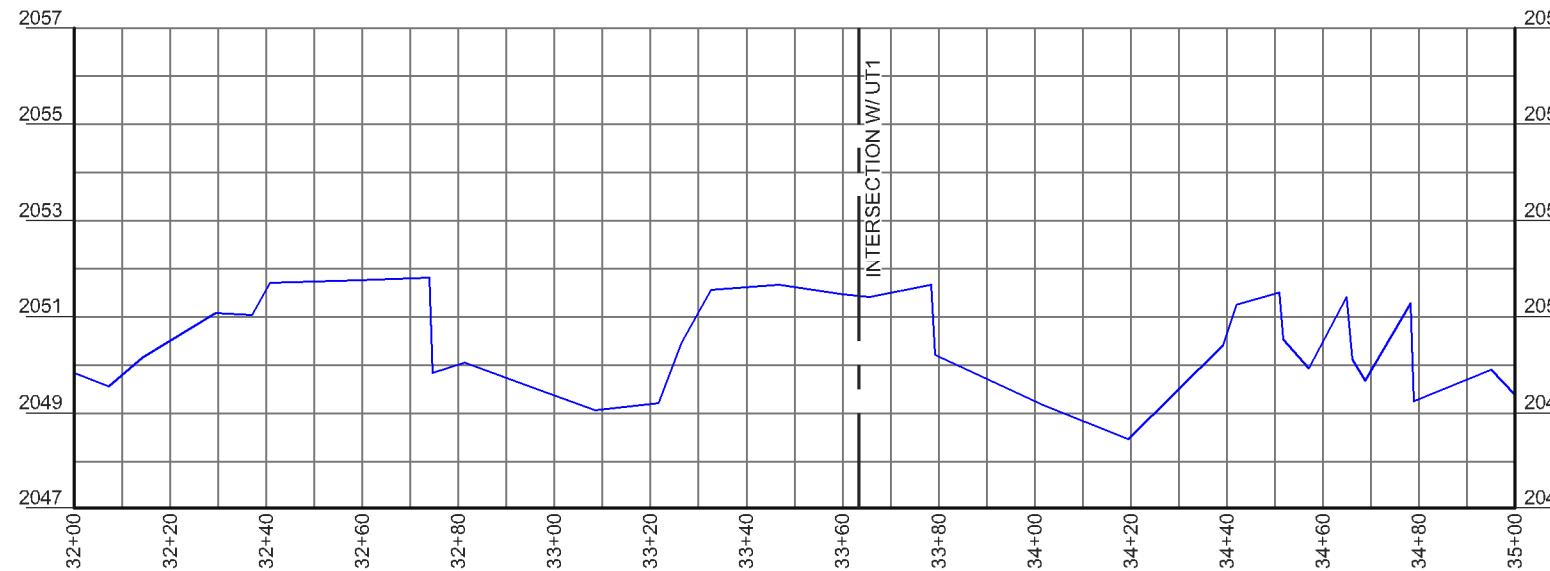
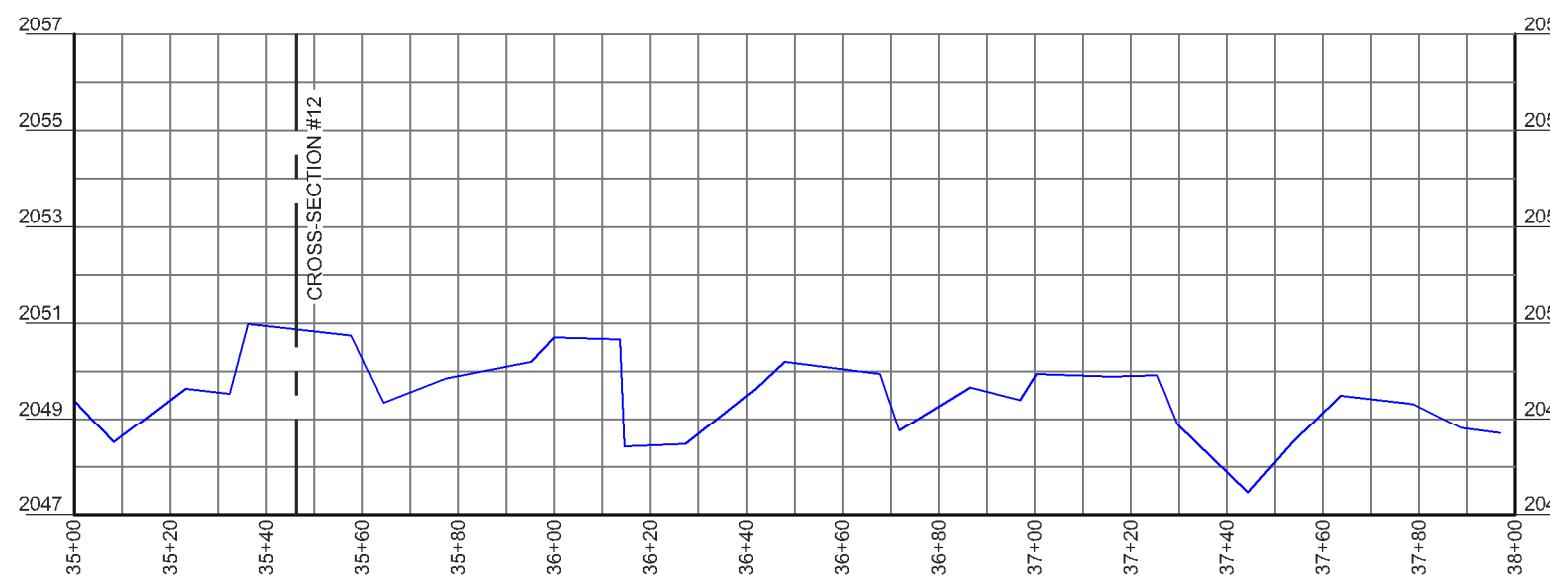
LONGITUDINAL PROFILE - BANNER CREEK

HORIZONTAL SCALE: 1" = 20' FULL SIZE, 1" = 40' HALF SIZE
VERTICAL SCALE: 1" = 2' FULL SIZE, 1" = 4' HALF SIZE

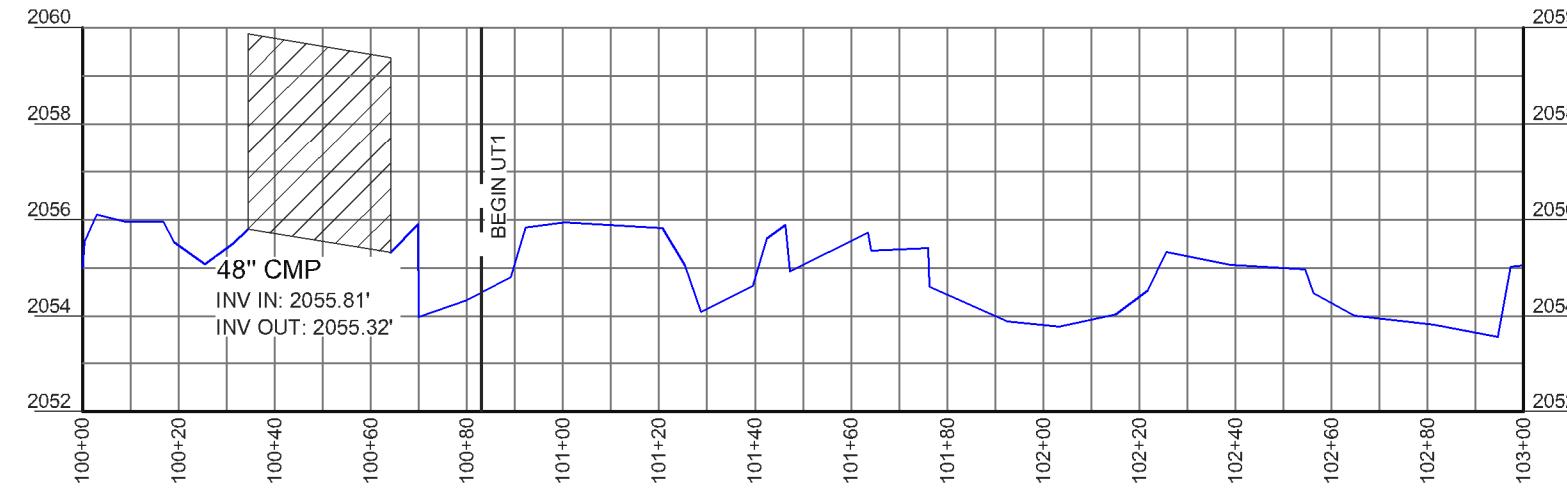
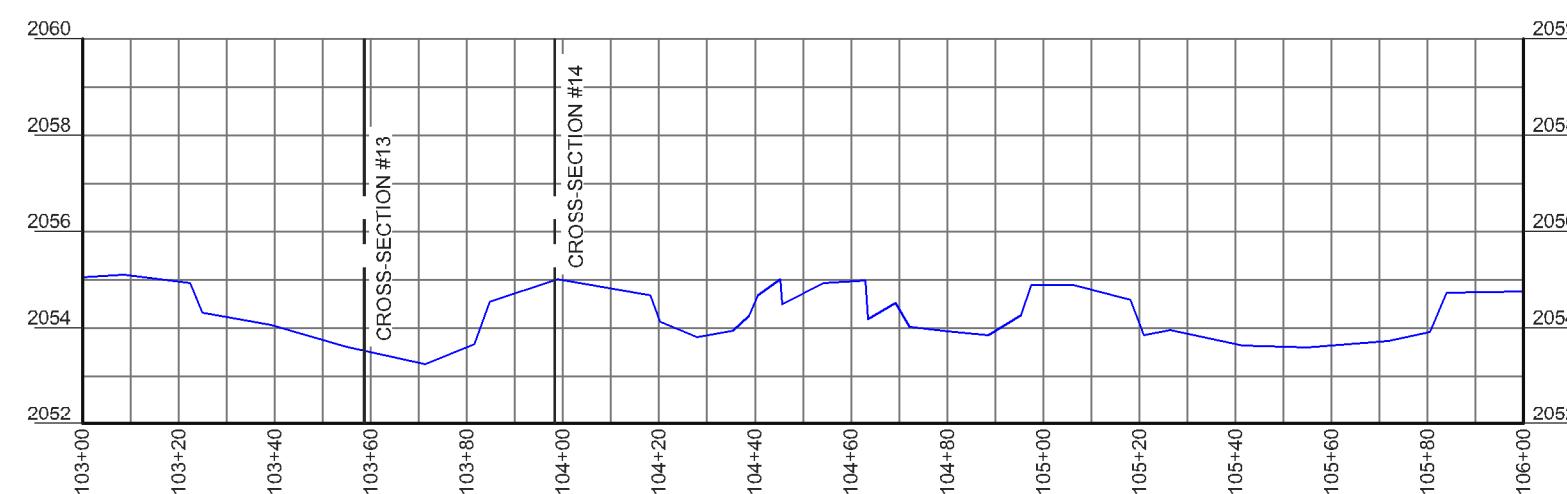
LONGITUDINAL PROFILE- UT1
HORIZONTAL SCALE: 1" = 20' FULL SIZE, 1" = 40' HALF SIZE
VERTICAL SCALE: 1" = 2' FULL SIZE, 1" = 4' HALF SIZE

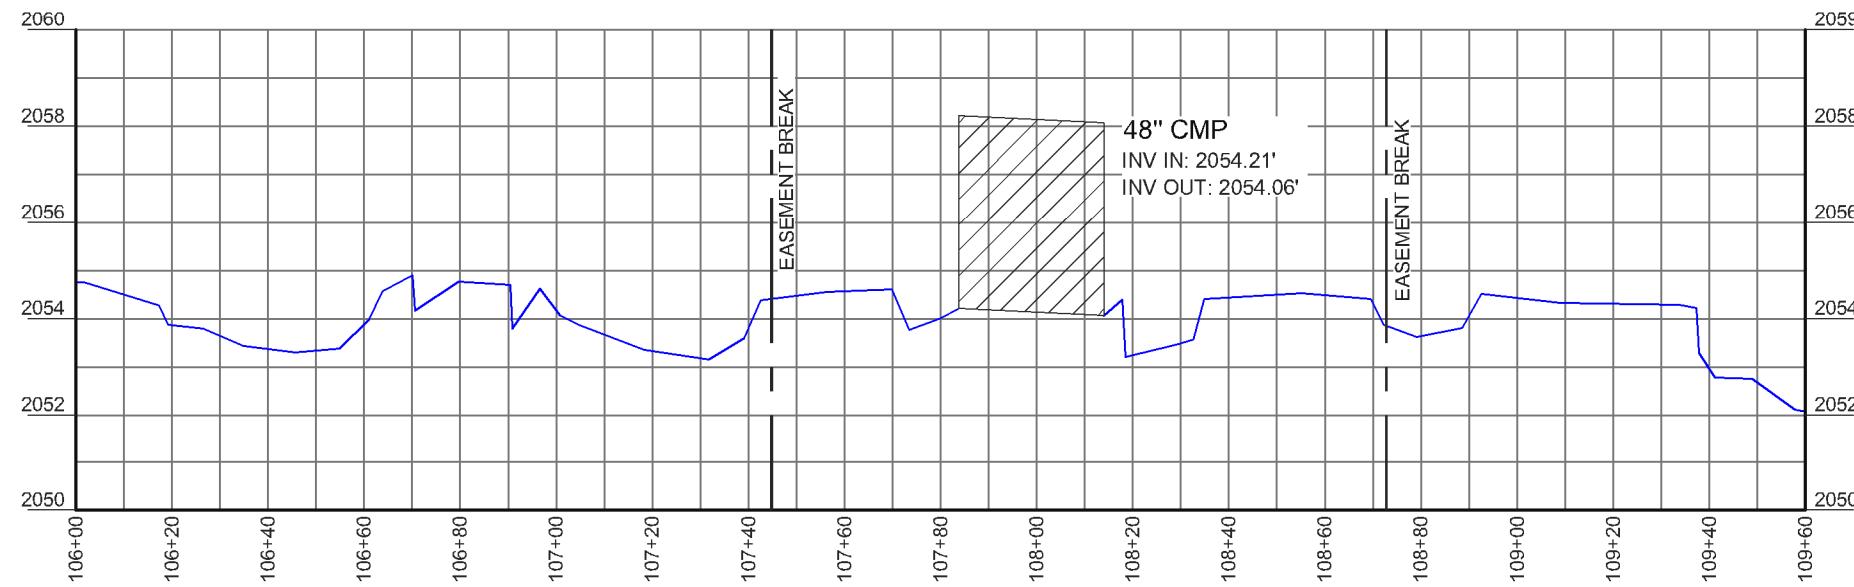
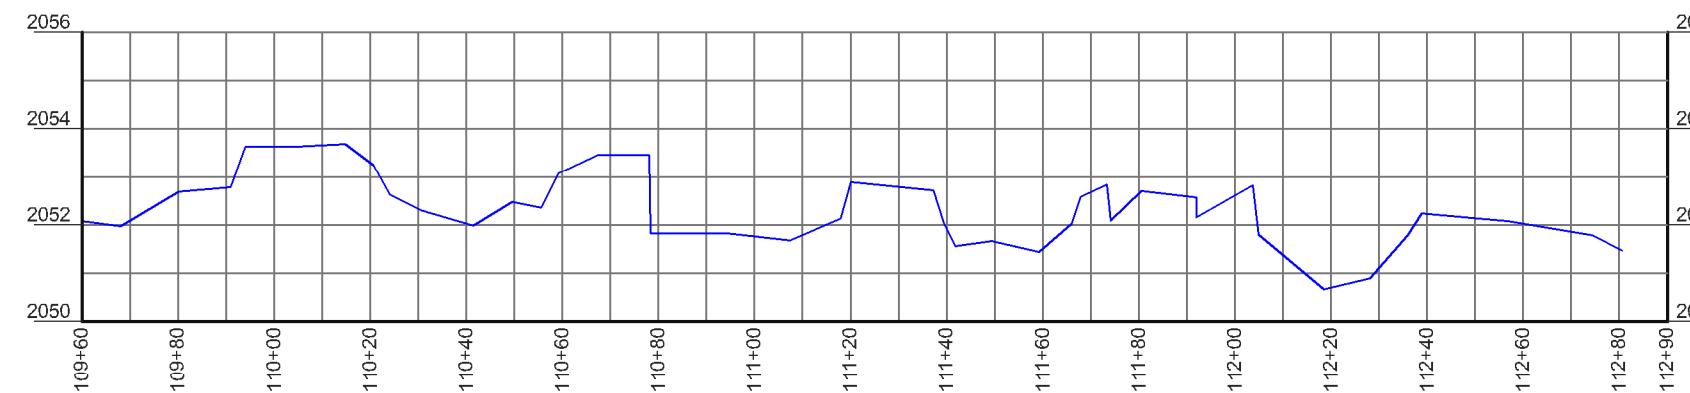
LONGITUDINAL PROFILE- UT1
HORIZONTAL SCALE: 1" = 20' FULL SIZE, 1" = 40' HALF SIZE
VERTICAL SCALE: 1" = 2' FULL SIZE, 1" = 4' HALF SIZE
