MONITORING YEAR 0 ANNUAL REPORT

BANNER FARM MITIGATION SITE

Henderson County, NC
French Broad River Basin
HUC 06010105

DMS Project No. 100062

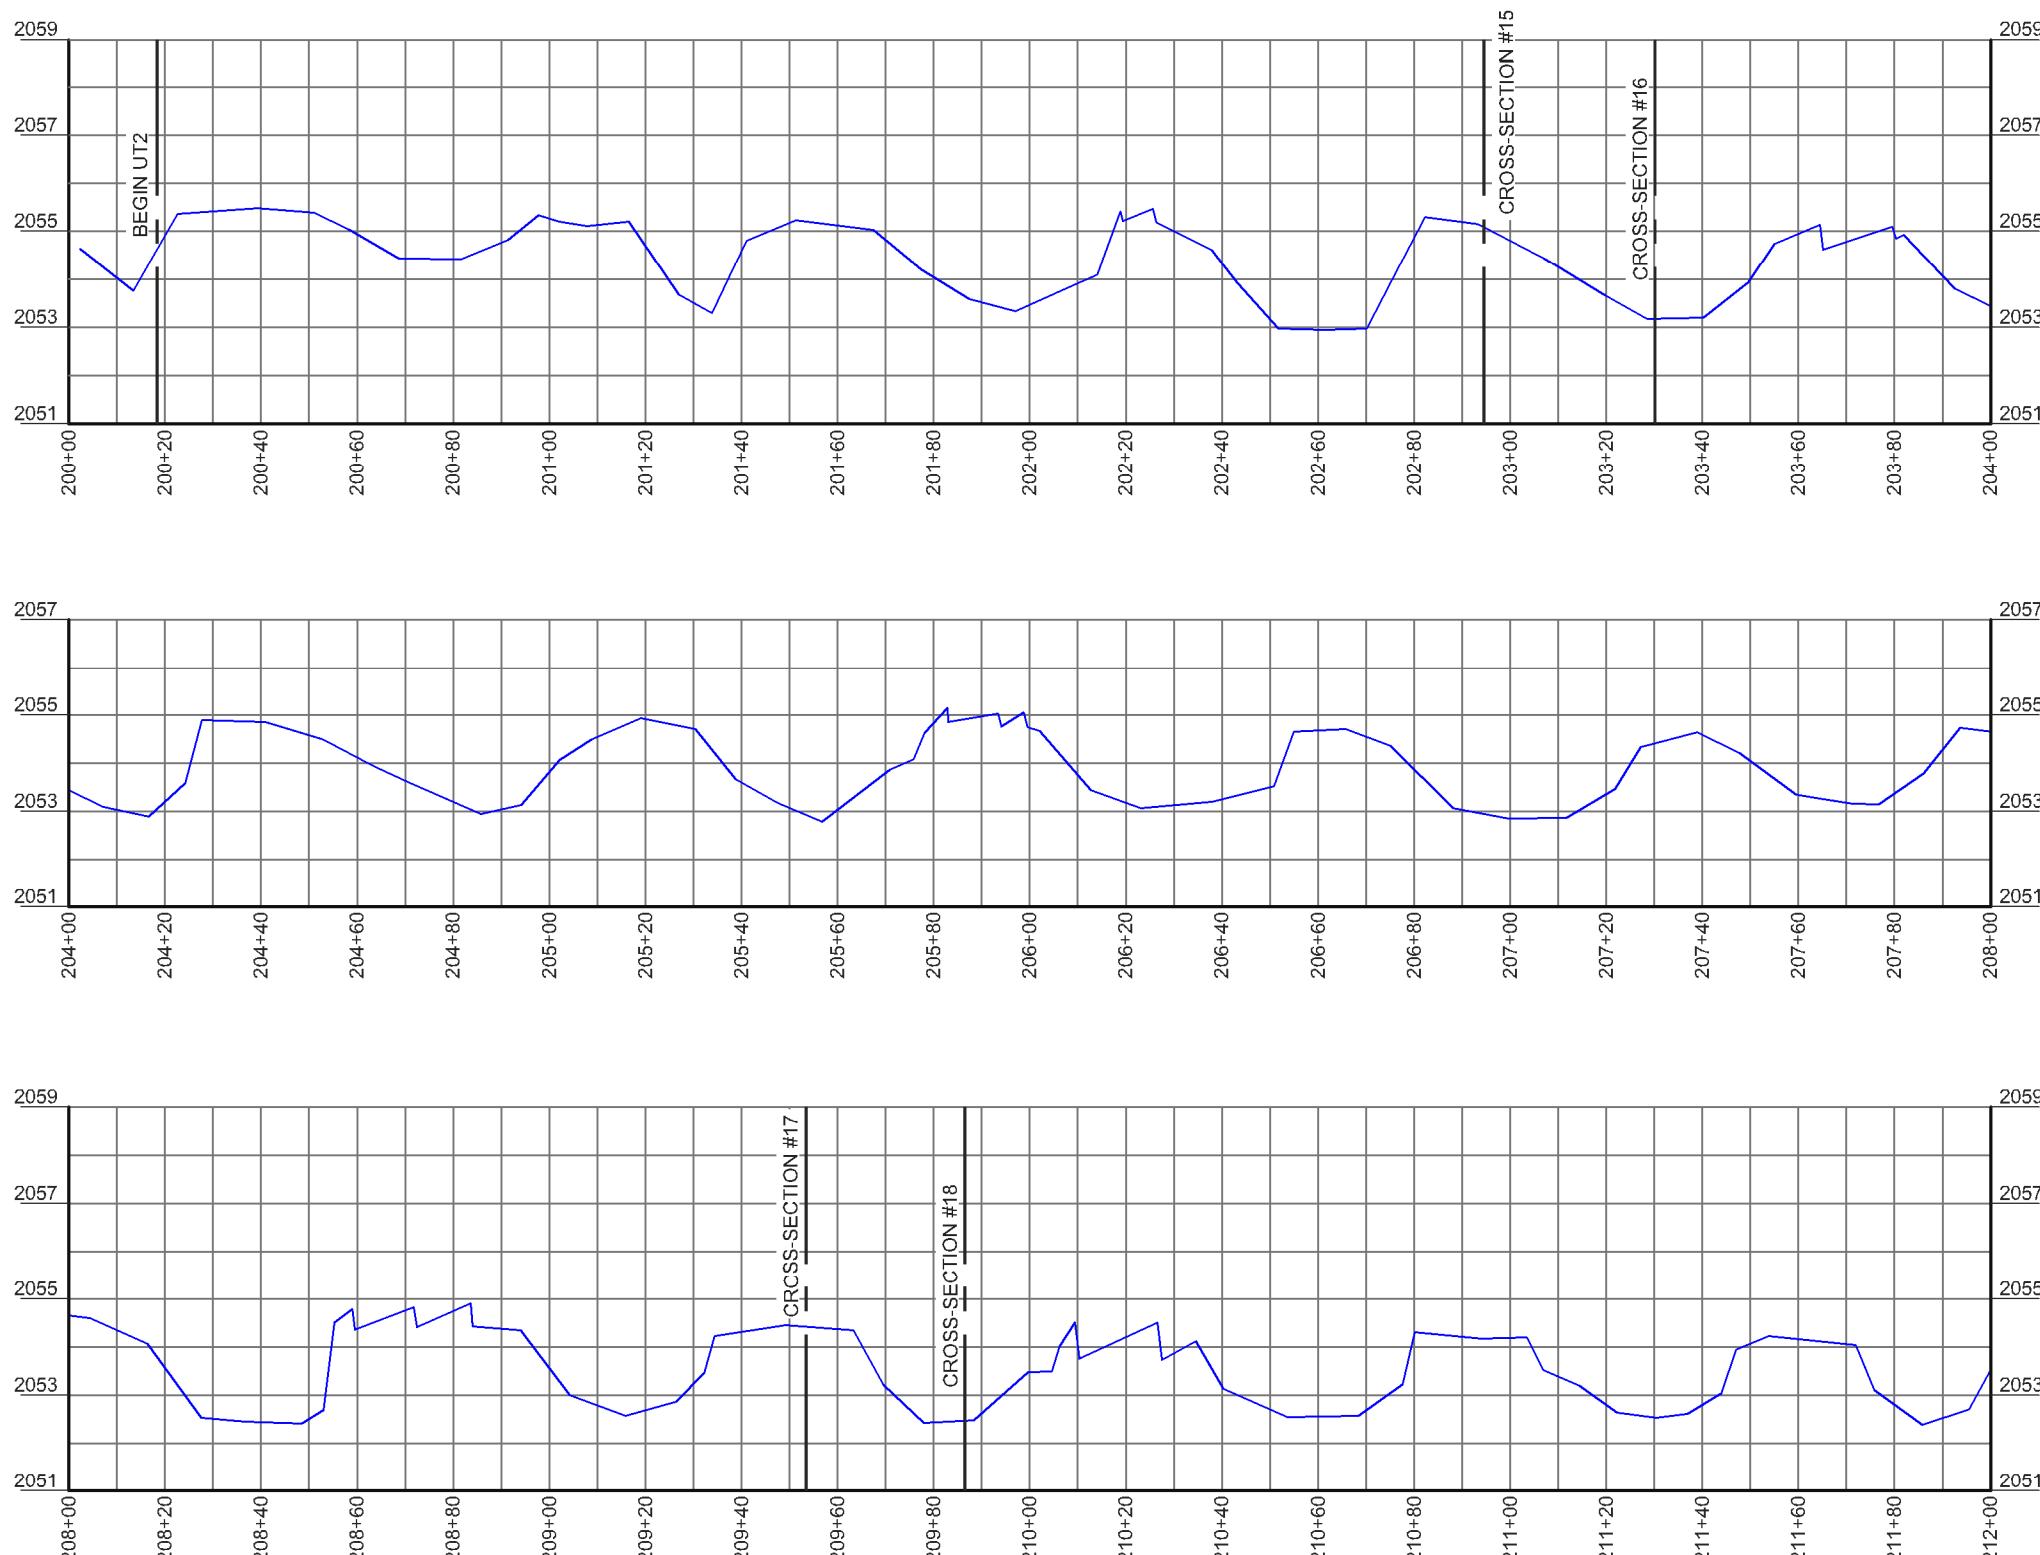
LONGITUDINAL PROFILE- UT2

HORIZONTAL SCALE: 1" = 20' FULL SIZE, 1" = 40' HALF SIZE

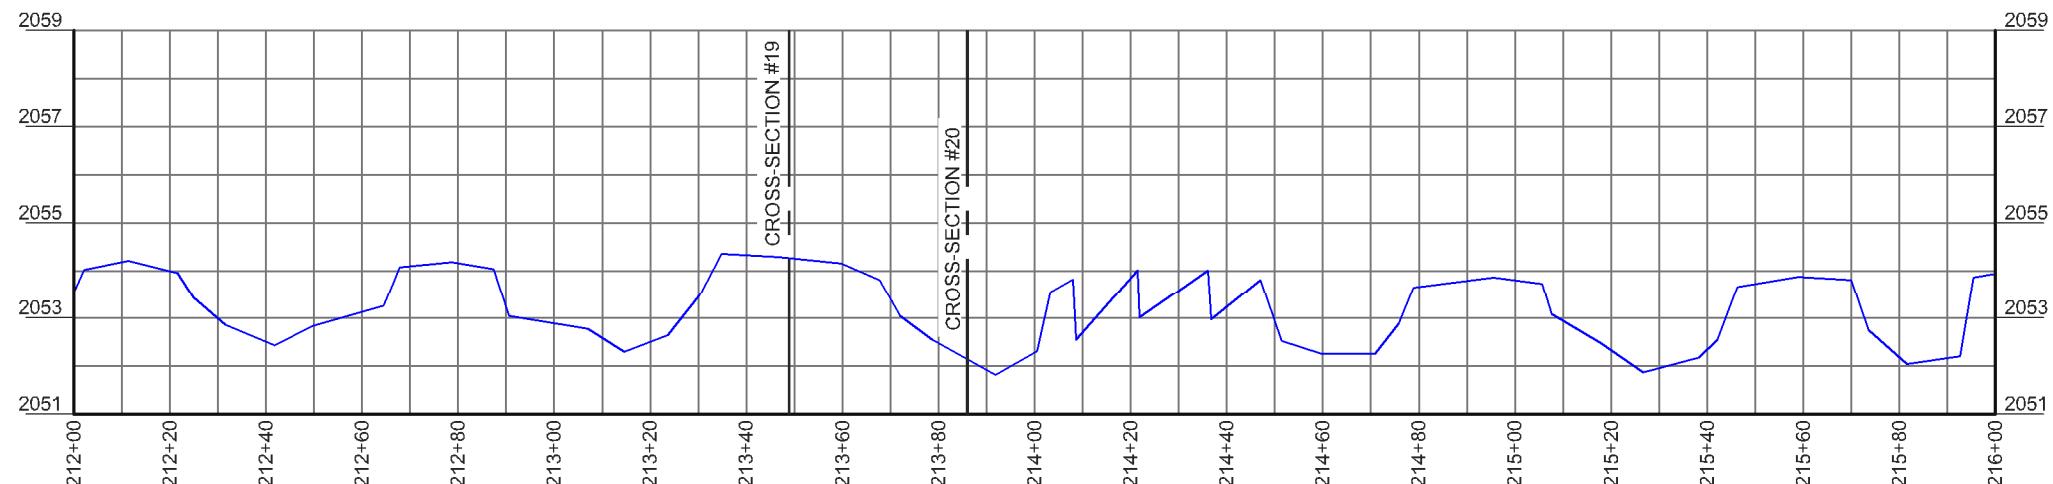
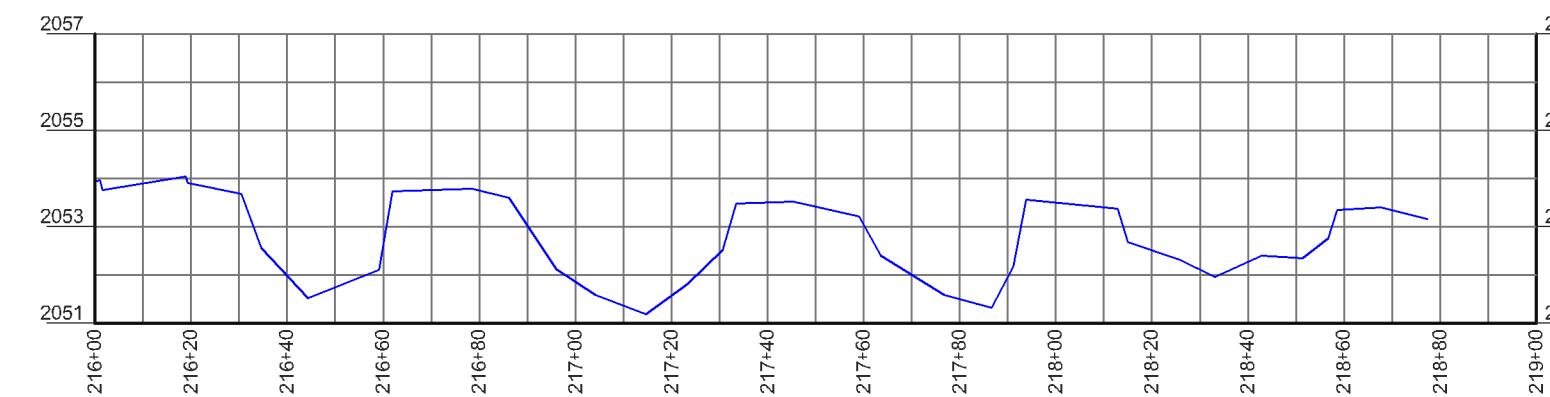
LONGITUDINAL PROFILE- UT2
HORIZONTAL SCALE: 1" = 20' FULL SIZE, 1" = 40' HALF SIZE
VERTICAL SCALE: 1" = 2' FULL SIZE, 1" = 4' HALF SIZE
