MY0 FINAL MONITORING REPORT

Bull Chute Stream and Riparian Wetland Mitigation Site

Randolph County, NC
Yadkin River Basin
Cataloging Unit 03040103

DMS Project ID No. 100137
Full Delivery Contract No. 7878-01
RFP #16-007878 (Issued: 5/6/2019)
USACE Action ID No. SAW-2020-00049
DWR Project No. 20200021

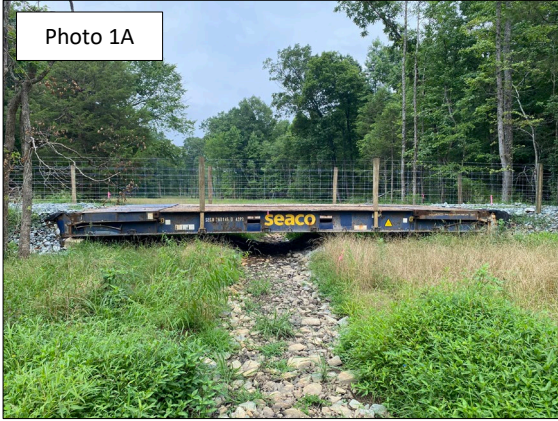
Photo 1A

**Bull Chute Mitigation Site
MYO (2022) Permanent Photo Points (taken July 8, 2022)**

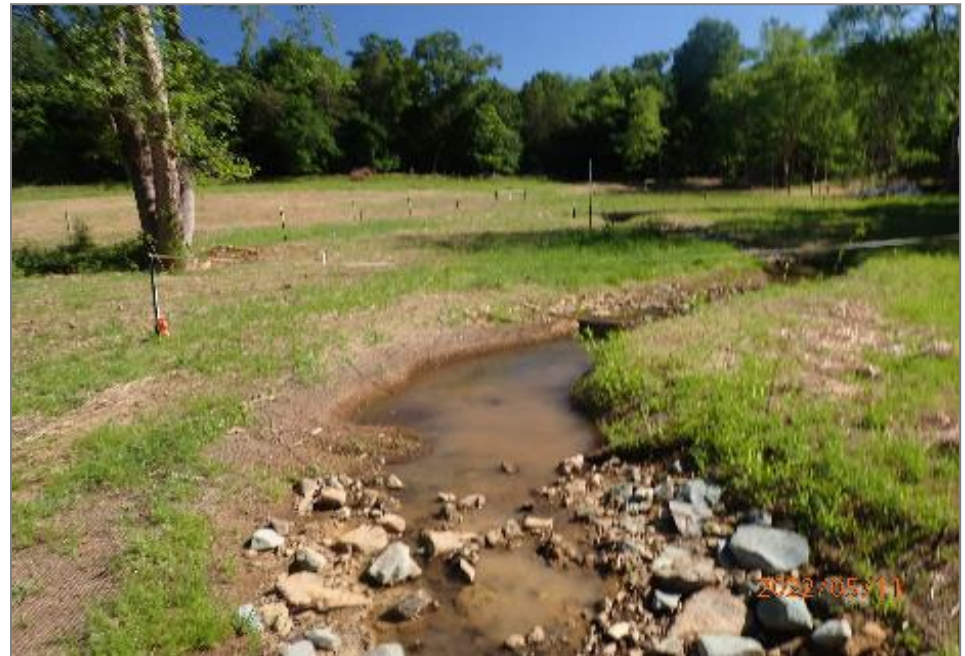
Site	Bull Chute Site
Watershed:	Yadkin River Basin, 03040103
XS ID	UT1, XS -2
Feature	Pool
Date:	5/11/2022
Field Crew:	Lewis

Station	Elevation
0.0	714.9
3.4	714.7
5.5	714.9
7.1	714.8
8.3	714.3
9.1	713.7
9.7	713.5
10.2	713.0
11.1	713.0
11.5	712.8
11.7	712.6
12.3	712.6
12.7	712.7
13.1	713.1
13.6	713.2
14.2	713.3
14.8	713.5
15.3	714.1
15.7	714.4
16.4	714.7
16.9	714.88
17.6	714.9
18.9	714.9
20.5	714.9
22.0	714.9
22.8	714.8

SUMMARY DATA	
Bankfull Elevation:	714.80
Bank Height Ratio:	1.00
Thalweg Elevation:	712.56
LTOB Elevation:	714.80
LTOB Max Depth:	2.24
LTOB Cross Sectional Area:	11.7

Stream Type	E/C 4
--------------------	-------
