**601 North II
Stream Restoration Site
NCEEP Project Number: 95925
Monitoring Contract Number: 003991
Monitoring Year 1
2013**

**601 North II
Stream Restoration Site
2013 Monitoring Report (MY 1)**

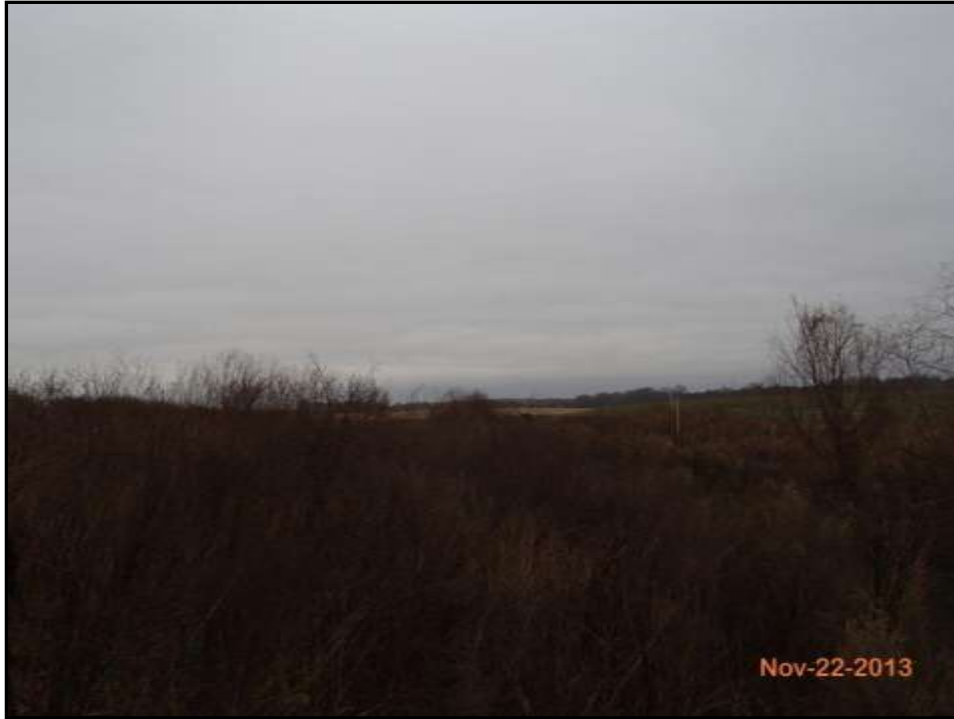
601 North II – Permanent Photo Station 1
Looking Downstream

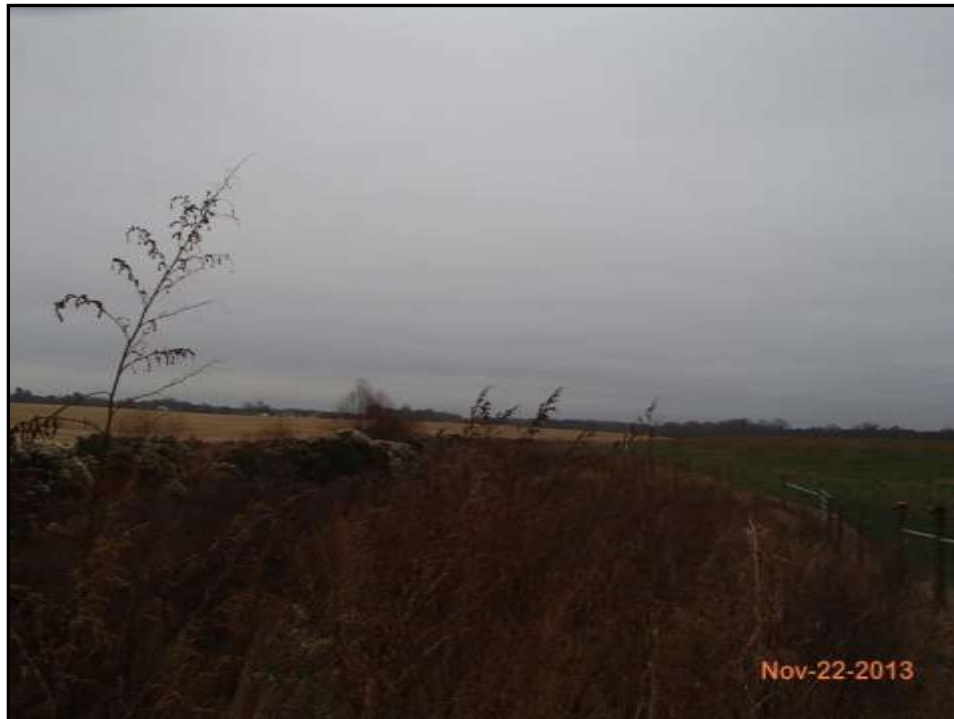
601 North II – Permanent Photo Station 2
Looking Downstream

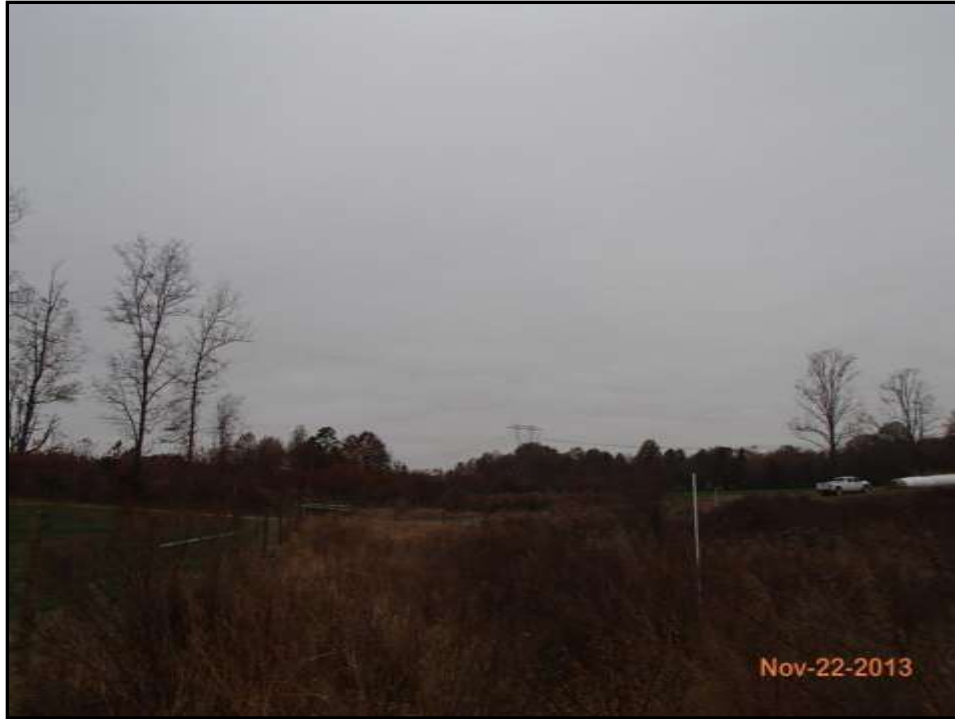
601 North II – Permanent Photo Station 2
Looking Upstream

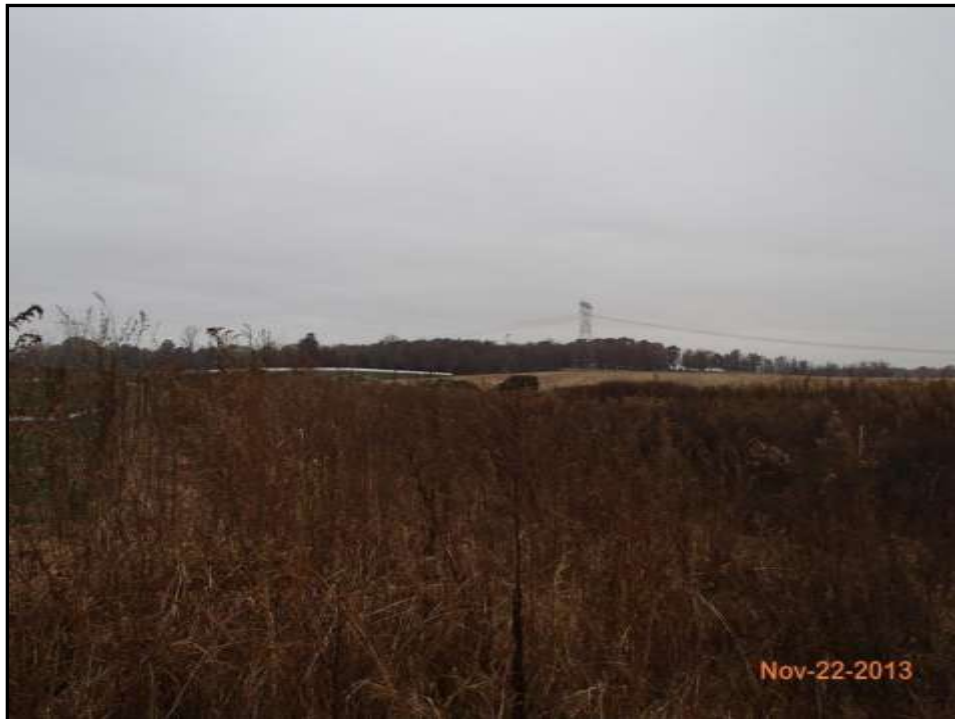
601 North II – Permanent Photo Station 3
Looking Upstream

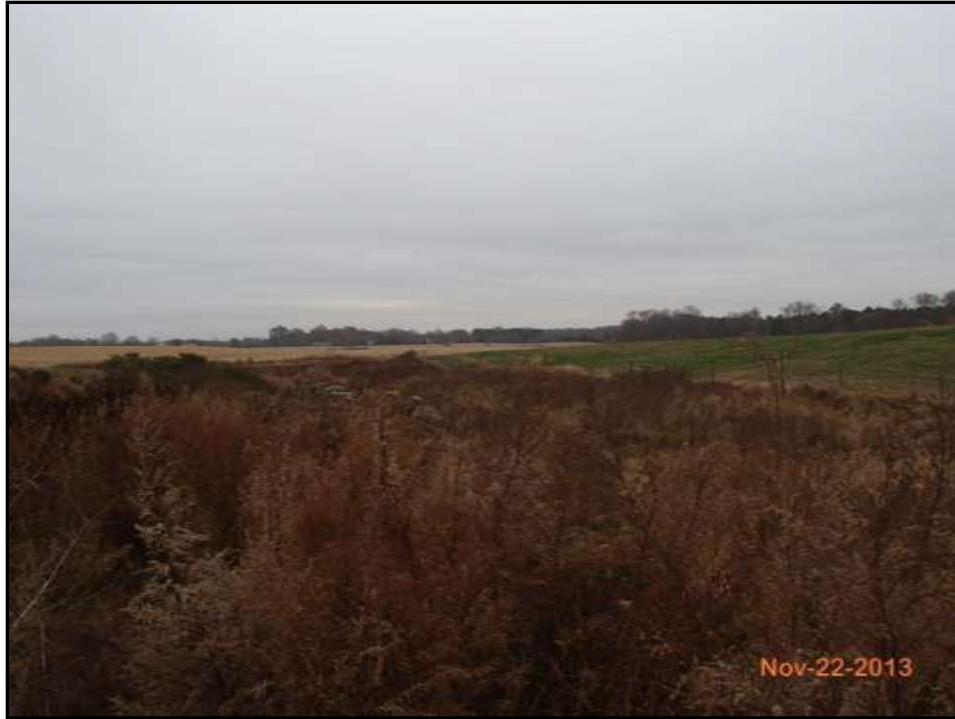
601 North II – Permanent Photo Station 4
Looking Downstream

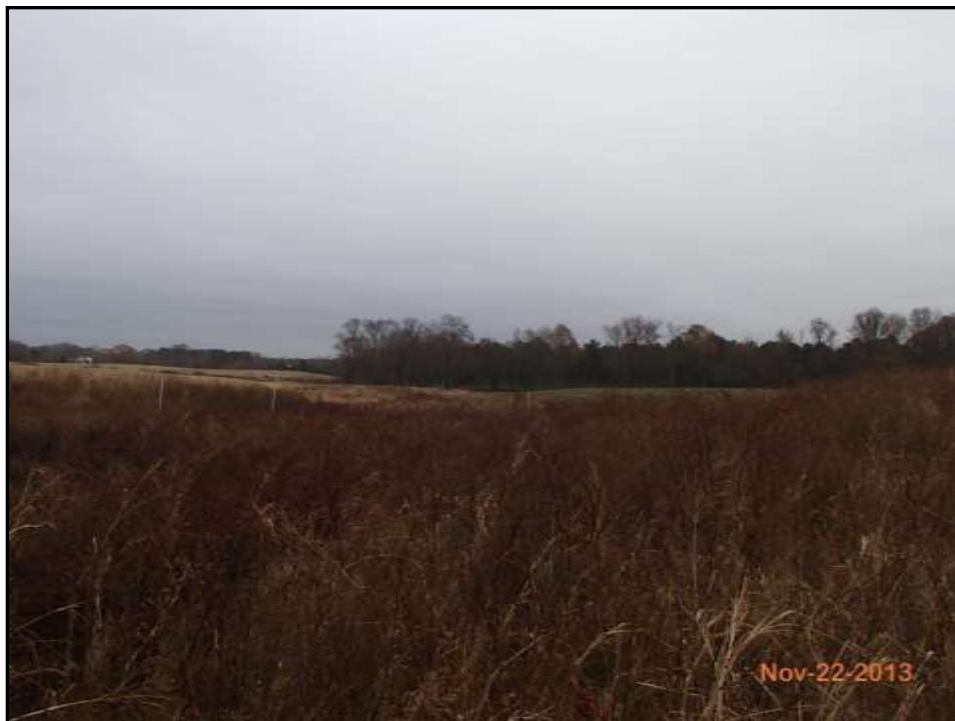
601 North II – Permanent Photo Station 5
Looking Downstream

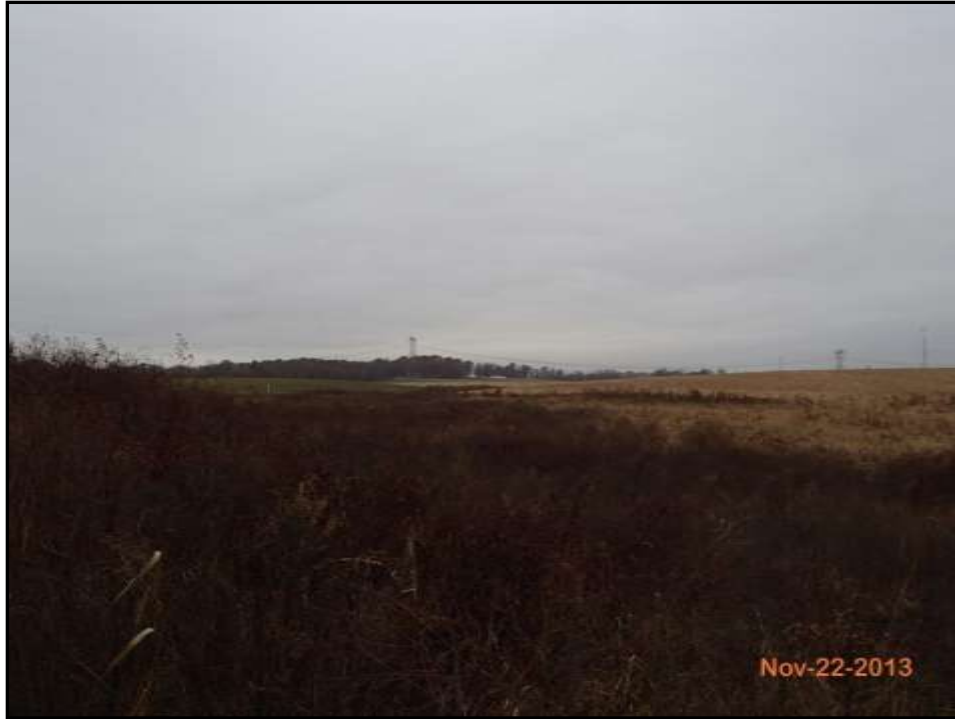
601 North II – Permanent Photo Station 5
Looking Upstream

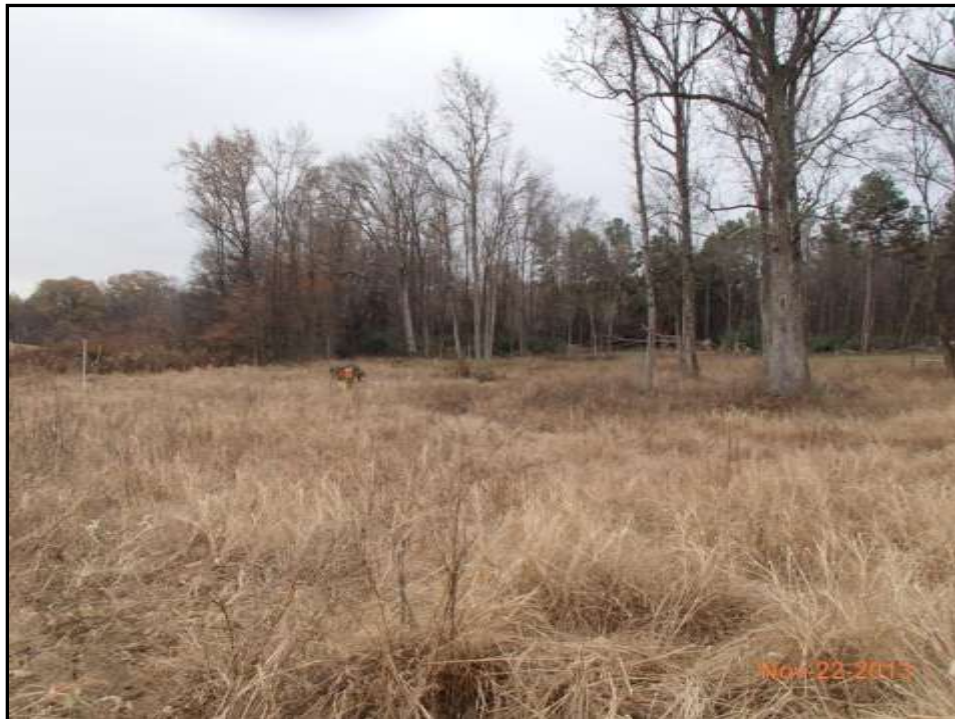
601 North II – Permanent Photo Station 6
Looking Downstream

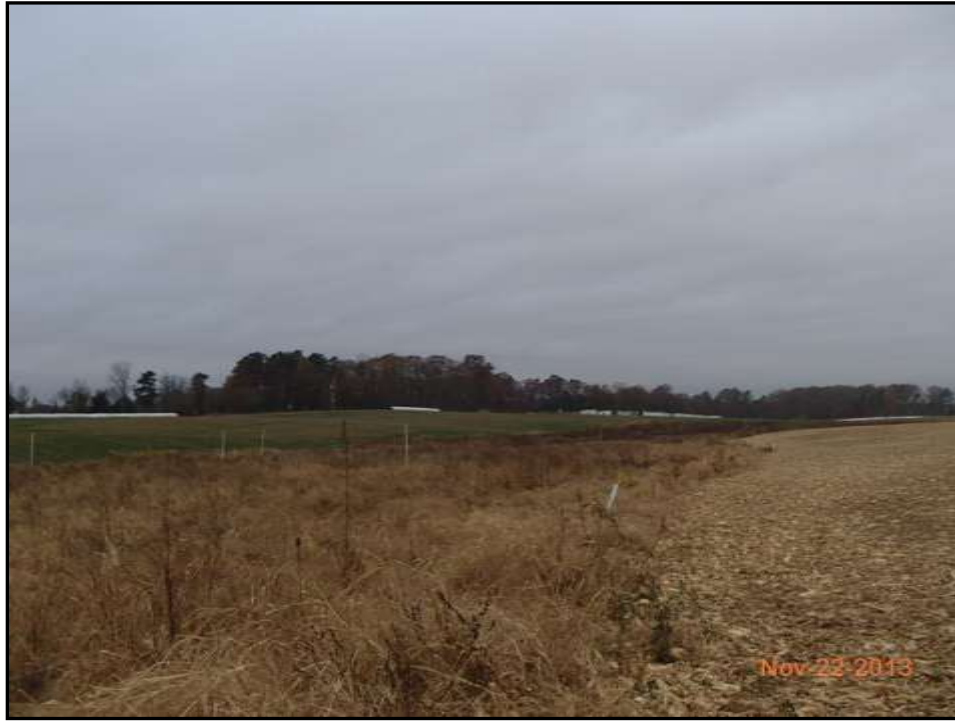
601 North II -Permanent Photo Station 6
Looking Upstream

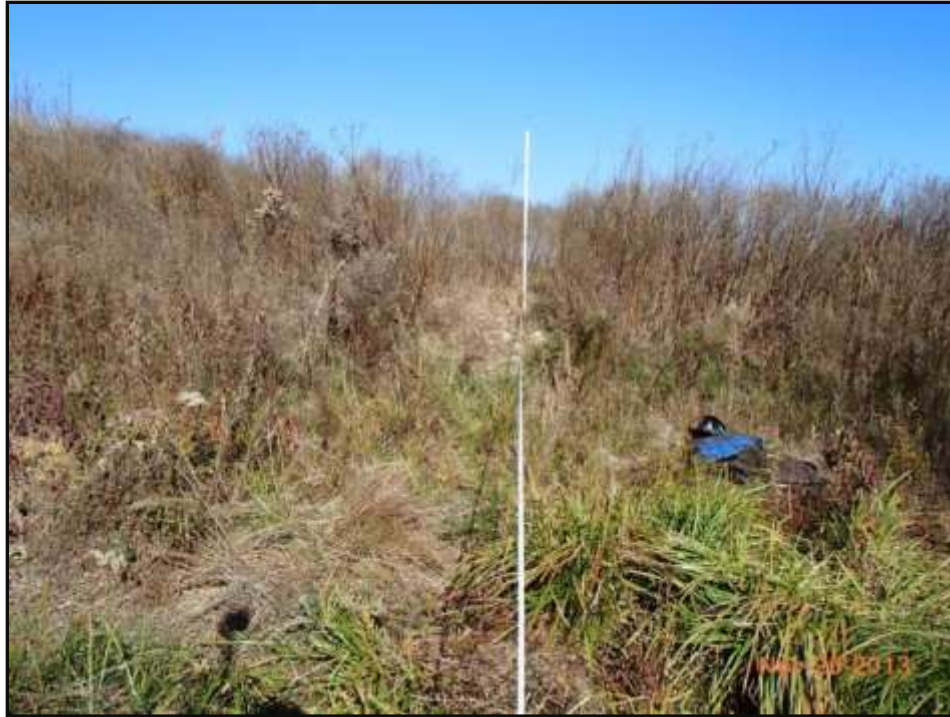
601 North II – Cross-Section 1 – Riffle
Left Bank Descending
Monitoring Year 1 – Nov 20, 2013

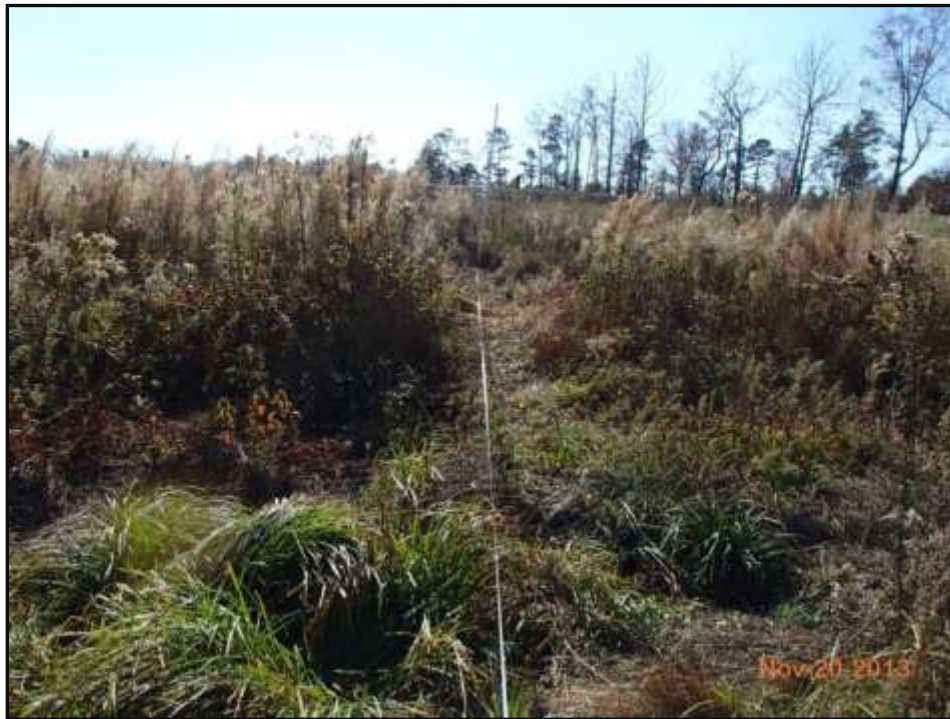
601 North II – Cross-Section 1 – Riffle
Right Bank Descending
Monitoring Year 1 – Nov 20, 2013

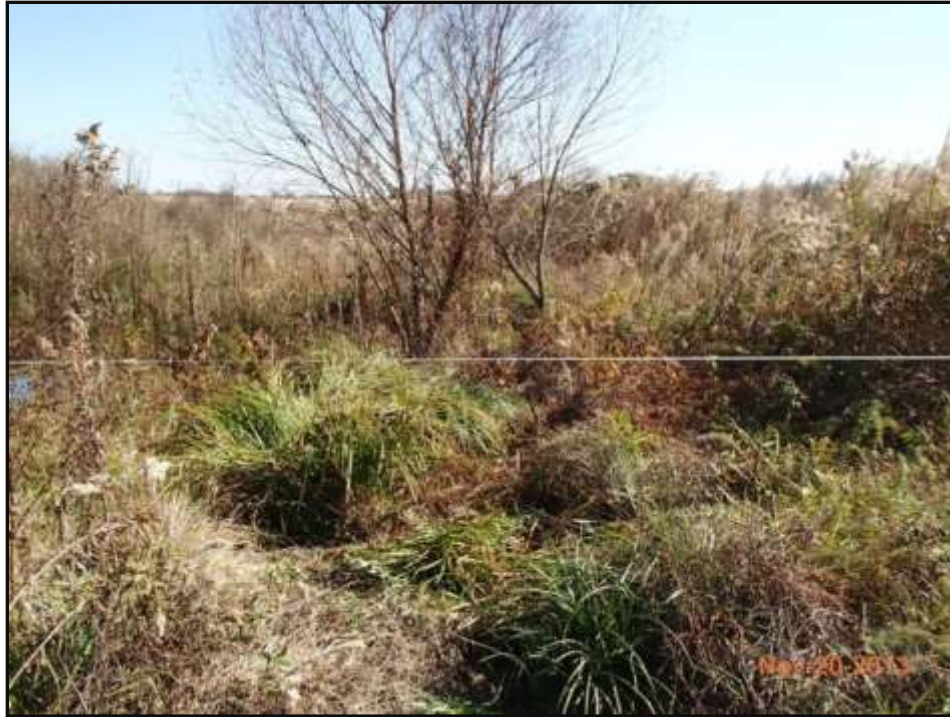
601 North II – Cross-Section 1 – Riffle
Looking Downstream
Monitoring Year 1 – Nov 20, 2013

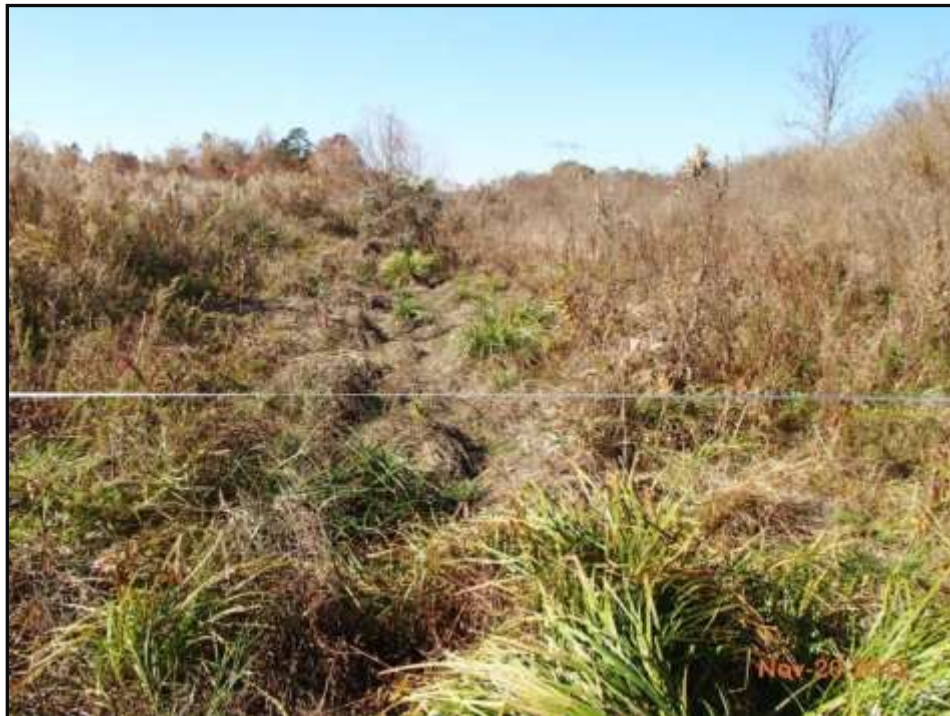
601 North II – Cross-Section 1 – Riffle
Looking Upstream
Monitoring Year 1 – Nov 20, 2013

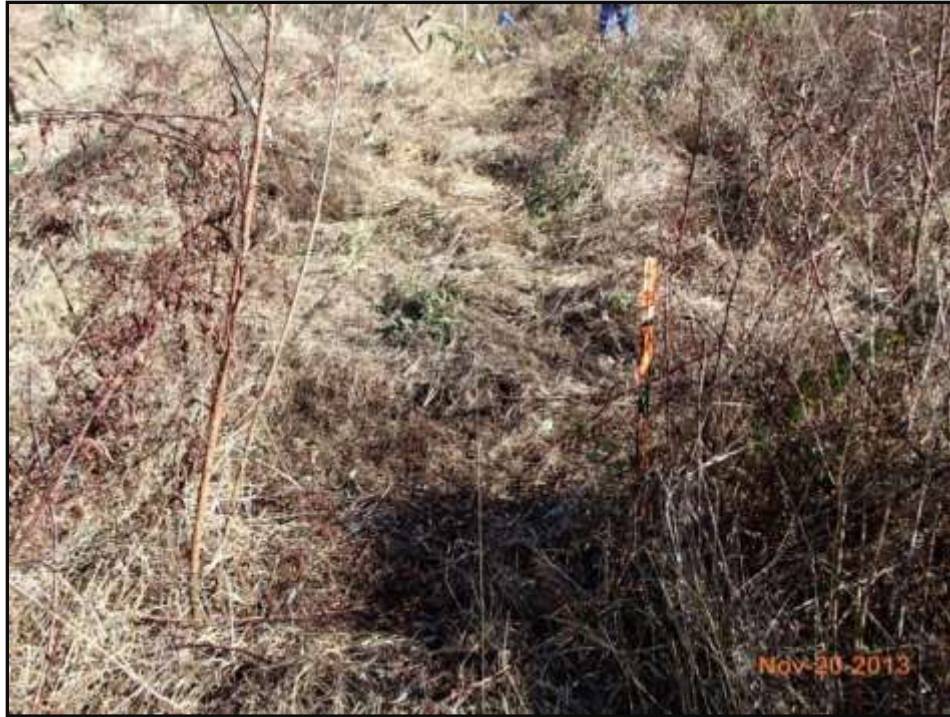
601 North II – Cross-Section 2 – Pool
Left Bank Descending
Monitoring Year 1 – Nov 20, 2013

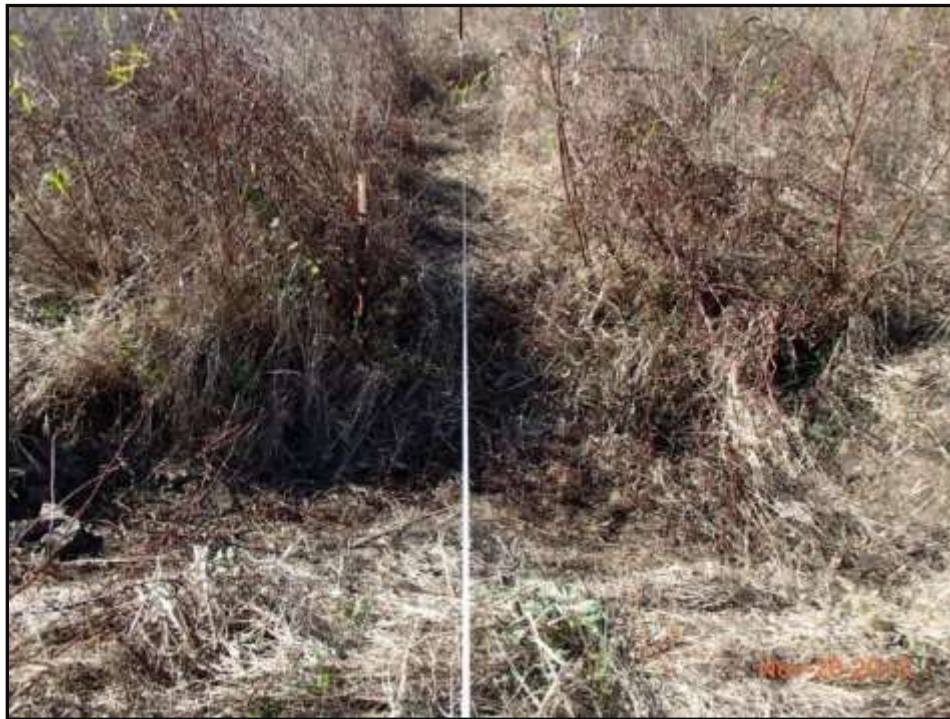
601 North II – Cross-Section 2 – Pool
Right Bank Descending
Monitoring Year 1 – Nov 20, 2013

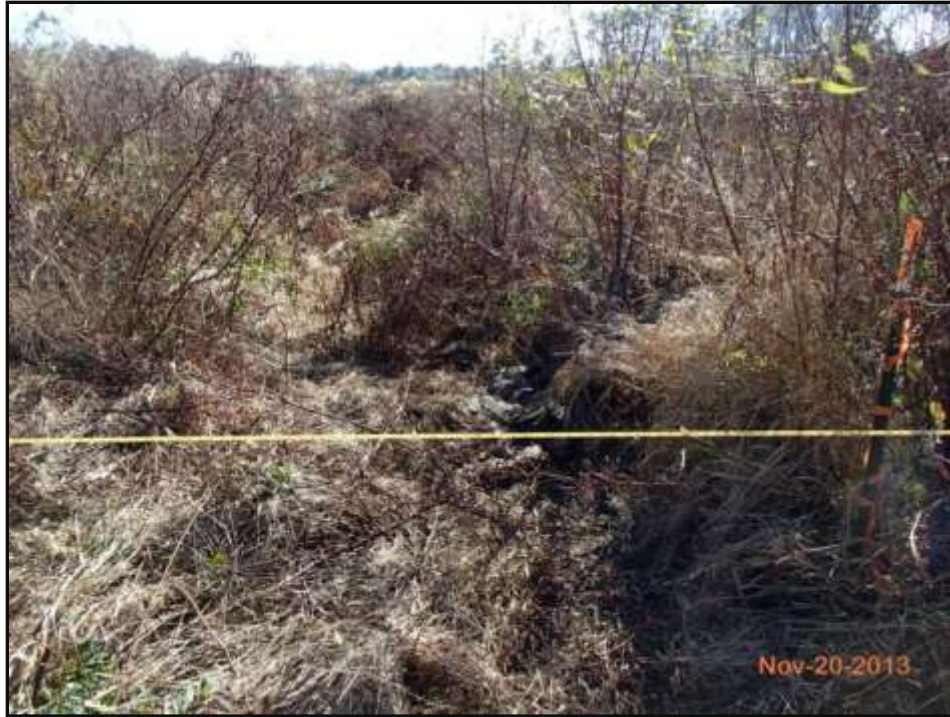
601 North II – Cross-Section 2 – Pool
Downstream
Monitoring Year 1 – Nov 20, 2013

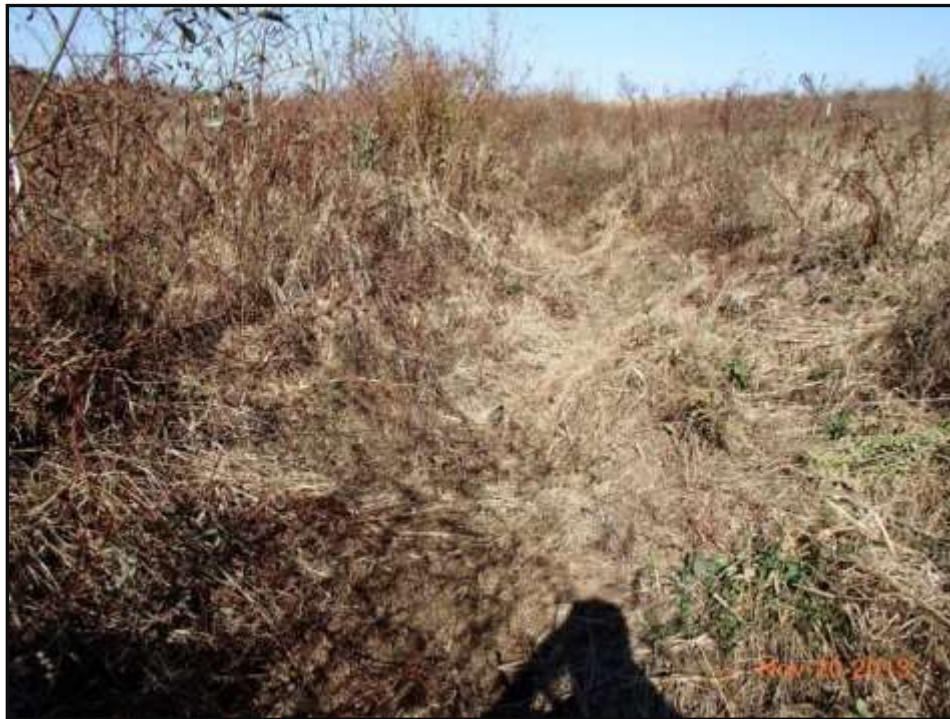
601 North II – Cross-Section 2 – Pool
Upstream
Monitoring Year 1 – Nov 20, 2013

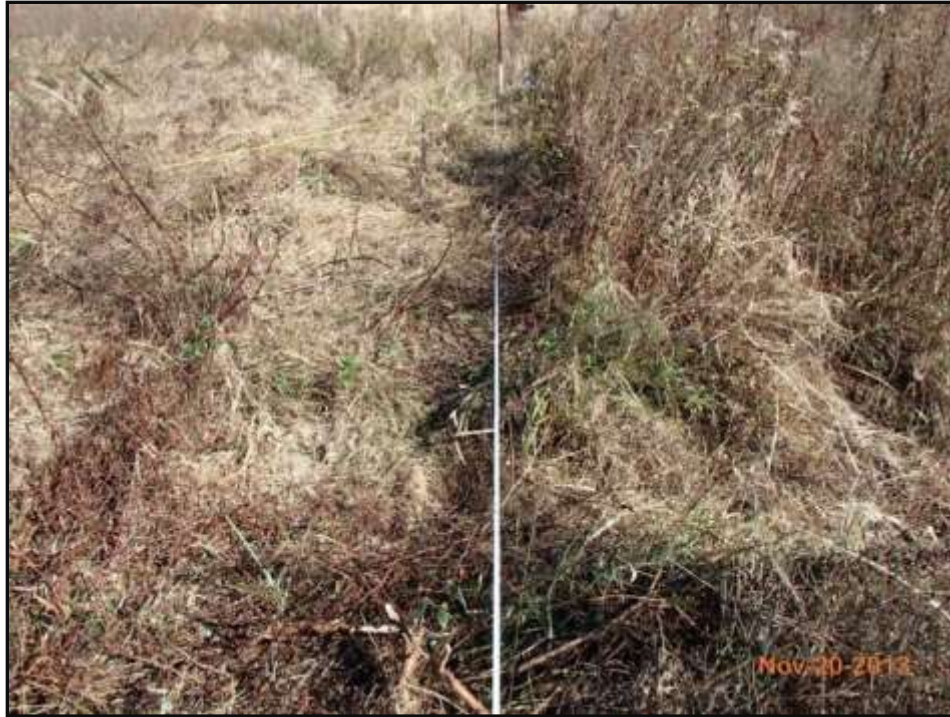
601 North II – Cross-Section 3 – Riffle
Left Bank Descending
Monitoring Year 1 – Nov 20, 2013

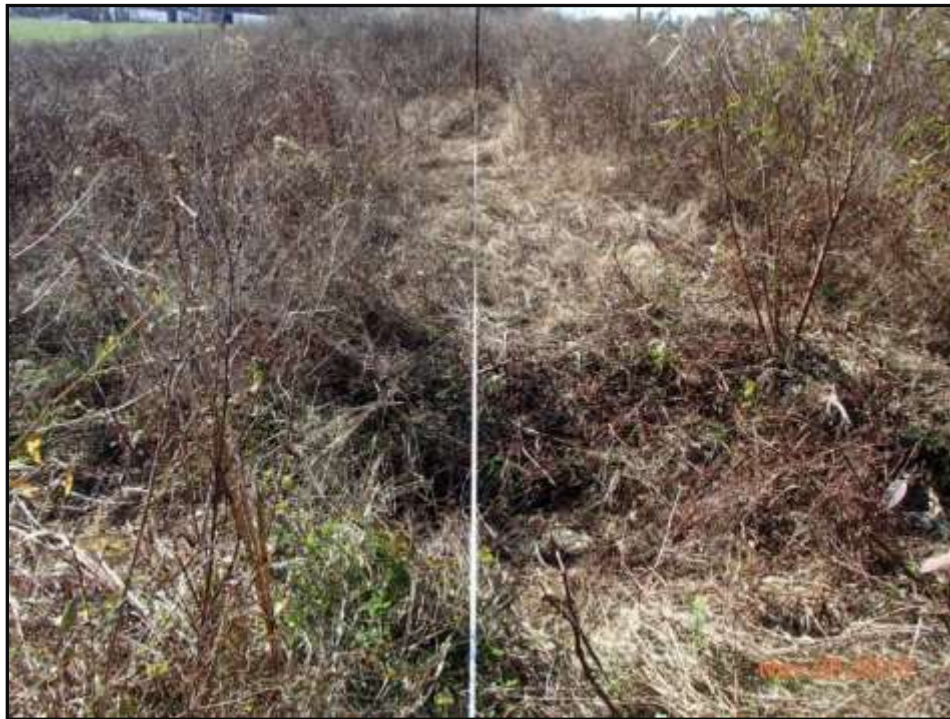
601 North II – Cross-Section 3 – Riffle
Right Bank Descending
Monitoring Year 1 – Nov 20, 2013

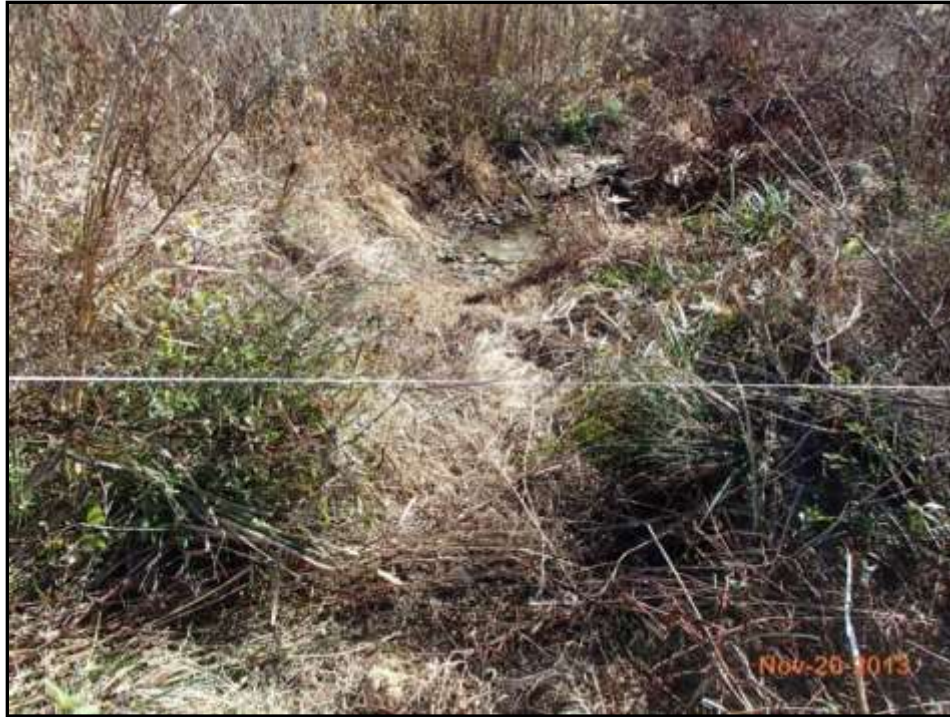
601 North II – Cross-Section 3 – Riffle
Looking Downstream
Monitoring Year 1 – Nov 20, 2013

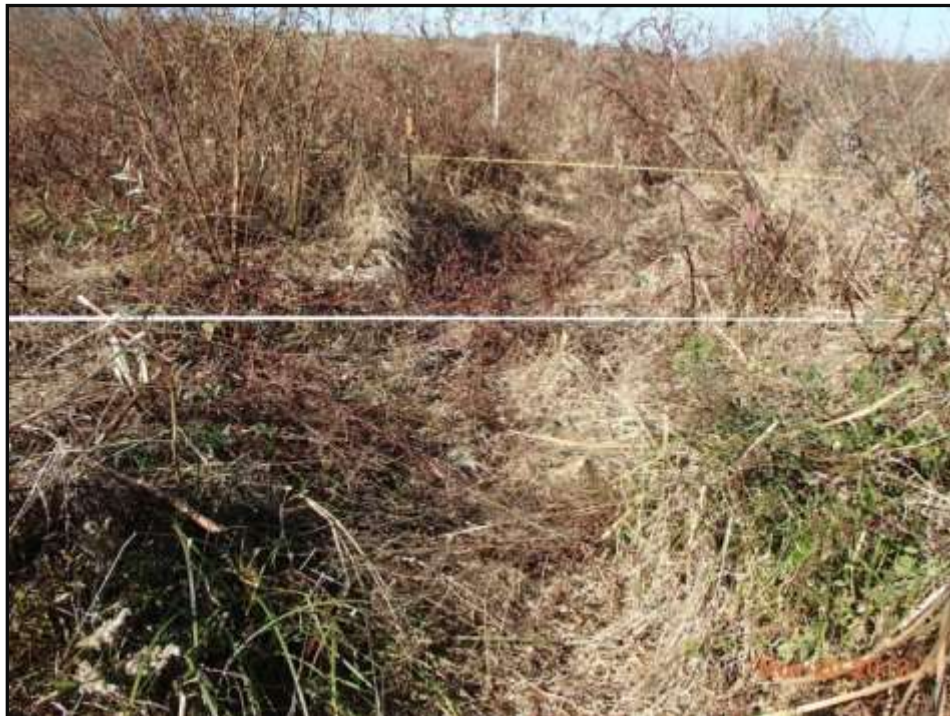
601 North II – Cross-Section 3 – Riffle
Looking Upstream
Monitoring Year 1 – Nov 20, 2013
