# 601 North Stream Restoration Project Annual Monitoring Report

**Monitoring Year: 2011**

**NCEEP Project Number: D 06054-A**

North Carolina State University  
Department of Biological and Agricultural Engineering  
3100 Faucette Drive / Campus Box 7625  
Raleigh, NC 27695-7625

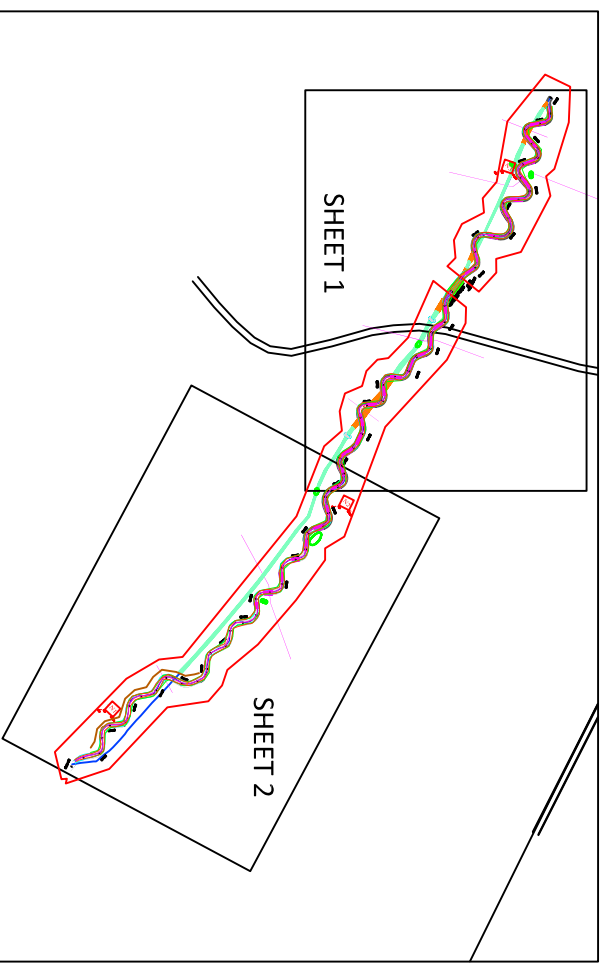
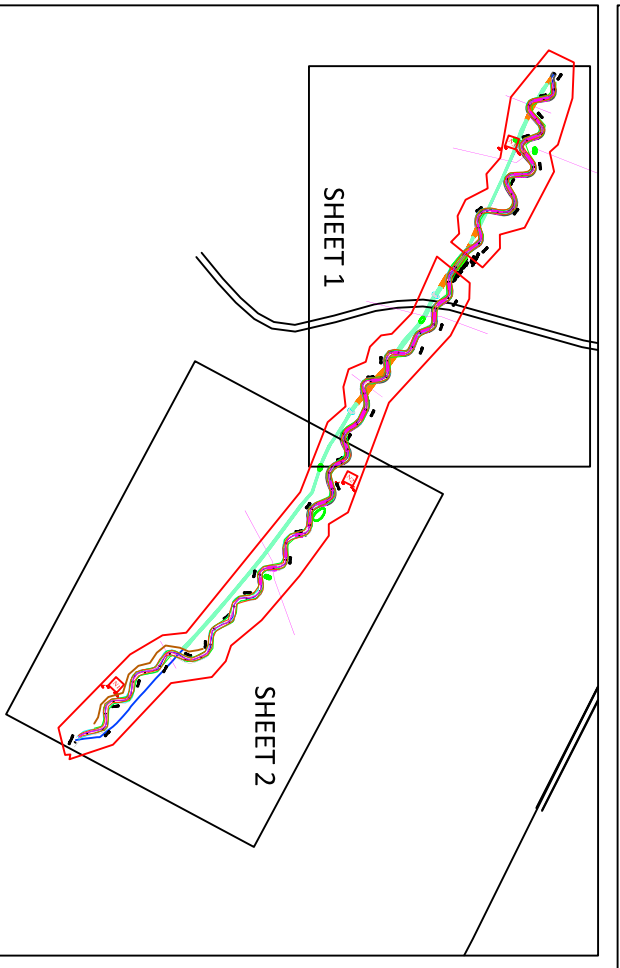
**Figure B 1 - 601 North Reach 1 Sheet 1**

**Figure B 2 - 601 North Reach 1 Sheet 2**

—	DESIGN TOP OF BANK
- - -	MONITORING ALIGNMENT (ALL YEARS)
—	2008 (MY1) THALWEG
—	2008 (MY1) TOP OF BANK
—	2009 (MY2) THALWEG
—	2009 (MY2) TOP OF BANK
—	2009 (MY3) THALWEG
—	2009 (MY3) TOP OF BANK
—	2010 (MY4) THALWEG
—	2010 (MY4) TOP OF BANK
—	2011 (MY4) THALWEG
—	2011 (MY4) TOP OF BANK

DESIGN TOP OF BANK
	MONITORING ALIGNMENT (ALL YEARS)
	2008 (MY1) THALWEG
	2008 (MY1) TOP OF BANK
	2009 (MY2) THALWEG
	2009 (MY2) TOP OF BANK
	2010 (MY3) THALWEG
	2010 (MY3) TOP OF BANK
	2011 (MY4) THALWEG
	2011 (MY4) TOP OF BANK
