**FINAL**  
**BASELINE MONITORING DOCUMENT AND**  
**AS-BUILT BASELINE REPORT**

**ABBEY LAMM**  
**STREAM AND WETLAND MITIGATION SITE**

Alamance County, North Carolina  
Full Delivery Contract No. 5790

Data Collection: April and May 2015  
Submission: July 2015

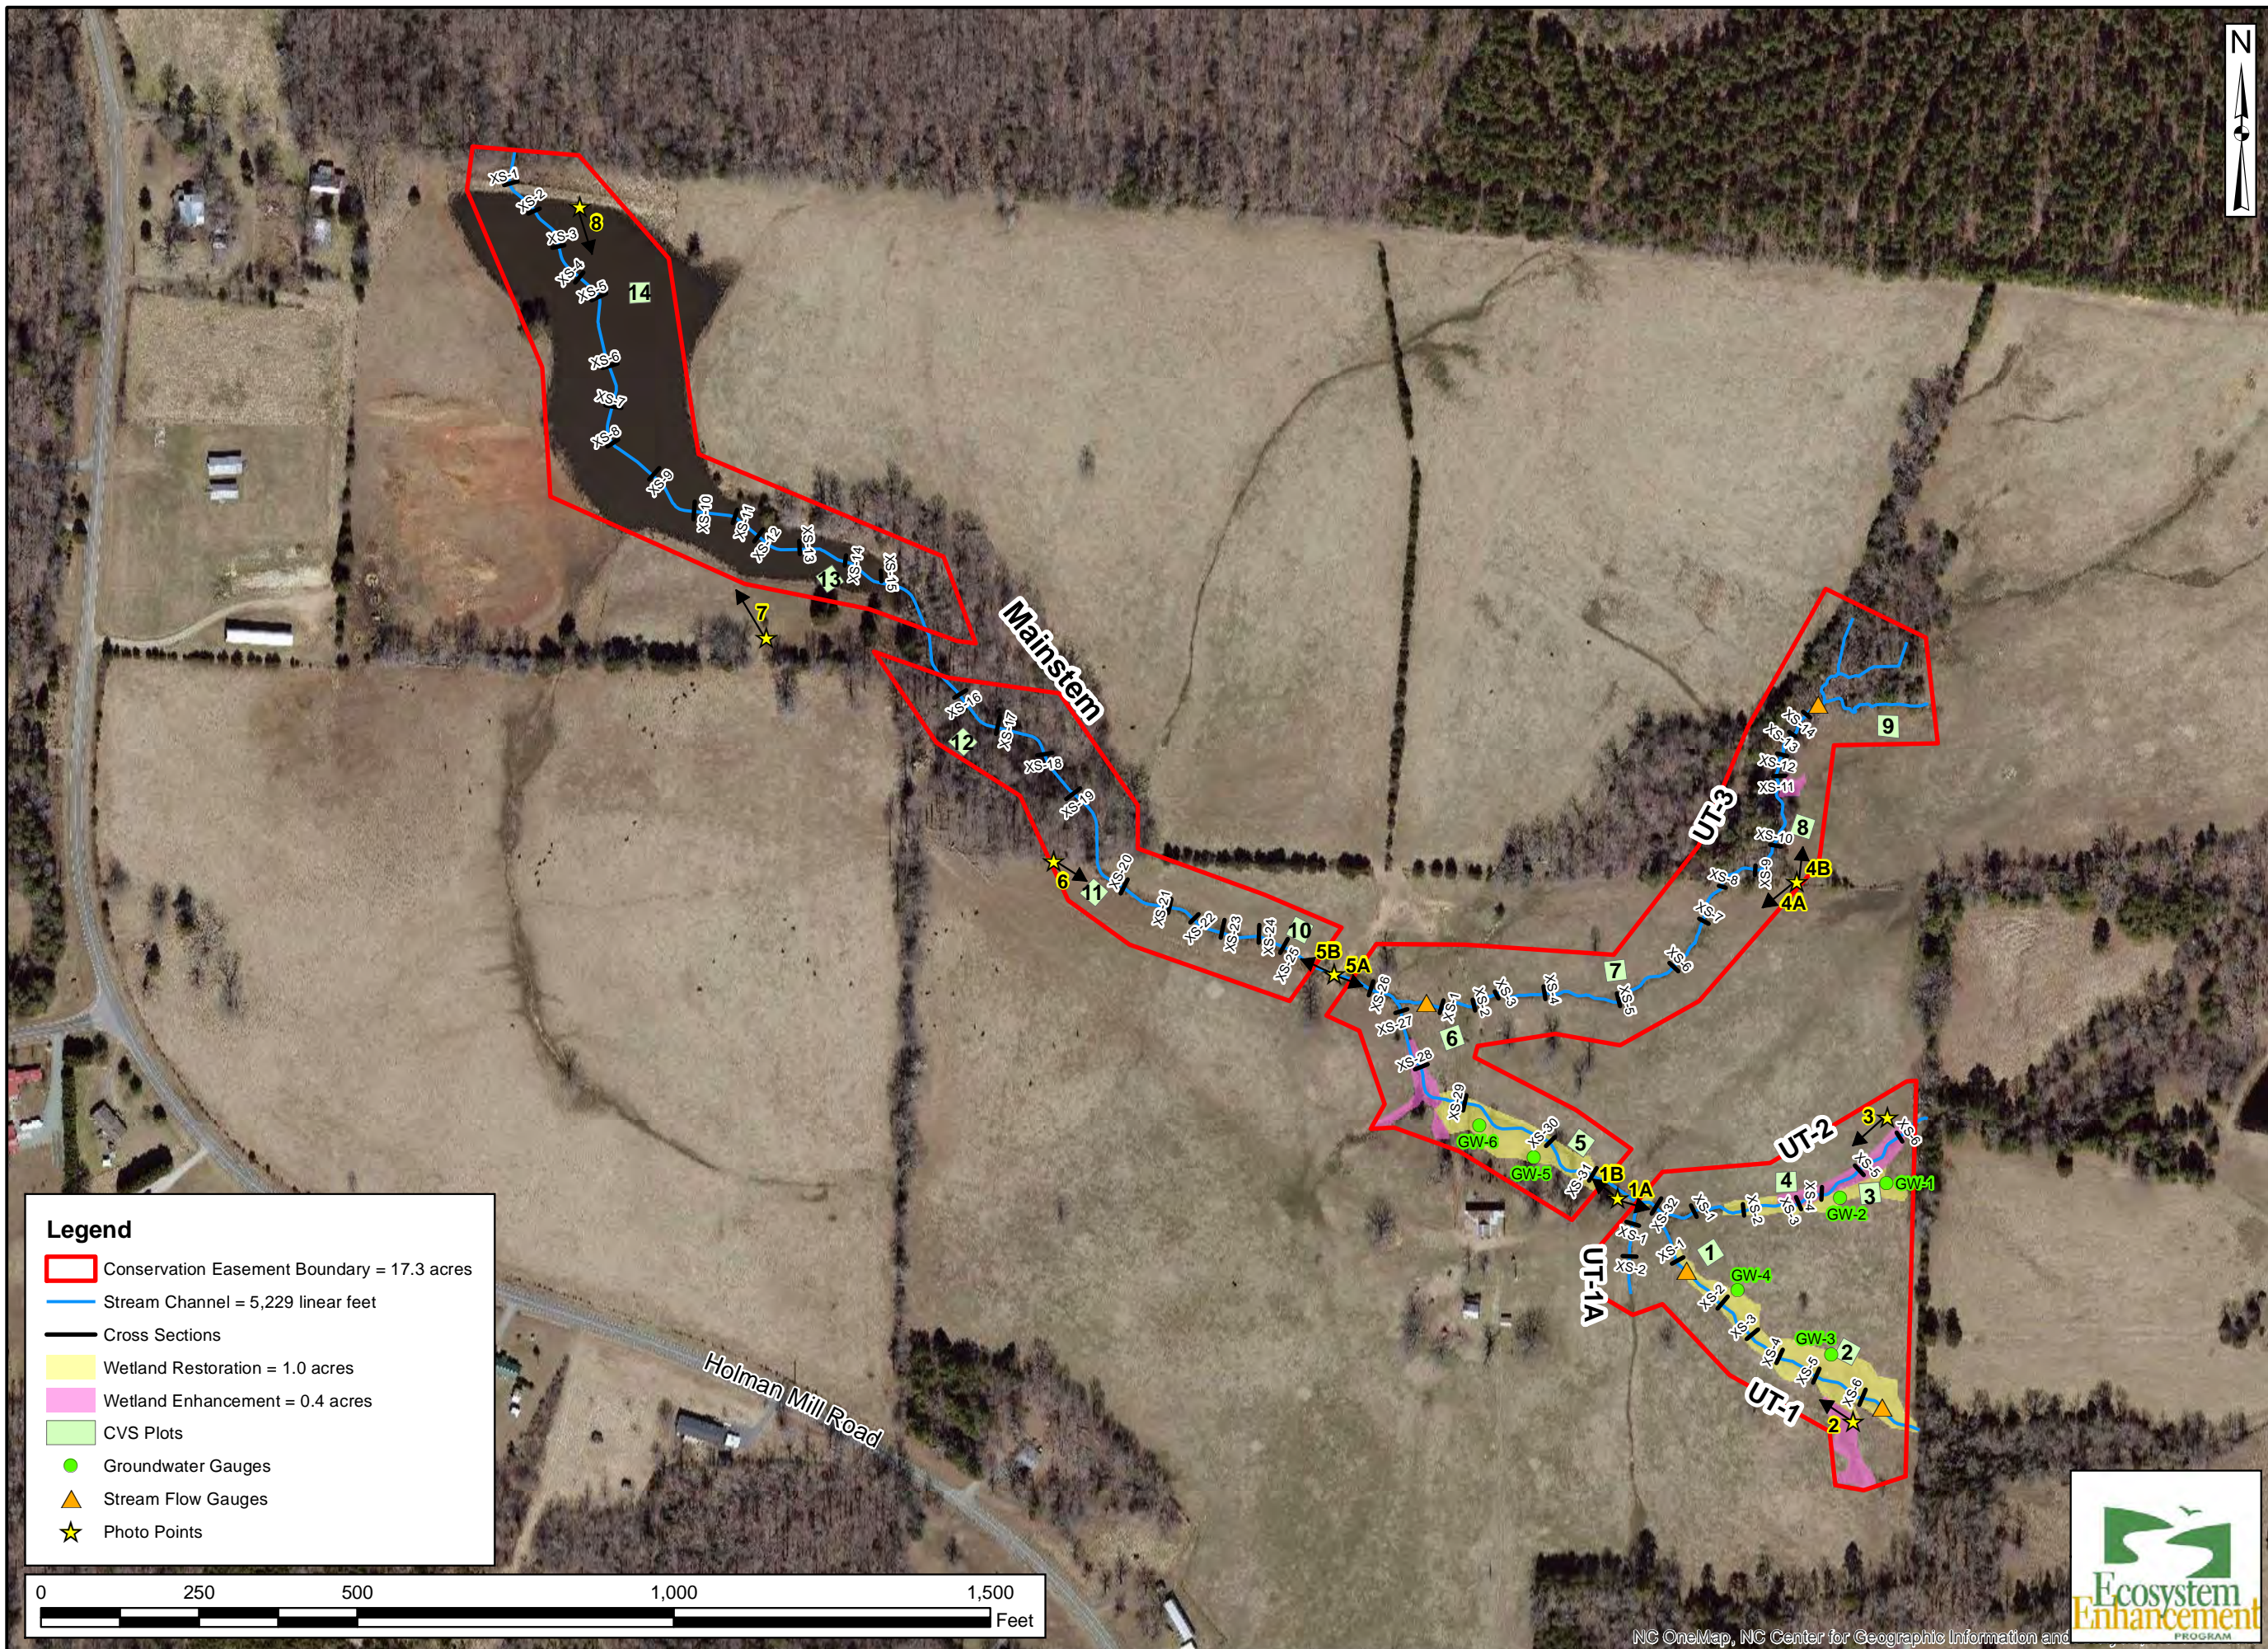
2

### Current Conditions Plan View

- Conservation Easement Boundary = 17.3 acres
- Stream Channel = 5,229 linear feet
- Cross Sections
- Wetland Restoration = 1.0 acres
- Wetland Enhancement = 0.4 acres
- CVS Plots
- Groundwater Gauges
- ▲ Stream Flow Gauges
- ★ Photo Points

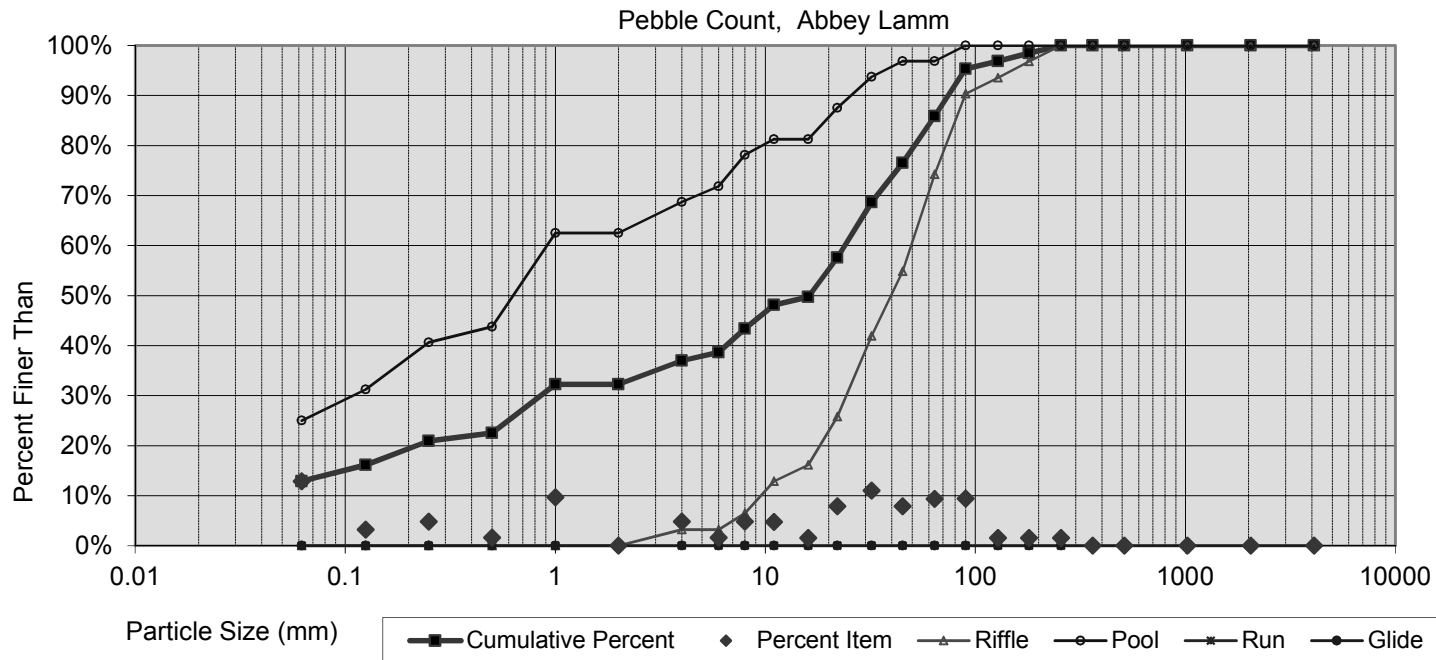
Note: **Mainstem - Reach-wide**

Size percent less than (mm)					Percent by substrate type					
D16	D35	D50	D84	D95	silt/clay	sand	gravel	cobble	boulder	bedrock
0.122	2.99	16.2	60	89	13%	19%	52%	14%	0%	3%

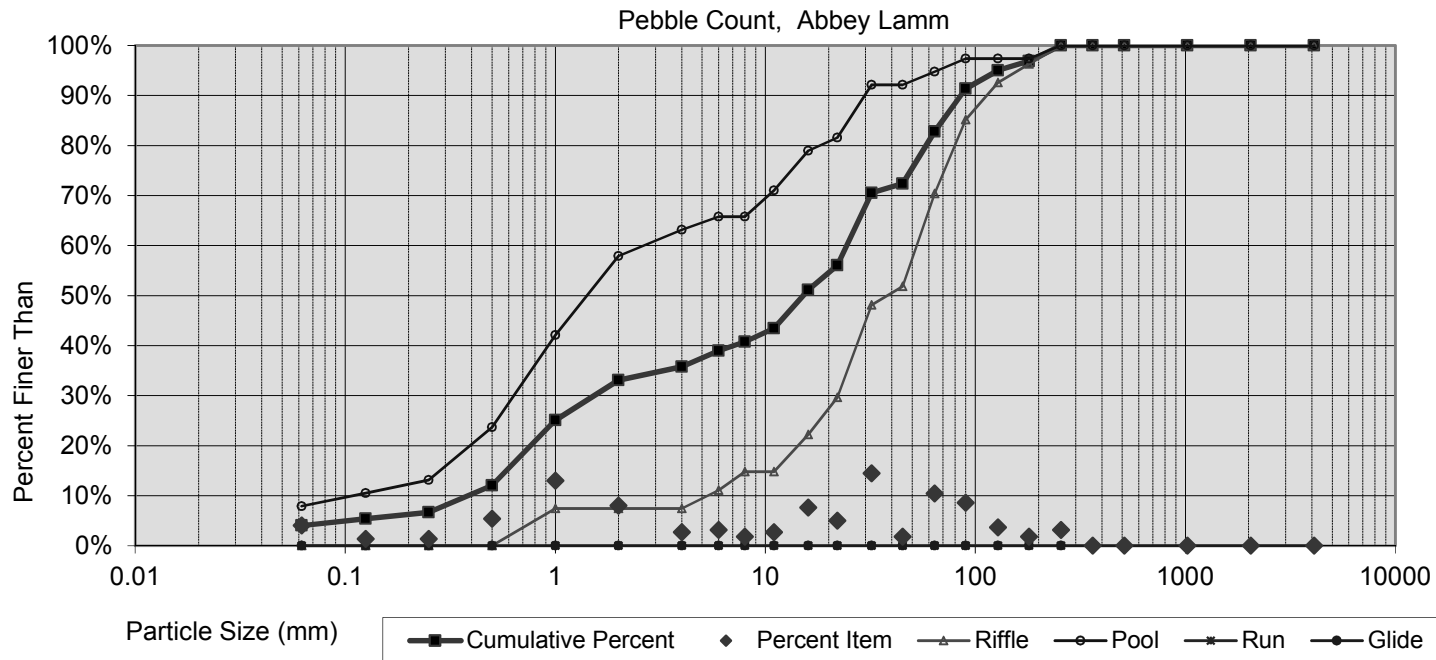
Note: **UT-1 - Reach-wide**

Size percent less than (mm)					Percent by substrate type					
D16	D35	D50	D84	D95	silt/clay	sand	gravel	cobble	boulder	bedrock
0.617	3.26	15.2	67	128	4%	29%	49%	17%	0%	2%

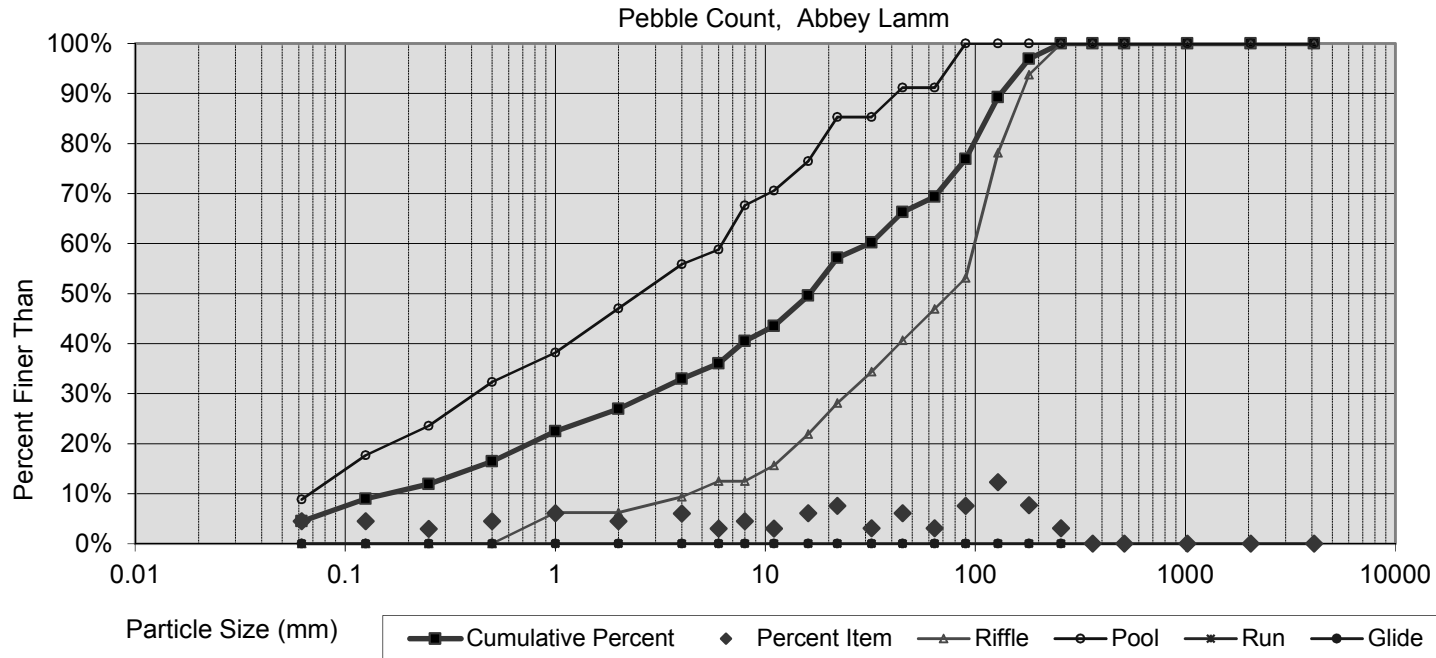
Note: **UT-2 - Reach-wide**

Size percent less than (mm)					Percent by substrate type					
D16	D35	D50	D84	D95	silt/clay	sand	gravel	cobble	boulder	bedrock
0.468	5.24	16.3	110	165	4%	22%	42%	30%	0%	2%

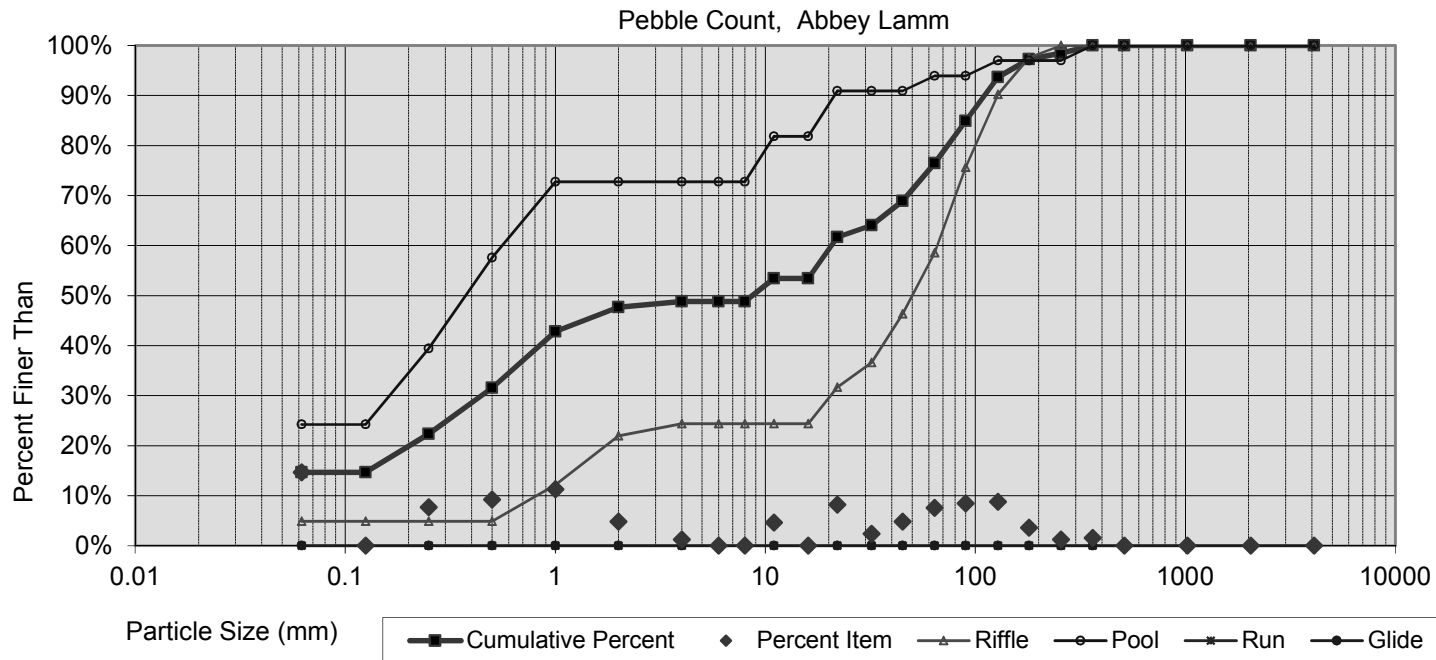
Note: **UT-3 - Reach-wide**

Size percent less than (mm)					Percent by substrate type					
D16	D35	D50	D84	D95	silt/clay	sand	gravel	cobble	boulder	bedrock
0.141	0.62	8.7	87	145	15%	33%	28%	22%	2%	1%

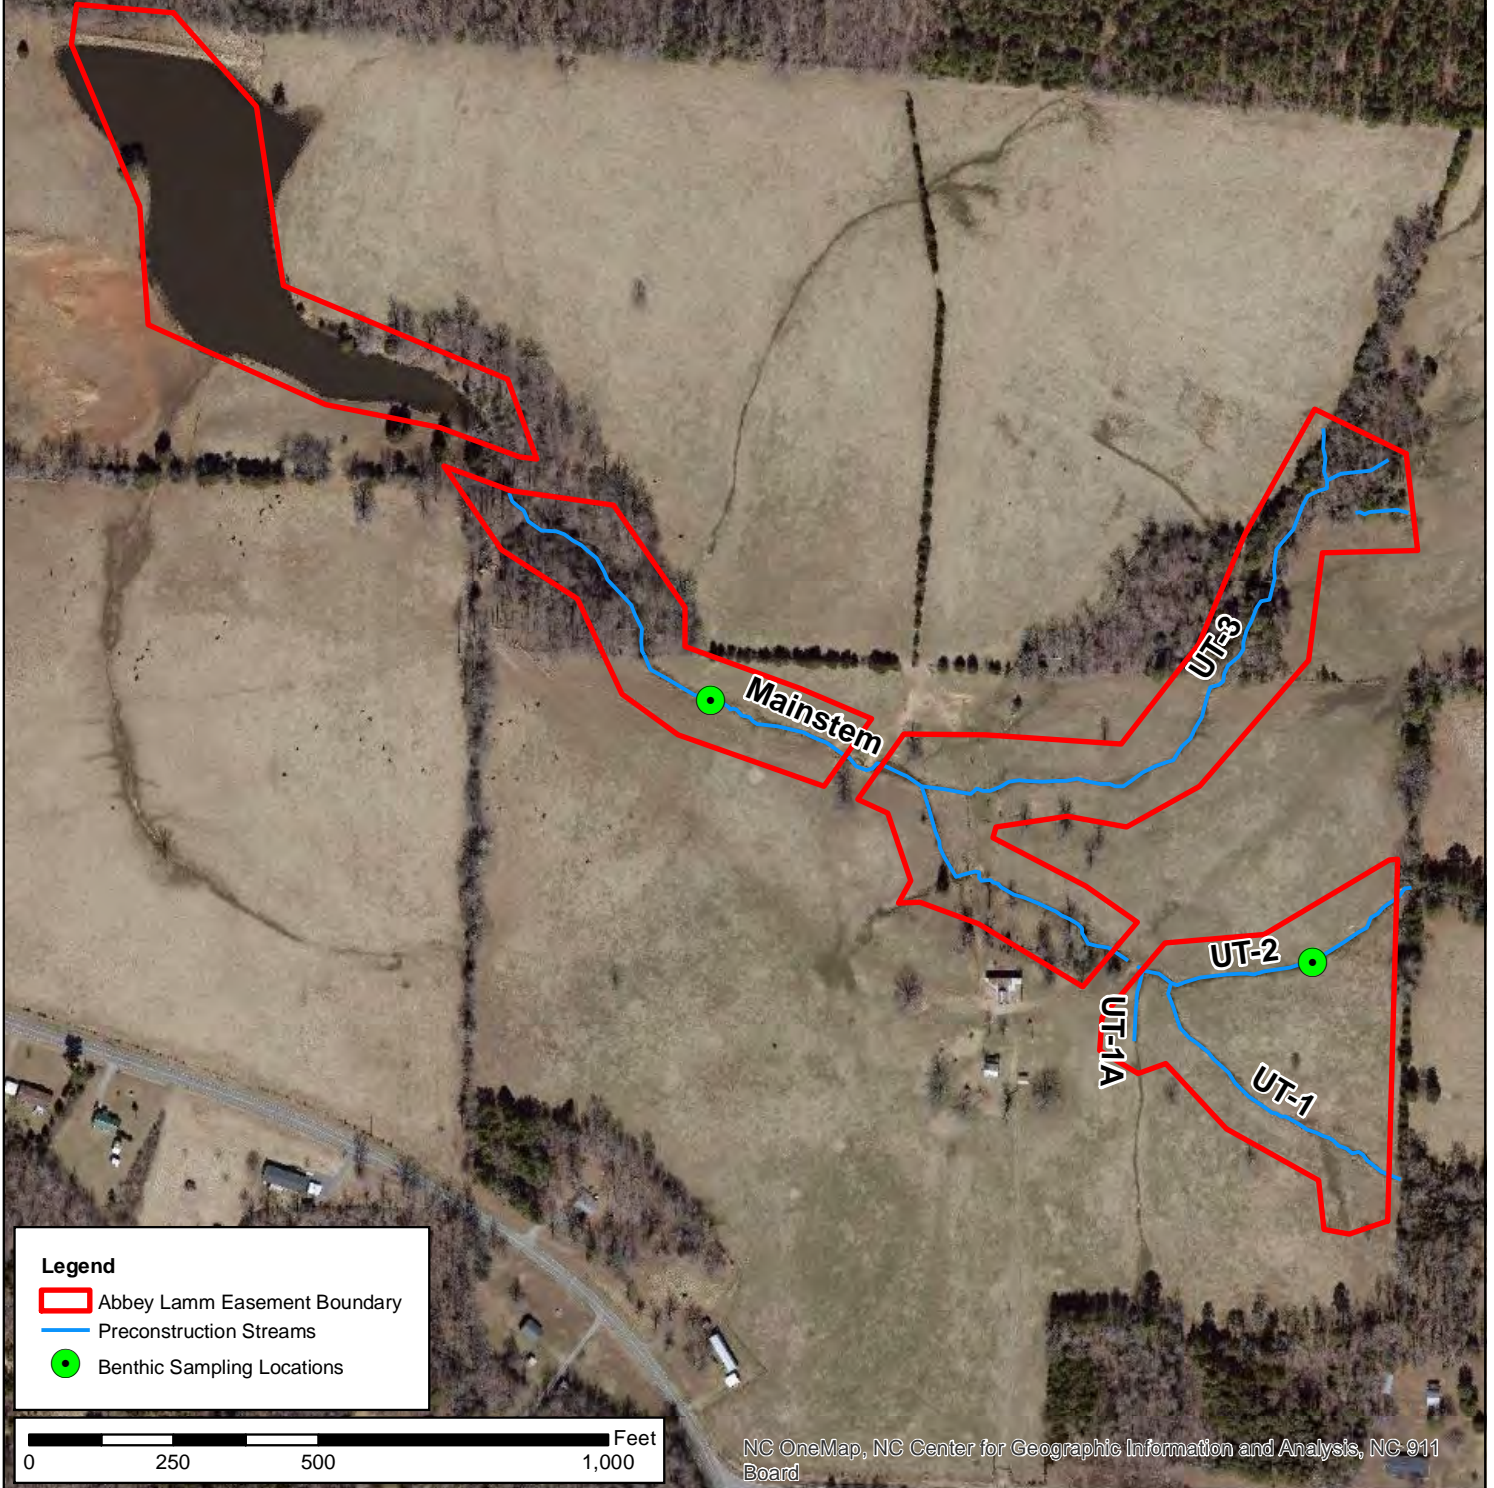
Figure E1. Preconstruction Benthic Station Locations  
Preconstruction Benthic Sample Results  
Habitat Assessment Field Datasheets

- ▭ Abbey Lamm Easement Boundary
- Preconstruction Streams
- Benthic Sampling Locations

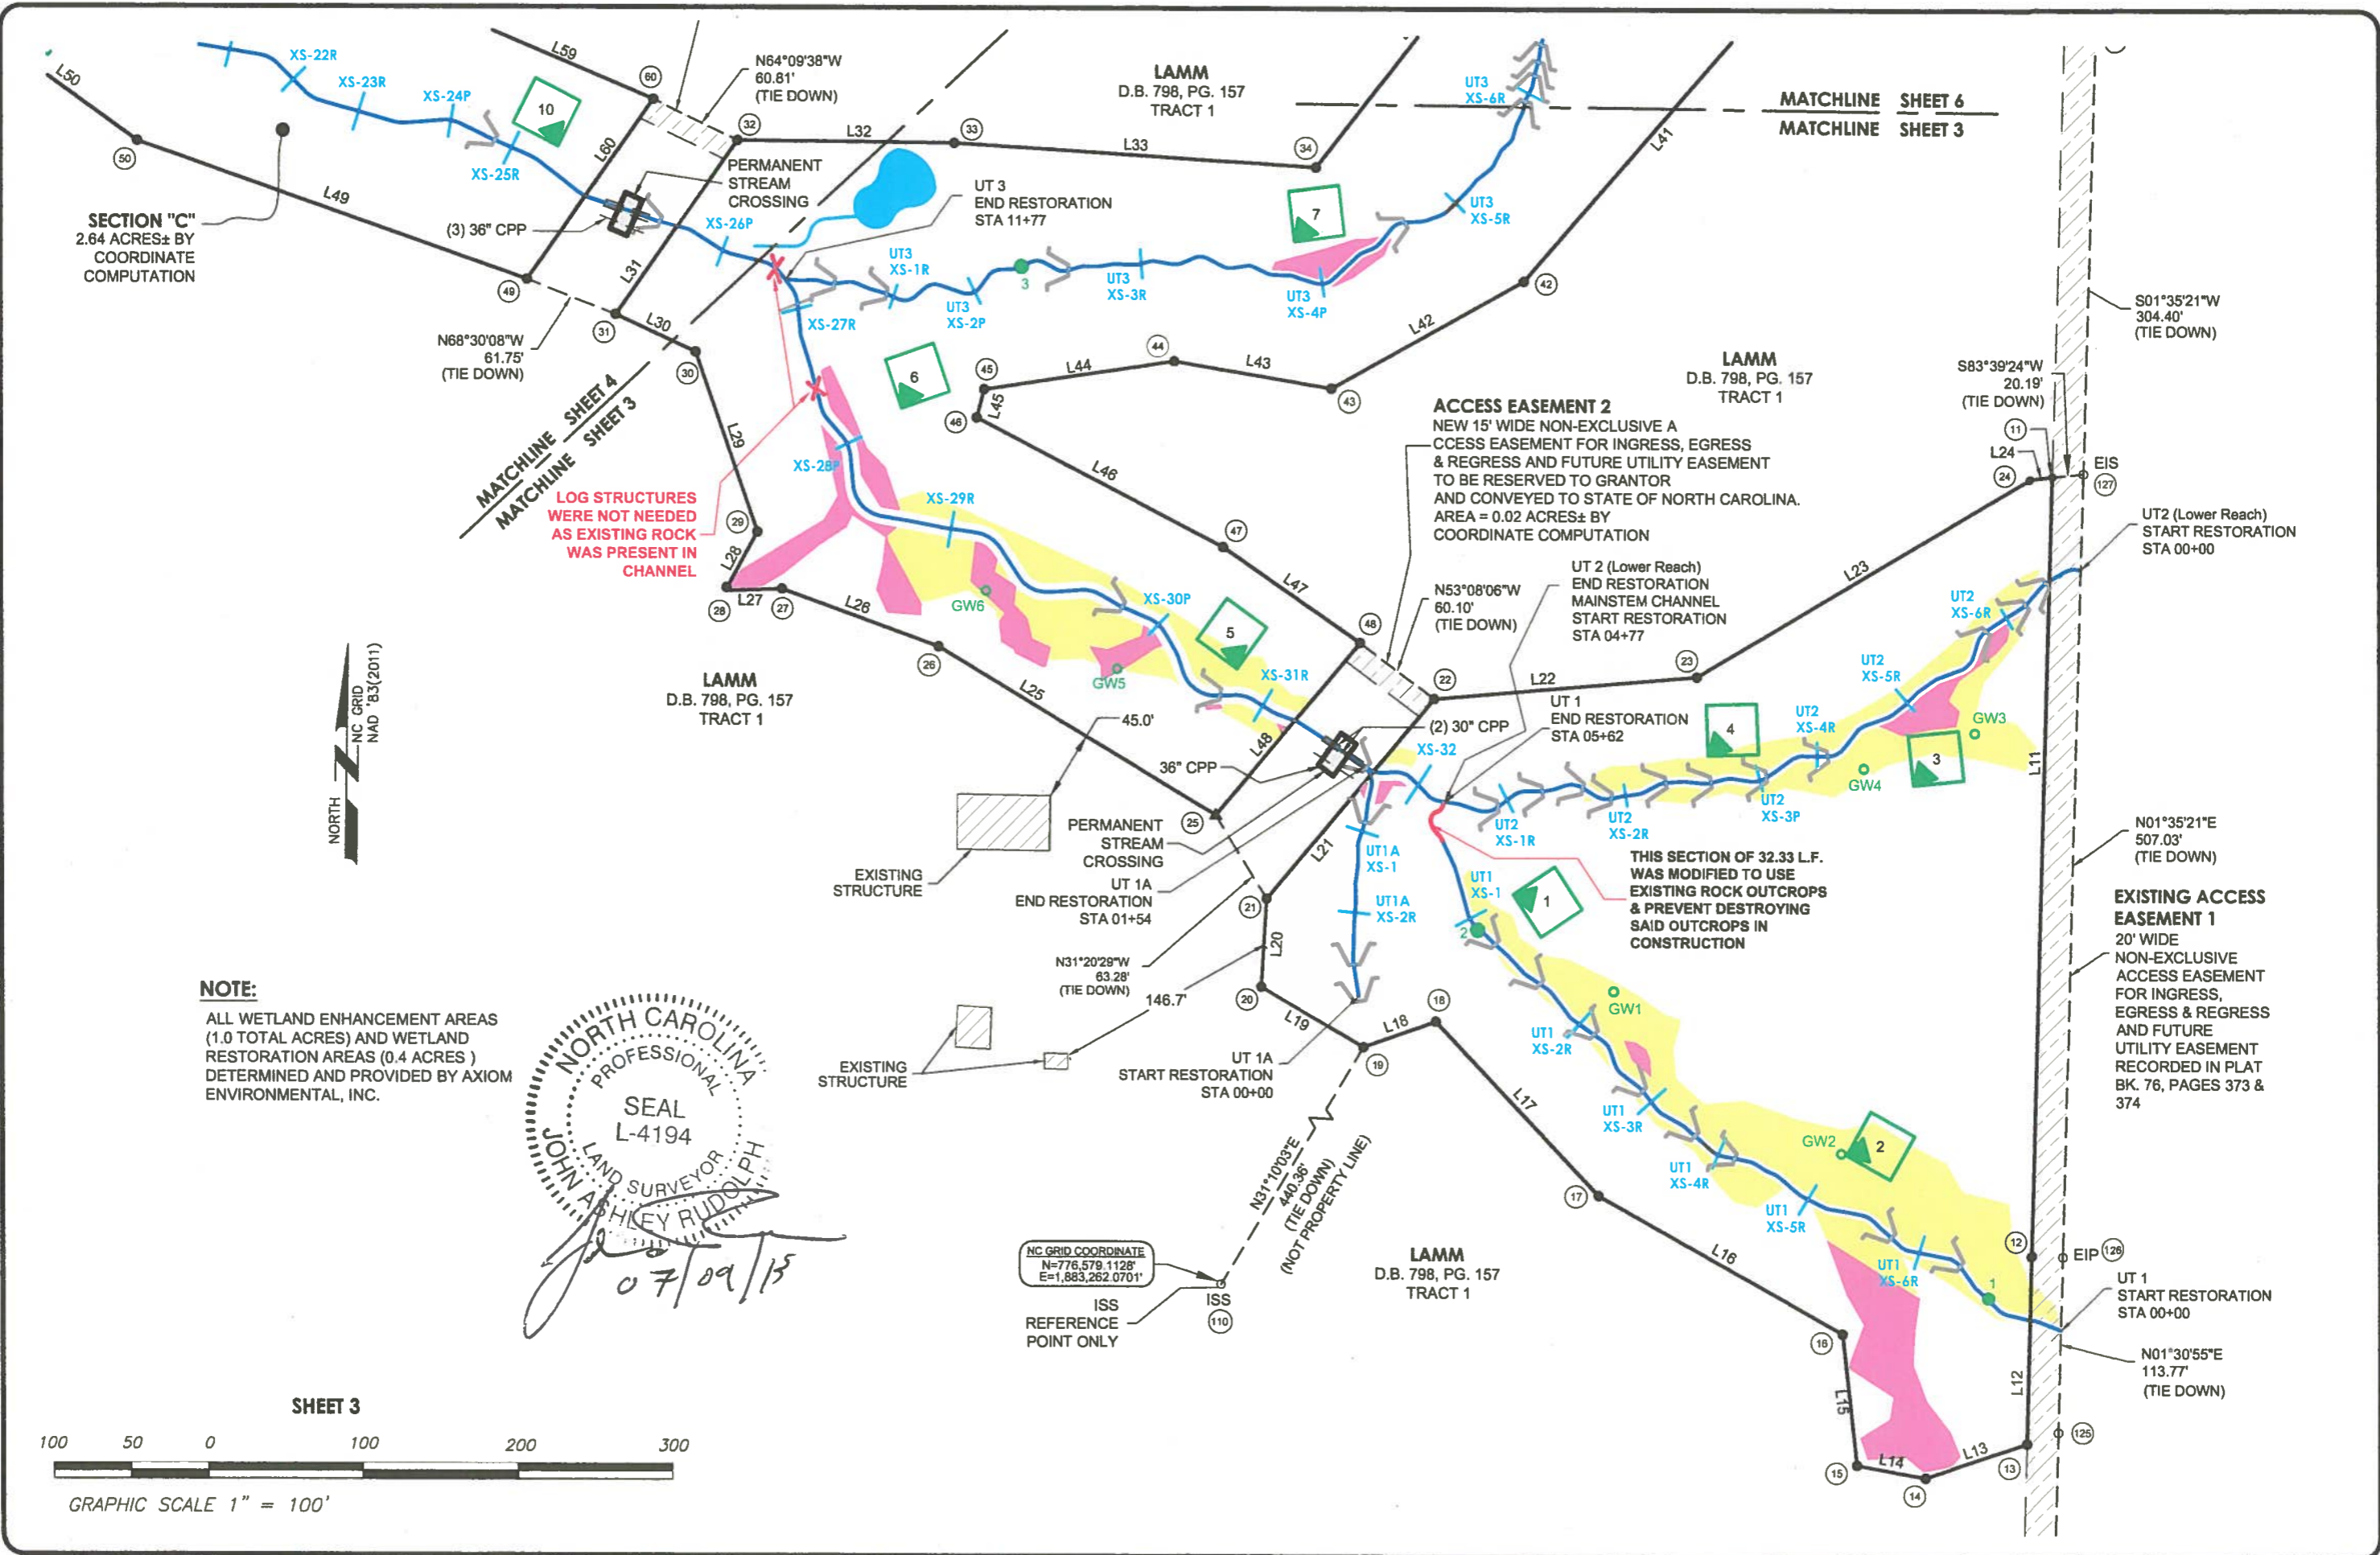
SHEET 2  
 AS-BUILT SURVEY  
 FOR  
**THE STATE OF NORTH CAROLINA,**  
**DIVISION OF MITIGATION SERVICES**  
 DMS PROJECT ID# 96311  
 SPO FILE # 01-U  
 NC DMS CONTRACT# 5790  
 RFP# 16-005568  
 ABBEY LAMM STREAM  
 AND WETLAND RESTORATION SITE  
 NEWLIN TOWNSHIP ALAMANCE COUNTY NORTH CAROLINA

SECTION "C"  
2.64 ACRES± BY  
COORDINATE  
COMPUTATION

MATCHLINE SHEET 4  
MATCHLINE SHEET 3  
LOG STRUCTURES  
WERE NOT NEEDED  
AS EXISTING ROCK  
WAS PRESENT IN  
CHANNEL

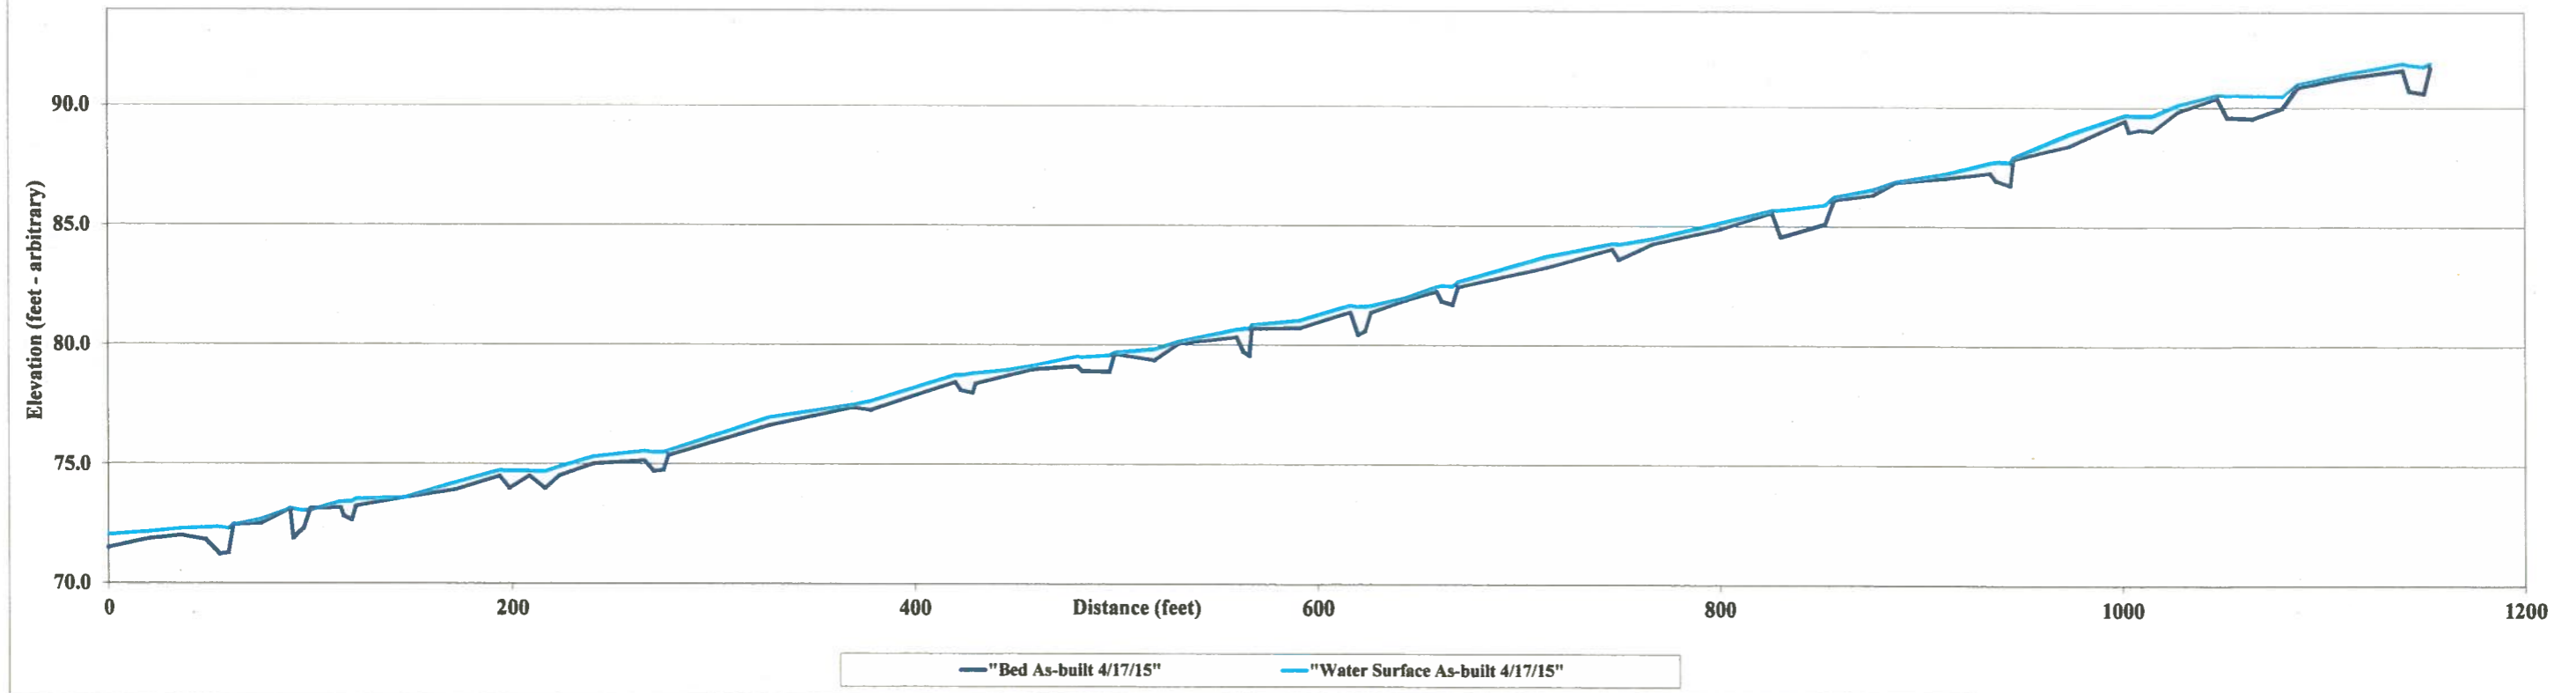
Lamm (Main Lower Reach) As-built Profile 2015

As-built	As needed		
Avg. Water Surface Slope	0.0172			
Rifle Length	59			
Avg. Rifle Slope	0.0193			
Pool Length	18

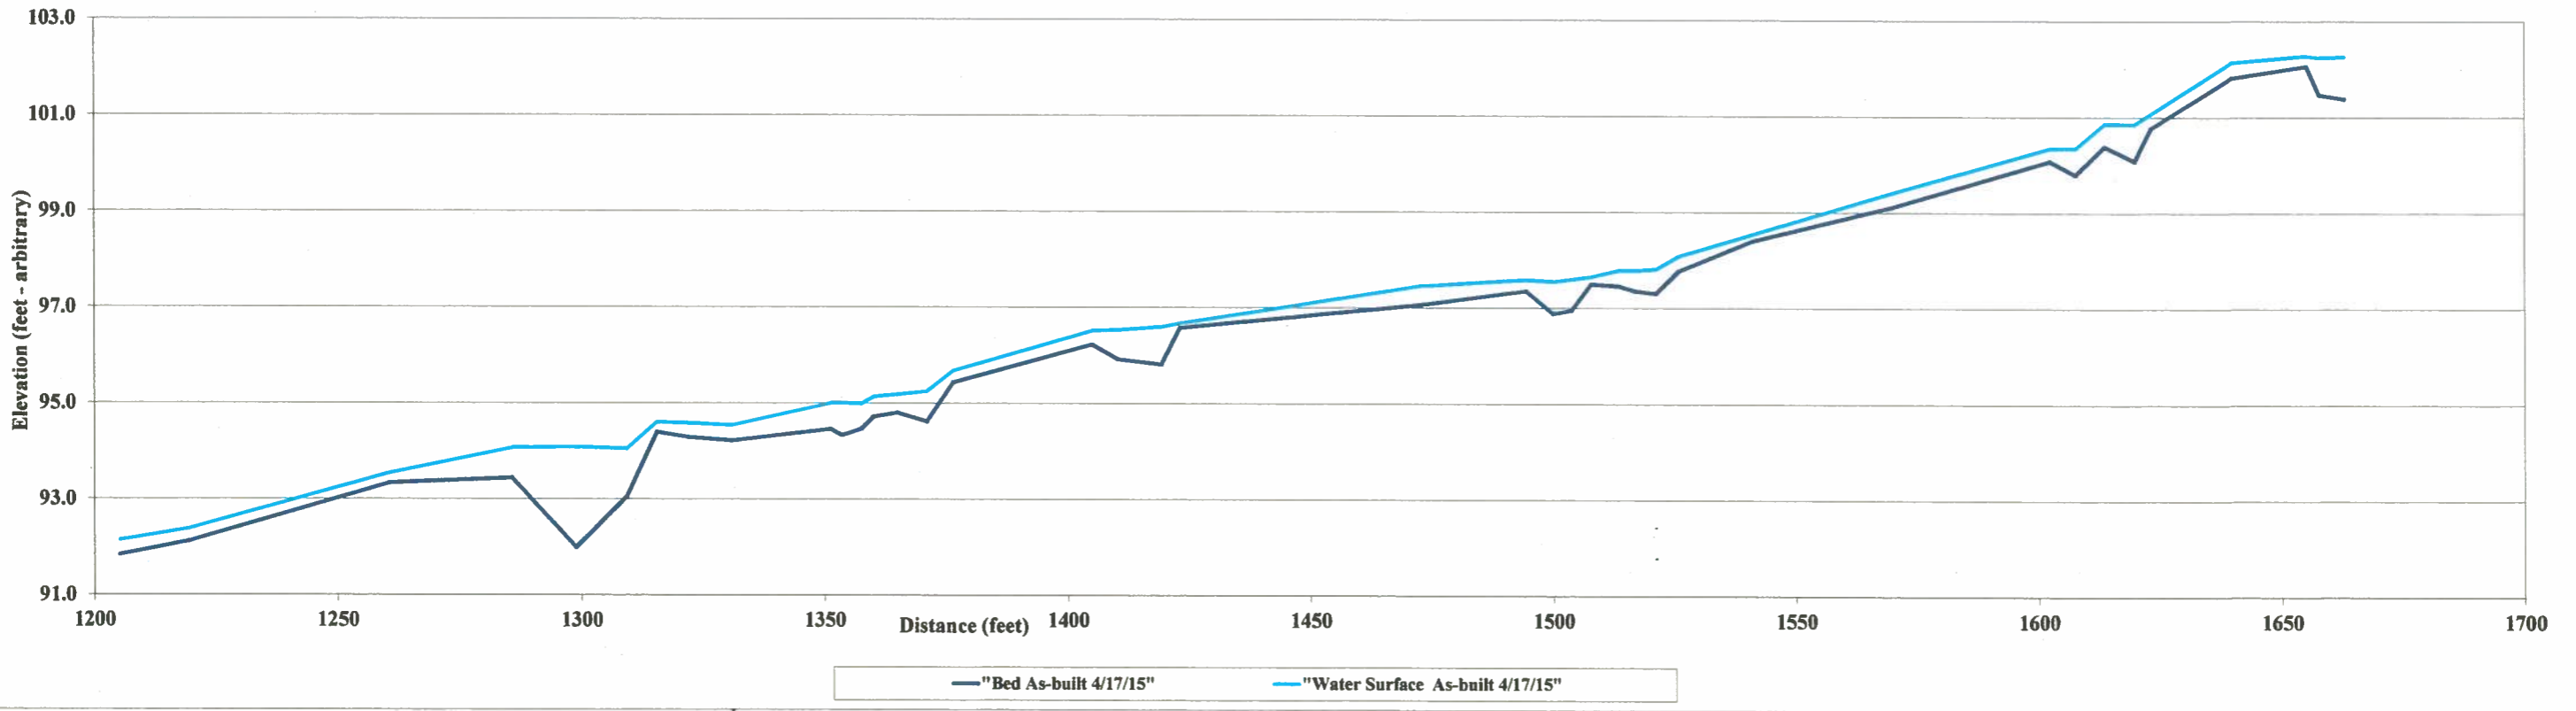
Lamm (Main Lower Reach Woods) As-built Profile 2015

Project Name		Lamm - As-built (2015) Profile									
Reach		Main Lower (Woods)									
Feature		Profile									
Date		4/17/15									
Crew		Perkinson, Gibbons									
2015 As-built Survey			2015 As-built Survey			As needed			As needed		
Station	Bed Elevation	Water Elevation	Station	Bed Elevation	Water Elevation	Station	Bed Elevation	Water Elevation	Station	Bed Elevation	Water Elevation
1205.2	91.8	92.1	1521.2	97.3	97.8						
1219.4	92.1	92.4	1525.9	97.8	98.1						
1260.5	93.3	93.5	1540.9	98.4	98.5						
1285.7	93.4	94.1	1569.7	99.1	99.4						
1298.8	92.0	94.1	1602.4	100.1	100.4						
1309.3	93.1	94.0	1607.6	99.8	100.4						
1315.5	94.4	94.6	1613.6	100.4	100.9						
1322.0	94.3	94.6	1619.7	100.1	100.8						
1330.9	94.2	94.5	1623.1	100.8	101.1						
1351.2	94.5	95.0	1639.6	101.8	102.1						
1353.5	94.3	95.0	1654.9	102.1	102.3						
1357.5	94.5	95.0	1657.7	101.5	102.2						
1360.1	94.7	95.1	1662.8	101.4	102.3

As-built	As needed		
Avg. Water Surface Slope	0.0172			
Riffle Length	42			
Avg. Riffle Slope	0.0241			
Pool Length	14

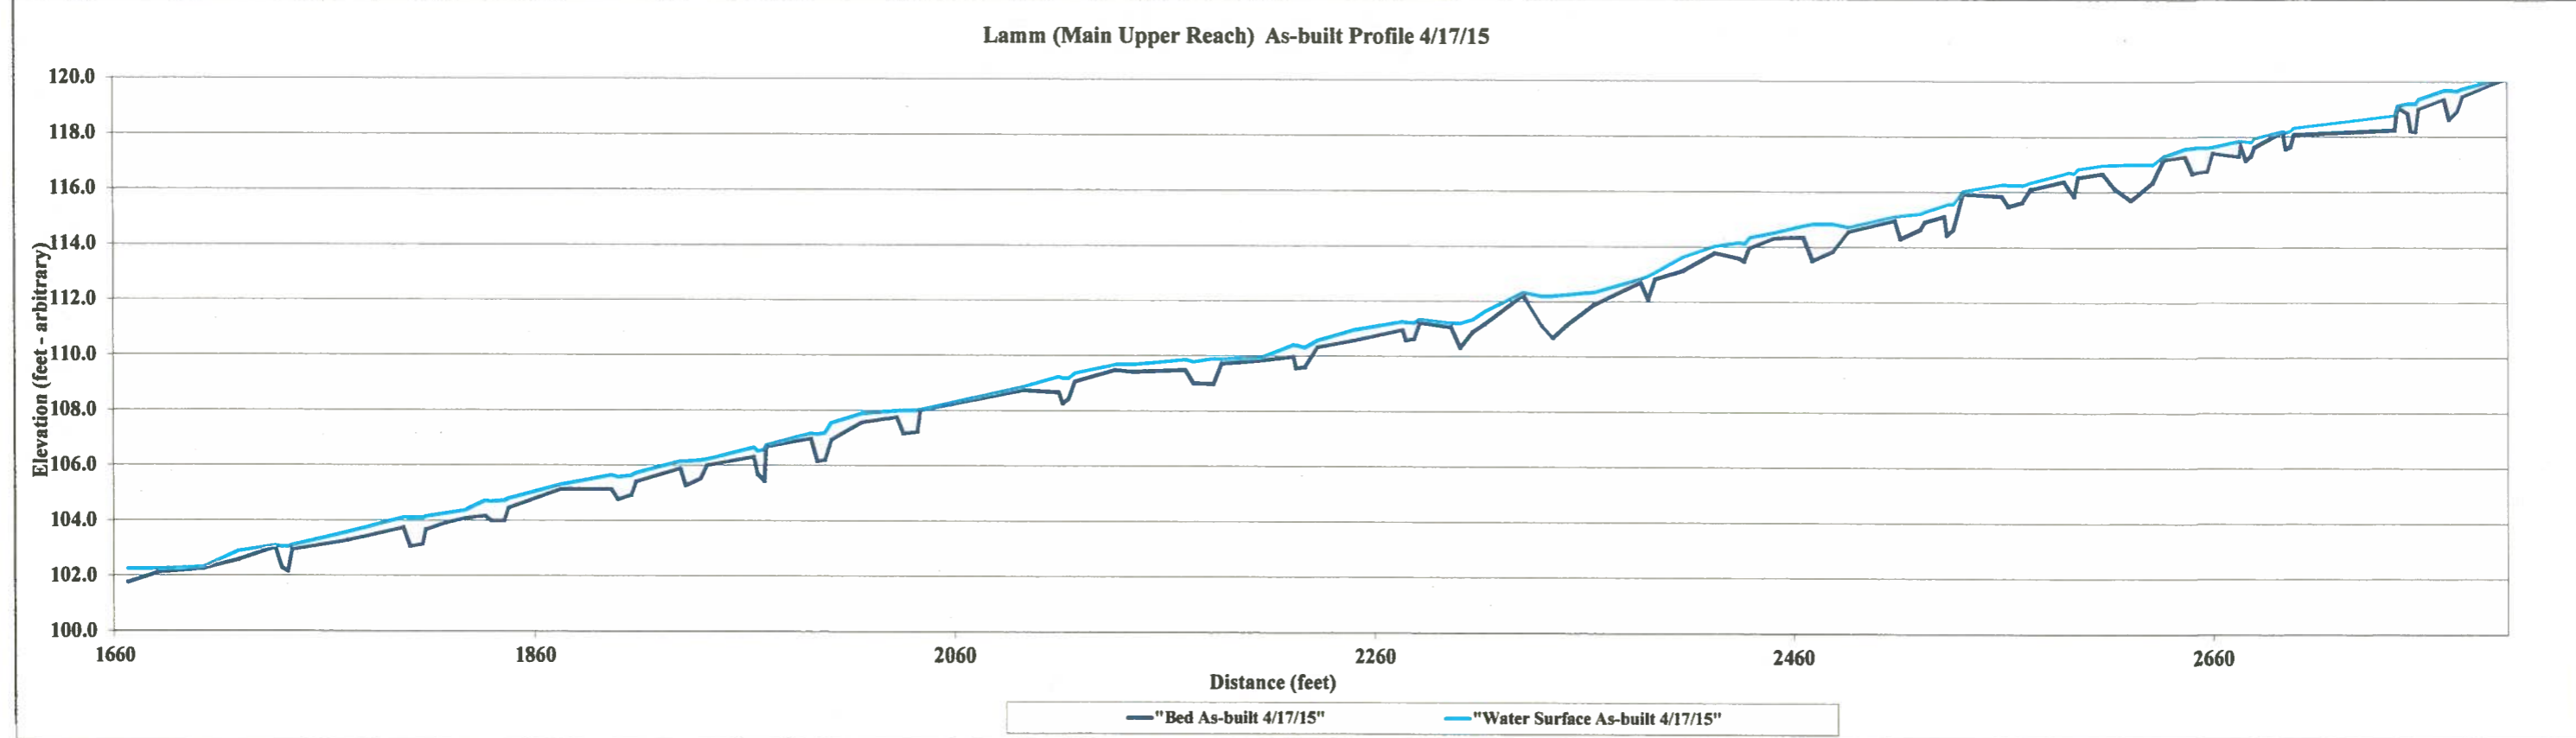
**Project Name** Lamm - As-built (2015) Profile  
**Reach** Main Upper Reach  
**Feature** Profile  
**Date** 4/17/15  
**Crew** Perkinson, Gibbons

As-built	As needed		
Avg. Water Surface Slope	0.0157			
Riffle Length	26			
Avg. Riffle Slope	0.0186			
Pool Length	12

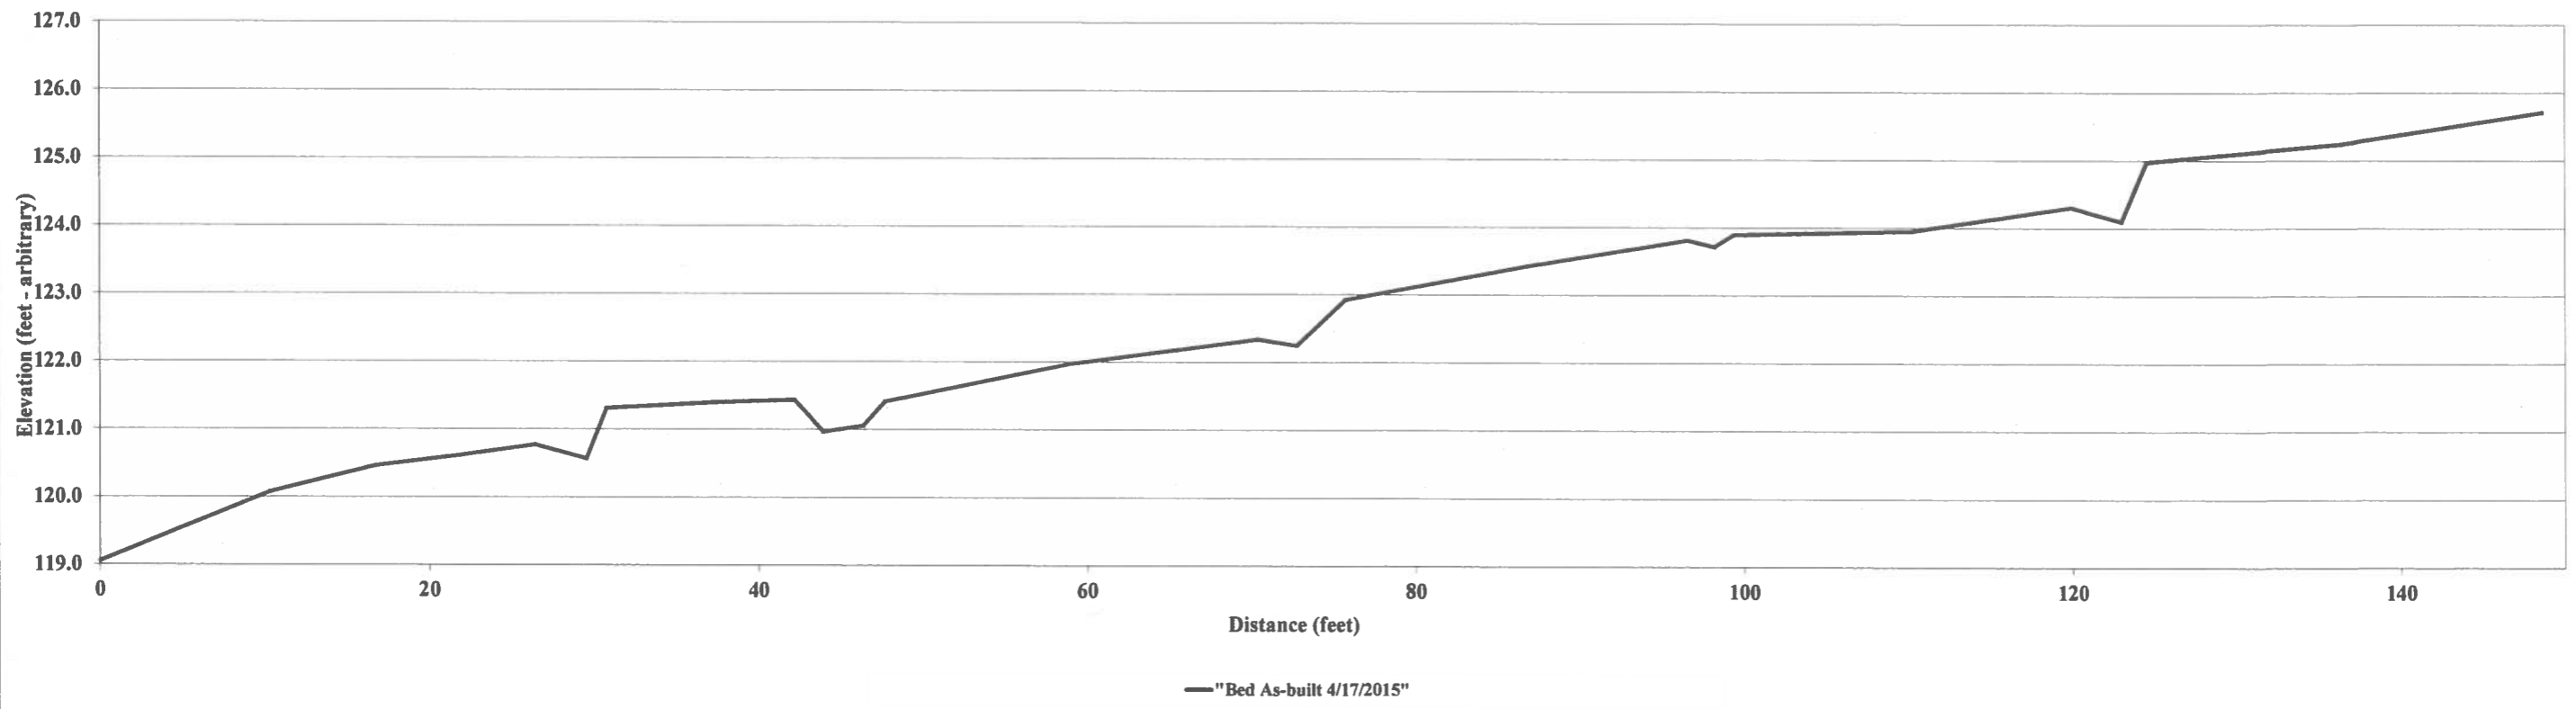
Lamm (UT 1a) As-built Profile 2015

Project Name Lamm - As-built (2015) Profile											
Reach Tributary 1a											
Feature Profile											
Date 4/17/15											
Crew Perkinson, Gibbons											
2015 As-built Survey			As needed			As needed			As needed		
Station	Bed Elevation	Water Elevation	Station	Bed Elevation	Water Elevation	Station	Bed Elevation	Water Elevation	Station	Bed Elevation	Water Elevation

As-built	As needed		
Avg. Water Surface Slope	NA			
Riffle Length	21			
Avg. Riffle Slope	NA			
Pool Length	5
