**FINAL**  
**BASELINE MONITORING DOCUMENT AND**  
**AS-BUILT BASELINE REPORT**

**ABBEY LAMM**  
**STREAM AND WETLAND MITIGATION SITE**

Alamance County, North Carolina  
Full Delivery Contract No. 5790

Data Collection: April and May 2015  
Submission: July 2015

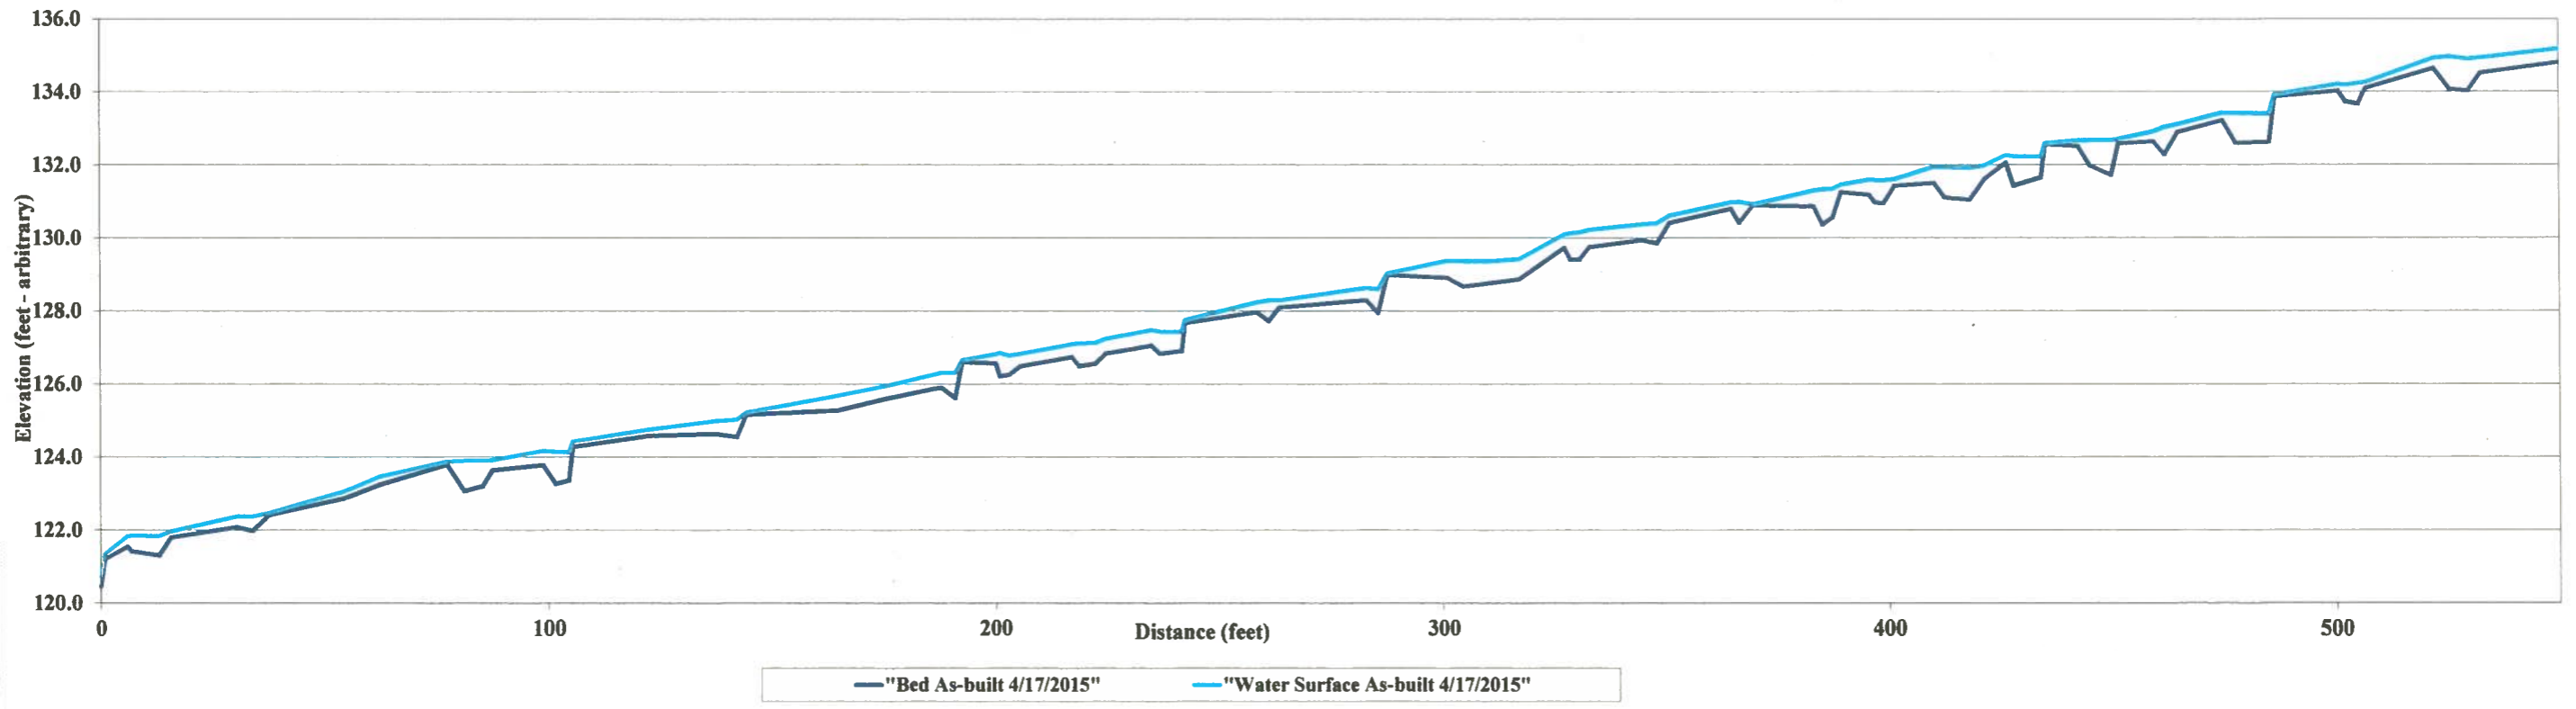
Lamm (UT 1) As-built Profile 2015

**Project Name** Lamm - As-built (2015) Profile  
**Reach** Tributary 1  
**Feature** Profile  
**Date** 4/17/15  
**Crew** Perkinson, Gibbons

As-built	As needed	
Avg. Water Surface Slope	0.0256		
Riffle Length	15		
Avg. Riffle Slope	0.0298		
Pool Length	7

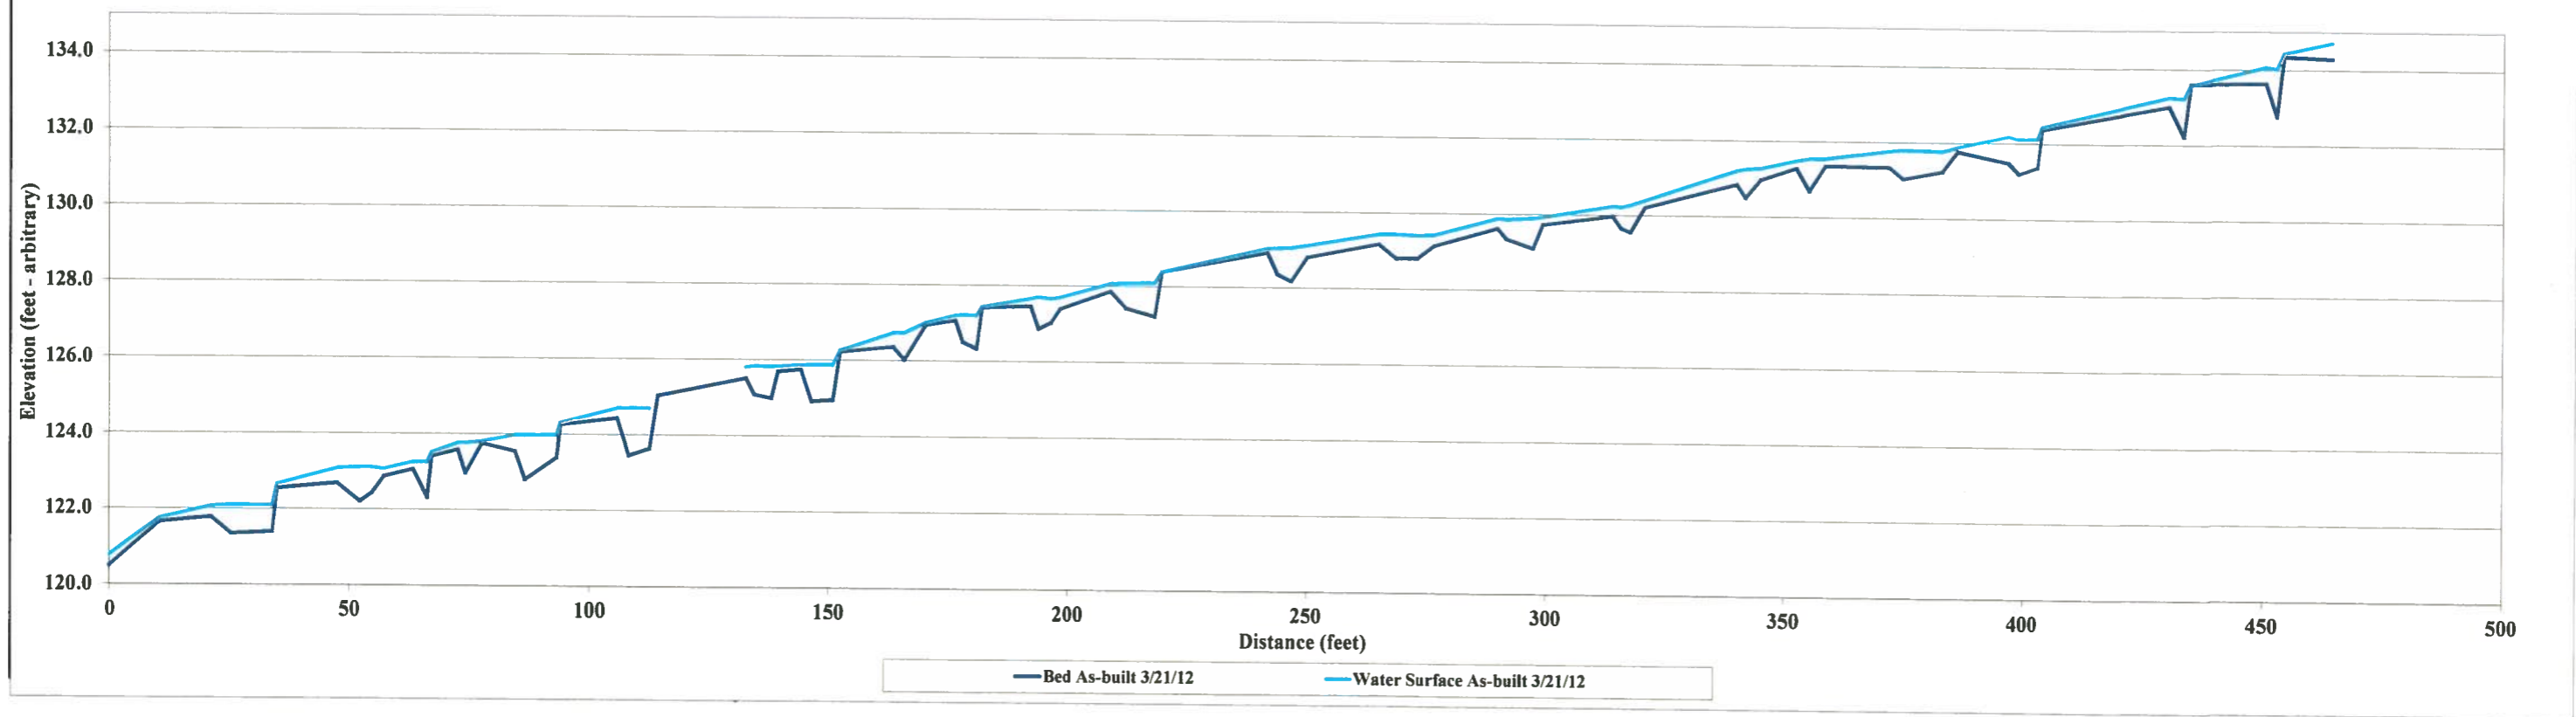
Lamm (UT2) As-built Profile 2015

Project Name Lamm - As-built (2015) Profile											
Reach Tributary 2											
Feature Profile											
Date 4/17/15											
Crew Perkinson, Gibbons											
2015 As-built Survey			2015 As-built Survey			2015 As-built Survey			2015 As-built Survey		
Station	Bed Elevation	Water Elevation	Station	Bed Elevation	Water Elevation	Station	Bed Elevation	Water Elevation	Station	Bed Elevation	Water Elevation

As-built	As needed		
Avg. Water Surface Slope	0.0301			
Riffle Length	12			
Avg. Riffle Slope	0.0294			
Pool Length	7.79

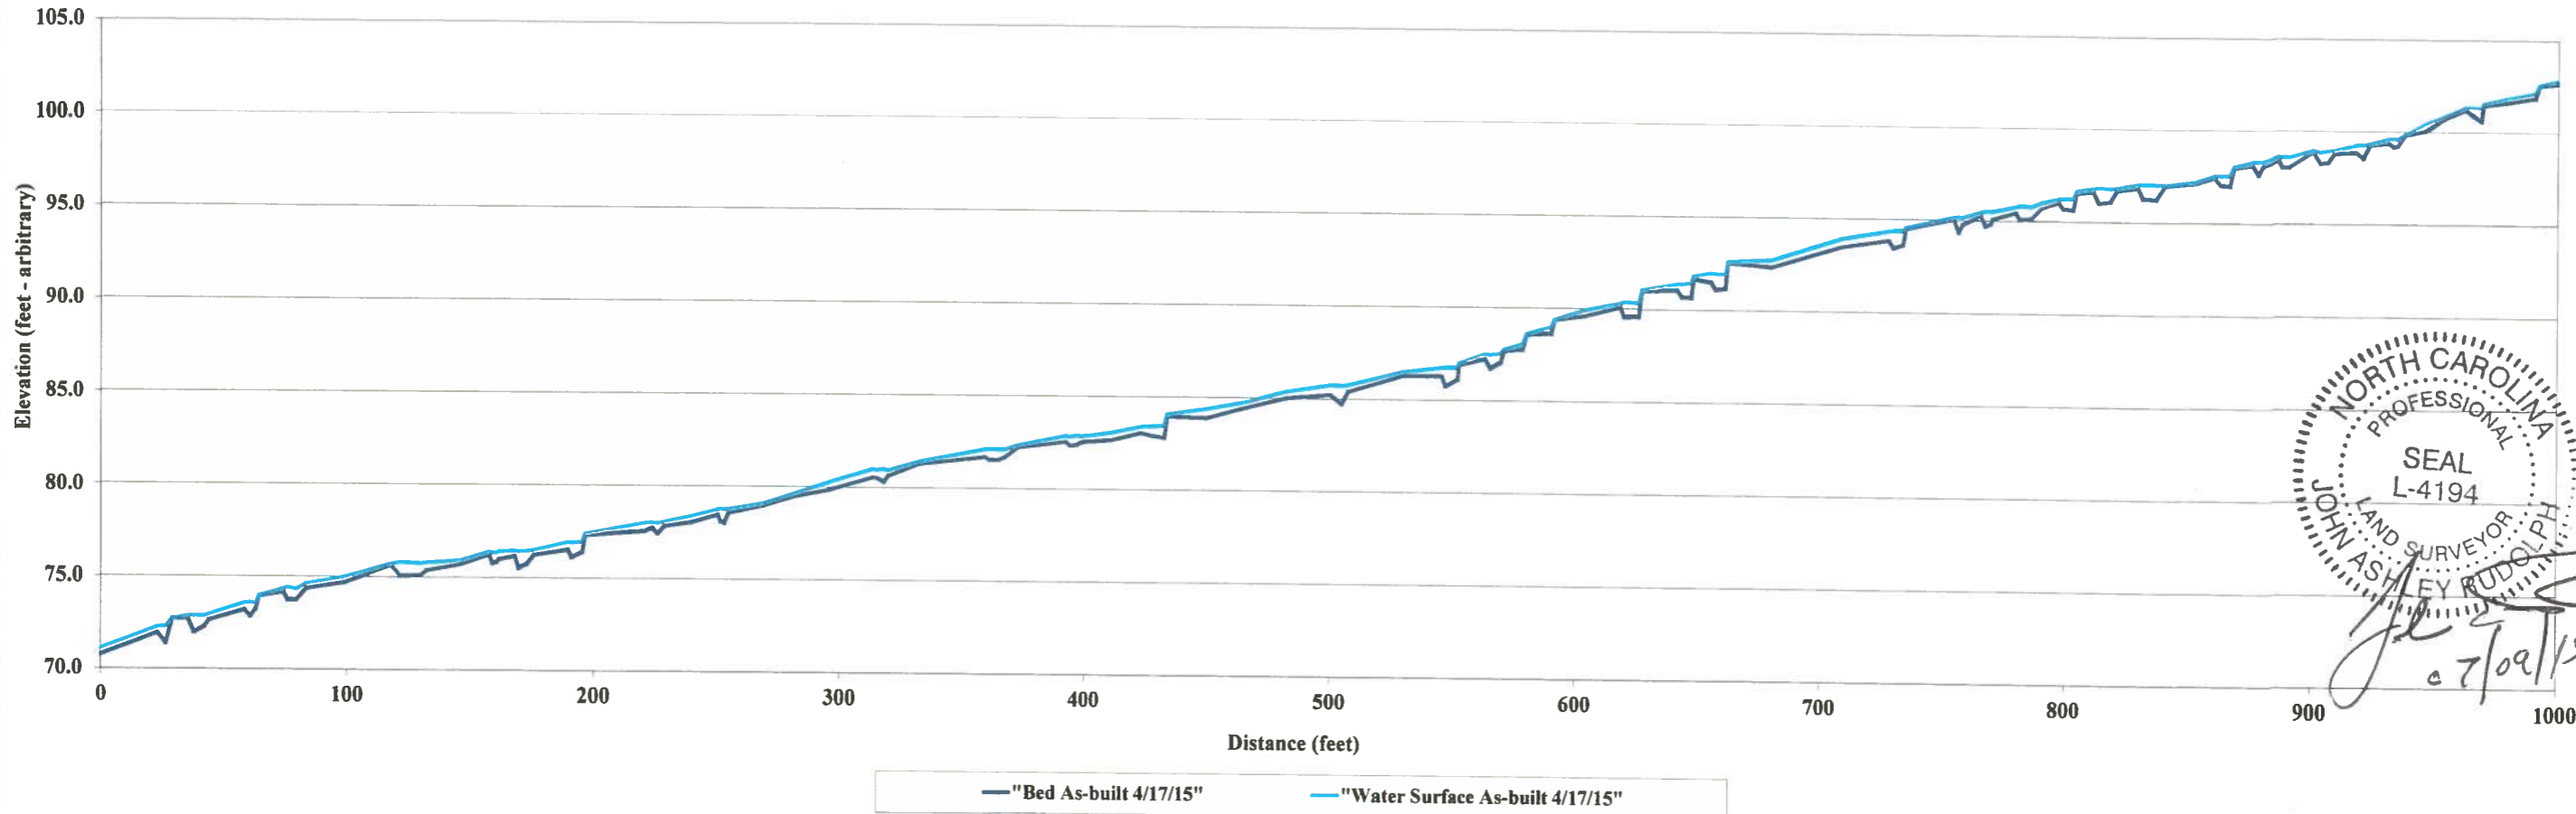
Lamm (UT3) As-built Profile 2015

**Project Name** Lamm - As-built (2015) Profile  
**Reach** UT 3  
**Feature** Profile  
**Date** 4/17/15  
**Crew** Perkinson, Gibbons

Avg. Water Surface Slope	0.0319	As-built	1010.5	102.8	103.1
Riffle Length	20.7		1011.7	102.5	103.2
Avg. Riffle Slope	0.0313		1014.3	102.3	103.2
Pool Length	7.4		1015.3	103.4	103.5

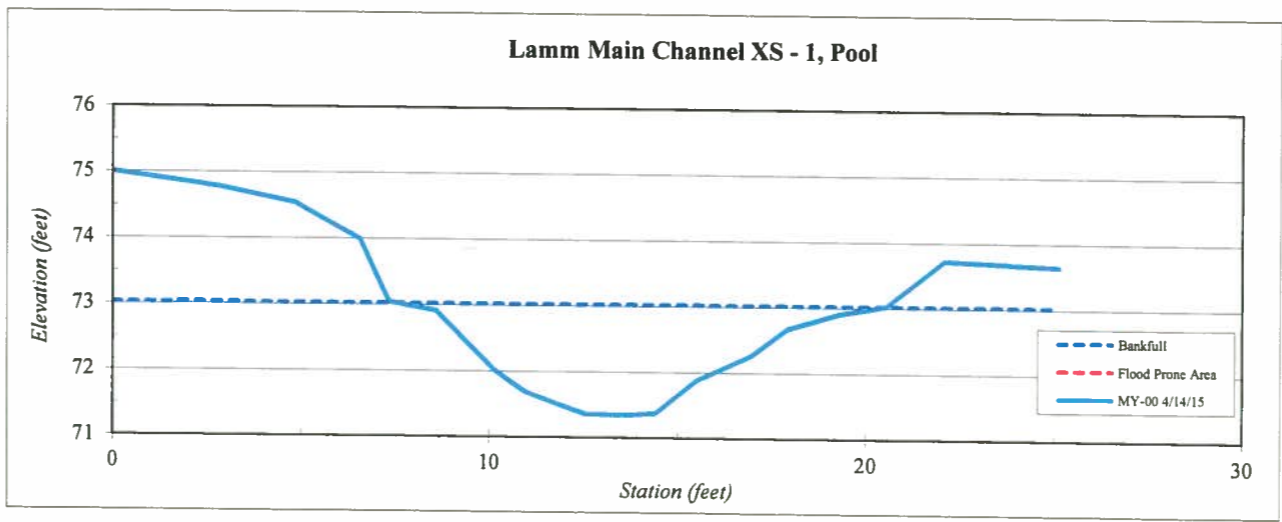
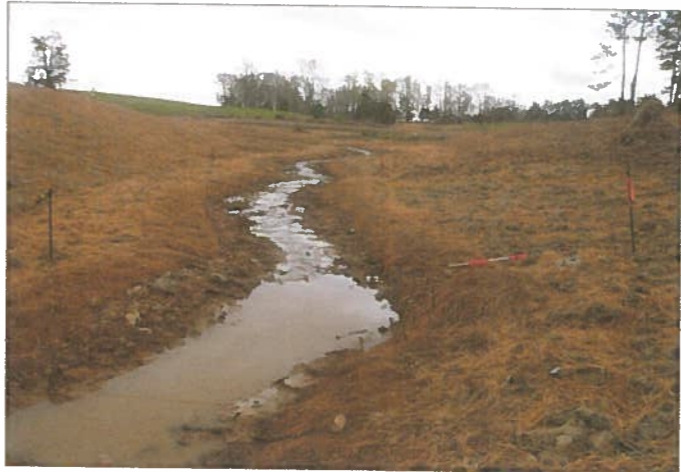
Site	Abbey Lamm
Watershed:	Cape Fear, 0303002
XS ID	Main Channel XS - 1, Pool
Feature	Pool
Date:	4/14/2015
Field Crew:	Perkinson, Gibbons

SUMMARY DATA	
Bankfull Elevation:	73.0
Bankfull Cross-Sectional Area:	11.2
Bankfull Width:	13.0
Flood Prone Area Elevation:	NA
Flood Prone Width:	NA
Max Depth at Bankfull:	1.7
Mean Depth at Bankfull:	0.9
W / D Ratio:	NA
Entrenchment Ratio:	NA
Bank Height Ratio:	1.0

Stream Type C/E

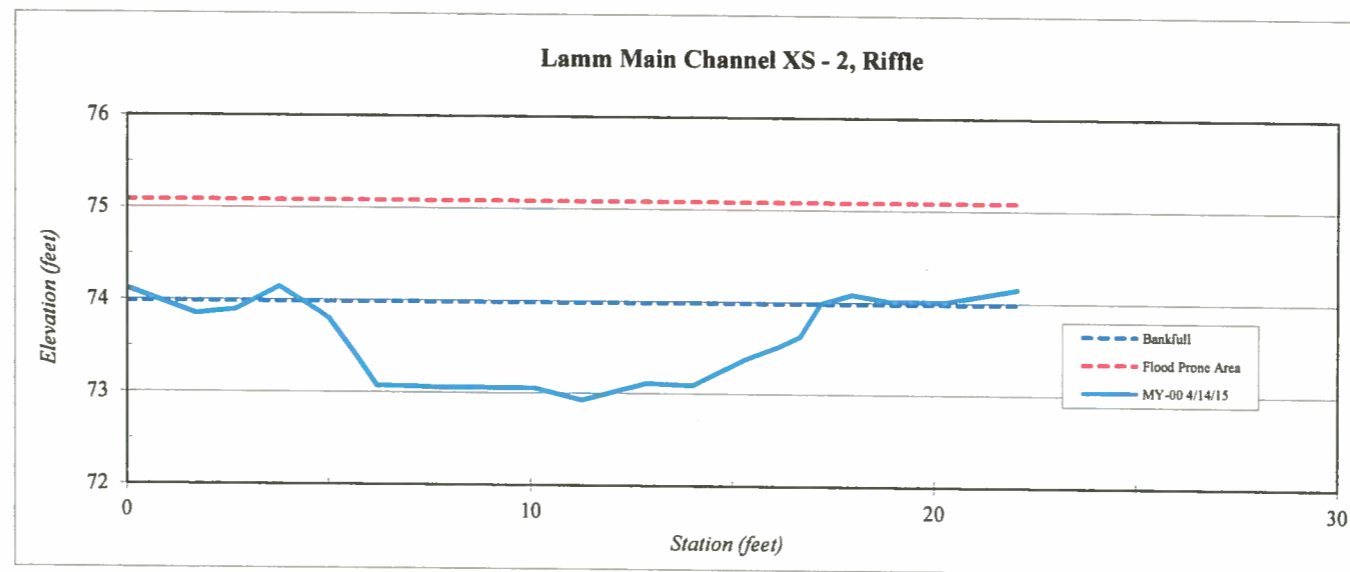
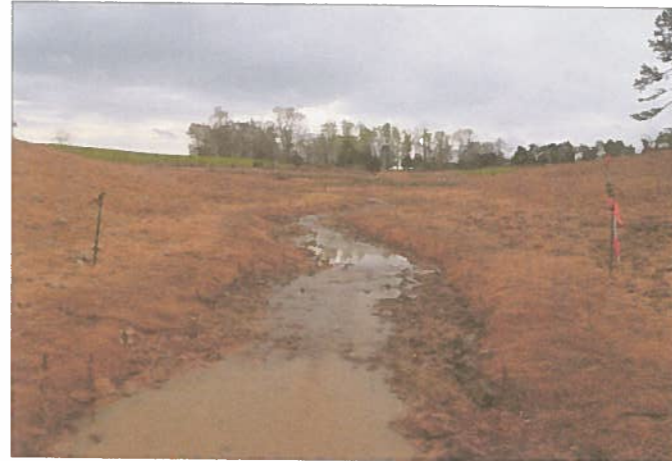
<b>Site</b>	Abbey Lamm
<b>Watershed:</b>	Cape Fear, 0303002
<b>XS ID</b>	Main Channel XS - 2, Riffle
<b>Feature</b>	Riffle
<b>Date:</b>	4/14/2015
<b>Field Crew:</b>	Perkinson, Gibbons

SUMMARY DATA	
Bankfull Elevation:	74.0
Bankfull Cross-Sectional Area:	9.7
Bankfull Width:	12.8
Flood Prone Area Elevation:	75.1
Flood Prone Width:	90.0
Max Depth at Bankfull:	1.1
Mean Depth at Bankfull:	0.8
W / D Ratio:	16.9
Entrenchment Ratio:	7.0
Bank Height Ratio:	1.0

Stream Type C/E

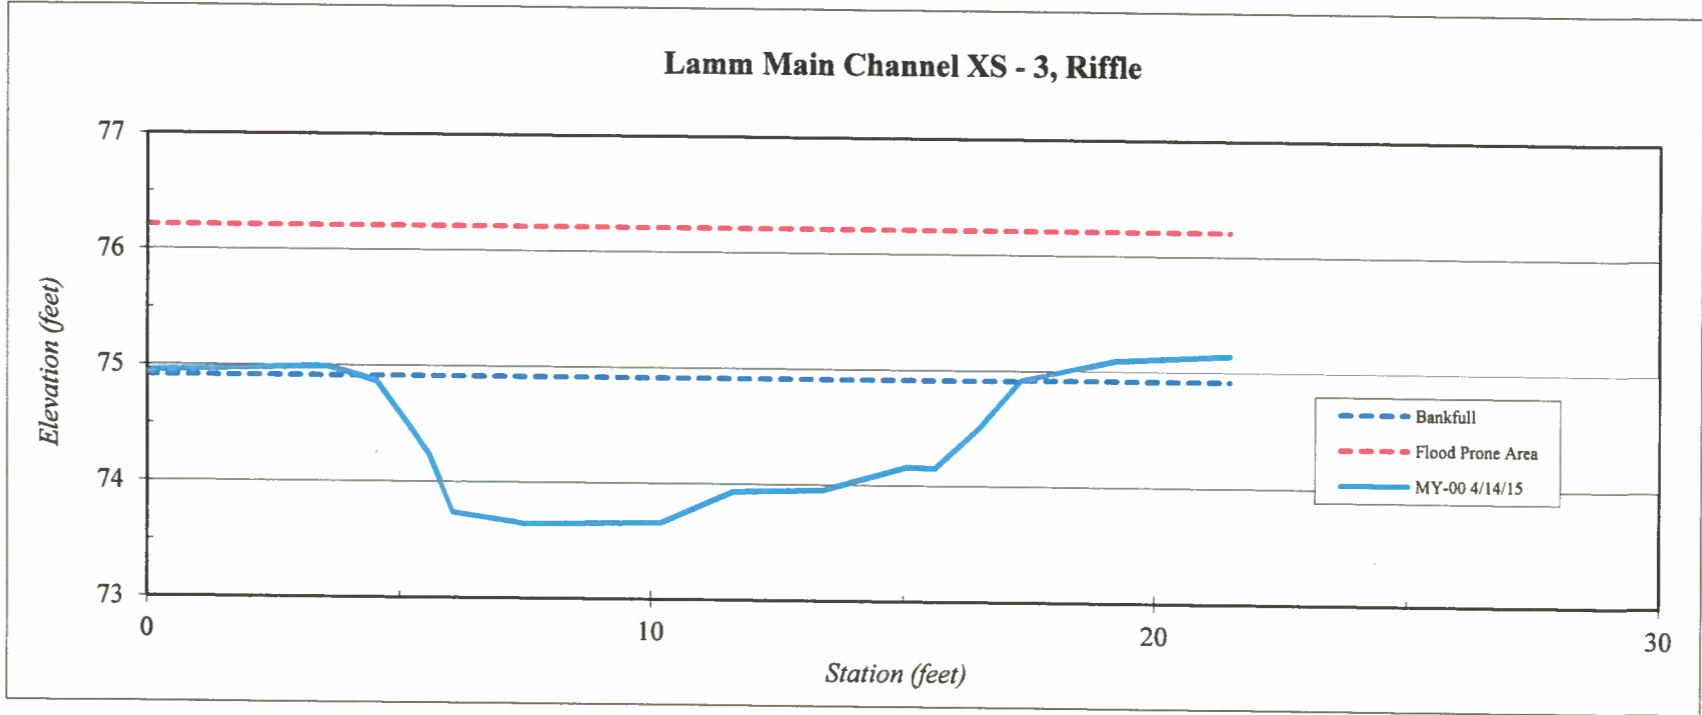
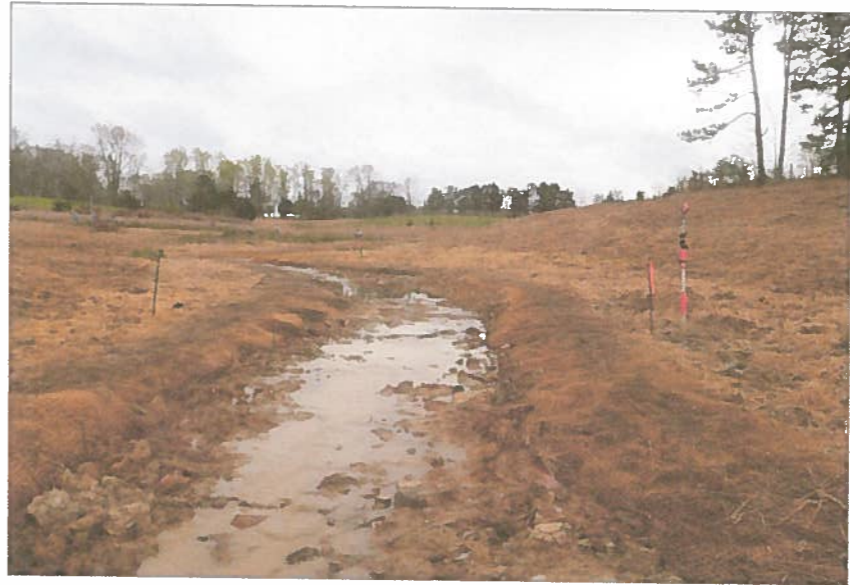
Site	Abbey Lamm
Watershed:	Cape Fear, 0303002
XS ID	Main Channel XS - 3, Riffle
Feature	Riffle
Date:	4/14/2015
Field Crew:	Perkinson, Gibbons

SUMMARY DATA	
Bankfull Elevation:	74.9
Bankfull Cross-Sectional Area:	11.8
Bankfull Width:	13.1
Flood Prone Area Elevation:	76.2
Flood Prone Width:	90.0
Max Depth at Bankfull:	1.3
Mean Depth at Bankfull:	0.9
W / D Ratio:	14.5
Entrenchment Ratio:	6.9
Bank Height Ratio:	1.0

Stream Type: C/E

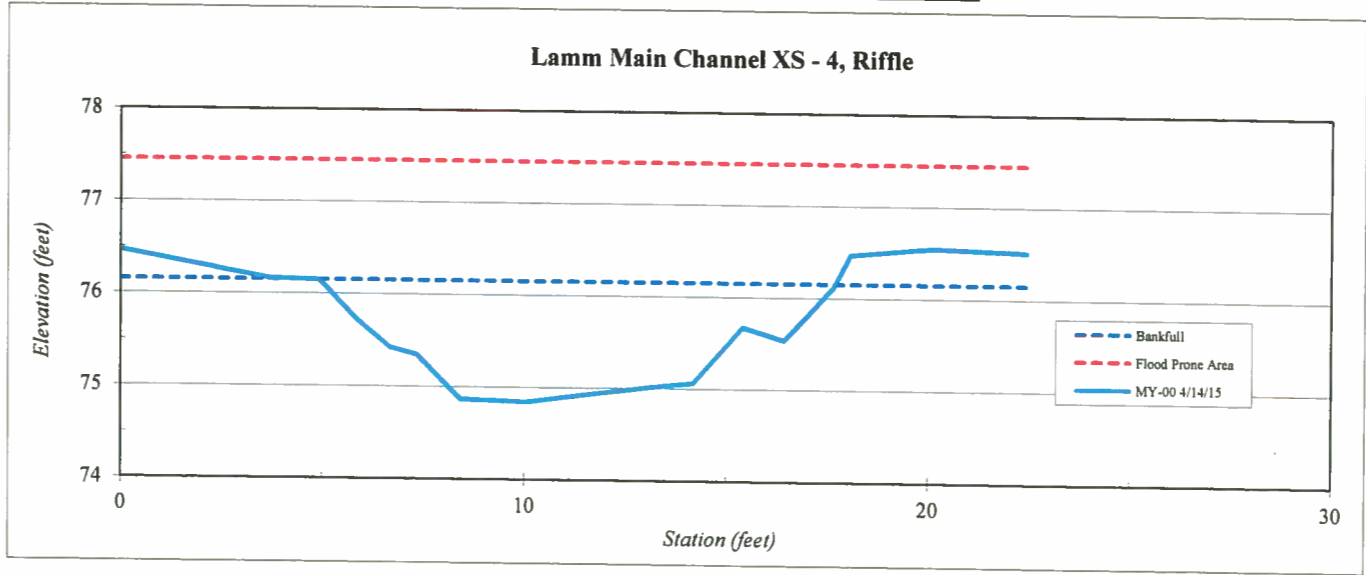
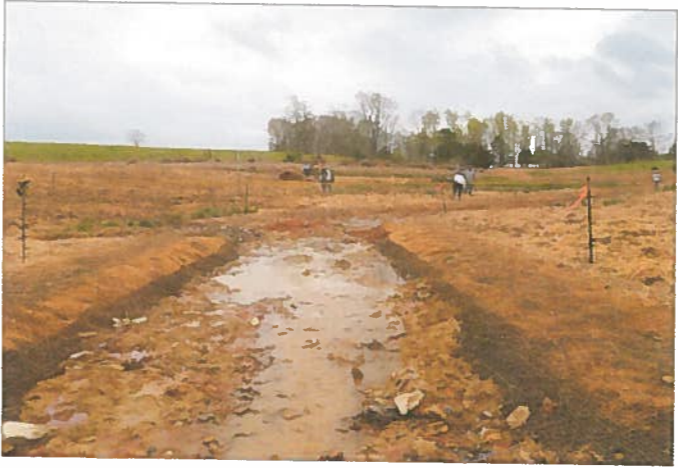
<b>Site</b>	Abbey Lamm
<b>Watershed:</b>	Cape Fear, 0303002
<b>XS ID</b>	Main Channel XS - 4, Riffle
<b>Feature</b>	Riffle
<b>Date:</b>	4/14/2015
<b>Field Crew:</b>	Perkinson, Gibbons

SUMMARY DATA	
<b>Bankfull Elevation:</b>	76.2
<b>Bankfull Cross-Sectional Area:</b>	11.3
<b>Bankfull Width:</b>	13.0
<b>Flood Prone Area Elevation:</b>	77.5
<b>Flood Prone Width:</b>	90.0
<b>Max Depth at Bankfull:</b>	1.3
<b>Mean Depth at Bankfull:</b>	0.9
<b>W / D Ratio:</b>	15.0
<b>Entrenchment Ratio:</b>	6.9
<b>Bank Height Ratio:</b>	1.0

Stream Type: C/E

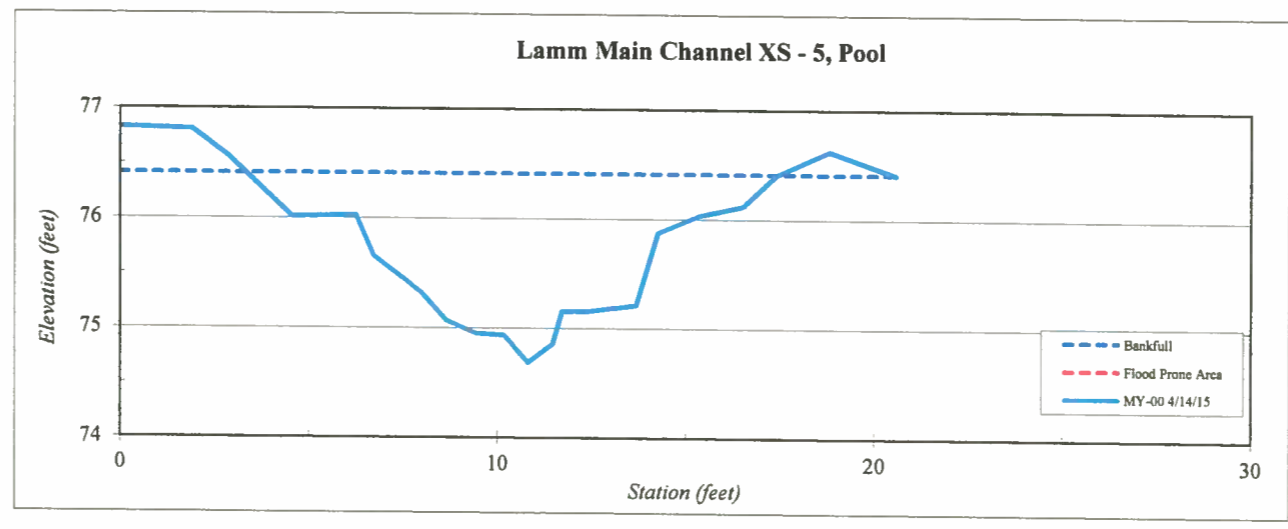
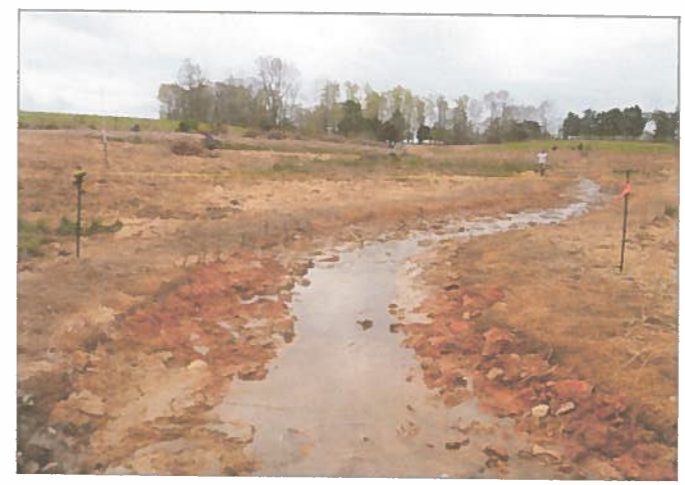
<b>Site</b>	Abbey Lamm
<b>Watershed:</b>	Cape Fear, 0303002
<b>XS ID</b>	Main Channel XS - 5, Pool
<b>Feature</b>	Pool
<b>Date:</b>	4/14/2015
<b>Field Crew:</b>	Perkinson, Gibbons

SUMMARY DATA	
<b>Bankfull Elevation:</b>	76.4
<b>Bankfull Cross-Sectional Area:</b>	11.8
<b>Bankfull Width:</b>	14.1
<b>Flood Prone Area Elevation:</b>	NA
<b>Flood Prone Width:</b>	NA
<b>Max Depth at Bankfull:</b>	1.7
<b>Mean Depth at Bankfull:</b>	0.8
<b>W / D Ratio:</b>	NA
<b>Entrenchment Ratio:</b>	NA
<b>Bank Height Ratio:</b>	1.0

Stream Type: C/E

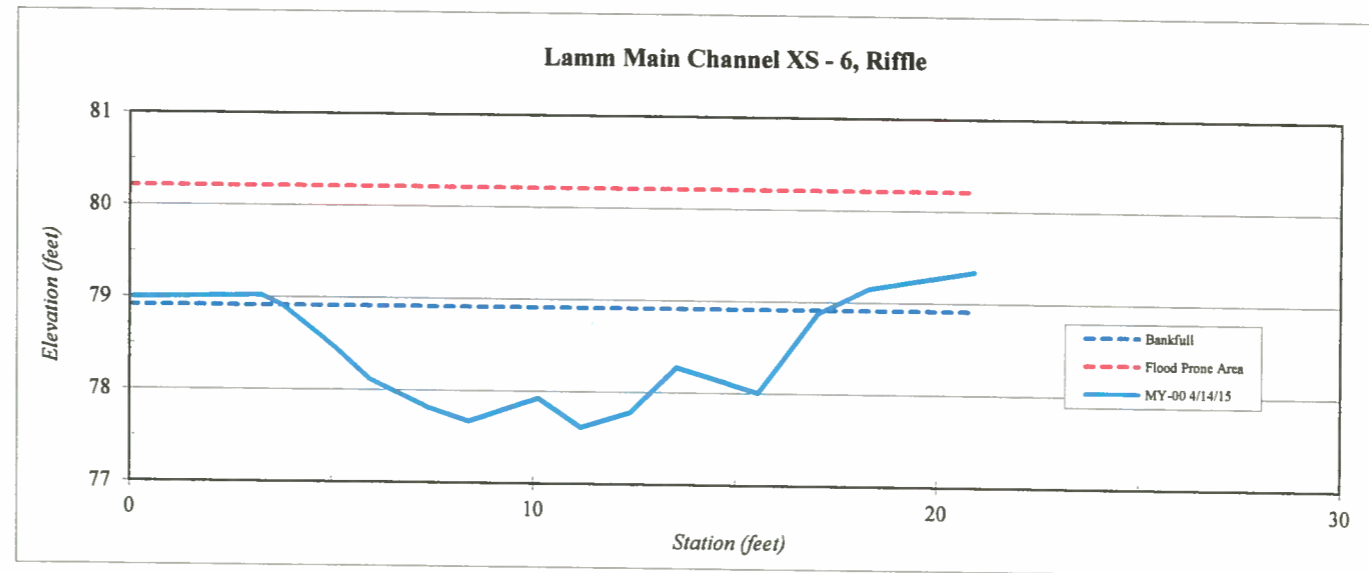
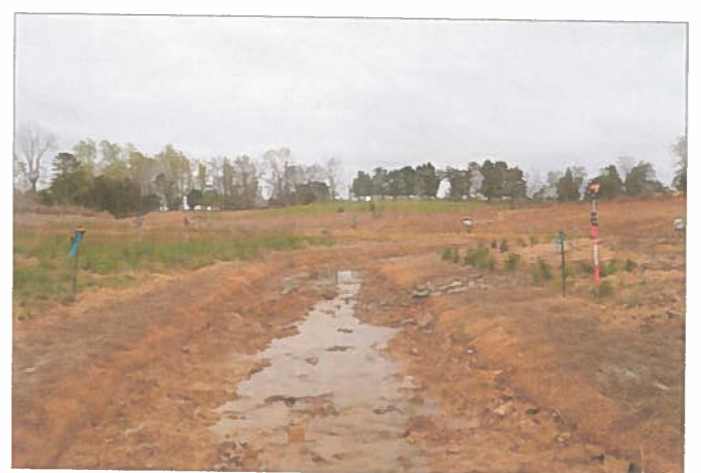
Site	Abbey Lamm
Watershed:	Cape Fear, 0303002
XS ID	Main Channel XS - 6, Riffle
Feature	Riffle
Date:	4/14/2015
Field Crew:	Perkinson, Gibbons

SUMMARY DATA	
Bankfull Elevation:	78.9
Bankfull Cross-Sectional Area:	11.3
Bankfull Width:	13.4
Flood Prone Area Elevation:	80.2
Flood Prone Width:	90.0
Max Depth at Bankfull:	1.3
Mean Depth at Bankfull:	0.8
W / D Ratio:	15.9
Entrenchment Ratio:	6.7
Bank Height Ratio:	1.0

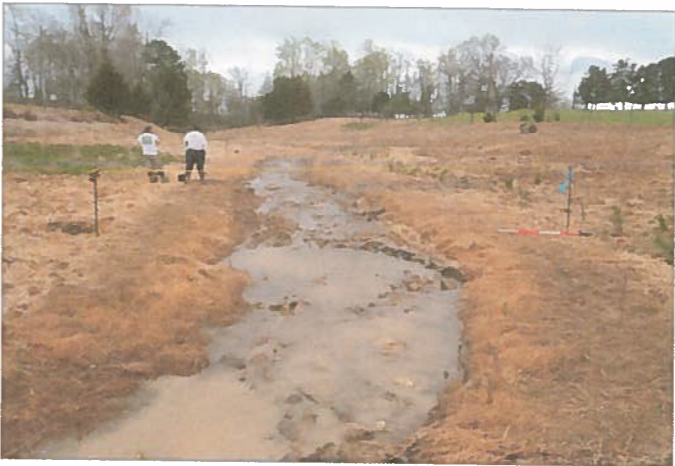
Site	Abbey Lamm
Watershed:	Cape Fear, 0303002
XS ID	Main Channel XS - 8, Riffle
Feature	Riffle
Date:	4/14/2015
Field Crew:	Perkinson, Gibbons

Station	Elevation
0.0	80.91
3.8	80.74
5.4	80.65
6.7	79.96
7.9	80.02
9.9	79.17
11.4	79.31
13.1	79.41
14.2	78.91
15.3	78.81
16.7	79.20
18.3	79.55
18.8	80.05
20.2	80.47
23.3	80.63

SUMMARY DATA	
Bankfull Elevation:	80.3
Bankfull Cross-Sectional Area:	11.6
Bankfull Width:	13.6
Flood Prone Area Elevation:	81.8
Flood Prone Width:	90.0
Max Depth at Bankfull:	1.5
Mean Depth at Bankfull:	0.9
W / D Ratio:	15.9
Entrenchment Ratio:	6.6
Bank Height Ratio:	1.0

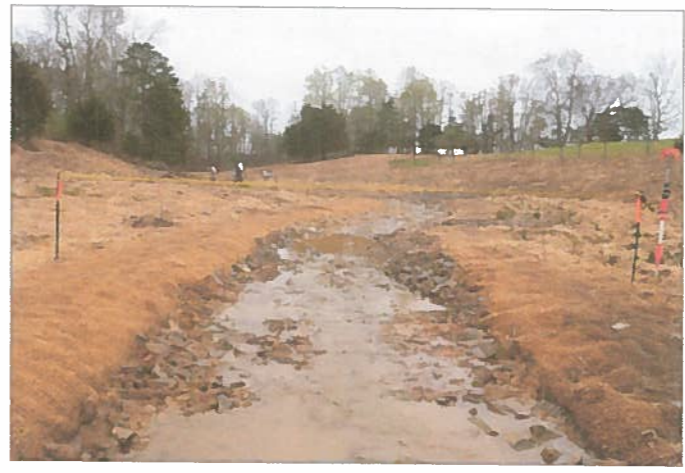
<b>Site</b>	Abbey Lamm
<b>Watershed:</b>	Cape Fear, 0303002
<b>XS ID</b>	Main Channel XS - 9, Riffle
<b>Feature</b>	Riffle
<b>Date:</b>	4/14/2015
<b>Field Crew:</b>	Perkinson, Gibbons

Station	Elevation
0.0	82.13
2.3	82.15
3.8	82.27
4.5	81.99
5.0	81.70
5.6	81.51
6.4	81.29
7.4	80.95
9.1	80.95
10.6	81.15
12.0	81.31
13.2	81.32
14.2	81.05
15.0	81.48
15.8	81.61
16.5	82.10
17.7	82.26
18.4	82.45
20.1	82.47
22.3	82.57

SUMMARY DATA	
<b>Bankfull Elevation:</b>	82.1
<b>Bankfull Cross-Sectional Area:</b>	9.8
<b>Bankfull Width:</b>	12.3
<b>Flood Prone Area Elevation:</b>	83.3
<b>Flood Prone Width:</b>	90.0
<b>Max Depth at Bankfull:</b>	1.2
<b>Mean Depth at Bankfull:</b>	0.8
<b>W / D Ratio:</b>	15.4
<b>Entrenchment Ratio:</b>	7.3
<b>Bank Height Ratio:</b>	1.0

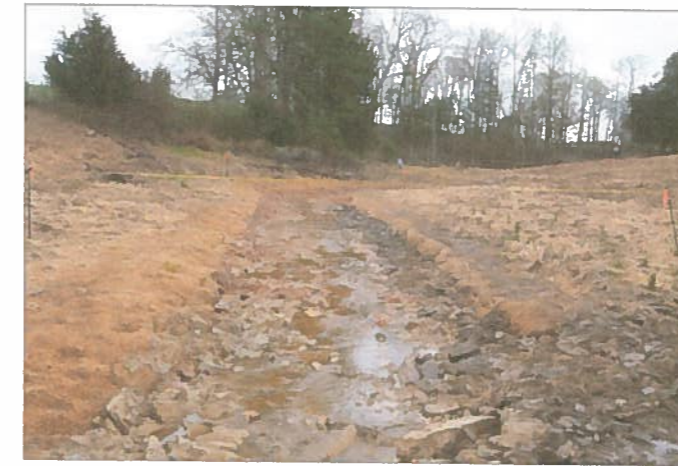
<b>Site</b>	Abbey Lamm
<b>Watershed:</b>	Cape Fear, 0303002
<b>XS ID</b>	Main Channel XS - 10, Riffle
<b>Feature</b>	Riffle
<b>Date:</b>	4/14/2015
<b>Field Crew:</b>	Perkinson, Gibbons

Station	Elevation
0.0	84.46
4.5	84.43
6.1	84.18
7.0	83.97
8.4	83.73
9.6	83.71
10.3	83.50
10.9	83.33
12.0	83.25
13.3	82.93
14.9	83.02
16.7	82.76
18.0	83.09
19.2	82.85
20.4	83.03
21.8	83.71
22.8	84.04
24.4	84.26
26.2	84.43
28.4	84.60

SUMMARY DATA	
<b>Bankfull Elevation:</b>	84.0
<b>Bankfull Cross-Sectional Area:</b>	12.4
<b>Bankfull Width:</b>	16.1
<b>Flood Prone Area Elevation:</b>	85.3
<b>Flood Prone Width:</b>	90.0
<b>Max Depth at Bankfull:</b>	1.3
<b>Mean Depth at Bankfull:</b>	0.8
<b>W / D Ratio:</b>	20.9
<b>Entrenchment Ratio:</b>	5.6
<b>Bank Height Ratio:</b>	1.0

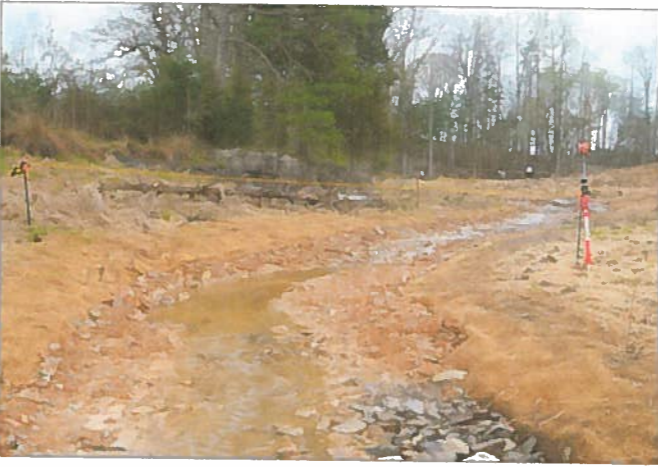
Site	Abbey Lamm
Watershed:	Cape Fear, 0303002
XS ID	Main Channel XS - 11, Pool
Feature	Pool
Date:	4/14/2015
Field Crew:	Perkinson, Gibbons

Station	Elevation
0.0	85.3
2.4	85.4
3.7	85.2
5.4	85.0
6.6	84.8
7.9	84.8
8.9	84.4
10.0	84.3
11.4	84.1
12.1	83.9
13.1	83.7
14.6	83.6
16.0	83.9
16.7	83.8
18.1	84.5
19.4	85.4
20.8	85.7
22.2	86.2
23.8	86.6

SUMMARY DATA	
Bankfull Elevation:	85.0
Bankfull Cross-Sectional Area:	9.8
Bankfull Width:	13.4
Flood Prone Area Elevation:	NA
Flood Prone Width:	NA
Max Depth at Bankfull:	1.4
Mean Depth at Bankfull:	0.7
W / D Ratio:	NA
Entrenchment Ratio:	NA
Bank Height Ratio:	1.0

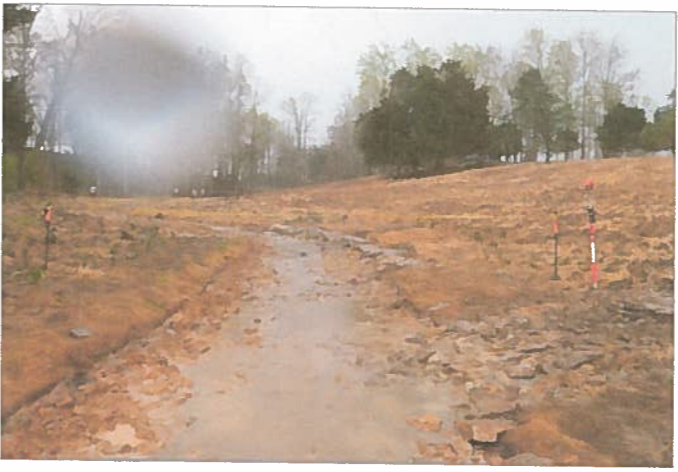
Site	Abbey Lamm
Watershed:	Cape Fear, 0303002
XS ID	Main Channel XS - 12, Riffle
Feature	Riffle
Date:	4/14/2015
Field Crew:	Perkinson, Gibbons

Station	Elevation
0.0	86.16
2.5	85.97
4.2	85.87
5.8	85.69
7.4	85.28
8.9	85.22
10.7	84.71
12.4	84.82
14.1	84.94
16.2	85.10
16.9	85.26
18.4	86.09
20.6	86.22
23.9	86.27

SUMMARY DATA	
Bankfull Elevation:	85.7
Bankfull Cross-Sectional Area:	7.2
Bankfull Width:	11.9
Flood Prone Area Elevation:	86.7
Flood Prone Width:	90.0
Max Depth at Bankfull:	1.0
Mean Depth at Bankfull:	0.6
W / D Ratio:	19.7
Entrenchment Ratio:	7.6
Bank Height Ratio:	1.0

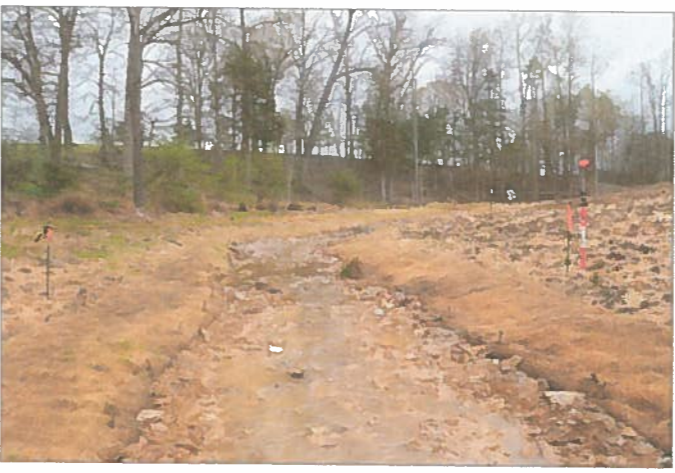
<b>Site</b>	Abbey Lamm
<b>Watershed:</b>	Cape Fear, 0303002
<b>XS ID</b>	Main Channel XS - 13, Riffle
<b>Feature</b>	Riffle
<b>Date:</b>	4/14/2015
<b>Field Crew:</b>	Perkinson, Gibbons

Station	Elevation
0.0	87.80
2.5	87.54
4.5	87.25
6.6	86.62
8.4	86.62
10.8	86.44
12.6	86.35
14.3	86.41
15.5	86.57
17.9	87.09
20.2	87.27
22.0	87.40

SUMMARY DATA	
<b>Bankfull Elevation:</b>	87.3
<b>Bankfull Cross-Sectional Area:</b>	8.6
<b>Bankfull Width:</b>	15.4
<b>Flood Prone Area Elevation:</b>	88.2
<b>Flood Prone Width:</b>	90.0
<b>Max Depth at Bankfull:</b>	0.9
<b>Mean Depth at Bankfull:</b>	0.6
<b>W / D Ratio:</b>	27.6
<b>Entrenchment Ratio:</b>	5.8
<b>Bank Height Ratio:</b>	1.0

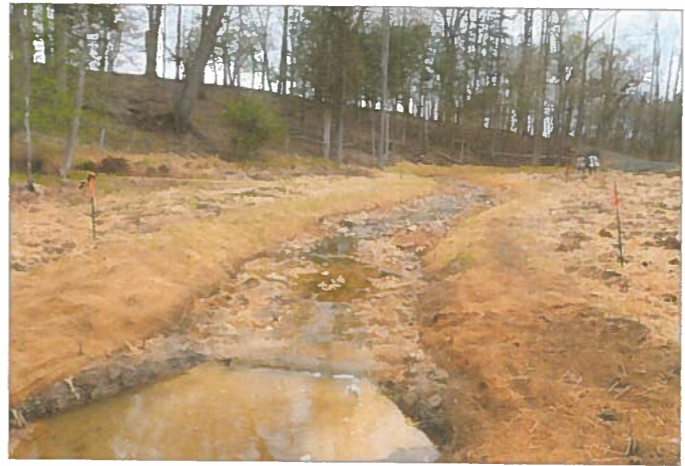
Station	Elevation
0.0	89.58
2.7	89.37
5.0	89.11
7.3	88.18
9.5	87.89
11.6	87.79
12.7	87.69
14.6	87.81
15.9	87.82
16.7	88.54
18.4	89.26
20.6	89.33
22.4	89.33

SUMMARY DATA	
Bankfull Elevation:	89.1
Bankfull Cross-Sectional Area:	12.9
Bankfull Width:	13.0
Flood Prone Area Elevation:	90.5
Flood Prone Width:	90.0
Max Depth at Bankfull:	1.4
Mean Depth at Bankfull:	1.0
W / D Ratio:	13.1
Entrenchment Ratio:	6.9
Bank Height Ratio:	1.0

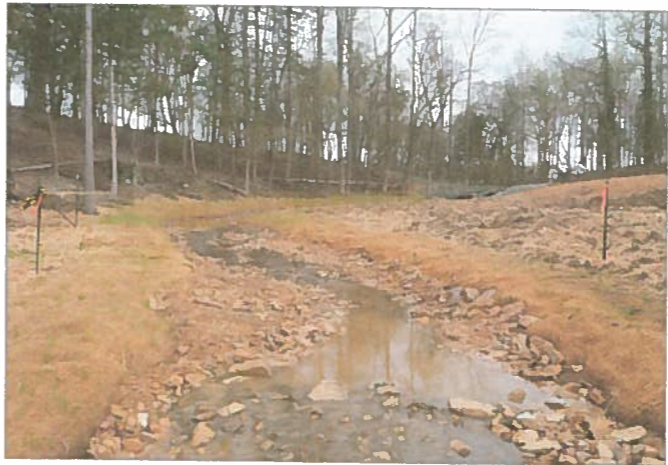
<b>Site</b>	Abbey Lamm
<b>Watershed:</b>	Cape Fear, 0303002
<b>XS ID</b>	Main Channel XS - 15, Pool
<b>Feature</b>	Pool
<b>Date:</b>	4/14/2015
<b>Field Crew:</b>	Perkinson, Gibbons

Station	Elevation
0.0	91.1
3.2	91.0
5.4	90.5
6.8	90.1
8.2	89.6
9.3	89.1
10.4	89.1
11.1	89.7
13.2	89.9
15.0	90.1
17.0	90.5
18.6	90.5
19.9	90.9
22.6	90.9

SUMMARY DATA	
<b>Bankfull Elevation:</b>	90.9
<b>Bankfull Cross-Sectional Area:</b>	12.7
<b>Bankfull Width:</b>	16.1
<b>Flood Prone Area Elevation:</b>	NA
<b>Flood Prone Width:</b>	NA
<b>Max Depth at Bankfull:</b>	1.8
<b>Mean Depth at Bankfull:</b>	0.8
<b>W / D Ratio:</b>	NA
<b>Entrenchment Ratio:</b>	NA
<b>Bank Height Ratio:</b>	1.0

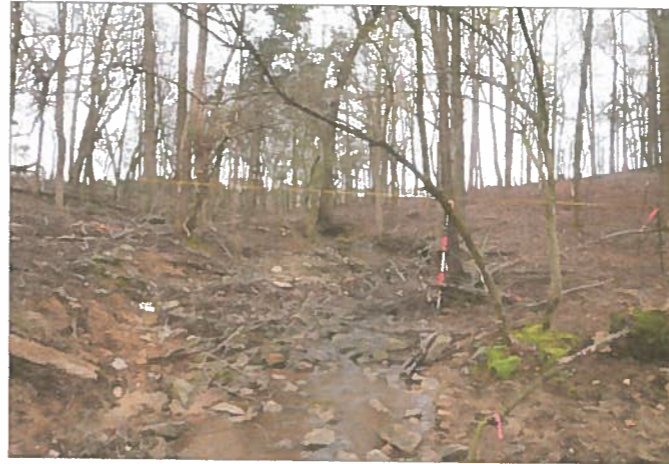
Site	Abbey Lamm
Watershed:	Cape Fear, 0303002
XS ID	Main Channel XS - 16, Riffle
Feature	Riffle
Date:	4/14/2015
Field Crew:	Perkinson, Gibbons

Station	Elevation
0.0	95.39
4.8	95.19
7.7	94.04
9.8	93.39
12.3	93.26
15.7	93.28
20.1	93.31
23.4	93.77
25.1	94.56
26.9	95.75
29.5	96.27
31.9	96.74

SUMMARY DATA	
Bankfull Elevation:	94.0
Bankfull Cross-Sectional Area:	10.1
Bankfull Width:	16.2
Flood Prone Area Elevation:	94.8
Flood Prone Width:	20.0
Max Depth at Bankfull:	0.8
Mean Depth at Bankfull:	0.6
W / D Ratio:	26.0
Entrenchment Ratio:	1.2
Bank Height Ratio:	1.0

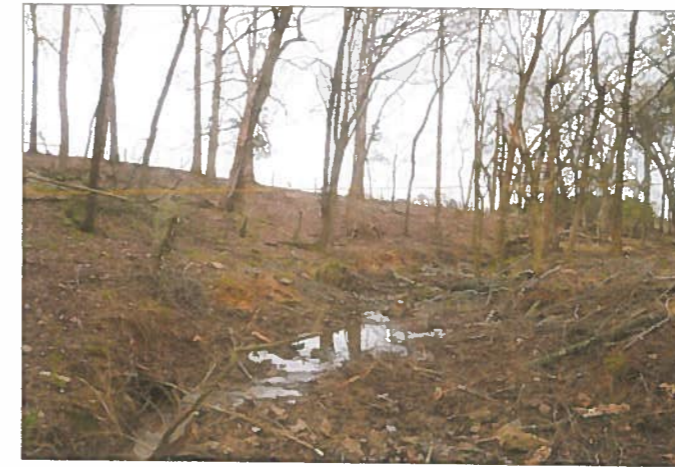
Site	Abbey Lamm
Watershed:	Cape Fear, 0303002
XS ID	Main Channel XS - 17, Riffle
Feature	Riffle
Date:	4/14/2015
Field Crew:	Perkinson, Gibbons

Station	Elevation
0.0	97.87
2.0	97.13
5.3	94.71
7.9	94.88
11.4	94.96
12.7	94.70
14.2	94.70
15.0	94.30
16.4	94.79
17.7	94.67
19.0	96.40
21.0	97.03
23.4	97.25
25.5	97.45

SUMMARY DATA	
Bankfull Elevation:	95.6
Bankfull Cross-Sectional Area:	11.2
Bankfull Width:	14.3
Flood Prone Area Elevation:	96.9
Flood Prone Width:	19.0
Max Depth at Bankfull:	1.3
Mean Depth at Bankfull:	0.8
W / D Ratio:	18.3
Entrenchment Ratio:	1.3
Bank Height Ratio:	1.0

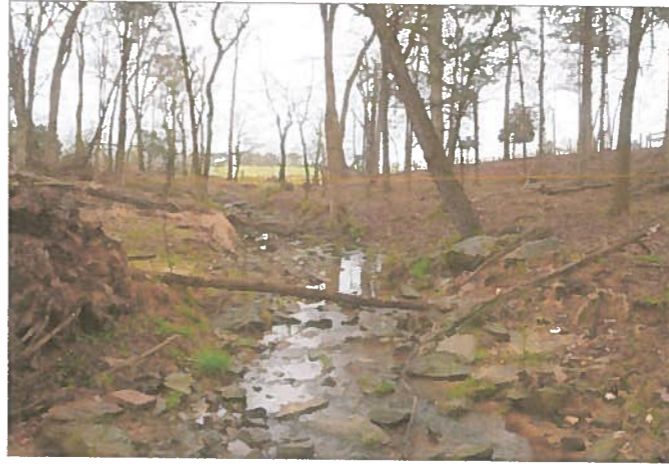
Site	Abbey Lamm
Watershed:	Cape Fear, 0303002
XS ID	Main Channel XS - 18, Riffle
Feature	Riffle
Date:	4/14/2015
Field Crew:	Perkinson, Gibbons

Station	Elevation
0.0	99.53
4.0	99.40
7.1	97.91
8.4	97.48
10.4	97.43
11.9	97.00
13.3	96.90
14.2	97.16
16.5	96.99
17.9	97.72
19.1	97.39
20.7	98.77
23.5	98.81
26.3	98.86

SUMMARY DATA	
Bankfull Elevation:	98.1
Bankfull Cross-Sectional Area:	10.1
Bankfull Width:	13.2
Flood Prone Area Elevation:	99.3
Flood Prone Width:	31.0
Max Depth at Bankfull:	1.2
Mean Depth at Bankfull:	0.8
W / D Ratio:	17.3
Entrenchment Ratio:	2.3
Bank Height Ratio:	1.0

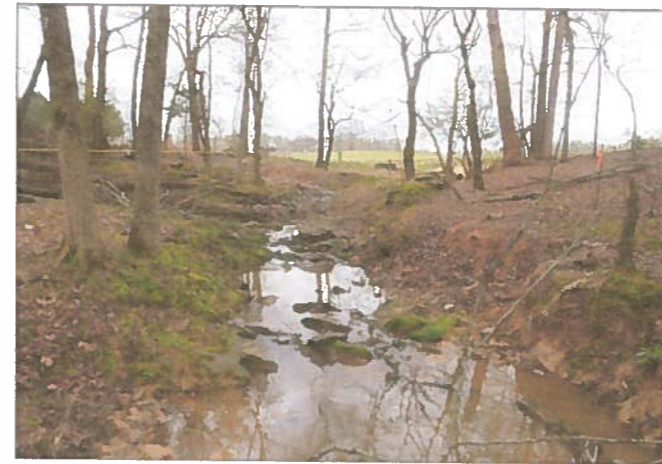
Site	Abbey Lamm
Watershed:	Cape Fear, 0303002
XS ID	Main Channel XS - 19, Pool
Feature	Pool
Date:	4/14/2015
Field Crew:	Perkinson, Gibbons

Station	Elevation
0.0	101.4
3.5	101.1
6.6	100.6
8.3	98.7
10.4	97.6
12.3	97.3
14.6	97.2
17.1	97.3
18.5	97.6
19.7	97.5
20.5	98.6
22.7	99.9
25.5	100.2
28.8	100.5

SUMMARY DATA	
Bankfull Elevation:	98.6
Bankfull Cross-Sectional Area:	13.1
Bankfull Width:	12.0
Flood Prone Area Elevation:	NA
Flood Prone Width:	NA
Max Depth at Bankfull:	1.4
Mean Depth at Bankfull:	1.1
W / D Ratio:	NA
Entrenchment Ratio:	NA
Bank Height Ratio:	1.0

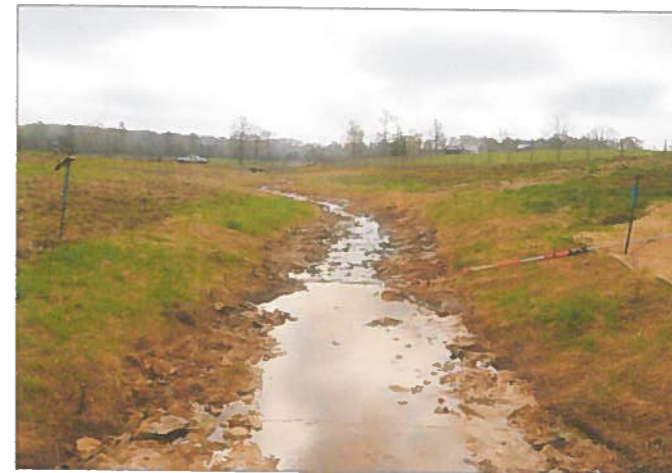
Site	Abbey Lamm
Watershed:	Cape Fear, 0303002
XS ID	Main Channel XS - 20, Pool
Feature	Pool
Date:	4/14/2015
Field Crew:	Perkinson, Gibbons

Station	Elevation
0.0	104.3
3.8	102.9
5.6	102.5
6.7	102.5
7.5	101.5
8.6	101.3
9.7	101.5
10.3	101.5
11.9	101.4
12.5	101.4
13.2	101.2
14.0	102.6
14.7	102.6
15.7	102.9
16.8	103.5
17.6	103.9
19.0	104.1
20.5	104.2
21.9	104.4

SUMMARY DATA	
Bankfull Elevation:	102.5
Bankfull Cross-Sectional Area:	6.7
Bankfull Width:	7.1
Flood Prone Area Elevation:	NA
Flood Prone Width:	NA
Max Depth at Bankfull:	1.3
Mean Depth at Bankfull:	0.9
W / D Ratio:	NA
Entrenchment Ratio:	NA
Bank Height Ratio:	1.0

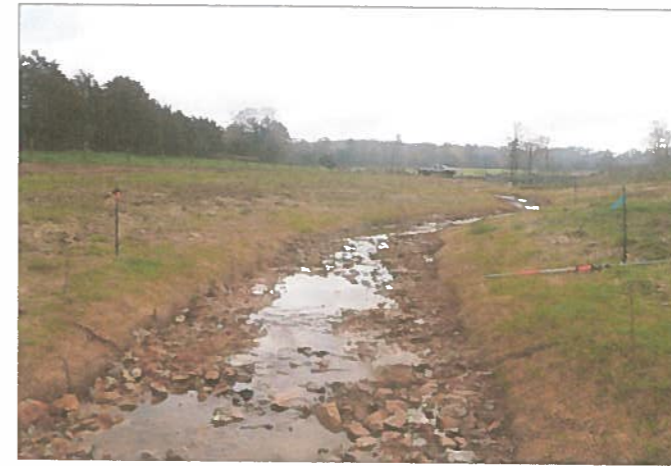
Site	Abbey Lamm
Watershed:	Cape Fear, 0303002
XS ID	Main Channel XS - 21, Riffle
Feature	Riffle
Date:	4/14/2015
Field Crew:	Perkinson, Gibbons

Station	Elevation
0.0	105.02
1.7	104.83
3.9	104.89
4.9	104.58
6.2	104.26
6.9	103.91
8.2	103.58
9.2	103.63
10.4	103.36
11.8	103.56
12.3	103.49
13.5	103.32
14.4	103.49
15.5	103.75
16.5	103.75
17.3	104.21
17.8	104.70
19.5	104.78
20.7	104.92
22.1	105.02

SUMMARY DATA	
Bankfull Elevation:	104.7
Bankfull Cross-Sectional Area:	12.5
Bankfull Width:	13.3
Flood Prone Area Elevation:	106.1
Flood Prone Width:	90.0
Max Depth at Bankfull:	1.4
Mean Depth at Bankfull:	0.9
W / D Ratio:	16.9
Entrenchment Ratio:	7.0
Bank Height Ratio:	1.0

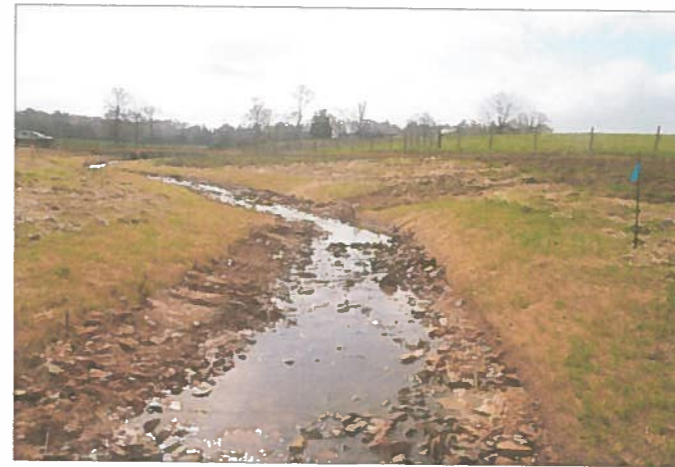
Station	Elevation
0.0	106.03
2.9	105.87
4.1	105.40
5.0	104.91
6.0	104.22
7.0	104.02
8.0	103.99
9.6	104.13
11.0	104.10
12.5	104.01
13.6	104.50
14.7	104.48
15.5	104.86
16.8	105.37
18.7	105.64
22.1	105.96

SUMMARY DATA	
Bankfull Elevation:	105.4
Bankfull Cross-Sectional Area:	12.5
Bankfull Width:	12.6
Flood Prone Area Elevation:	106.8
Flood Prone Width:	90.0
Max Depth at Bankfull:	1.4
Mean Depth at Bankfull:	1.0
W / D Ratio:	12.7
Entrenchment Ratio:	7.1
Bank Height Ratio:	1.0

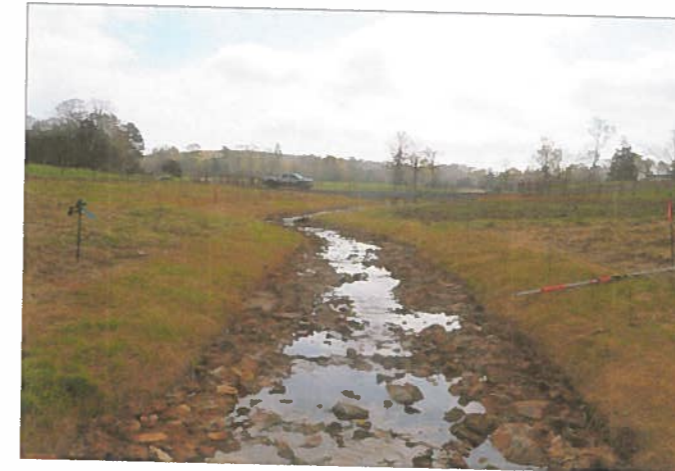
Station	Elevation
0.0	107.23
2.6	107.02
5.2	106.41
6.5	106.01
8.4	105.07
9.1	105.26
10.7	105.62
11.2	105.22
12.2	105.07
13.2	105.16
14.1	105.23
15.2	105.06
16.5	105.22
17.8	105.61
18.6	106.06
19.9	106.30
21.6	106.37
25.0	106.52

SUMMARY DATA	
Bankfull Elevation:	106.1
Bankfull Cross-Sectional Area:	8.8
Bankfull Width:	12.3
Flood Prone Area Elevation:	107.1
Flood Prone Width:	90.0
Max Depth at Bankfull:	1.0
Mean Depth at Bankfull:	0.7
W/D Ratio:	17.2
Entrenchment Ratio:	7.3
Bank Height Ratio:	1.0

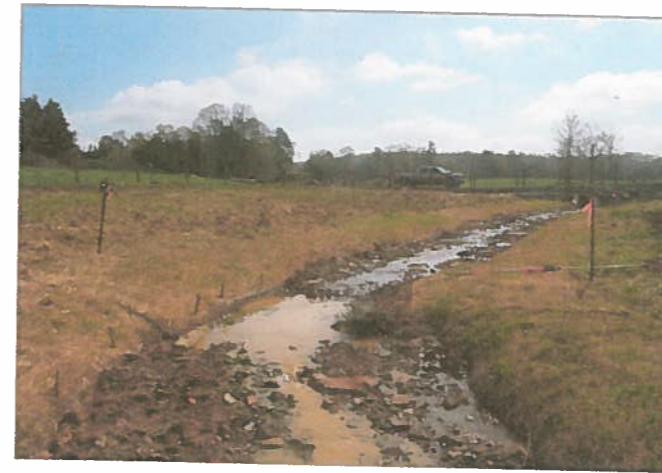
Site	Abbey Lamm
Watershed:	Cape Fear, 0303002
XS ID	Main Channel XS - 24, Pool
Feature	Pool
Date:	4/14/2015
Field Crew:	Perkinson, Gibbons

Stream Type      C/E

Station	Elevation
0.0	107.3
3.3	107.2
4.9	107.0
6.7	106.4
8.4	105.9
9.8	105.8
10.4	105.5
11.4	105.4
12.0	105.4
12.9	105.4
13.7	105.7
14.4	106.4
15.5	107.0
17.3	107.7
19.0	108.0
21.0	108.2

SUMMARY DATA	
Bankfull Elevation:	107.3
Bankfull Cross-Sectional Area:	13.1
Bankfull Width:	12.8
Flood Prone Area Elevation:	NA
Flood Prone Width:	NA
Max Depth at Bankfull:	1.8
Mean Depth at Bankfull:	1.0
W / D Ratio:	NA
Entrenchment Ratio:	NA
Bank Height Ratio:	1.0

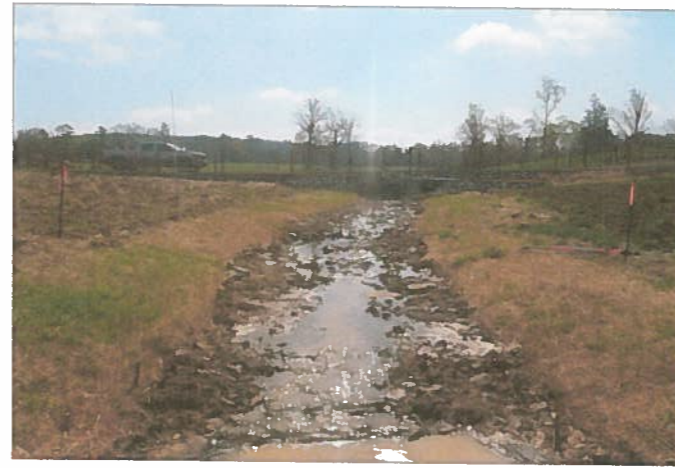
Site	Abbey Lamm
Watershed:	Cape Fear, 0303002
XS ID	Main Channel XS - 25, Riffle
Feature	Riffle
Date:	4/14/2015
Field Crew:	Perkinson, Gibbons

Station	Elevation
0.0	107.91
2.8	107.91
4.6	107.83
5.5	107.36
6.5	106.91
7.3	106.87
7.9	106.86
9.5	106.83
10.1	106.64
10.9	106.41
11.5	106.45
12.1	106.66
13.0	106.67
13.9	107.01
15.8	106.97
16.4	107.37
17.4	107.79
18.6	108.15
20.3	108.33
22.9	108.87

SUMMARY DATA	
Bankfull Elevation:	107.8
Bankfull Cross-Sectional Area:	11.3
Bankfull Width:	13.0
Flood Prone Area Elevation:	109.2
Flood Prone Width:	90.0
Max Depth at Bankfull:	1.4
Mean Depth at Bankfull:	0.9
W / D Ratio:	15.0
Entrenchment Ratio:	6.9
Bank Height Ratio:	1.0
