**FINAL**  
**BASELINE MONITORING DOCUMENT AND**  
**AS-BUILT BASELINE REPORT**

**ABBEY LAMM**  
**STREAM AND WETLAND MITIGATION SITE**

Alamance County, North Carolina  
Full Delivery Contract No. 5790

Data Collection: April and May 2015  
Submission: July 2015

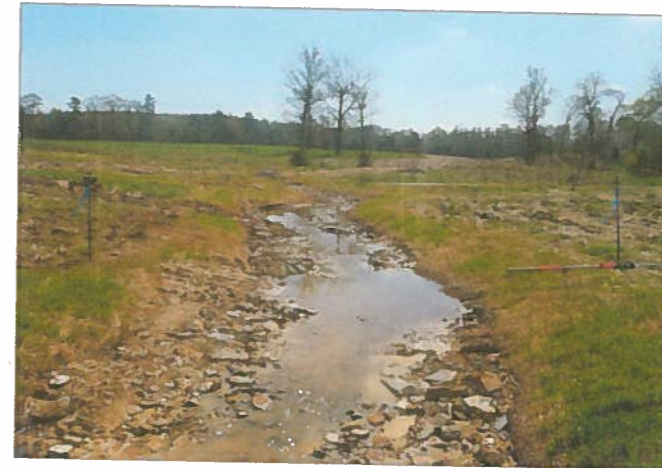
Site	Abbey Lamm
Watershed:	Cape Fear, 0303002
XS ID	Main Channel XS - 26, Pool
Feature	Pool
Date:	4/14/2015
Field Crew:	Perkinson, Gibbons

Station	Elevation
0.0	110.7
2.2	110.7
4.1	110.3
5.1	110.0
6.0	109.6
6.9	109.3
7.2	108.9
7.8	108.9
8.9	108.5
10.1	108.7
11.3	109.2
12.6	109.4
14.2	109.5
15.6	109.9
17.3	110.3
19.7	110.6

SUMMARY DATA	
Bankfull Elevation:	110.3
Bankfull Cross-Sectional Area:	12.1
Bankfull Width:	13.3
Flood Prone Area Elevation:	NA
Flood Prone Width:	NA
Max Depth at Bankfull:	1.8
Mean Depth at Bankfull:	0.9
W / D Ratio:	NA
Entrenchment Ratio:	NA
Bank Height Ratio:	1.0

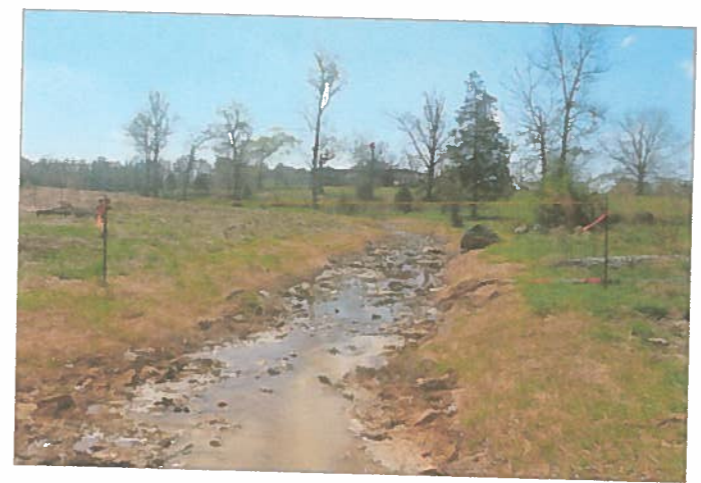
Site	Abbey Lamm
Watershed:	Cape Fear, 0303002
XS ID	Main Channel XS - 27, Riffle
Feature	Riffle
Date:	4/14/2015
Field Crew:	Perkinson, Gibbons

Station	Elevation
0.0	111.78
2.8	111.51
4.6	110.94
6.1	110.16
7.6	110.01
9.8	109.97
11.2	109.78
11.9	109.75
13.5	110.03
14.7	110.27
16.6	110.94
18.1	111.20
20.3	111.12

SUMMARY DATA	
Bankfull Elevation:	110.9
Bankfull Cross-Sectional Area:	9.5
Bankfull Width:	12.0
Flood Prone Area Elevation:	112.1
Flood Prone Width:	90.0
Max Depth at Bankfull:	1.2
Mean Depth at Bankfull:	0.8
W / D Ratio:	15.2
Entrenchment Ratio:	7.5
Bank Height Ratio:	1.0

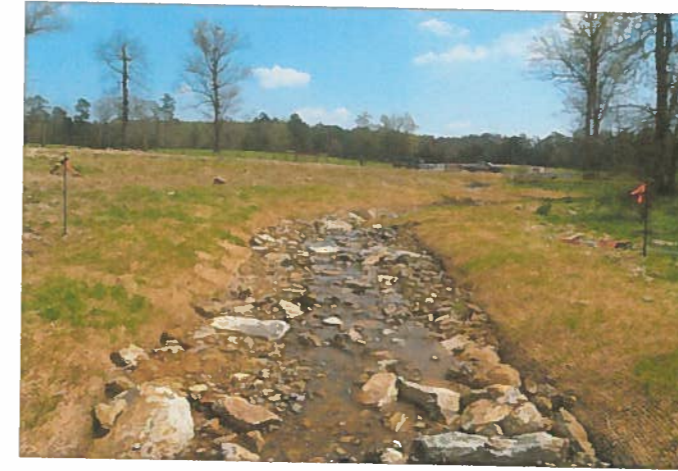
Site	Abbey Lamm
Watershed:	Cape Fear, 0303002
XS ID	Main Channel XS - 29, Riffle
Feature	Riffle
Date:	4/14/2015
Field Crew:	Perkinson, Gibbons

Station	Elevation
0.0	114.71
3.2	114.72
5.5	114.59
6.4	114.34
7.4	113.86
8.1	113.35
9.9	113.34
11.7	113.32
12.6	113.20
13.9	113.36
15.1	113.71
16.3	113.52
17.0	113.97
17.6	114.38
18.9	114.80
21.1	115.00
23.6	115.16

SUMMARY DATA	
Bankfull Elevation:	114.6
Bankfull Cross-Sectional Area:	12.1
Bankfull Width:	12.8
Flood Prone Area Elevation:	116.0
Flood Prone Width:	90.0
Max Depth at Bankfull:	1.4
Mean Depth at Bankfull:	0.9
W / D Ratio:	13.5
Entrenchment Ratio:	7.0
Bank Height Ratio:	1.0

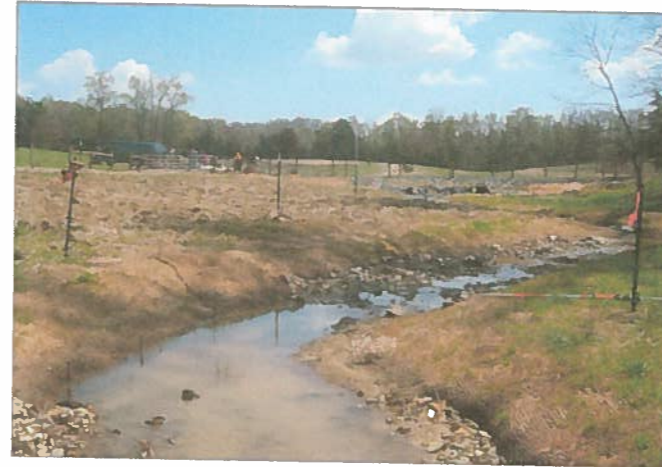
Site	Abbey Lamm
Watershed:	Cape Fear, 0303002
XS ID	Main Channel XS - 30, Pool
Feature	Pool
Date:	4/14/2015
Field Crew:	Perkinson, Gibbons

Station	Elevation
0.0	117.3
2.2	117.6
4.1	117.1
6.1	116.6
7.2	116.4
8.2	116.2
9.3	116.0
10.3	115.8
11.0	115.6
11.8	115.6
12.7	116.1
13.5	116.5
14.5	116.7
15.3	117.3
16.2	117.8
18.0	118.0

SUMMARY DATA	
Bankfull Elevation:	117.4
Bankfull Cross-Sectional Area:	11.5
Bankfull Width:	12.3
Flood Prone Area Elevation:	NA
Flood Prone Width:	NA
Max Depth at Bankfull:	1.7
Mean Depth at Bankfull:	0.9
W / D Ratio:	NA
Entrenchment Ratio:	NA
Bank Height Ratio:	1.0

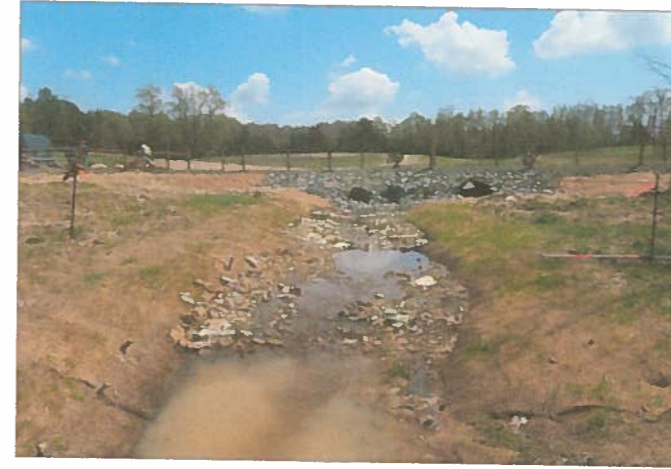
Site	Abbey Lamm
Watershed:	Cape Fear, 0303002
XS ID	Main Channel XS - 30, Riffle
Feature	Riffle
Date:	4/14/2015
Field Crew:	Perkinson, Gibbons

Station	Elevation
0.0	118.76
2.8	118.94
4.5	118.77
6.0	118.47
7.2	117.95
8.3	117.74
10.0	117.48
11.0	117.48
12.3	117.56
13.3	117.45
14.8	117.51
15.4	117.79
16.4	117.90
17.5	118.44
18.6	119.06
21.0	119.02
22.1	119.33
24.0	119.39

SUMMARY DATA	
Bankfull Elevation:	118.5
Bankfull Cross-Sectional Area:	8.6
Bankfull Width:	11.6
Flood Prone Area Elevation:	119.5
Flood Prone Width:	90.0
Max Depth at Bankfull:	1.0
Mean Depth at Bankfull:	0.7
W / D Ratio:	15.6
Entrenchment Ratio:	7.8
Bank Height Ratio:	1.0

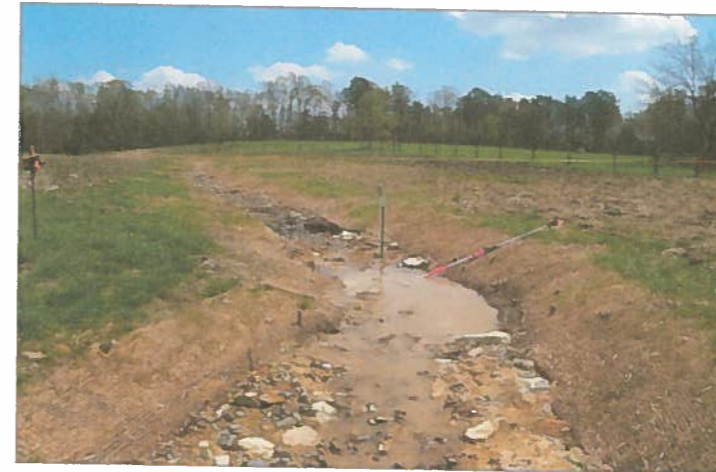
Site	Abbey Lamm
Watershed:	Cape Fear, 0303002
XS ID	UT 1 XS - 1, Pool
Feature	Pool
Date:	4/14/2015
Field Crew:	Perkinson, Gibbons

Station	Elevation
0.0	125.6
2.7	125.5
4.6	125.3
6.0	124.7
7.3	123.7
8.4	123.4
9.2	123.1
9.9	123.0
10.7	123.2
11.5	123.4
12.4	123.5
13.4	123.7
14.6	124.3
16.3	124.7
18.3	125.2
20.8	125.6
22.5	125.8

SUMMARY DATA	
Bankfull Elevation:	124.3
Bankfull Cross-Sectional Area:	6.4
Bankfull Width:	8.1
Flood Prone Area Elevation:	NA
Flood Prone Width:	NA
Max Depth at Bankfull:	1.3
Mean Depth at Bankfull:	0.8
W / D Ratio:	NA
Entrenchment Ratio:	NA
Bank Height Ratio:	1.0

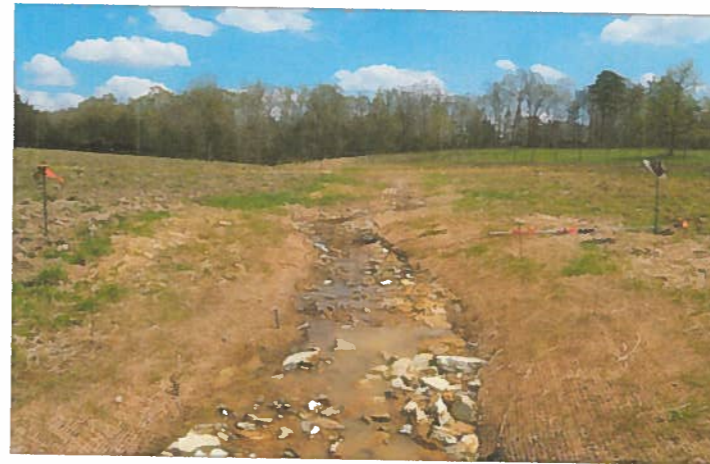
<b>Site</b>	Abbey Lamm
<b>Watershed:</b>	Cape Fear, 0303002
<b>XS ID</b>	UT 1 XS - 2, Riffle
<b>Feature</b>	Riffle
<b>Date:</b>	4/14/2015
<b>Field Crew:</b>	Perkinson, Gibbons

Station	Elevation
0.0	127.96
3.9	127.78
6.6	127.22
8.2	126.76
9.8	126.10
10.9	125.99
12.4	125.73
13.7	125.80
14.7	126.20
16.2	126.72
19.3	127.04
22.5	127.47
24.8	127.49

SUMMARY DATA	
<b>Bankfull Elevation:</b>	126.7
<b>Bankfull Cross-Sectional Area:</b>	5.0
<b>Bankfull Width:</b>	8.0
<b>Flood Prone Area Elevation:</b>	127.7
<b>Flood Prone Width:</b>	50.0
<b>Max Depth at Bankfull:</b>	1.0
<b>Mean Depth at Bankfull:</b>	0.6
<b>W / D Ratio:</b>	13.0
<b>Entrenchment Ratio:</b>	6.2
<b>Bank Height Ratio:</b>	1.0

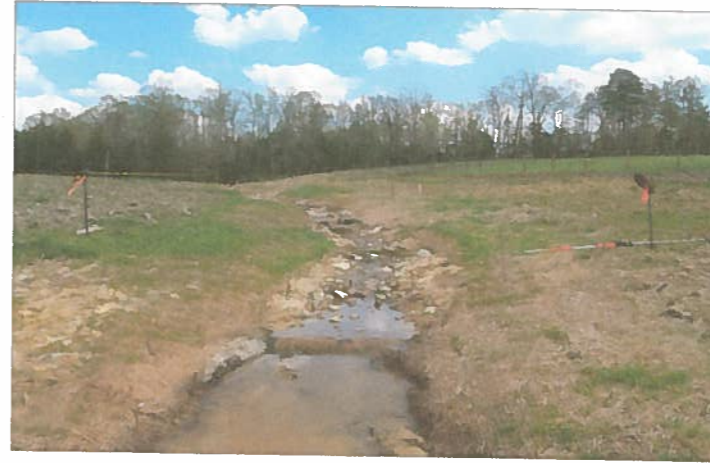
Site	Abbey Lamm
Watershed:	Cape Fear, 0303002
XS ID	UT 1 XS - 3, Riffle
Feature	Riffle
Date:	4/14/2015
Field Crew:	Perkinson, Gibbons

Station	Elevation
0.0	129.57
4.2	129.32
6.7	129.00
7.8	128.68
9.7	128.07
10.8	127.92
11.6	127.79
12.5	127.76
13.4	128.17
14.2	128.21
14.9	128.51
15.9	129.07
18.8	129.22
21.8	129.50
24.1	129.76

SUMMARY DATA	
Bankfull Elevation:	129.0
Bankfull Cross-Sectional Area:	6.7
Bankfull Width:	9.1
Flood Prone Area Elevation:	130.2
Flood Prone Width:	50.0
Max Depth at Bankfull:	1.2
Mean Depth at Bankfull:	0.7
W / D Ratio:	12.4
Entrenchment Ratio:	5.5
Bank Height Ratio:	1.0

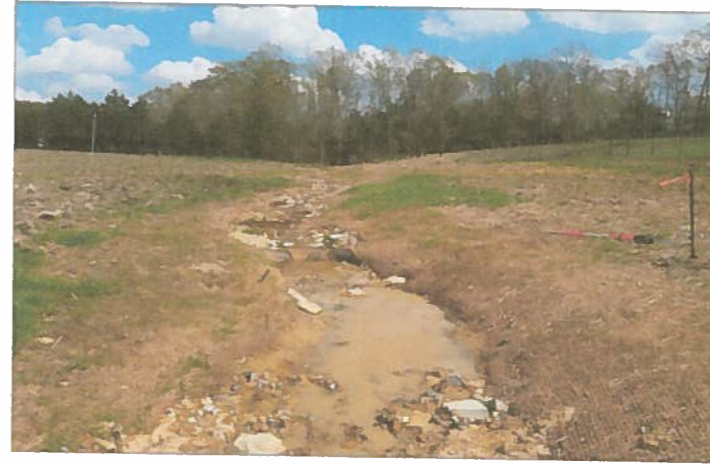
<b>Site</b>	Abbey Lamm
<b>Watershed:</b>	Cape Fear, 0303002
<b>XS ID</b>	UT 1 XS - 4, Riffle
<b>Feature</b>	Riffle
<b>Date:</b>	4/14/2015
<b>Field Crew:</b>	Perkinson, Gibbons

Station	Elevation
0.0	131.02
3.8	130.77
5.4	130.47
6.6	129.71
7.8	129.07
8.5	128.80
9.8	128.74
10.8	128.86
11.6	129.04
12.7	129.63
14.9	129.75
17.3	130.16
21.5	130.57

SUMMARY DATA	
<b>Bankfull Elevation:</b>	129.6
<b>Bankfull Cross-Sectional Area:</b>	3.6
<b>Bankfull Width:</b>	6.0
<b>Flood Prone Area Elevation:</b>	130.5
<b>Flood Prone Width:</b>	50.0
<b>Max Depth at Bankfull:</b>	0.9
<b>Mean Depth at Bankfull:</b>	0.6
<b>W/D Ratio:</b>	10.0
<b>Entrenchment Ratio:</b>	8.3
<b>Bank Height Ratio:</b>	1.0

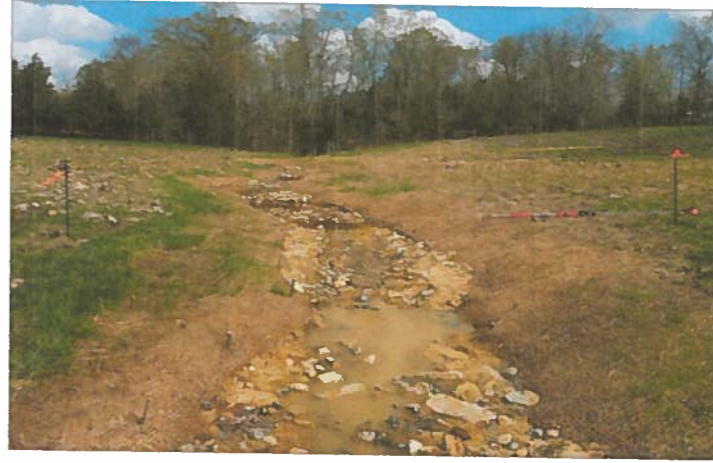
Site	Abbey Lamm
Watershed:	Cape Fear, 0303002
XS ID	UT 1 XS - 5, Riffle
Feature	Riffle
Date:	4/14/2015
Field Crew:	Perkinson, Gibbons

Station	Elevation
0.0	133.33
4.4	132.84
6.2	132.22
8.4	131.42
9.8	131.53
10.7	130.91
11.8	130.79
13.3	131.07
14.5	131.31
16.3	131.71
19.3	132.00
22.4	132.16

SUMMARY DATA	
Bankfull Elevation:	131.7
Bankfull Cross-Sectional Area:	4.0
Bankfull Width:	8.7
Flood Prone Area Elevation:	132.6
Flood Prone Width:	50.0
Max Depth at Bankfull:	0.9
Mean Depth at Bankfull:	0.5
W / D Ratio:	18.9
Entrenchment Ratio:	5.7
Bank Height Ratio:	1.0

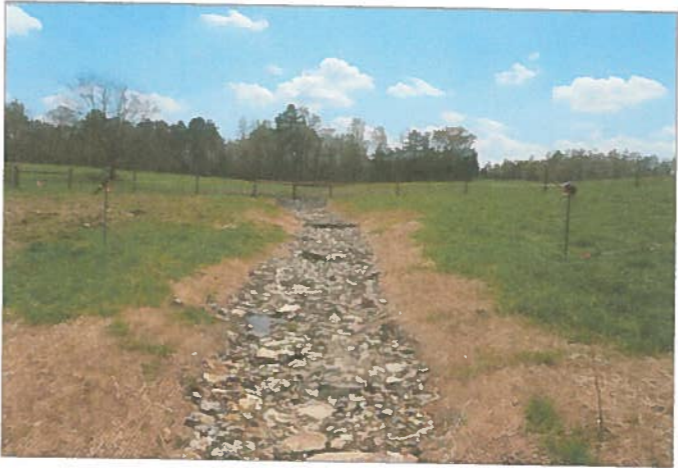
Site	Abbey Lamm
Watershed:	Cape Fear, 0303002
XS ID	UT 1a XS - 2, Riffle
Feature	Riffle
Date:	4/14/2015
Field Crew:	Perkinson, Gibbons

Station	Elevation
0.0	124.95
3.1	124.83
5.4	124.47
7.2	124.27
8.0	123.80
9.8	123.65
10.9	123.69
13.3	123.77
14.1	124.10
15.7	124.40
17.1	124.66
19.9	124.67

SUMMARY DATA	
Bankfull Elevation:	124.3
Bankfull Cross-Sectional Area:	3.4
Bankfull Width:	7.8
Flood Prone Area Elevation:	124.9
Flood Prone Width:	50.0
Max Depth at Bankfull:	0.6
Mean Depth at Bankfull:	0.4
W / D Ratio:	17.6
Entrenchment Ratio:	6.4
Bank Height Ratio:	1.0

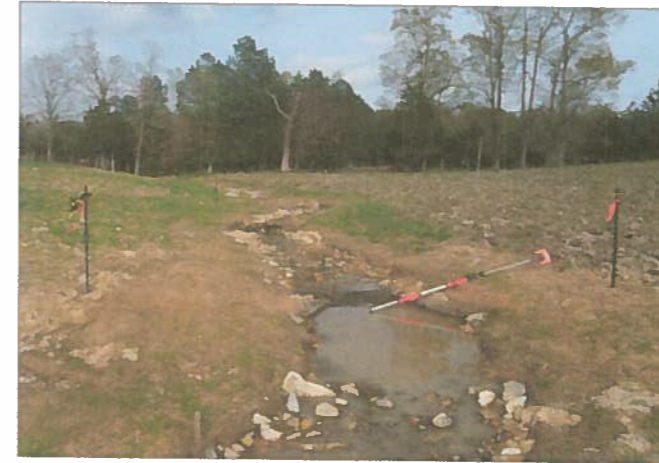
<b>Site</b>	Abbey Lamm
<b>Watershed:</b>	Cape Fear, 0303002
<b>XS ID</b>	UT 2 XS - 3, Pool
<b>Feature</b>	Pool
<b>Date:</b>	4/14/2015
<b>Field Crew:</b>	Perkinson, Gibbons

Station	Elevation
0.0	129.2
3.1	129.3
4.0	129.0
5.1	127.8
5.8	127.4
7.0	127.2
8.1	127.4
8.9	127.4
9.5	127.4
10.4	128.0
11.8	128.6
13.3	129.0
14.3	129.2
15.5	129.2
17.5	129.2

SUMMARY DATA	
<b>Bankfull Elevation:</b>	128.6
<b>Bankfull Cross-Sectional Area:</b>	7.2
<b>Bankfull Width:</b>	7.5
<b>Flood Prone Area Elevation:</b>	NA
<b>Flood Prone Width:</b>	NA
<b>Max Depth at Bankfull:</b>	1.4
<b>Mean Depth at Bankfull:</b>	1.0
<b>W / D Ratio:</b>	NA
<b>Entrenchment Ratio:</b>	NA
<b>Bank Height Ratio:</b>	1.0

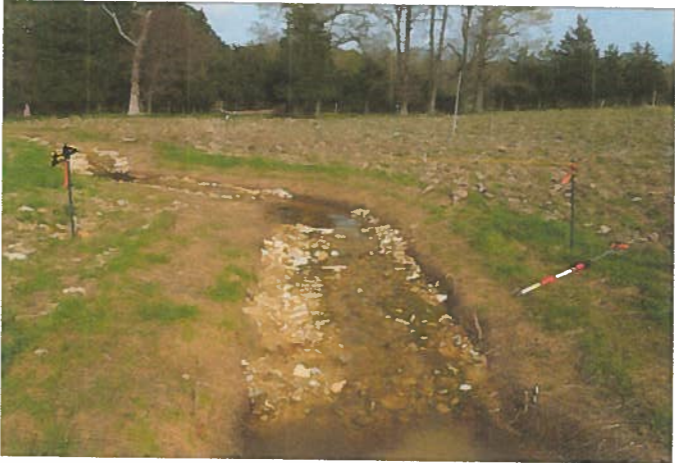
Site	Abbey Lamm
Watershed:	Cape Fear, 0303002
XS ID	UT 2 XS - 4, Riffle
Feature	Riffle
Date:	4/14/2015
Field Crew:	Perkinson, Gibbons

Station	Elevation
0.0	129.85
2.5	129.85
3.8	129.70
4.7	129.45
5.3	129.04
6.5	129.12
7.2	129.04
8.5	129.23
9.6	129.12
10.6	129.26
11.4	129.71
13.1	129.81
17.0	130.28

SUMMARY DATA	
Bankfull Elevation:	129.7
Bankfull Cross-Sectional Area:	3.6
Bankfull Width:	7.6
Flood Prone Area Elevation:	130.4
Flood Prone Width:	50.0
Max Depth at Bankfull:	0.7
Mean Depth at Bankfull:	0.5
W / D Ratio:	16.0
Entrenchment Ratio:	6.6
Bank Height Ratio:	1.0

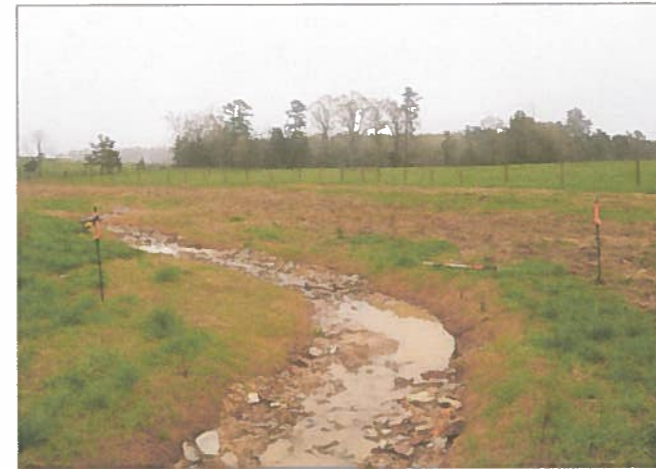
Site	Abbey Lamm
Watershed:	Cape Fear, 0303002
XS ID	UT 3 XS - 4, Pool
Feature	Pool
Date:	4/14/2015
Field Crew:	Perkinson, Gibbons

Station	Elevation
0.0	83.2
2.2	83.1
3.5	83.1
5.4	82.4
6.8	81.7
7.4	81.6
8.7	81.6
9.5	81.7
10.1	81.8
11.9	82.1
13.0	82.3
14.8	82.8
16.7	83.0
19.4	83.0

SUMMARY DATA	
Bankfull Elevation:	82.8
Bankfull Cross-Sectional Area:	7.5
Bankfull Width:	10.4
Flood Prone Area Elevation:	NA
Flood Prone Width:	NA
Max Depth at Bankfull:	1.2
Mean Depth at Bankfull:	0.7
W / D Ratio:	NA
Entrenchment Ratio:	NA
Bank Height Ratio:	1.0

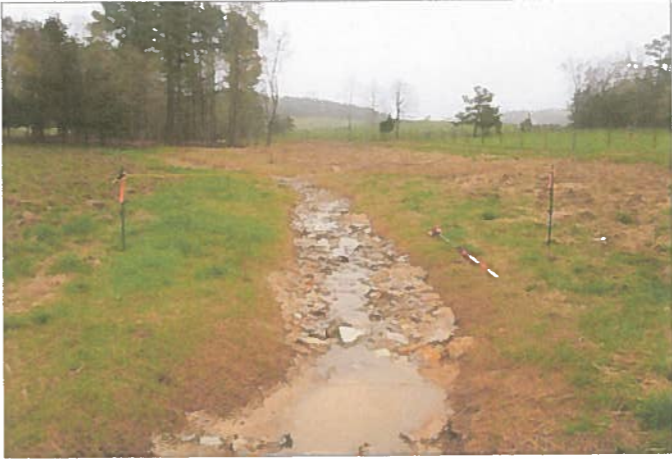
<b>Site</b>	Abbey Lamm
<b>Watershed:</b>	Cape Fear, 0303002
<b>XS ID</b>	UT 3 XS - 5, Riffle
<b>Feature</b>	Riffle
<b>Date:</b>	4/14/2015
<b>Field Crew:</b>	Perkinson, Gibbons

Station	Elevation
0.0	85.94
3.1	85.72
4.5	85.58
5.8	85.17
7.5	84.66
7.8	84.56
8.6	84.55
9.4	84.79
10.8	85.05
12.1	85.37
13.0	85.79
15.2	85.83
17.6	85.77

SUMMARY DATA	
<b>Bankfull Elevation:</b>	85.4
<b>Bankfull Cross-Sectional Area:</b>	3.1
<b>Bankfull Width:</b>	6.9
<b>Flood Prone Area Elevation:</b>	86.2
<b>Flood Prone Width:</b>	50.0
<b>Max Depth at Bankfull:</b>	0.8
<b>Mean Depth at Bankfull:</b>	0.4
<b>W / D Ratio:</b>	15.4
<b>Entrenchment Ratio:</b>	7.2
<b>Bank Height Ratio:</b>	1.0

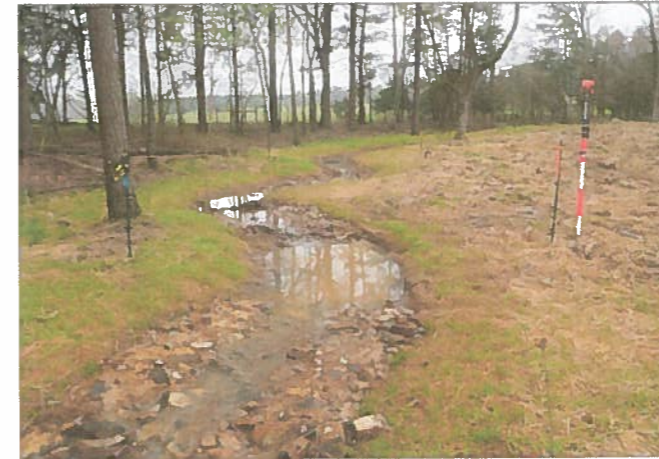
Site	Abbey Lamm
Watershed:	Cape Fear, 0303002
XS ID	UT 3 XS - 10, Pool
Feature	Pool
Date:	4/14/2015
Field Crew:	Perkinson, Gibbons

Station	Elevation
0.0	97.4
2.7	97.3
3.8	97.2
4.6	96.6
5.4	96.2
6.3	96.1
7.2	96.3
8.2	96.4
9.1	96.5
10.0	96.6
10.7	96.9
11.6	97.2
14.1	97.2

SUMMARY DATA	
Bankfull Elevation:	97.2
Bankfull Cross-Sectional Area:	5.0
Bankfull Width:	7.8
Flood Prone Area Elevation:	NA
Flood Prone Width:	NA
Max Depth at Bankfull:	1.0
Mean Depth at Bankfull:	0.6
W / D Ratio:	NA
Entrenchment Ratio:	NA
Bank Height Ratio:	1.0

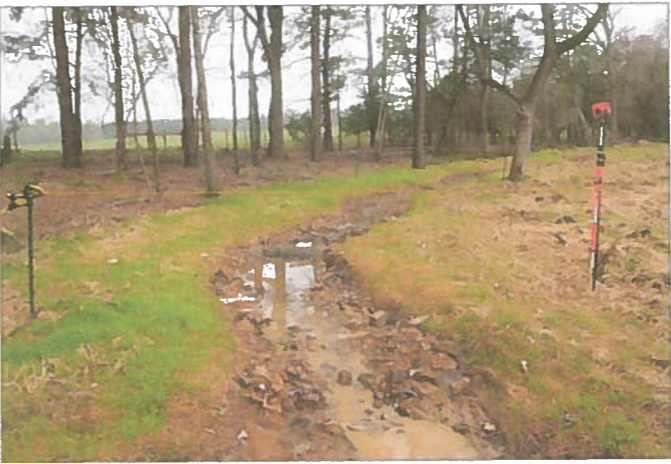
Site	Abbey Lamm
Watershed:	Cape Fear, 0303002
XS ID	UT 3 XS - 11, Riffle
Feature	Riffle
Date:	4/14/2015
Field Crew:	Perkinson, Gibbons

Station	Elevation
0.0	98.17
3.0	98.17
3.7	98.17
5.0	97.49
6.1	97.43
7.6	97.21
8.8	97.29
10.0	97.43
10.7	97.80
11.3	98.09
14.8	98.38

SUMMARY DATA	
Bankfull Elevation:	97.8
Bankfull Cross-Sectional Area:	2.5
Bankfull Width:	6.3
Flood Prone Area Elevation:	98.4
Flood Prone Width:	50.0
Max Depth at Bankfull:	0.6
Mean Depth at Bankfull:	0.4
W / D Ratio:	15.9
Entrenchment Ratio:	7.9
Bank Height Ratio:	1.0

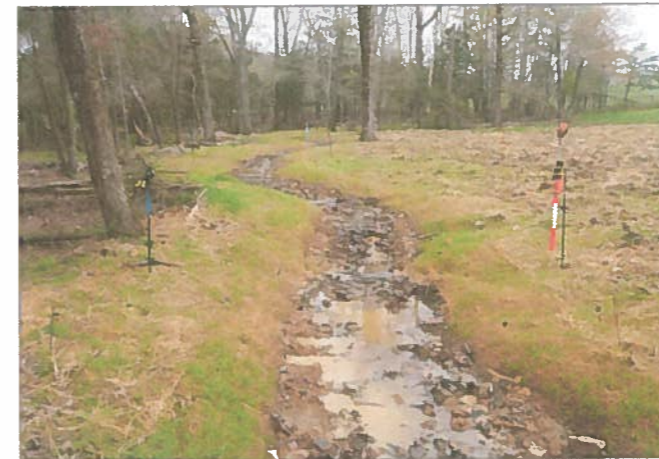
Site	Abbey Lamm
Watershed:	Cape Fear, 0303002
XS ID	UT 3 XS - 13, Pool
Feature	Pool
Date:	4/14/2015
Field Crew:	Perkinson, Gibbons

Station	Elevation
0.0	100.5
1.9	100.1
3.6	100.0
4.2	98.9
4.8	99.3
5.5	99.4
6.2	99.3
6.8	99.2
7.4	99.1
7.8	99.2
8.2	99.3
8.9	100.1
10.2	100.3
11.4	100.5
13.2	100.8

SUMMARY DATA	
Bankfull Elevation:	100.1
Bankfull Cross-Sectional Area:	4.1
Bankfull Width:	7.0
Flood Prone Area Elevation:	NA
Flood Prone Width:	NA
Max Depth at Bankfull:	1.2
Mean Depth at Bankfull:	0.6
W / D Ratio:	NA
Entrenchment Ratio:	NA
Bank Height Ratio:	1.0
