***BASELINE MONITORING DOCUMENT &
AS-BUILT BASELINE REPORT***

**ADKIN BRANCH STREAM RESTORATION PROJECT
PHASE 1 – WASHINGTON AVE. TO LINCOLN ST.**

Lenoir County, North Carolina
Project ID No. 050656101

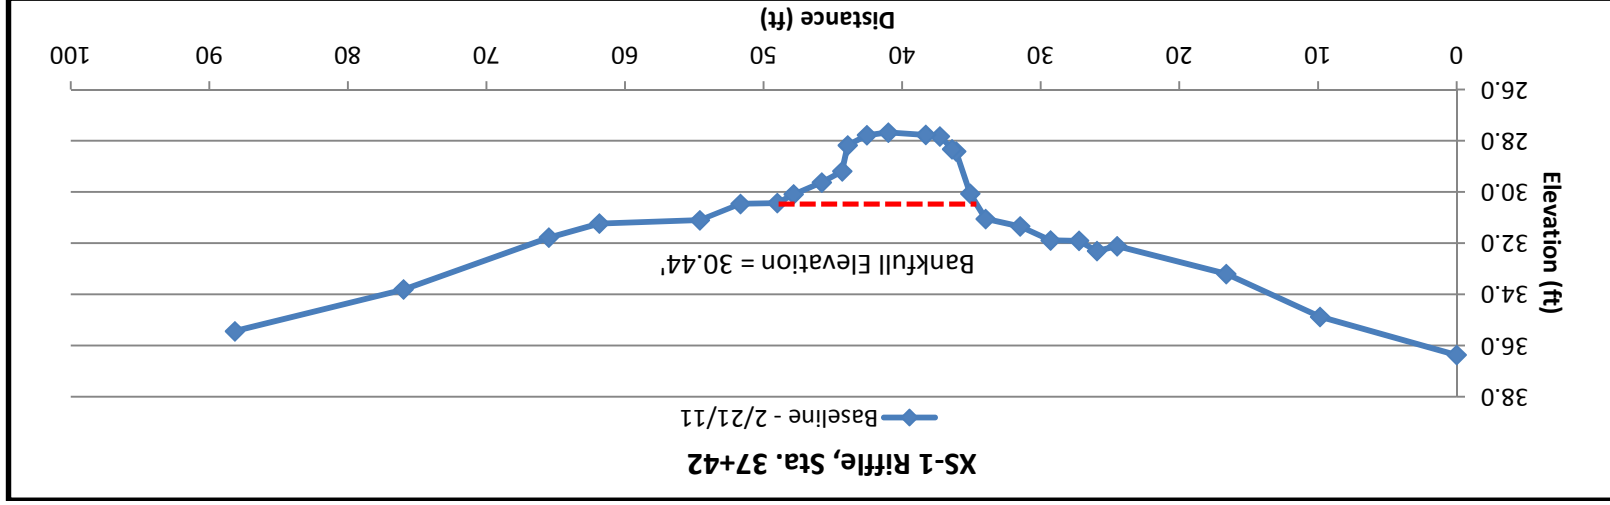
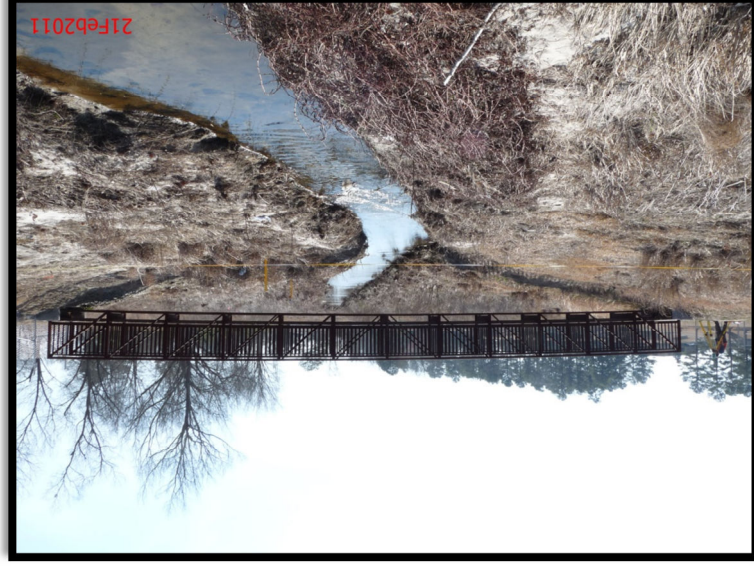
Reach 1 Cross Sections – Washington Ave. to Gordon St.

| 14.84 | Bankfull Width (ft) |
| 56.25 | Floodprone Width (ft) |
| 3.79 | Bankfull Entrenchment Ratio |
| 1 | Bankfull Bank Height Ratio |

Upon completion of grading and structure installation, a baseline survey was performed for the three monitoring reaches and 17 cross-sections. Baseline morphologic data is summarized in Tables 5a-c and Table 6 in Appendix B. Plots of the profiles are shown in Figures 14-16 in Appendix B. Cross-section plots and photos can also be found in Appendix B. Cross-section photos were taken facing in the downstream direction.

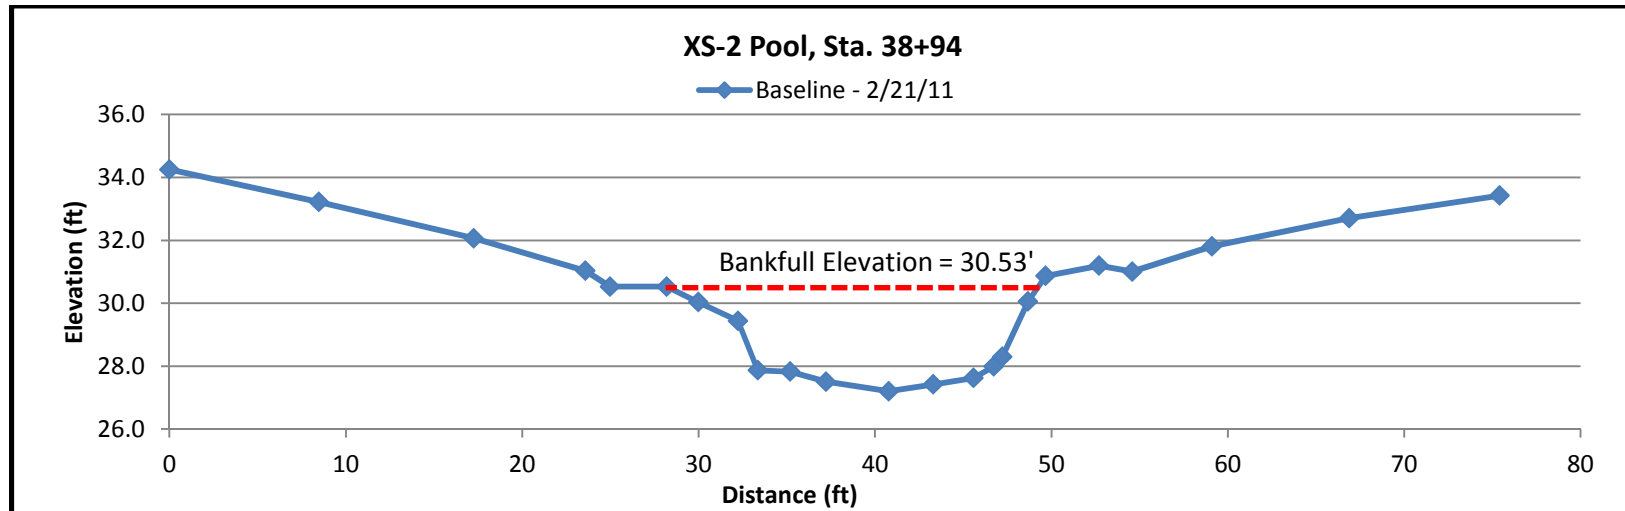
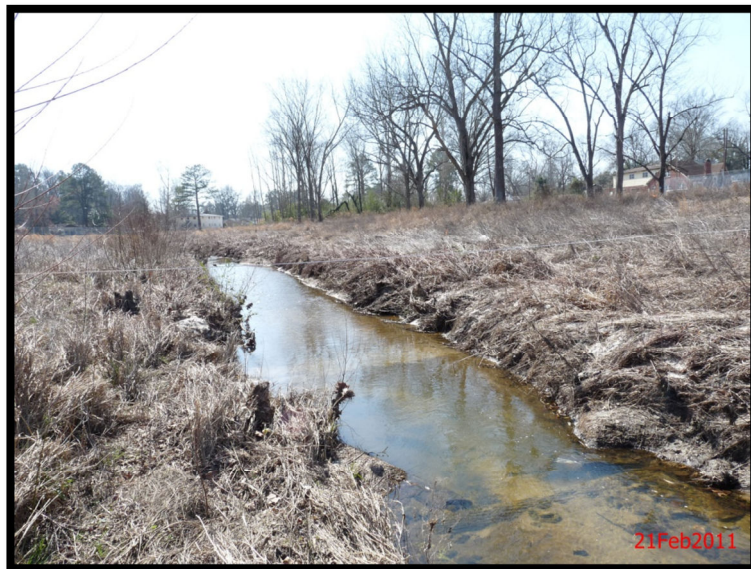
| Bankfull Width (ft) | 24.28 |
| Floodprone Width (ft) | 72.2 |
| Bankfull Entrenchment Ratio | 2.97 |
| Bankfull Bank Height Ratio | 1 |

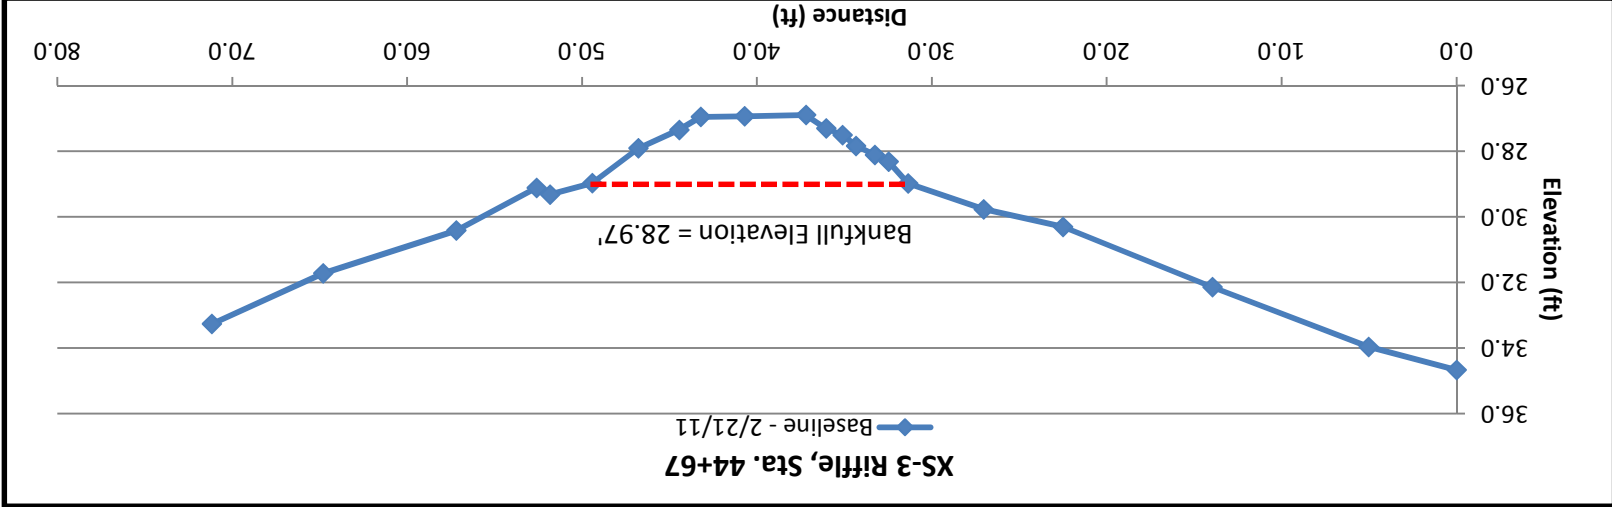
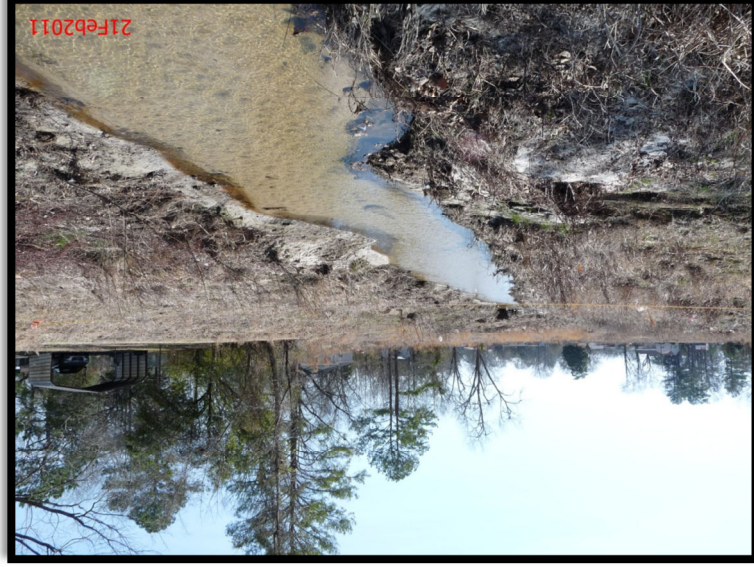
| Bankfull Width (ft) | 18.03 |
| Floodprone Width (ft) | 41.72 |
| Bankfull Entrenchment Ratio | 2.31 |
| Bankfull Bank Height Ratio | 1 |

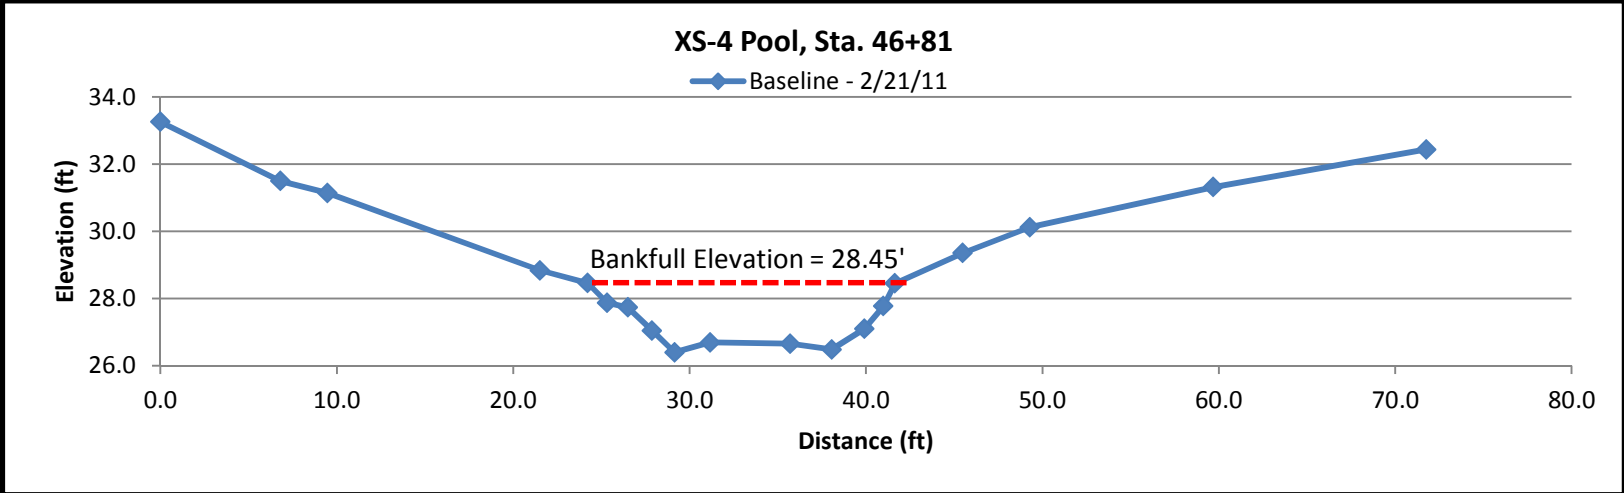
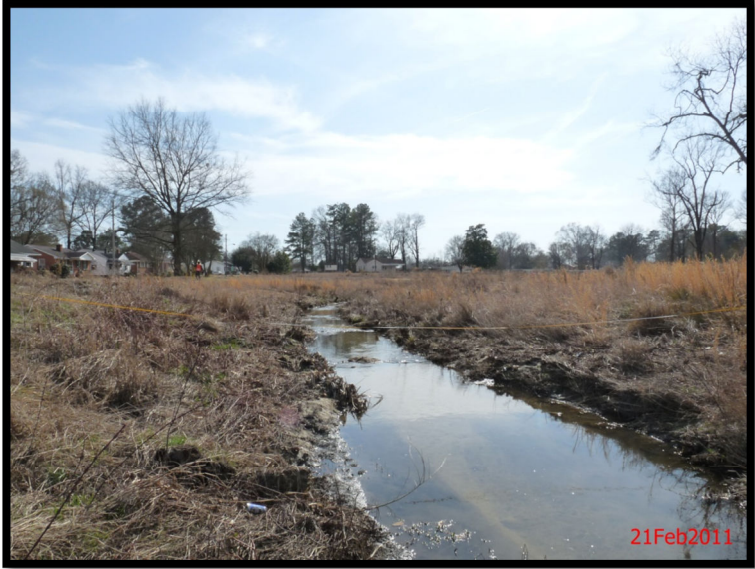
| Bankfull Width (ft) | 17.42 |
| Floodprone Width (ft) | 39.81 |
| Bankfull Bank Height Ratio | 1 |

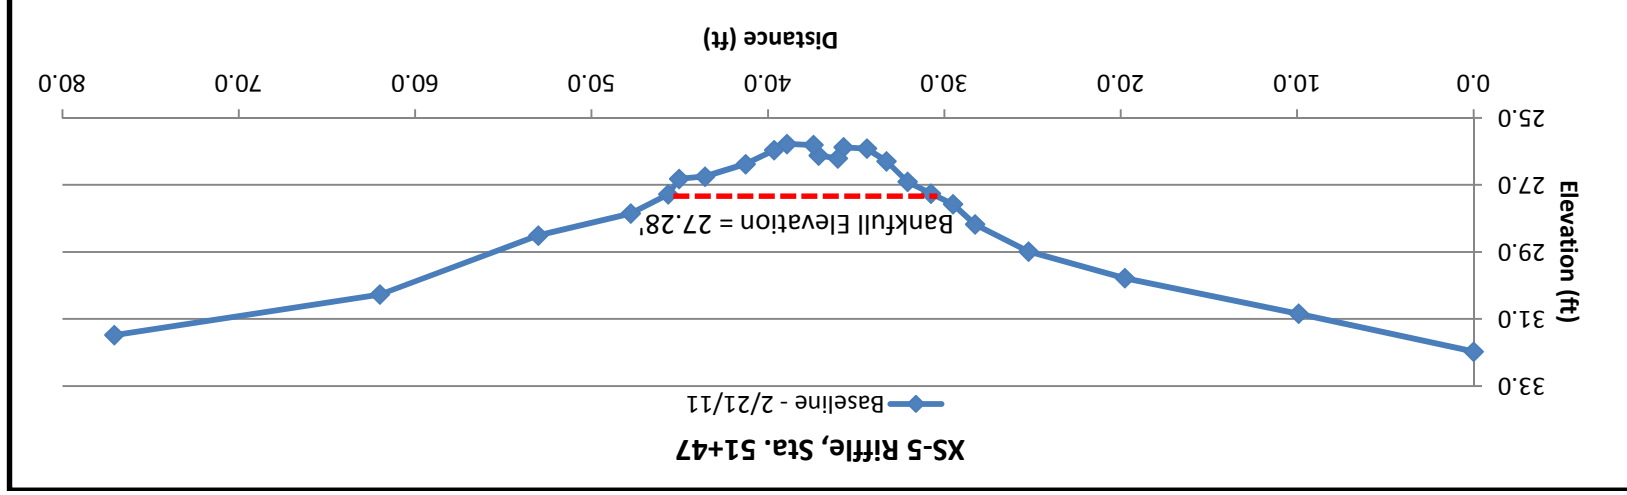
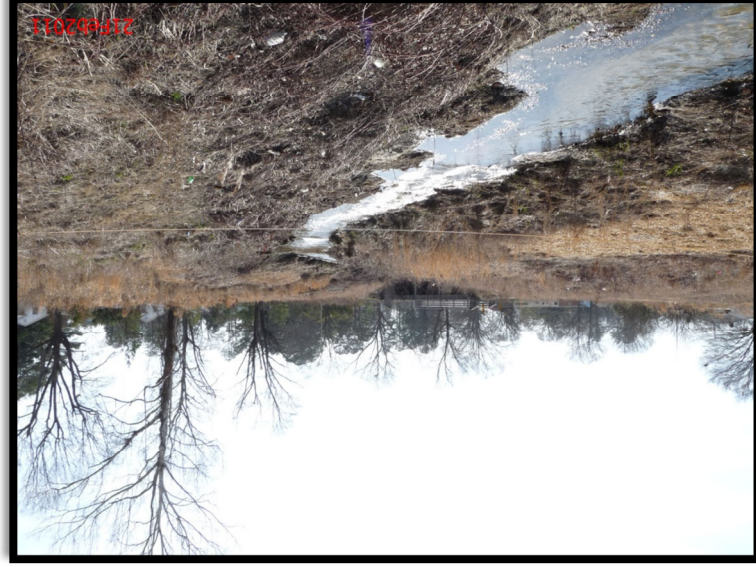
| Bankfull Width (ft) | 14.99 |
| Floodprone Width (ft) | 28.45 |

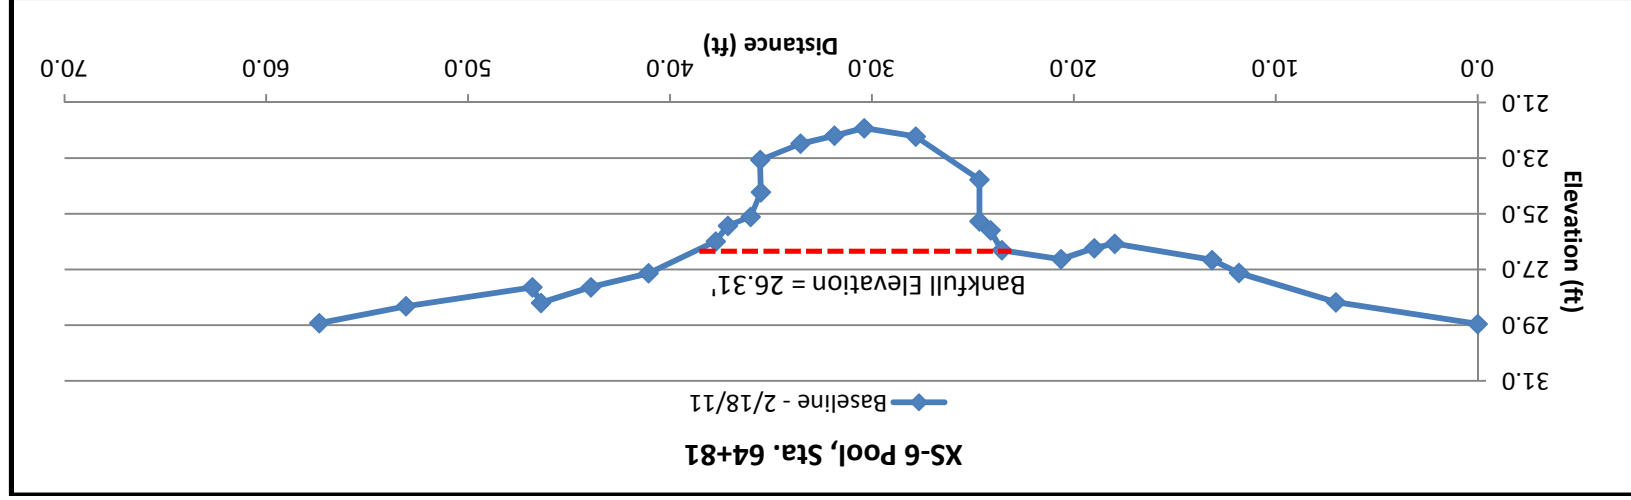
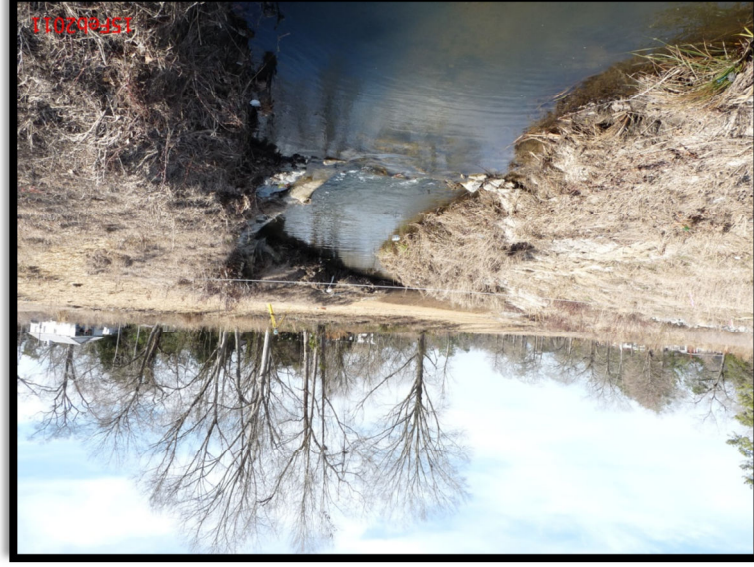
Reach 2 Cross Sections – Caswell St. to Lincoln St.

| Bankfull Width (ft) | 15.1 |
| Floodprone Width (ft) | 57.39 |
| Bankfull Entrenchment Ratio | 3.8 |
| Bankfull Bank Height Ratio | 1 |

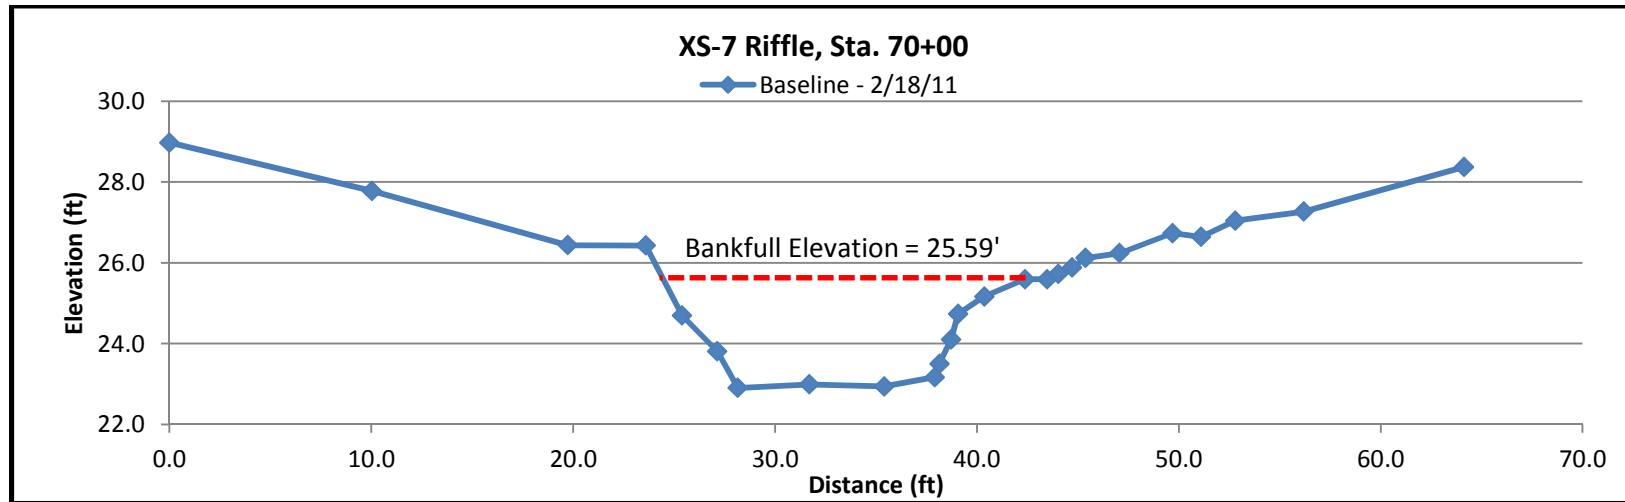
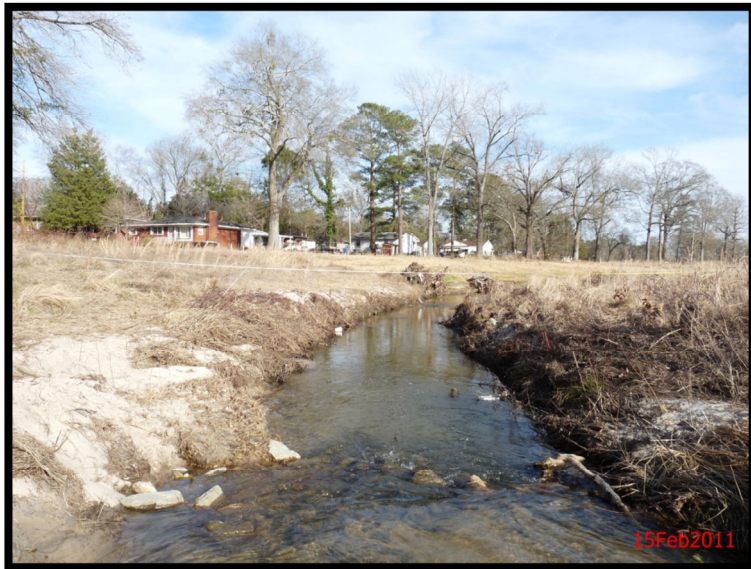
| Bankfull Width (ft) | 17.91 |
| Floodprone Width (ft) | 57.58 |
| Bankfull Entrenchment Ratio | 3.22 |
| Bankfull Bank Height Ratio | 1 |

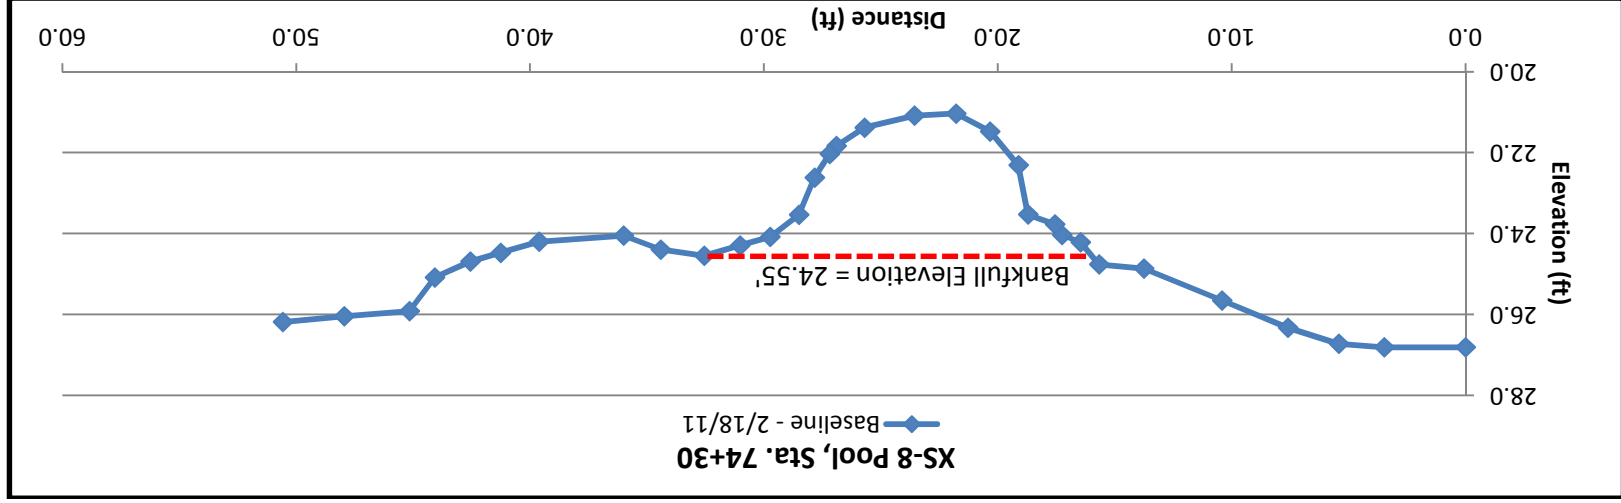
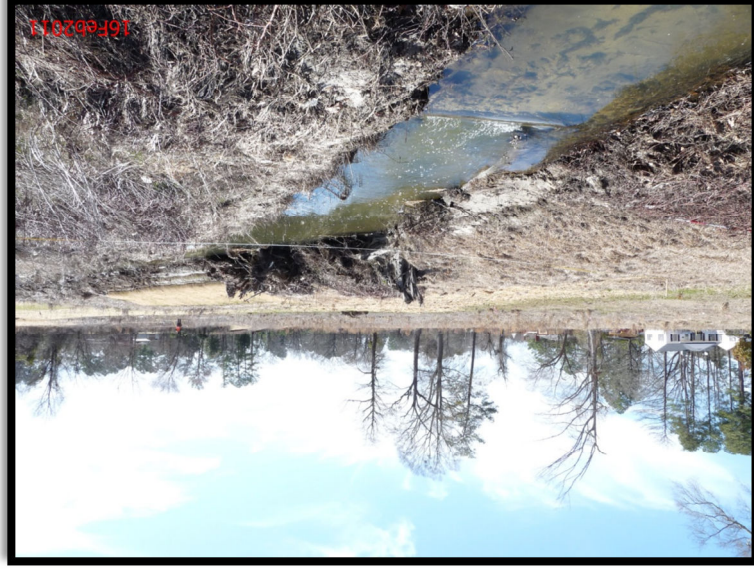
| 16.57 | Bankfull Width (ft) |
| 50.57 | Floodprone Width (ft) |
| 1 | Bankfull Bank Height Ratio |

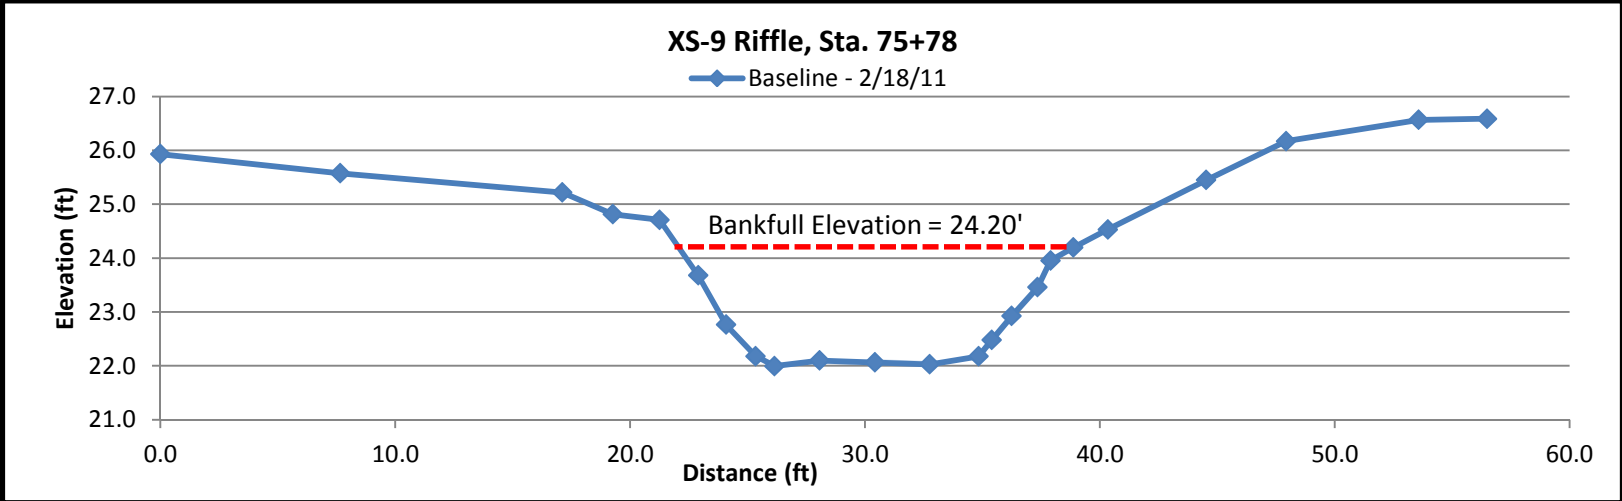
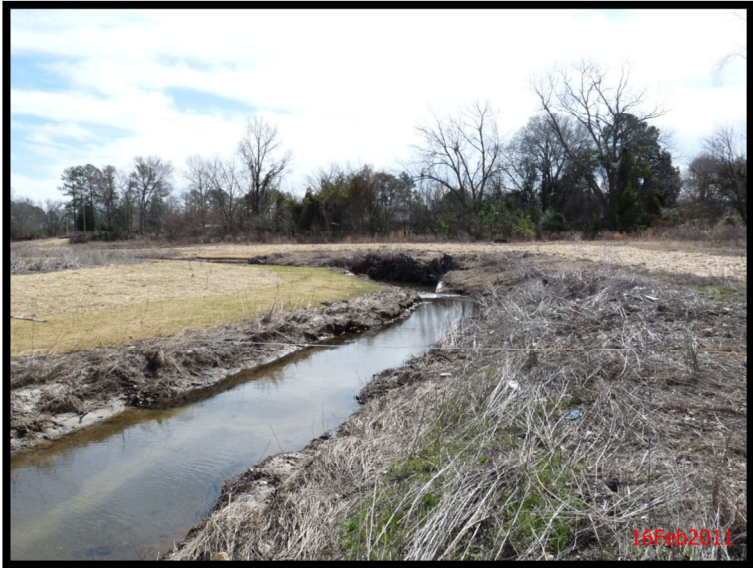
| Bankfull Width (ft) | 16.81 |
| Floodprone Width (ft) | 51.29 |
| Bankfull Entrenchment Ratio | 3.05 |
| Bankfull Bank Height Ratio | 1 |

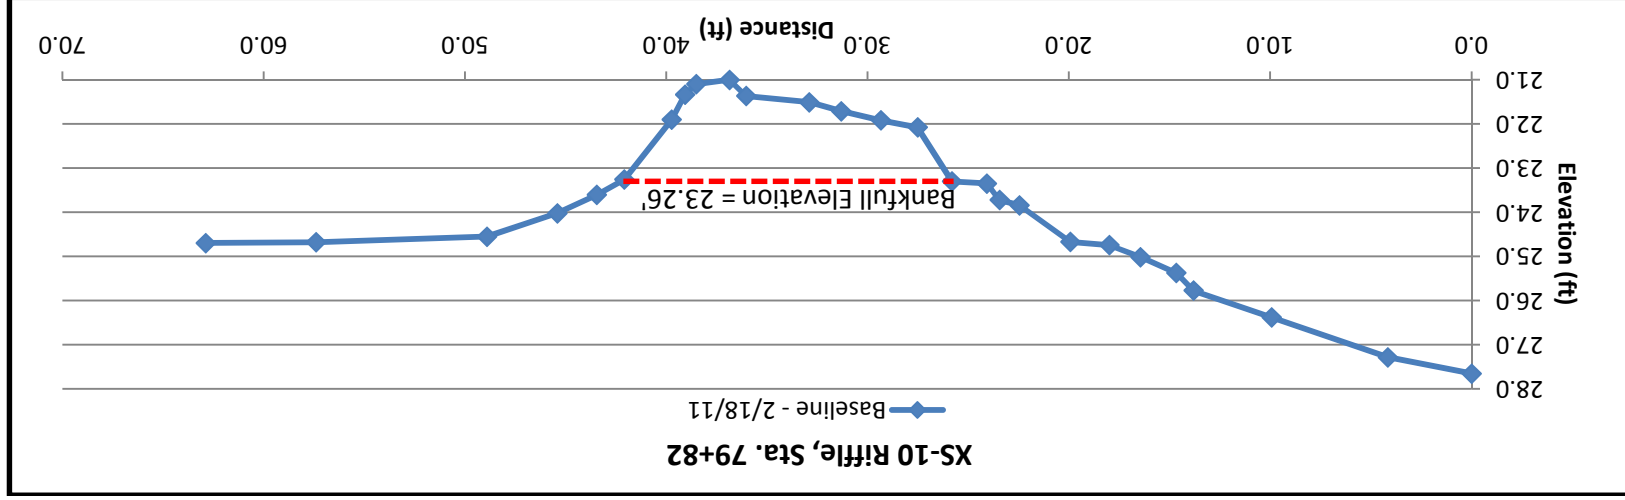
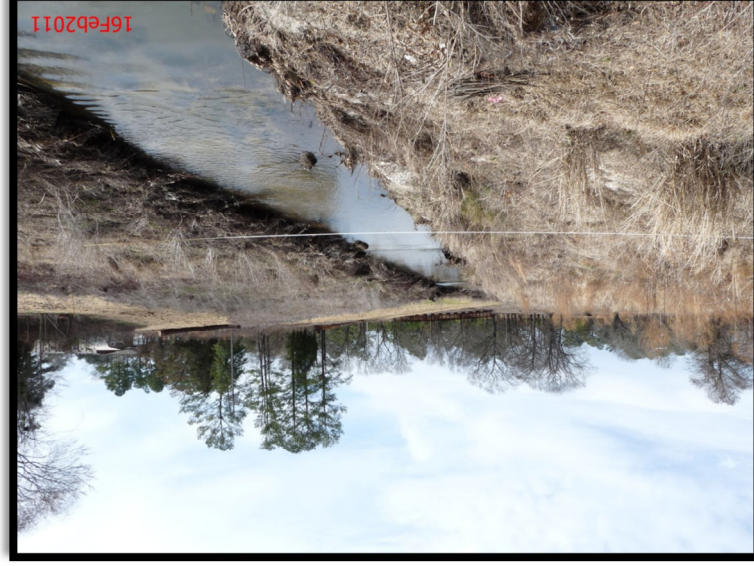
| Bankfull Width (ft) | 16.23 |
| Floodprone Width (ft) | 48.33 |
| Bankfull Bank Height Ratio | 1 |

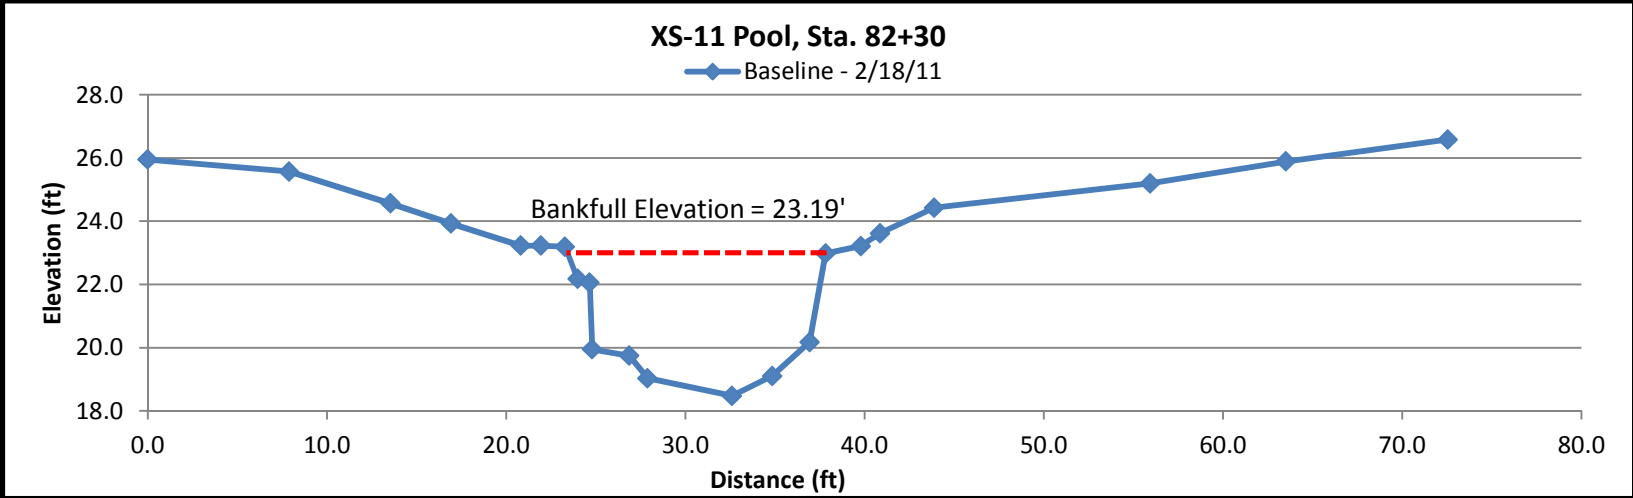
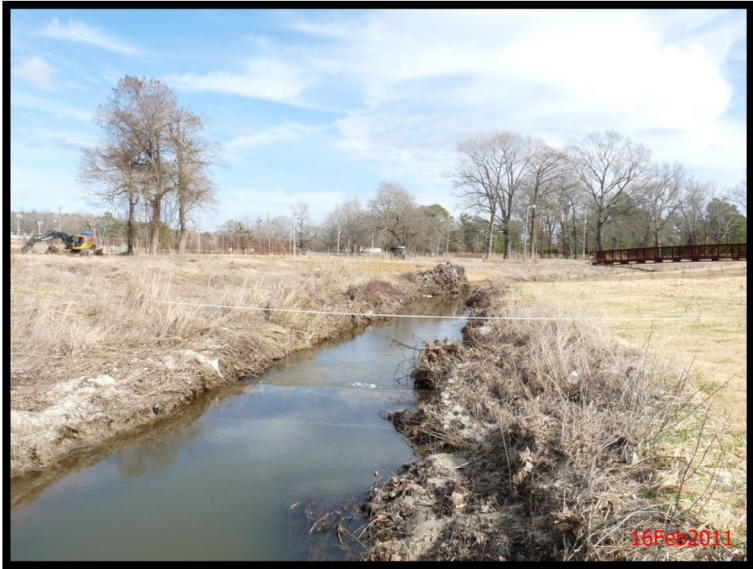
| Bankfull Width (ft) | 16.31 |
| Floodprone Width (ft) | 72.56 |

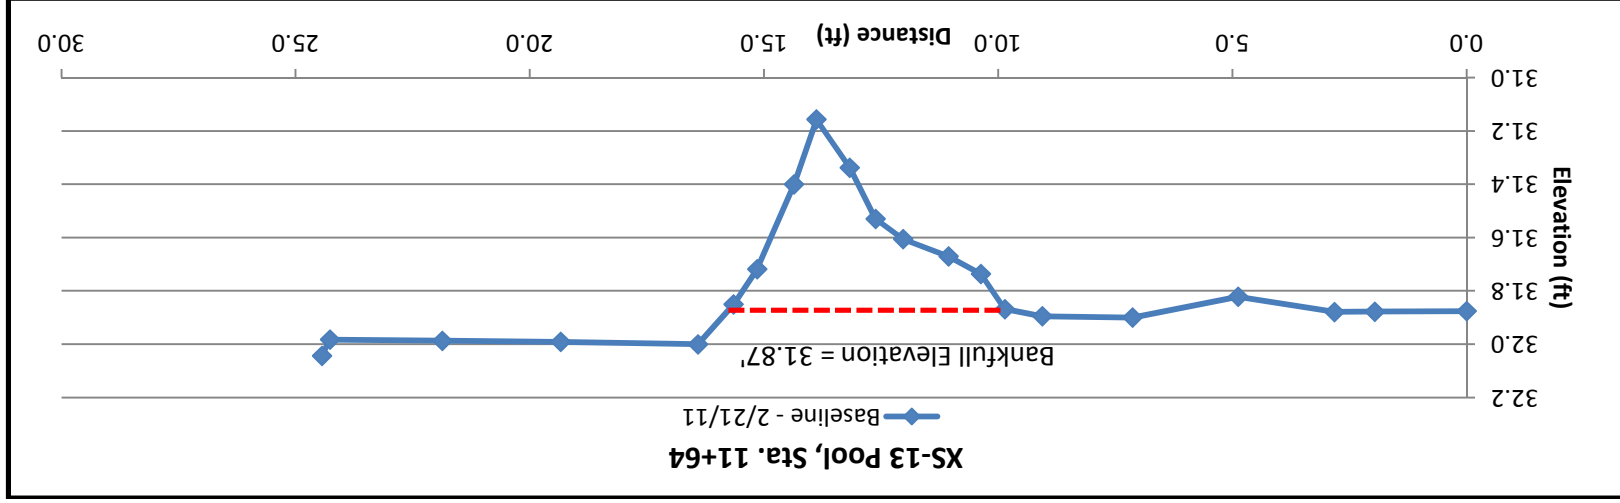
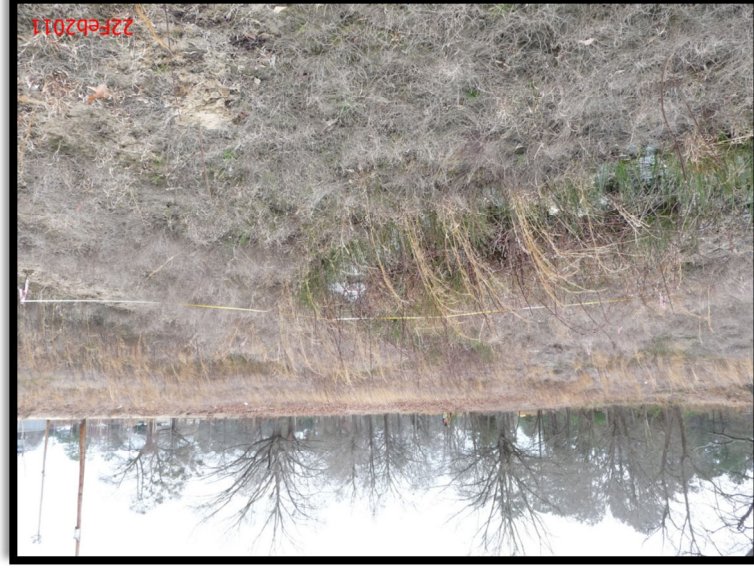
Reach 3 Cross Sections – UT to Adkin Branch

| Bankfull Width (ft) | 5.89 |
| Floodprone Width (ft) | 24.44 |
| Bankfull Entrenchment Ratio | 4.15 |
| Bankfull Bank Height Ratio | 1 |

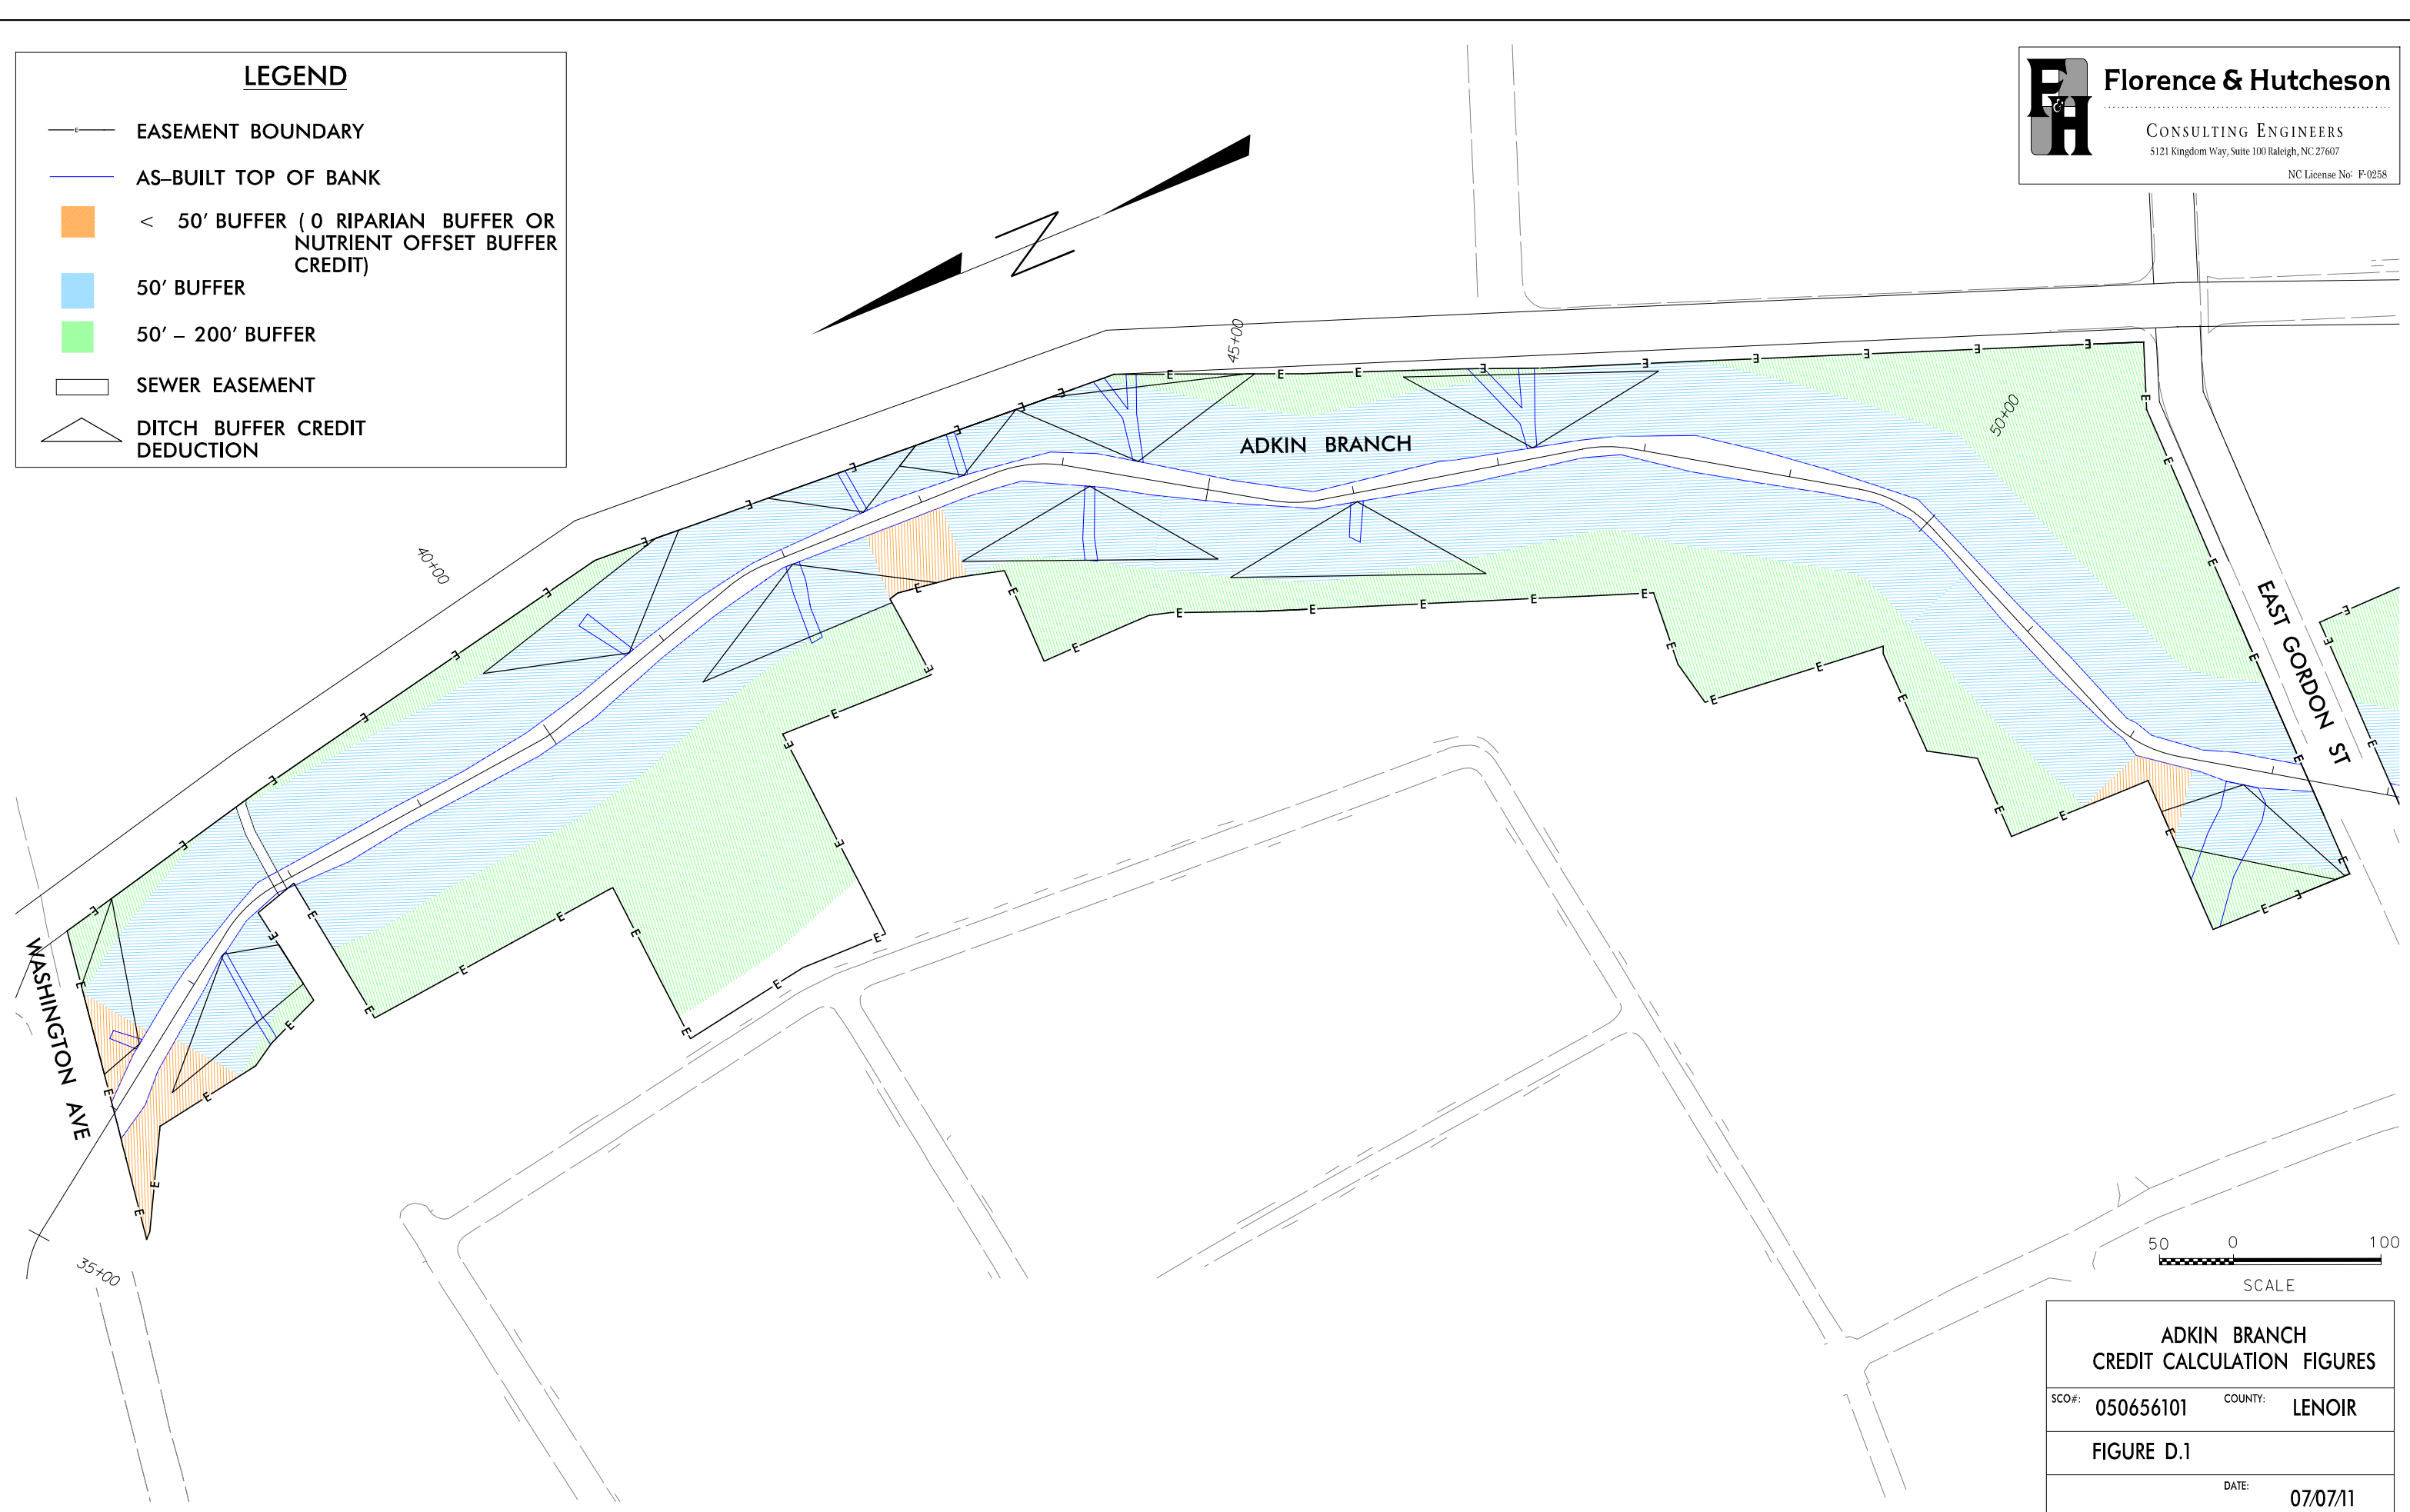
| ADKIN BRANCH CREDIT CALCULATION FIGURES | |

DITCH BUFFER CREDIT DEDUCTION

Stream lengths and buffer areas were outlined and measured in MicroStation. For each buffered ditch entering the project area, 0.10 acres was deducted from the corresponding buffer area (DWQ Memo #2008-019, dated August 19, 2008). For areas with buffer widths between 50’ to 200’, the buffers were divided into areas with similar widths and assigned an average width to determine the appropriate buffer correction factor. A similar approach was used for SR credits. Each reach was divided into segments with similar buffer widths to determine the percent increase or decrease in stream restoration credit. Left and right banks were calculated separately and then averaged to determine total credits.
