***BASELINE MONITORING DOCUMENT &
AS-BUILT BASELINE REPORT***

**ADKIN BRANCH STREAM RESTORATION PROJECT
PHASE 1 – WASHINGTON AVE. TO LINCOLN ST.**

Lenoir County, North Carolina
Project ID No. 050656101

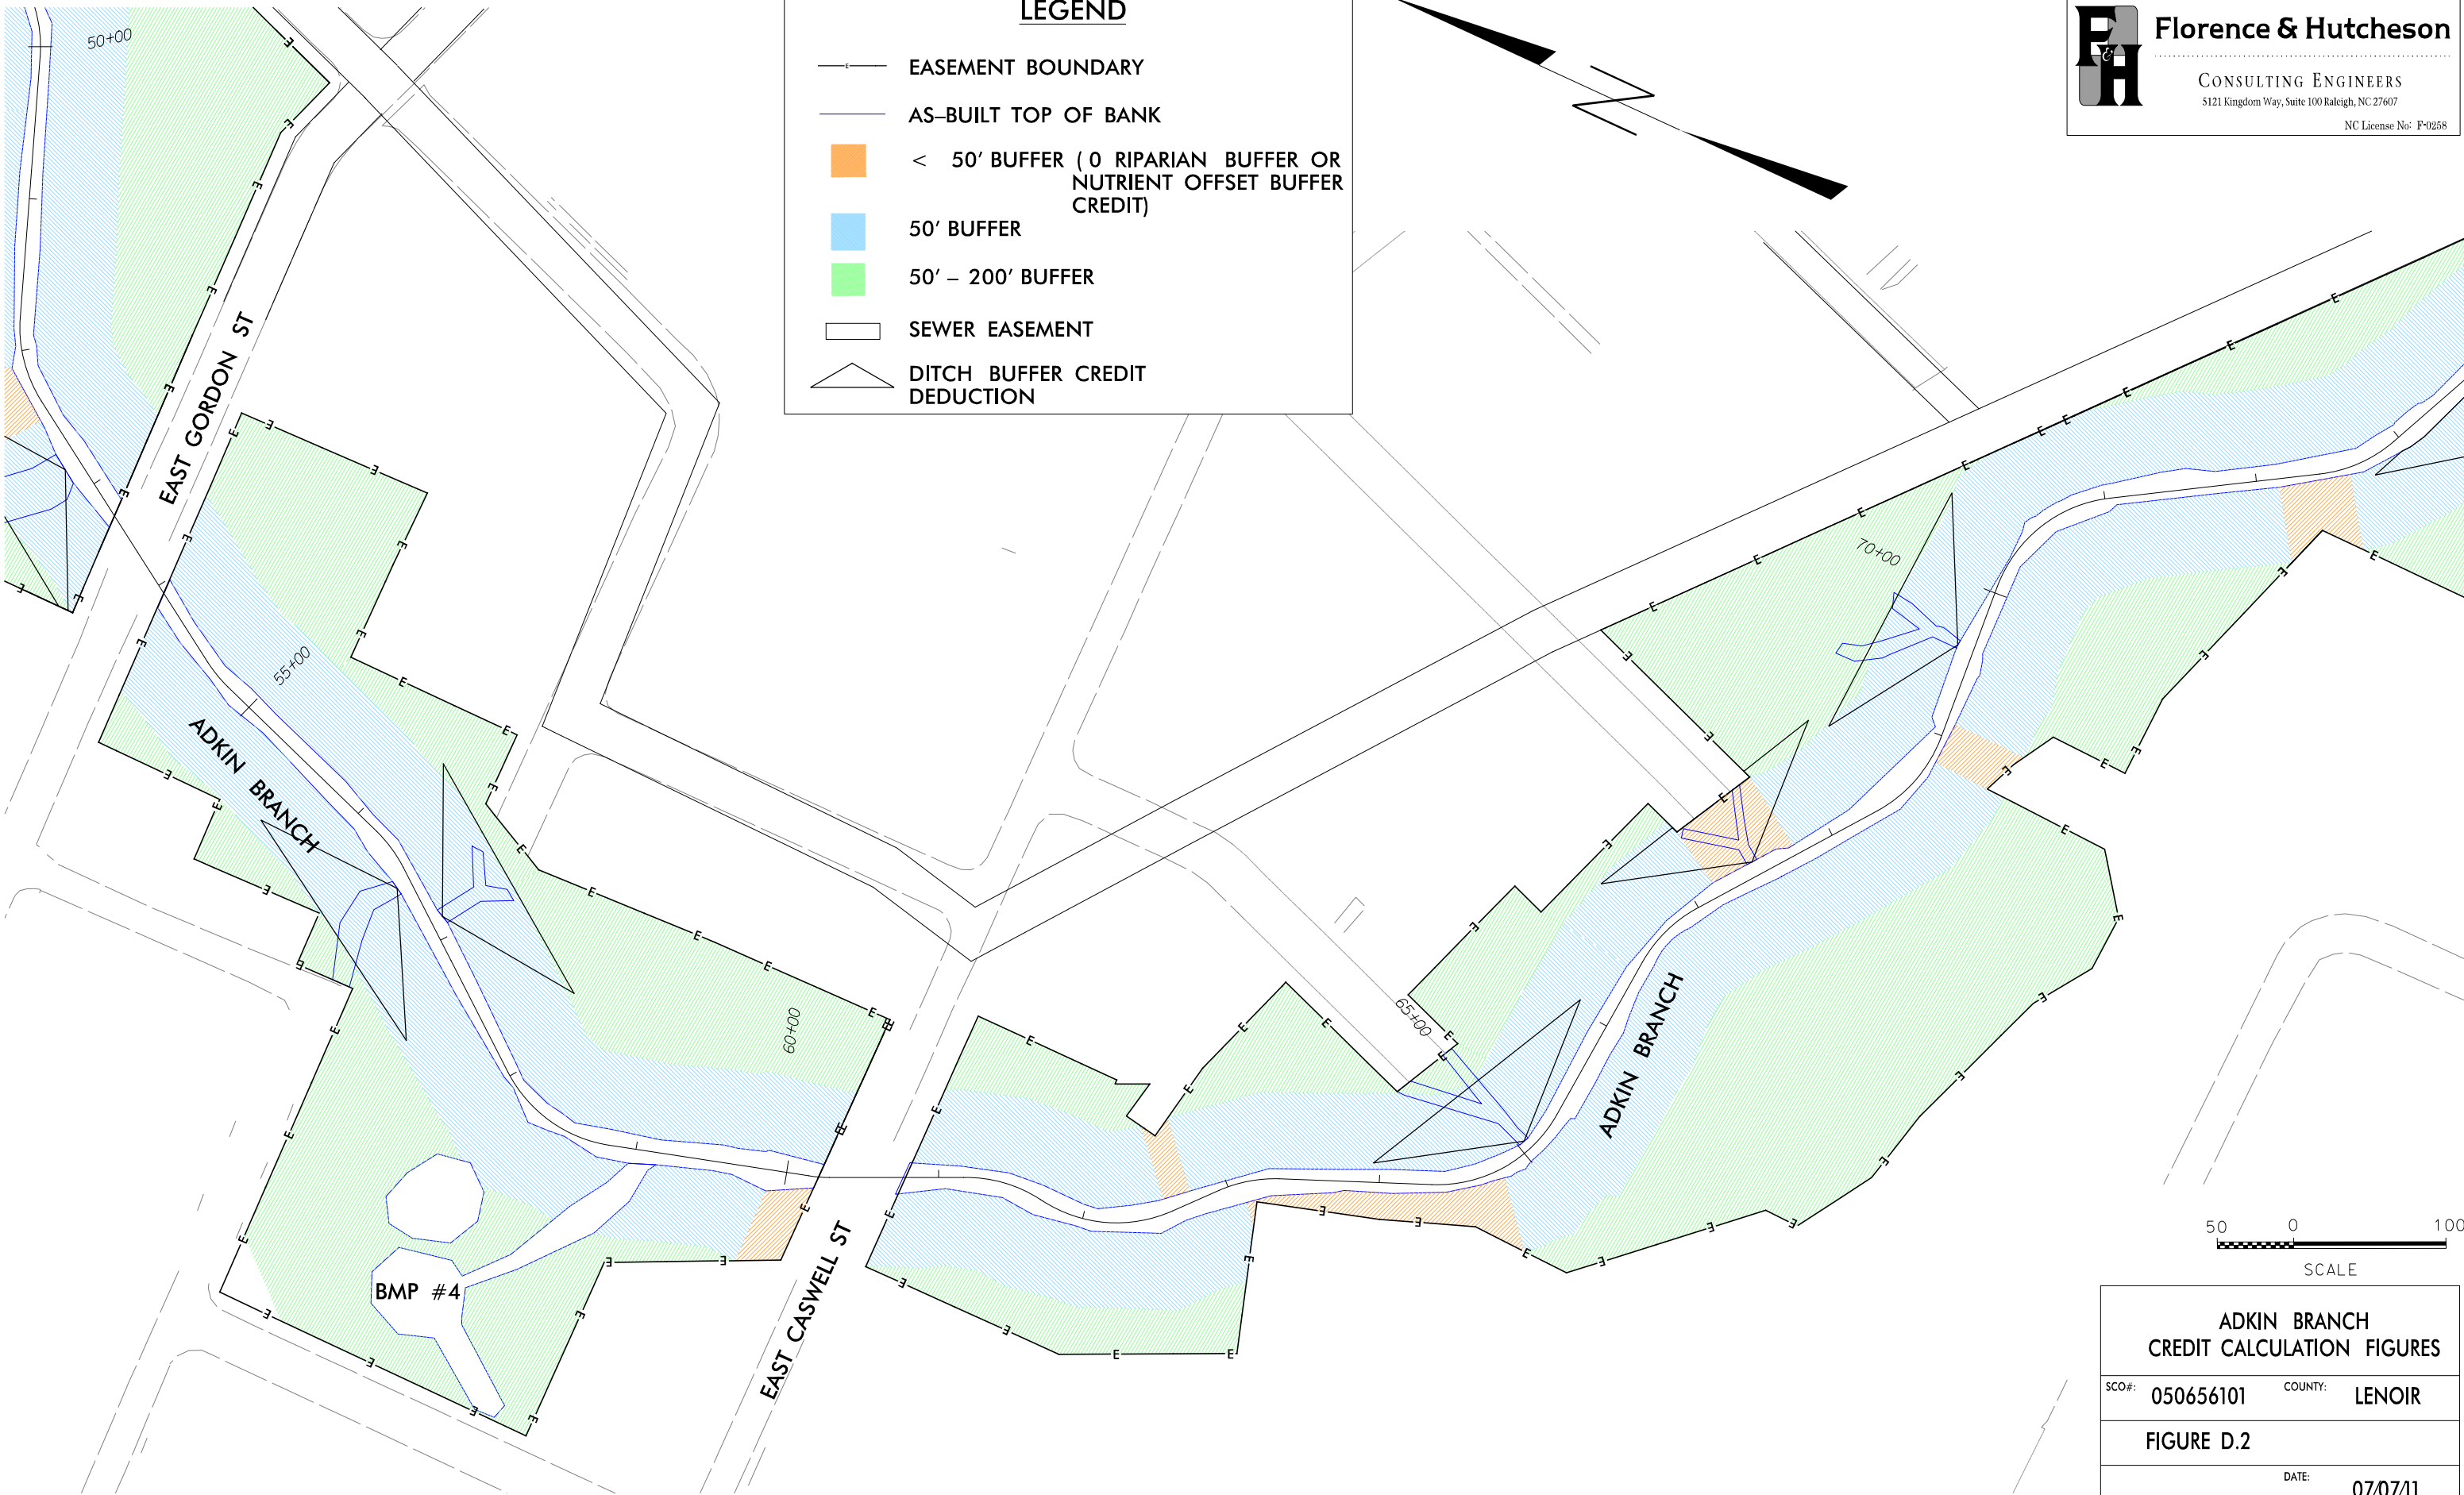
| ADKIN BRANCH CREDIT CALCULATION FIGURES | |

DITCH BUFFER CREDIT DEDUCTION

Stream lengths and buffer areas were outlined and measured in MicroStation. For each buffered ditch entering the project area, 0.10 acres was deducted from the corresponding buffer area (DWQ Memo #2008-019, dated August 19, 2008). For areas with buffer widths between 50’ to 200’, the buffers were divided into areas with similar widths and assigned an average width to determine the appropriate buffer correction factor. A similar approach was used for SR credits. Each reach was divided into segments with similar buffer widths to determine the percent increase or decrease in stream restoration credit. Left and right banks were calculated separately and then averaged to determine total credits.

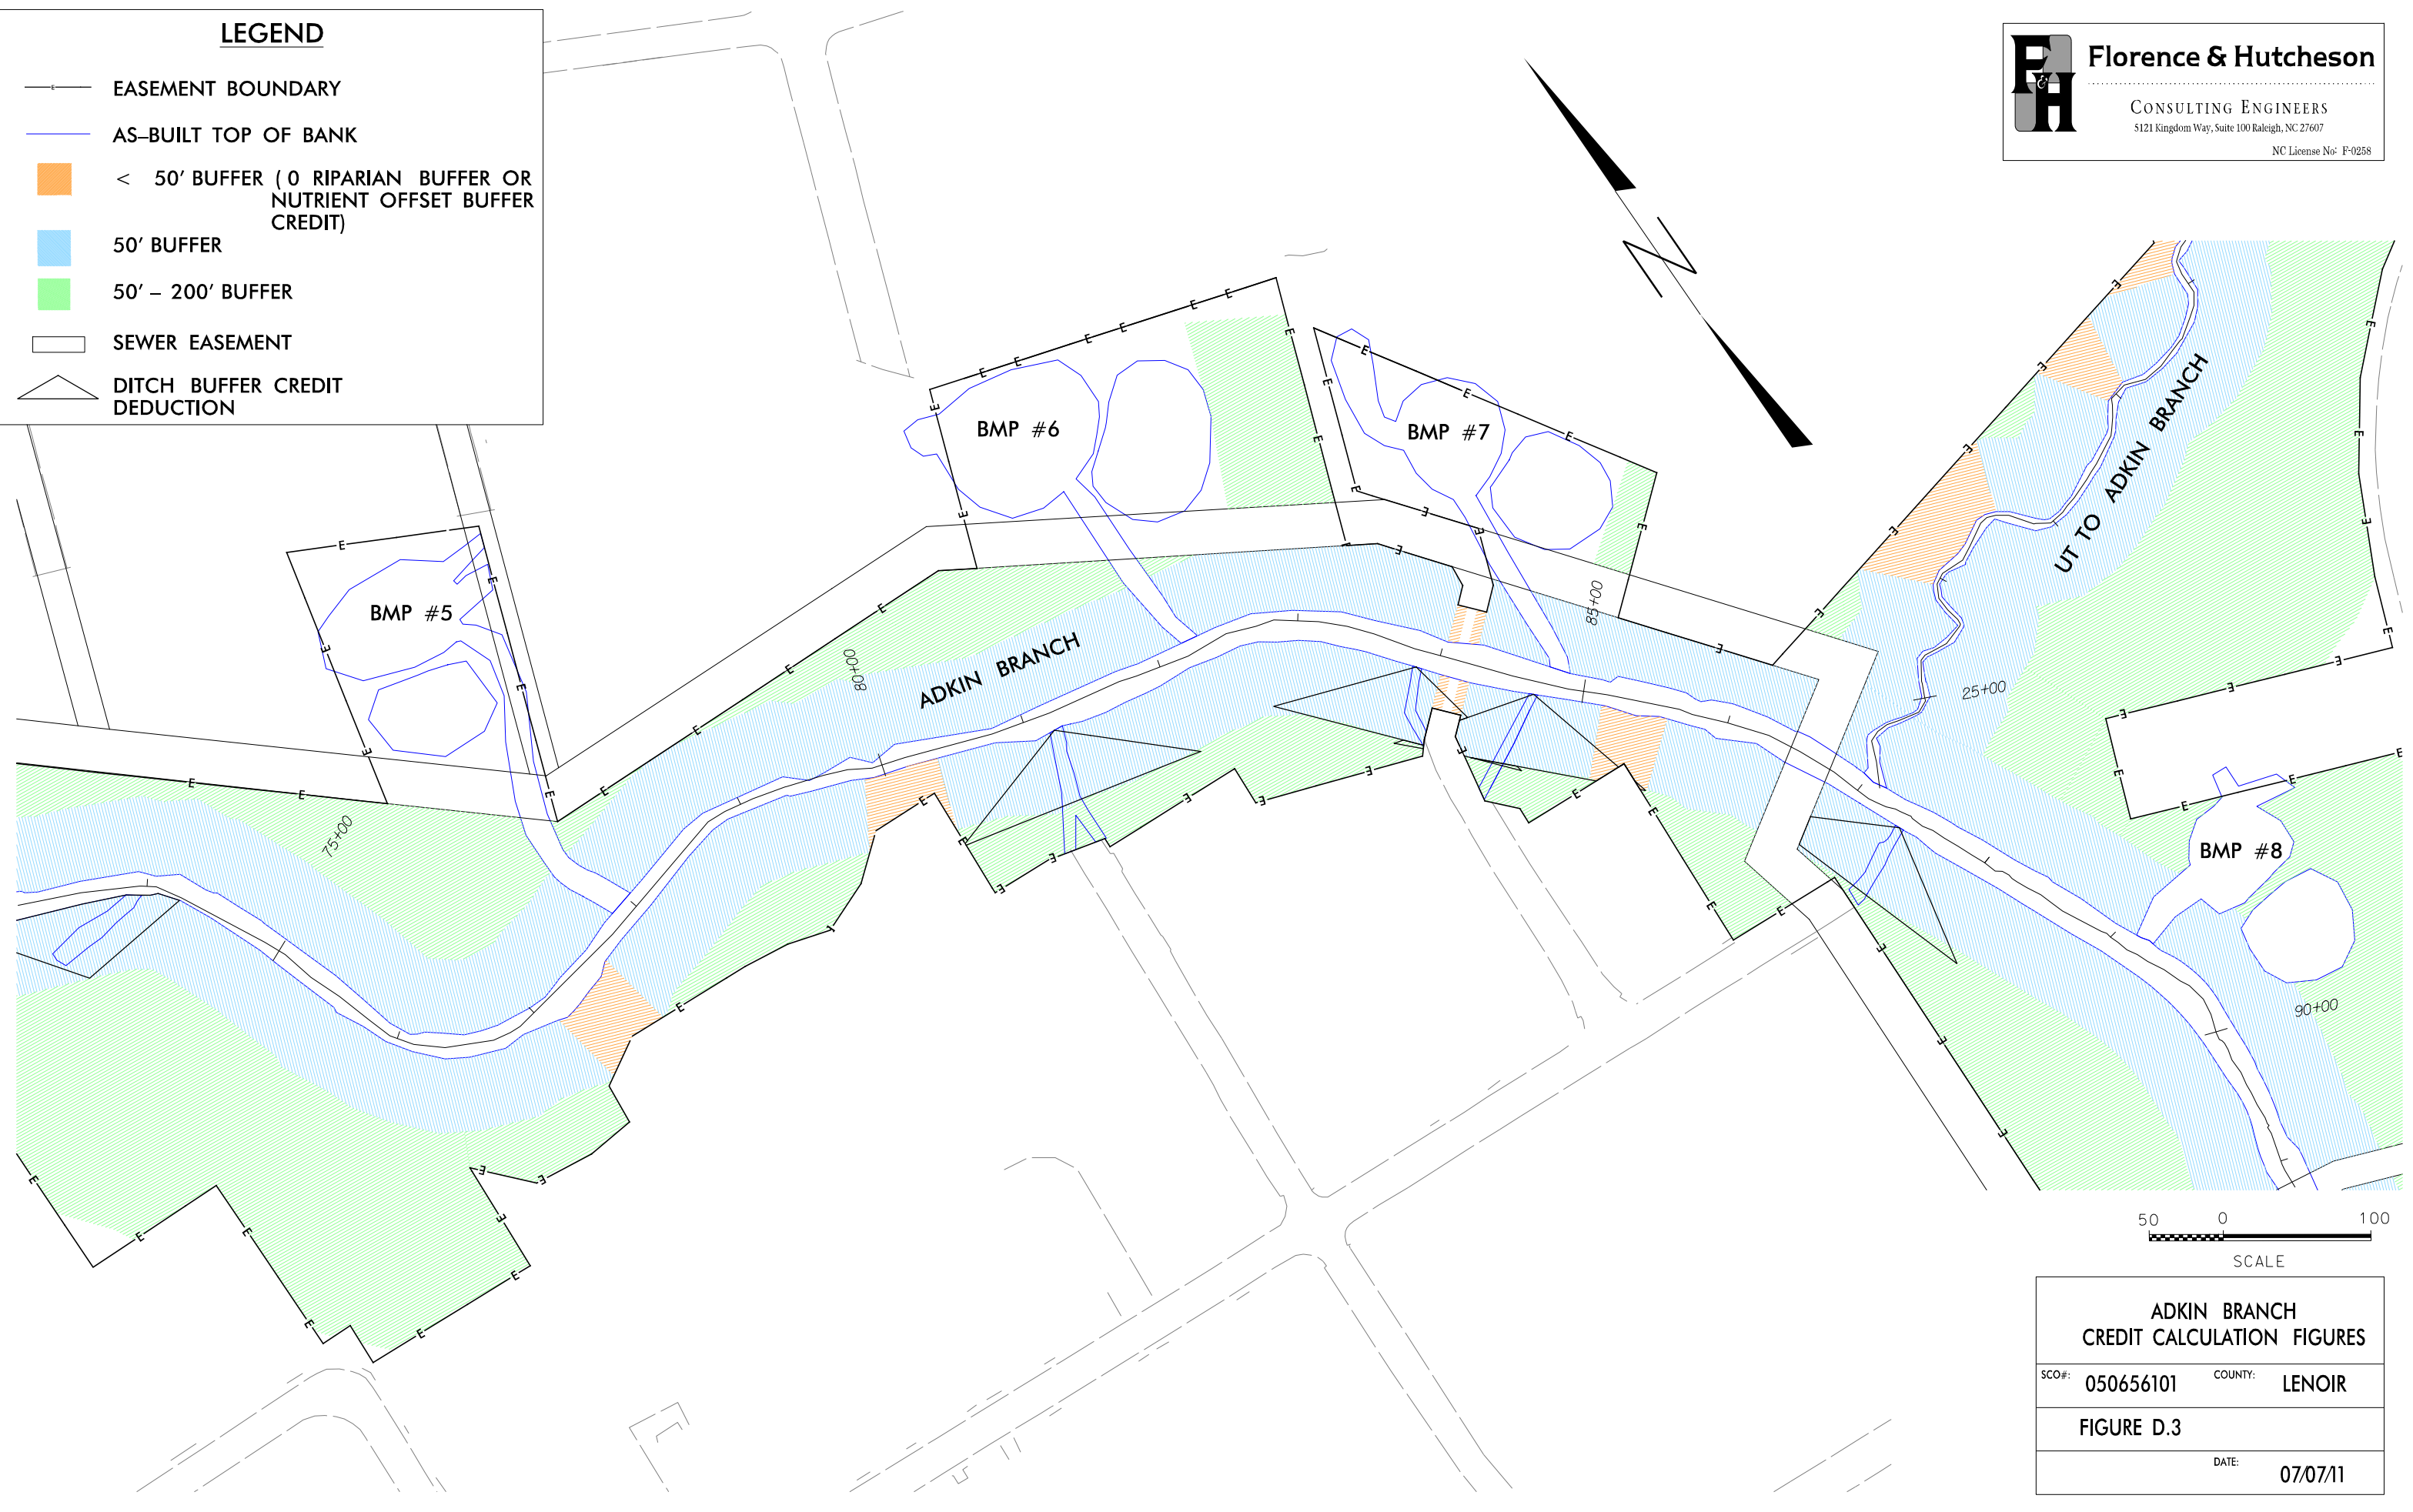
| ADKIN BRANCH CREDIT CALCULATION FIGURES | |
|--|---|
| FIGURE D.3 | |

DITCH BUFFER CREDIT DEDUCTION

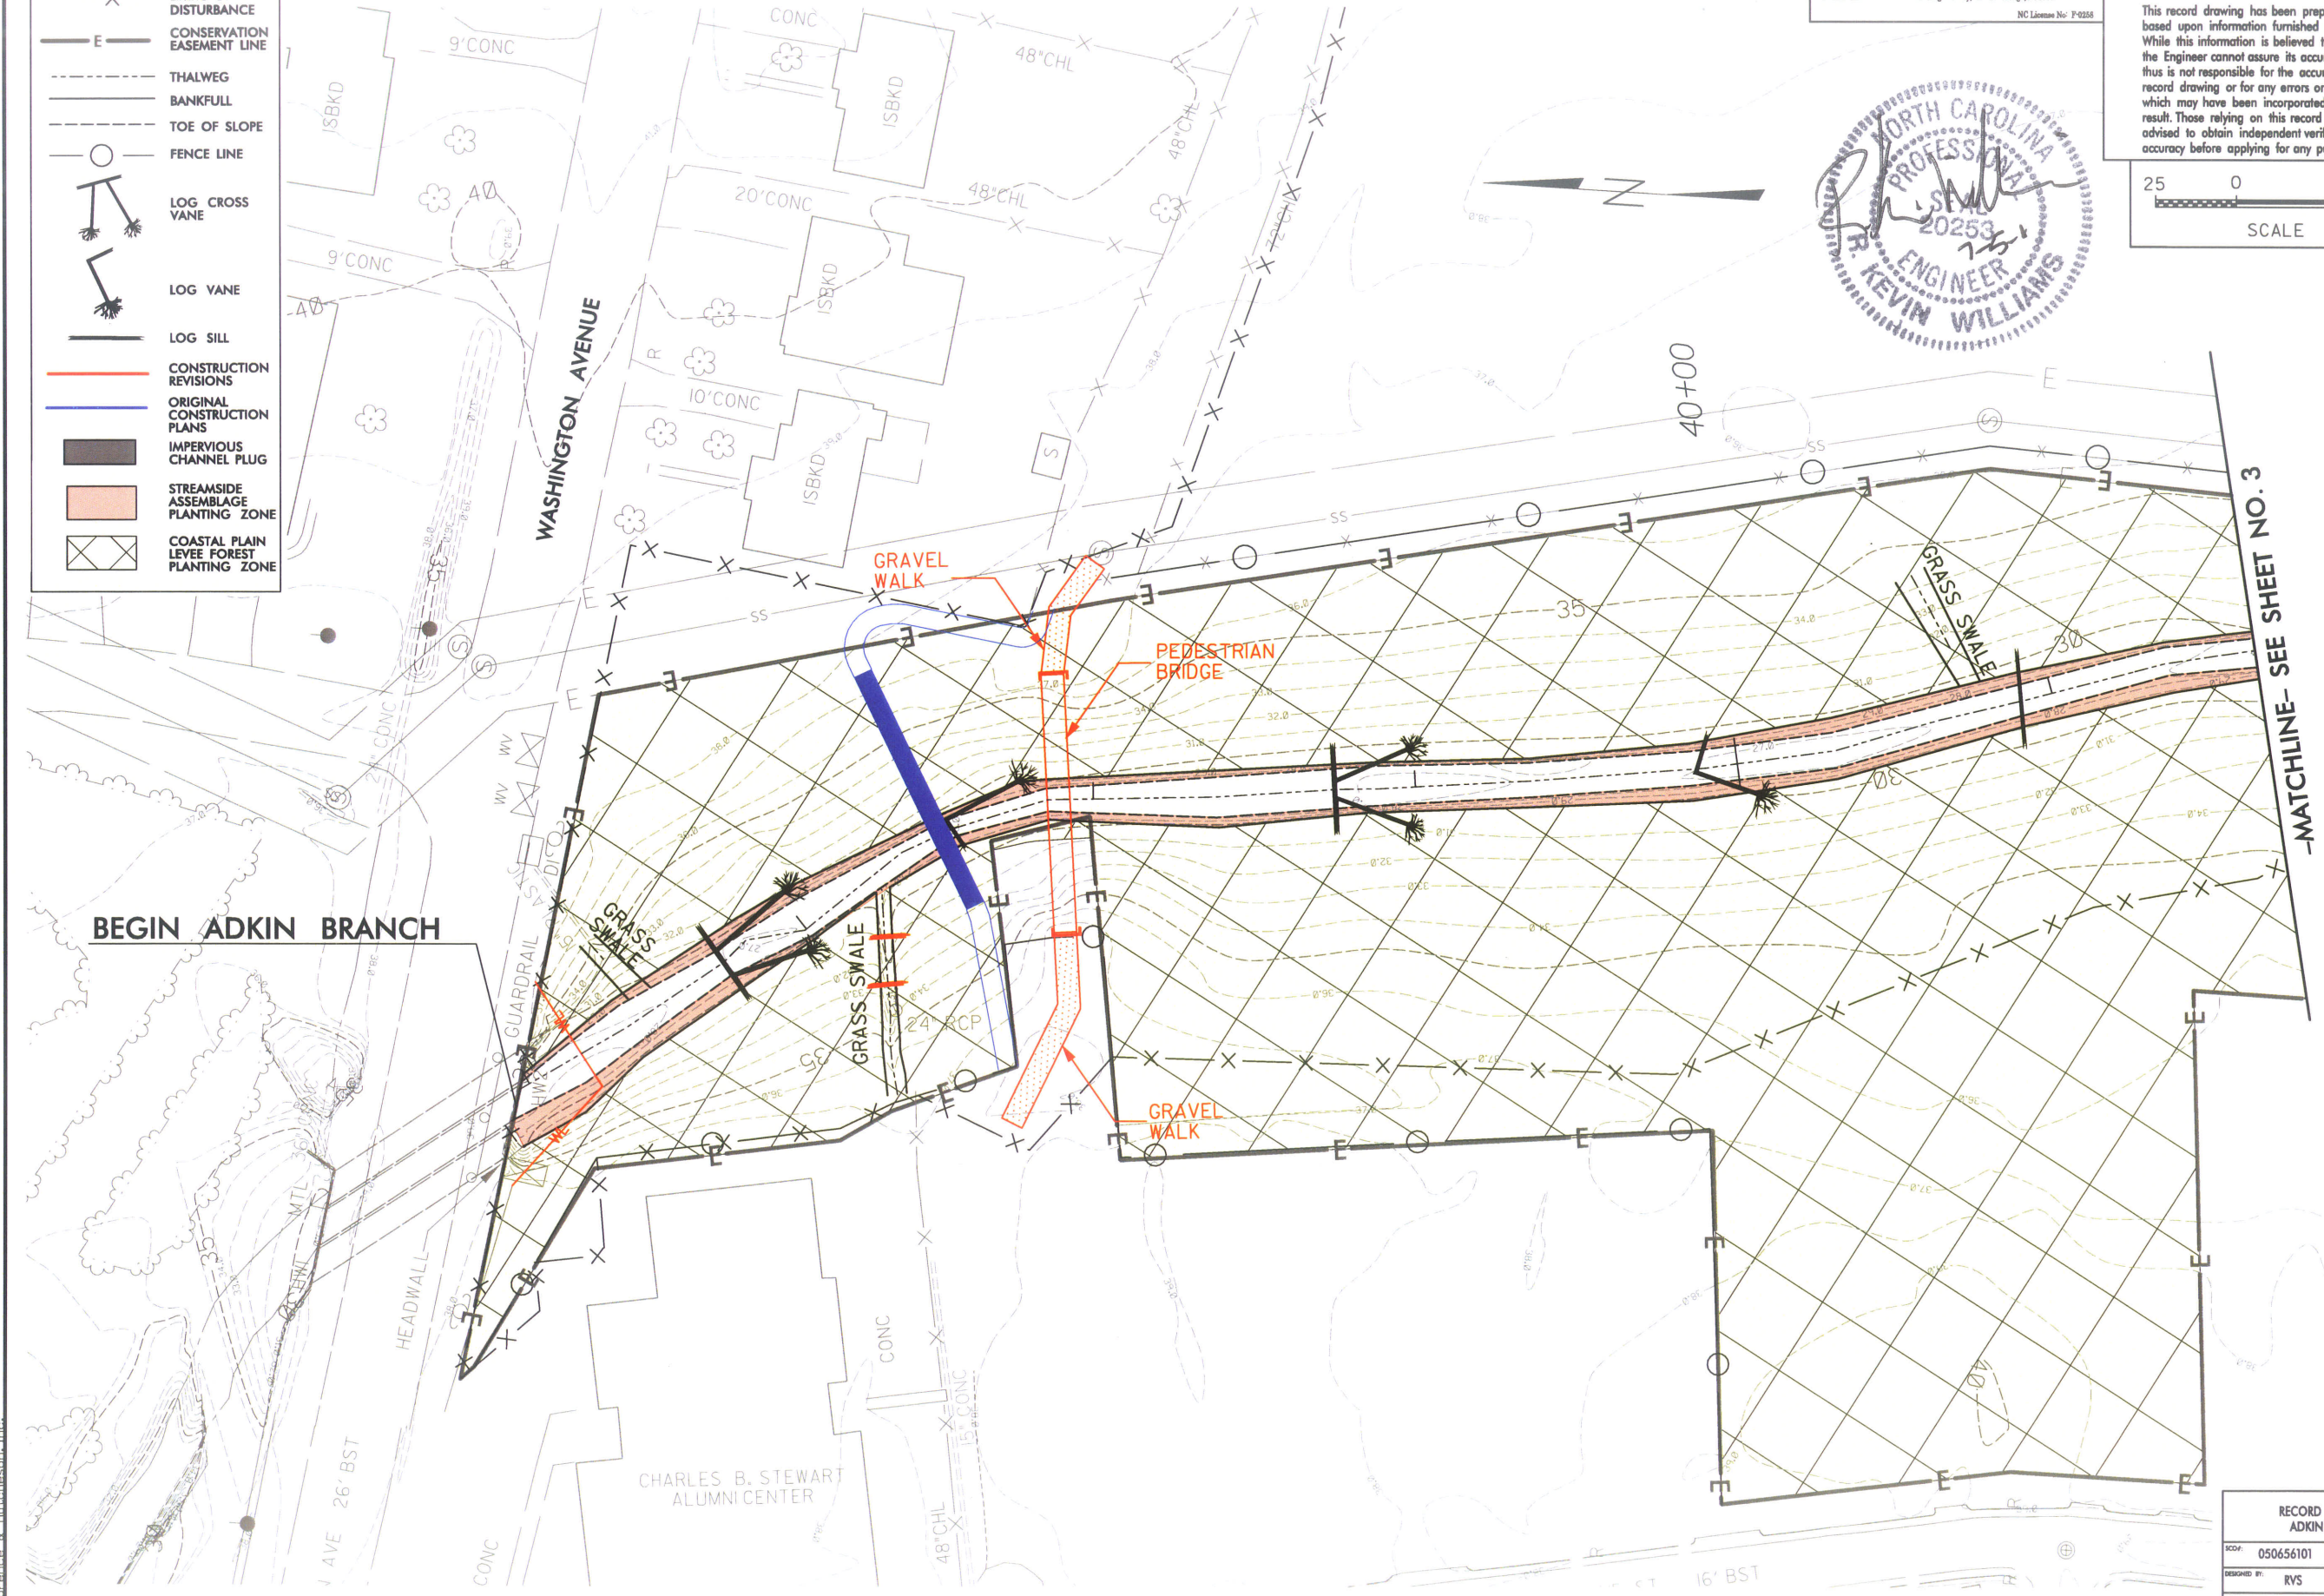
| ADKIN BRANCH | 2 |

BEGIN ADKIN BRANCH

-MATCHLINE- SEE SHEET NO. 3

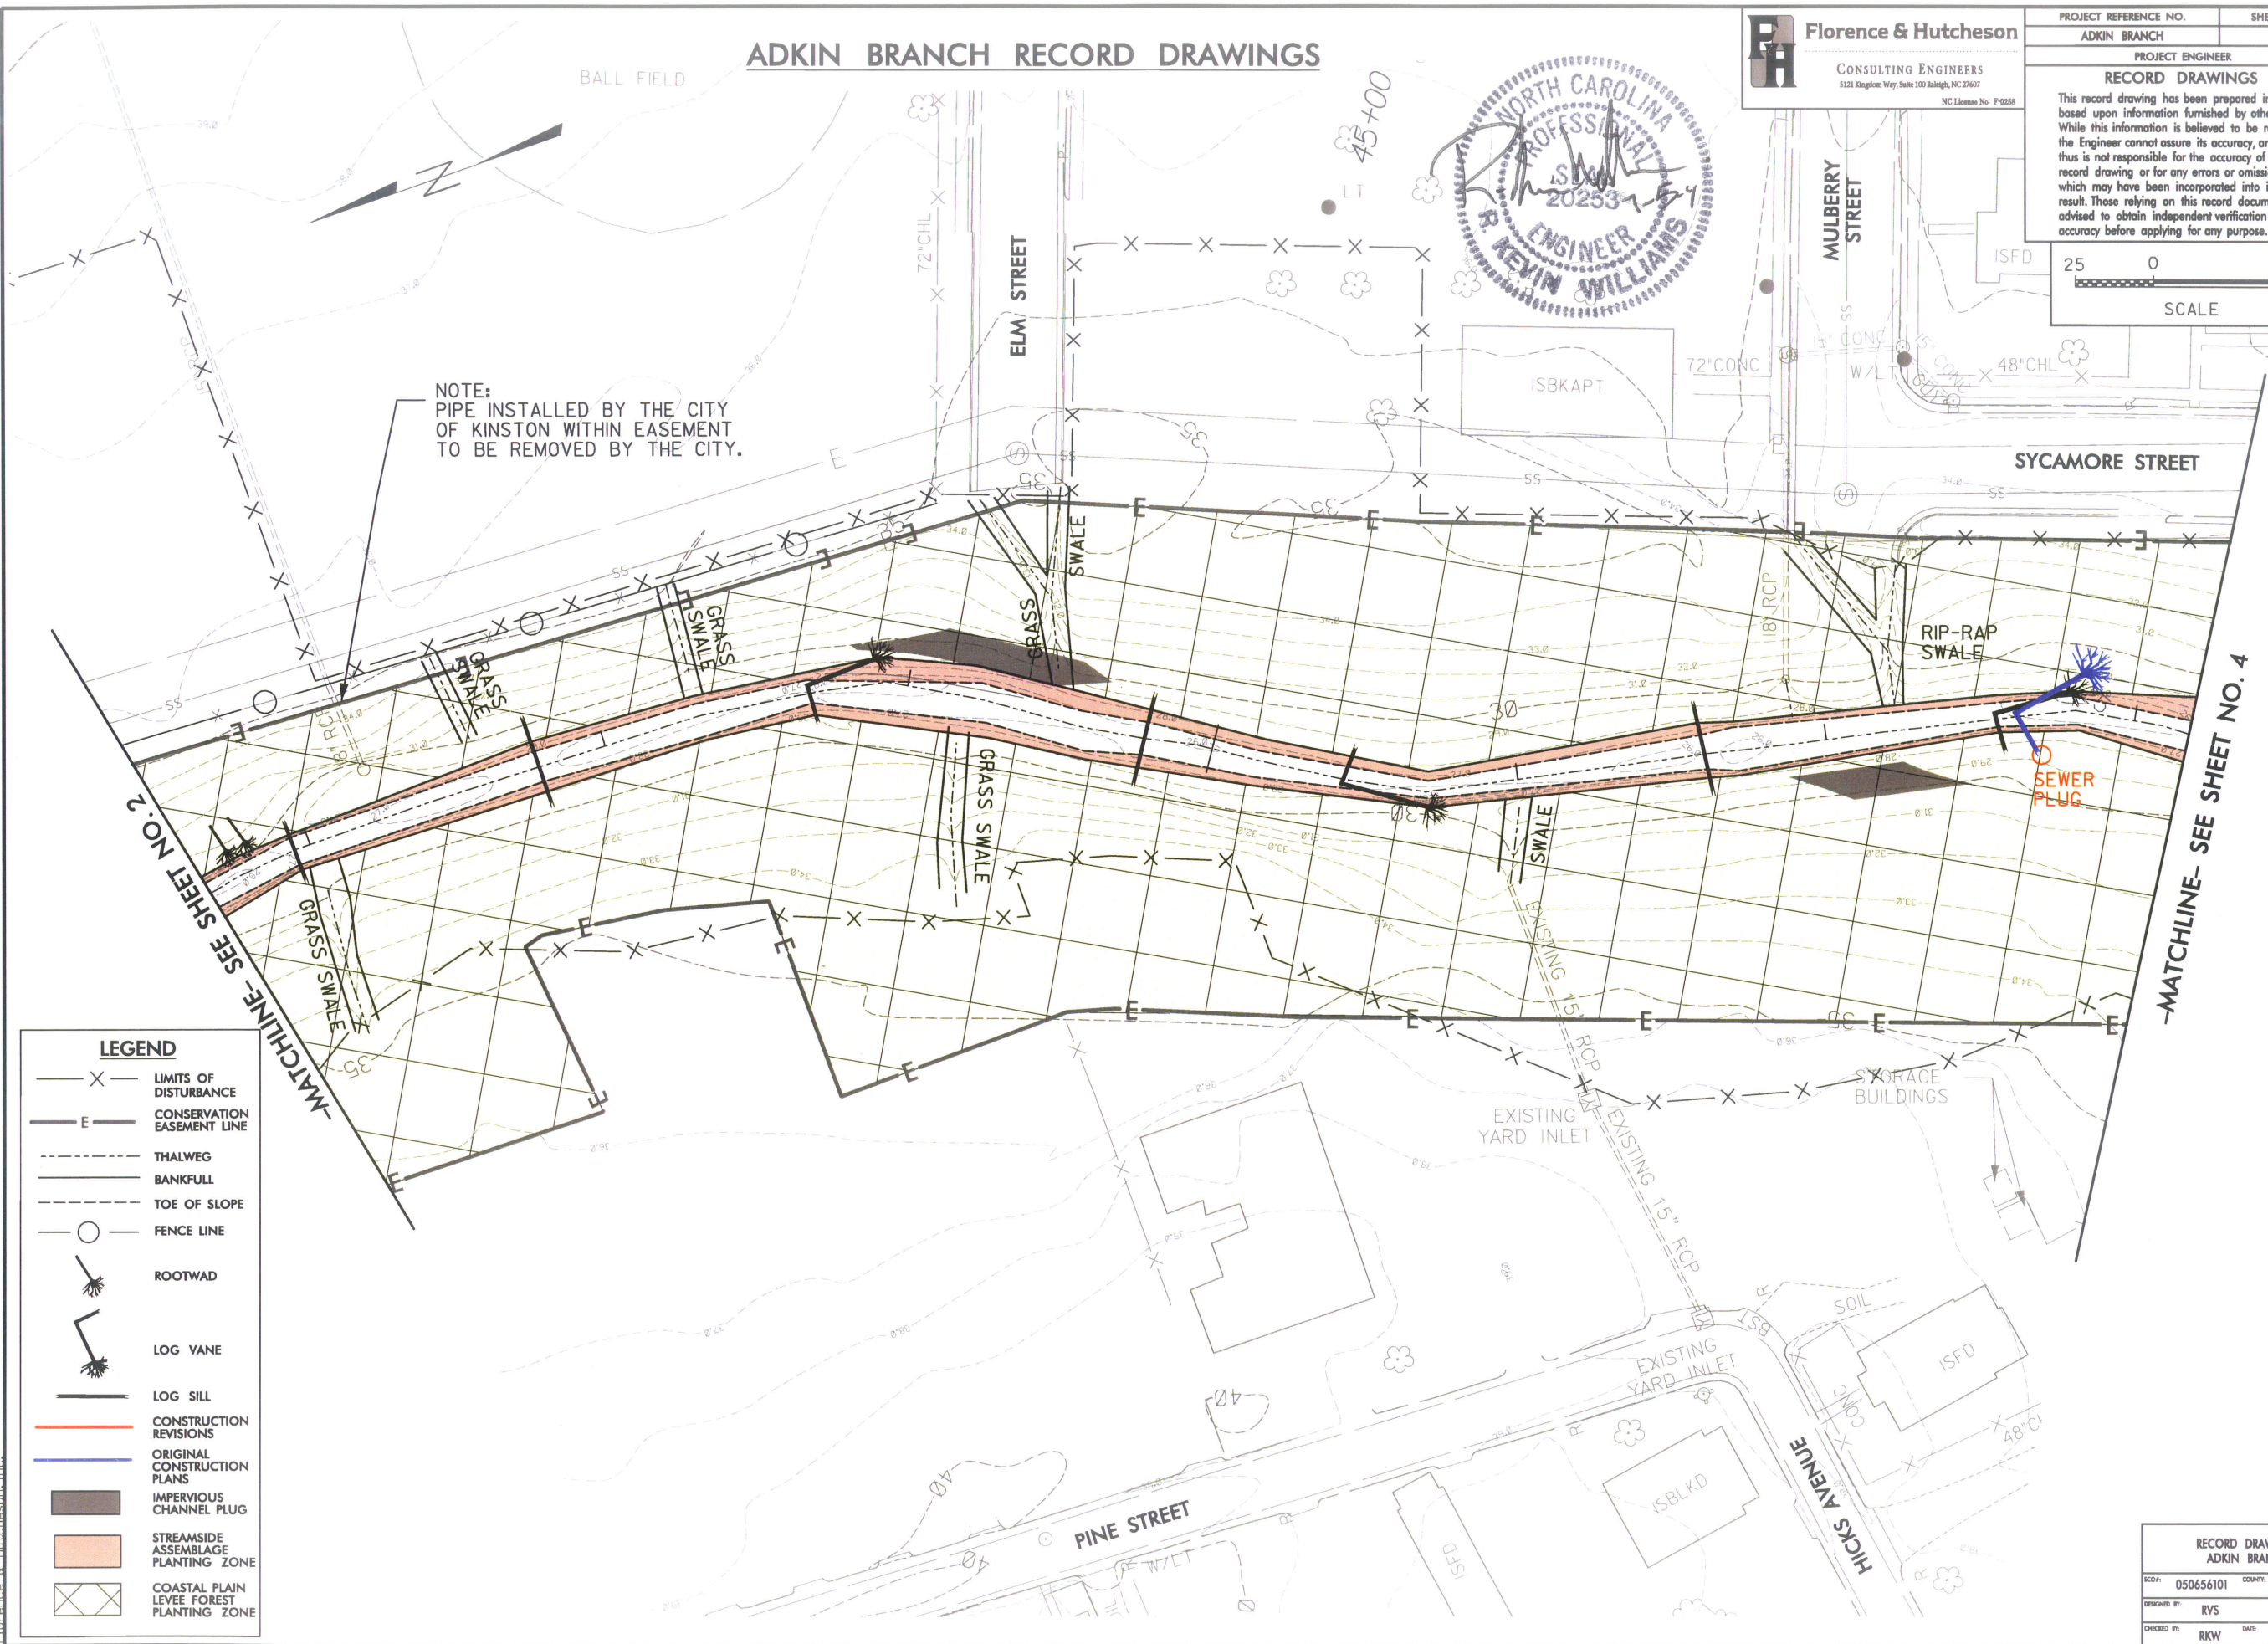
NOTE:
 PIPE INSTALLED BY THE CITY
 OF KINSTON WITHIN EASEMENT
 TO BE REMOVED BY THE CITY.

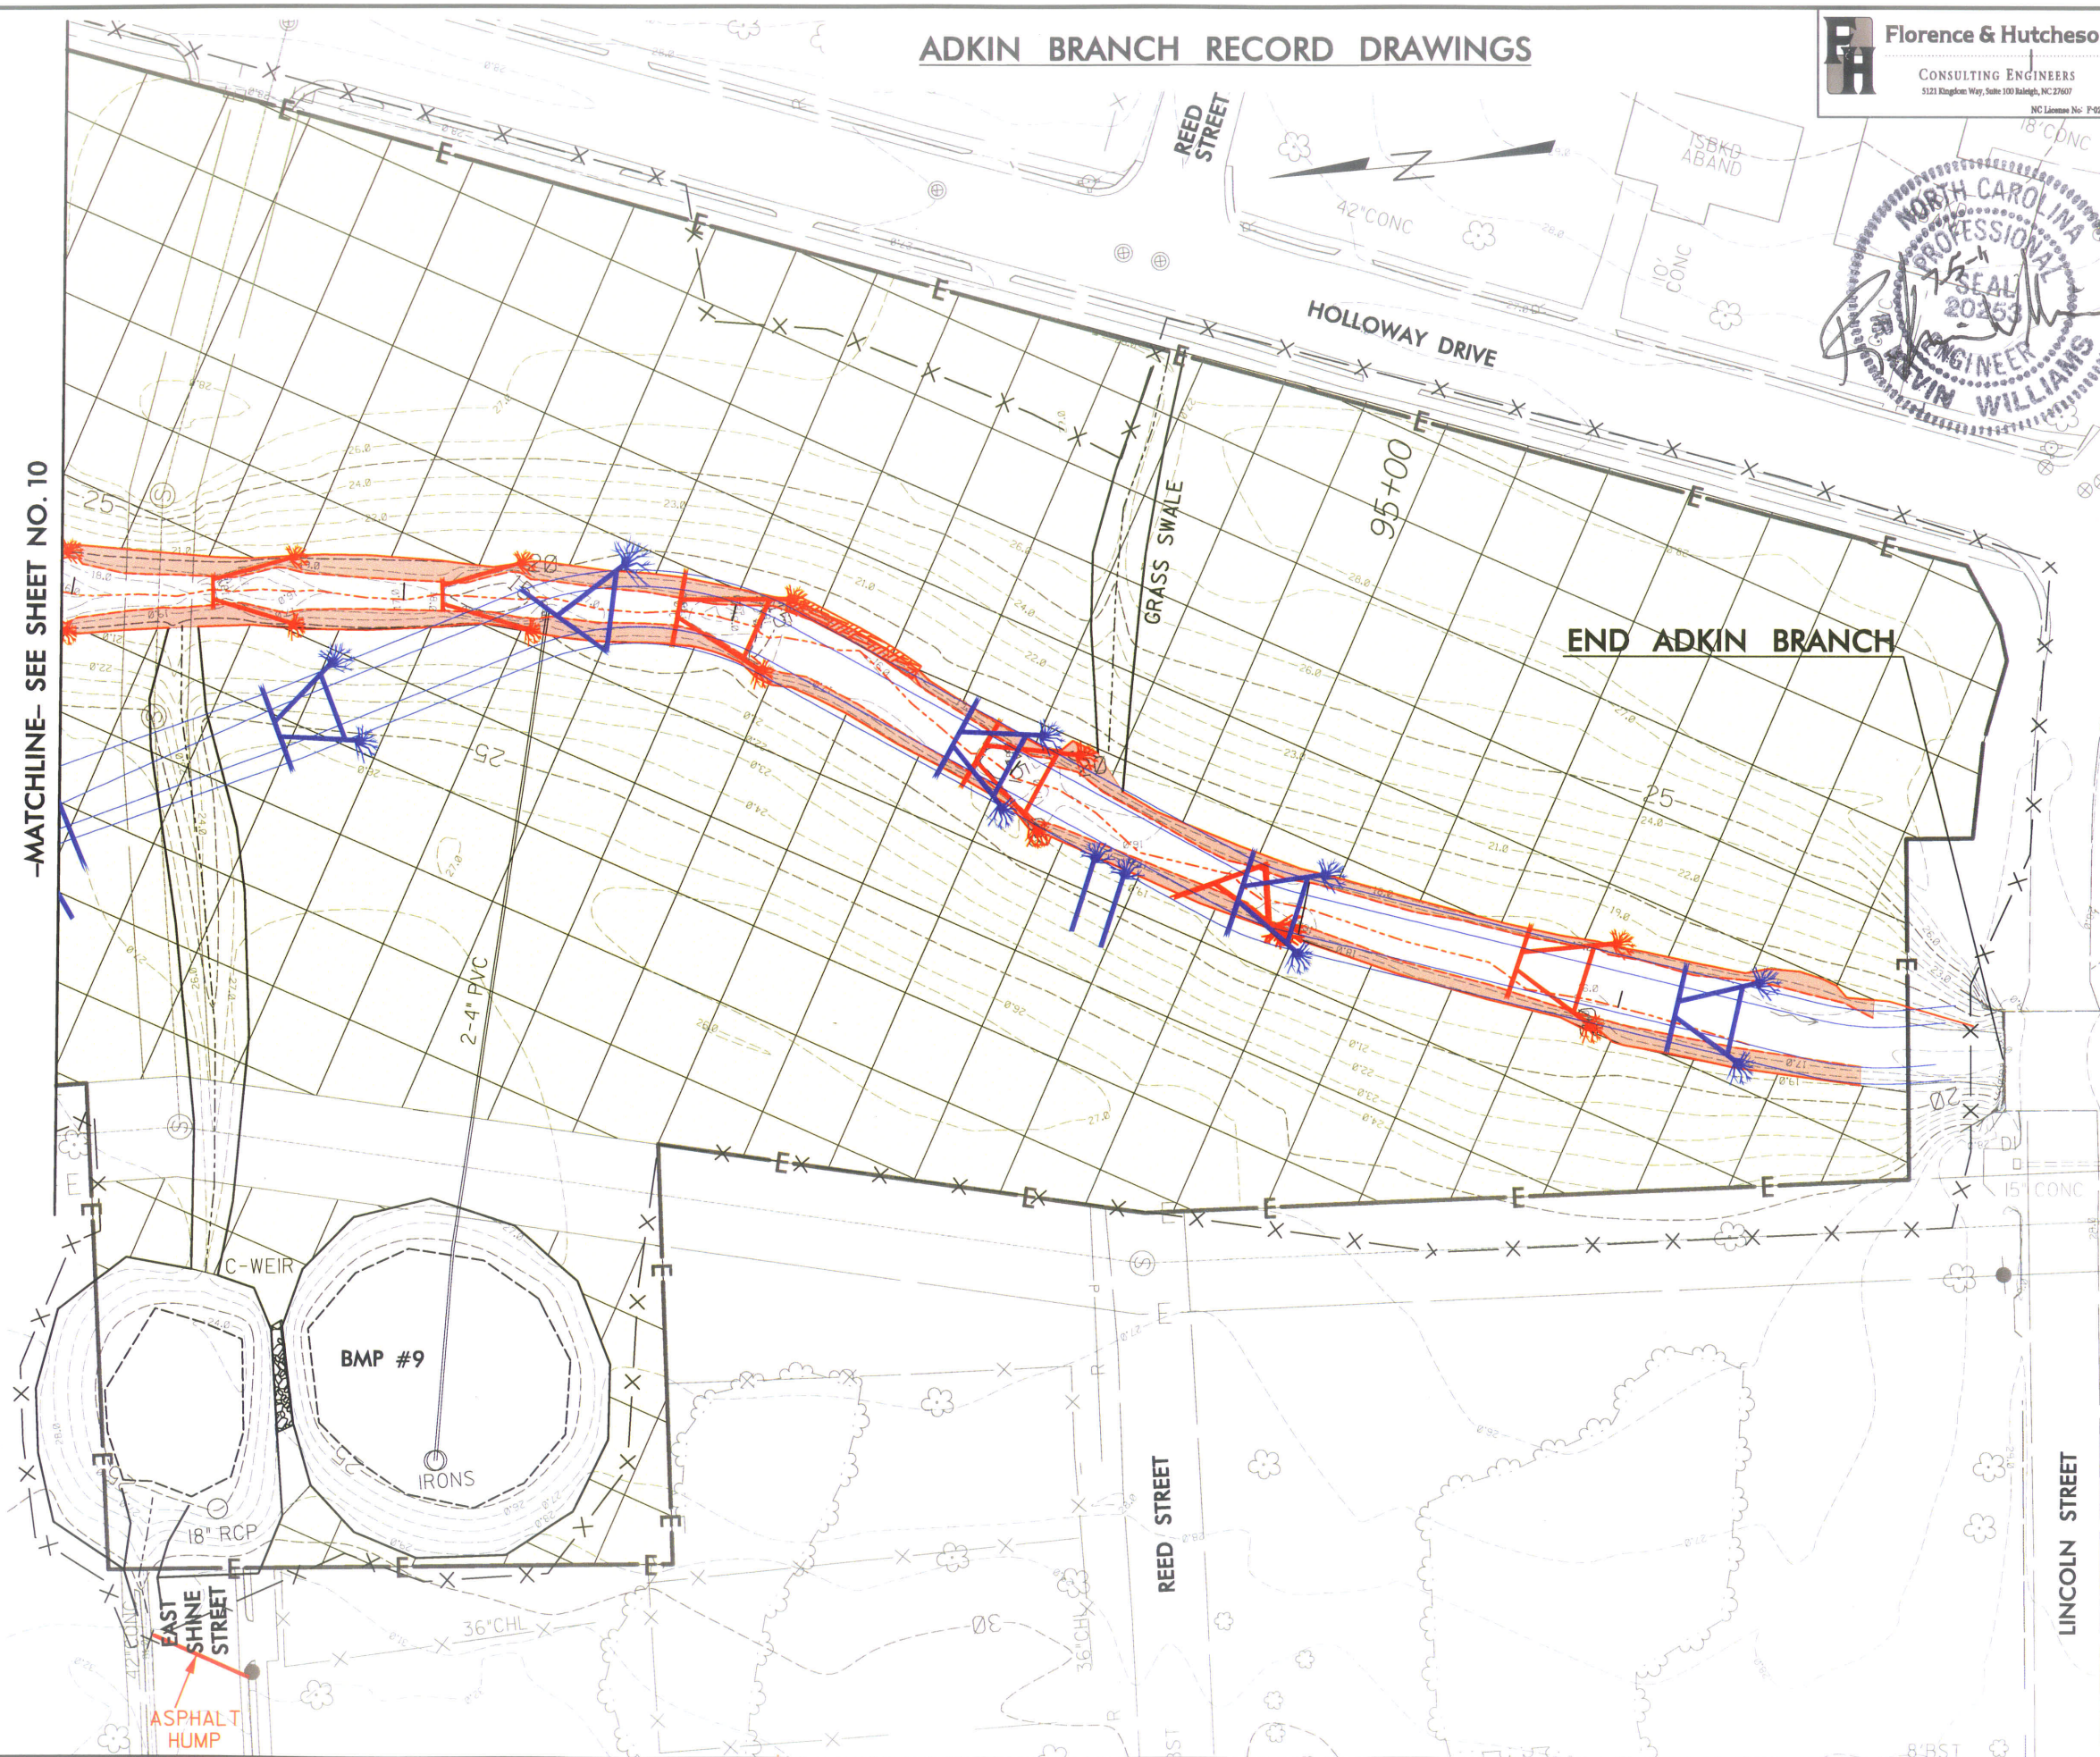
PROJECT REFERENCE NO. ADKIN BRANCH SHEET NO. 11

-MATCHLINE- SEE SHEET NO. 10

END ADKIN BRANCH

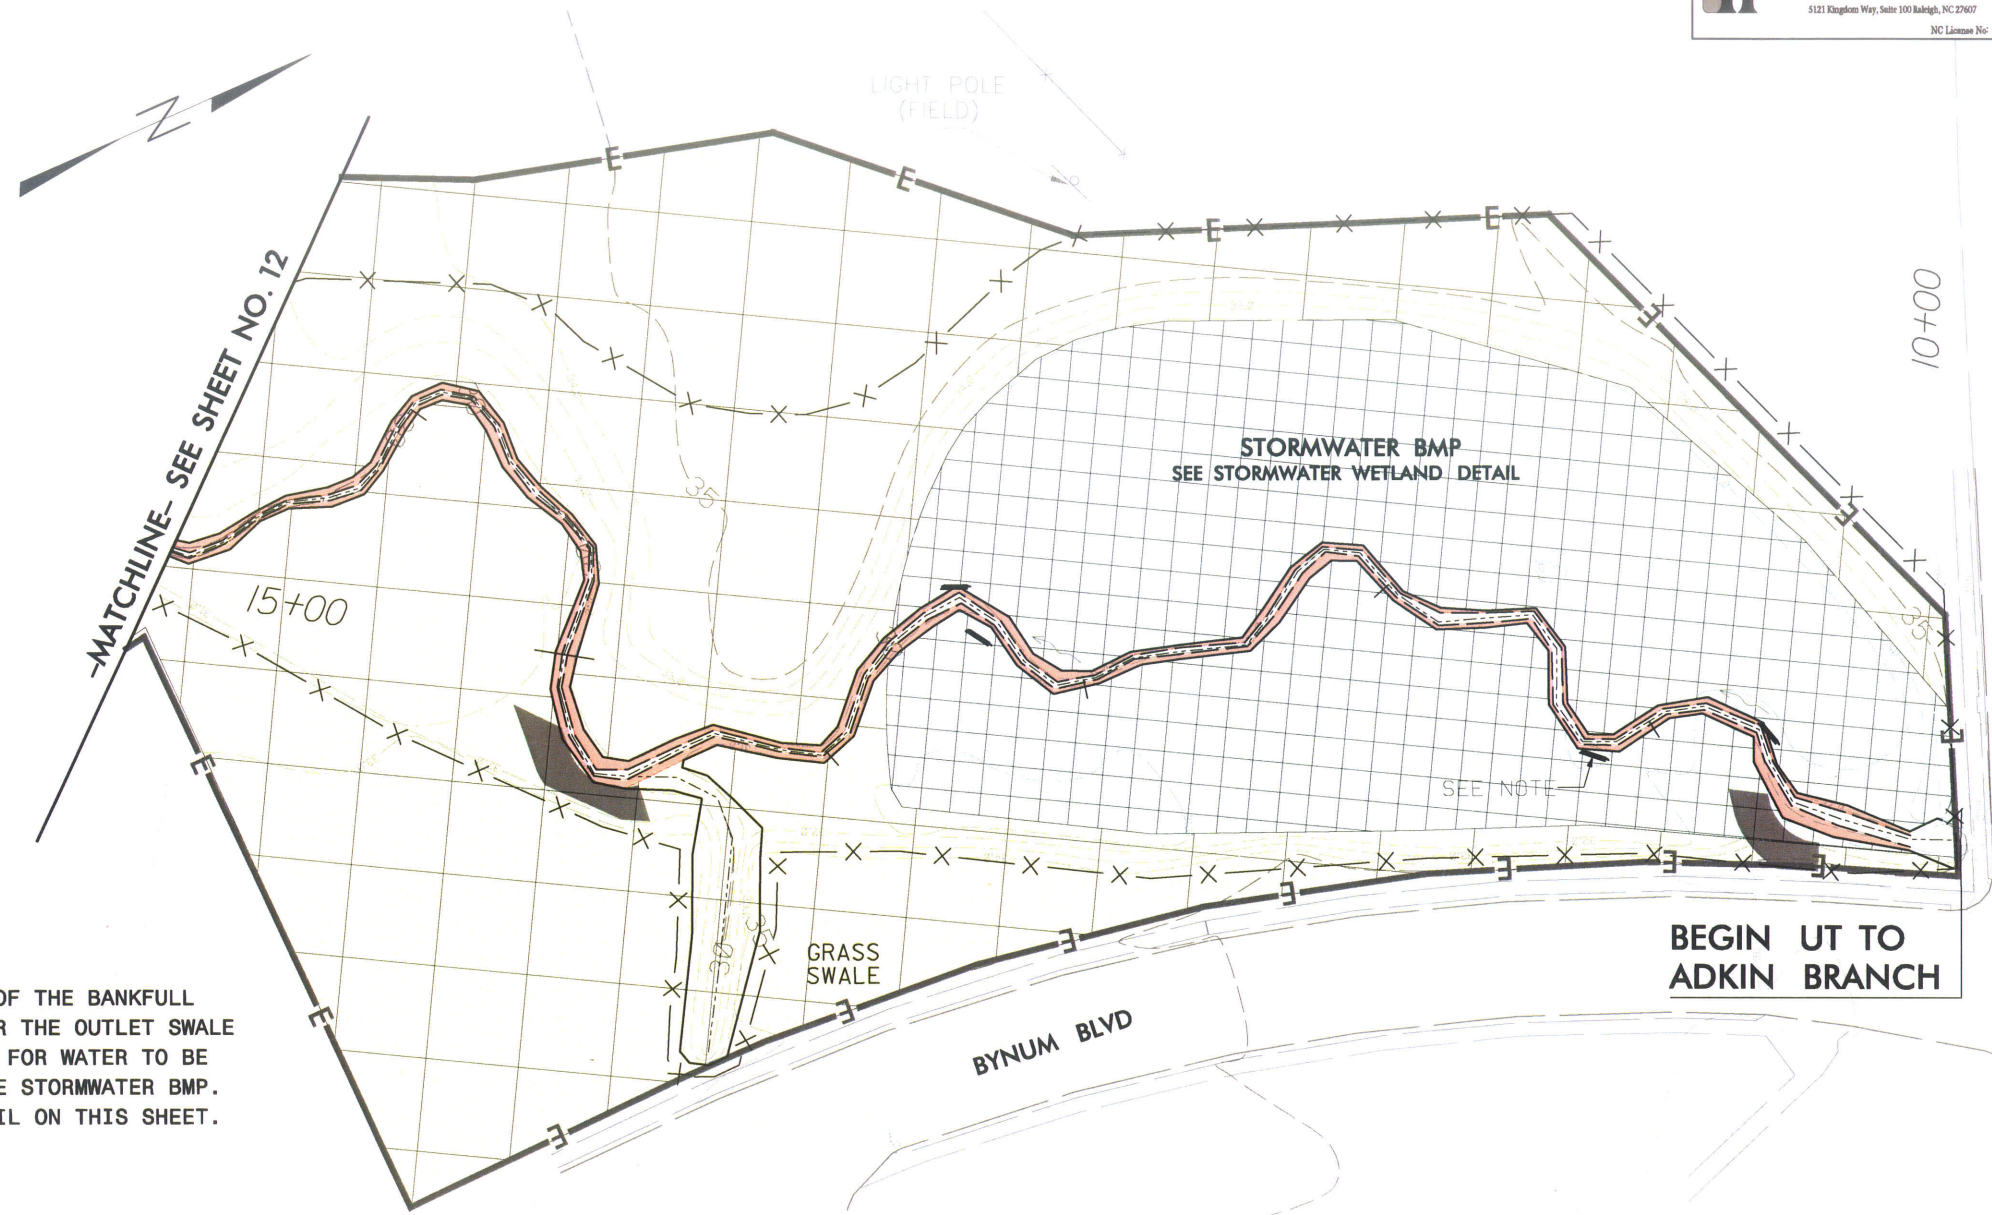
NOTE:
 LOG SILLS PLACED OUTSIDE OF THE BANKFULL CHANNEL MAINTAIN GRADE FOR THE OUTLET SWALE AT HALF BANKFULL TO ALLOW FOR WATER TO BE DISTRIBUTED THROUGHOUT THE STORMWATER BMP. SEE THE CONSTRUCTION DETAIL ON THIS SHEET.

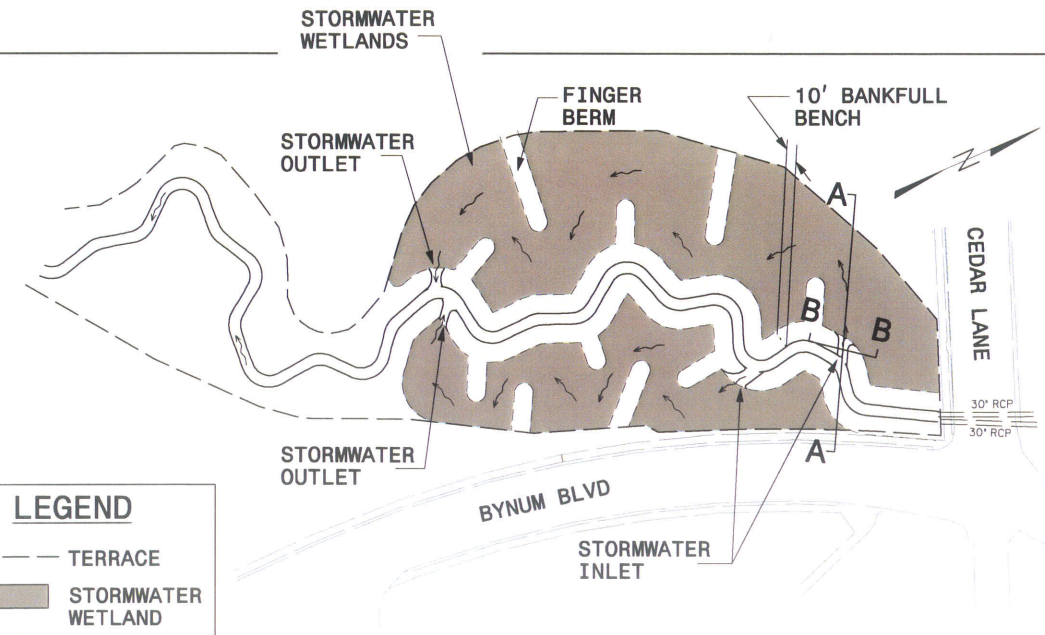
- - - TERRACE
- STORMWATER WETLAND

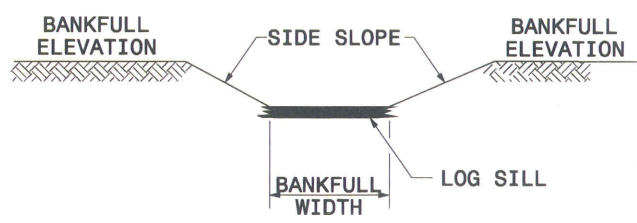
STORMWATER INLET/OUTLET CROSS-SECTION SECTION B-B

- NOTES:**
1. INVERT SET AT 1/2 BANKFULL DEPTH.
 2. LOG SILL SET AT INVERT TO PROTECT FROM SCOUR.
 3. BASE WIDTH SHALL BE 1/2 BANKFULL CHANNEL BASE WIDTH. SIDE SLOPES SHALL BE BUILT AT A 3:1 SLOPE.

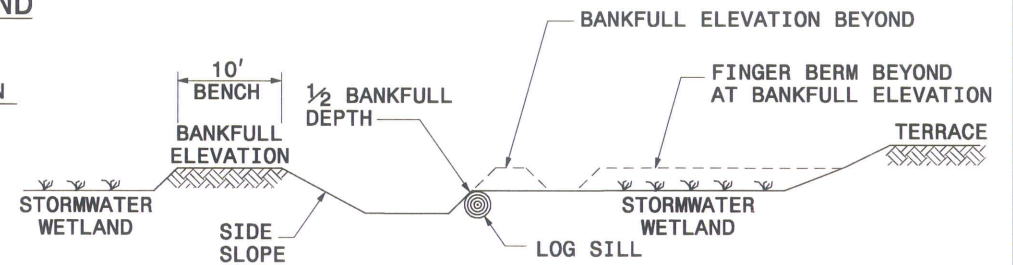
STORMWATER INLET/OUTLET PROFILE SECTION A-A

- NOTES:**
1. STORMWATER WETLAND'S ELEVATION SHALL BE SET AT 1/2 THE BANKFULL DEPTH UP FROM CHANNEL INVERT.
