BASELINE MONITORING DOCUMENT AND AS-BUILT BASELINE REPORT

AGONY ACRES MITIGATION SITE

Guilford County, NC

NCEEP Project Number 95716

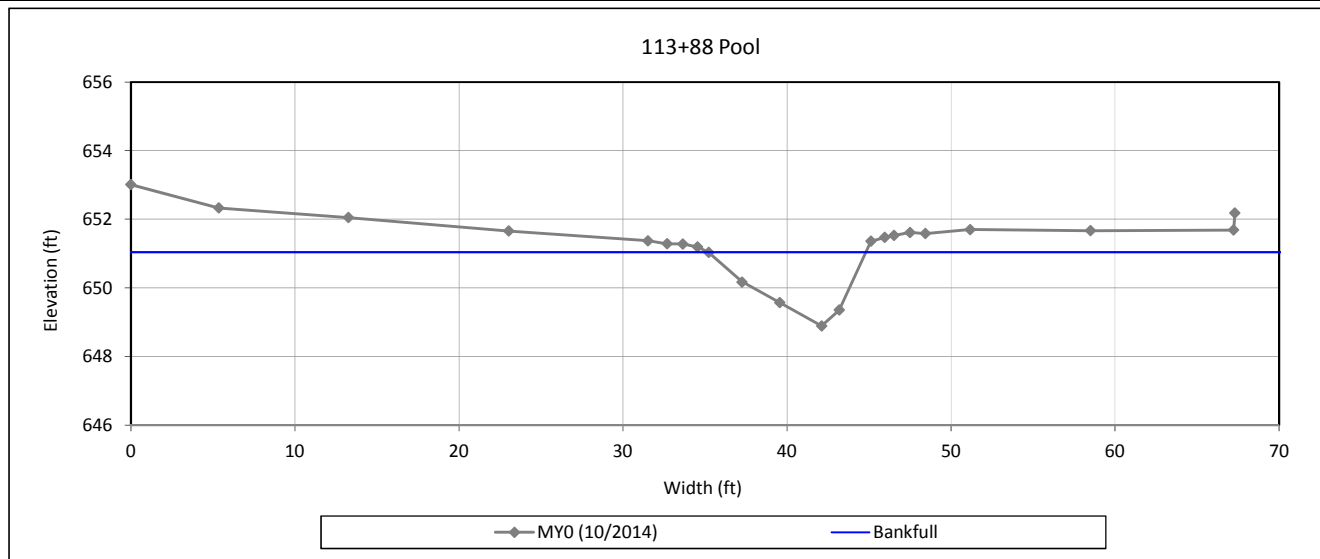
Cross Section 2-UT1 Reach 2

Bankfull Dimensions

11.6	x-section area (ft.sq.)
9.6	width (ft)
1.2	mean depth (ft)
2.1	max depth (ft)
10.7	wetted parimeter (ft)
1.1	hyd radi (ft)
7.9	width-depth ratio

Survey Date: 10/2014
Field Crew: Kee Mapping & Surveying

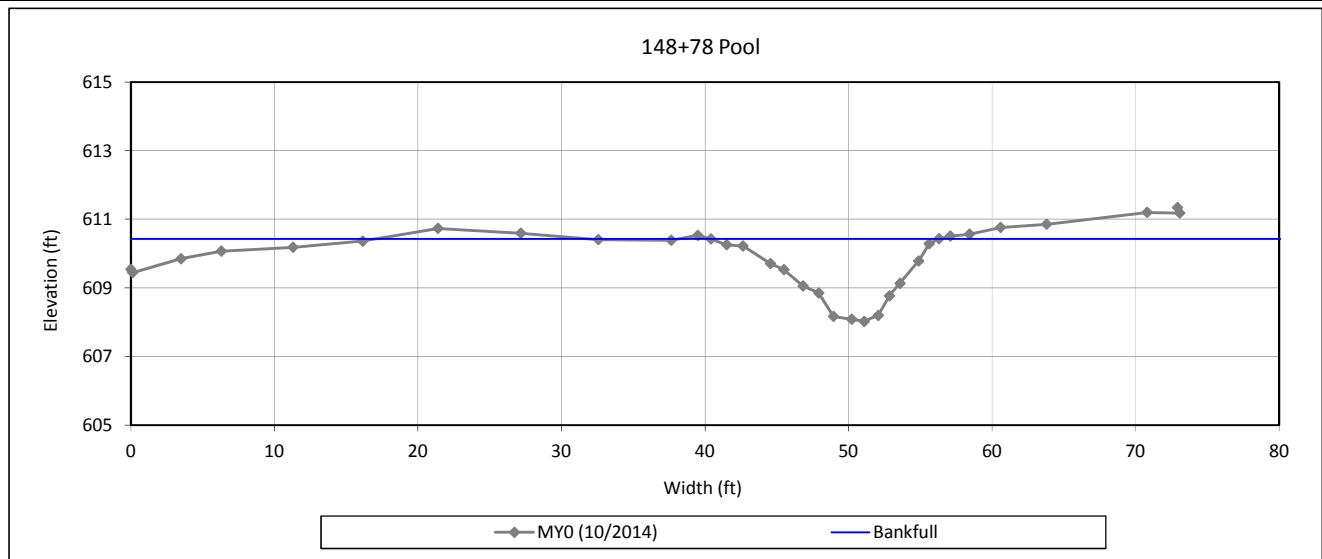
Cross Section 5-UT1 Reach 5

Bankfull Dimensions

18.5	x-section area (ft.sq.)
15.9	width (ft)
1.2	mean depth (ft)
2.4	max depth (ft)
16.9	wetted perimeter (ft)
1.1	hyd radi (ft)
13.6	width-depth ratio

Survey Date: 10/2014
Field Crew: Kee Mapping & Surveying

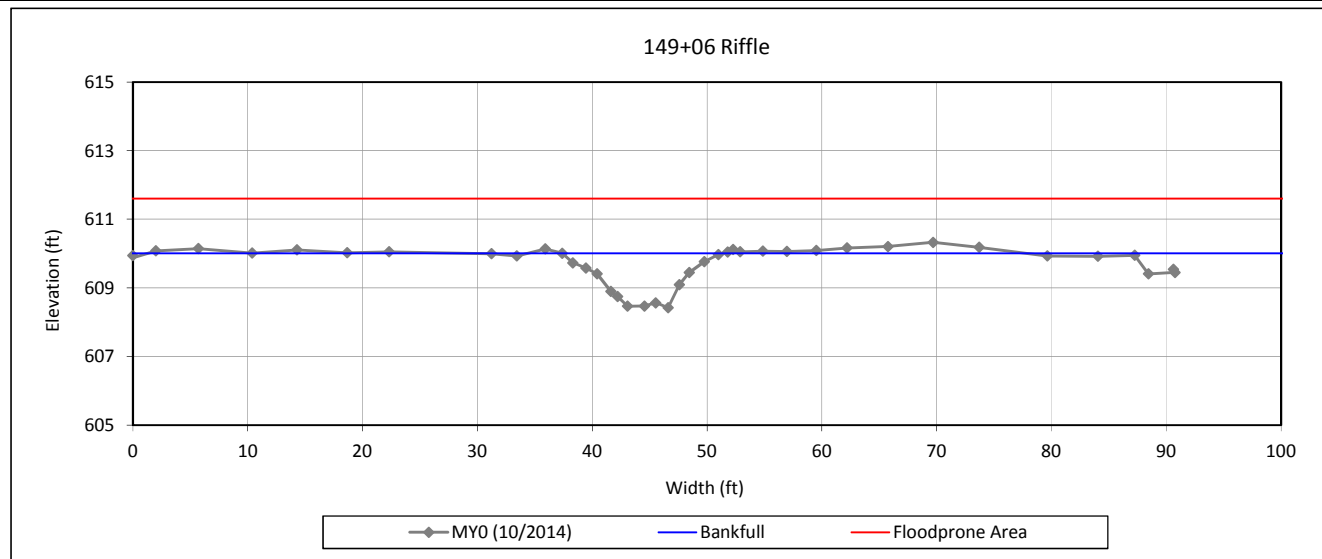
Cross Section 6-UT1 Reach 5

Bankfull Dimensions

11.9	x-section area (ft.sq.)
13.6	width (ft)
0.9	mean depth (ft)
1.6	max depth (ft)
14.2	wetted perimeter (ft)
0.8	hyd radi (ft)
15.5	width-depth ratio
200.0	W flood prone area (ft)
14.7	entrenchment ratio
1.0	low bank height ratio

Survey Date: 10/2014

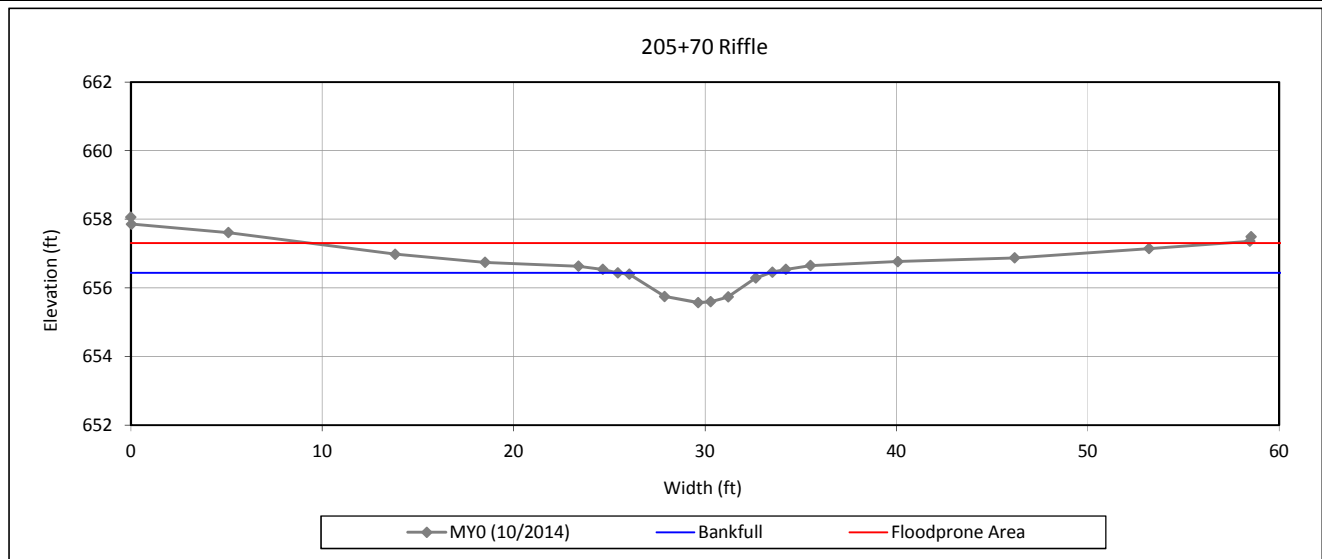
Cross Section 9-UT1A Reach 1

Bankfull Dimensions

4.0	x-section area (ft.sq.)
8.0	width (ft)
0.5	mean depth (ft)
0.9	max depth (ft)
8.2	wetted perimeter (ft)
0.5	hyd radi (ft)
15.9	width-depth ratio
50.0	W flood prone area (ft)
6.3	entrenchment ratio
1.0	low bank height ratio

Survey Date: 10/2014

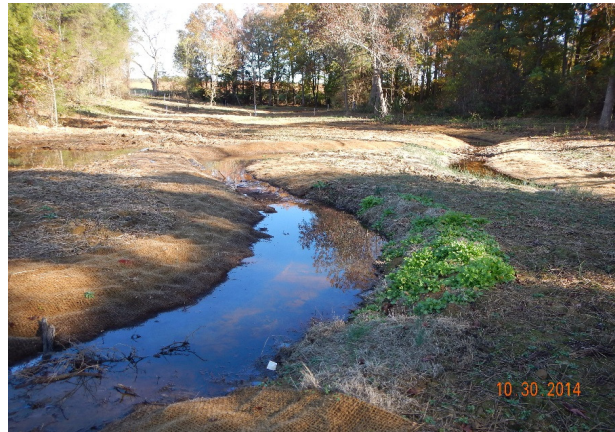
View Downstream

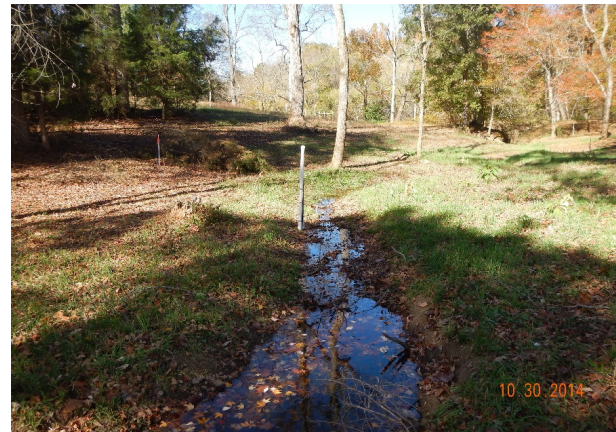
View Downstream

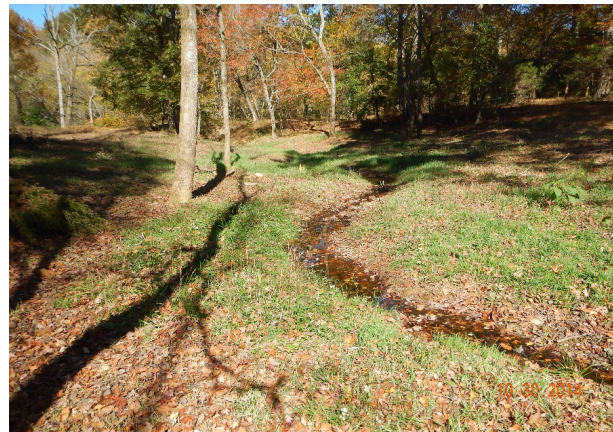
View Downstream

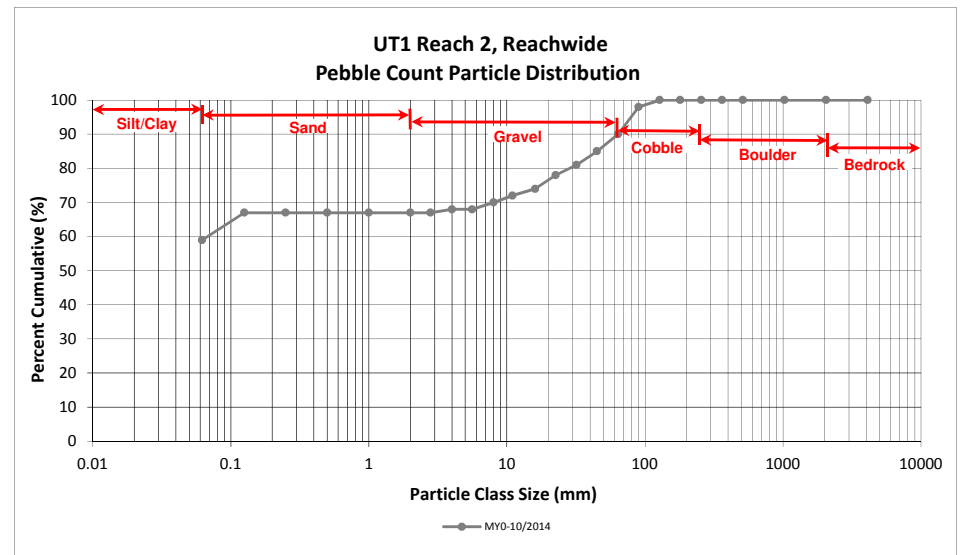
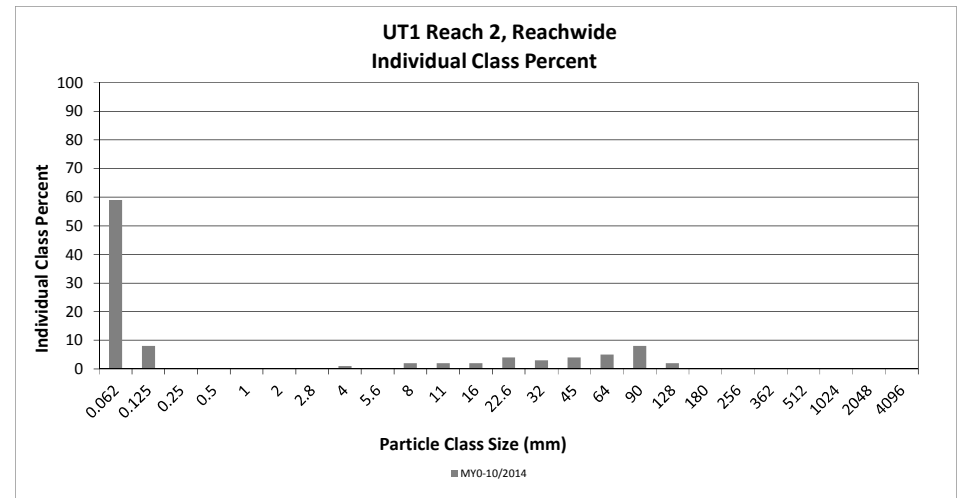
Particle Class		Diameter (mm)		Particle Count			Reach Summary	
		min	max	Riffle	Pool	Total	Class Percentage	Percent Cumulative
SILT/CLAY	Silt/Clay	0.000	0.062	25	34	59	59	59
SAND	Very fine	0.062	0.125	2	6	8	8	67
	Fine	0.125	0.250					67
	Medium	0.25	0.50					67
	Coarse	0.5	1.0					67
	Very Coarse	1.0	2.0					67
GRAVEL	Very Fine	2.0	2.8					67
	Very Fine	2.8	4.0	1		1	1	68
	Fine	4.0	5.6					68
	Fine	5.6	8.0	2		2	2	70
	Medium	8.0	11.0	2		2	2	72
	Medium	11.0	16.0	2		2	2	74
	Coarse	16.0	22.6	4		4	4	78
	Coarse	22.6	32	3		3	3	81
	Very Coarse	32	45	4		4	4	85
Very Coarse	45	64	5		5	5	90	
COBBLE	Small	64	90	8		8	8	98
	Small	90	128	2		2	2	100
	Large	128	180					100
	Large	180	256					100
BOULDER	Small	256	362					100
	Small	362	512					100
	Medium	512	1024					100
	Large/Very Large	1024	2048					100
BEDROCK	Bedrock	2048	>2048					100
Total				60	40	100	100	100

Reachwide	
Channel materials (mm)	
D ₁₆ =	Silt/Clay
D ₃₅ =	Silt/Clay
D ₅₀ =	Silt/Clay
D ₈₄ =	41.3
D ₉₅ =	79.2
D ₁₀₀ =	128.0

As-built shear stresses and velocities are similar to design calculations and should reduce the risk of further erosion along all restoration reaches. The as-built condition for each of these reaches indicates an overall increase in substrate particle size (Table 5a – 5d). The substrate data for each constructed reach was compared to the design shear stress parameters from the mitigation plan to assess the potential for bed degradation. The shear stresses calculated for the constructed channels are within the allowable range, which indicates the channel is not at risk to trend toward channel degradation.

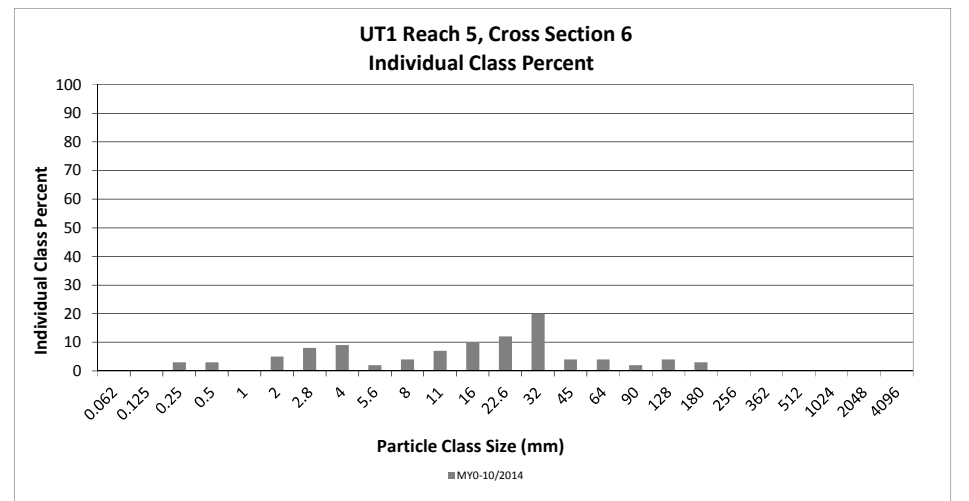
Particle Class		Diameter (mm)		Riffle 100-Count	Summary	
		min	max		Class Percentage	Percent Cumulative
<i>SILT/CLAY</i>	Silt/Clay	0.000	0.062			0
SAND	Very fine	0.062	0.125			0
	Fine	0.125	0.250	3	3	3
	Medium	0.25	0.50	3	3	6
	Coarse	0.5	1.0			6
	Very Coarse	1.0	2.0	5	5	11
GRAVEL	Very Fine	2.0	2.8	8	8	19
	Very Fine	2.8	4.0	9	9	28
	Fine	4.0	5.6	2	2	30
	Fine	5.6	8.0	4	4	34
	Medium	8.0	11.0	7	7	41
	Medium	11.0	16.0	10	10	51
	Coarse	16.0	22.6	12	12	63
	Coarse	22.6	32	20	20	83
	Very Coarse	32	45	4	4	87
	Very Coarse	45	64	4	4	91
COBBLE	Small	64	90	2	2	93
	Small	90	128	4	4	97
	Large	128	180	3	3	100
	Large	180	256			100
BOULDER	Small	256	362			100
	Small	362	512			100
	Medium	512	1024			100
	Large/Very Large	1024	2048			100
BEDROCK	Bedrock	2048	>2048			100
		Total		100	100	100

Cross Section 6	
Channel materials (mm)	
D ₁₆ =	2.47
D ₃₅ =	8.37
D ₅₀ =	15.4
D ₈₄ =	34.8
D ₉₅ =	107.3
D ₁₀₀ =	180.0

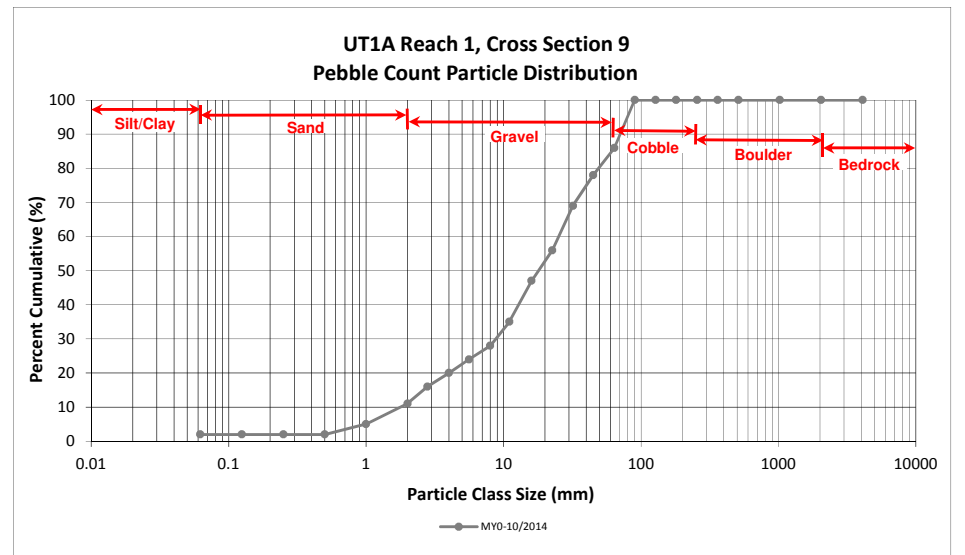
Particle Class		Diameter (mm)		Riffle 100-Count	Summary	
		min	max		Class Percentage	Percent Cumulative
SILT/CLAY	Silt/Clay	0.000	0.062	2	2	2
SAND	Very fine	0.062	0.125			2
	Fine	0.125	0.250			2
	Medium	0.25	0.50			2
	Coarse	0.5	1.0	3	3	5
	Very Coarse	1.0	2.0	6	6	11
GRAVEL	Very Fine	2.0	2.8	5	5	16
	Very Fine	2.8	4.0	4	4	20
	Fine	4.0	5.6	4	4	24
	Fine	5.6	8.0	4	4	28
	Medium	8.0	11.0	7	7	35
	Medium	11.0	16.0	12	12	47
	Coarse	16.0	22.6	9	9	56
	Coarse	22.6	32	13	13	69
	Very Coarse	32	45	9	9	78
	Very Coarse	45	64	8	8	86
COBBLE	Small	64	90	14	14	100
	Small	90	128			100
	Large	128	180			100
	Large	180	256			100
BOULDER	Small	256	362			100
	Small	362	512			100
	Medium	512	1024			100
	Large/Very Large	1024	2048			100
BEDROCK	Bedrock	2048	>2048			100
Total				100	100	100

Cross Section 9	
Channel materials (mm)	
D ₁₆ =	2.80
D ₃₅ =	11.00
D ₅₀ =	18.0
D ₈₄ =	58.6
D ₉₅ =	79.7
D ₁₀₀ =	90.0

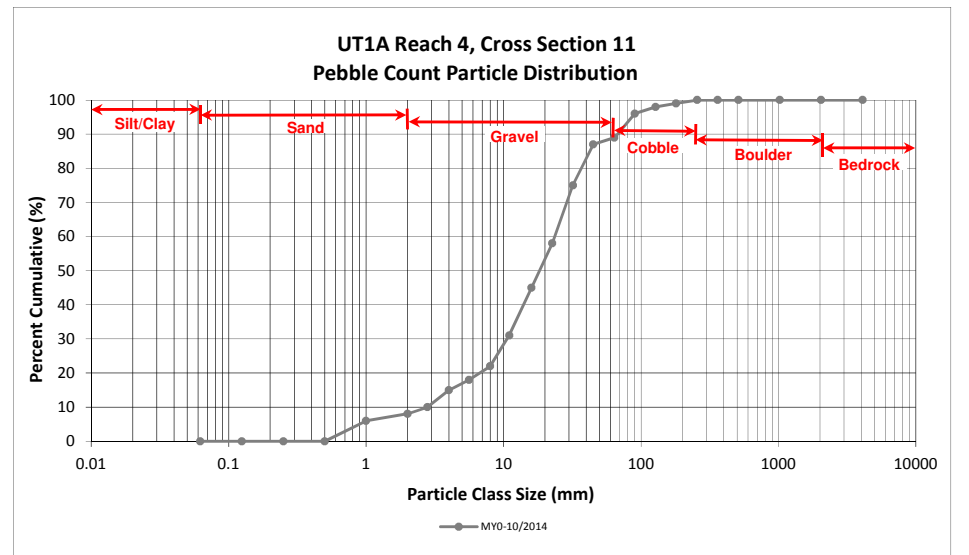
Particle Class		Diameter (mm)		Riffle 100-Count	Summary	
		min	max		Class Percentage	Percent Cumulative
SILT/CLAY	Silt/Clay	0.000	0.062			0
SAND	Very fine	0.062	0.125			0
	Fine	0.125	0.250			0
	Medium	0.25	0.50			0
	Coarse	0.5	1.0	6	6	6
	Very Coarse	1.0	2.0	2	2	8
GRAVEL	Very Fine	2.0	2.8	2	2	10
	Very Fine	2.8	4.0	5	5	15
	Fine	4.0	5.6	3	3	18
	Fine	5.6	8.0	4	4	22
	Medium	8.0	11.0	9	9	31
	Medium	11.0	16.0	14	14	45
	Coarse	16.0	22.6	13	13	58
	Coarse	22.6	32	17	17	75
	Very Coarse	32	45	12	12	87
	Very Coarse	45	64	2	2	89
COBBLE	Small	64	90	7	7	96
	Small	90	128	2	2	98
	Large	128	180	1	1	99
	Large	180	256	1	1	100
BOULDER	Small	256	362			100
	Small	362	512			100
	Medium	512	1024			100
	Large/Very Large	1024	2048			100
BEDROCK	Bedrock	2048	>2048			100
		Total		100	100	100

Cross Section 11	
Channel materials (mm)	
D ₁₆ =	4.47
D ₃₅ =	12.24
D ₅₀ =	18.3
D ₈₄ =	41.3
D ₉₅ =	85.7
D ₁₀₀ =	256.0

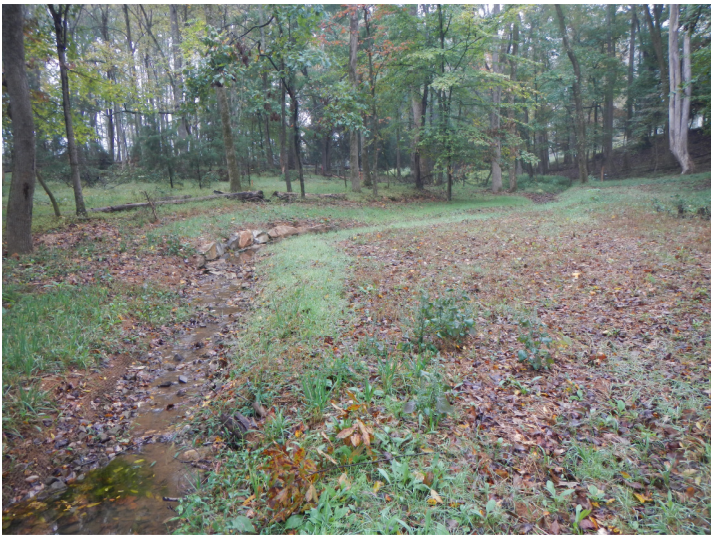
PHOTO POINT 1 – looking upstream (10/13/2014)

Photographs should illustrate the site's vegetation and morphological stability on an annual basis. Cross section photos should demonstrate no excessive erosion or degradation of the banks. Longitudinal photos should indicate the absence of persistent bars within the channel or vertical incision. Grade control structures should remain stable. Deposition of sediment on the bank side of vane arms is preferable. Maintenance of scour pools on the channel side of vane arms is expected.

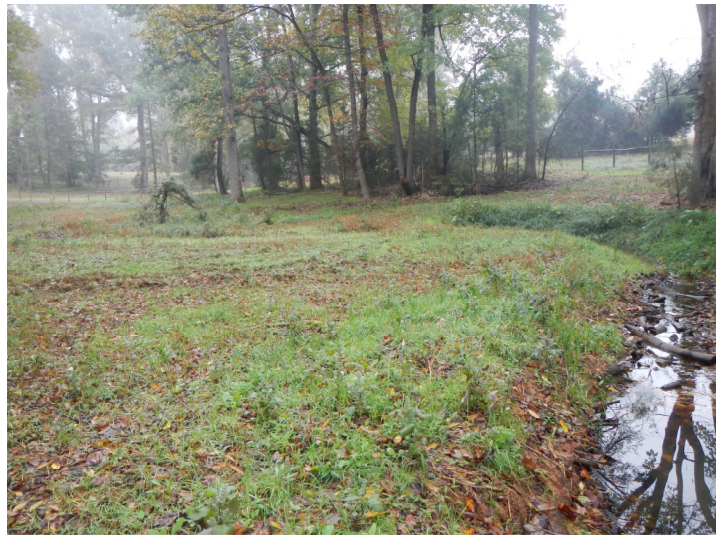
PHOTO POINT 1 – looking downstream (10/13/2014)

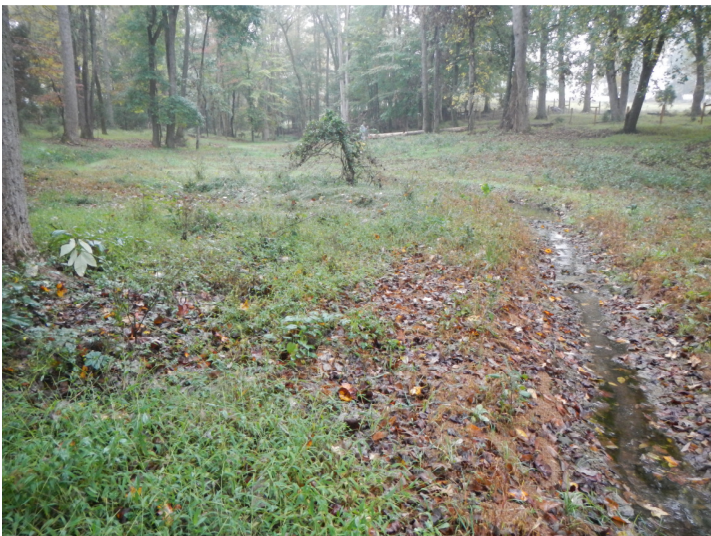
PHOTO POINT 2 – looking upstream (10/13/2014)

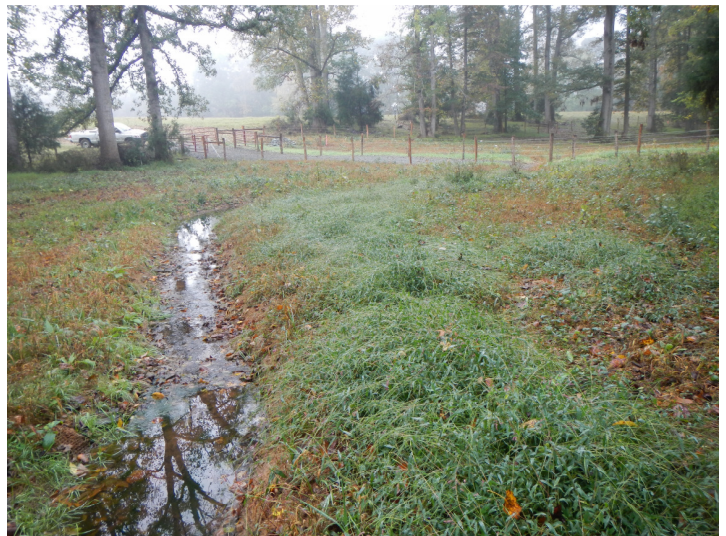
PHOTO POINT 2 – looking downstream (10/13/2014)
