**BACK CREEK SITE  
DETAILED STREAM AND WETLAND MITIGATION PLAN  
MECKLENBURG COUNTY, NORTH CAROLINA**

**North Carolina Department of Transportation  
Raleigh, North Carolina**

**EcoScience Corporation  
1101 Haynes Street, Suite 101  
Raleigh, North Carolina 27604**

**January 2003**

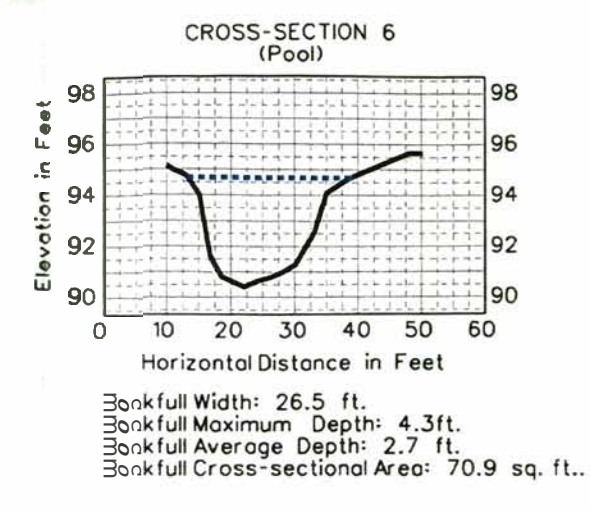
FIGURE  
**8**

NOTE:  
All Cross-sections Facing the Upstream Direction

Legend:  
 — EXISTING GRADE  
 - - - - - BANKFULL ELEVATION  
 - - - - - WIDTH OF PROPOSED FLOOD PRONE AREA

Stream geometry measurements under existing conditions are depicted in Figures 8 and 9 and summarized in Table 1. Back Creek is characterized by three distinct stream channel types: 1) upstream straightened (E-type), 2) downstream sinuous (C-type), and 3) downstream sinuous (E-type). Individual cross-section data and other morphological data (including a morphological measurement table) are included in Appendix B.

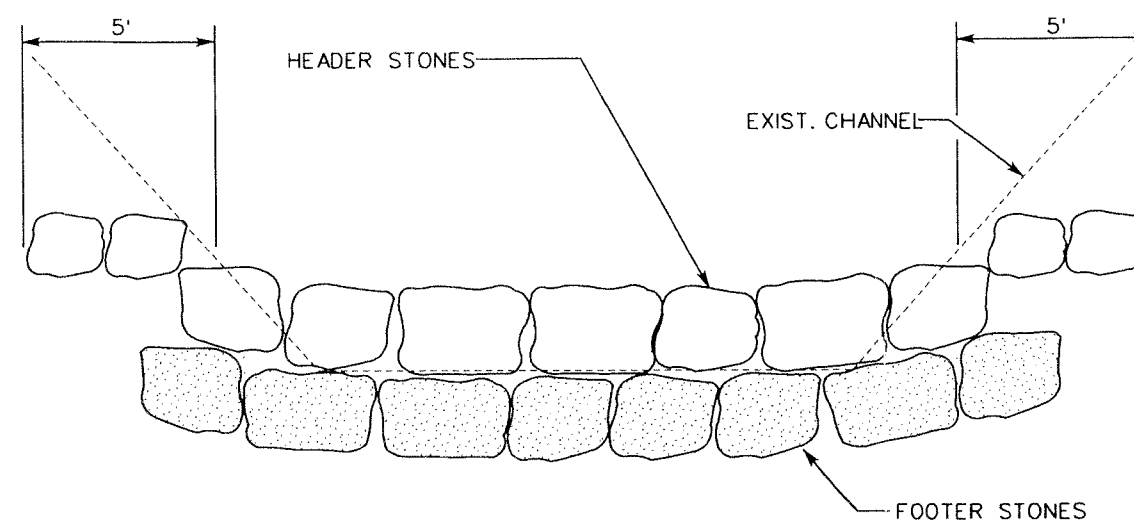
PLAN VIEW

NOTE: HEADER AND FOOTER STONES ARE LARGE BOULDERS APPROXIMATELY 36" IN DIAMETER

SECTION A-A

SECTION B-B
